Federal Lands Highway Road Inventory Program

Road Inventory and Condition Assessment

Chickamauga and Chattanooga National Military Park CHCH

Cycle 5 Report

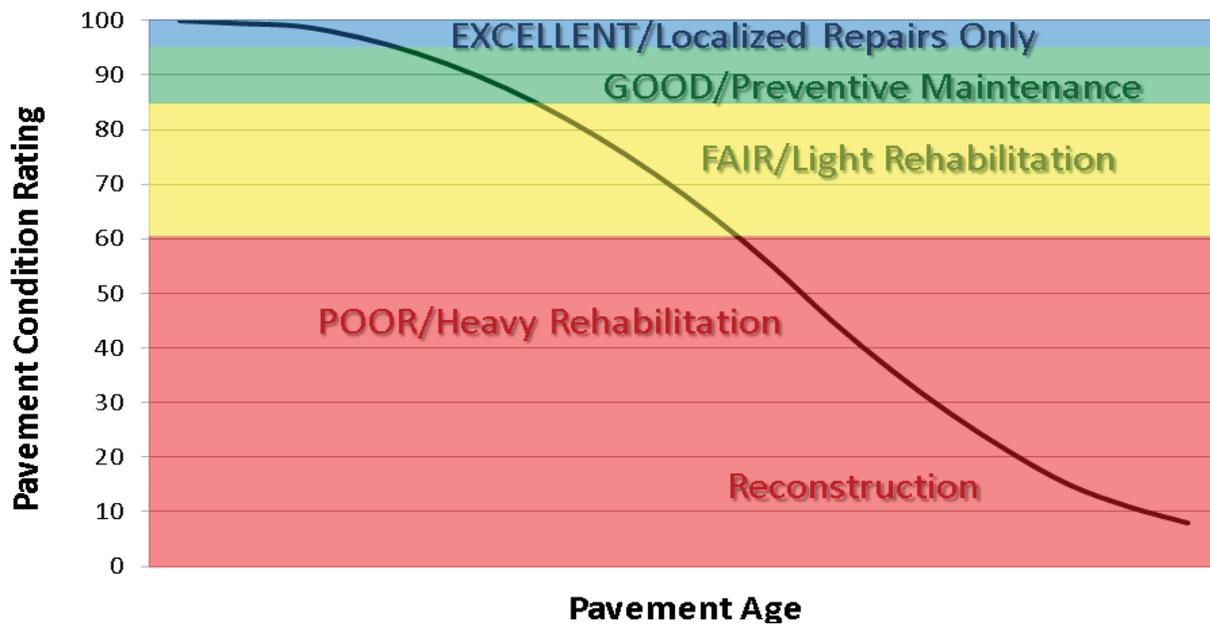
Condition Categories and Treatments

- Excellent/New: PCR of 95-100. Pavements in this range will require only spot repairs
- Good: PCR of 85-94. Pavements in this range will likely be candidates for Preventive Maintenance. Examples include Chip and Slurry Seals, Micro Surfacing and Thin Overlays.
- Fair: PCR of 61-84. Pavements in this range will likely be candidates of Light Rehabilitation (L3R). Examples include single-lift overlays up to 2.5 inches in total thickness, milling and overlays.
- Poor: PCR of 0-60. Pavements in this range will likely be candidates of Heavy Rehabilitation or Reconstruction (H3R or 4R). Examples include Pulverization, Multiple Lift Overlays, and Reconstruction.

At this time, specific Maintenance and Rehabilitation activities should be evaluated and recommended at the project level. Site-specific conditions that influence treatment type should be determined based on performing a subsurface investigation and/or pavement condition survey, and not be based solely on RIP data. Additionally, RIP produces a snapshot of conditions the year in which the data was collected. For further information or to obtain additional Pavement Management System's data from our Highway Pavement Management Application (HPMA) please contact the Eastern Federal Lands pavement team.

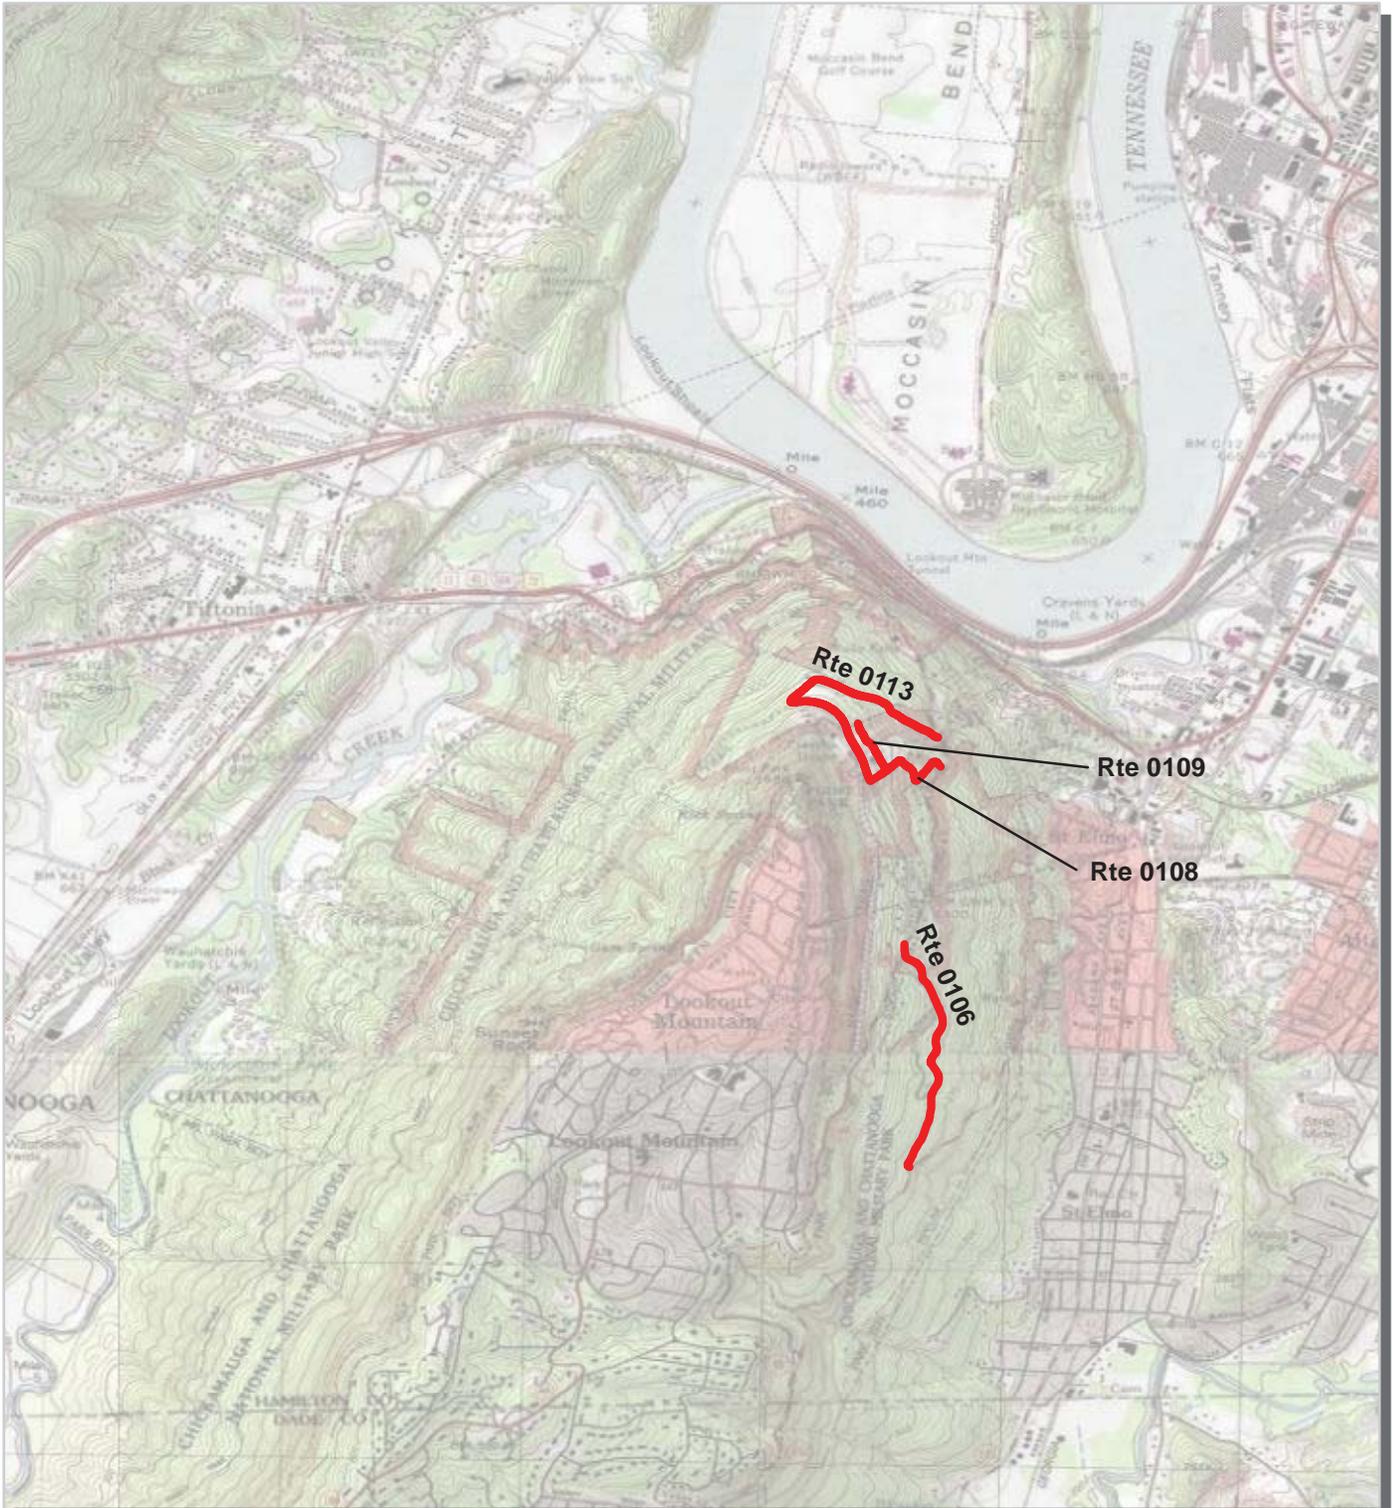
Area 3

PCR	Poor	Fair	Good	Excellent	No Data

(0 - 60)	(61 - 84)	(85 - 94)	(95 - 100)

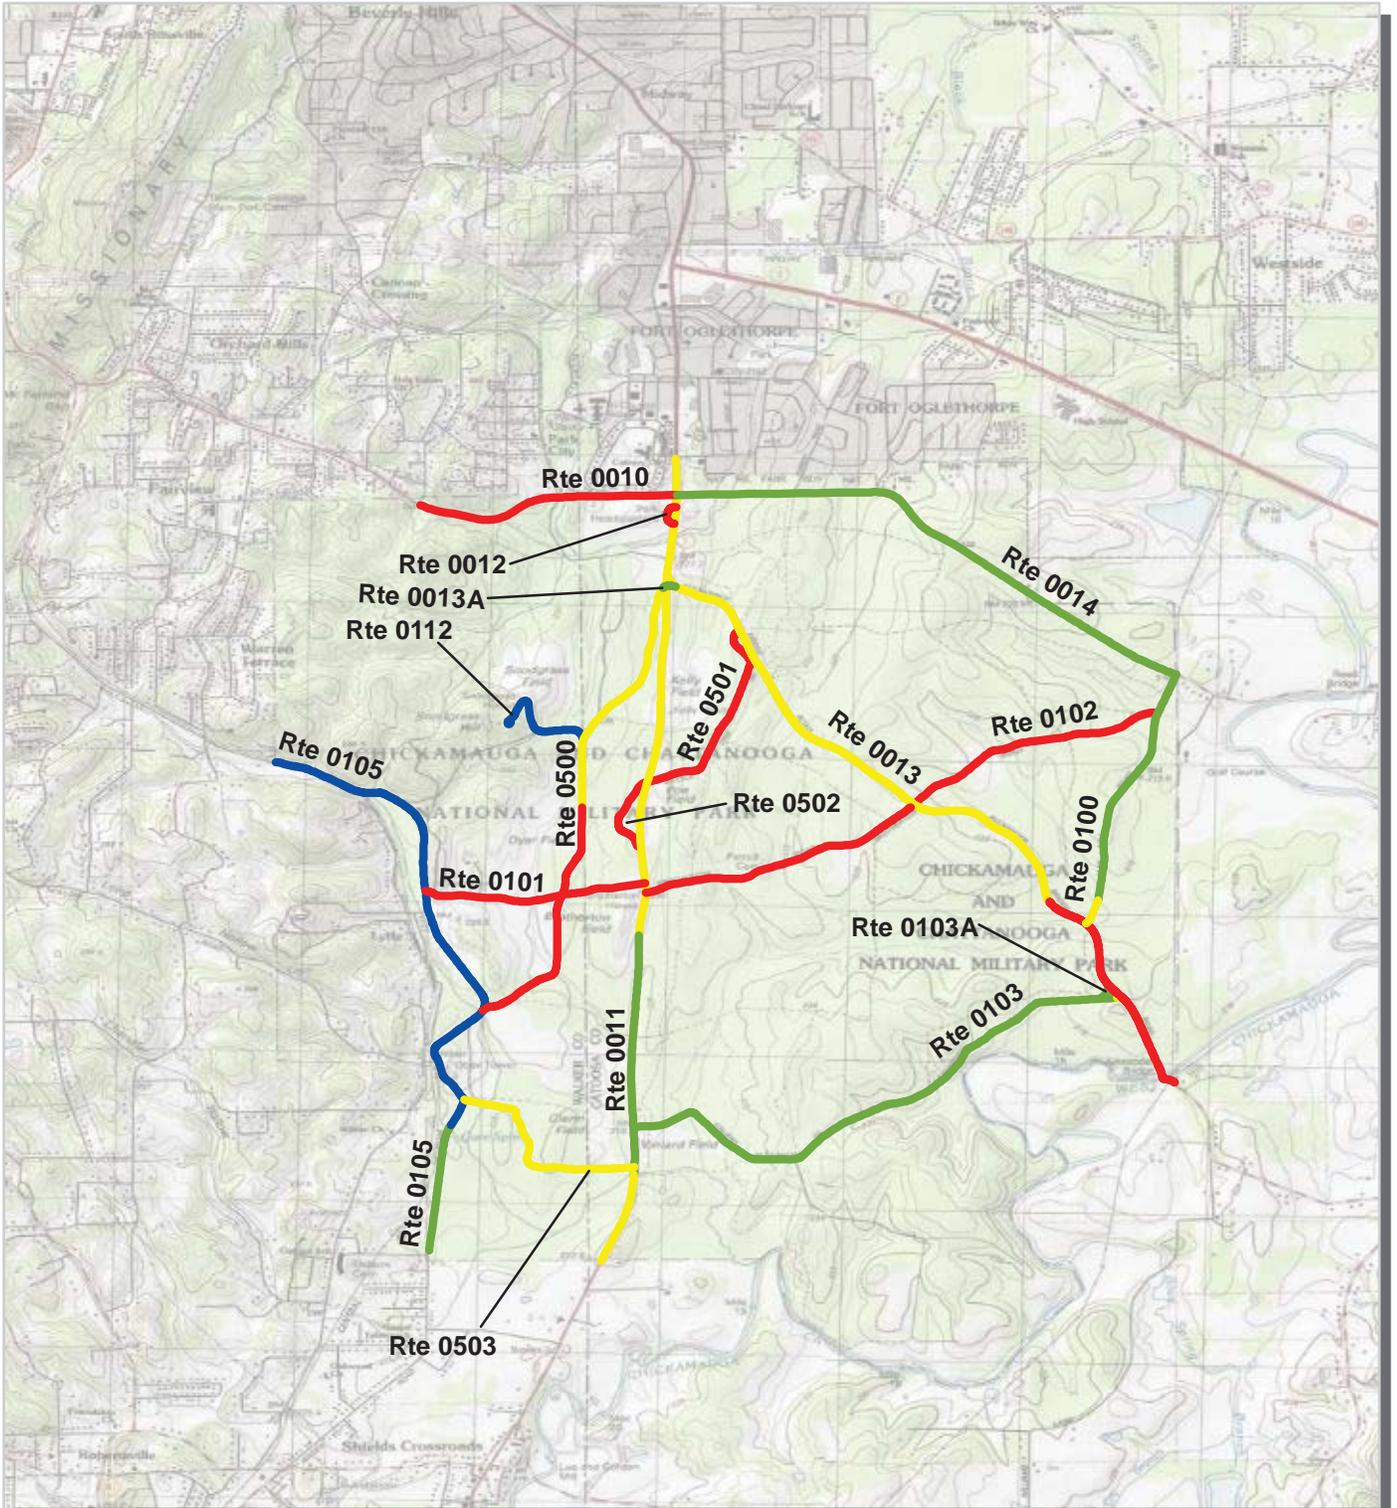
Area 4

PCR	Poor	Fair	Good	Excellent	No Data
	(0 - 60)	(61 - 84)	(85 - 94)	(95 - 100)

* If the PCR rating is not available for a section, the SCR rating will be displayed. See appendix for definitions and formulas.

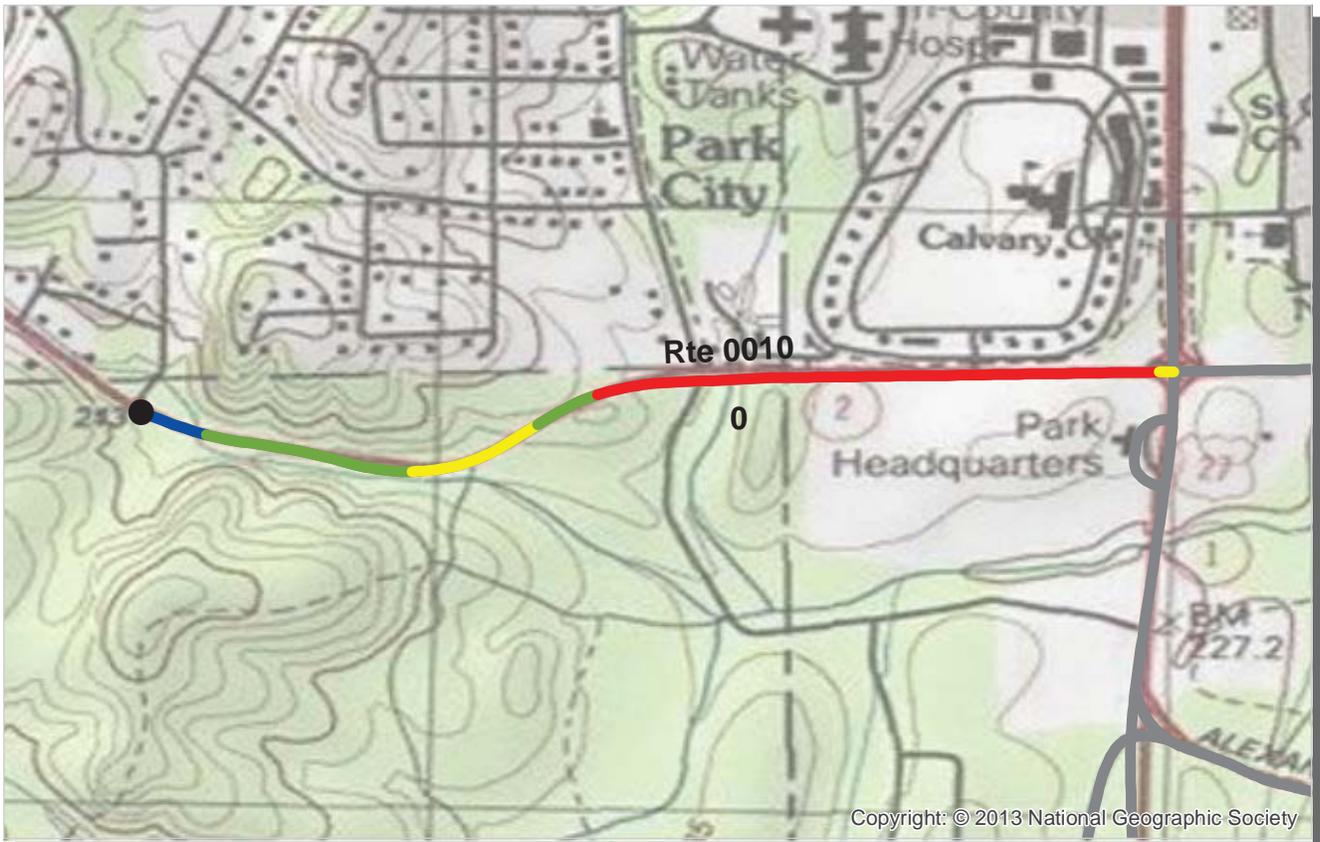
ROUTE: 0010 MCFARLAND GAP ROAD

Section Number	0				
Section Length (mi)	0.91				
Cross Section Information					
Number of Lanes	2				
Paved Width (ft)	27				
Lane Width (ft)	11				
Roadway Condition Information					
SCR (Surface Condition Rating)	0				
PCR (Pavement Condition Rating)	40				
Distress Index Values					
Structural Crack Index	0				
Transverse Cracking Index	94				
Patching Index	100				
Rutting Index	96				
Roughness Condition Index (RCI)	100

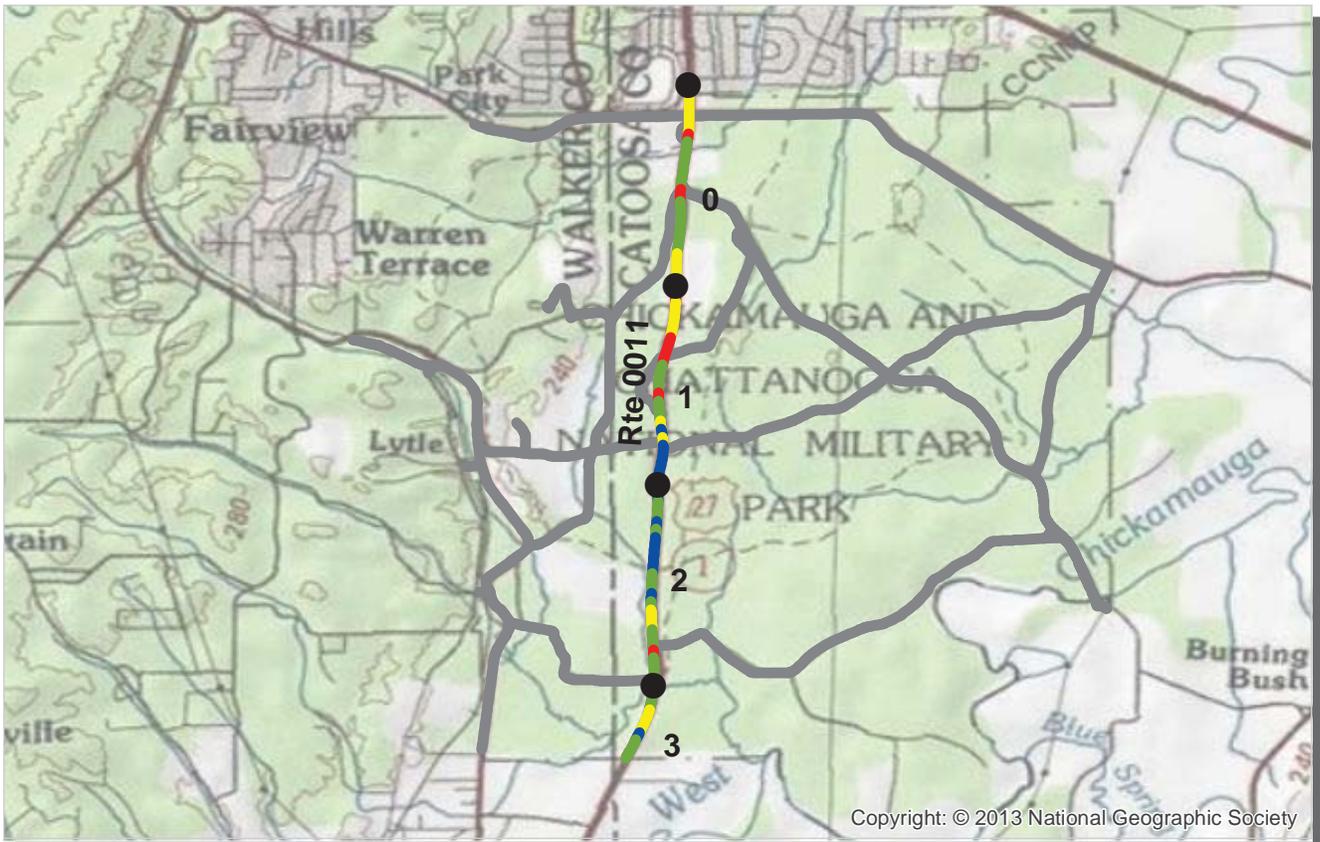
ROUTE: 0011 LAFAYETTE ROAD

<i>Section Number</i>	0	1	2	3
<i>Section Length (mi)</i>	1.00	1.00	1.00	0.38
<i>Cross Section Information</i>				
Number of Lanes	2	2	2	2
Paved Width (ft)	28	24	24	26
Lane Width (ft)	11	11	11	11
<i>Roadway Condition Information</i>				
SCR (Surface Condition Rating)	64	59	81	73
PCR (Pavement Condition Rating)	78	75	89	84
<i>Distress Index Values</i>				
Structural Crack Index	64	59	81	73
Transverse Cracking Index	94	93	93	91
Patching Index	100	100	100	100
Rutting Index	99	100	100	100
Roughness Condition Index (RCI)	100	100	100	100

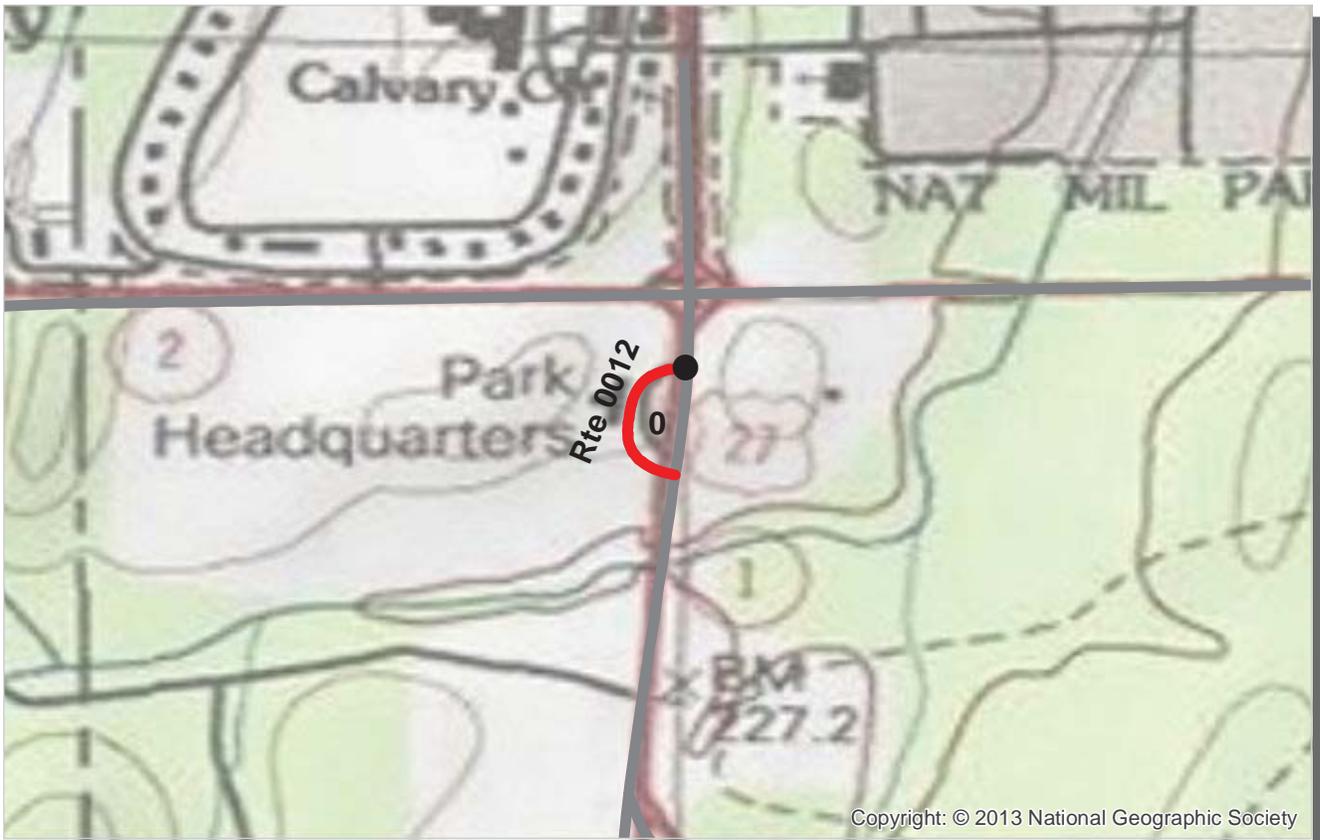
ROUTE: 0012 VISITOR CENTER ACCESS ROAD

Section Number	0				
Section Length (mi)	0.10				
Cross Section Information					
Number of Lanes	1				
Paved Width (ft)	20				
Lane Width (ft)	19				
Roadway Condition Information					
SCR (Surface Condition Rating)	0				
PCR (Pavement Condition Rating)	0				
Distress Index Values					
Structural Crack Index	0				
Transverse Cracking Index	92				
Patching Index	100				
Rutting Index	97				
Roughness Condition Index (RCI)	NC

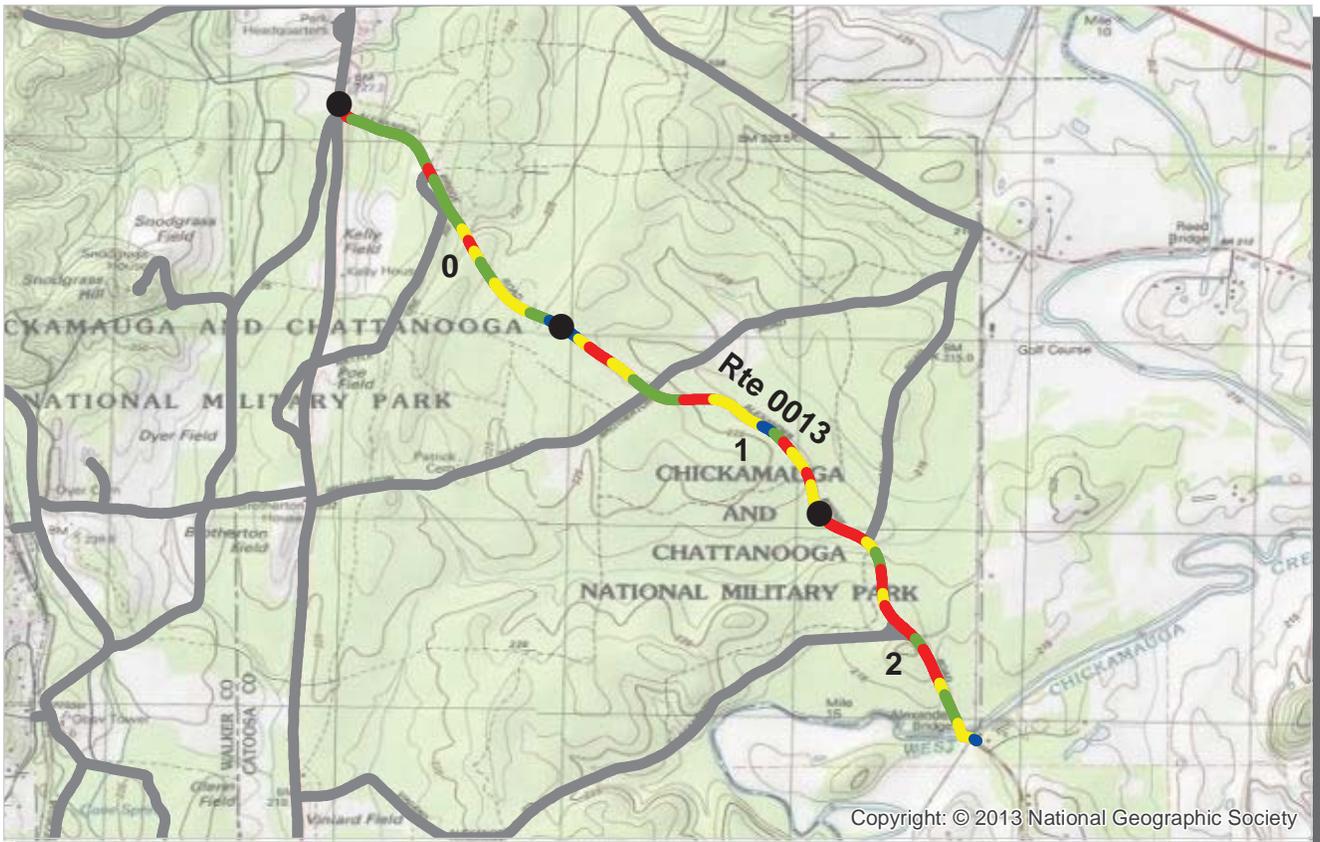
ROUTE: 0013 ALEXANDER BRIDGE ROAD

<i>Section Number</i>	0	1	2		
<i>Section Length (mi)</i>	1.00	1.00	0.91		
<i>Cross Section Information</i>					
Number of Lanes	2	2	2		
Paved Width (ft)	21	20	19		
Lane Width (ft)	9	9	9		
<i>Roadway Condition Information</i>					
SCR (Surface Condition Rating)	65	58	33		
PCR (Pavement Condition Rating)	78	71	56		
<i>Distress Index Values</i>					
Structural Crack Index	65	58	33		
Transverse Cracking Index	98	98	96		
Patching Index	100	100	99		
Rutting Index	98	99	99		
Roughness Condition Index (RCI)	98	90	91

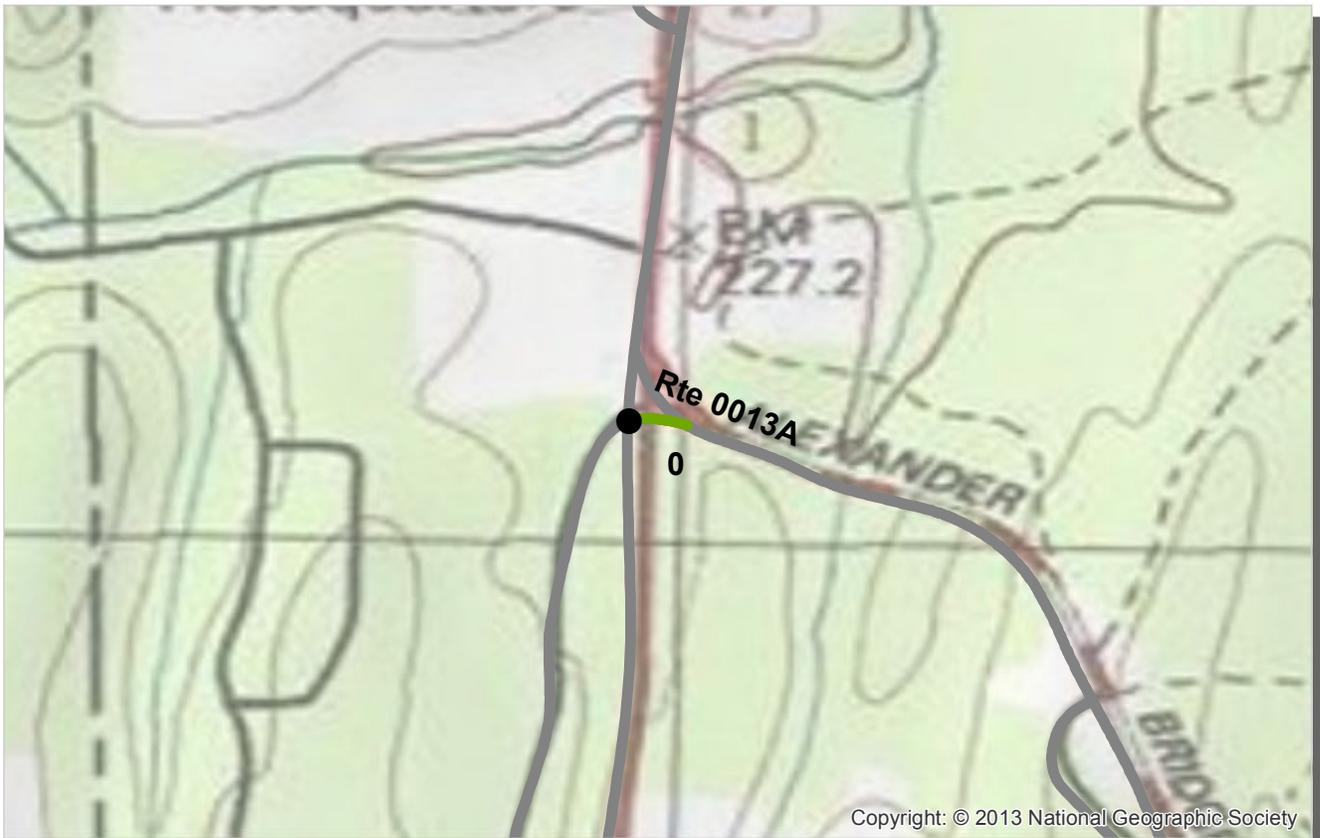
ROUTE: 0013A ALEXANDER BRIDGE ROAD SPUR

Section Number	0				
Section Length (mi)	0.03				
Cross Section Information					
Number of Lanes	2				
Paved Width (ft)	24				
Lane Width (ft)	9				
Roadway Condition Information					
SCR (Surface Condition Rating)	91				
PCR (Pavement Condition Rating)	91				
Distress Index Values					
Structural Crack Index	98				
Transverse Cracking Index	91				
Patching Index	100				
Rutting Index	98				
Roughness Condition Index (RCI)	NC

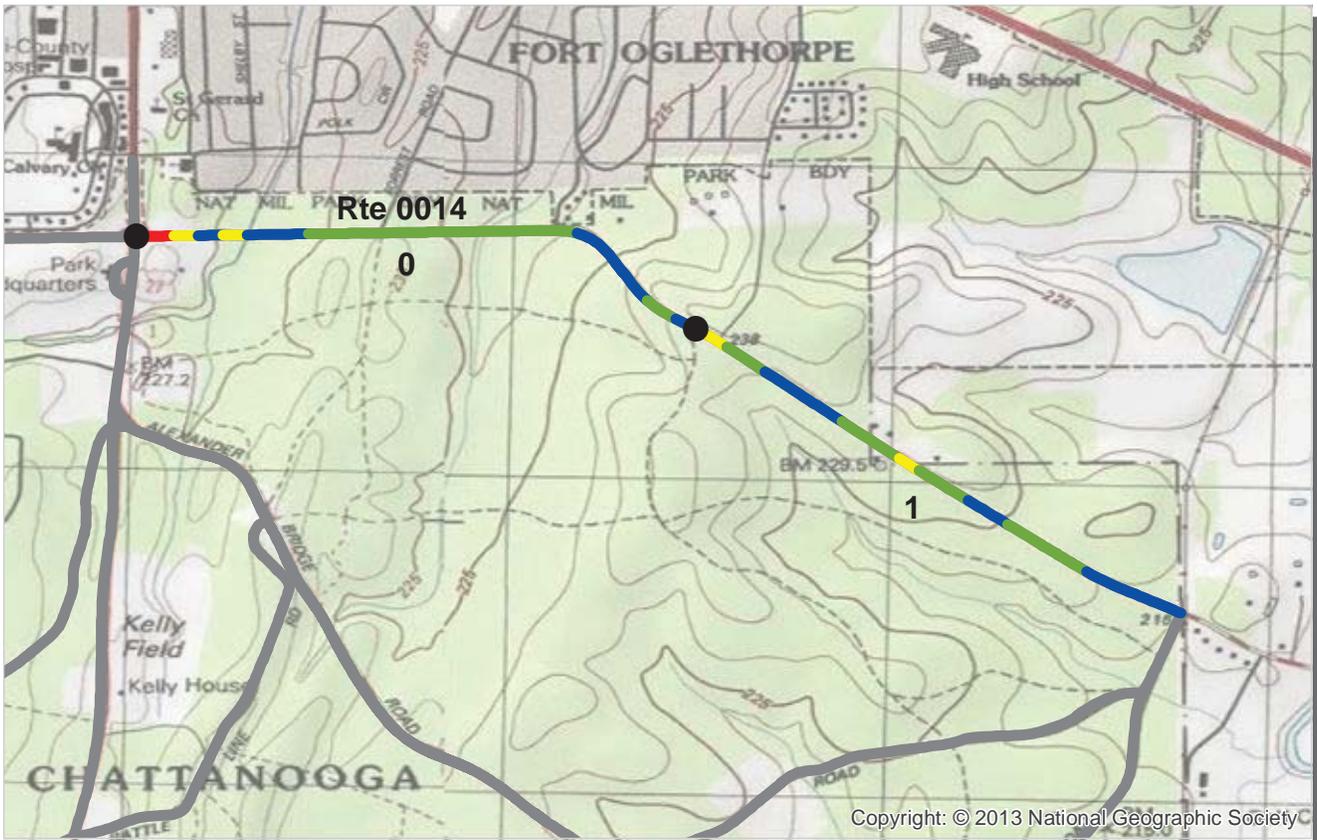
ROUTE: 0014 REEDS BRIDGE ROAD

<i>Section Number</i>	0	1			
<i>Section Length (mi)</i>	1.00	0.98			
<i>Cross Section Information</i>					
Number of Lanes	2	2			
Paved Width (ft)	21	20			
Lane Width (ft)	9	9			
<i>Roadway Condition Information</i>					
SCR (Surface Condition Rating)	89	90			
PCR (Pavement Condition Rating)	93	94			
<i>Distress Index Values</i>					
Structural Crack Index	93	97			
Transverse Cracking Index	89	90			
Patching Index	100	100			
Rutting Index	99	99			
Roughness Condition Index (RCI)	100	100

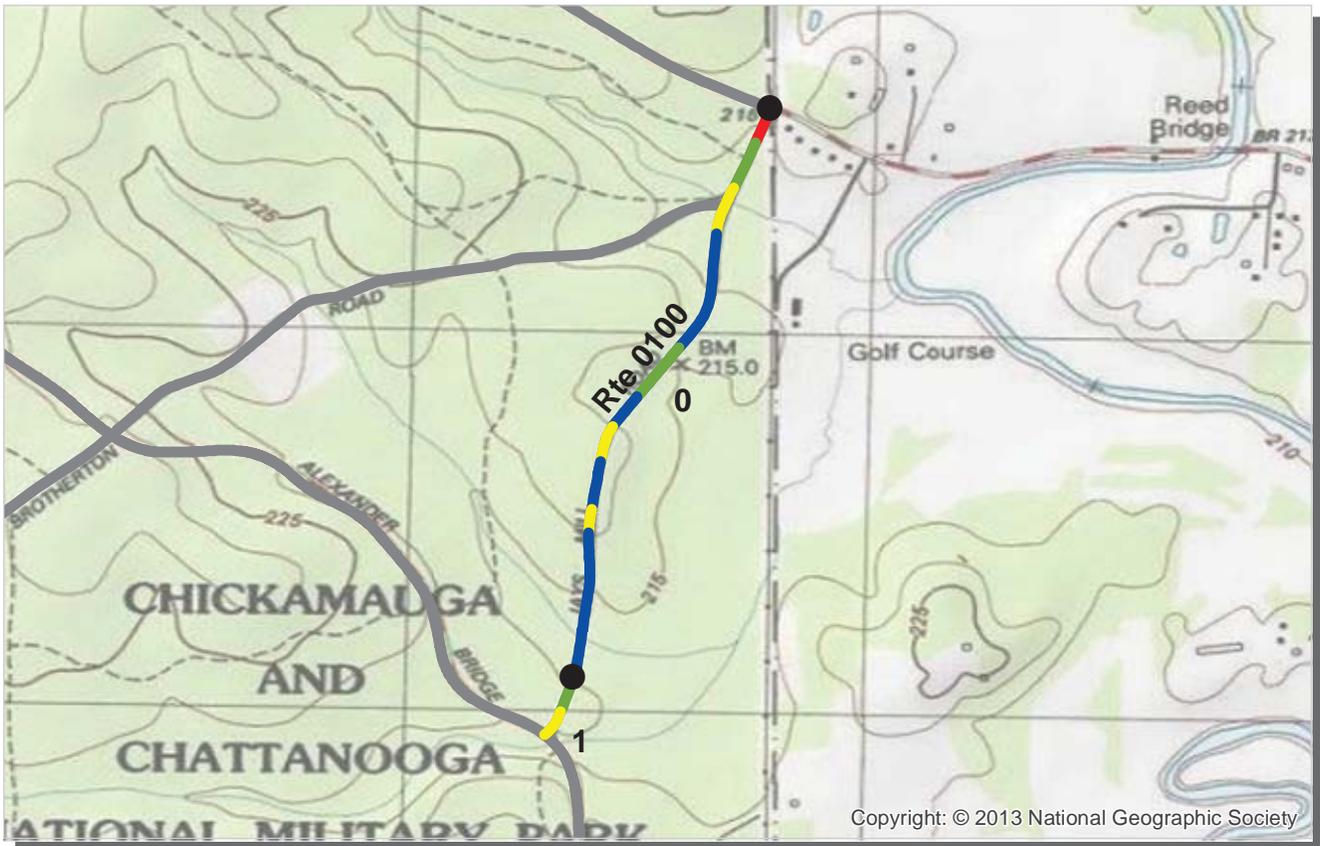
ROUTE: 0100 JAYS MILL ROAD

Section Number	0	1			
Section Length (mi)	1.00	0.10			
Cross Section Information					
Number of Lanes	2	2			
Paved Width (ft)	16	17			
Lane Width (ft)	8	8			
Roadway Condition Information					
SCR (Surface Condition Rating)	90	78			
PCR (Pavement Condition Rating)	87	79			
Distress Index Values					
Structural Crack Index	90	78			
Transverse Cracking Index	100	95			
Patching Index	100	100			
Rutting Index	99	99			
Roughness Condition Index (RCI)	82	81

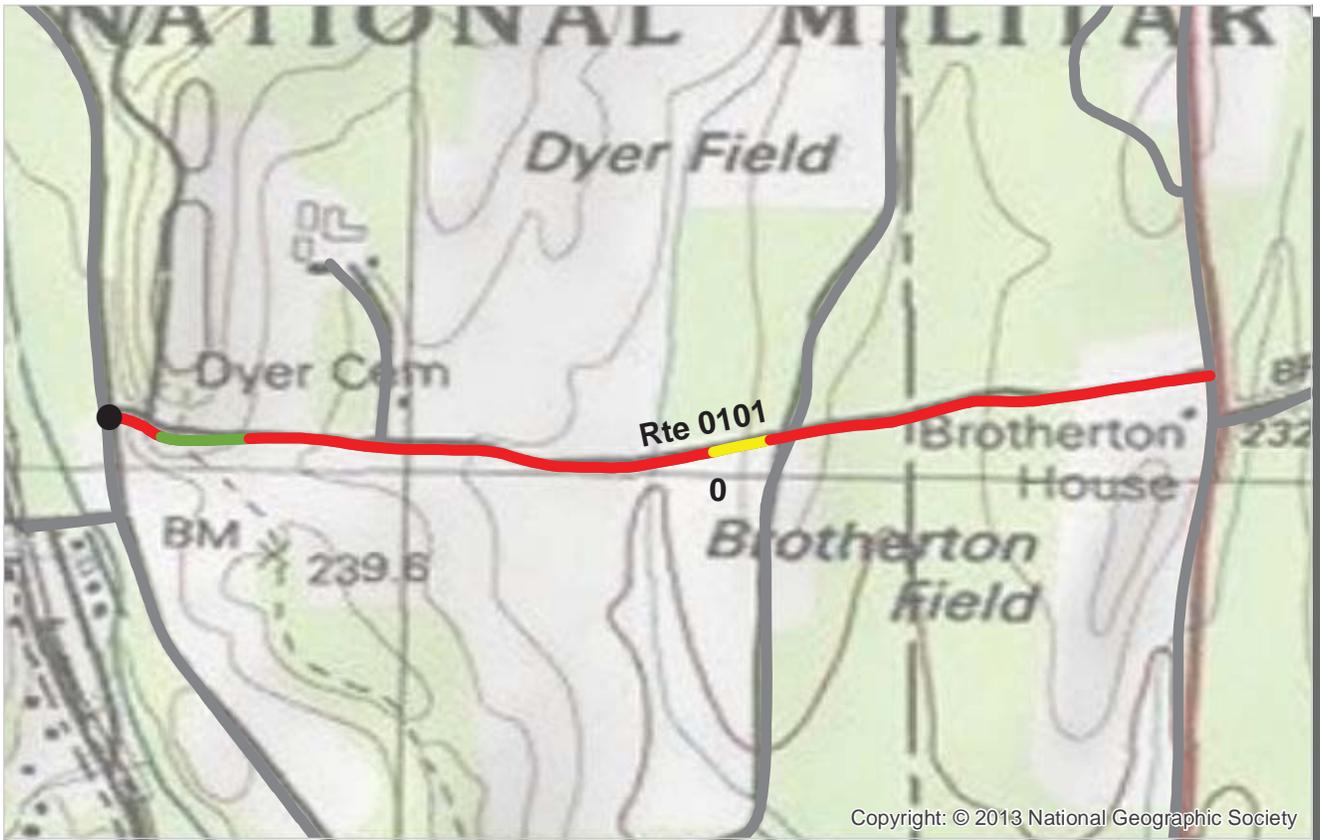
ROUTE: 0101 DYER ROAD

<i>Section Number</i>	0				
<i>Section Length (mi)</i>	0.76				
<i>Cross Section Information</i>					
Number of Lanes	2				
Paved Width (ft)	17				
Lane Width (ft)	9				
<i>Roadway Condition Information</i>					
SCR (Surface Condition Rating)	3				
PCR (Pavement Condition Rating)	29				
<i>Distress Index Values</i>					
Structural Crack Index	3				
Transverse Cracking Index	90				
Patching Index	100				
Rutting Index	100				
Roughness Condition Index (RCI)	69

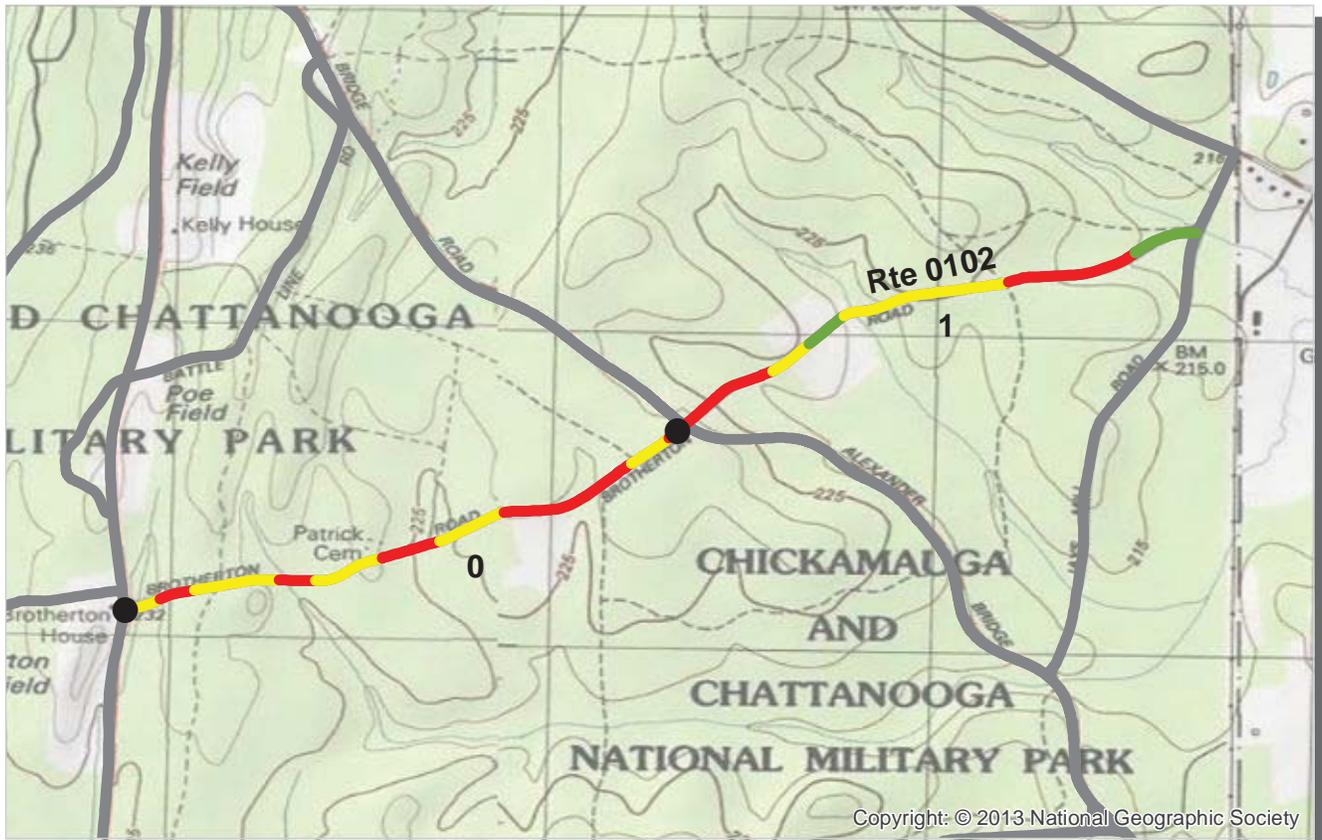
ROUTE: 0102 BROTHERTON ROAD

Section Number	0	1			
Section Length (mi)	1.00	0.96			
Cross Section Information					
Number of Lanes	2	2			
Paved Width (ft)	15	15			
Lane Width (ft)	8	7			
Roadway Condition Information					
SCR (Surface Condition Rating)	40	40			
PCR (Pavement Condition Rating)	47	55			
Distress Index Values					
Structural Crack Index	40	40			
Transverse Cracking Index	96	96			
Patching Index	100	100			
Rutting Index	97	99			
Roughness Condition Index (RCI)	58	77

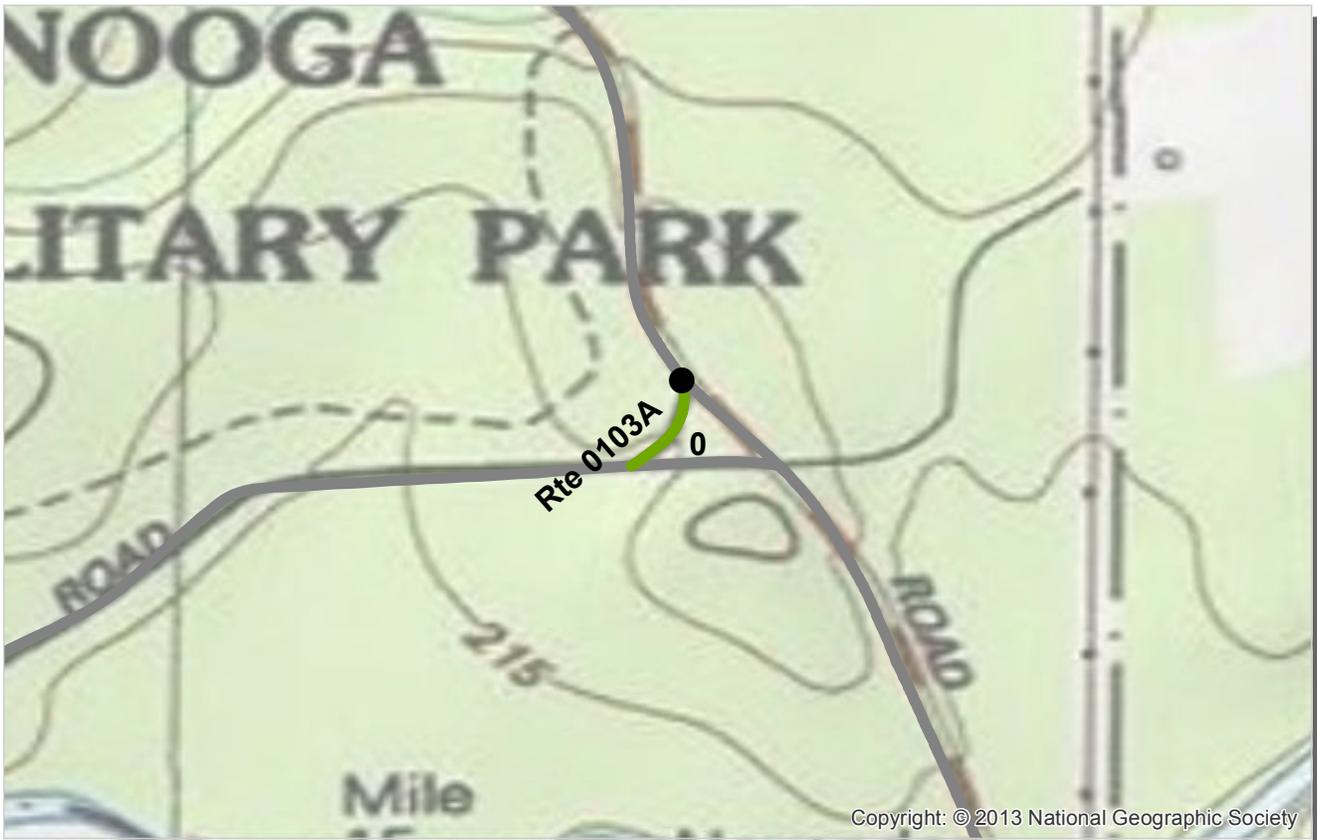
ROUTE: 0103A VINYARD ALEXANDER ROAD SPUR

Section Number	0				
Section Length (mi)	0.06				
Cross Section Information					
Number of Lanes	2				
Paved Width (ft)	16				
Lane Width (ft)	8				
Roadway Condition Information					
SCR (Surface Condition Rating)	93				
PCR (Pavement Condition Rating)	93				
Distress Index Values					
Structural Crack Index	93				
Transverse Cracking Index	100				
Patching Index	100				
Rutting Index	99				
Roughness Condition Index (RCI)	NC

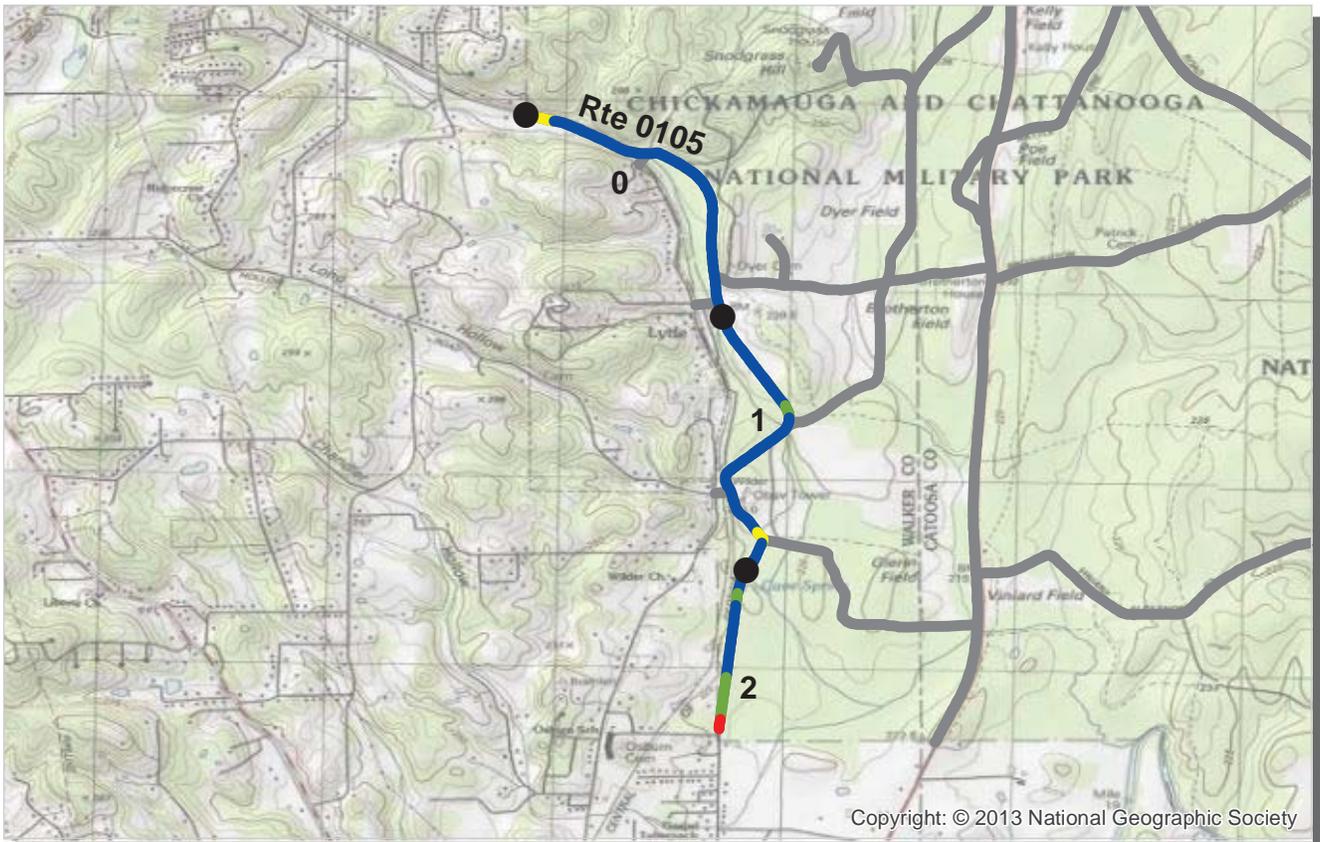
ROUTE: 0105 CHICK-VITTETOE ROAD

<i>Section Number</i>	0	1	2		
<i>Section Length (mi)</i>	1.00	1.00	0.53		
<i>Cross Section Information</i>					
Number of Lanes	2	2	2		
Paved Width (ft)	19	19	20		
Lane Width (ft)	9	10	10		
<i>Roadway Condition Information</i>					
SCR (Surface Condition Rating)	99	99	92		
PCR (Pavement Condition Rating)	99	99	94		
<i>Distress Index Values</i>					
Structural Crack Index	99	99	92		
Transverse Cracking Index	100	100	100		
Patching Index	100	100	100		
Rutting Index	99	100	99		
Roughness Condition Index (RCI)	100	100	98

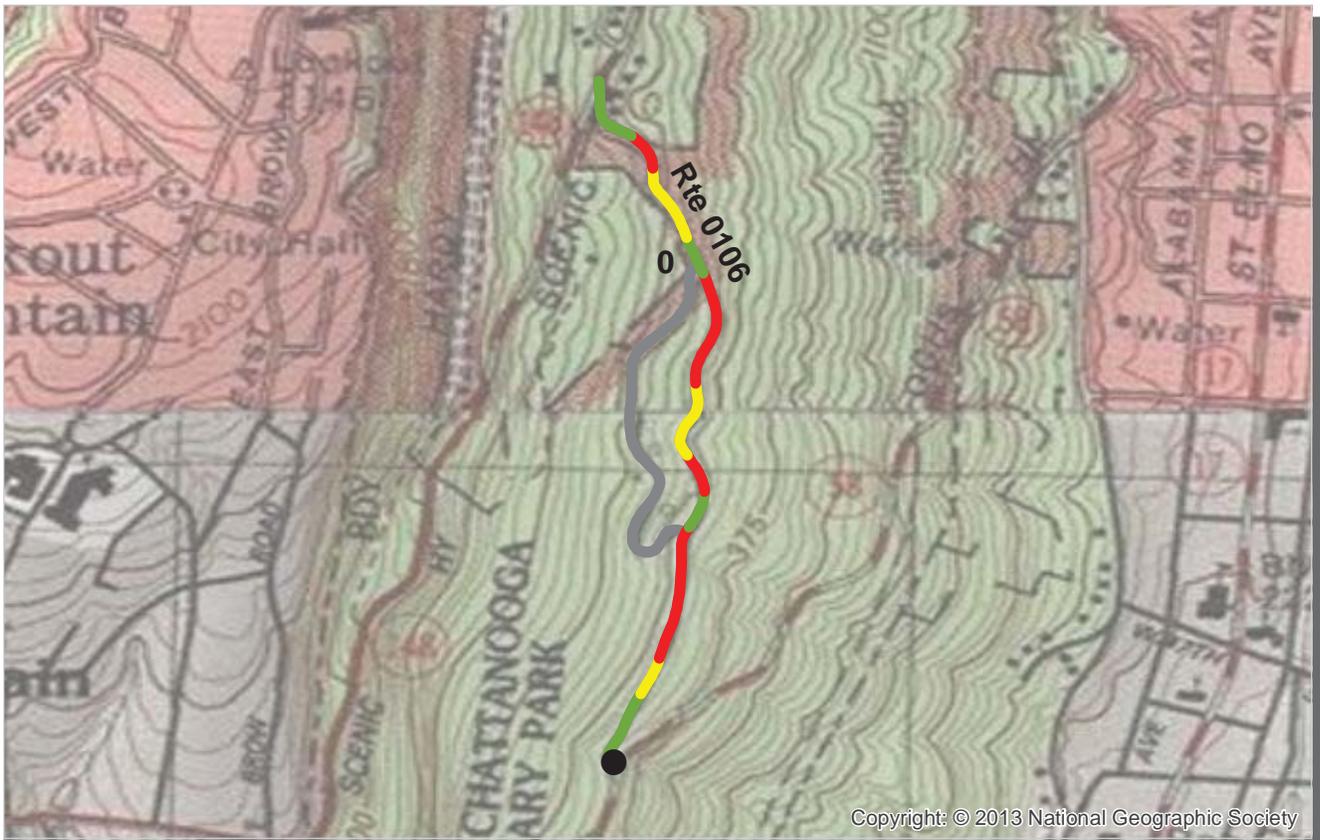
ROUTE: 0106 SANDERS ROAD

Section Number	0				
Section Length (mi)	0.77				
Cross Section Information					
Number of Lanes	2				
Paved Width (ft)	22				
Lane Width (ft)	9				
Roadway Condition Information					
SCR (Surface Condition Rating)	58				
PCR (Pavement Condition Rating)	58				
Distress Index Values					
Structural Crack Index	58				
Transverse Cracking Index	97				
Patching Index	100				
Rutting Index	89				
Roughness Condition Index (RCI)	NC

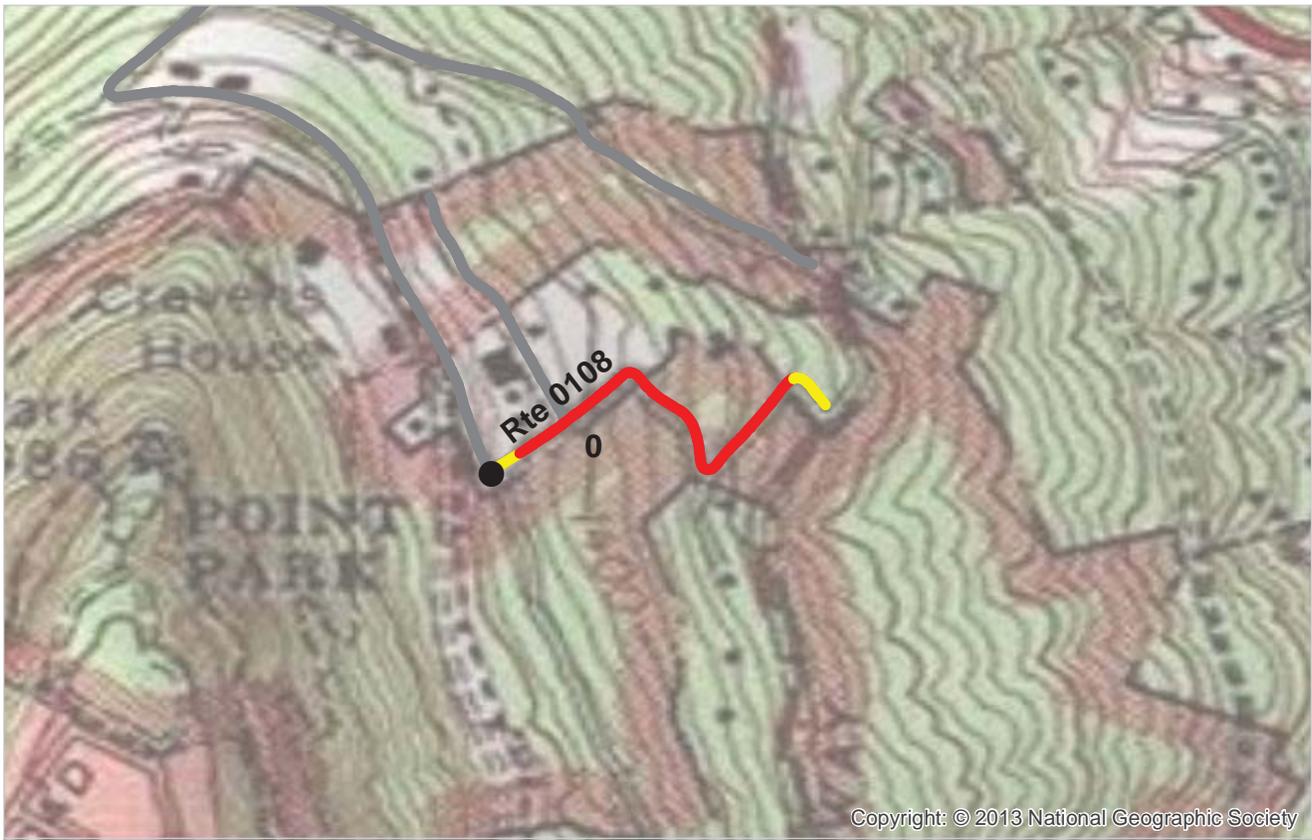
ROUTE: 0108 MILITARY ROAD

Section Number	0				
Section Length (mi)	0.29				
Cross Section Information					
Number of Lanes	2				
Paved Width (ft)	13				
Lane Width (ft)	7				
Roadway Condition Information					
SCR (Surface Condition Rating)	13				
PCR (Pavement Condition Rating)	13				
Distress Index Values					
Structural Crack Index	13				
Transverse Cracking Index	99				
Patching Index	92				
Rutting Index	67				
Roughness Condition Index (RCI)	NC

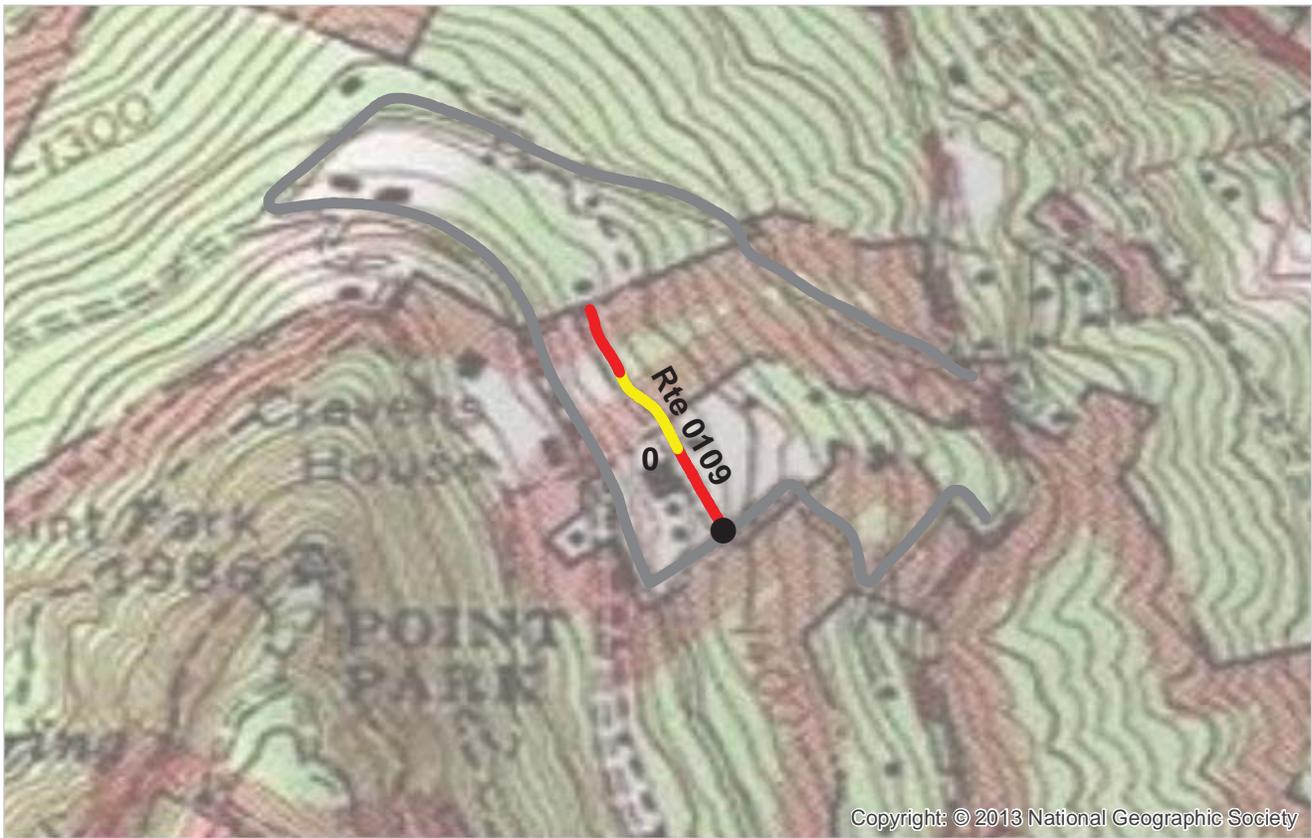
ROUTE: 0109 CAROLINE ROAD

Section Number	0				
Section Length (mi)	0.17				
Cross Section Information					
Number of Lanes	2				
Paved Width (ft)	9				
Lane Width (ft)	4				
Roadway Condition Information					
SCR (Surface Condition Rating)	60				
PCR (Pavement Condition Rating)	60				
Distress Index Values					
Structural Crack Index	60				
Transverse Cracking Index	98				
Patching Index	100				
Rutting Index	63				
Roughness Condition Index (RCI)	NC
