Federal Lands Highway Road Inventory Program

Road Inventory and Condition Assessment

Chickamauga and Chattanooga National Military Park CHCH

Cycle 5 Report

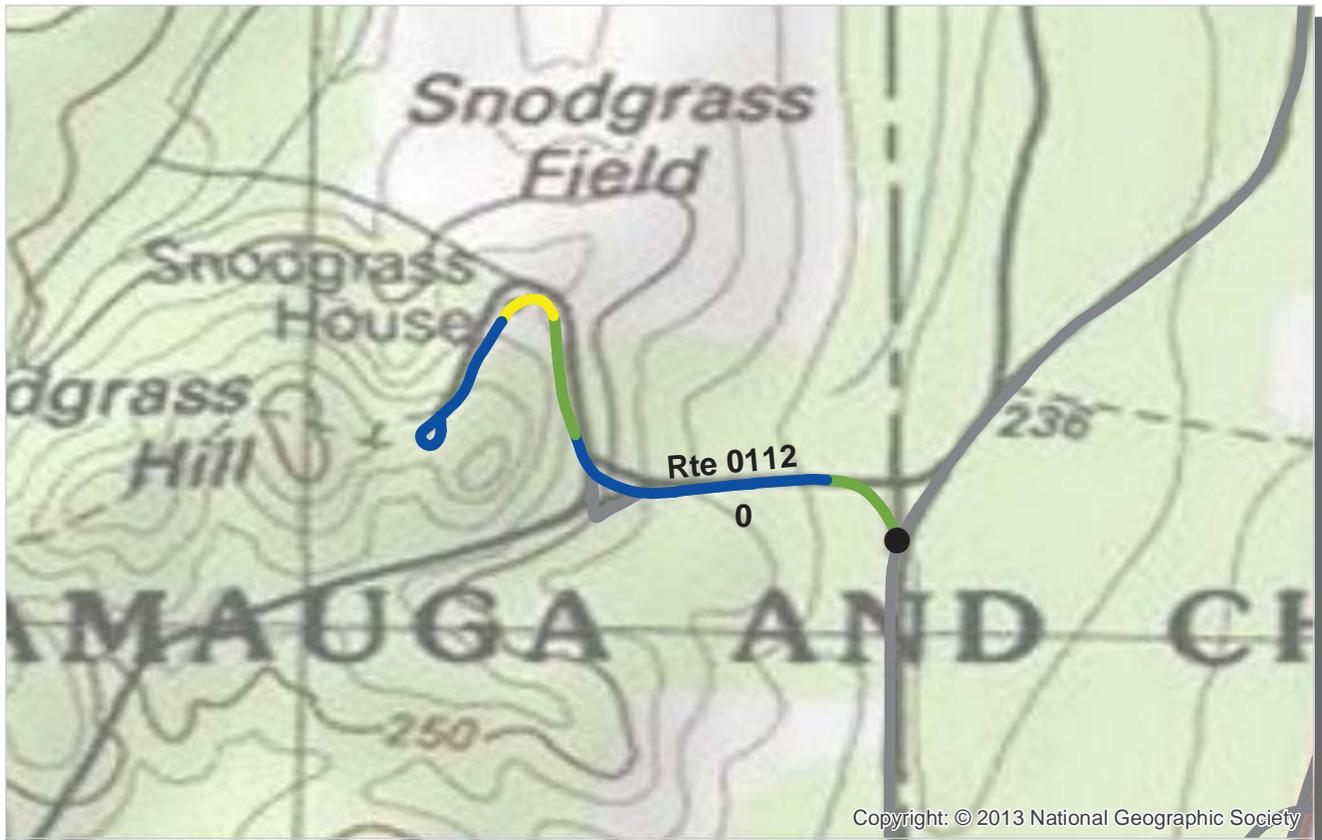
ROUTE: 0112 SNODGRASS ROAD

Section Number	0				
Section Length (mi)	0.45				
Cross Section Information					
Number of Lanes	2				
Paved Width (ft)	18				
Lane Width (ft)	9				
Roadway Condition Information					
SCR (Surface Condition Rating)	95				
PCR (Pavement Condition Rating)	95				
Distress Index Values					
Structural Crack Index	95				
Transverse Cracking Index	98				
Patching Index	100				
Rutting Index	98				
Roughness Condition Index (RCI)	NC

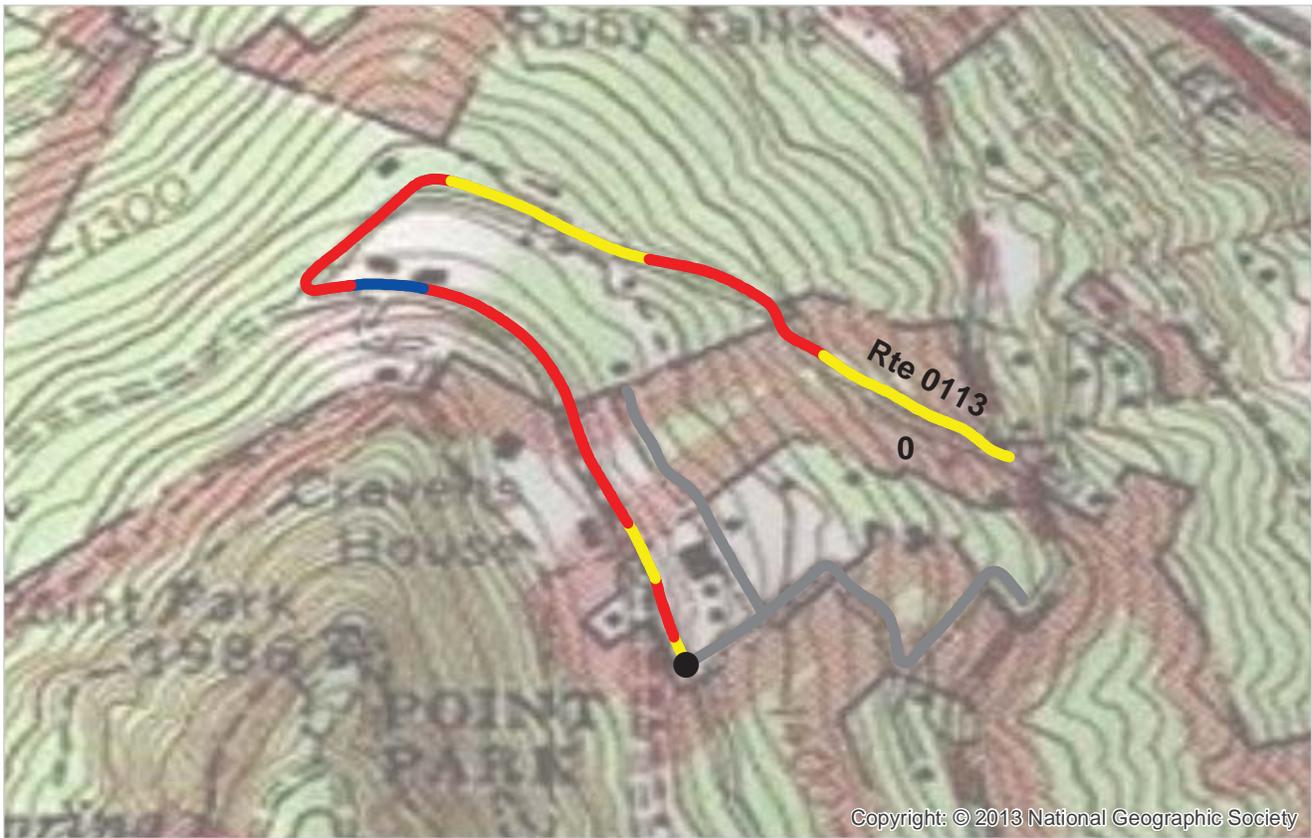
ROUTE: 0113 CRAVENS TERRACE ROAD

Section Number	0				
Section Length (mi)	0.84				
Cross Section Information					
Number of Lanes	2				
Paved Width (ft)	16				
Lane Width (ft)	11				
Roadway Condition Information					
SCR (Surface Condition Rating)	5				
PCR (Pavement Condition Rating)	5				
Distress Index Values					
Structural Crack Index	5				
Transverse Cracking Index	99				
Patching Index	95				
Rutting Index	84				
Roughness Condition Index (RCI)	NC

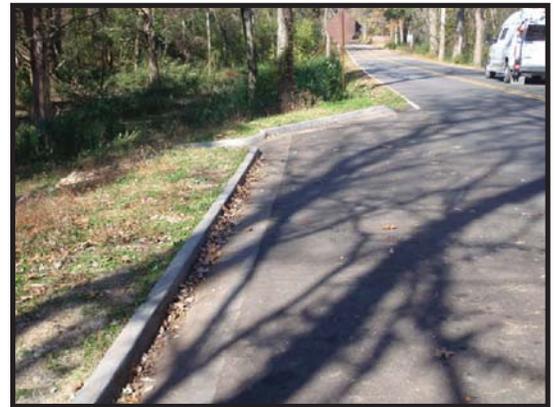
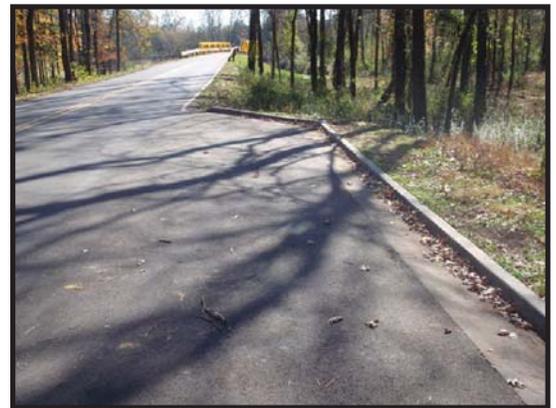
Route Number	Public / NonPublic	Date Visited	Area (sq ft)	Lane Miles *	Surface Type
0920	PUBLIC	11/3/2012	1,048	0.02	AS
Culverts	Drop Inlets	Gates	Curb & Gutter	Curb	PCR
0	0	0	CONCRETE CURB AND GUTTER	NO CURB	GOOD/90

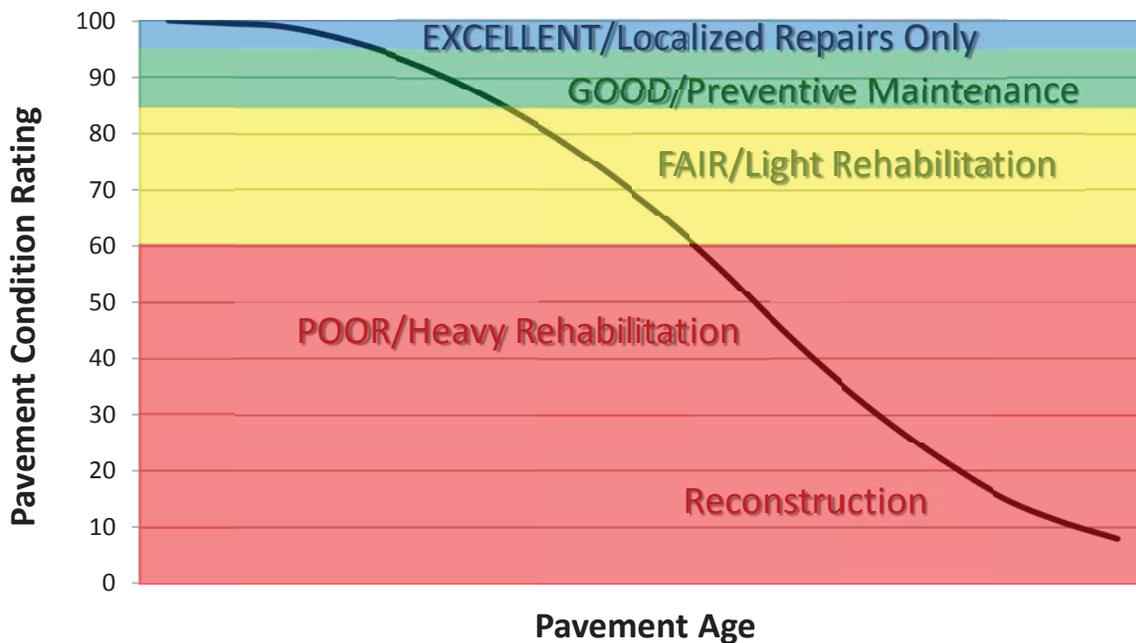
Condition Categories and Treatments

Specific Maintenance and Rehabilitation activities should be evaluated and recommended at the project level. Site-specific conditions that influence treatment type should be determined based on performing a subsurface investigation and/or pavement condition survey, and not be based solely on RIP data. Additionally, RIP produces a snapshot of conditions the year in which the data was collected. For further information or to obtain additional Pavement Management System's data from our Highway Pavement Management Application (HPMA) please contact the Eastern Federal Lands pavement team.
