Federal Lands Highway Road Inventory Program

Road Inventory and Condition Assessment

Chiricahua National Monument

Cycle 5 Report

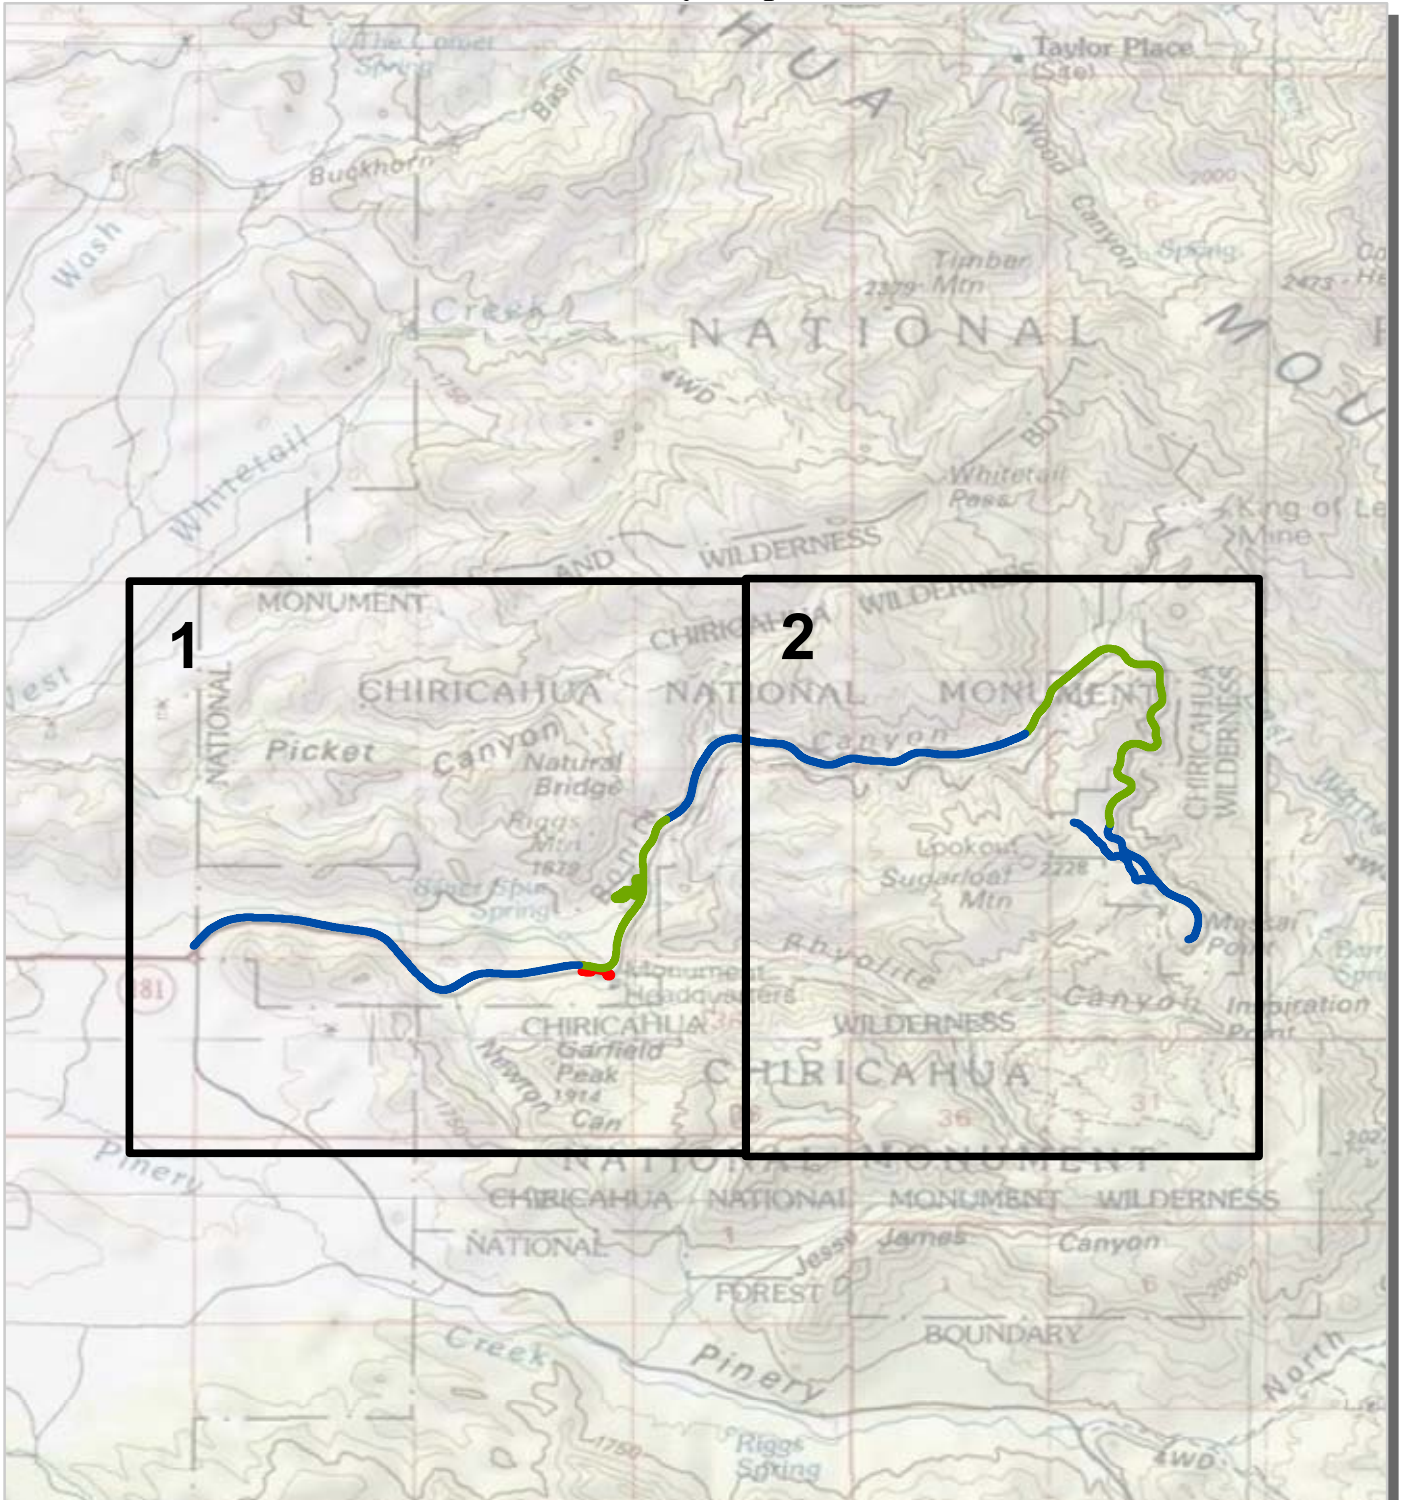
Key Map

PCR	Poor		Fair		Good		Excellent		No Data	
	(0 - 60)		(61 - 84)	(85 - 94)		(95 - 100)

* If the PCR rating is not available for a section, the SCR rating will be displayed. See appendix for definitions and formulas.

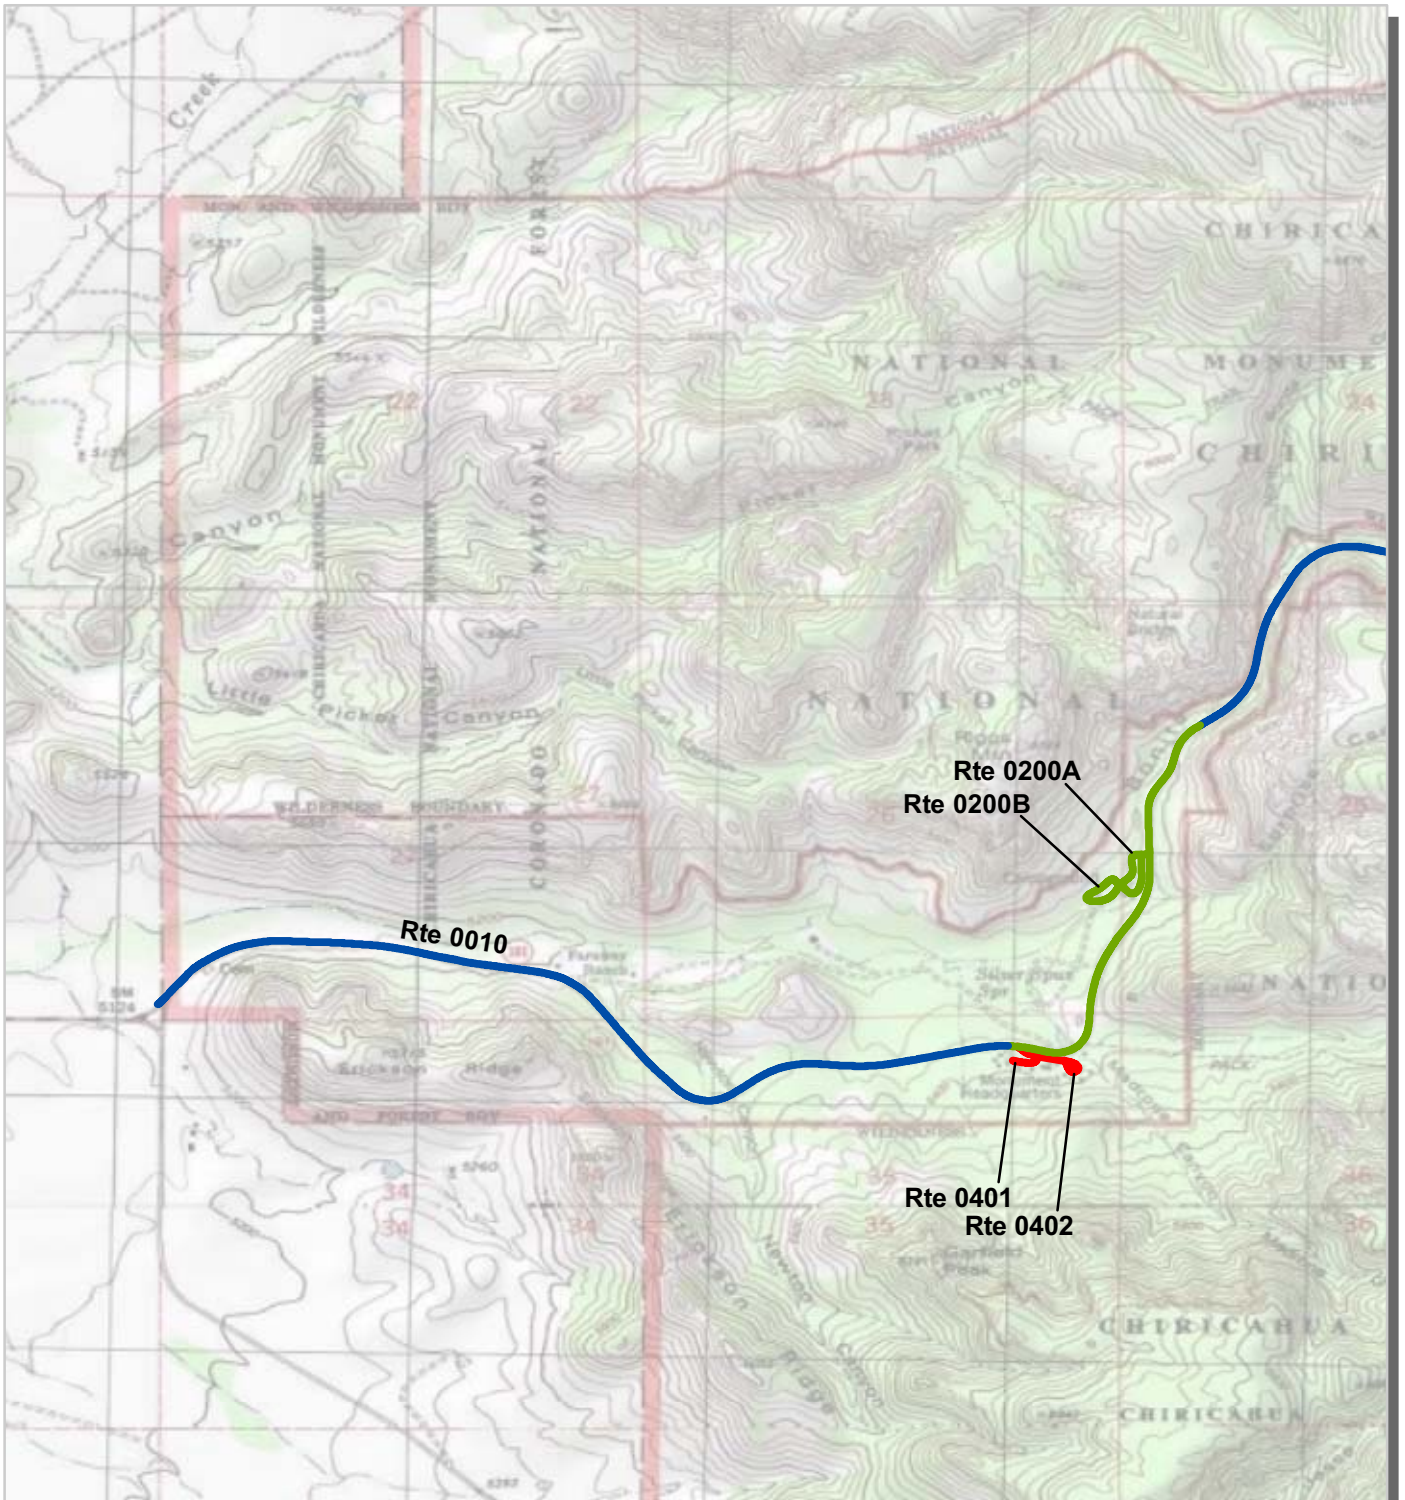
Area 1

PCR	Poor	Fair	Good	Excellent	No Data
	■	■	■	■	■
	(0 - 60)	(61 - 84)	(85 - 94)	(95 - 100)

* If the PCR rating is not available for a section, the SCR rating will be displayed. See appendix for definitions and formulas.

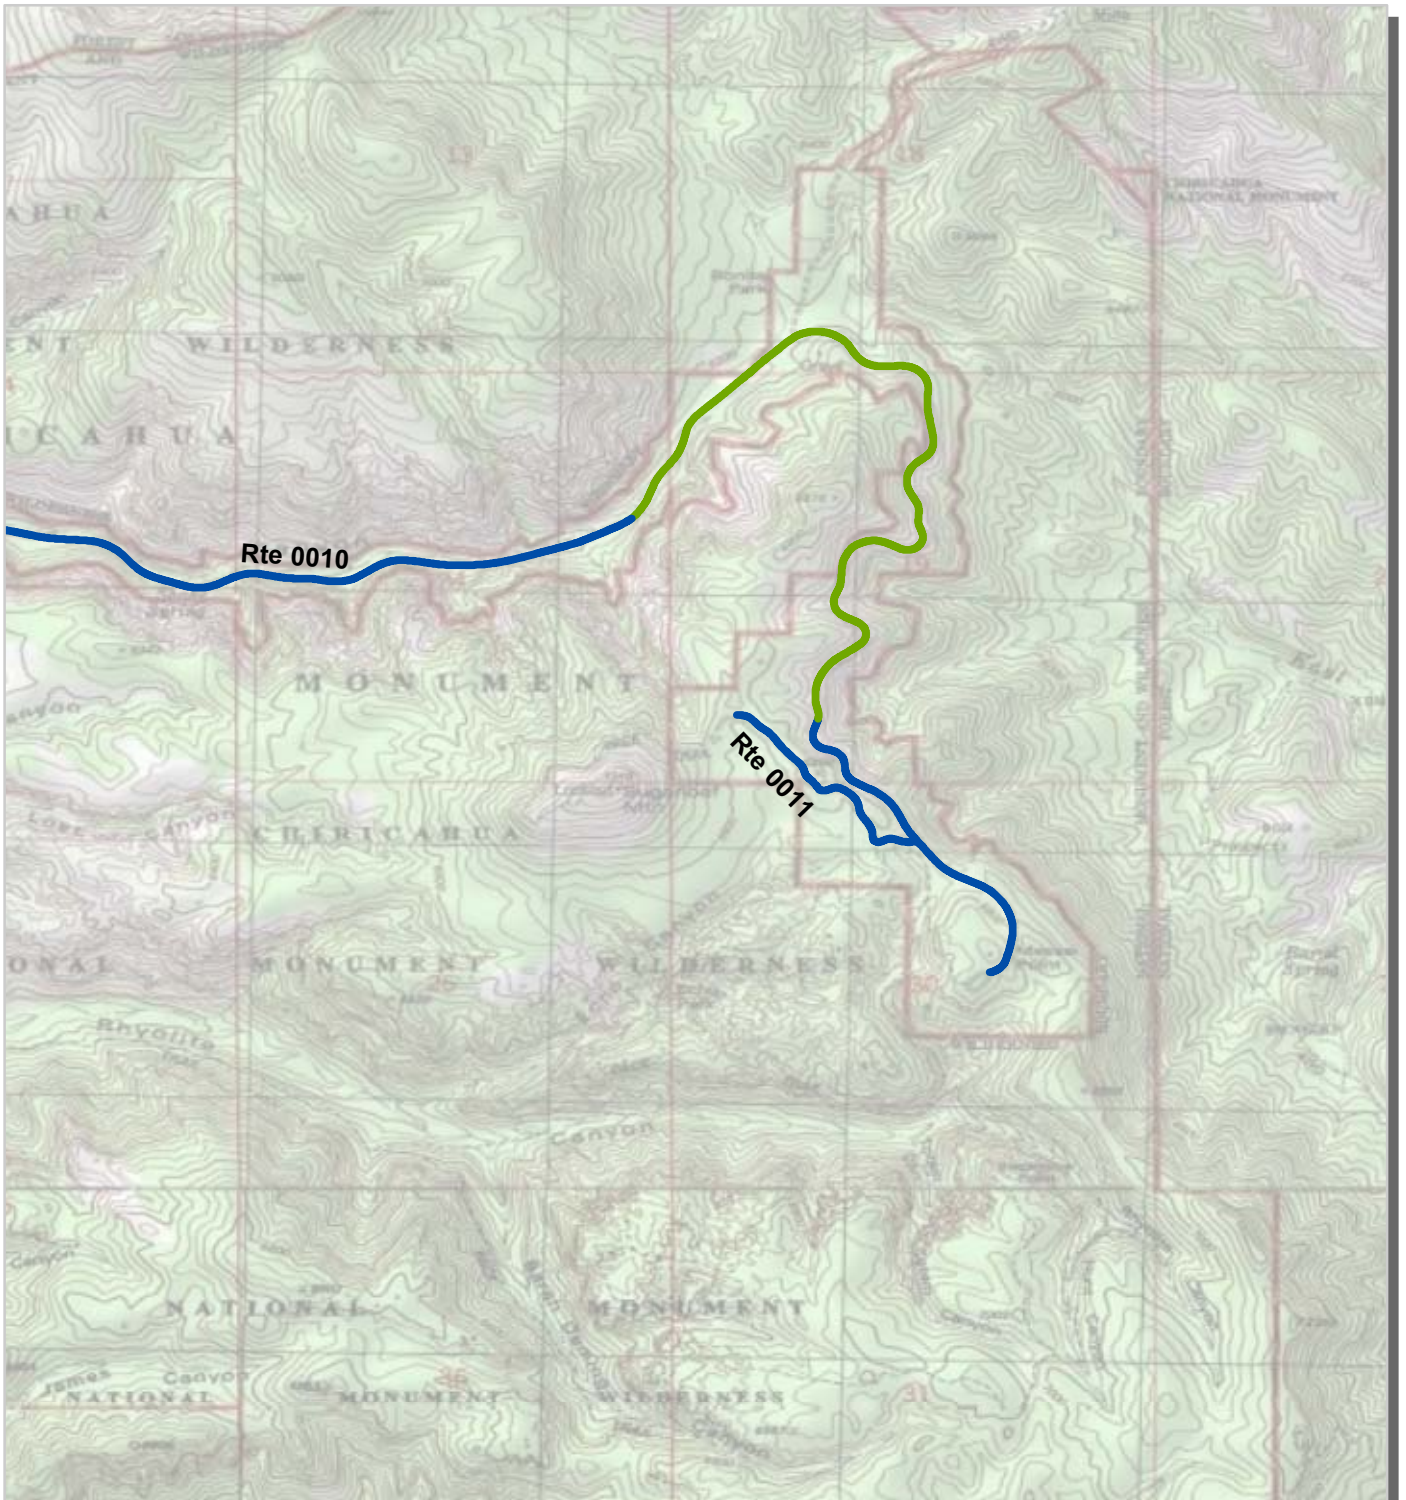
Area 2

PCR	Poor		Fair		Good		Excellent		No Data	
	(0 - 60)		(61 - 84)	(85 - 94)		(95 - 100)

* If the PCR rating is not available for a section, the SCR rating will be displayed. See appendix for definitions and formulas.

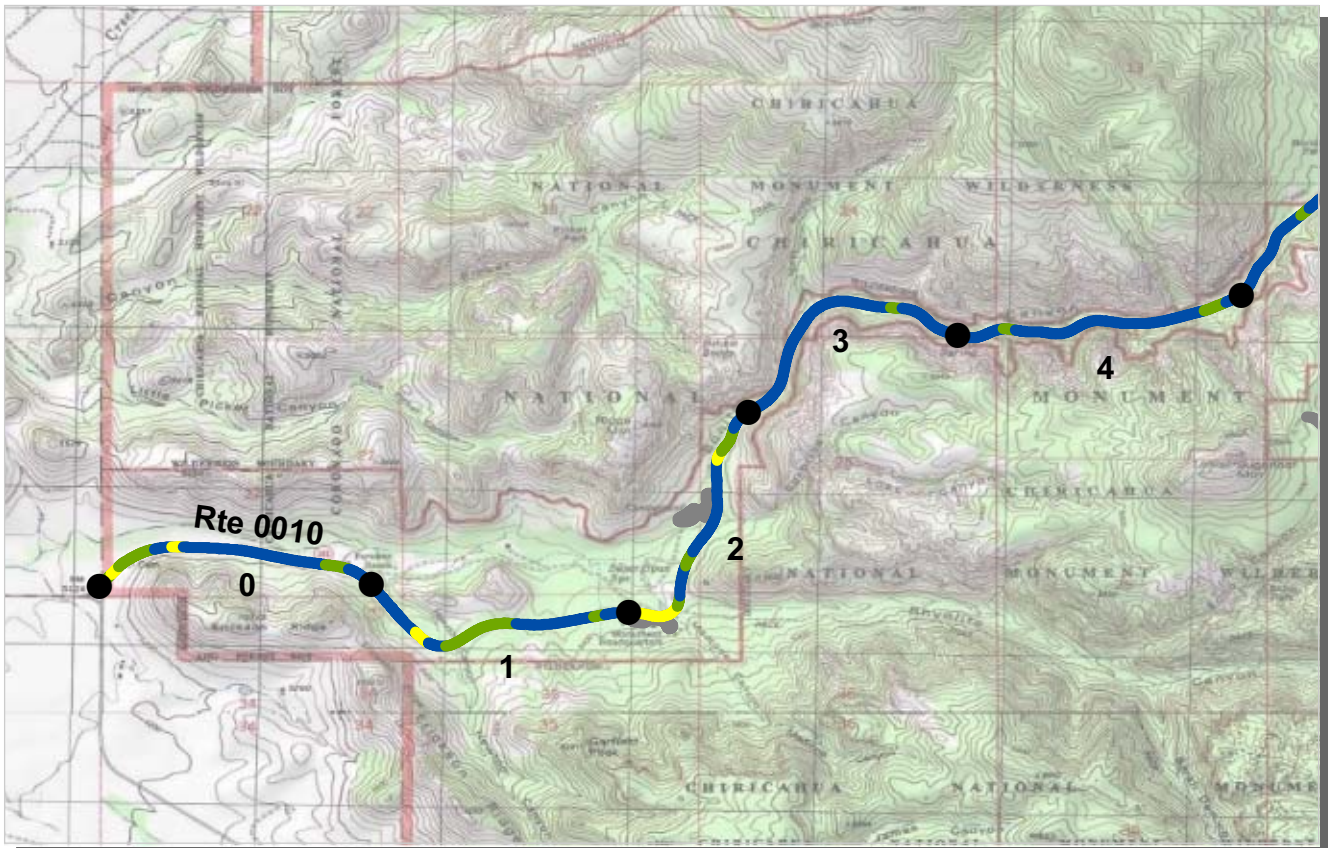
ROUTE: 0010 WEST ENTRANCE TO MASSAI POINT

<i>Section Number</i>	0	1	2	3	4
<i>Section Length (mi)</i>	1.00	1.00	1.00	1.00	1.00
<i>Cross Section Information</i>					
Number of Lanes	2	2	2	2	2
Paved Width (ft)	21	23	23	21	21
Lane Width (ft)	12	10	11	10	10
<i>Roadway Condition Information</i>					
SCR (Surface Condition Rating)	95	97	97	97	98
PCR (Pavement Condition Rating)	96	95	93	97	97
<i>Distress Index Values</i>					
Structural Crack Index	95	97	99	100	100
Transverse Cracking Index	96	98	99	100	99
Patching Index	100	100	100	100	100
Rutting Index	99	98	97	97	98
Roughness Condition Index (RCI)	97	93	88	96	95

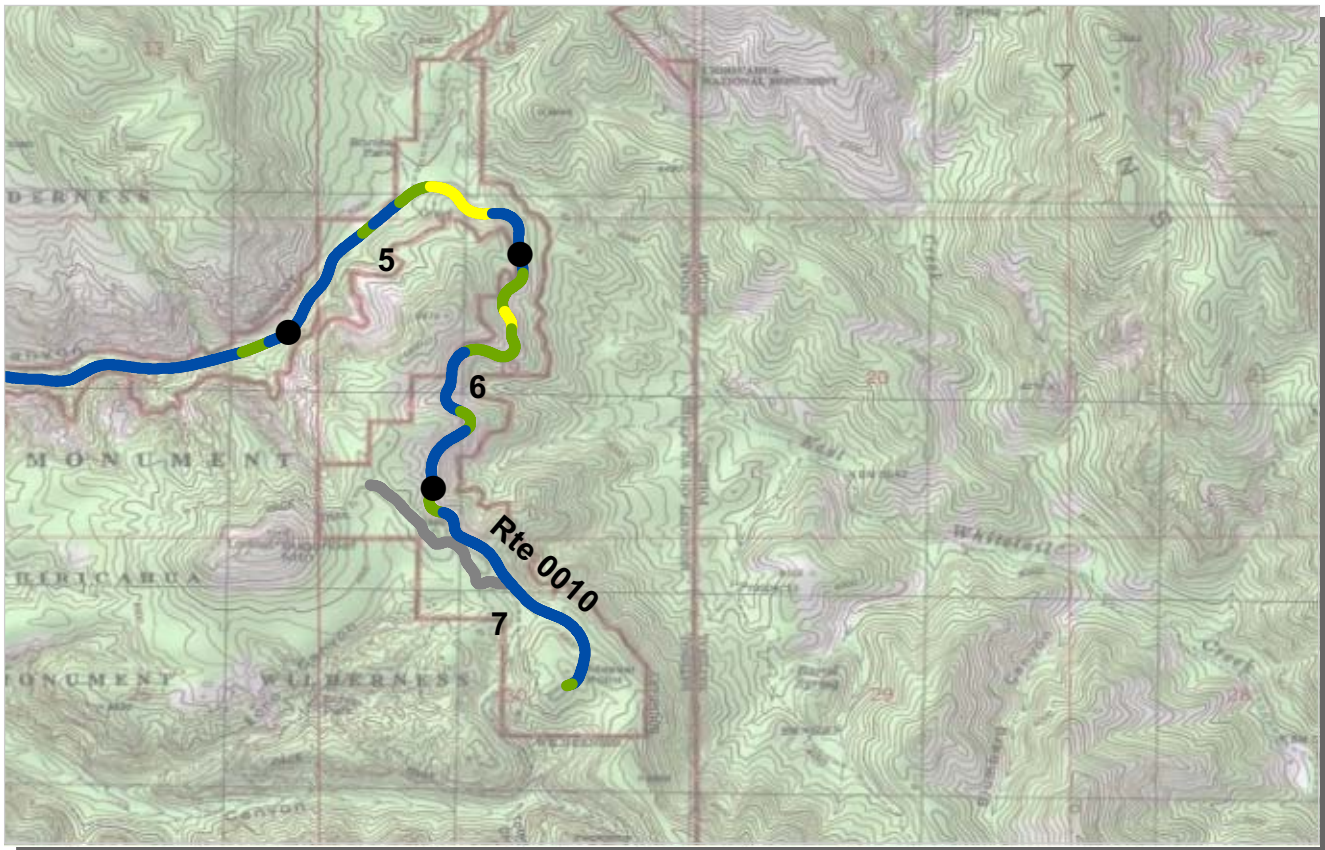
Section Number	5	6	7		
Section Length (mi)	1.00	1.00	0.84		
Cross Section Information					
Number of Lanes	2	2	2		
Paved Width (ft)	22	21	23		
Lane Width (ft)	11	10	11		
Roadway Condition Information					
SCR (Surface Condition Rating)	98	97	99		
PCR (Pavement Condition Rating)	94	94	98		
Distress Index Values					
Structural Crack Index	98	99	100		
Transverse Cracking Index	99	99	99		
Patching Index	100	100	100		
Rutting Index	98	97	99		
Roughness Condition Index (RCI)	87	89	96

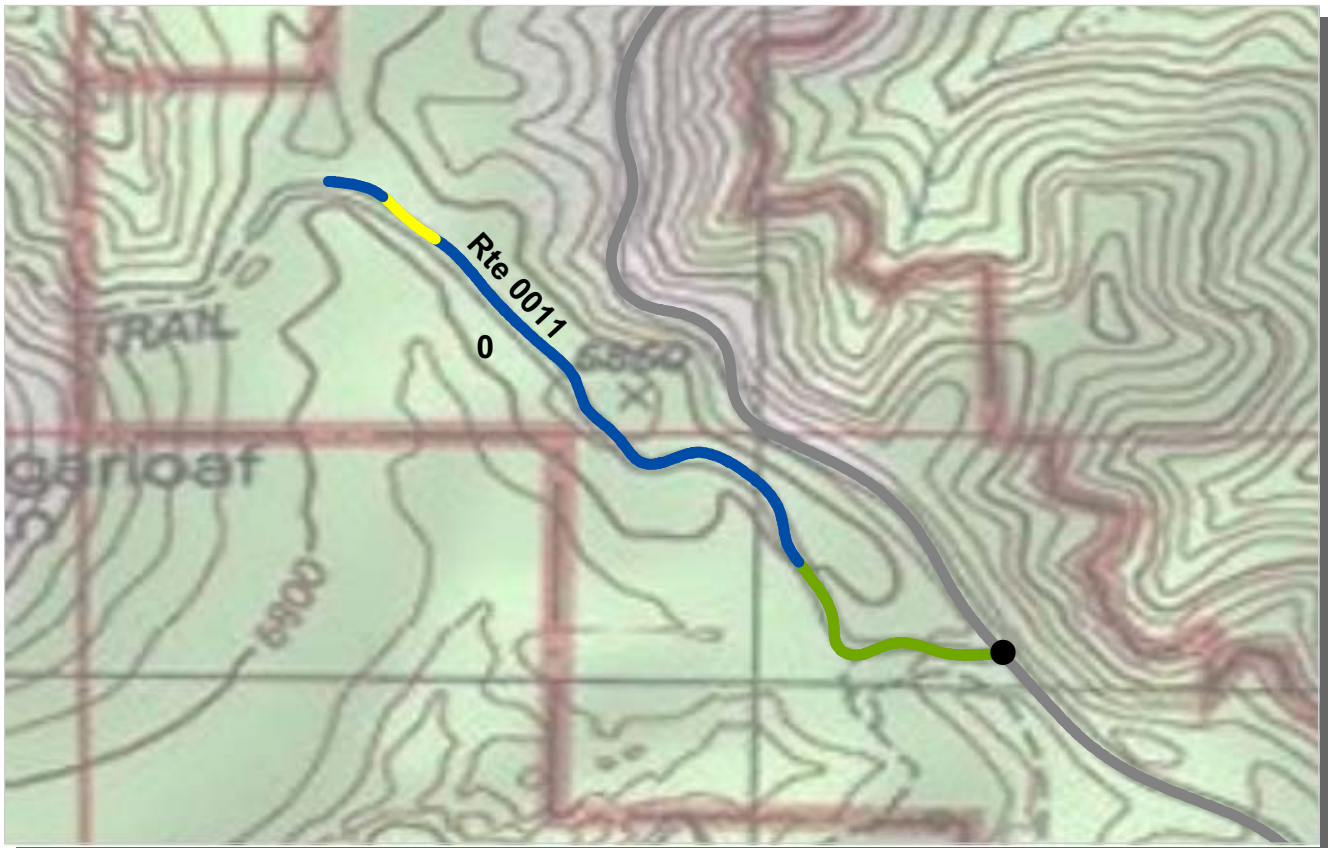
ROUTE: 0011 SUGARLOAF MOUNTAIN ROAD

Section Number	0				
Section Length (mi)	0.55				
Cross Section Information					
Number of Lanes	2				
Paved Width (ft)	21				
Lane Width (ft)	10				
Roadway Condition Information					
SCR (Surface Condition Rating)	97				
PCR (Pavement Condition Rating)	97				
Distress Index Values					
Structural Crack Index	97				
Transverse Cracking Index	97				
Patching Index	100				
Rutting Index	98				
Roughness Condition Index (RCI)	NC

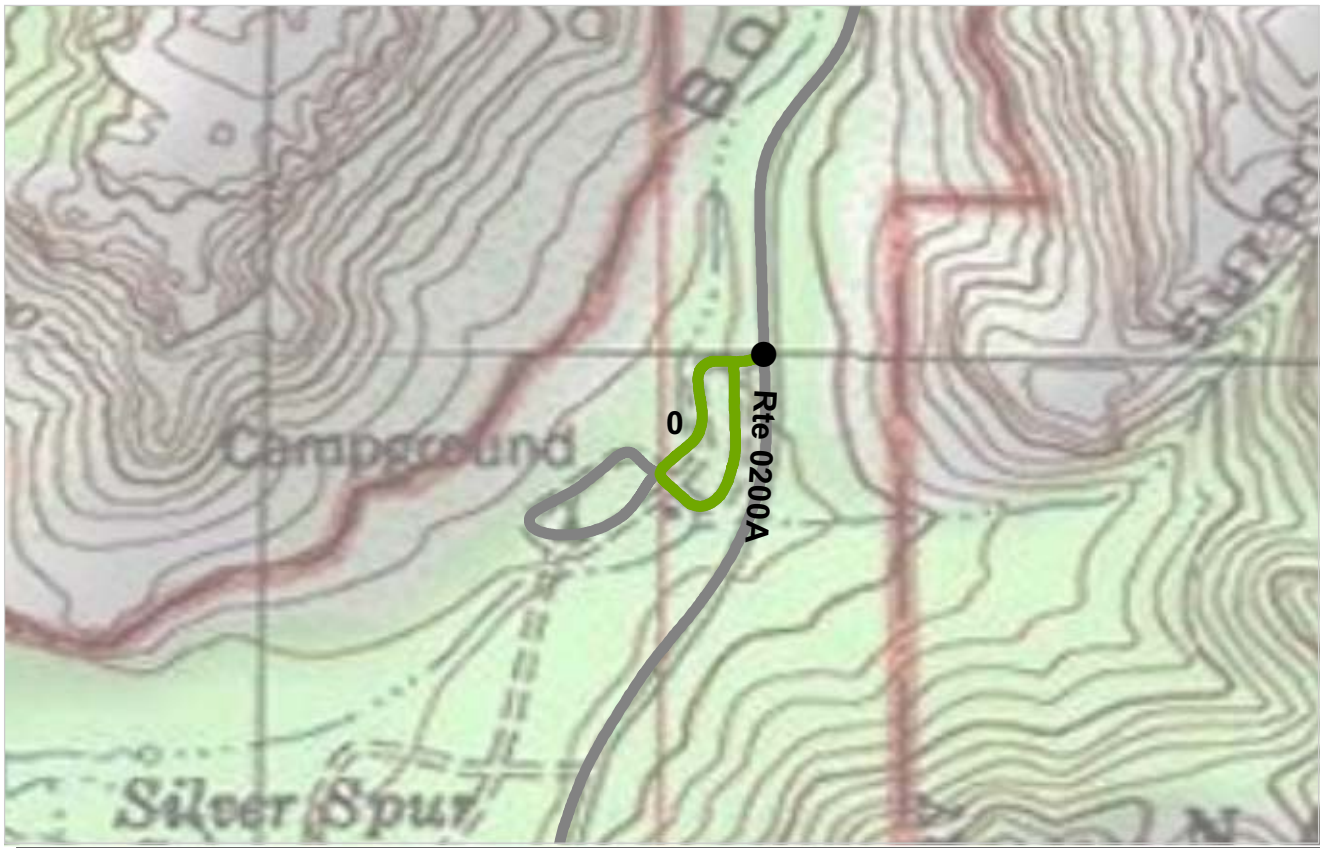
ROUTE: 0200A BONITA CANYON CAMPGROUND LOOP A

Section Number	0				
Section Length (mi)	0.24				
Cross Section Information					
Number of Lanes	1				
Paved Width (ft)	17				
Lane Width (ft)	17				
Roadway Condition Information					
SCR (Surface Condition Rating)	86				
PCR (Pavement Condition Rating)	86				
Distress Index Values					
Structural Crack Index	86				
Transverse Cracking Index	96				
Patching Index	99				
Rutting Index	91				
Roughness Condition Index (RCI)	NC

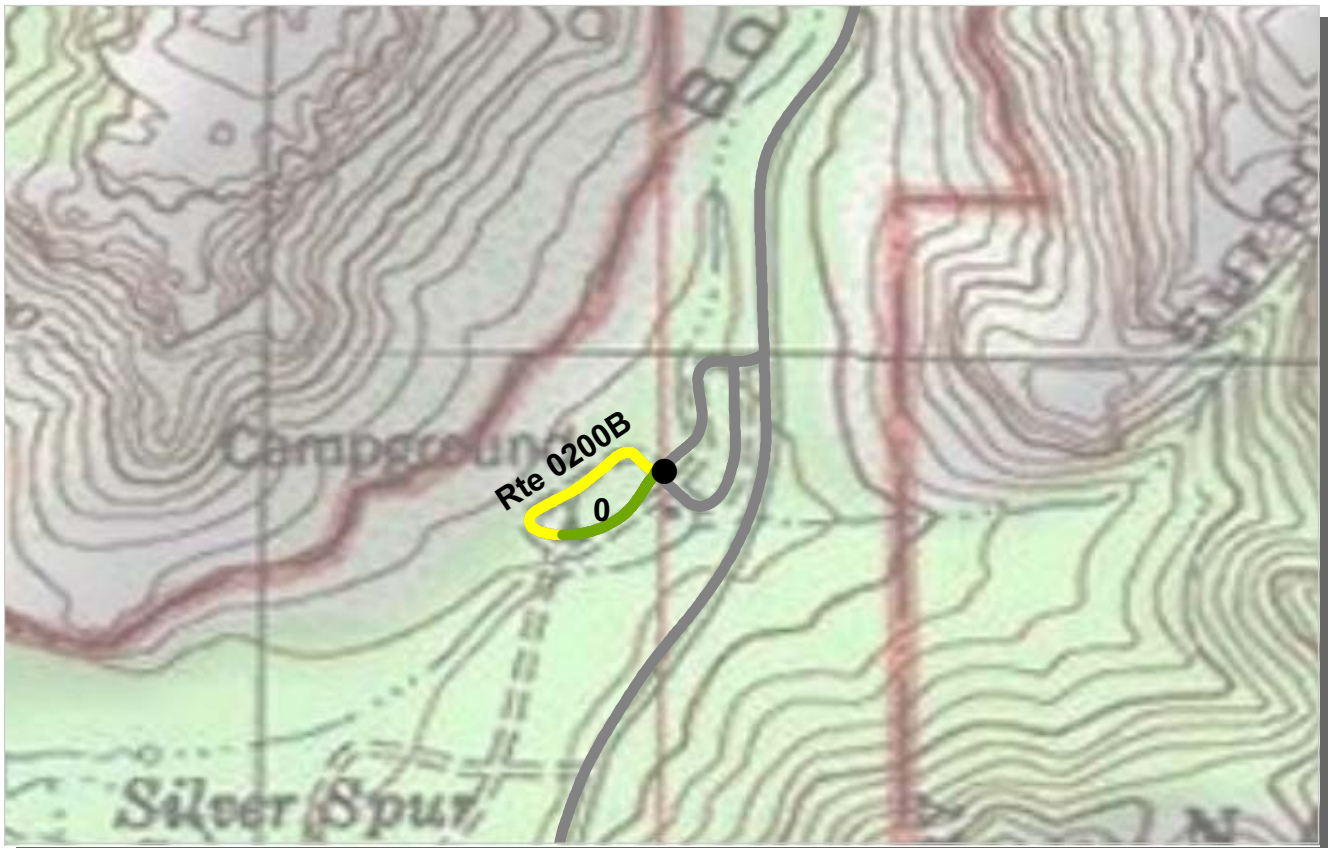
ROUTE: 0200B BONITA CANYON CAMPGROUND LOOP B

Section Number	0				
Section Length (mi)	0.19				
Cross Section Information					
Number of Lanes	1				
Paved Width (ft)	15				
Lane Width (ft)	15				
Roadway Condition Information					
SCR (Surface Condition Rating)	86				
PCR (Pavement Condition Rating)	86				
Distress Index Values					
Structural Crack Index	86				
Transverse Cracking Index	95				
Patching Index	100				
Rutting Index	90				
Roughness Condition Index (RCI)	NC

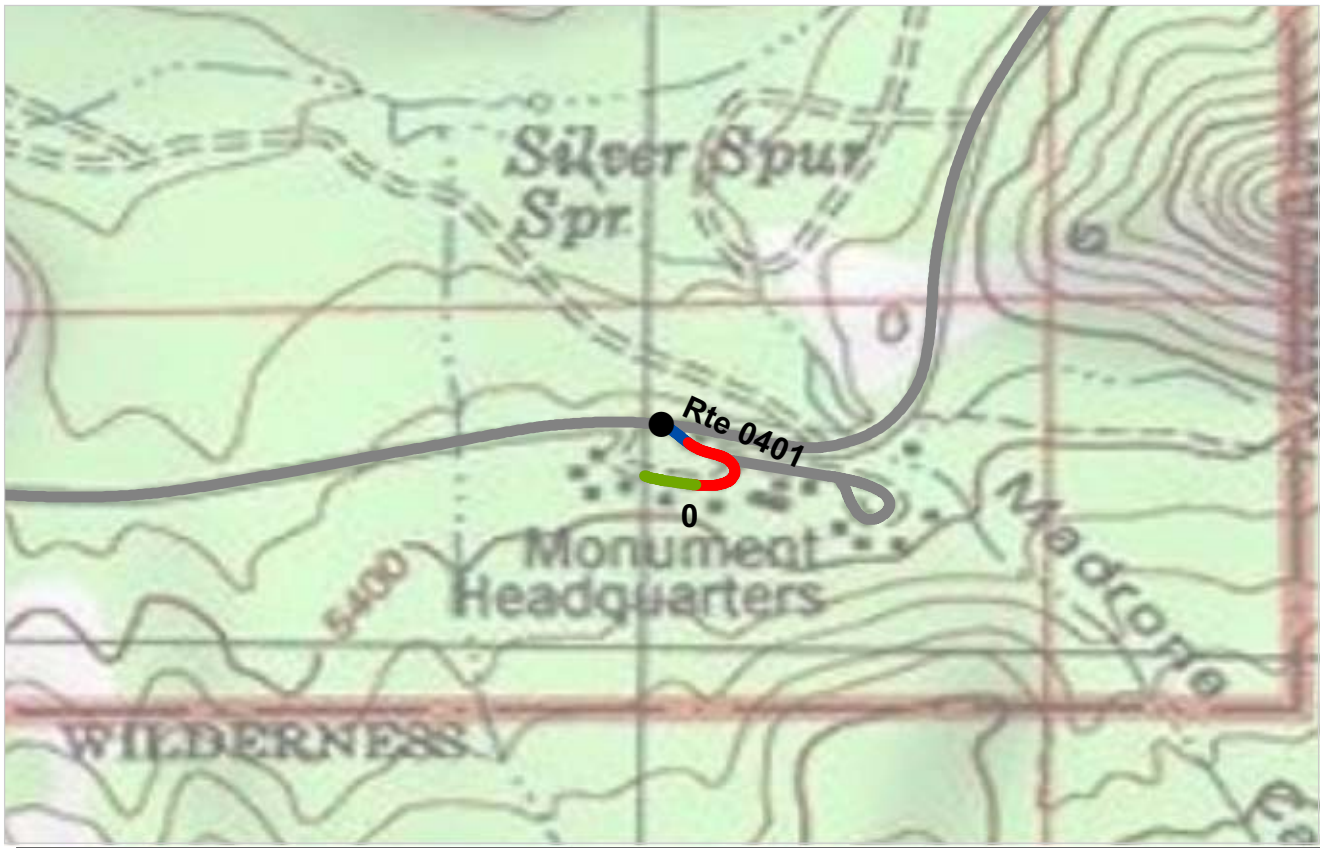
ROUTE: 0401 WEST HOUSING ROAD

Section Number	0				
Section Length (mi)	0.11				
Cross Section Information					
Number of Lanes	2				
Paved Width (ft)	21				
Lane Width (ft)	11				
Roadway Condition Information					
SCR (Surface Condition Rating)	58				
PCR (Pavement Condition Rating)	58				
Distress Index Values					
Structural Crack Index	58				
Transverse Cracking Index	91				
Patching Index	100				
Rutting Index	94				
Roughness Condition Index (RCI)	NC

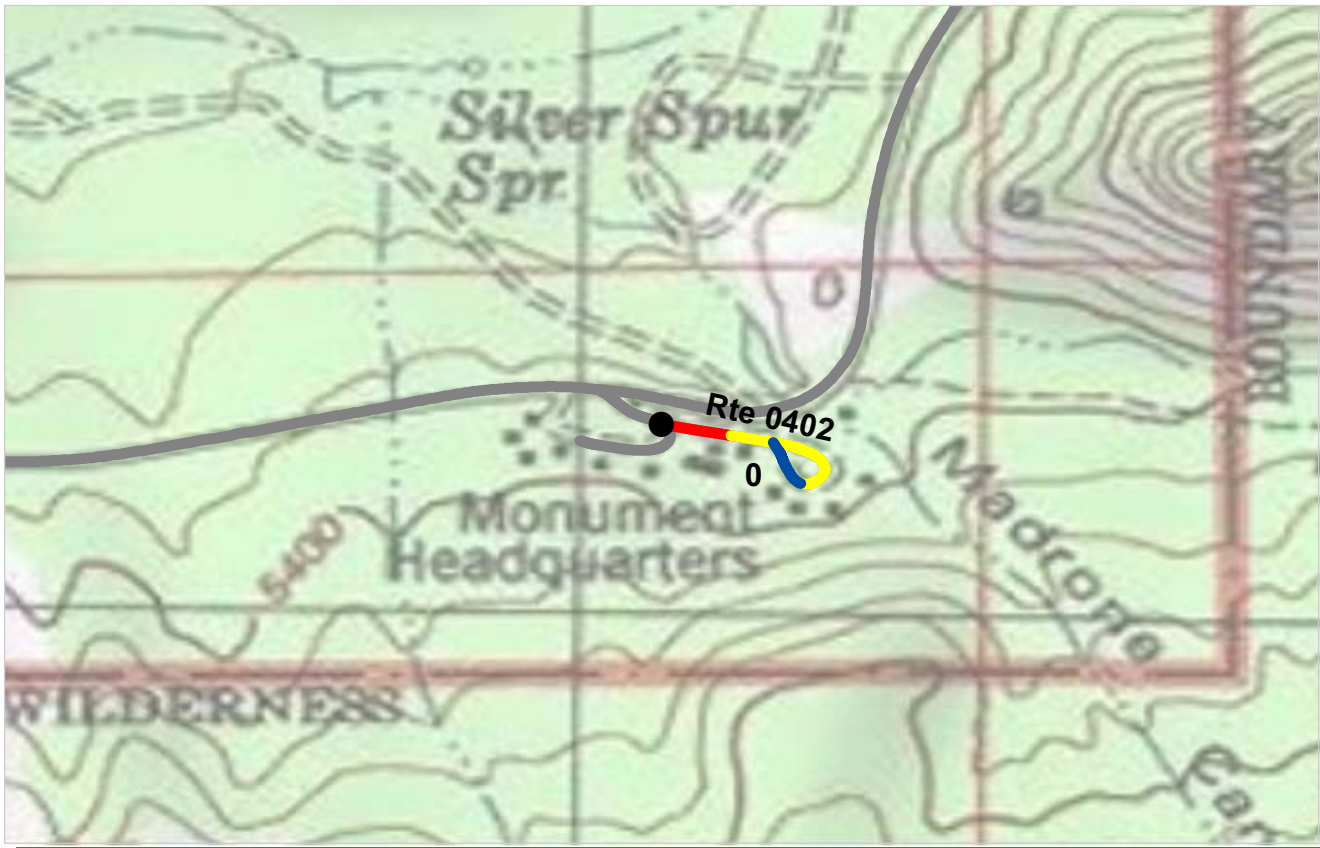
ROUTE: 0402 EAST HOUSING ROAD

Section Number	0				
Section Length (mi)	0.15				
Cross Section Information					
Number of Lanes	2				
Paved Width (ft)	17				
Lane Width (ft)	8				
Roadway Condition Information					
SCR (Surface Condition Rating)	46				
PCR (Pavement Condition Rating)	46				
Distress Index Values					
Structural Crack Index	46				
Transverse Cracking Index	90				
Patching Index	98				
Rutting Index	95				
Roughness Condition Index (RCI)	NC

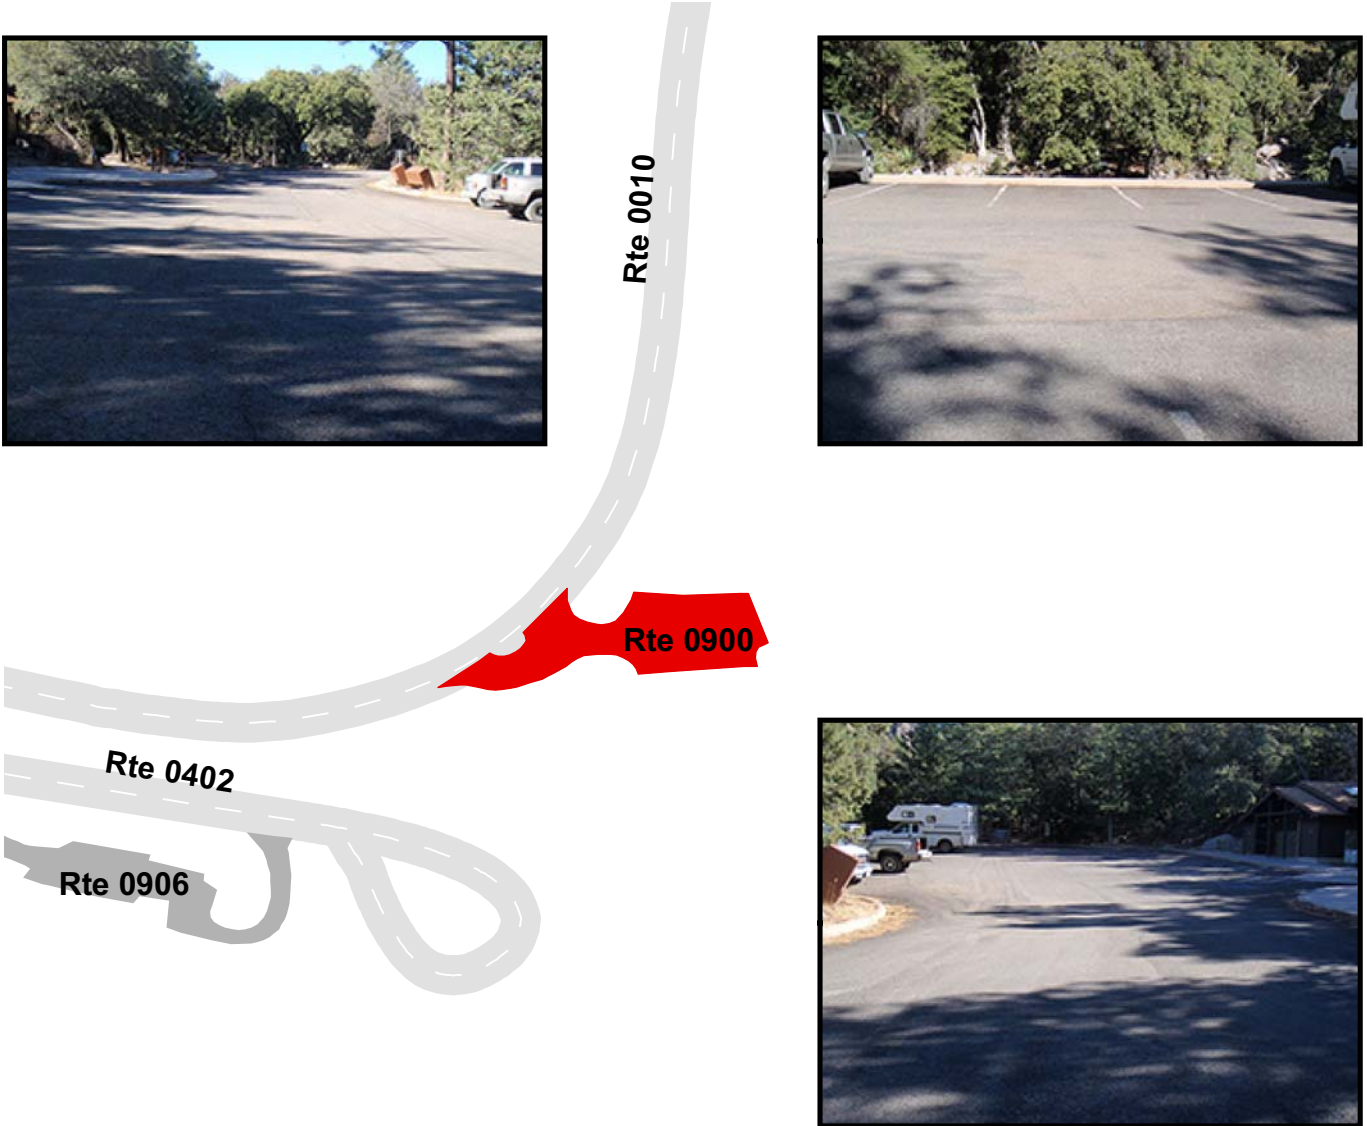
Route Number	Public / NonPublic	Date Visited	Area (sq ft)	Lane Miles *	Surface Type
0900	PUBLIC	12/6/2010	13,949	0.24	AS
Culverts	Drop Inlets	Gates	Curb & Gutter	Curb	PCR
0	0	0	CONCRETE CURB AND GUTTER	CONCRETE CURB	FAIR/73

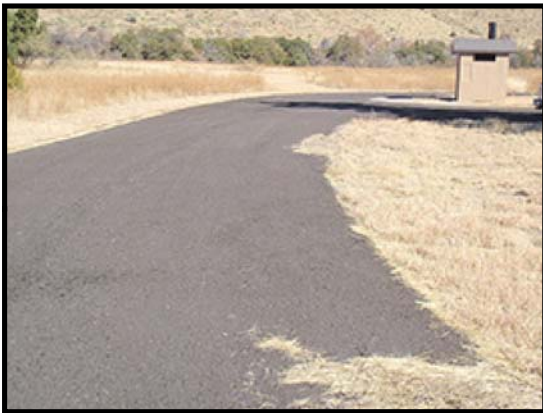
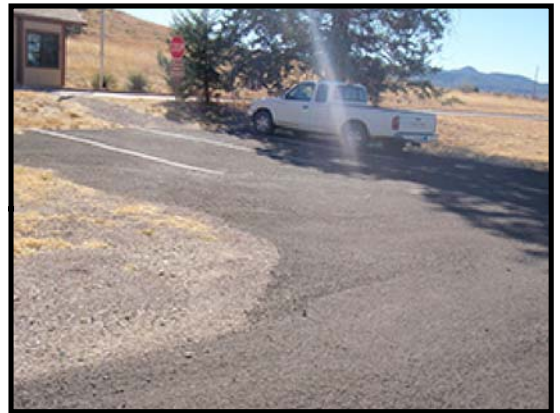
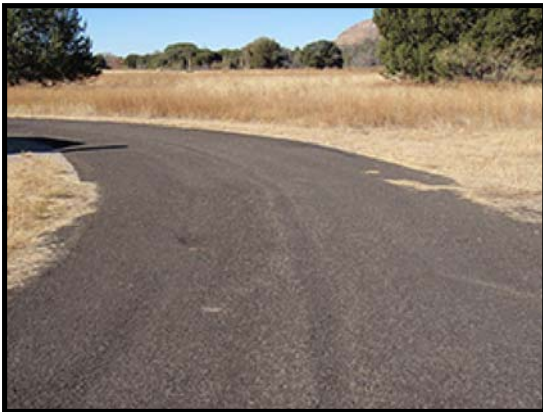
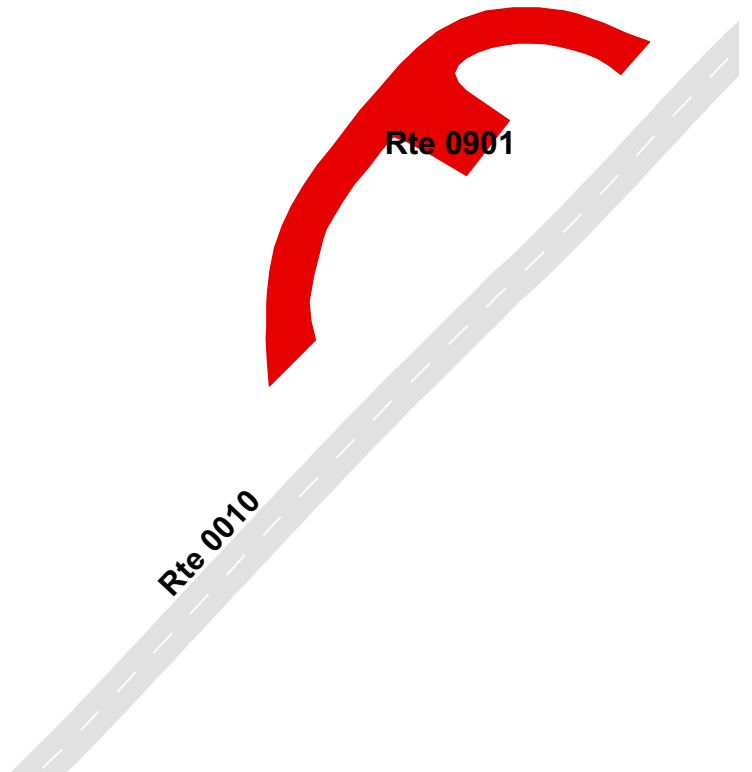
Route 0901

Route Number	Public / NonPublic	Date Visited	Area (sq ft)	Lane Miles *	Surface Type
0901	NONPUBLIC	12/6/2010	5,986	0.10	AS
Culverts	Drop Inlets	Gates	Curb & Gutter	Curb	PCR
0	0	1	NO CURB AND GUTTER	NO CURB	GOOD/90

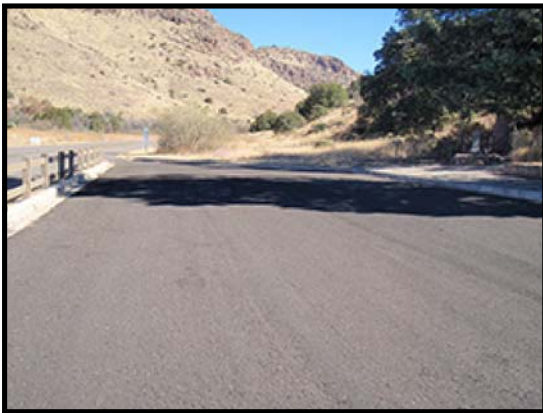
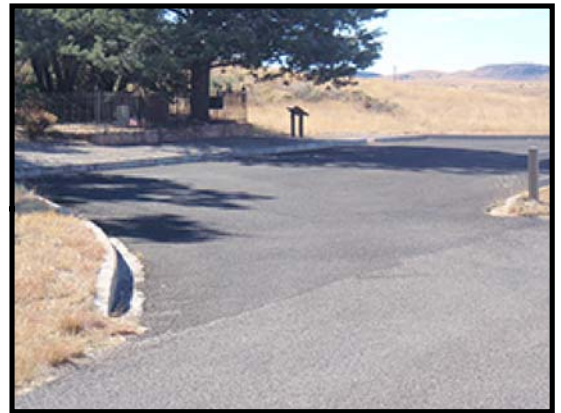
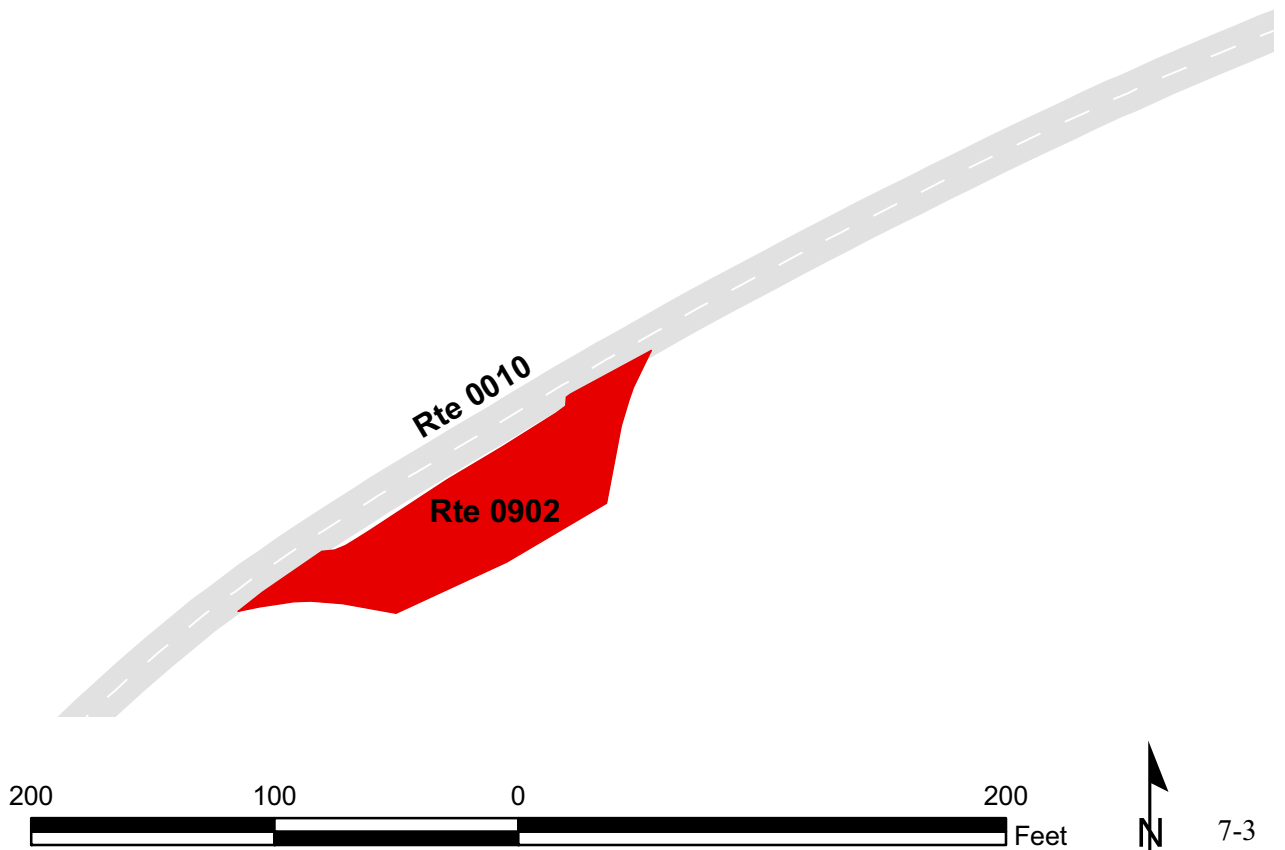
Route 0902

Route Number	Public / NonPublic	Date Visited	Area (sq ft)	Lane Miles *	Surface Type
0902	PUBLIC	12/6/2010	4,848	0.08	AS
Culverts	Drop Inlets	Gates	Curb & Gutter	Curb	PCR
0	1	0	CONCRETE CURB AND GUTTER	NO CURB	GOOD/90

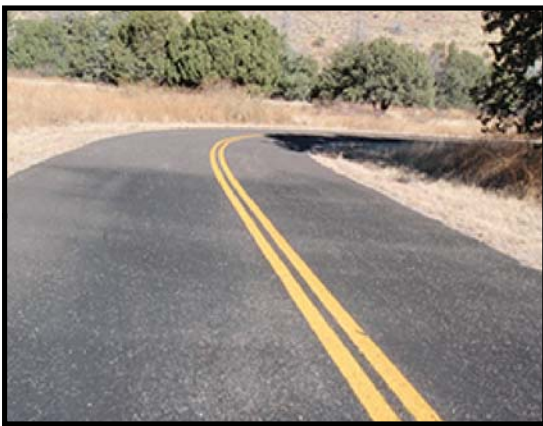
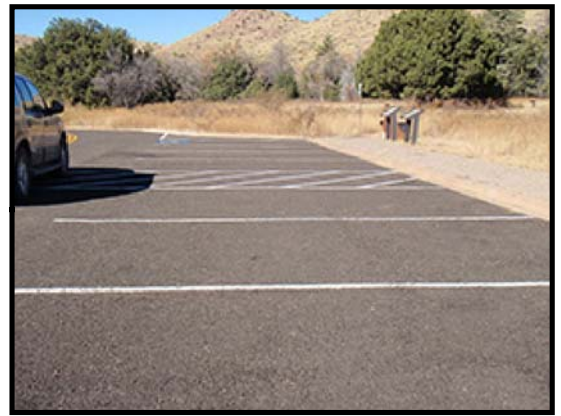
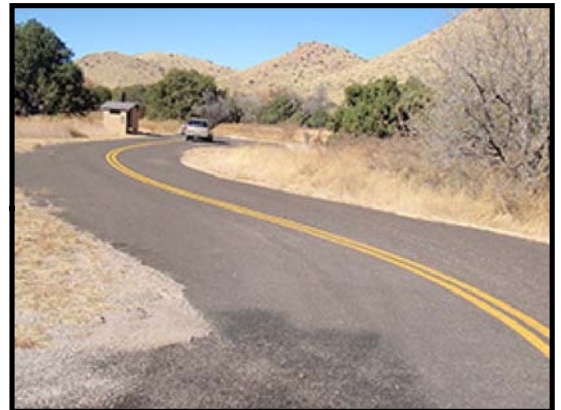
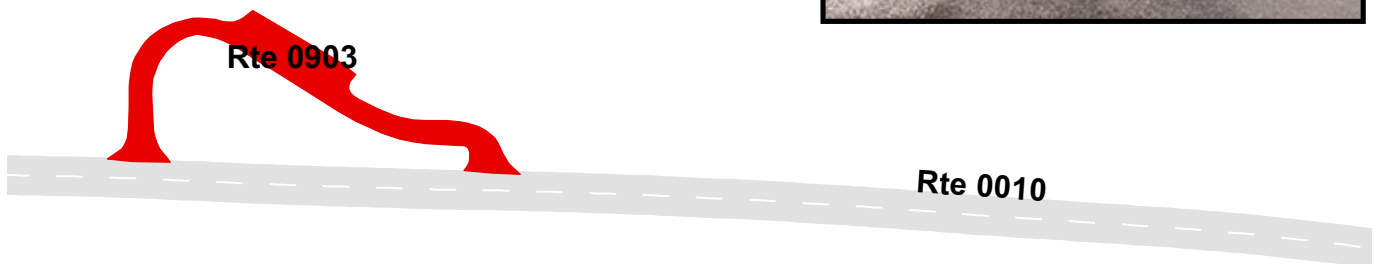
Route 0903

Route Number	Public / NonPublic	Date Visited	Area (sq ft)	Lane Miles *	Surface Type
0903	PUBLIC	12/6/2010	11,483	0.20	AS
Culverts	Drop Inlets	Gates	Curb & Gutter	Curb	PCR
0	0	0	CONCRETE CURB AND GUTTER	NO CURB	GOOD/90

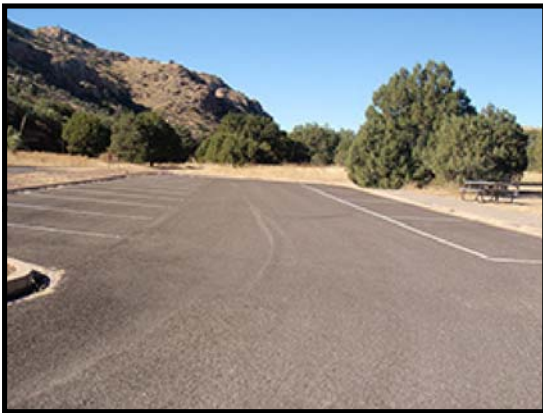
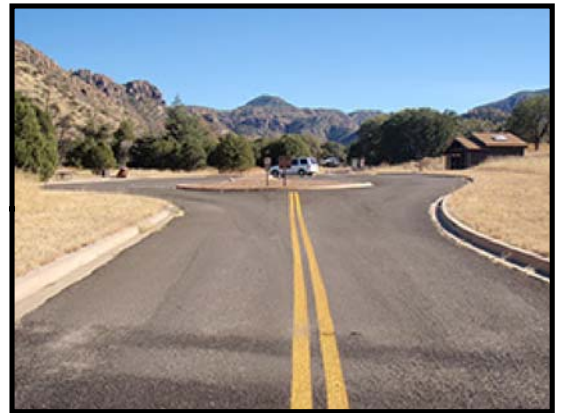
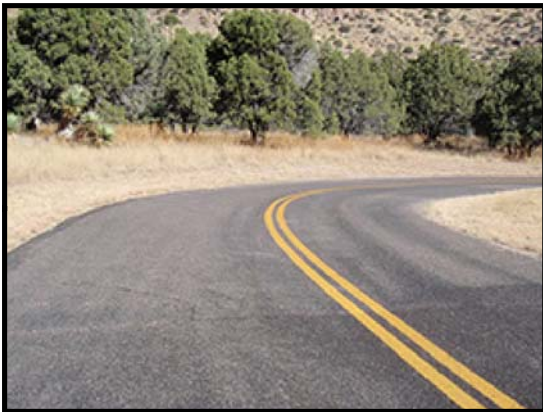
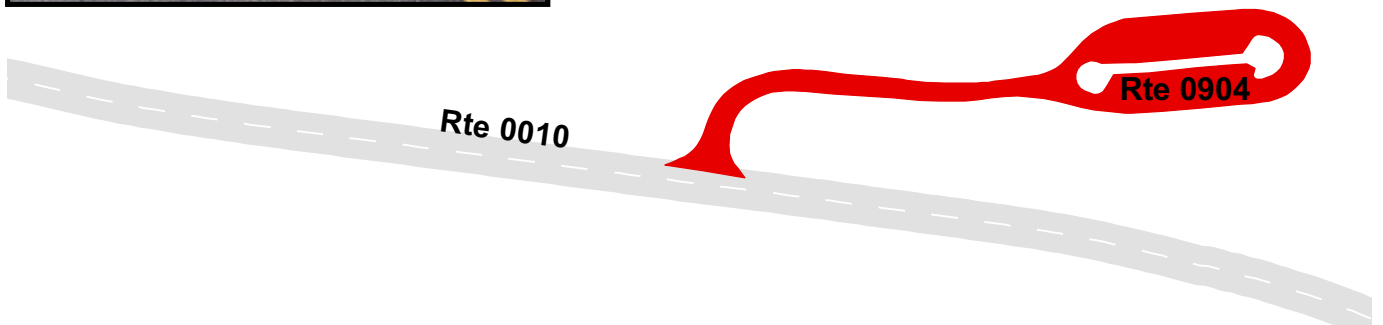
Route 0904

Route Number	Public / NonPublic	Date Visited	Area (sq ft)	Lane Miles *	Surface Type
0904	PUBLIC	12/6/2010	23,400	0.40	AS
Culverts	Drop Inlets	Gates	Curb & Gutter	Curb	PCR
0	0	0	CONCRETE CURB AND GUTTER	NO CURB	GOOD/90
