Federal Lands Highway Road Inventory Program

Road Inventory and Condition Assessment

Chiricahua National Monument

Cycle 5 Report

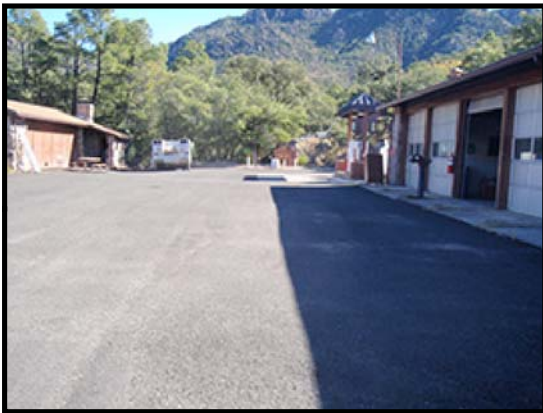
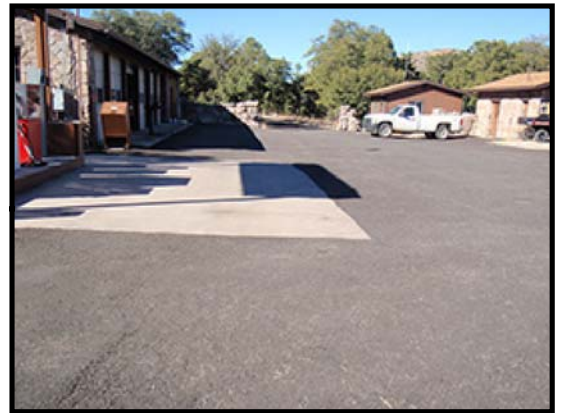
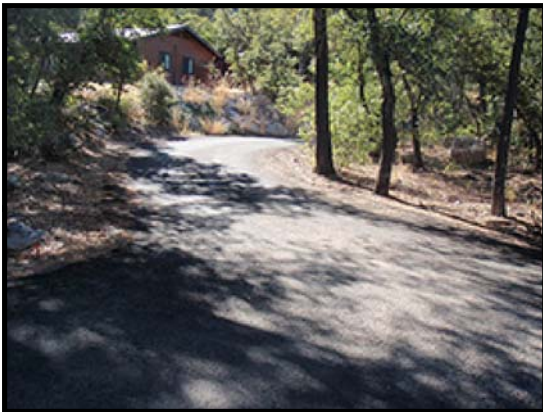
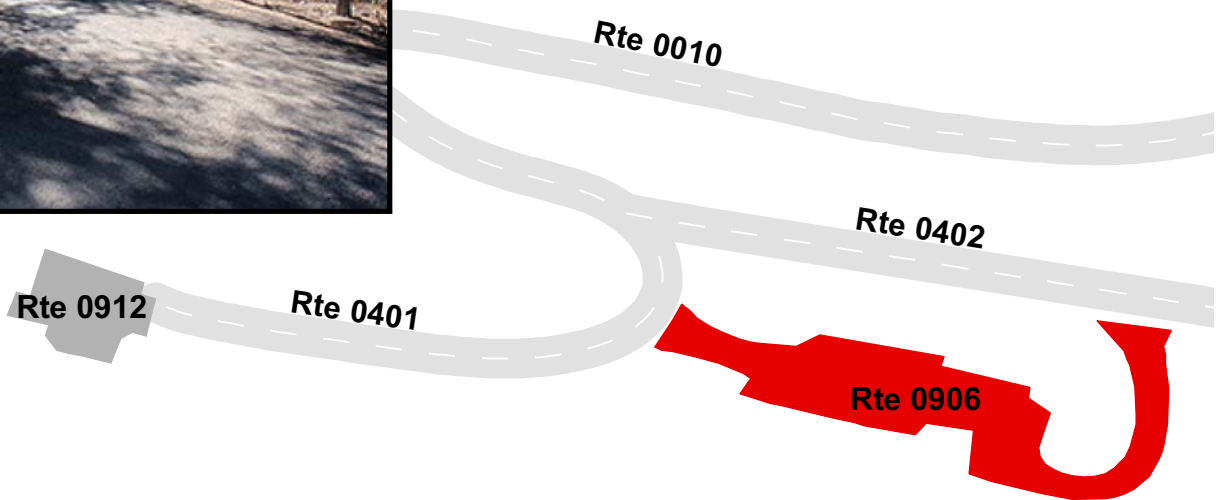
Route 0906

Route Number	Public / NonPublic	Date Visited	Area (sq ft)	Lane Miles *	Surface Type
0906	NONPUBLIC	12/6/2010	11,014	0.19	AS
Culverts	Drop Inlets	Gates	Curb & Gutter	Curb	PCR
1	0	0	NO CURB AND GUTTER	NO CURB	FAIR/73

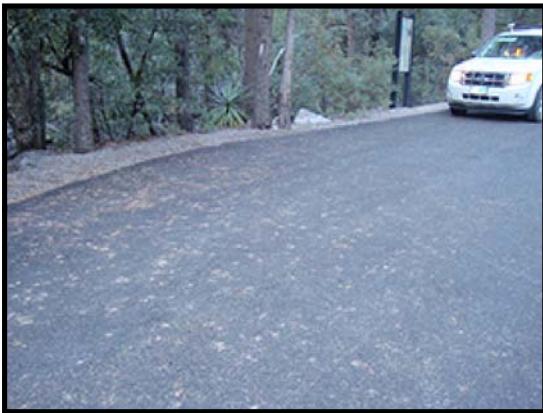
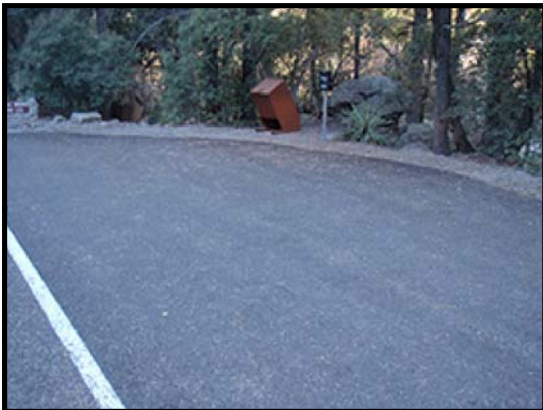
Route Number	Public / NonPublic	Date Visited	Area (sq ft)	Lane Miles *	Surface Type
0907	PUBLIC	12/6/2010	1,255	0.02	AS
Culverts	Drop Inlets	Gates	Curb & Gutter	Curb	PCR
0	0	0	NO CURB AND GUTTER	NO CURB	GOOD/90

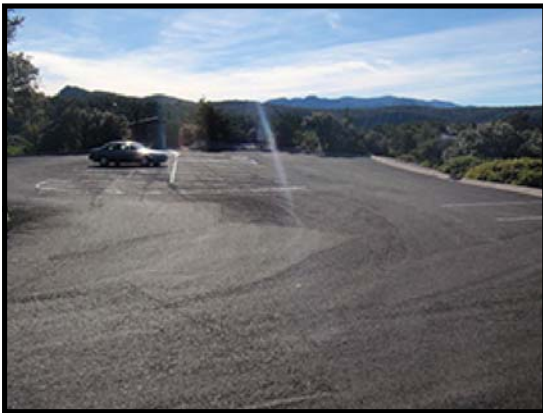
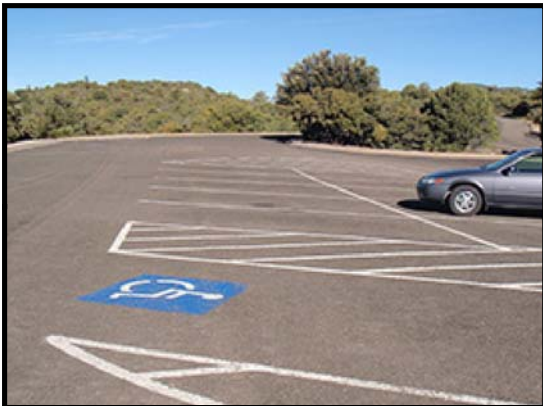
Route 0908

Route Number	Public / NonPublic	Date Visited	Area (sq ft)	Lane Miles *	Surface Type
0908	PUBLIC	12/6/2010	15,624	0.27	AS
Culverts	Drop Inlets	Gates	Curb & Gutter	Curb	PCR
0	0	0	CONCRETE CURB AND GUTTER	NO CURB	GOOD/90

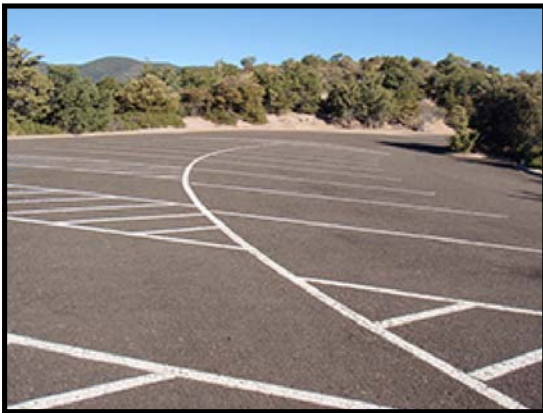
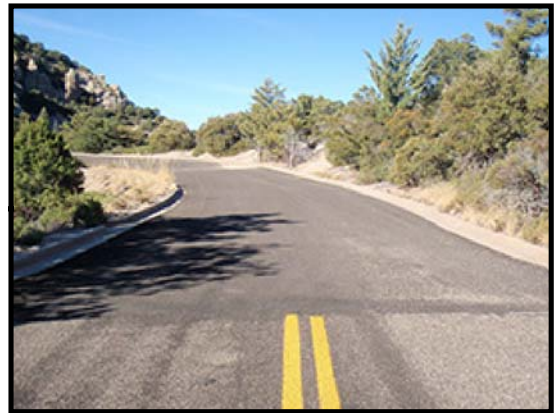
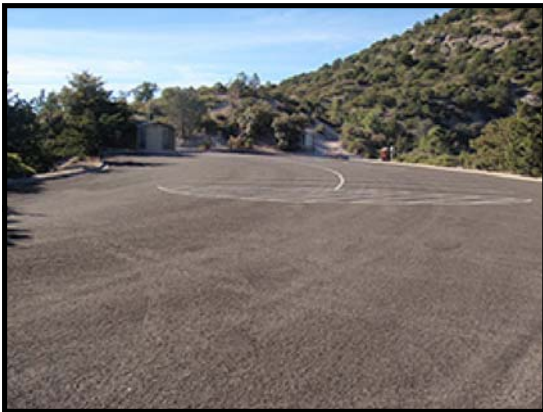
Route 0909

Route Number	Public / NonPublic	Date Visited	Area (sq ft)	Lane Miles *	Surface Type
0909	PUBLIC	12/6/2010	17,430	0.30	AS
Culverts	Drop Inlets	Gates	Curb & Gutter	Curb	PCR
0	0	0	CONCRETE CURB AND GUTTER	NO CURB	GOOD/90

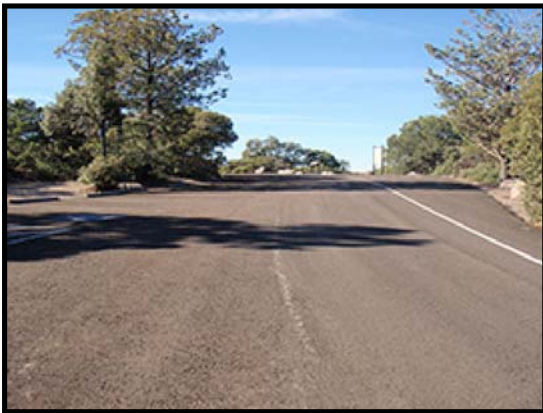
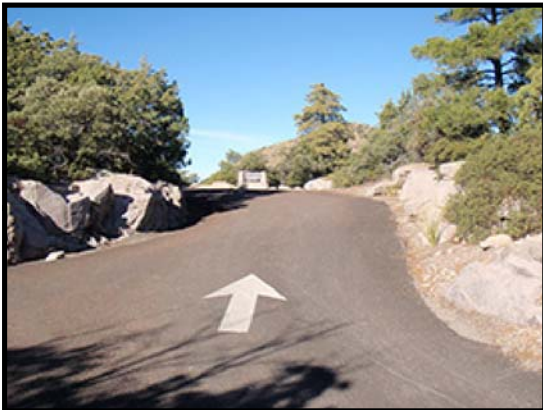
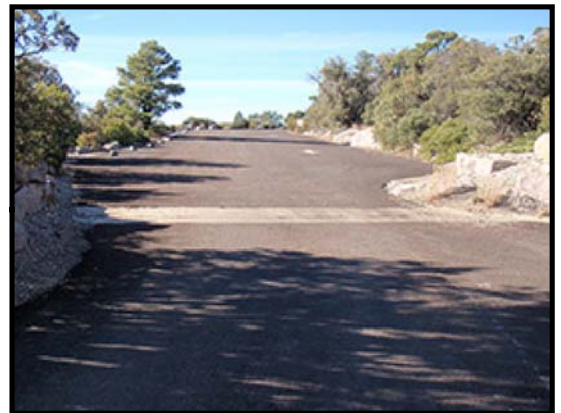
Route 0910

Route Number	Public / NonPublic	Date Visited	Area (sq ft)	Lane Miles *	Surface Type
0910	PUBLIC	12/6/2010	23,038	0.40	AS
Culverts	Drop Inlets	Gates	Curb & Gutter	Curb	PCR
1	0	0	NO CURB AND GUTTER	CONCRETE CURB	GOOD/90

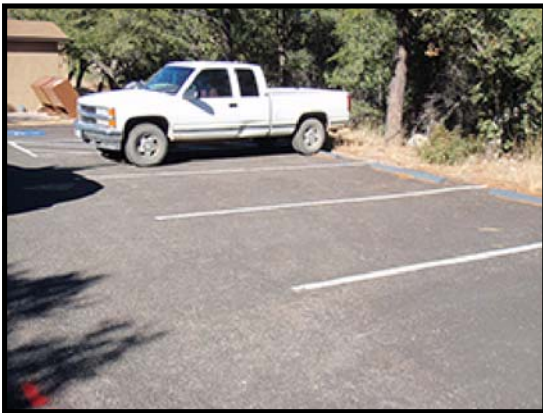
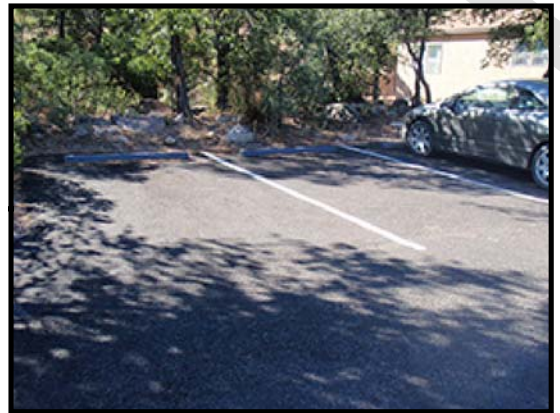
Route 0912

Route Number	Public / NonPublic	Date Visited	Area (sq ft)	Lane Miles *	Surface Type
0912	NONPUBLIC	12/6/2010	3,193	0.06	AS
Culverts	Drop Inlets	Gates	Curb & Gutter	Curb	PCR
0	0	0	NO CURB AND GUTTER	NO CURB	GOOD/90
