# Federal Lands Highway Road Inventory Program

Road Inventory and Condition Assessment

## Congaree National Park CONG

### Cycle 5 Report

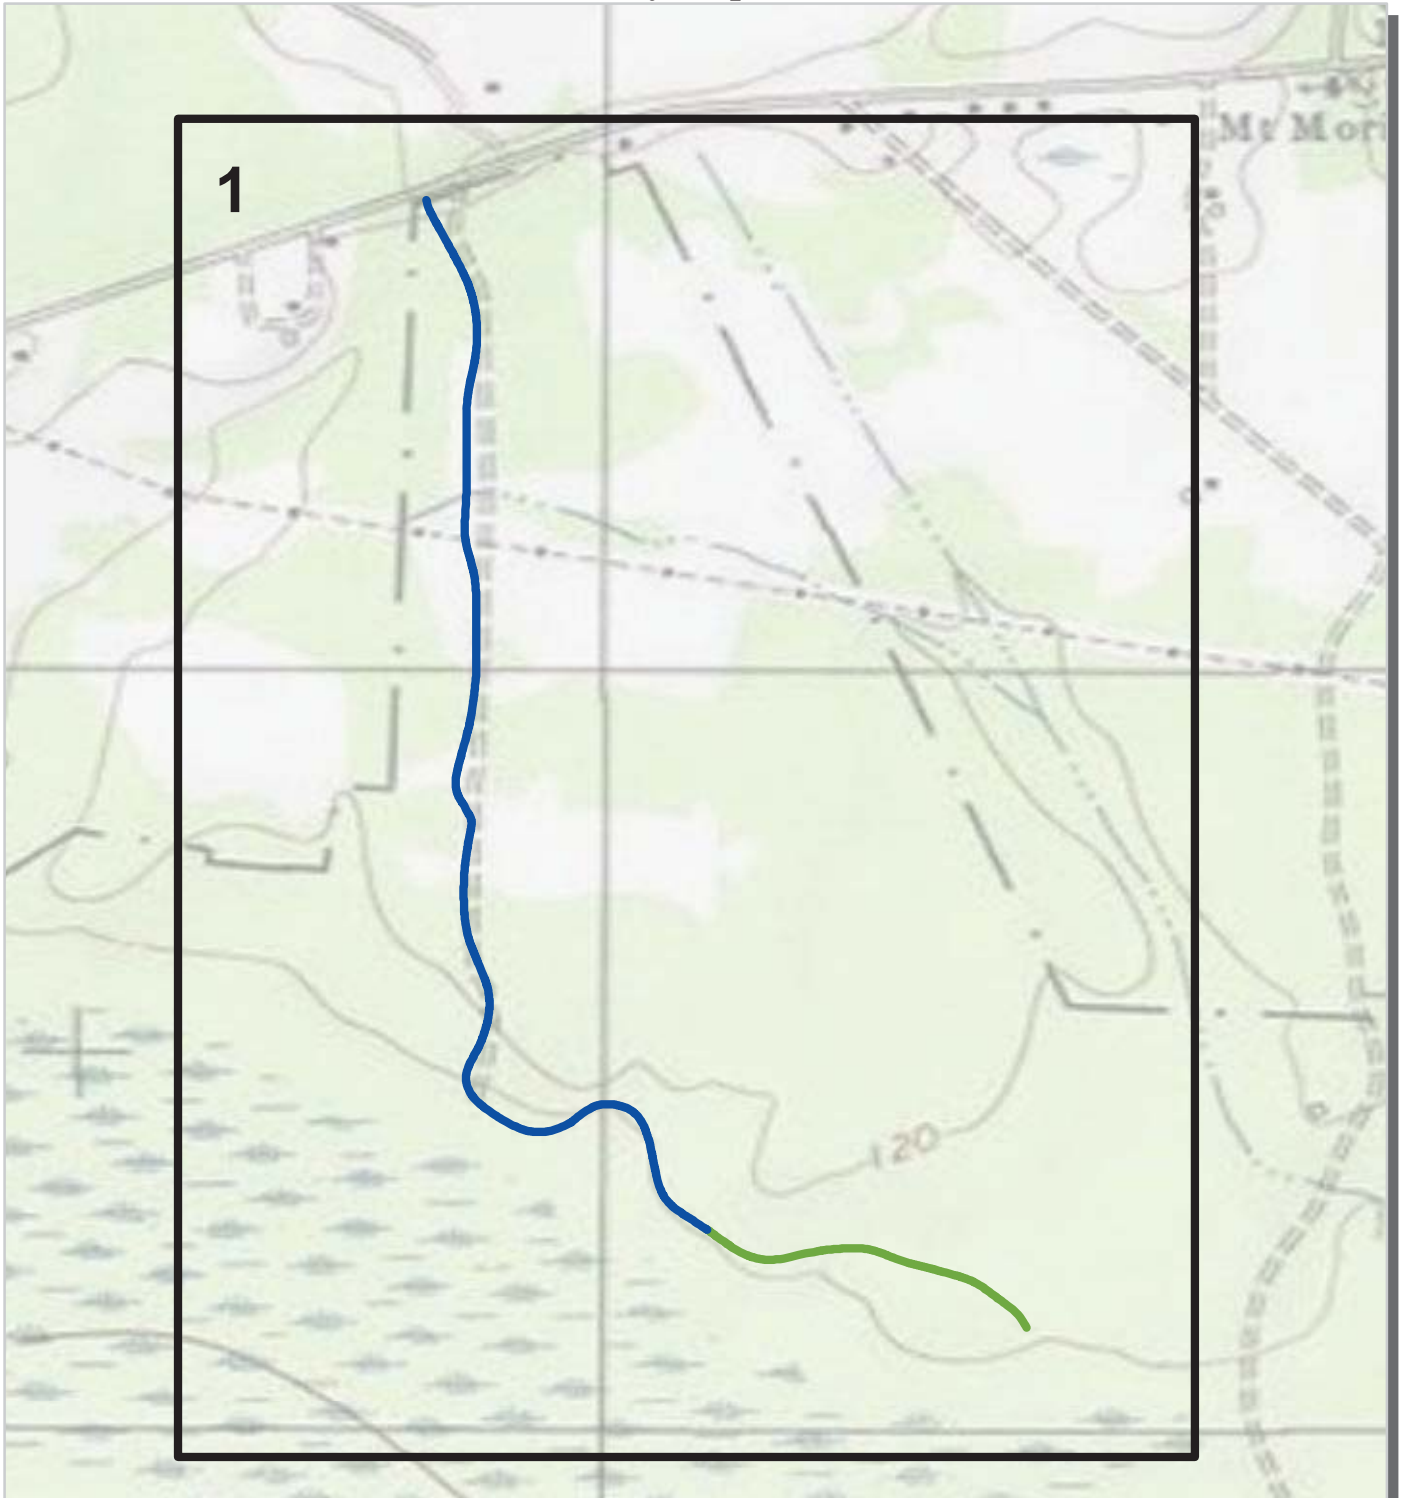
**Congaree National Park  
Route Condition Map  
PCR - Mile by Mile  
Key Map**

PCR	Poor	Fair	Good	Excellent	No Data
	(0 - 60)	(61 - 84)	(85 - 94)	(95 - 100)

\* If the PCR rating is not available for a section, the SCR rating will be displayed. See appendix for definitions and formulas.

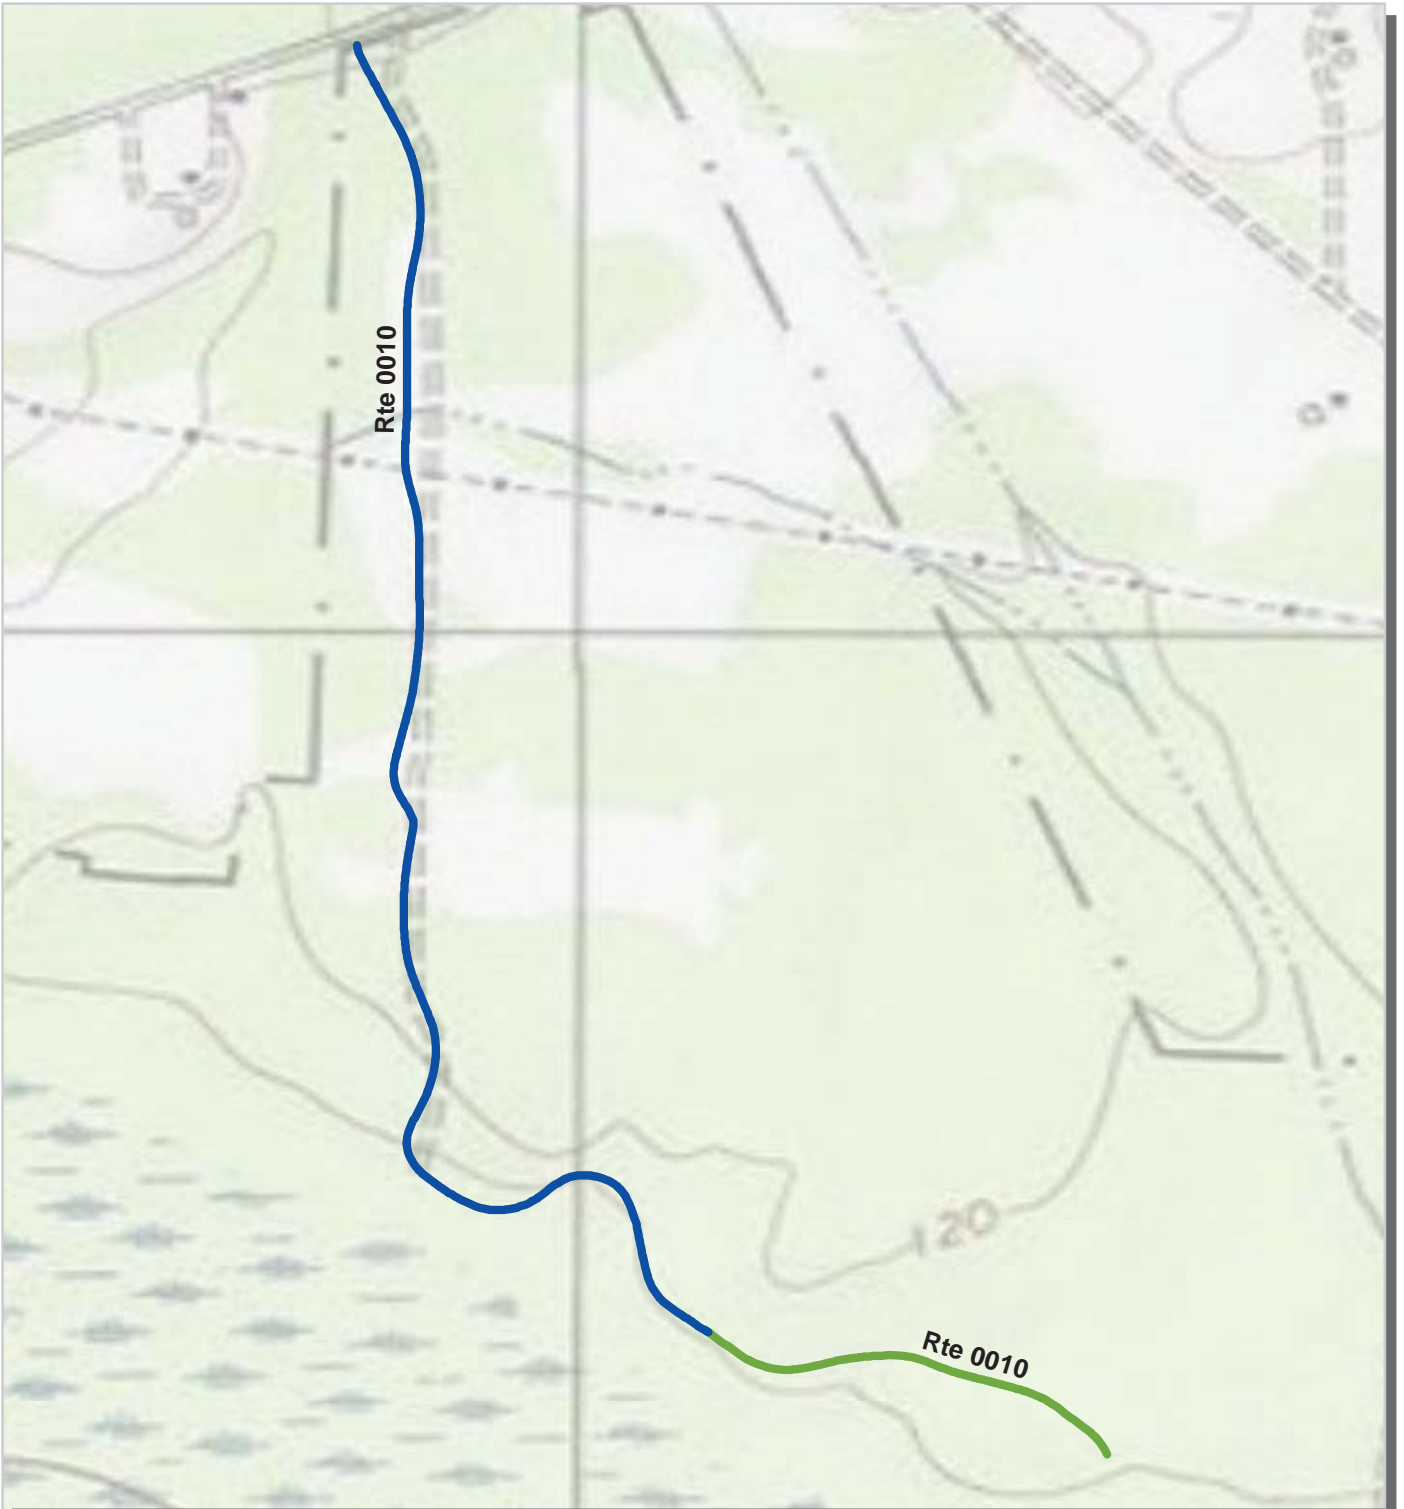
**Congaree National Park  
Route Condition Map  
PCR - Mile by Mile  
Area 1**

PCR	Poor	Fair	Good	Excellent	No Data
	(0 - 60)	(61 - 84)	(85 - 94)	(95 - 100)

\* If the PCR rating is not available for a section, the SCR rating will be displayed. See appendix for definitions and formulas.

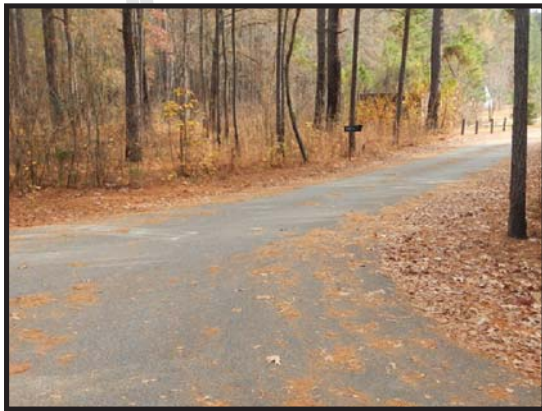
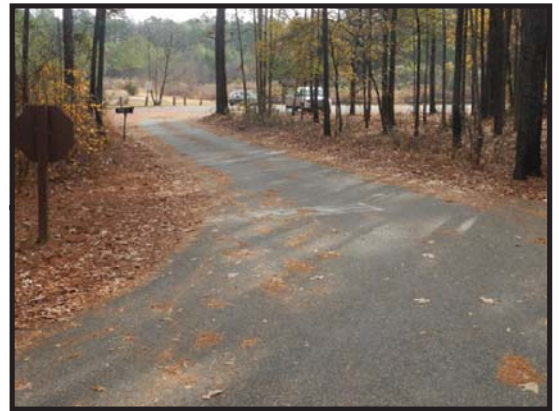
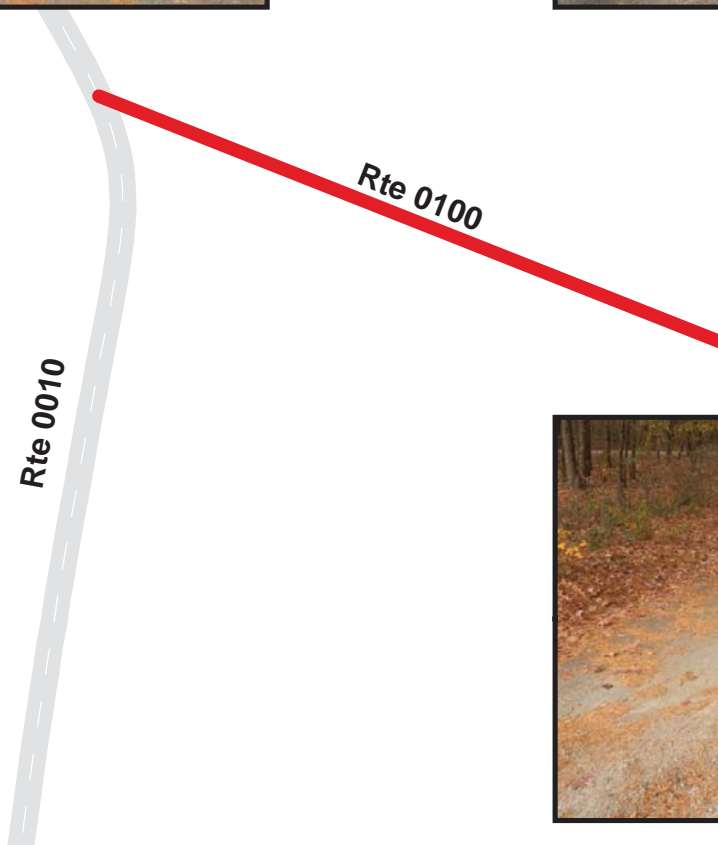
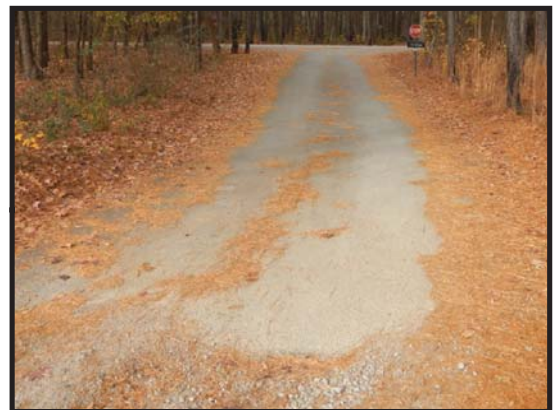
Route Number	Public / NonPublic	Date Visited	Area (sq ft)	Lane Miles *	Paved Length (mi)	Paved Width (ft)
0100	PUBLIC	12/4/2012	1,426	0.03	0.02	15
Culverts	Drop Inlets	Gates	Curb & Gutter	Curb	PCR	Surface Type
0	0	0	NO CURB AND GUTTER	NO CURB	GOOD/90	AS

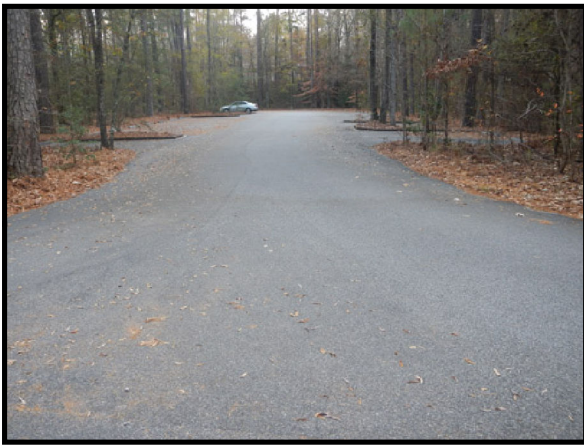
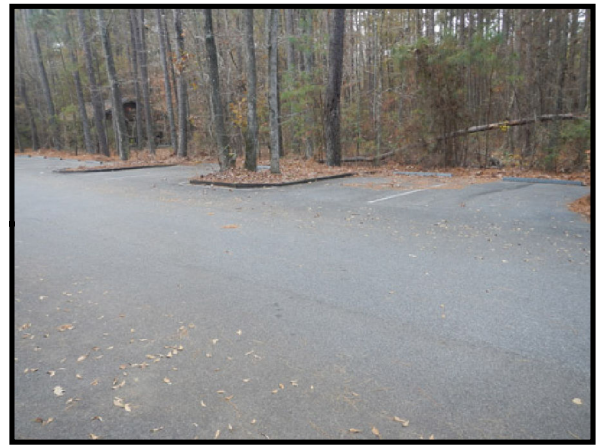
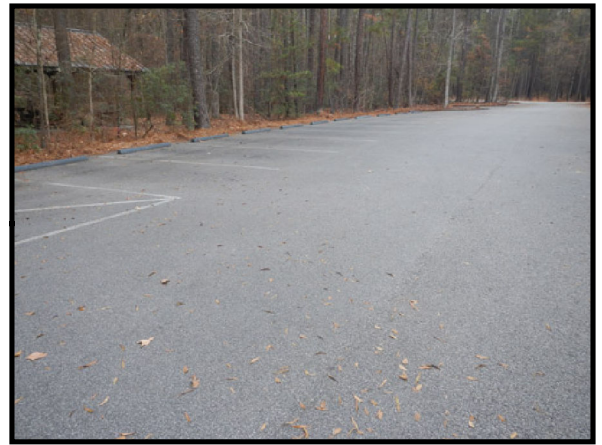
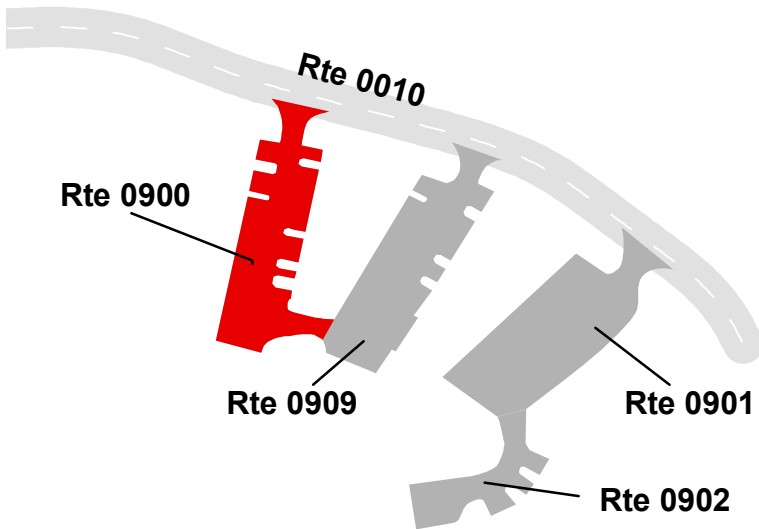
Route Number	Public / NonPublic	Date Visited	Area (sq ft)	Lane Miles *	Surface Type
0900	PUBLIC	12/4/2012	13,641	0.24	AS
Culverts	Drop Inlets	Gates	Curb & Gutter	Curb	PCR
0	0	0	NO CURB AND GUTTER	WOOD CURB	GOOD/90

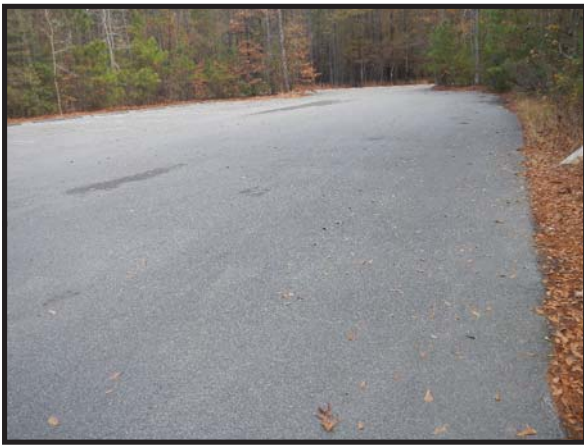
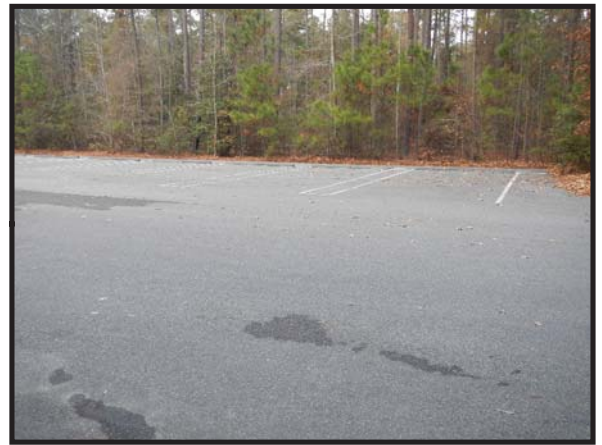
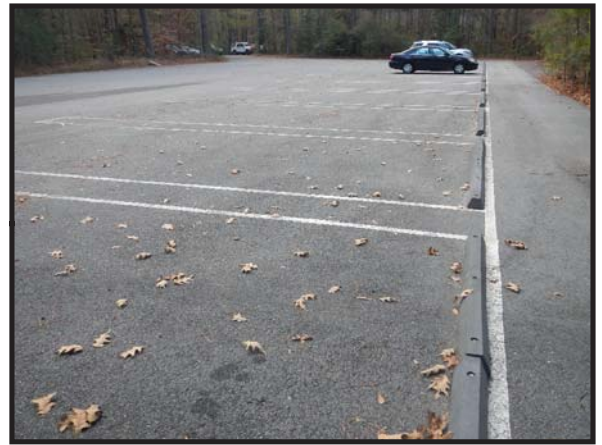
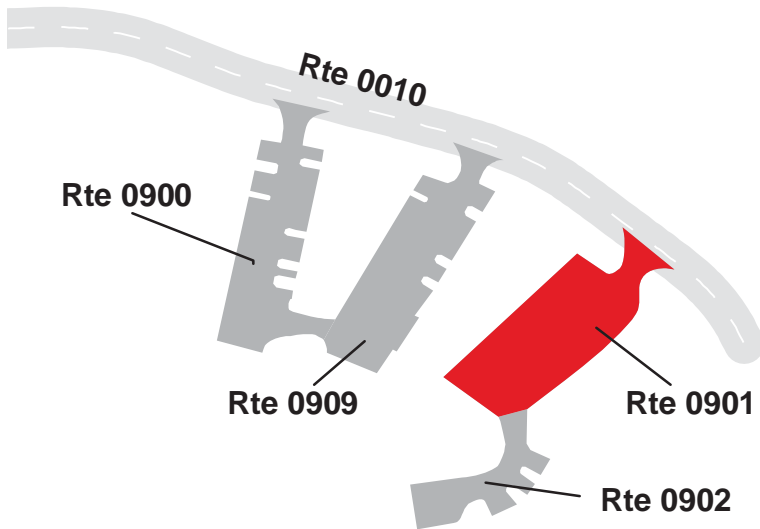
## Route 0901

Route Number	Public / NonPublic	Date Visited	Area (sq ft)	Lane Miles *	Surface Type
0901	PUBLIC	12/4/2012	16,491	0.28	AS
Culverts	Drop Inlets	Gates	Curb & Gutter	Curb	PCR
0	0	0	NO CURB AND GUTTER	NO CURB	GOOD/90

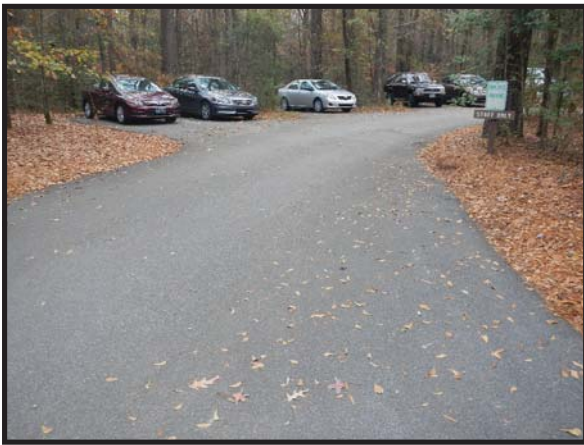
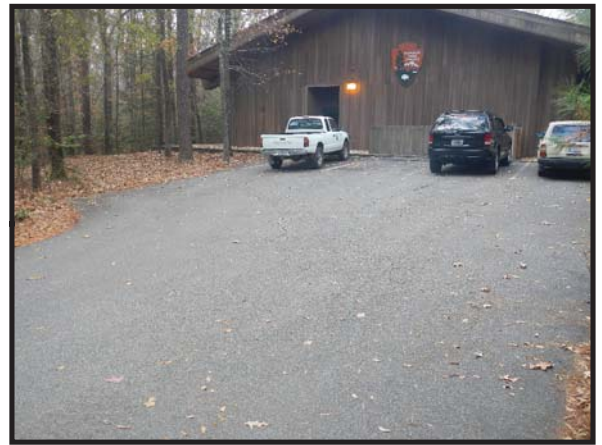
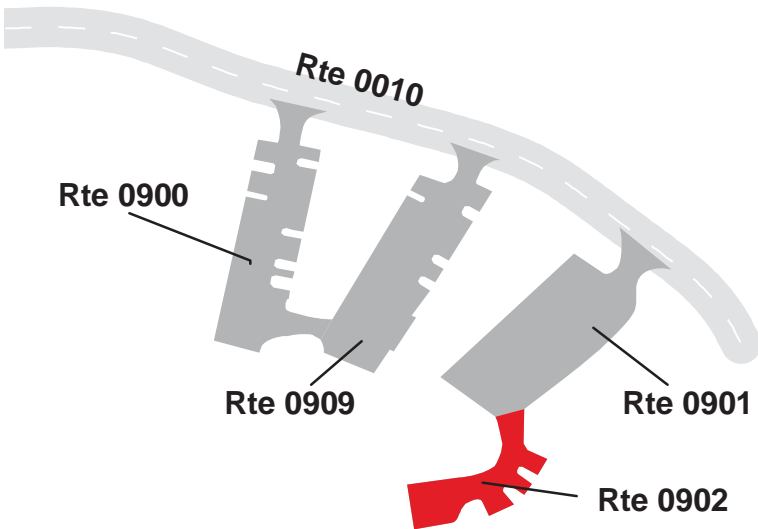
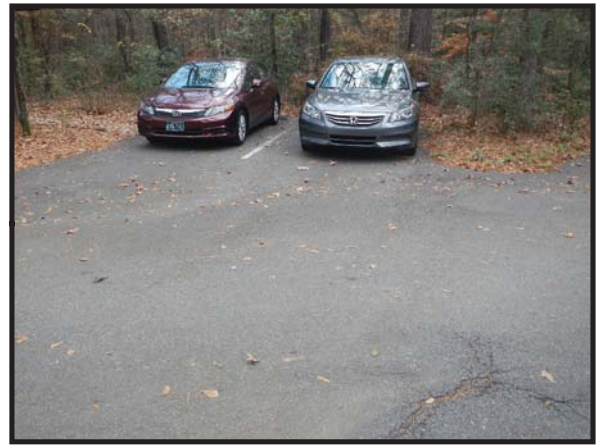
## Route 0902

Route Number	Public / NonPublic	Date Visited	Area (sq ft)	Lane Miles *	Surface Type
0902	NONPUBLIC	12/4/2012	5,801	0.10	AS
Culverts	Drop Inlets	Gates	Curb & Gutter	Curb	PCR
0	0	0	NO CURB AND GUTTER	NO CURB	GOOD/90

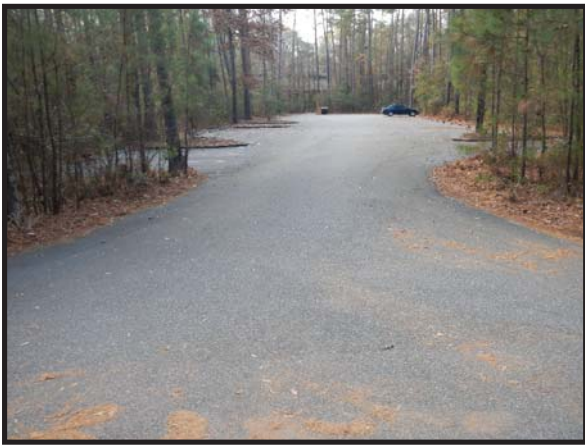
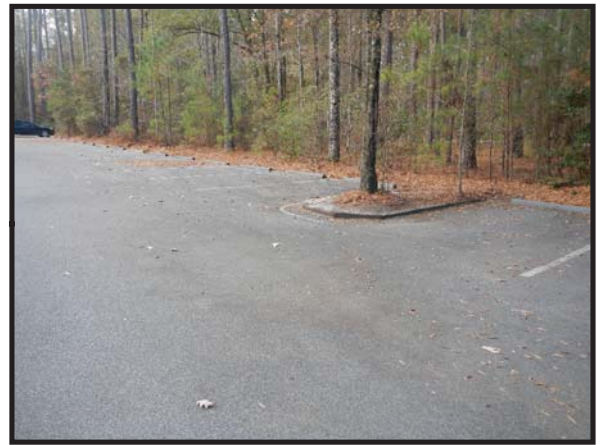
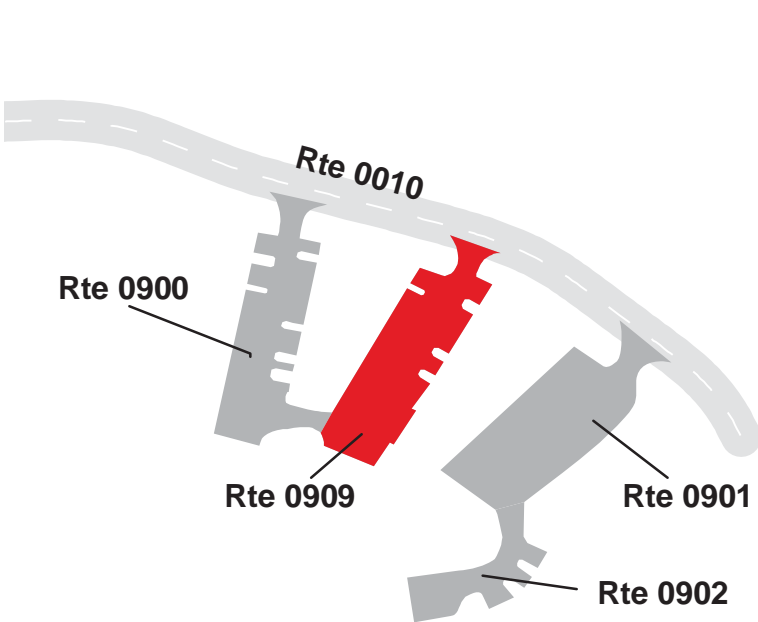
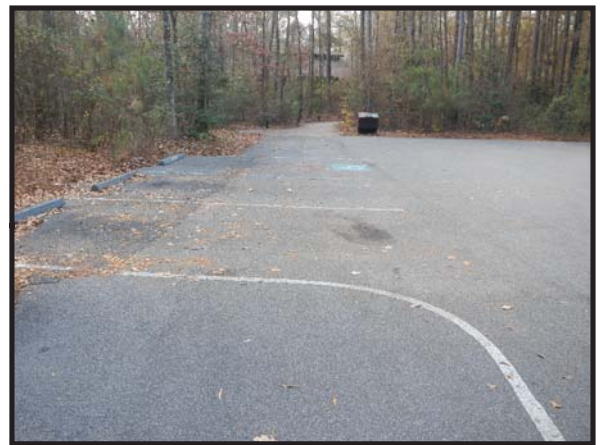
## Route 0909

Route Number	Public / NonPublic	Date Visited	Area (sq ft)	Lane Miles *	Surface Type
0909	PUBLIC	12/4/2012	14,455	0.25	AS
Culverts	Drop Inlets	Gates	Curb & Gutter	Curb	PCR
0	0	0	NO CURB AND GUTTER	WOOD CURB	GOOD/90
