Federal Lands Highway Road Inventory Program

Road Inventory and Condition Assessment

Coronado National Memorial CORO - 8630

Cycle 5 Report

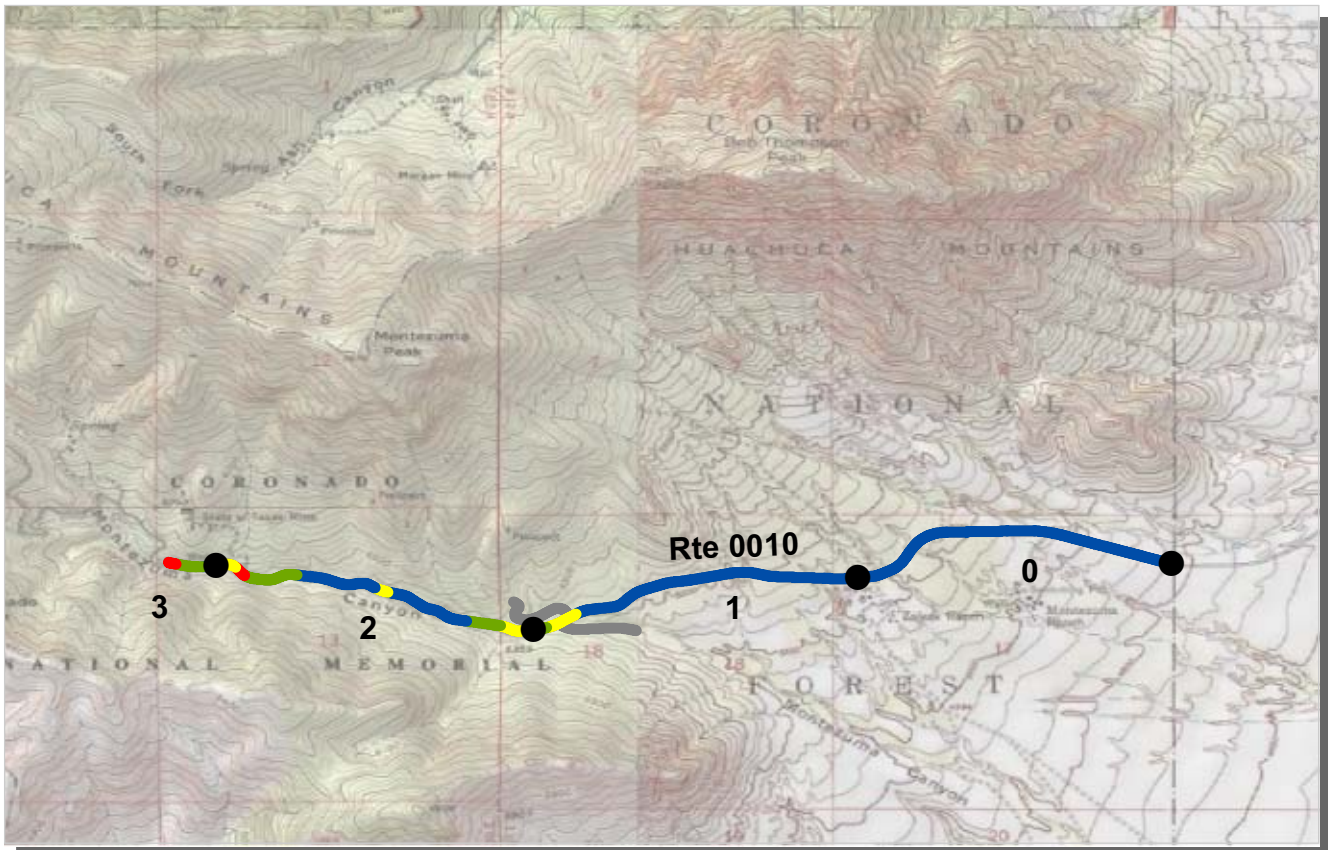
ROUTE: 0010 EAST MONTEZUMA CANYON ROAD

<i>Section Number</i>	0	1	2	3	
<i>Section Length (mi)</i>	1.00	1.00	1.00	0.14	
<i>Cross Section Information</i>					
Number of Lanes	2	2	2	2	
Paved Width (ft)	22	23	22	22	
Lane Width (ft)	12	12	11	11	
<i>Roadway Condition Information</i>					
SCR (Surface Condition Rating)	100	100	98	91	
PCR (Pavement Condition Rating)	100	98	89	86	
<i>Distress Index Values</i>					
Structural Crack Index	100	100	98	91	
Transverse Cracking Index	100	100	100	100	
Patching Index	100	100	100	100	
Rutting Index	100	100	100	100	
Roughness Condition Index (RCI)	100	94	76	78

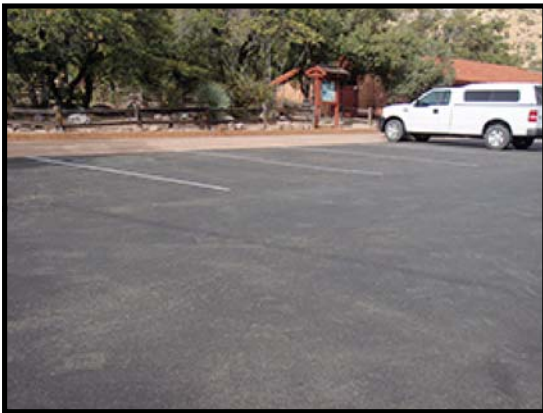
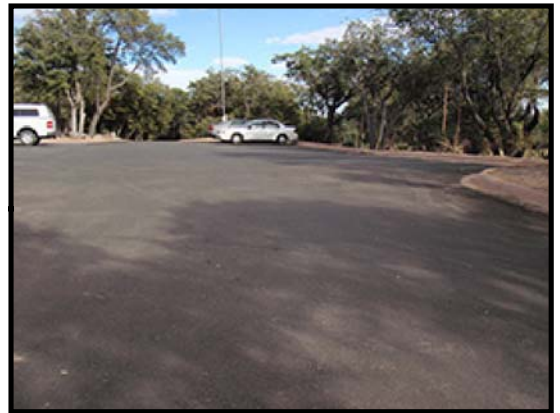
Route Number	Public / NonPublic	Date Visited	Area (sq ft)	Lane Miles *	Surface Type
0900	PUBLIC	12/6/2010	10,404	0.18	AS
Culverts	Drop Inlets	Gates	Curb & Gutter	Curb	PCR
0	1	0	CONCRETE CURB AND GUTTER	NO CURB	EXCELLENT/97

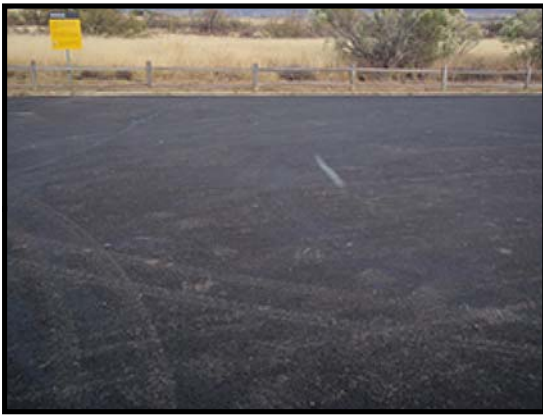
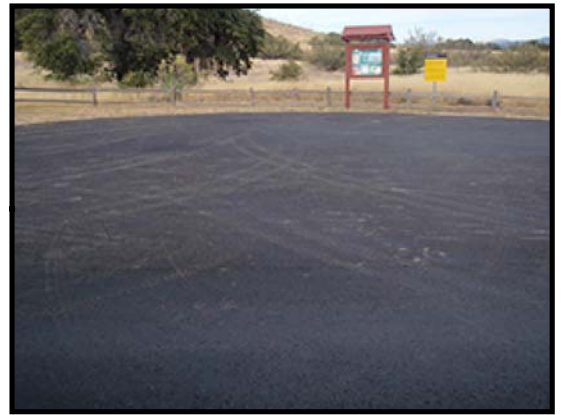
Route 0901

Route Number	Public / NonPublic	Date Visited	Area (sq ft)	Lane Miles *	Surface Type
0901	PUBLIC	12/6/2010	3,523	0.06	AS
Culverts	Drop Inlets	Gates	Curb & Gutter	Curb	PCR
0	0	0	NO CURB AND GUTTER	NO CURB	EXCELLENT/97

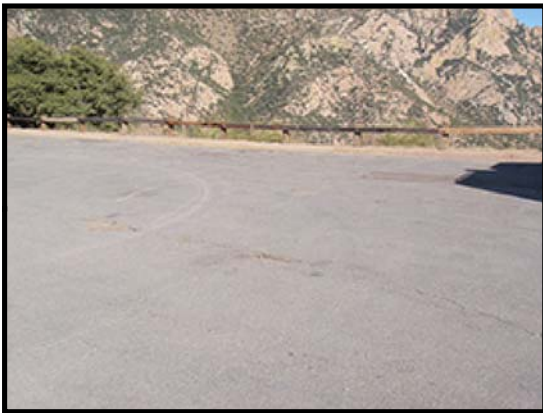
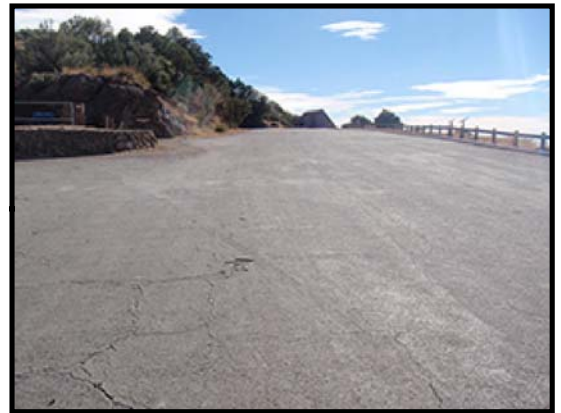
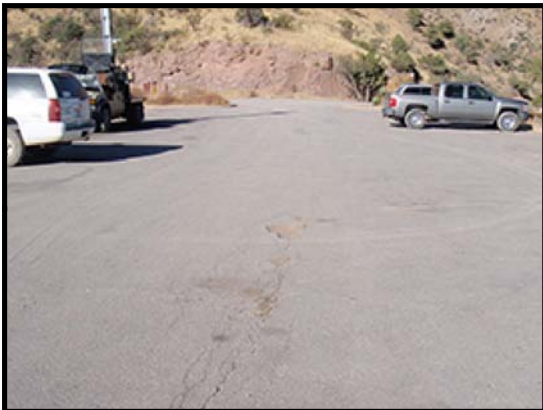
Route 0902

Route Number	Public / NonPublic	Date Visited	Area (sq ft)	Lane Miles *	Surface Type
0902	PUBLIC	12/6/2010	30,927	0.53	AS
Culverts	Drop Inlets	Gates	Curb & Gutter	Curb	PCR
0	2	1	CONCRETE CURB AND GUTTER	NO CURB	POOR/45

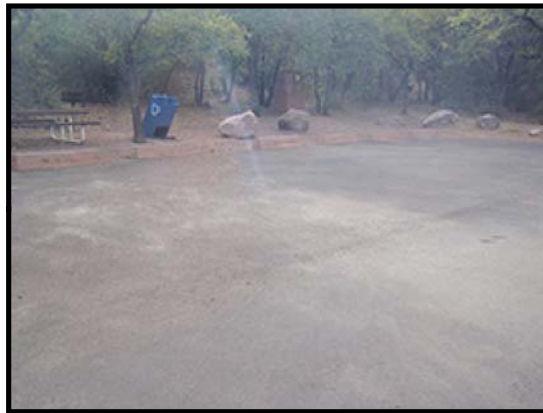
Route 0903A

Route Number	Public / NonPublic	Date Visited	Area (sq ft)	Lane Miles *	Surface Type
0903A	PUBLIC	12/6/2010	1,474	0.03	AS
Culverts	Drop Inlets	Gates	Curb & Gutter	Curb	PCR
0	0	0	NO CURB AND GUTTER	NO CURB	GOOD/90

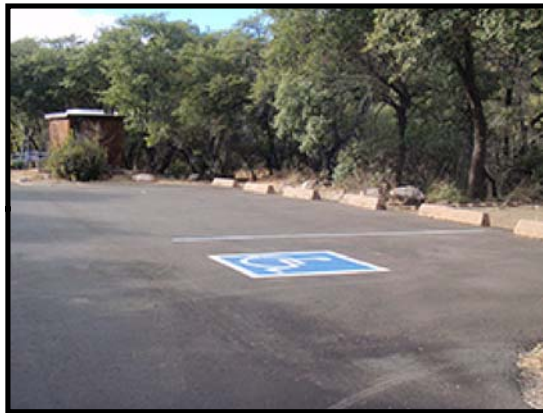
Route 0903B

Route Number	Public / NonPublic	Date Visited	Area (sq ft)	Lane Miles *	Surface Type
0903B	PUBLIC	12/6/2010	1,565	0.03	AS
Culverts	Drop Inlets	Gates	Curb & Gutter	Curb	PCR
0	0	0	NO CURB AND GUTTER	NO CURB	EXCELLENT/97

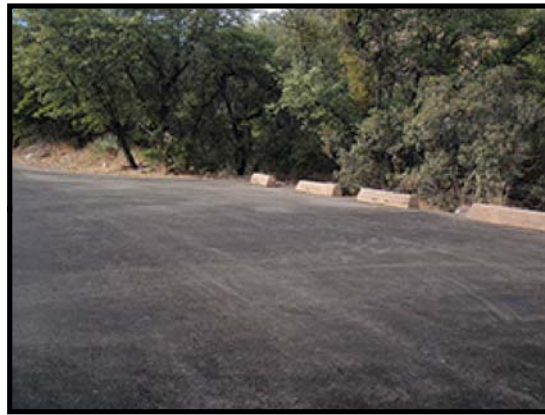
Route 0903C

Route Number	Public / NonPublic	Date Visited	Area (sq ft)	Lane Miles *	Surface Type
0903C	PUBLIC	12/6/2010	1,561	0.03	AS
Culverts	Drop Inlets	Gates	Curb & Gutter	Curb	PCR
0	0	0	NO CURB AND GUTTER	NO CURB	EXCELLENT/97

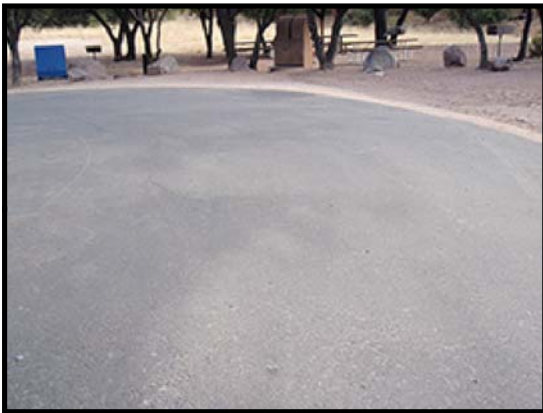
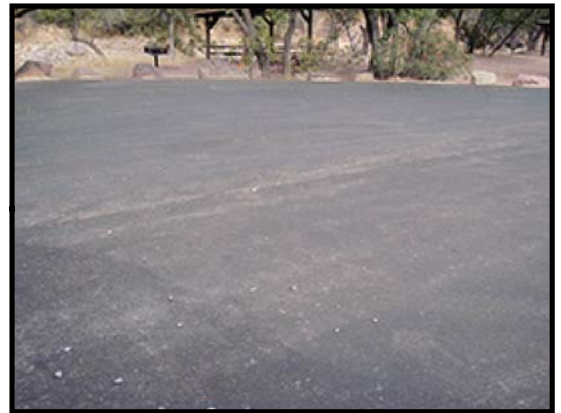
Route 0904

Route Number	Public / NonPublic	Date Visited	Area (sq ft)	Lane Miles *	Surface Type
0904	PUBLIC	12/6/2010	3,739	0.06	AS
Culverts	Drop Inlets	Gates	Curb & Gutter	Curb	PCR
0	0	0	NO CURB AND GUTTER	NO CURB	EXCELLENT/97

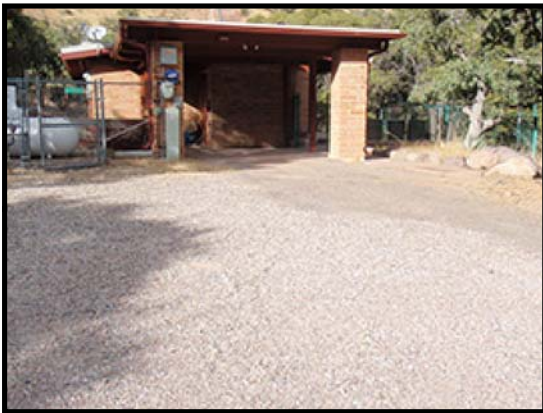
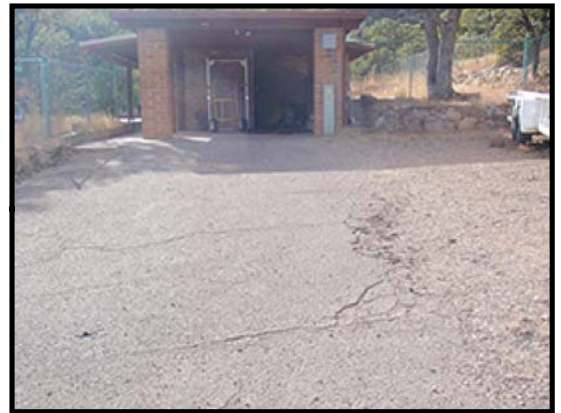
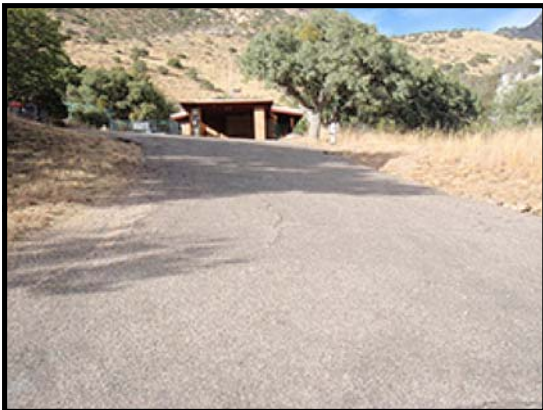
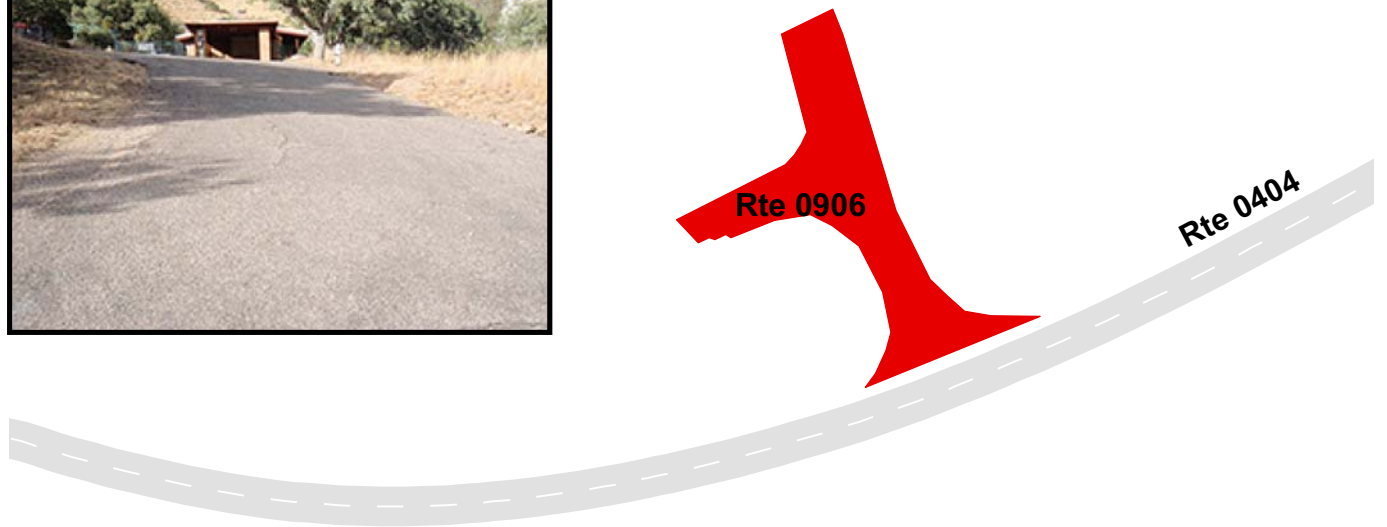
Route 0906

Route Number	Public / NonPublic	Date Visited	Area (sq ft)	Lane Miles *	Surface Type
0906	NONPUBLIC	12/6/2010	3,143	0.05	AS
Culverts	Drop Inlets	Gates	Curb & Gutter	Curb	PCR
0	0	1	NO CURB AND GUTTER	NO CURB	POOR/45

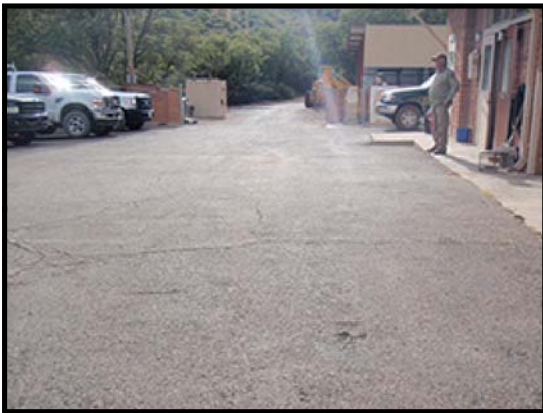
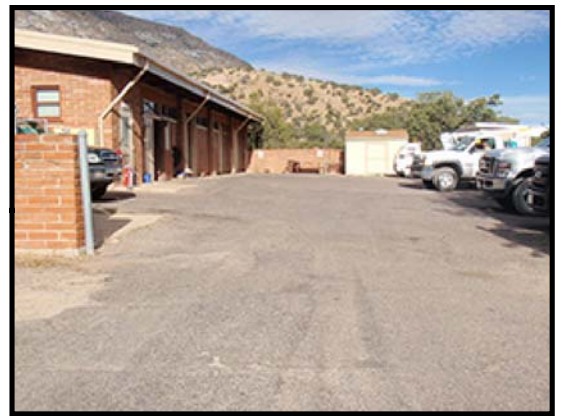
Route 0907

Route Number	Public / NonPublic	Date Visited	Area (sq ft)	Lane Miles *	Surface Type
0907	NONPUBLIC	12/6/2010	7,116	0.12	AS
Culverts	Drop Inlets	Gates	Curb & Gutter	Curb	PCR
0	0	1	NO CURB AND GUTTER	CONCRETE CURB	POOR/45

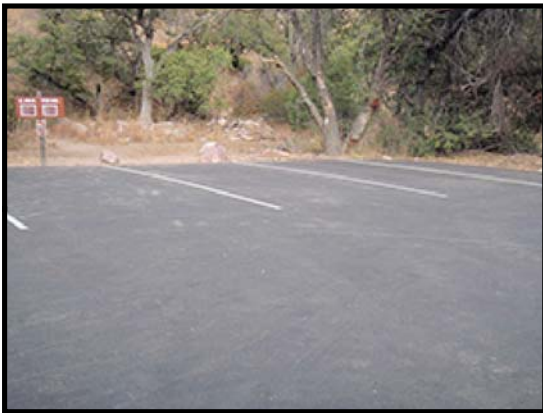
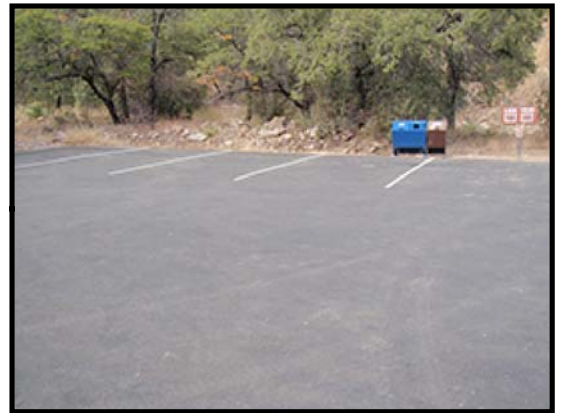
Route 0908

Route Number	Public / NonPublic	Date Visited	Area (sq ft)	Lane Miles *	Surface Type
0908	PUBLIC	12/6/2010	3,809	0.07	AS
Culverts	Drop Inlets	Gates	Curb & Gutter	Curb	PCR
0	0	0	NO CURB AND GUTTER	NO CURB	GOOD/90

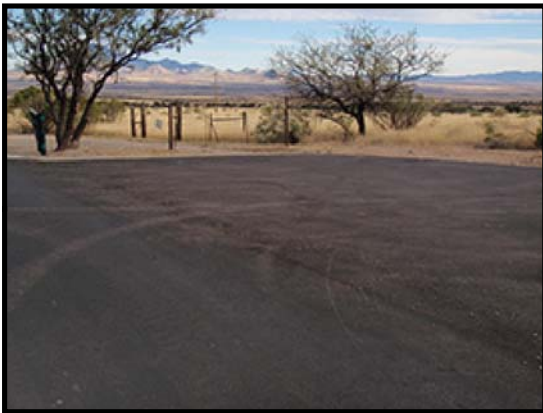
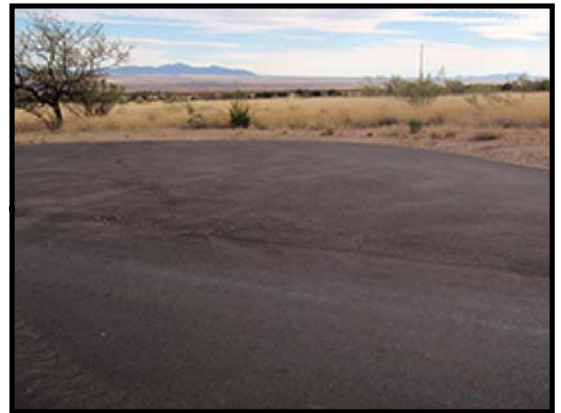
Route 0909

Route Number	Public / NonPublic	Date Visited	Area (sq ft)	Lane Miles *	Surface Type
0909	PUBLIC	12/6/2010	1,851	0.03	AS
Culverts	Drop Inlets	Gates	Curb & Gutter	Curb	PCR
0	0	0	NO CURB AND GUTTER	NO CURB	EXCELLENT/97
