# Federal Lands Highway Road Inventory Program

Road Inventory and Condition Assessment

**Crater Lake National Park**

**Cycle 5 Report**

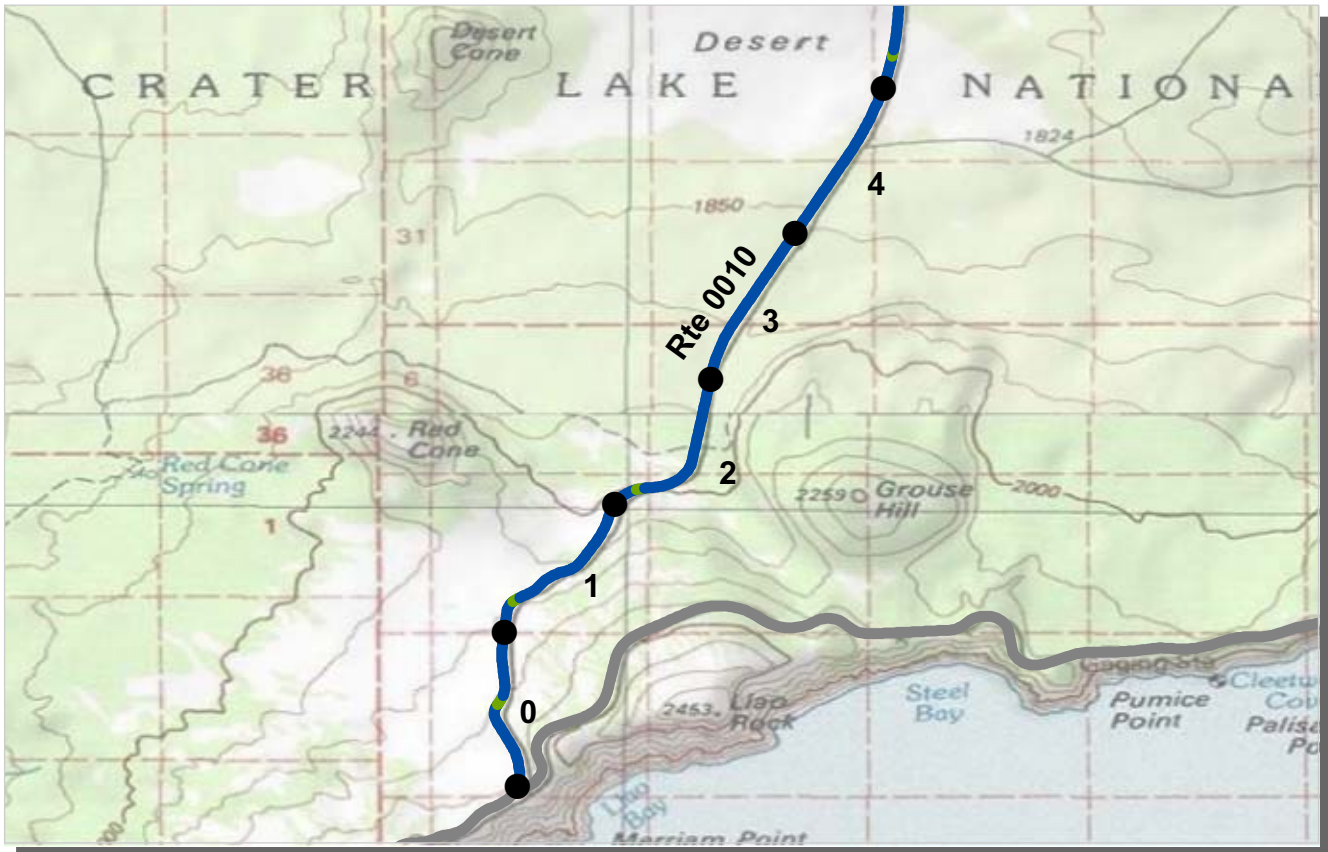
| <i>Section Number</i> | 0 | 1 | 2 | 3 | 4 |
|---|---|---|---|---|---|
| SCR (Surface Condition Rating) | 98 | 97 | 98 | 97 | 97 |
| PCR (Pavement Condition Rating) | 99 | 98 | 99 | 98 | 98 |

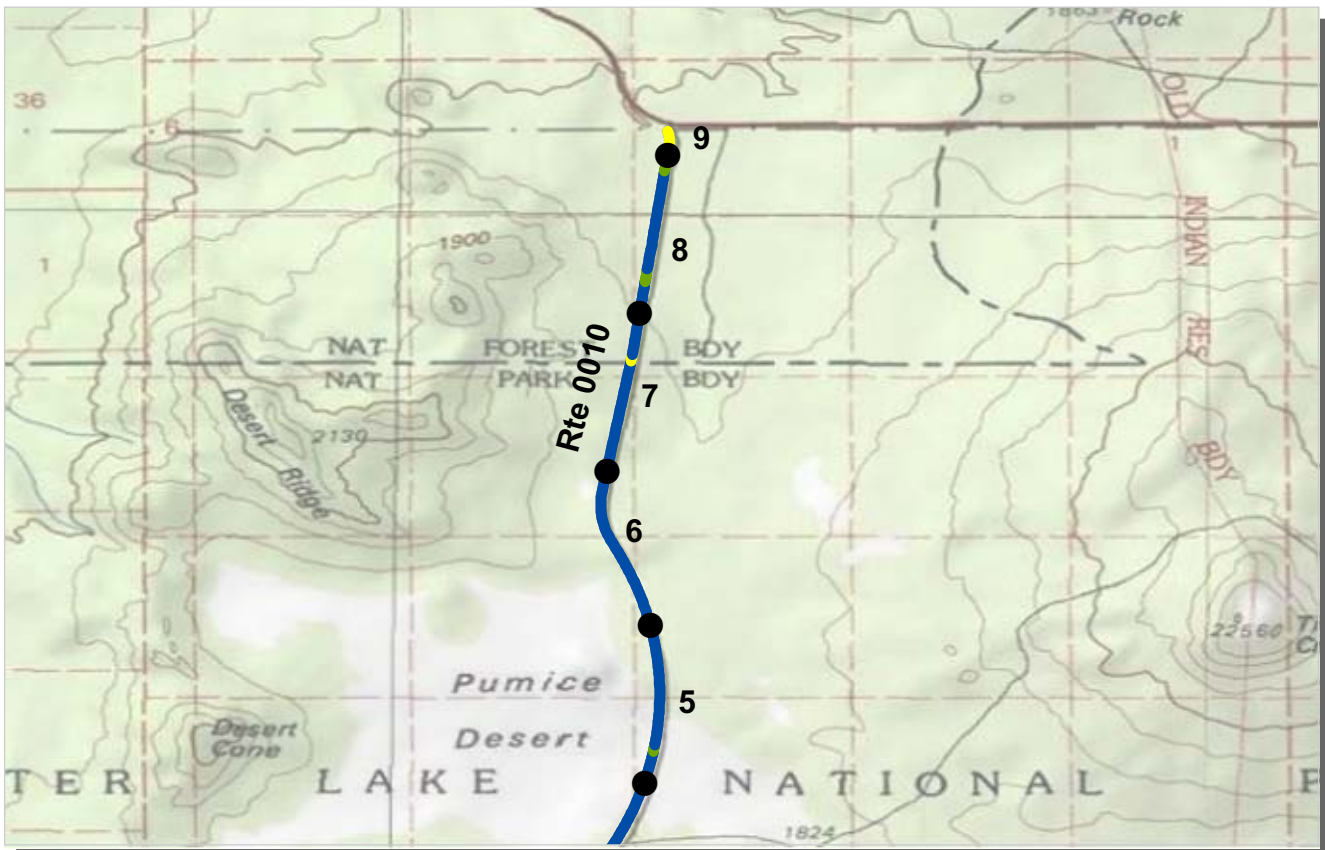
**ROUTE: 0010 NORTH ENTRANCE ROAD**

| <i>Section Number</i> | 5 | 6 | 7 | 8 | 9 |
|---|---|---|---|---|---|
| SCR (Surface Condition Rating) | 96 | 99 | 97 | 93 | 85 |
| PCR (Pavement Condition Rating) | 98 | 99 | 98 | 96 | 83 |

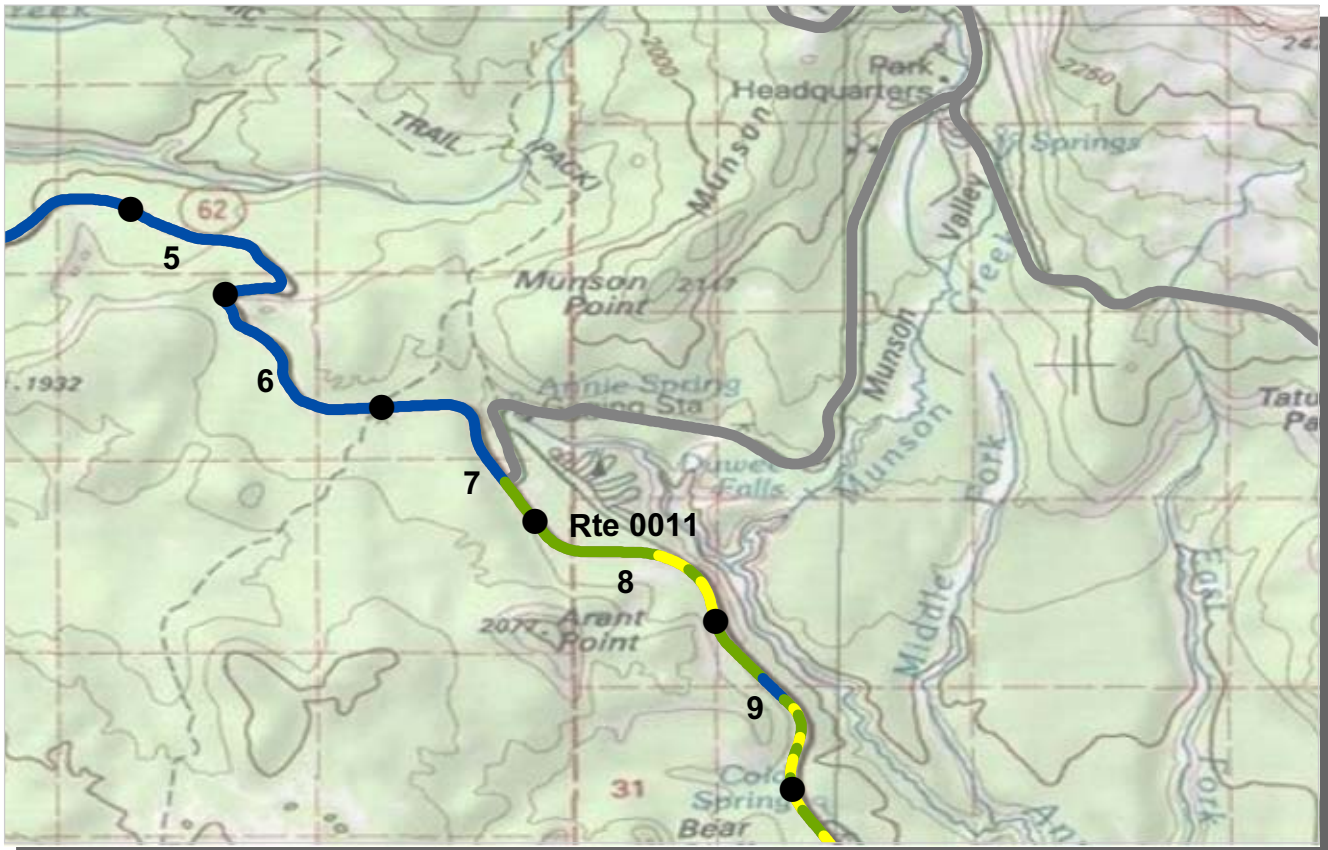
**ROUTE: 0011 CRATER LAKE HIGHWAY**

| <i>Section Number</i> | 5 | 6 | 7 | 8 | 9 |
|---|---|---|---|---|---|
| SCR (Surface Condition Rating) | 99 | 98 | 96 | 90 | 90 |
| PCR (Pavement Condition Rating) | 99 | 99 | 98 | 87 | 89 |

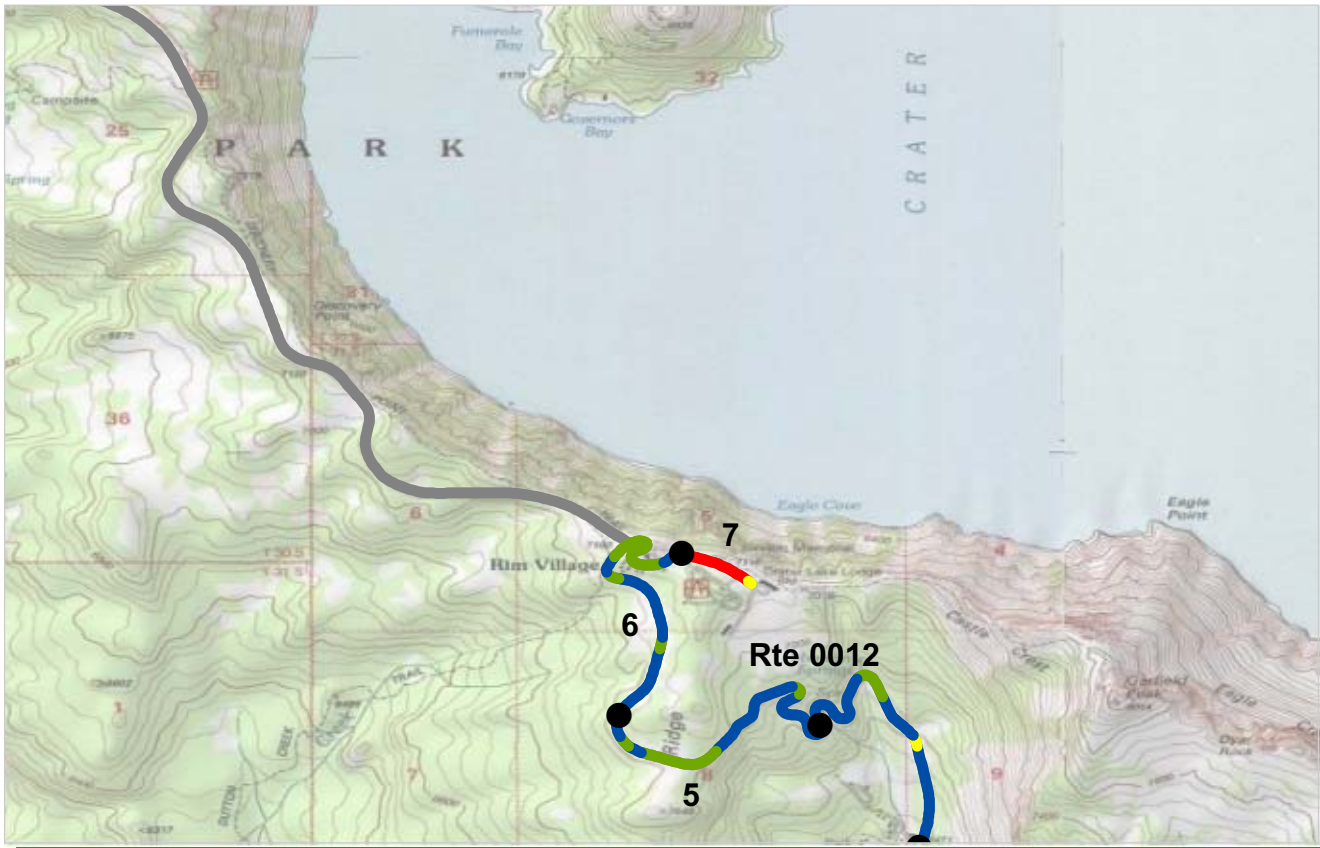
**ROUTE: 0012 MUNSON VALLEY ROAD**

| <i>Section Number</i> | 5 | 6 | 7 | | |
|---|---|---|---|--|--|
| SCR (Surface Condition Rating) | 97 | 97 | 65 | | |
| PCR (Pavement Condition Rating) | 97 | 93 | 56 | | |
| Roughness Condition Index (RCI) | 97 | 86 | 42 | | |
