# Federal Lands Highway Road Inventory Program

Road Inventory and Condition Assessment

## Craters of the Moon National Monument and Preserve CRMO - 9280

### Cycle 5 Report

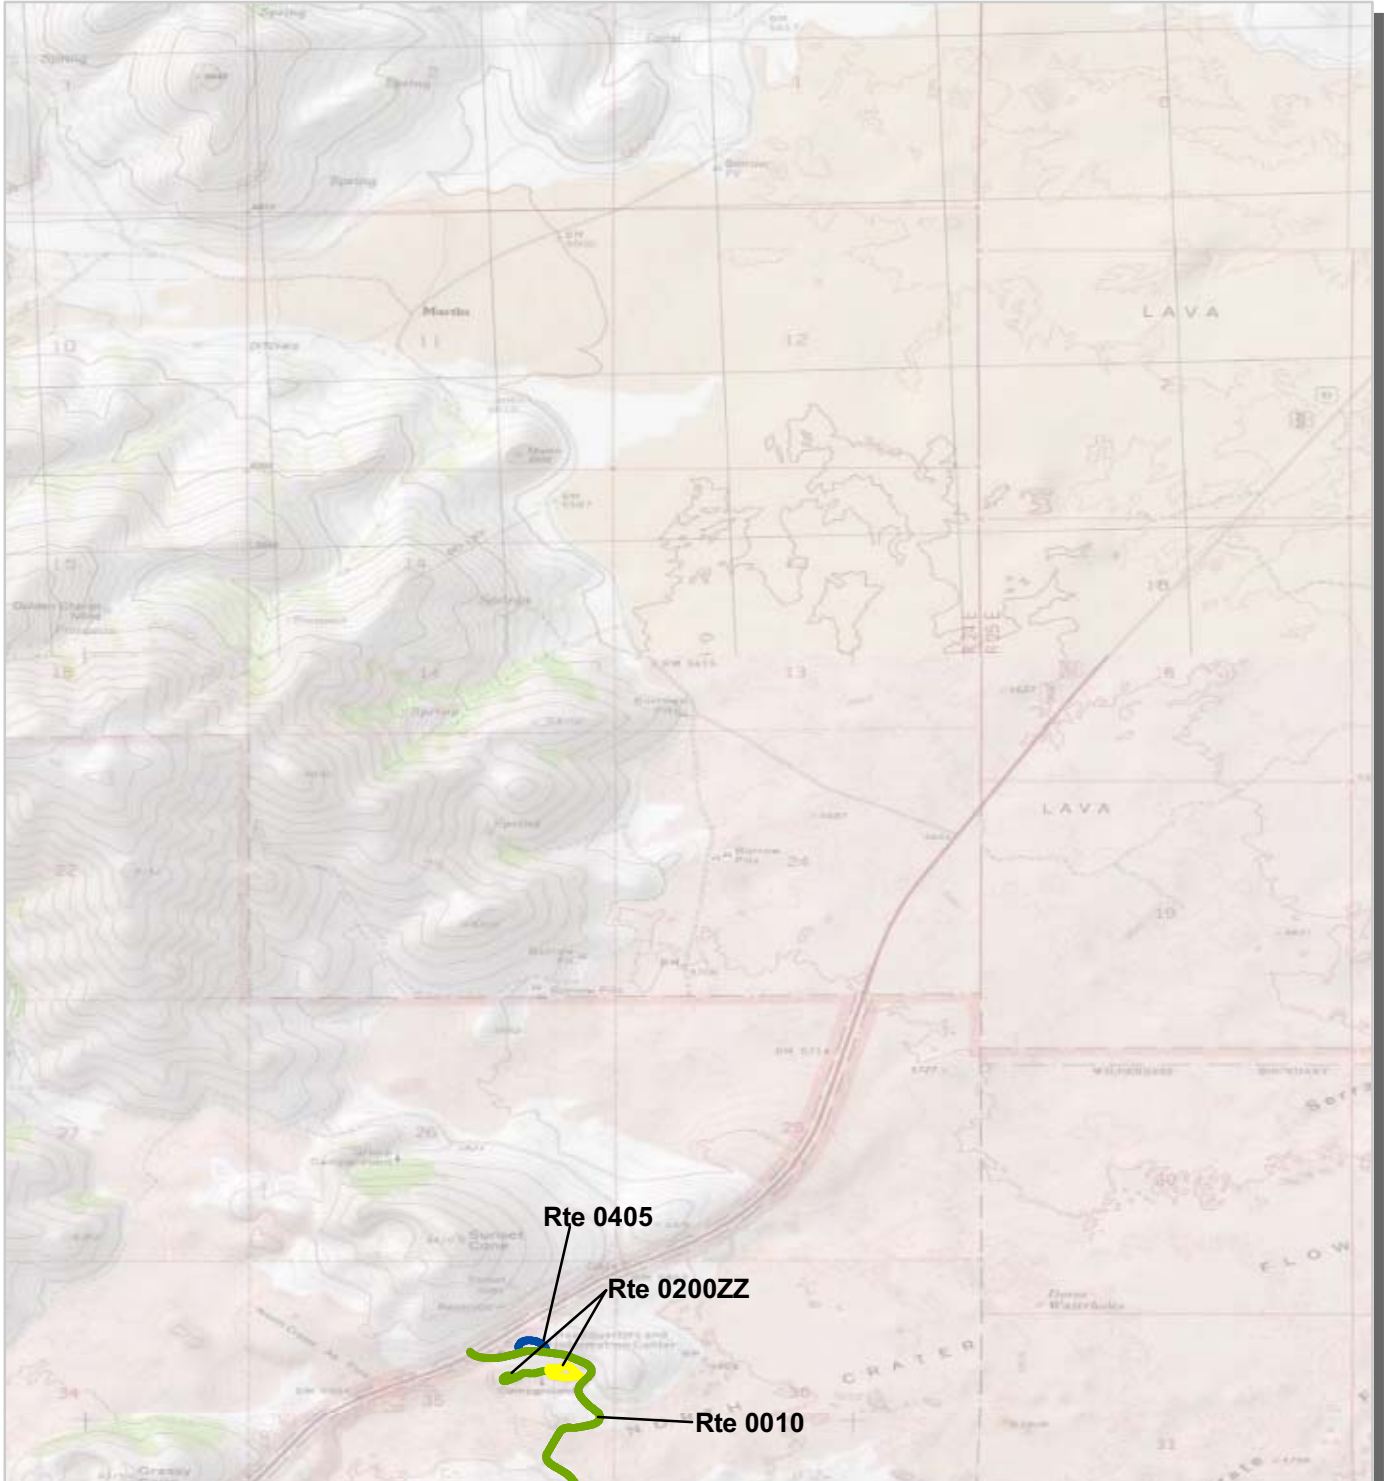
#### Area 1

PCR	Poor	<span style="display: inline-block; width: 20px; height: 10px; background-color: red; border: 1px solid black;"></span>	Fair	<span style="display: inline-block; width: 20px; height: 10px; background-color: yellow; border: 1px solid black;"></span>	Good	<span style="display: inline-block; width: 20px; height: 10px; background-color: green; border: 1px solid black;"></span>	Excellent	<span style="display: inline-block; width: 20px; height: 10px; background-color: blue; border: 1px solid black;"></span>	No Data	<span style="display: inline-block; width: 20px; height: 10px; background-color: black; border: 1px solid black;"></span>
	(0 - 60)		(61 - 84)	(85 - 94)	(95 - 100)

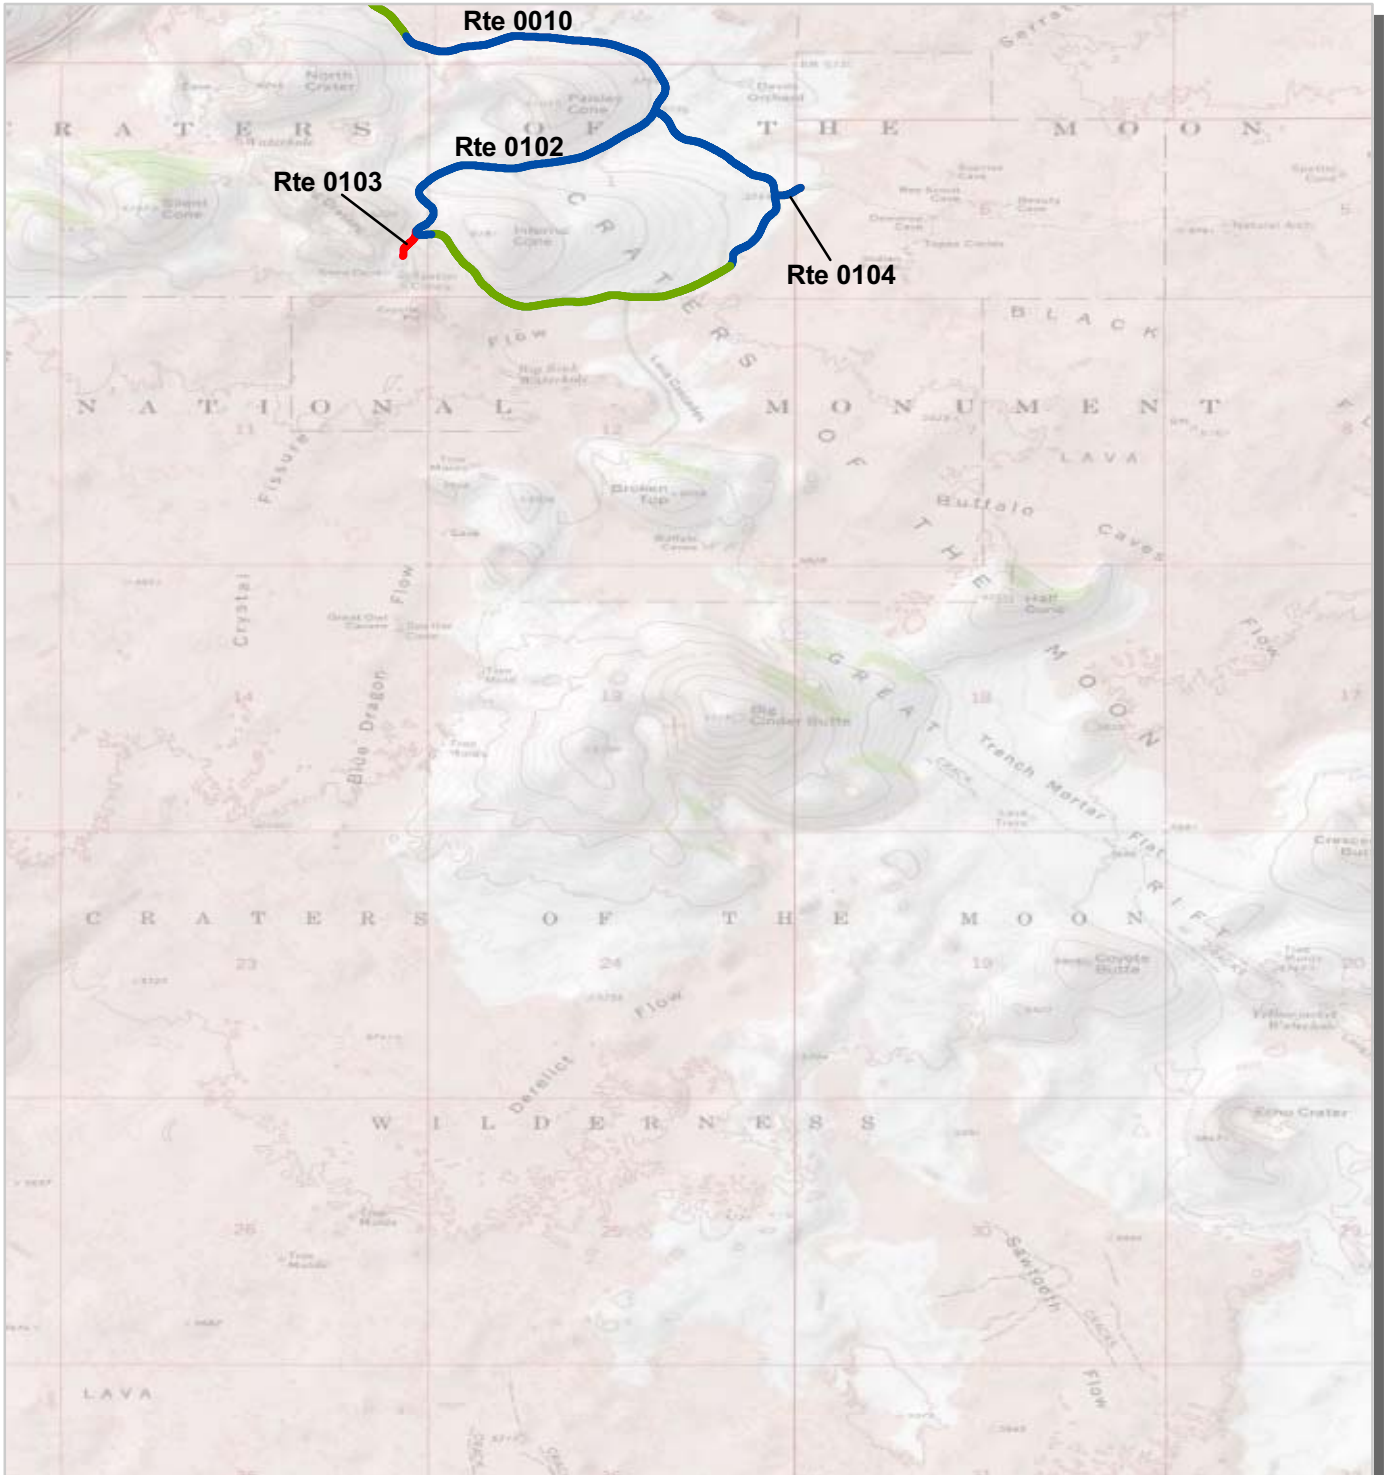
#### Area 2

PCR	Poor	<span style="color: red;">■</span>	Fair	<span style="color: yellow;">■</span>	Good	<span style="color: green;">■</span>	Excellent	<span style="color: blue;">■</span>	No Data	<span style="color: black;">■</span>
	(0 - 60)		(61 - 84)		(85 - 94)		(95 - 100)

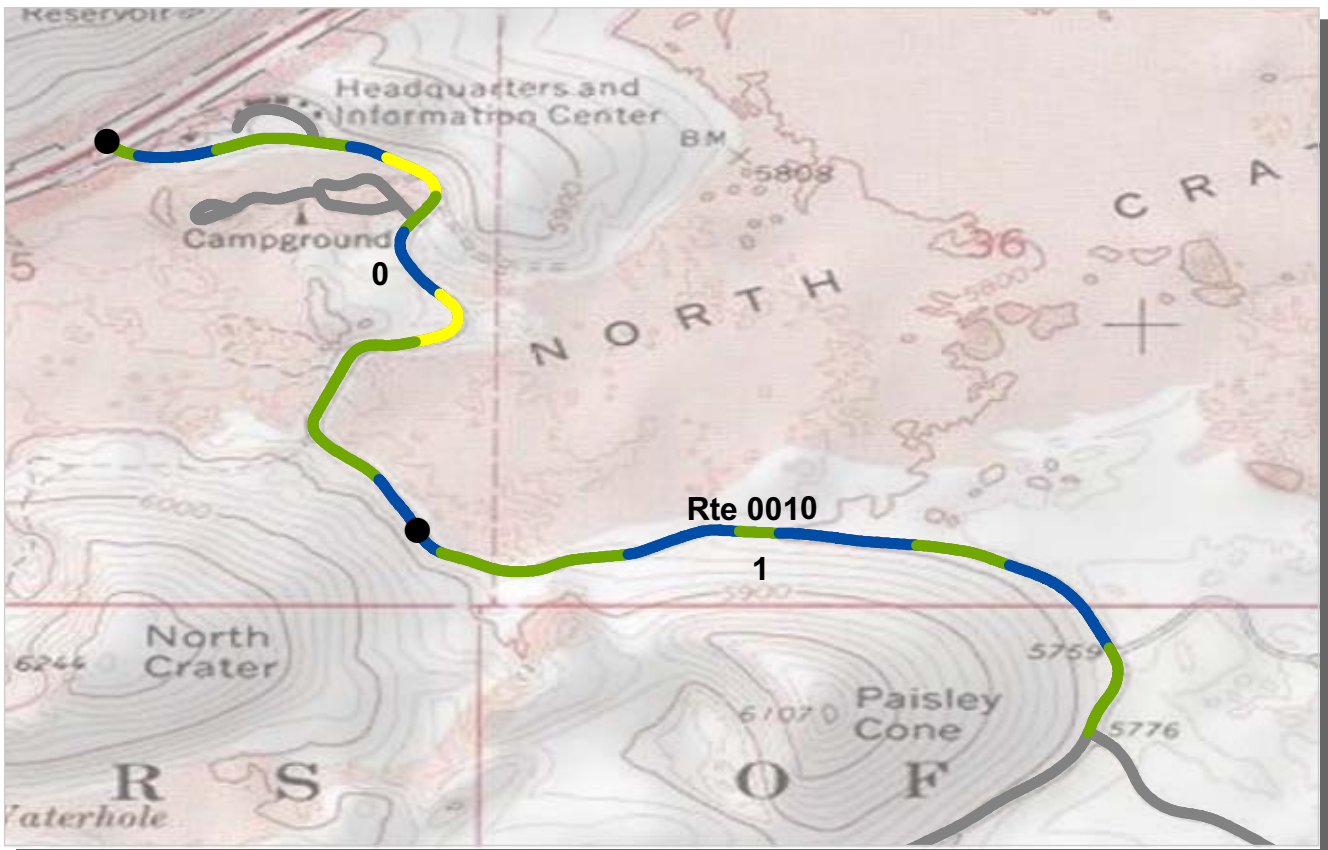
**ROUTE: 0010 ENTRANCE ROAD**

<i>Section Number</i>	0	1			
<i>Section Length (mi)</i>	1.00	0.93			
<i>Cross Section Information</i>					
Number of Lanes	2	2			
Paved Width (ft)	23	22			
Lane Width (ft)	11	11			
<i>Roadway Condition Information</i>					
SCR (Surface Condition Rating)	97	97			
PCR (Pavement Condition Rating)	92	95			
<i>Distress Index Values</i>					
Structural Crack Index	97	97			
Transverse Cracking Index	98	99			
Patching Index	100	100			
Rutting Index	100	100			
Roughness Condition Index (RCI)	84	92

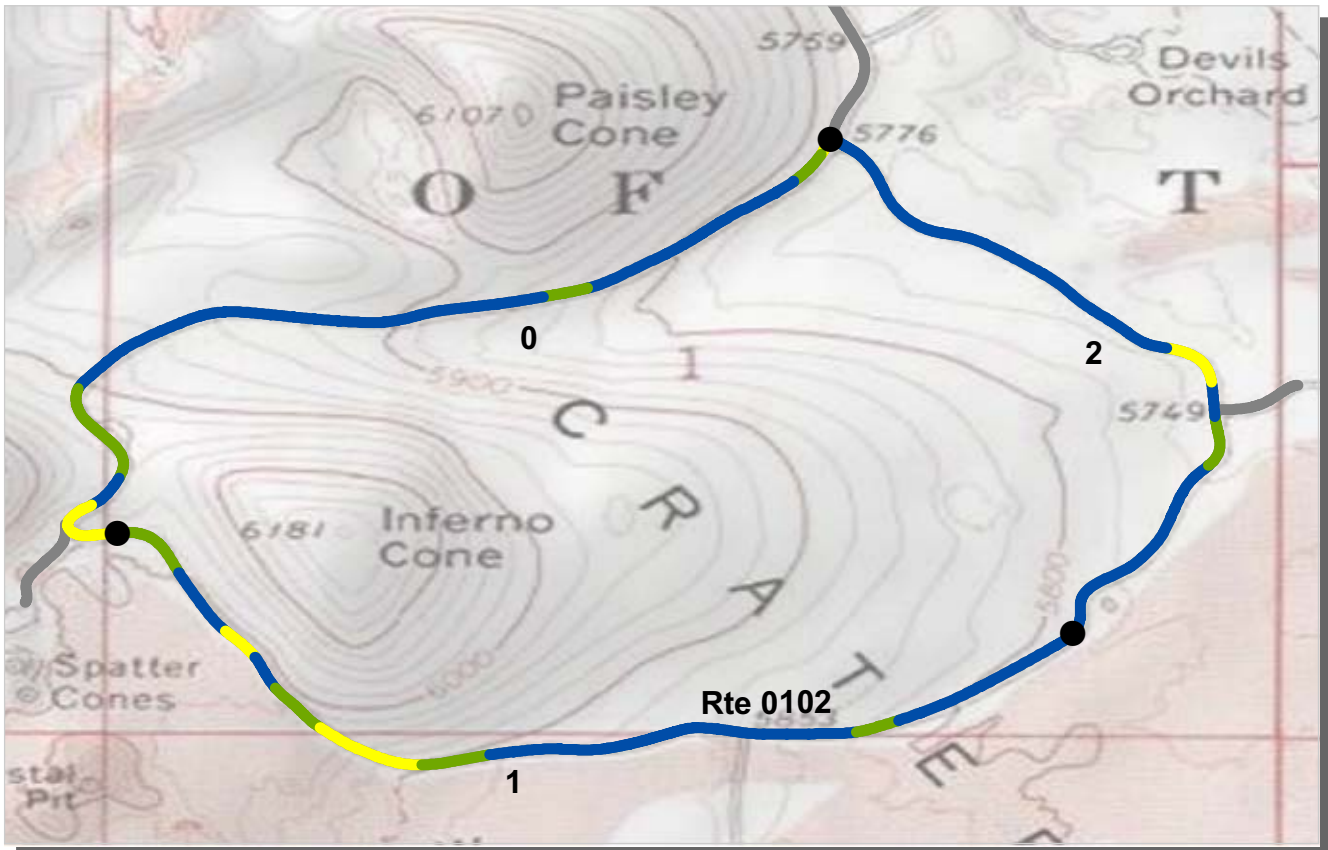
**ROUTE: 0102 SCENIC LOOP DRIVE**

<i>Section Number</i>	0	1	2		
<i>Section Length (mi)</i>	1.00	1.00	0.79		
<i>Cross Section Information</i>					
Number of Lanes	1	1	1		
Paved Width (ft)	15	16	15		
Lane Width (ft)	15	16	15		
<i>Roadway Condition Information</i>					
SCR (Surface Condition Rating)	98	97	99		
PCR (Pavement Condition Rating)	96	94	96		
<i>Distress Index Values</i>					
Structural Crack Index	98	97	99		
Transverse Cracking Index	98	100	99		
Patching Index	100	100	100		
Rutting Index	100	100	100		
Roughness Condition Index (RCI)	93	89	92

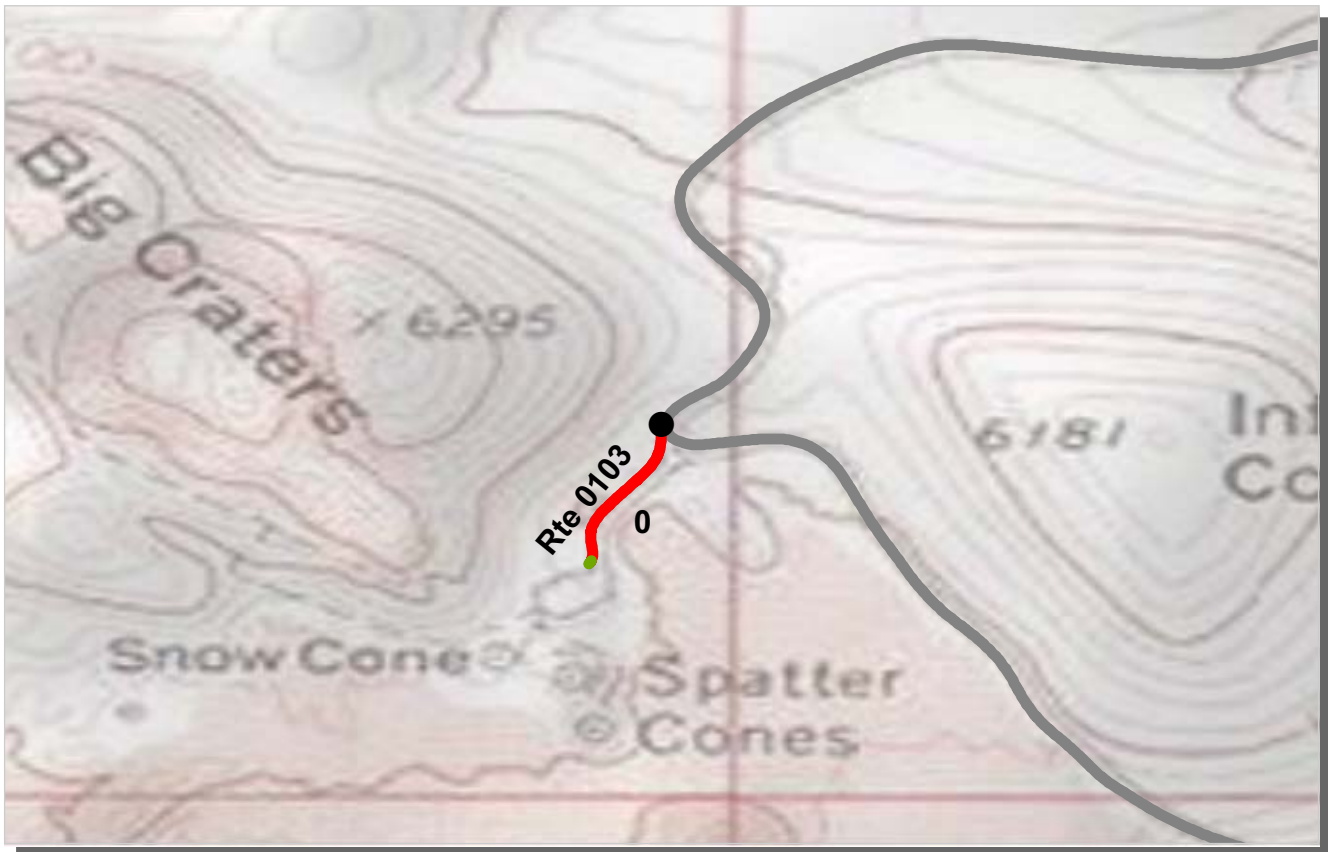
**ROUTE: 0103 SPATTER CONE ROAD**

<b>Section Number</b>	0				
<b>Section Length (mi)</b>	0.10				
<b>Cross Section Information</b>					
Number of Lanes	2				
Paved Width (ft)	23				
Lane Width (ft)	13				
<b>Roadway Condition Information</b>					
SCR (Surface Condition Rating)	48				
PCR (Pavement Condition Rating)	48				
<b>Distress Index Values</b>					
Structural Crack Index	84				
Transverse Cracking Index	48				
Patching Index	100				
Rutting Index	97				
Roughness Condition Index (RCI)	NC

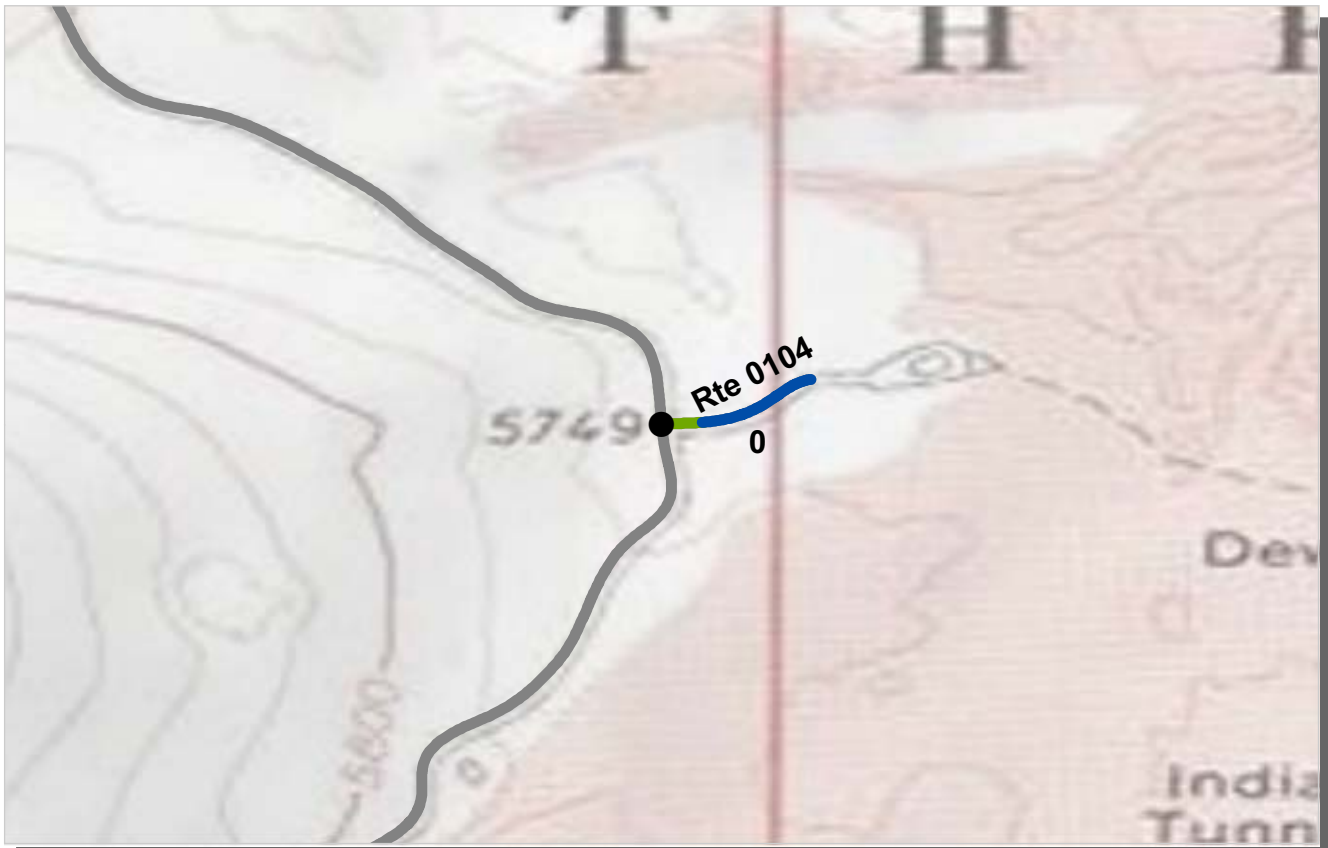
**ROUTE: 0104 CAVES TRAIL ROAD**

<b>Section Number</b>	0				
<b>Section Length (mi)</b>	0.08				
<b>Cross Section Information</b>					
Number of Lanes	2				
Paved Width (ft)	25				
Lane Width (ft)	13				
<b>Roadway Condition Information</b>					
SCR (Surface Condition Rating)	98				
PCR (Pavement Condition Rating)	98				
<b>Distress Index Values</b>					
Structural Crack Index	100				
Transverse Cracking Index	98				
Patching Index	100				
Rutting Index	99				
Roughness Condition Index (RCI)	NC

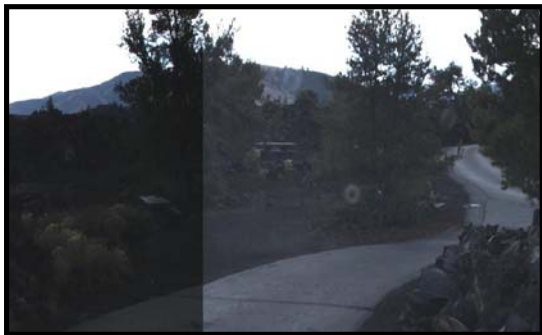
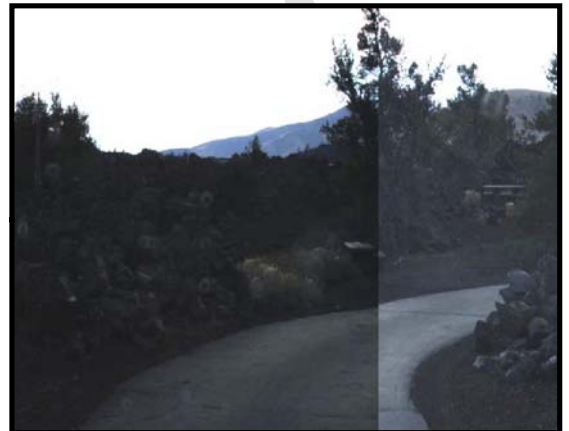
Route Number	Public / NonPublic	Date Visited	Area (sq ft)	Lane Miles *	MRL	
					Length (mi)	Width (ft)
0201Z	PUBLIC	10/5/2010	1,521	0.03	0.02	12
Culverts	Drop Inlets	Gates	Curb & Gutter	Curb	PCR	Surface Type
0	0	0	NO CURB AND GUTTER	NO CURB	FAIR/73	AS

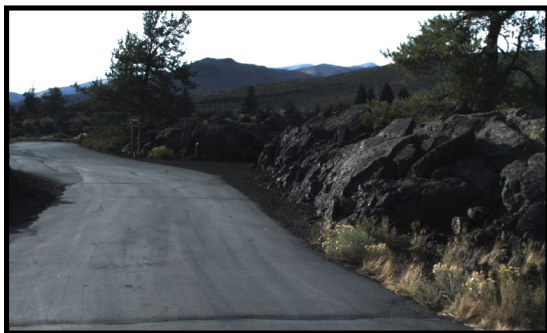
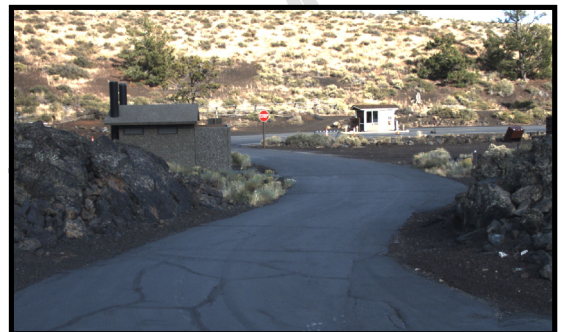
Route Number	Public / NonPublic	Date Visited	Area (sq ft)	Lane Miles *	MRL	
					Length (mi)	Width (ft)
0202Z	PUBLIC	10/5/2010	2,730	0.05	0.05	11
Culverts	Drop Inlets	Gates	Curb & Gutter	Curb	PCR	Surface Type
0	0	0	NO CURB AND GUTTER	NO CURB	FAIR/73	AS

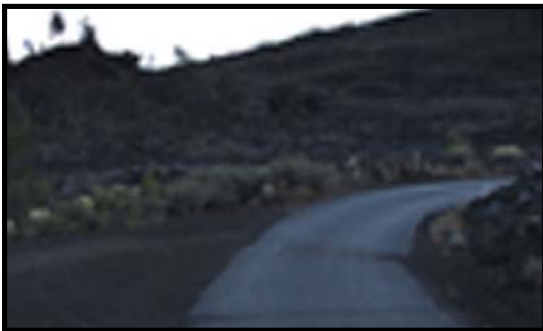
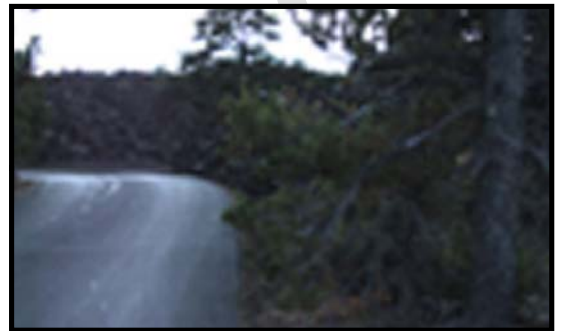
Route Number	Public / NonPublic	Date Visited	Area (sq ft)	Lane Miles *	MRL	
					Length (mi)	Width (ft)
0206Z	PUBLIC	10/5/2010	2,323	0.04	0.04	10
Culverts	Drop Inlets	Gates	Curb & Gutter	Curb	PCR	Surface Type
0	0	0	NO CURB AND GUTTER	NO CURB	FAIR/73	AS

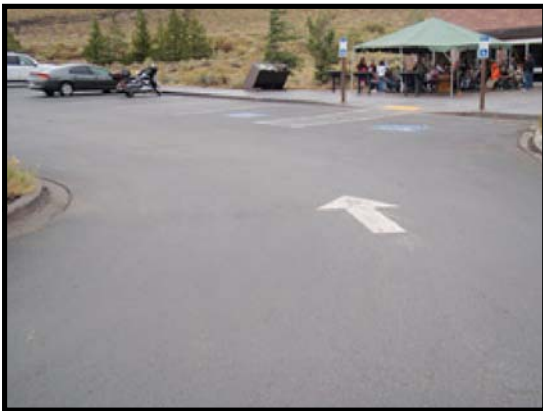
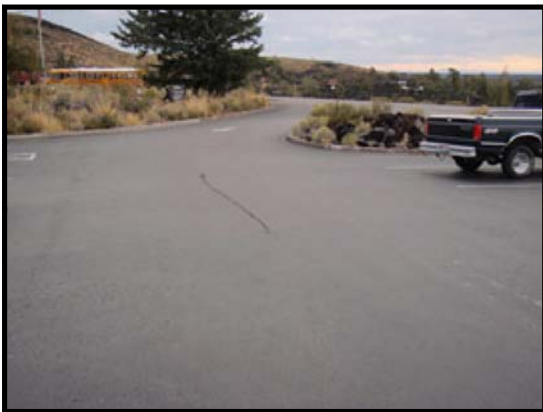
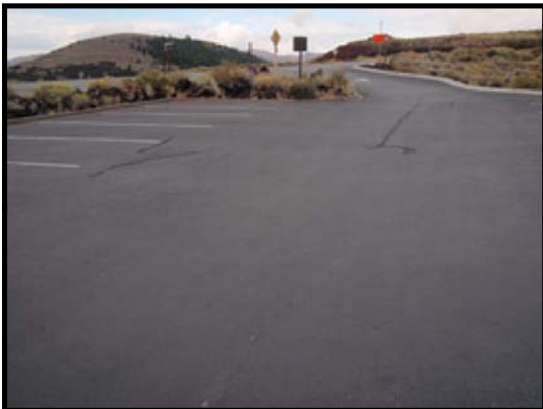
Route Number	Public / NonPublic	Date Visited	Area (sq ft)	Lane Miles *	Surface Type
0900	PUBLIC	10/5/2010	13,916	0.24	AS
Culverts	Drop Inlets	Gates	Curb & Gutter	Curb	PCR
0	1	0	CONCRETE CURB AND GUTTER	NO CURB	FAIR/73

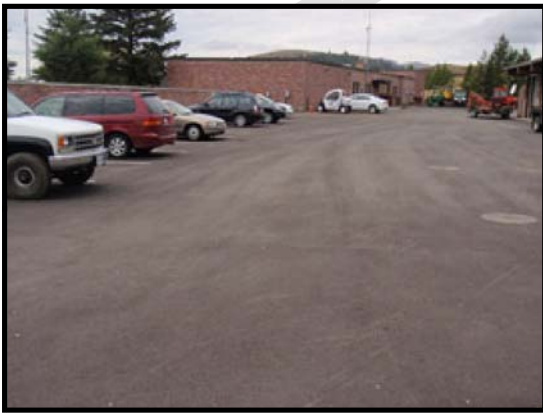
Route Number	Public / NonPublic	Date Visited	Area (sq ft)	Lane Miles *	Surface Type
0902	NONPUBLIC	10/5/2010	15,692	0.27	AS
Culverts	Drop Inlets	Gates	Curb & Gutter	Curb	PCR
0	0	0	CONCRETE CURB AND GUTTER	NO CURB	GOOD/90

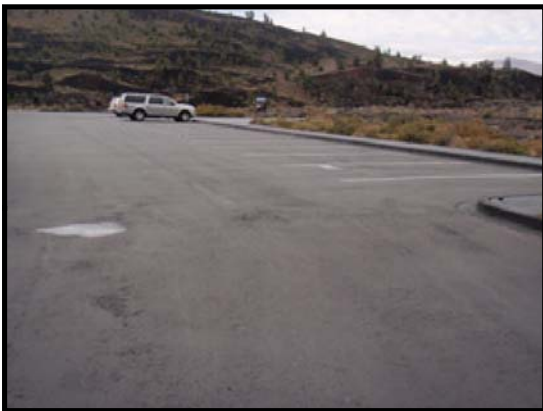
Route Number	Public / NonPublic	Date Visited	Area (sq ft)	Lane Miles *	Surface Type
0903	PUBLIC	10/5/2010	16,708	0.29	AS
Culverts	Drop Inlets	Gates	Curb & Gutter	Curb	PCR
0	0	0	CONCRETE CURB AND GUTTER	NO CURB	GOOD/90

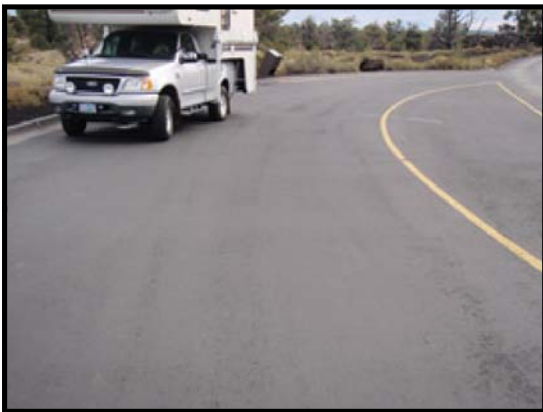
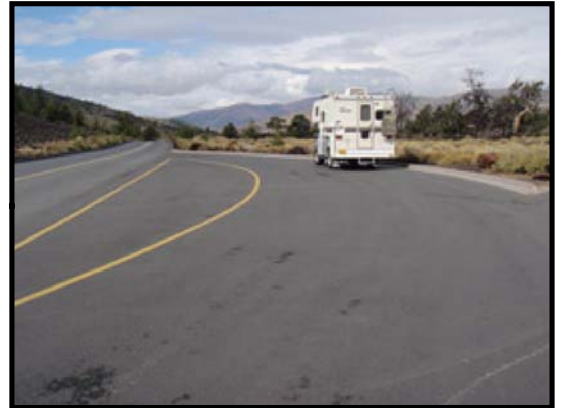
Route Number	Public / NonPublic	Date Visited	Area (sq ft)	Lane Miles *	Surface Type
0905	PUBLIC	10/5/2010	5,510	0.10	AS
Culverts	Drop Inlets	Gates	Curb & Gutter	Curb	PCR
0	0	0	CONCRETE CURB AND GUTTER	NO CURB	GOOD/90

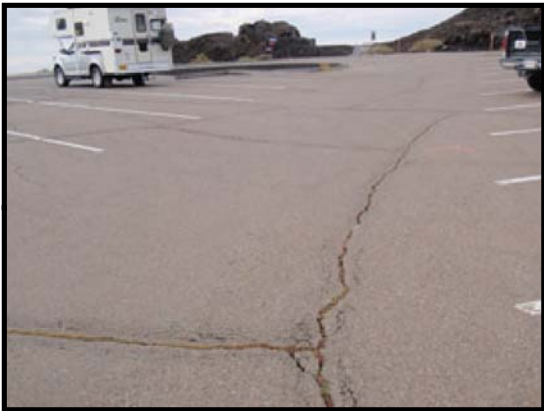
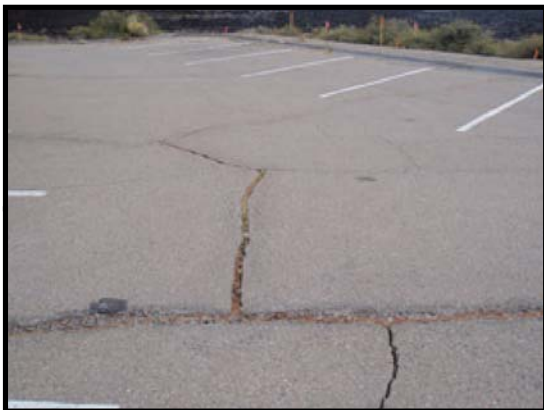
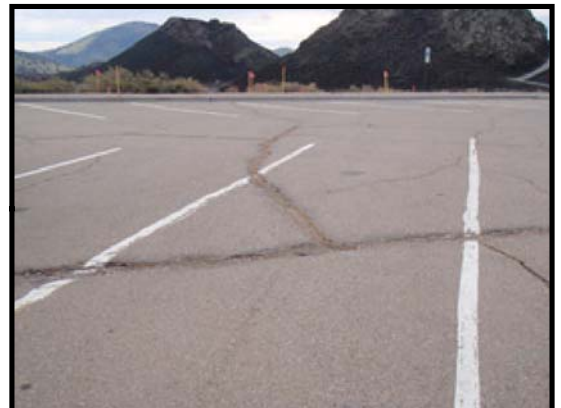
Route Number	Public / NonPublic	Date Visited	Area (sq ft)	Lane Miles *	Surface Type
0908	PUBLIC	10/5/2010	17,162	0.30	AS
Culverts	Drop Inlets	Gates	Curb & Gutter	Curb	PCR
0	1	0	CONCRETE CURB AND GUTTER	NO CURB	POOR/45

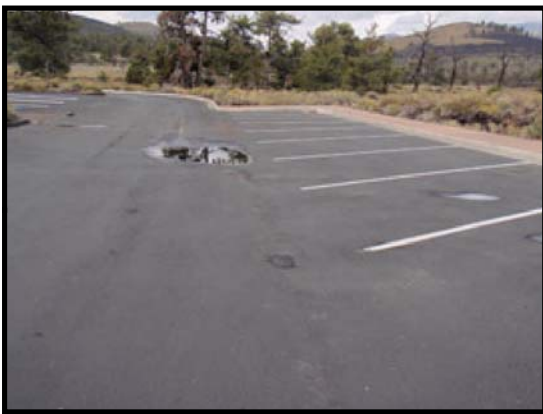
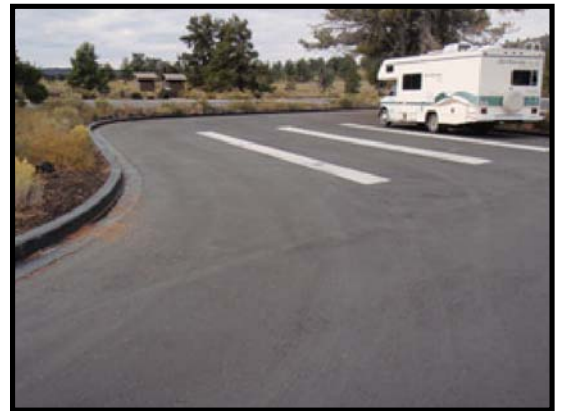
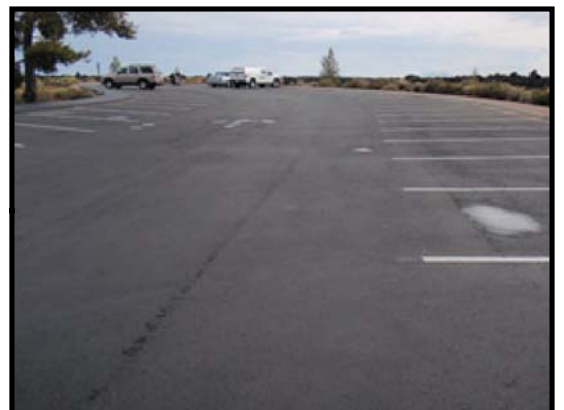
Route Number	Public / NonPublic	Date Visited	Area (sq ft)	Lane Miles *	Surface Type
0912	PUBLIC	10/5/2010	39,021	0.67	AS
Culverts	Drop Inlets	Gates	Curb & Gutter	Curb	PCR
0	2	0	CONCRETE CURB AND GUTTER	NO CURB	GOOD/90

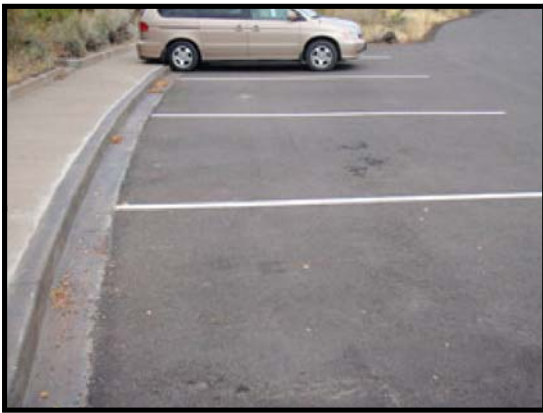
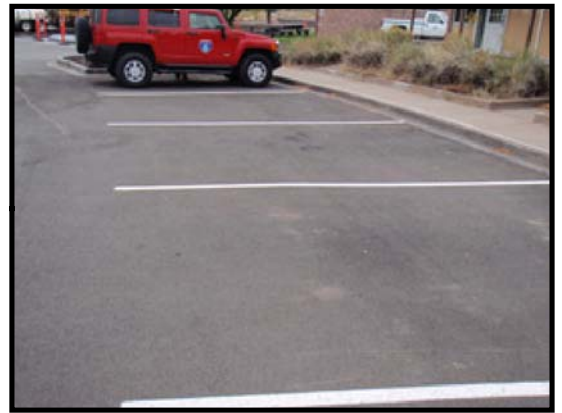
Route Number	Public / NonPublic	Date Visited	Area (sq ft)	Lane Miles *	Surface Type
0914AZ	NONPUBLIC	10/5/2010	1,303	0.02	AS
Culverts	Drop Inlets	Gates	Curb & Gutter	Curb	PCR
0	0	0	CONCRETE CURB AND GUTTER	NO CURB	GOOD/90

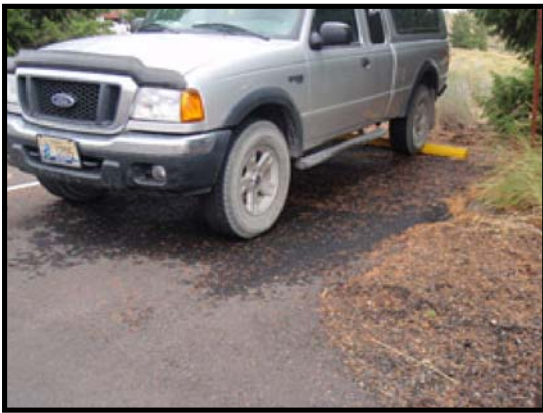
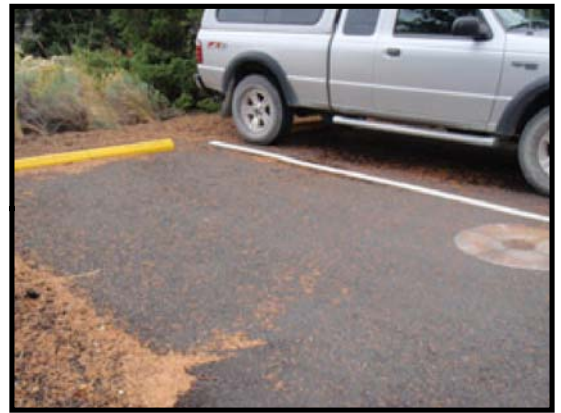
Route Number	Public / NonPublic	Date Visited	Area (sq ft)	Lane Miles *	Surface Type
0914BZ	NONPUBLIC	10/5/2010	414	0.01	AS
Culverts	Drop Inlets	Gates	Curb & Gutter	Curb	PCR
0	0	0	NO CURB AND GUTTER	NO CURB	GOOD/90

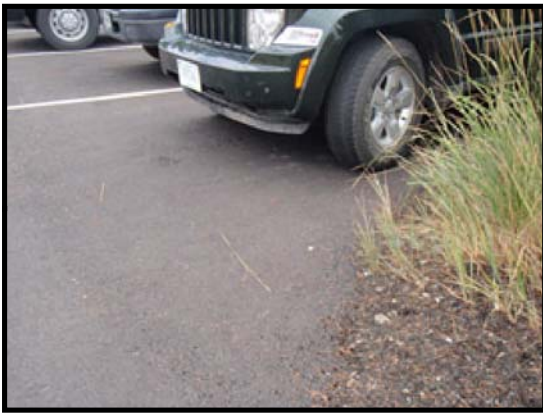
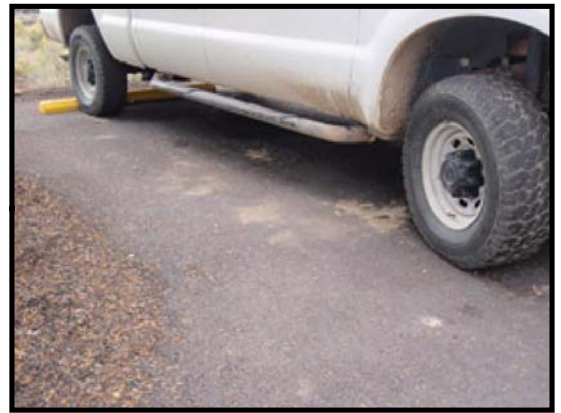
Route Number	Public / NonPublic	Date Visited	Area (sq ft)	Lane Miles *	Surface Type
0914CZ	NONPUBLIC	10/5/2010	795	0.01	AS
Culverts	Drop Inlets	Gates	Curb & Gutter	Curb	PCR
0	0	0	NO CURB AND GUTTER	NO CURB	GOOD/90
