# Federal Lands Highway Road Inventory Program

Road Inventory and Condition Assessment

## Cumberland Gap National Historical Park CUGA

### Cycle 5 Report

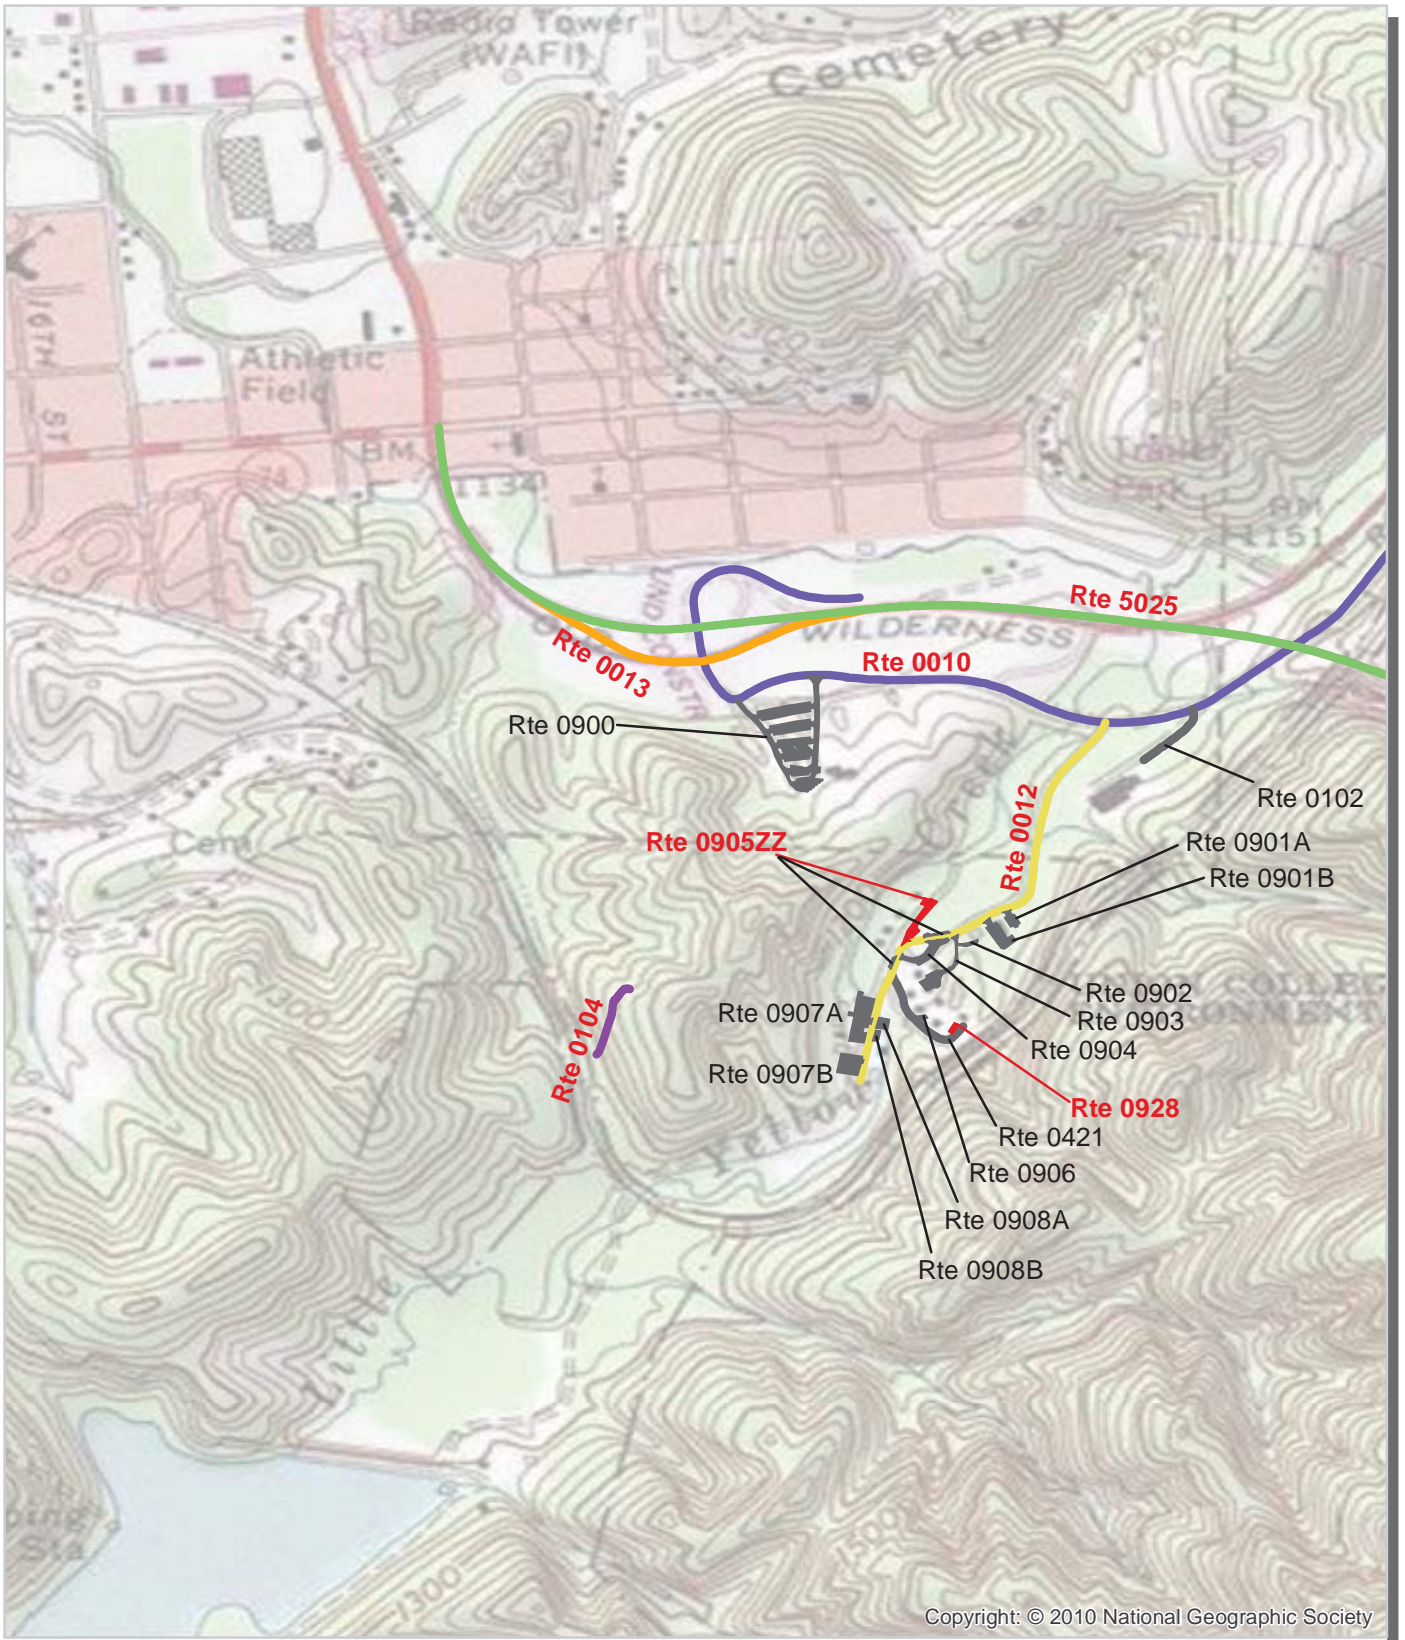
# Cumberland Gap National Historical Park Route Location Map Area 1

Unique colors used to differentiate routes

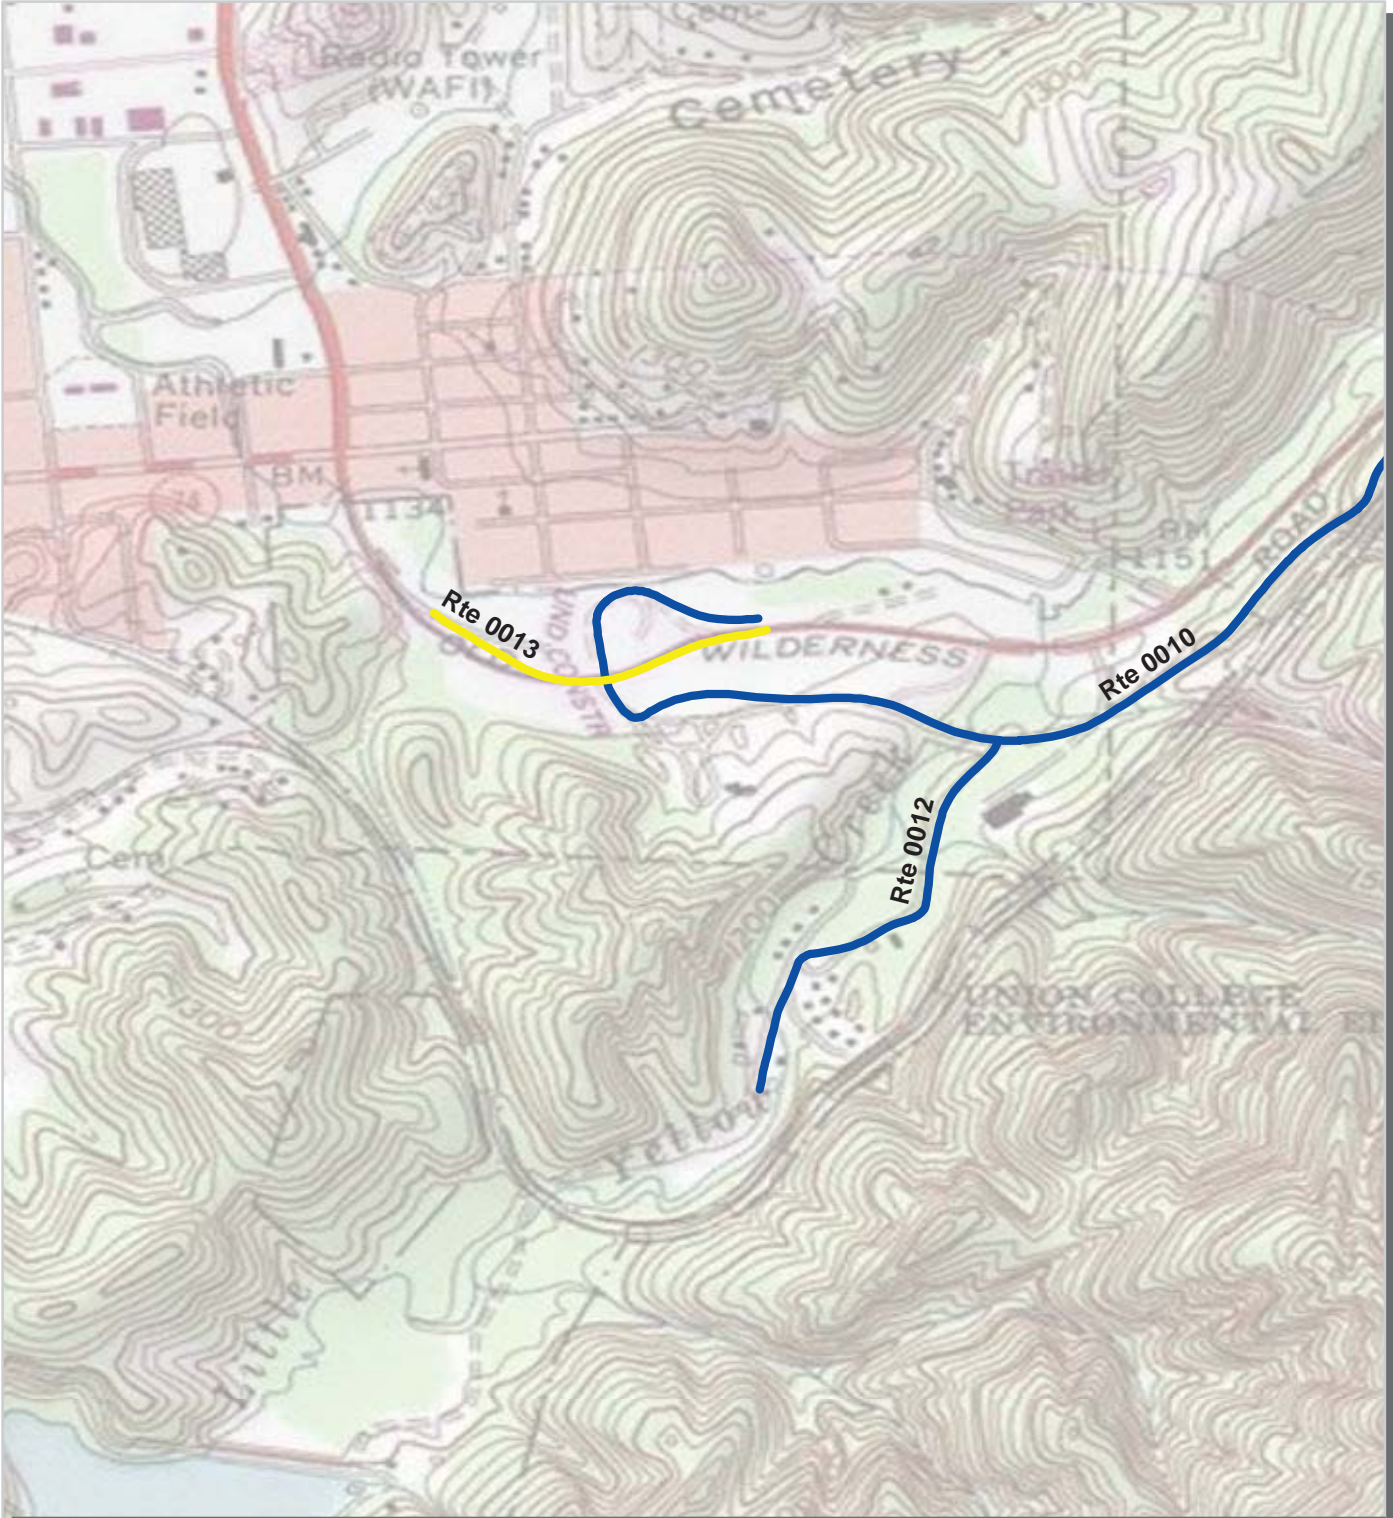
**Cumberland Gap National Historical Park  
Route Condition Map  
PCR - Mile by Mile  
Area 1**

PCR	Poor	Fair	Good	Excellent	No Data
	(0 - 60)	(61 - 84)	(85 - 94)	(95 - 100)

\* If the PCR rating is not available for a section, the SCR rating will be displayed. See appendix for definitions and formulas.

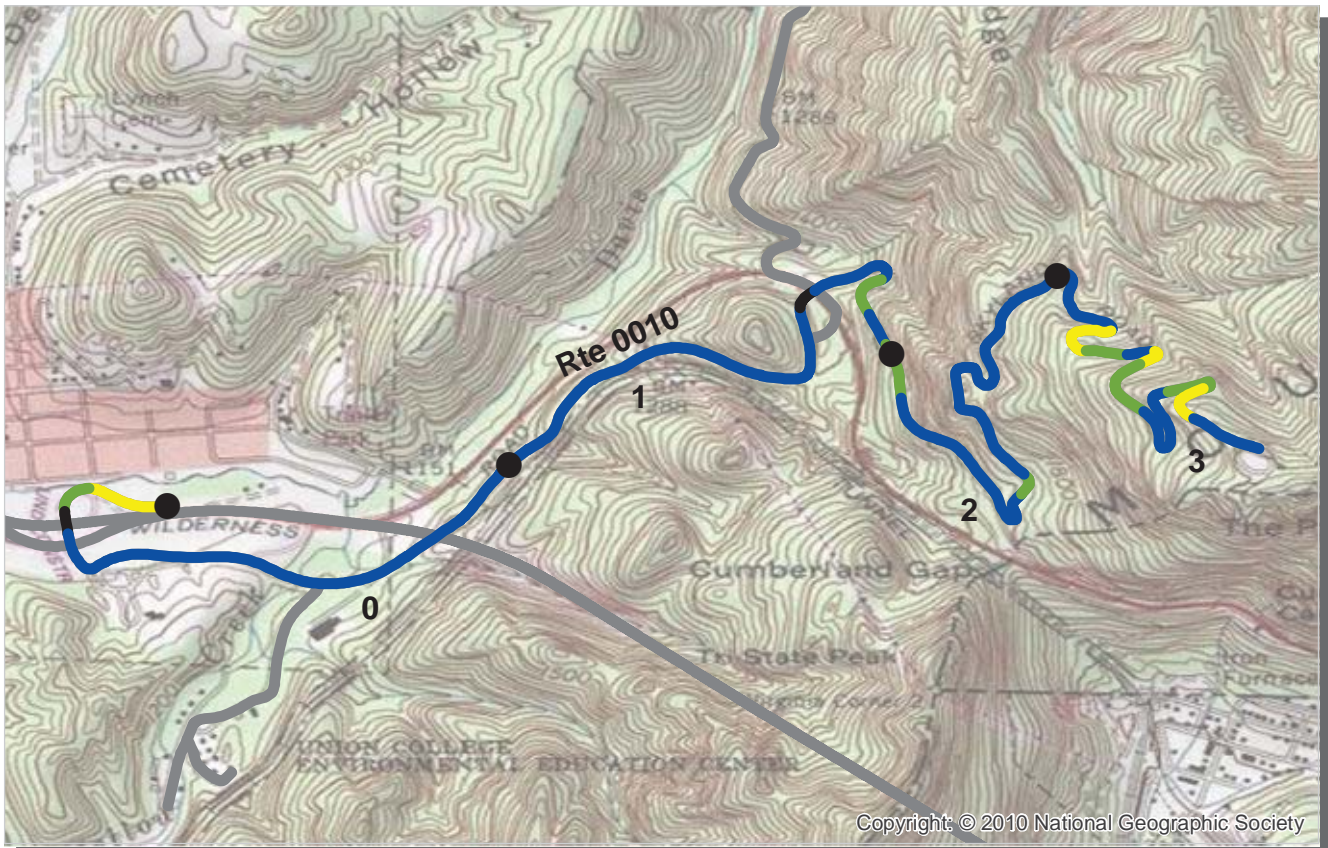
**ROUTE: 0010 PINNACLE ROAD**

<i>Section Number</i>	0	1	2	3
<i>Section Length (mi)</i>	1.00	1.00	1.00	0.99
<i>Cross Section Information</i>				
Number of Lanes	2	2	2	2
Paved Width (ft)	27	24	21	21
Lane Width (ft)	11	10	9	9
<i>Roadway Condition Information</i>				
SCR (Surface Condition Rating)	95	99	96	90
PCR (Pavement Condition Rating)	95	99	96	90
<i>Distress Index Values</i>				
Structural Crack Index	95	100	100	100
Transverse Cracking Index	100	100	100	100
Patching Index	100	100	100	100
Rutting Index	99	99	96	90
Roughness Condition Index (RCI)	NC	NC	NC	NC

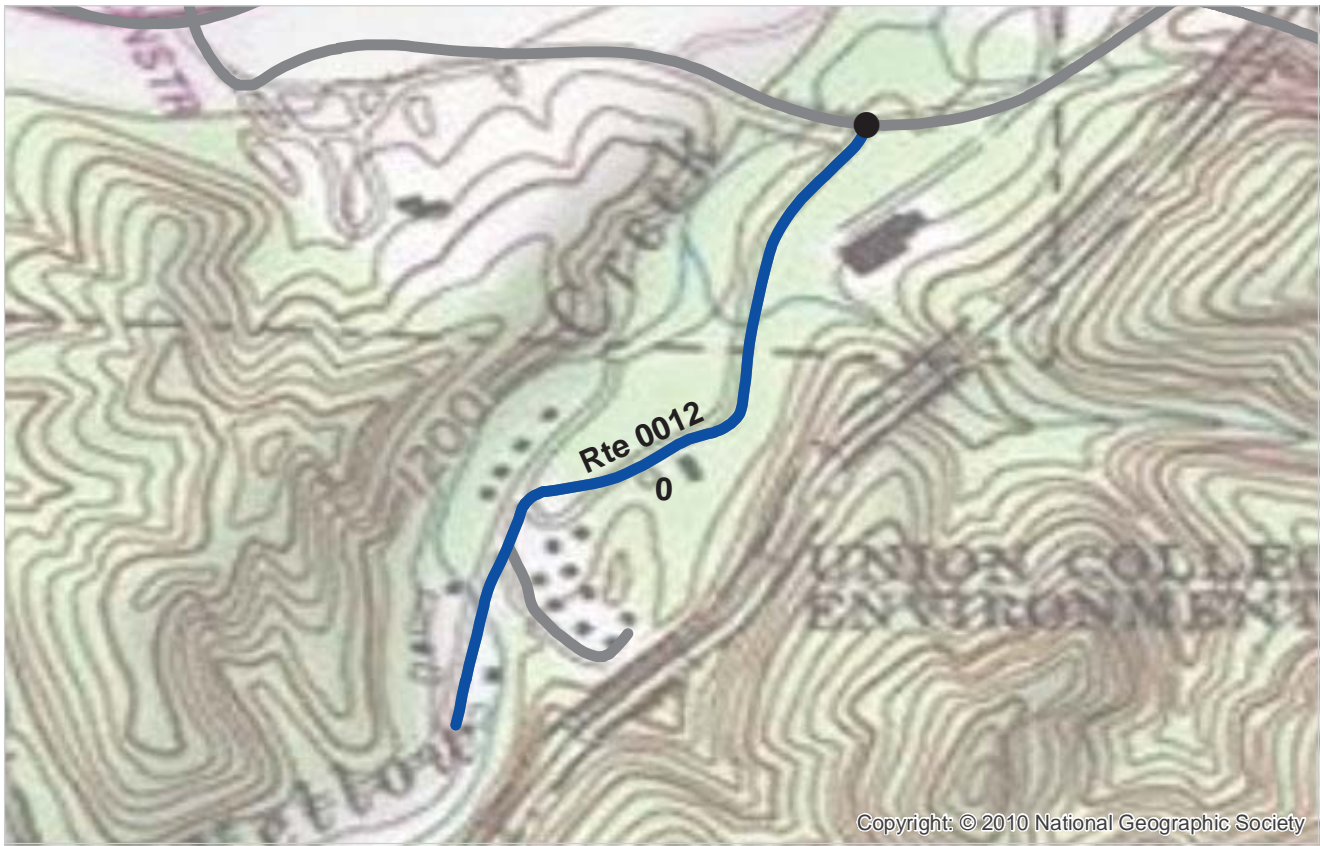
**ROUTE: 0012 BARTLETT PARK ROAD**

<b>Section Number</b>	0				
<b>Section Length (mi)</b>	0.49				
<b>Cross Section Information</b>					
Number of Lanes	2				
Paved Width (ft)	19				
Lane Width (ft)	9				
<b>Roadway Condition Information</b>					
SCR (Surface Condition Rating)	99				
PCR (Pavement Condition Rating)	99				
<b>Distress Index Values</b>					
Structural Crack Index	100				
Transverse Cracking Index	100				
Patching Index	99				
Rutting Index	99				
Roughness Condition Index (RCI)	NC

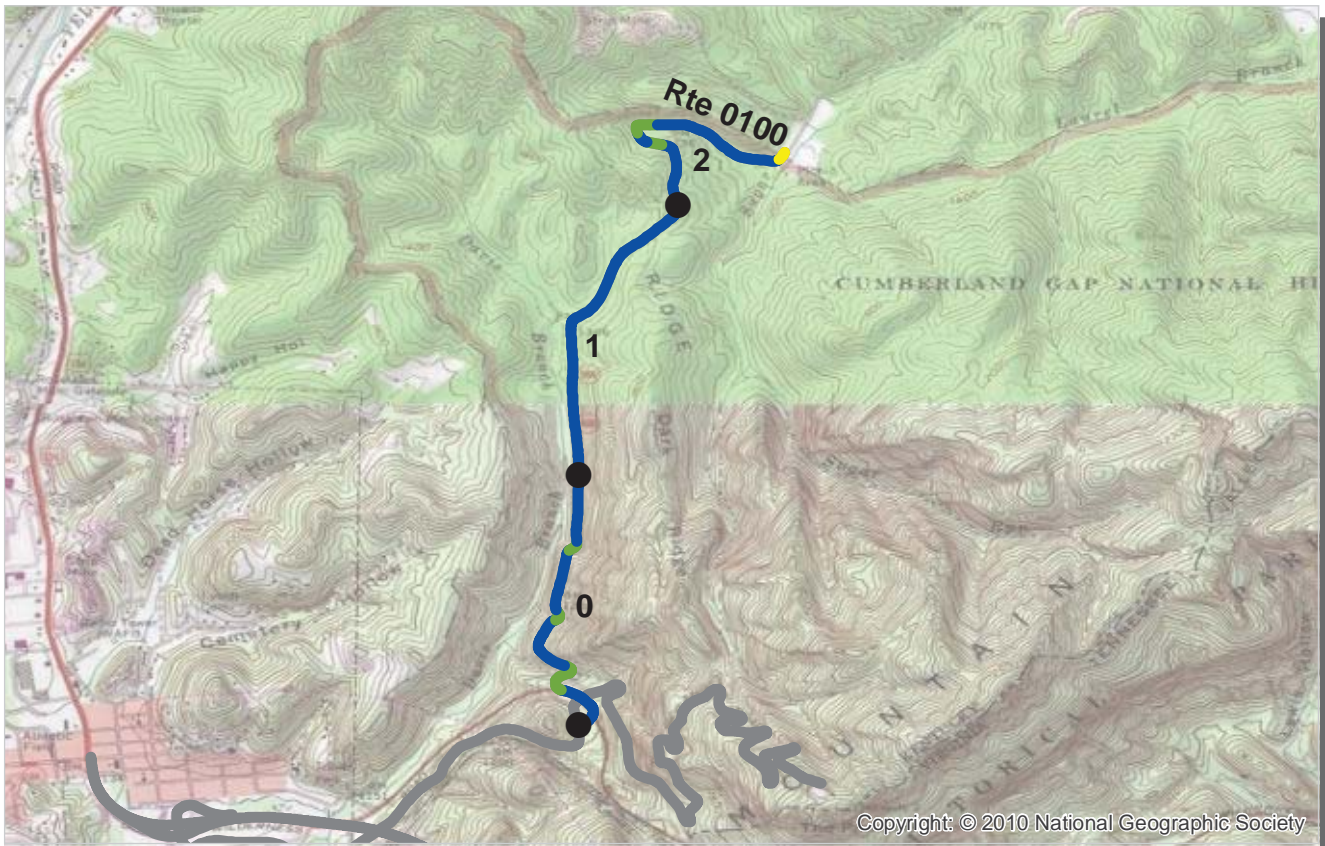
**ROUTE: 0100 SUGAR RUN OVERLOOK ROAD**

Section Number	0	1	2		
Section Length (mi)	1.00	1.00	0.77		
<b>Cross Section Information</b>					
Number of Lanes	2	2	2		
Paved Width (ft)	22	21	21		
Lane Width (ft)	10	9	10		
<b>Roadway Condition Information</b>					
SCR (Surface Condition Rating)	99	100	96		
PCR (Pavement Condition Rating)	97	100	97		
<b>Distress Index Values</b>					
Structural Crack Index	100	100	98		
Transverse Cracking Index	100	100	100		
Patching Index	100	100	100		
Rutting Index	99	100	96		
Roughness Condition Index (RCI)	95	100	99

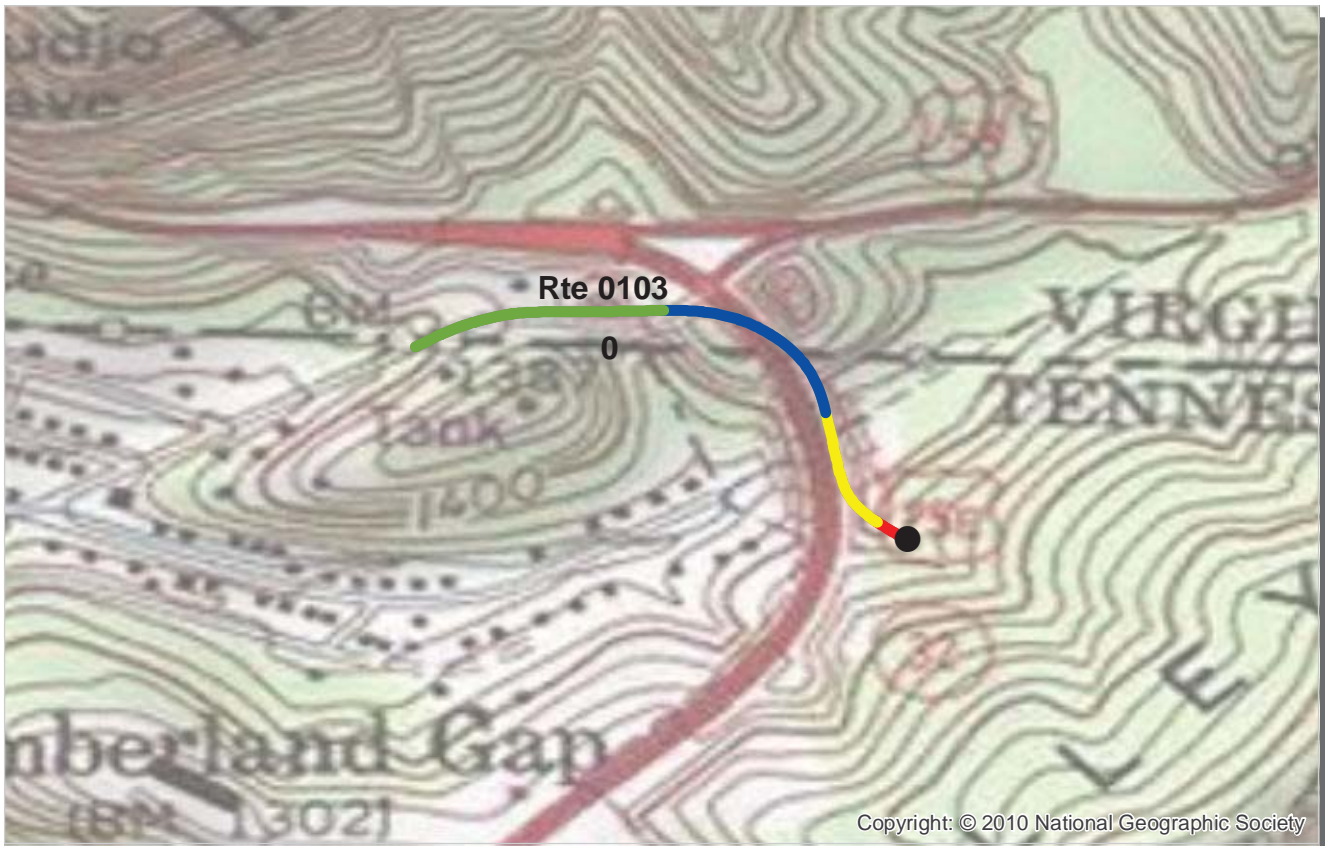
**ROUTE: 0103 DANIEL BOONE PARKING ACCESS ROAD**

<b>Section Number</b>	0				
<b>Section Length (mi)</b>	0.36				
<b>Cross Section Information</b>					
Number of Lanes	2				
Paved Width (ft)	32				
Lane Width (ft)	12				
<b>Roadway Condition Information</b>					
SCR (Surface Condition Rating)	82				
PCR (Pavement Condition Rating)	82				
<b>Distress Index Values</b>					
Structural Crack Index	82				
Transverse Cracking Index	100				
Patching Index	100				
Rutting Index	99				
Roughness Condition Index (RCI)	NC

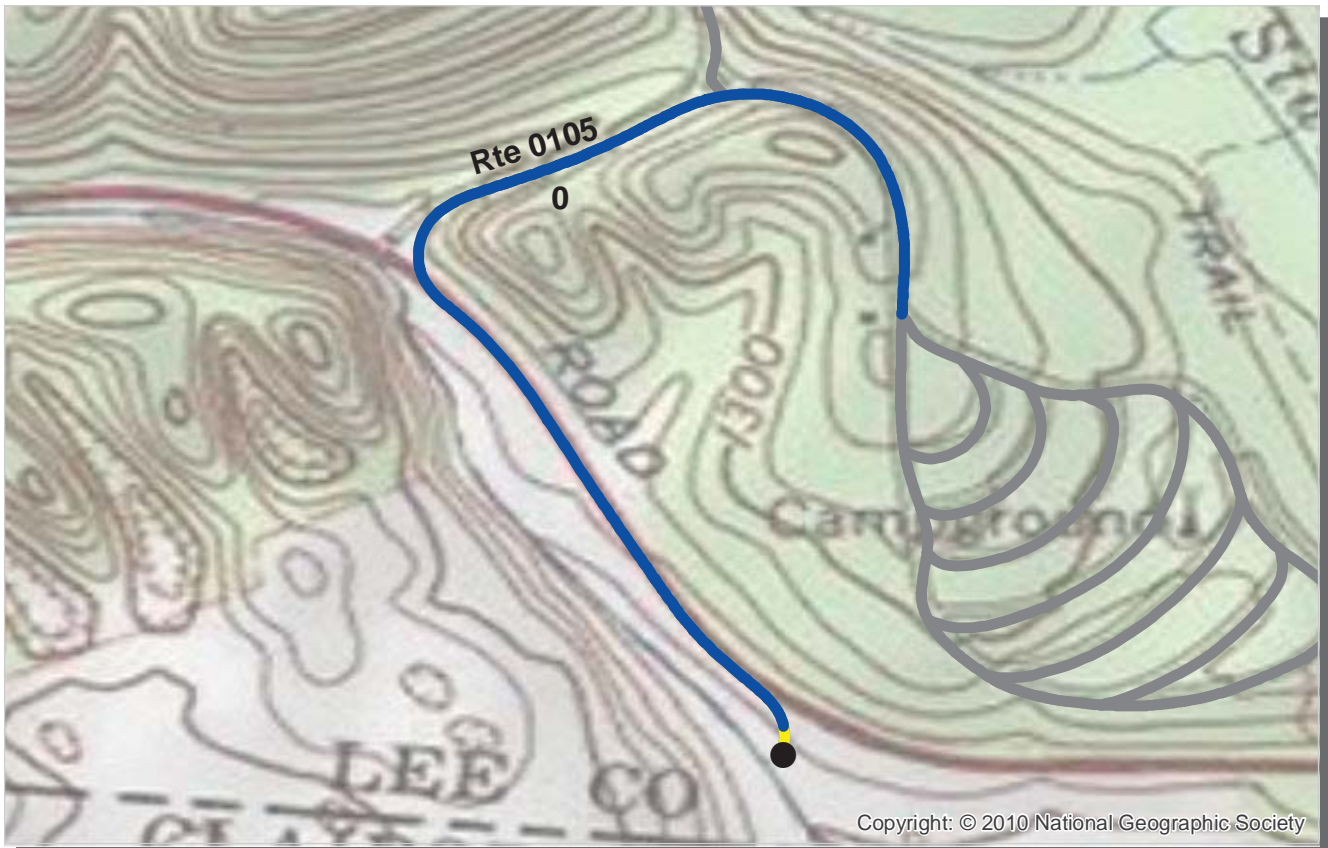
**ROUTE: 0105 WILDERNESS CAMPGROUND ACCESS ROAD**

<b>Section Number</b>	0				
<b>Section Length (mi)</b>	0.80				
<b>Cross Section Information</b>					
Number of Lanes	2				
Paved Width (ft)	24				
Lane Width (ft)	10				
<b>Roadway Condition Information</b>					
SCR (Surface Condition Rating)	100				
PCR (Pavement Condition Rating)	100				
<b>Distress Index Values</b>					
Structural Crack Index	100				
Transverse Cracking Index	100				
Patching Index	100				
Rutting Index	100				
Roughness Condition Index (RCI)	100

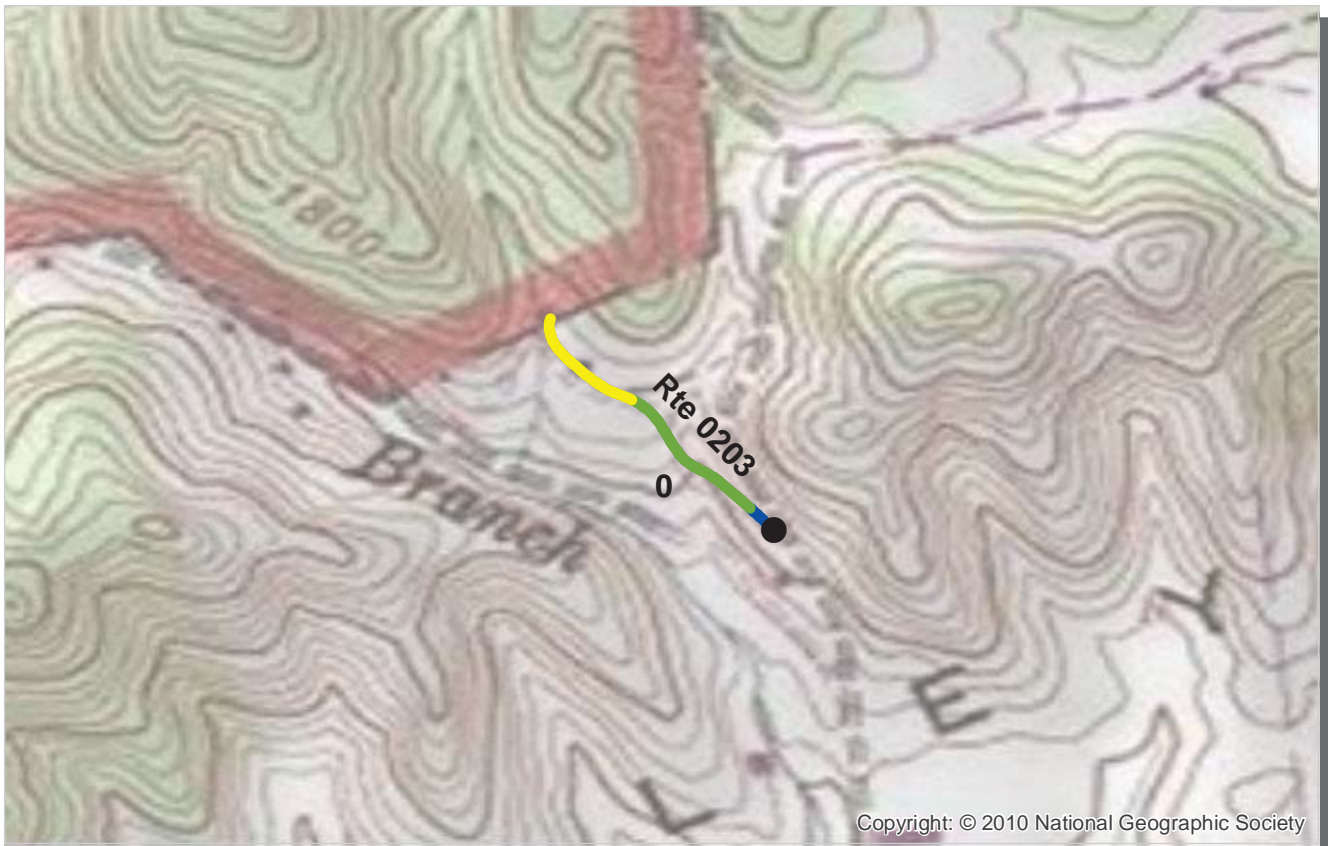
**ROUTE: 0203 ENTRANCE ROAD AT TWCP**

<b>Section Number</b>	0				
<b>Section Length (mi)</b>	0.19				
<b>Cross Section Information</b>					
Number of Lanes	1				
Paved Width (ft)	15				
Lane Width (ft)	10				
<b>Roadway Condition Information</b>					
SCR (Surface Condition Rating)	70				
PCR (Pavement Condition Rating)	70				
<b>Distress Index Values</b>					
Structural Crack Index	70				
Transverse Cracking Index	100				
Patching Index	100				
Rutting Index	90				
Roughness Condition Index (RCI)	NC

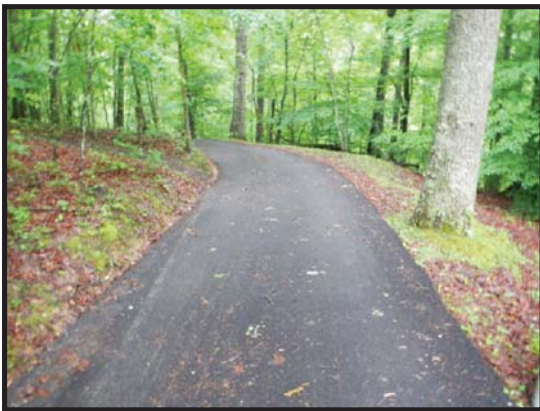
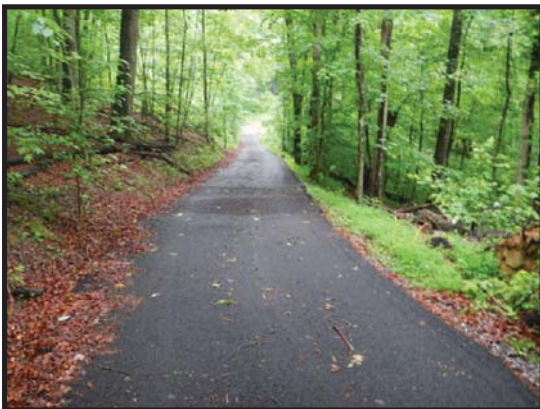
Route Number	Public / NonPublic	Date Visited	Area (sq ft)	Lane Miles *	Paved Length (mi)	Paved Width (ft)
0104	PUBLIC	5/23/2012	3,464	0.06	0.08	8
Culverts	Drop Inlets	Gates	Curb & Gutter	Curb	PCR	Surface Type
0	0	1	NO CURB AND GUTTER	NO CURB	EXCELLENT/97	AS

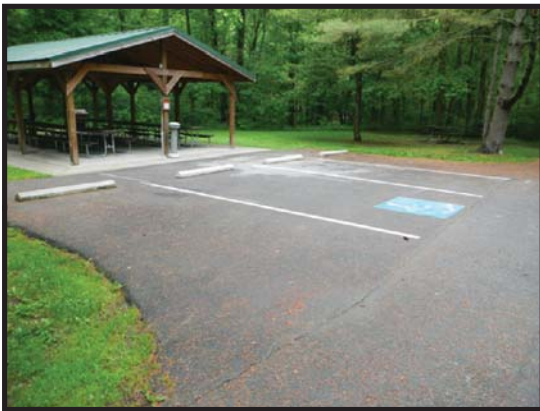
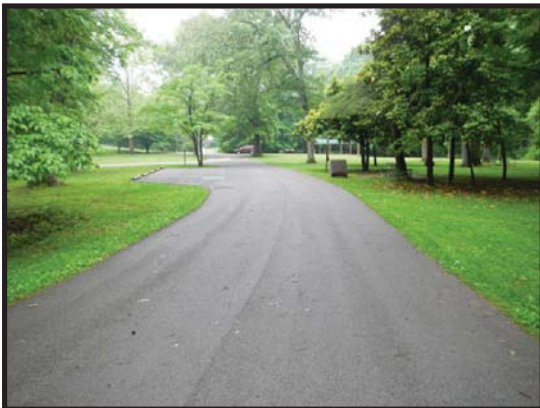
## Route 0905BZ

Route Number	Public / NonPublic	Date Visited	Area (sq ft)	Lane Miles *	Surface Type
0905BZ	PUBLIC	5/23/2012	10,560	0.18	AS
Culverts	Drop Inlets	Gates	Curb & Gutter	Curb	PCR
0	0	0	NO CURB AND GUTTER	NO CURB	EXCELLENT/97

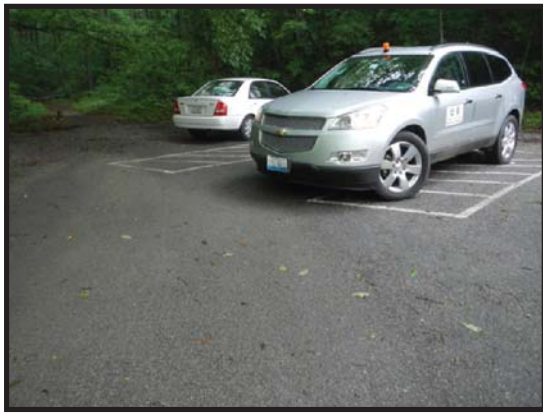
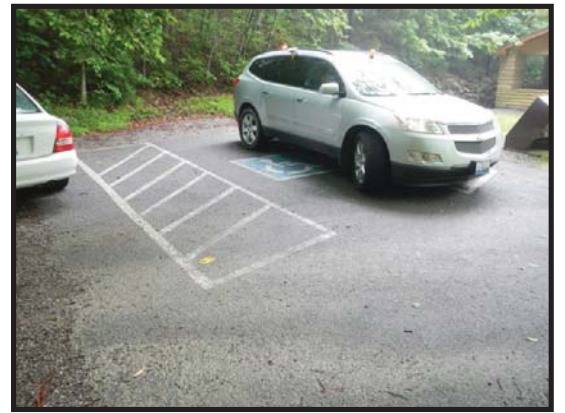
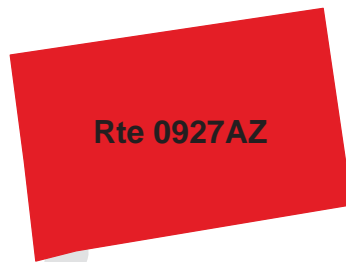
## Route 0927AZ

Route Number	Public / NonPublic	Date Visited	Area (sq ft)	Lane Miles *	Surface Type
0927AZ	PUBLIC	5/23/2012	2,386	0.04	AS
Culverts	Drop Inlets	Gates	Curb & Gutter	Curb	PCR
0	0	0	NO CURB AND GUTTER	NO CURB	GOOD/90

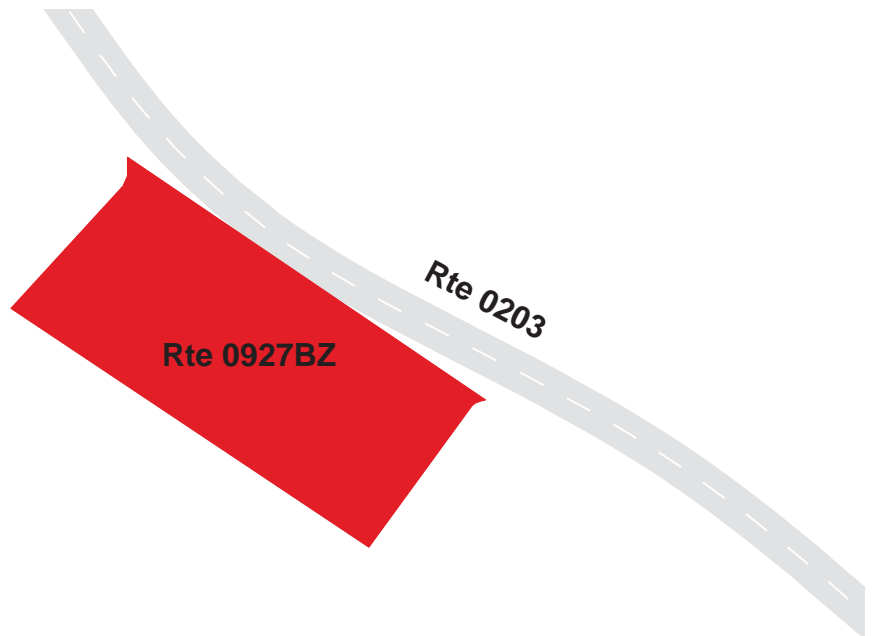
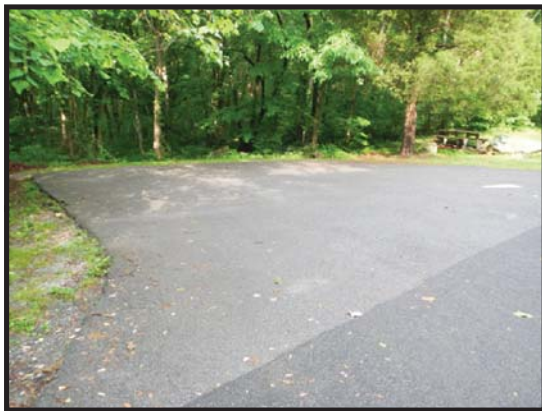
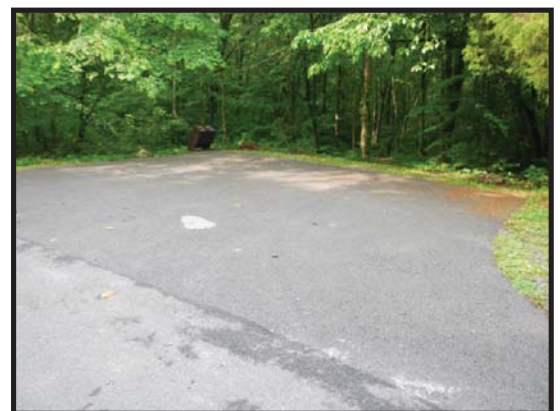
## Route 0927BZ

Route Number	Public / NonPublic	Date Visited	Area (sq ft)	Lane Miles *	Surface Type
0927BZ	PUBLIC	5/23/2012	2,829	0.05	AS
Culverts	Drop Inlets	Gates	Curb & Gutter	Curb	PCR
0	0	0	NO CURB AND GUTTER	NO CURB	GOOD/90

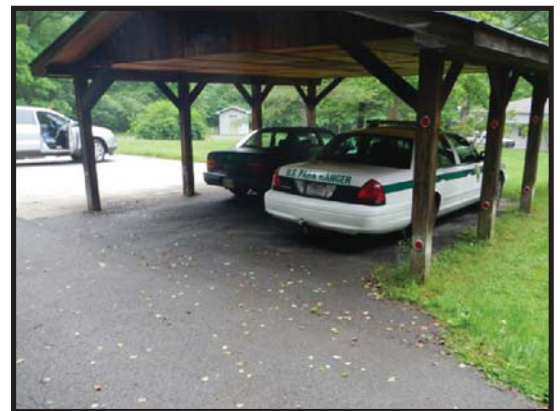
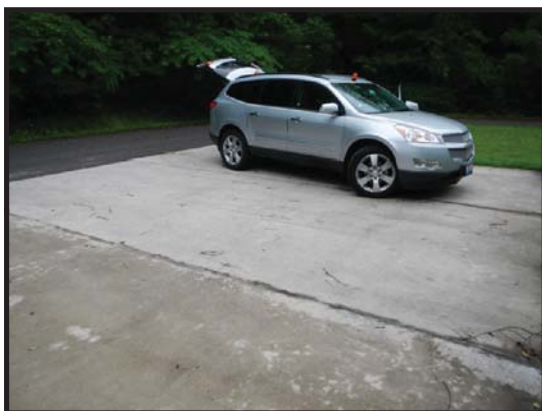
## Route 0928

Route Number	Public / NonPublic	Date Visited	Area (sq ft)	Lane Miles *	Surface Type
0928	NONPUBLIC	5/23/2012	1,489	0.03	CO
Culverts	Drop Inlets	Gates	Curb & Gutter	Curb	PCR
0	0	0	NO CURB AND GUTTER	NO CURB	GOOD/90

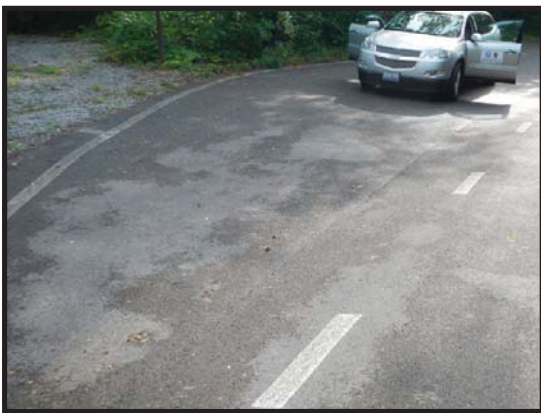
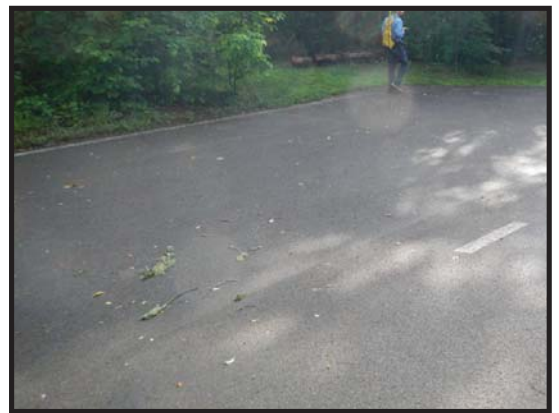
## Route 0929

Route Number	Public / NonPublic	Date Visited	Area (sq ft)	Lane Miles *	Surface Type
0929	PUBLIC	5/23/2012	1,487	0.03	AS
Culverts	Drop Inlets	Gates	Curb & Gutter	Curb	PCR
0	0	0	NO CURB AND GUTTER	NO CURB	GOOD/90
