Federal Lands Highway Road Inventory Program

Road Inventory and Condition Assessment

Curecanti National Recreation Area
CURE - 1379

Cycle 5 Report

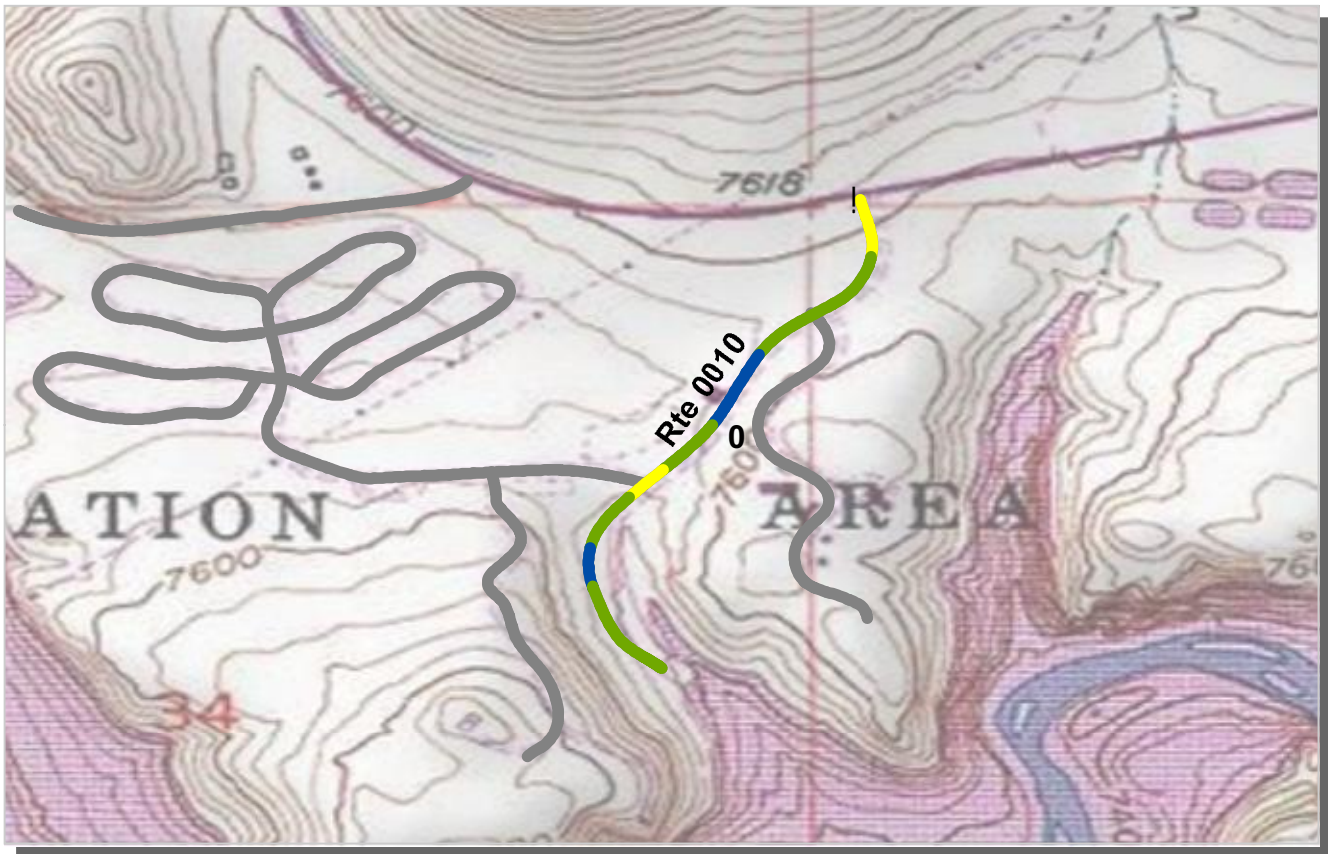
ROUTE: 0010 ELK CREEK ENTRANCE ROAD

<i>Section Number</i>	0				
<i>Section Length (mi)</i>	0.58				
<i>Cross Section Information</i>					
Number of Lanes	2				
Paved Width (ft)	21				
Lane Width (ft)	9				
<i>Roadway Condition Information</i>					
SCR (Surface Condition Rating)	99				
PCR (Pavement Condition Rating)	89				
<i>Distress Index Values</i>					
Structural Crack Index	99				
Transverse Cracking Index	99				
Patching Index	100				
Rutting Index	99				
Roughness Condition Index (RCI)	73

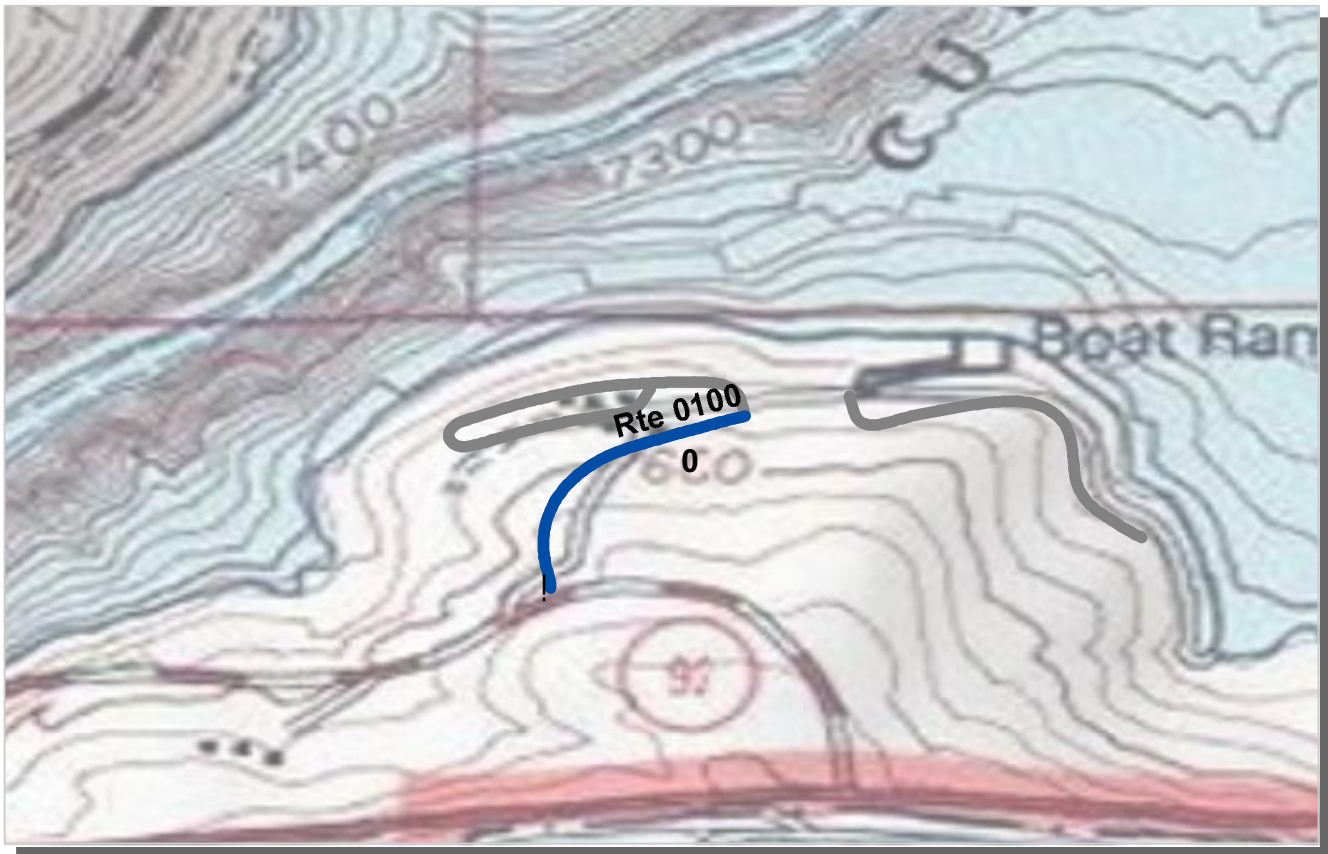
ROUTE: 0100 LAKE FORK CAMPGROUND ROAD

<i>Section Number</i>	0				
<i>Section Length (mi)</i>	0.18				
<i>Cross Section Information</i>					
Number of Lanes	2				
Paved Width (ft)	24				
Lane Width (ft)	10				
<i>Roadway Condition Information</i>					
SCR (Surface Condition Rating)	99				
PCR (Pavement Condition Rating)	99				
<i>Distress Index Values</i>					
Structural Crack Index	100				
Transverse Cracking Index	100				
Patching Index	100				
Rutting Index	99				
Roughness Condition Index (RCI)	NC

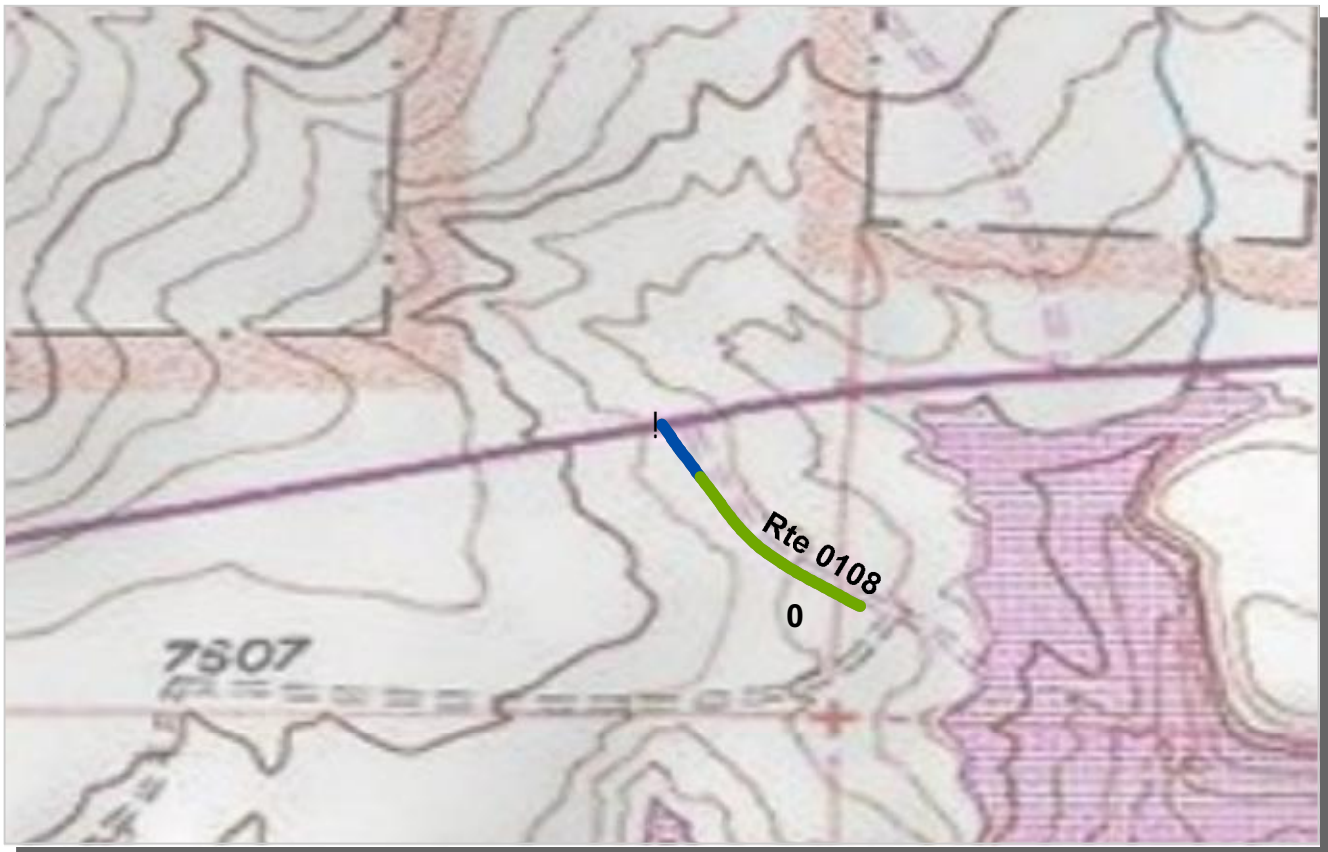
ROUTE: 0108 DRY CREEK ROAD

Section Number	0				
Section Length (mi)	0.16				
Cross Section Information					
Number of Lanes	2				
Paved Width (ft)	26				
Lane Width (ft)	14				
Roadway Condition Information					
SCR (Surface Condition Rating)	94				
PCR (Pavement Condition Rating)	94				
Distress Index Values					
Structural Crack Index	100				
Transverse Cracking Index	100				
Patching Index	100				
Rutting Index	94				
Roughness Condition Index (RCI)	NC

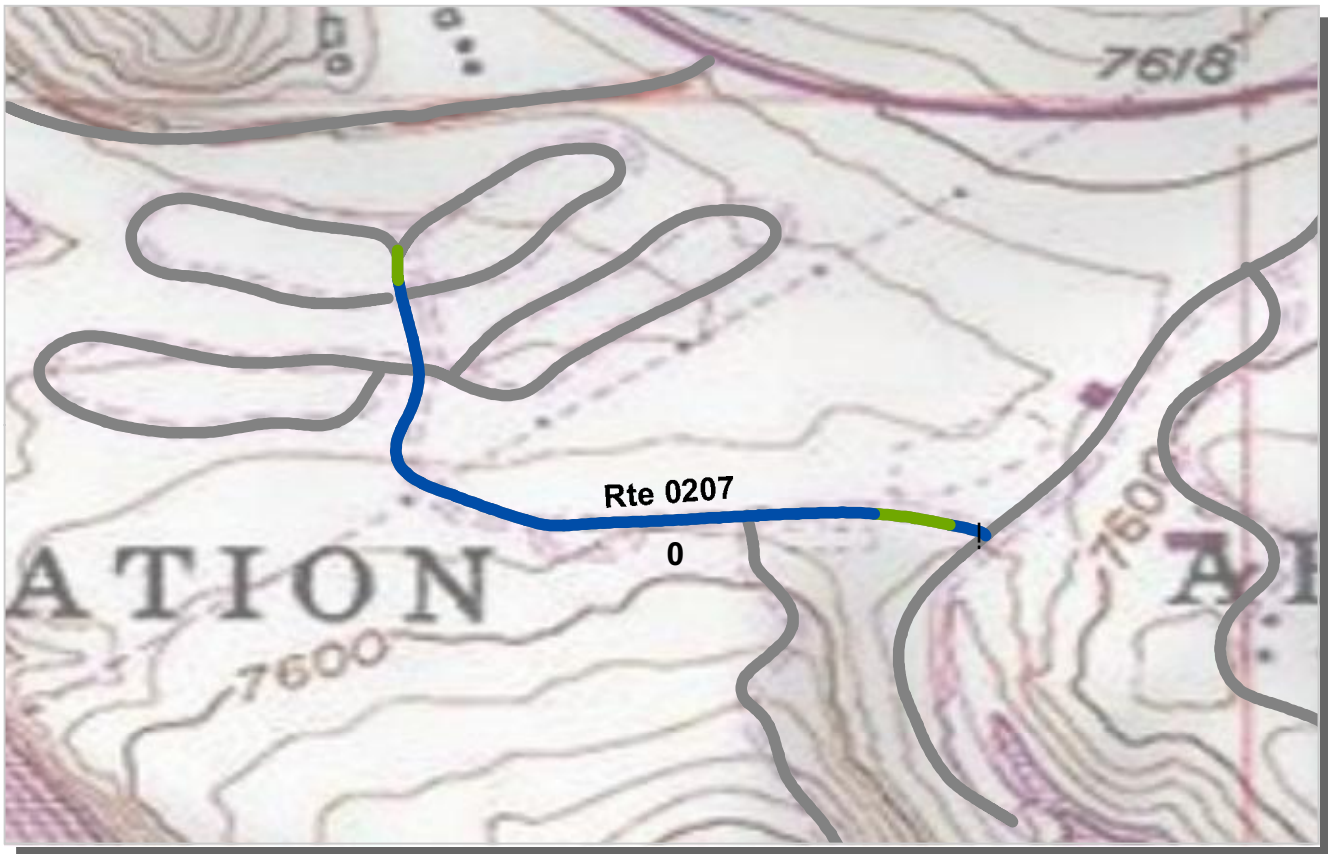
ROUTE: 0207 ELK CREEK CAMPGROUND ROAD

<i>Section Number</i>	0				
<i>Section Length (mi)</i>	0.46				
<i>Cross Section Information</i>					
Number of Lanes	2				
Paved Width (ft)	21				
Lane Width (ft)	9				
<i>Roadway Condition Information</i>					
SCR (Surface Condition Rating)	98				
PCR (Pavement Condition Rating)	98				
<i>Distress Index Values</i>					
Structural Crack Index	100				
Transverse Cracking Index	99				
Patching Index	100				
Rutting Index	98				
Roughness Condition Index (RCI)	NC

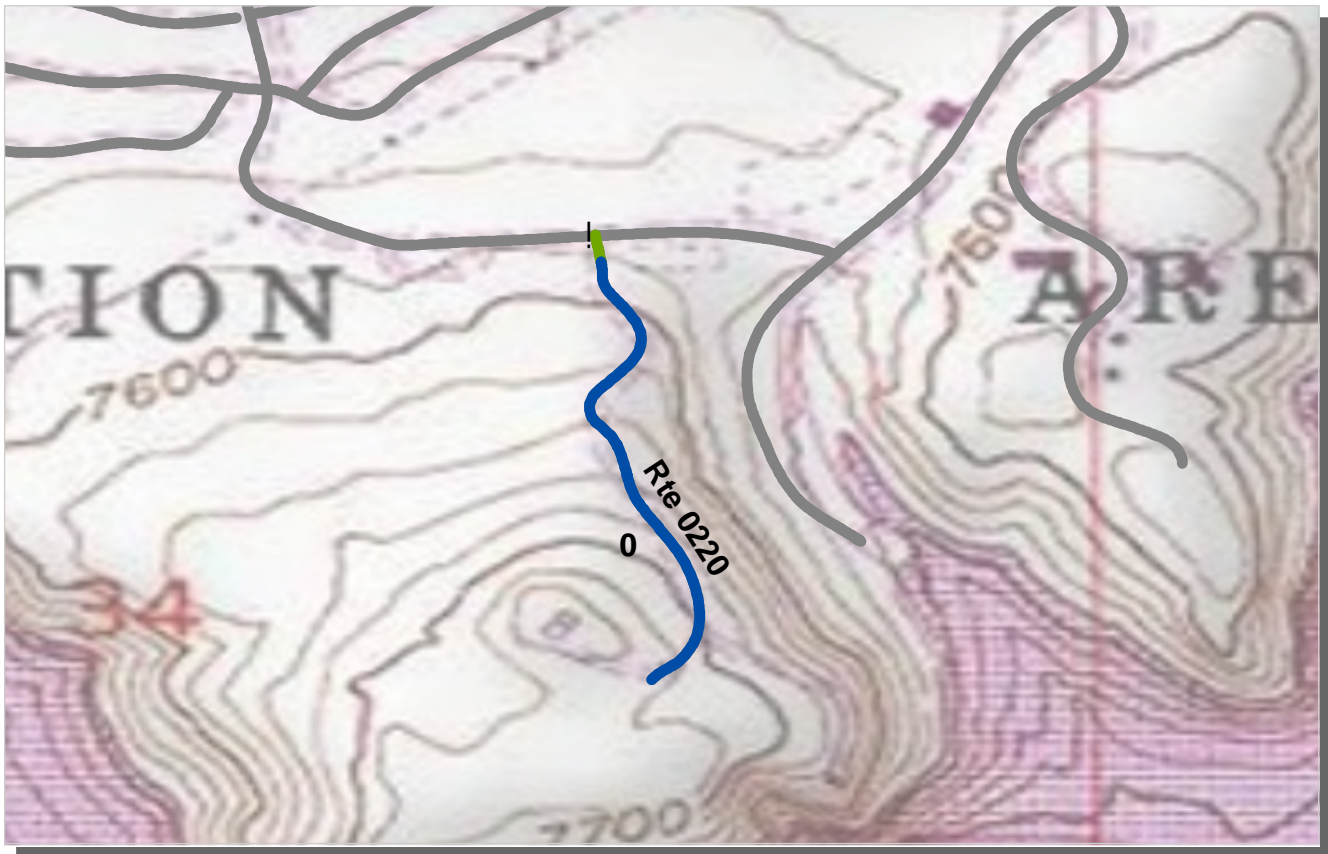
ROUTE: 0220 ELK CREEK SERVICE ROAD

Section Number	0				
Section Length (mi)	0.34				
Cross Section Information					
Number of Lanes	2				
Paved Width (ft)	17				
Lane Width (ft)	9				
Roadway Condition Information					
SCR (Surface Condition Rating)	98				
PCR (Pavement Condition Rating)	98				
Distress Index Values					
Structural Crack Index	100				
Transverse Cracking Index	100				
Patching Index	100				
Rutting Index	98				
Roughness Condition Index (RCI)	NC

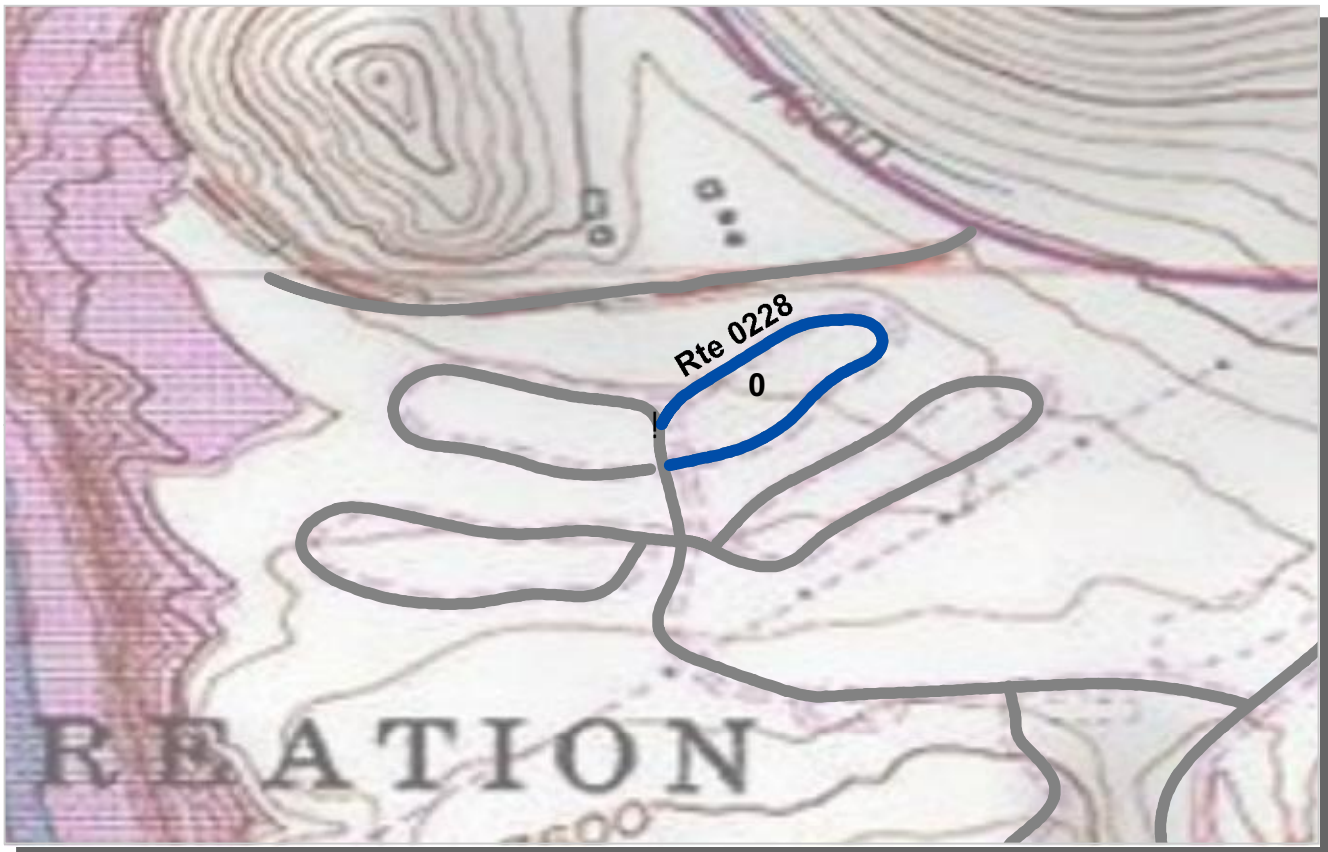
ROUTE: 0228 ELK CREEK CAMPGROUND LOOP C

Section Number	0				
Section Length (mi)	0.29				
Cross Section Information					
Number of Lanes	1				
Paved Width (ft)	14				
Lane Width (ft)	14				
Roadway Condition Information					
SCR (Surface Condition Rating)	97				
PCR (Pavement Condition Rating)	97				
Distress Index Values					
Structural Crack Index	97				
Transverse Cracking Index	100				
Patching Index	100				
Rutting Index	98				
Roughness Condition Index (RCI)	NC

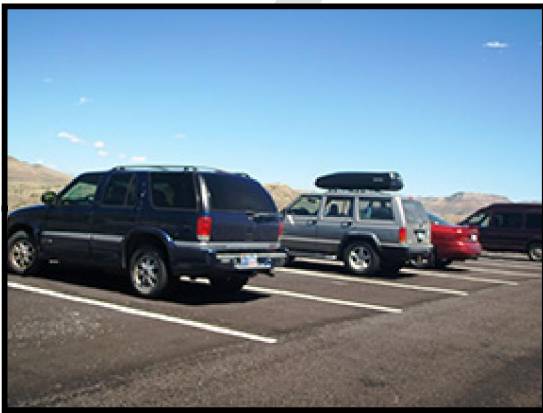
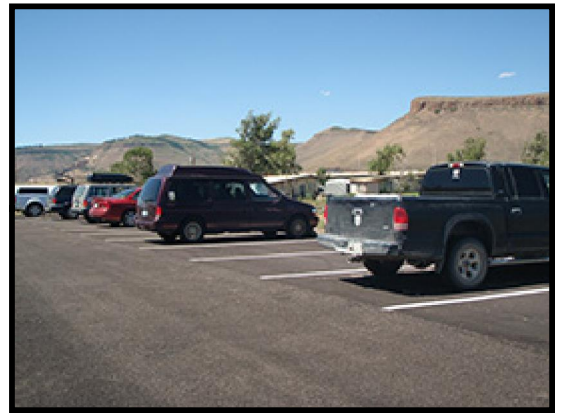
Route Number	Public / NonPublic	Date Visited	Area (sq ft)	Lane Miles *	Surface Type
0902A	NONPUBLIC	8/9/2011	2,414	0.04	AS
Culverts	Drop Inlets	Gates	Curb & Gutter	Curb	PCR
0	0	0	NO CURB AND GUTTER	NO CURB	GOOD/90

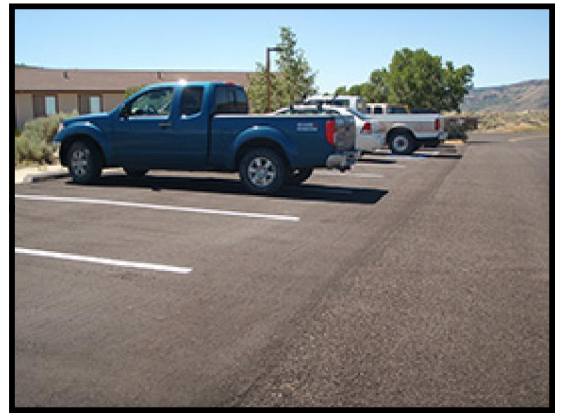
Route Number	Public / NonPublic	Date Visited	Area (sq ft)	Lane Miles *	Surface Type
0902B	NONPUBLIC	8/9/2011	1,771	0.03	AS
Culverts	Drop Inlets	Gates	Curb & Gutter	Curb	PCR
0	0	0	NO CURB AND GUTTER	NO CURB	GOOD/90

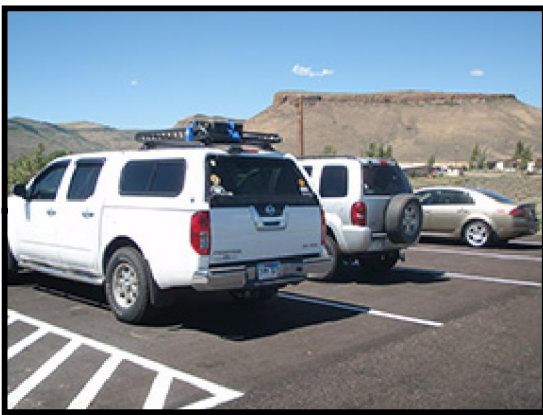
Route Number	Public / NonPublic	Date Visited	Area (sq ft)	Lane Miles *	Surface Type
0902C	NONPUBLIC	8/9/2011	1,460	0.03	AS
Culverts	Drop Inlets	Gates	Curb & Gutter	Curb	PCR
0	0	0	NO CURB AND GUTTER	NO CURB	GOOD/90

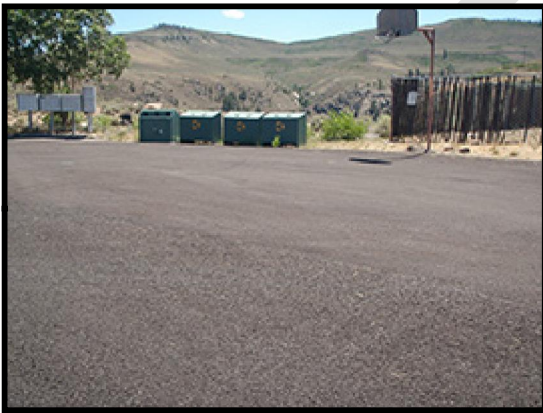
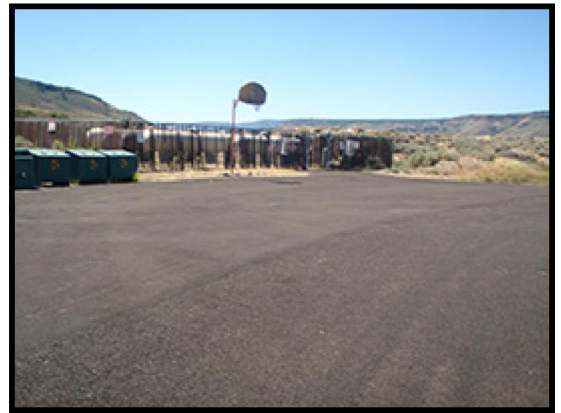
Route Number	Public / NonPublic	Date Visited	Area (sq ft)	Lane Miles *	Surface Type
0902D	NONPUBLIC	8/9/2011	2,779	0.05	AS
Culverts	Drop Inlets	Gates	Curb & Gutter	Curb	PCR
0	0	0	NO CURB AND GUTTER	NO CURB	GOOD/90

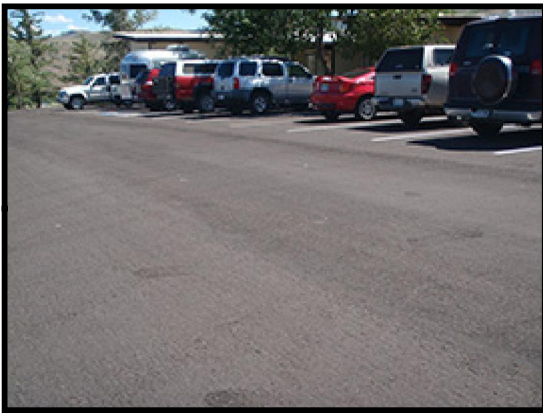
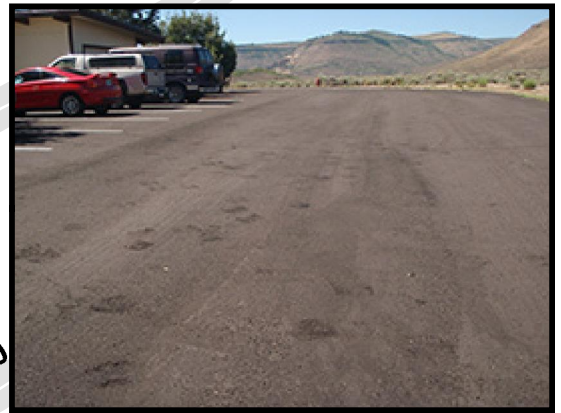
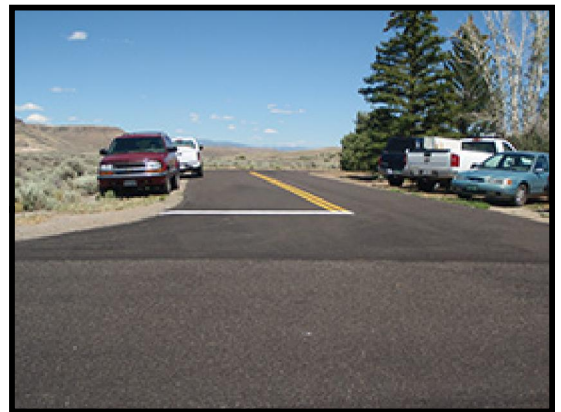
Route 0902E

Route Number	Public / NonPublic	Date Visited	Area (sq ft)	Lane Miles *	Surface Type
0902E	NONPUBLIC	8/9/2011	11,348	0.20	AS
Culverts	Drop Inlets	Gates	Curb & Gutter	Curb	PCR
0	0	0	NO CURB AND GUTTER	NO CURB	GOOD/90

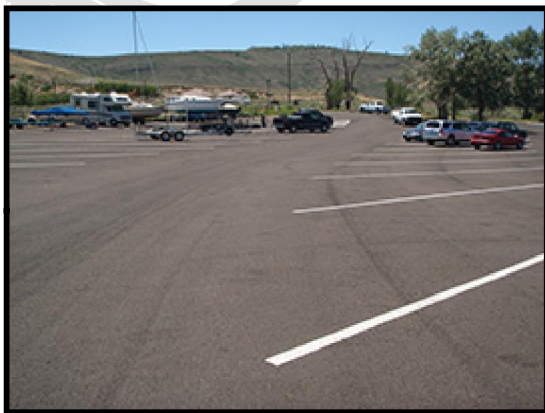
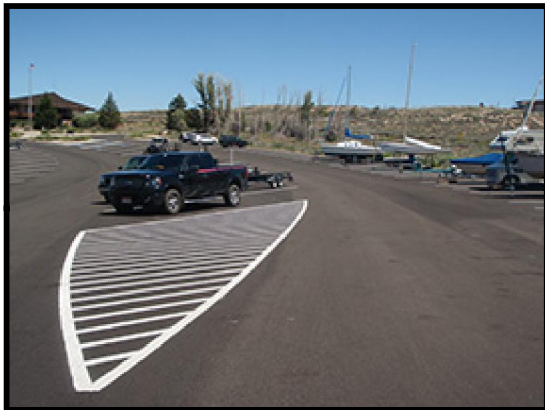
Route 0903

Route Number	Public / NonPublic	Date Visited	Area (sq ft)	Lane Miles *	Surface Type
0903	PUBLIC	8/9/2011	75,190	1.30	AS
Culverts	Drop Inlets	Gates	Curb & Gutter	Curb	PCR
0	1	0	CONCRETE CURB AND GUTTER	NO CURB	GOOD/90

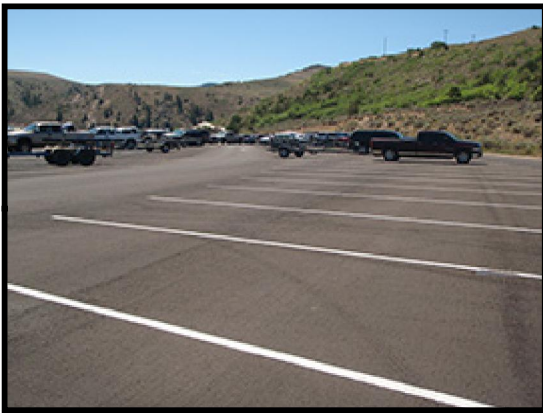
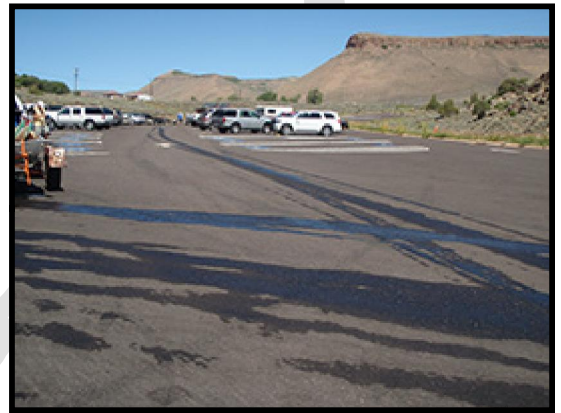
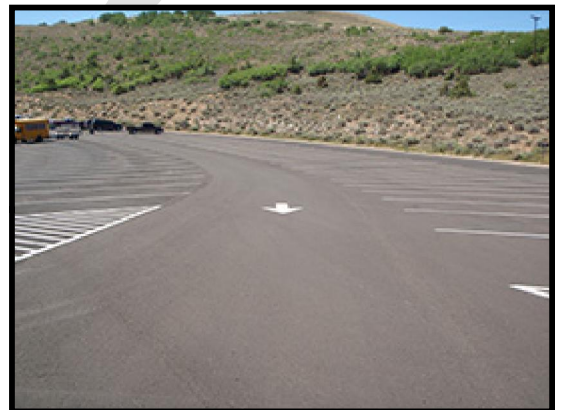
Route 0904

Route Number	Public / NonPublic	Date Visited	Area (sq ft)	Lane Miles *	Surface Type
0904	PUBLIC	8/9/2011	94,462	1.63	AS
Culverts	Drop Inlets	Gates	Curb & Gutter	Curb	PCR
0	2	1	CONCRETE CURB AND GUTTER	NO CURB	GOOD/90

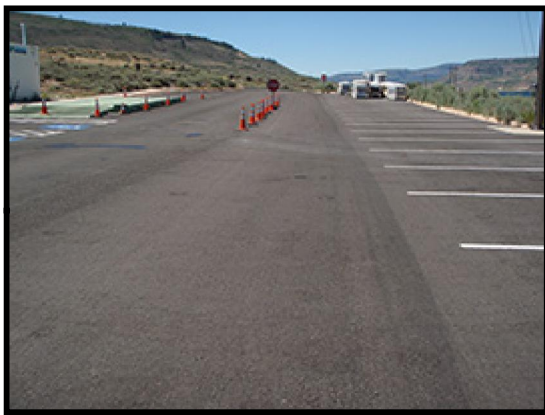
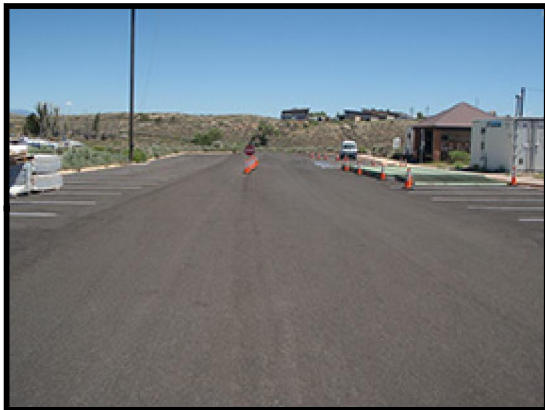
Route 0906

Route Number	Public / NonPublic	Date Visited	Area (sq ft)	Lane Miles *	Surface Type
0906	PUBLIC	8/9/2011	16,815	0.29	AS
Culverts	Drop Inlets	Gates	Curb & Gutter	Curb	PCR
0	1	0	CONCRETE CURB AND GUTTER	NO CURB	GOOD/90

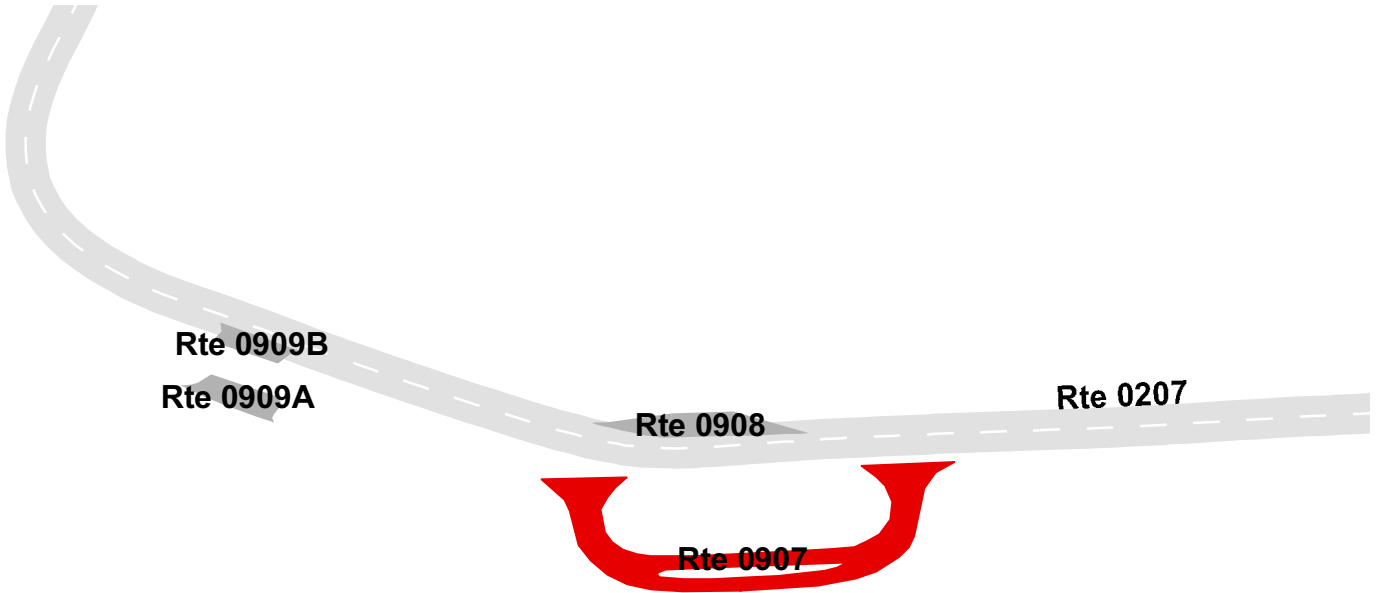
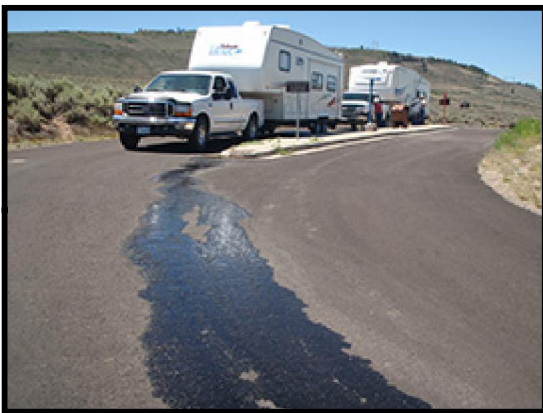
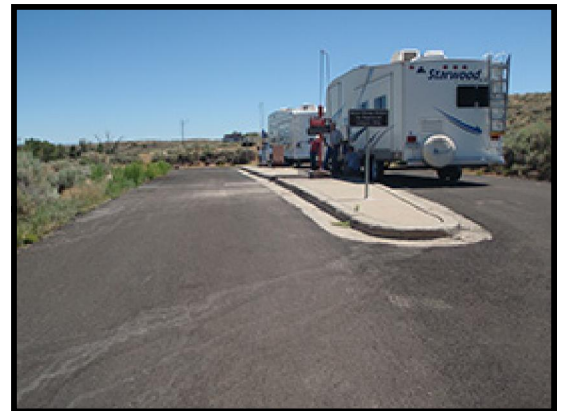
Route Number	Public / NonPublic	Date Visited	Area (sq ft)	Lane Miles *	Surface Type
0907	PUBLIC	8/9/2011	8,646	0.15	AS
Culverts	Drop Inlets	Gates	Curb & Gutter	Curb	PCR
0	0	2	CONCRETE CURB AND GUTTER	NO CURB	GOOD/90

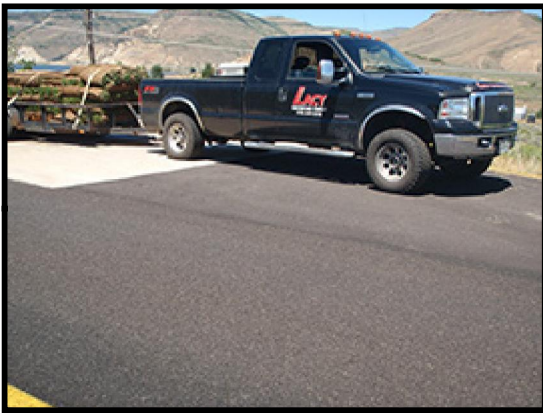
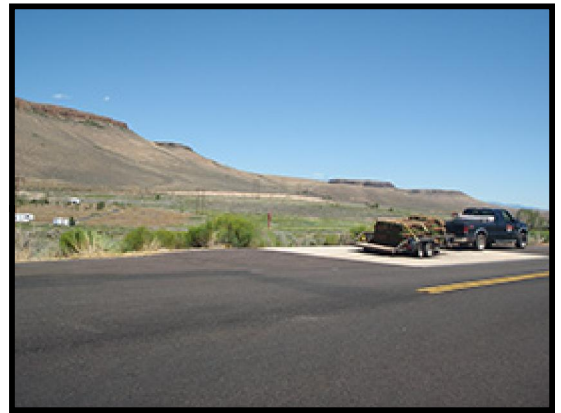
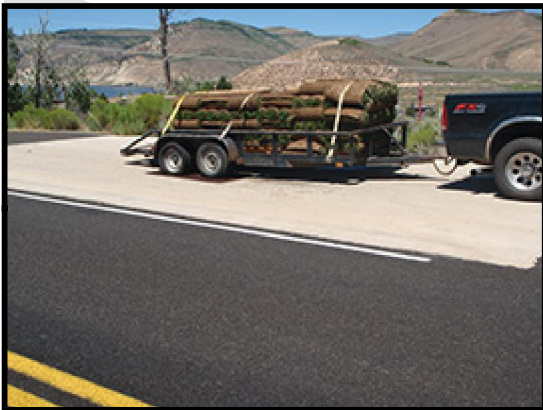
Route Number	Public / NonPublic	Date Visited	Area (sq ft)	Lane Miles *	Surface Type
0908	PUBLIC	8/9/2011	2,066	0.04	AS
Culverts	Drop Inlets	Gates	Curb & Gutter	Curb	PCR
0	0	0	NO CURB AND GUTTER	NO CURB	GOOD/90

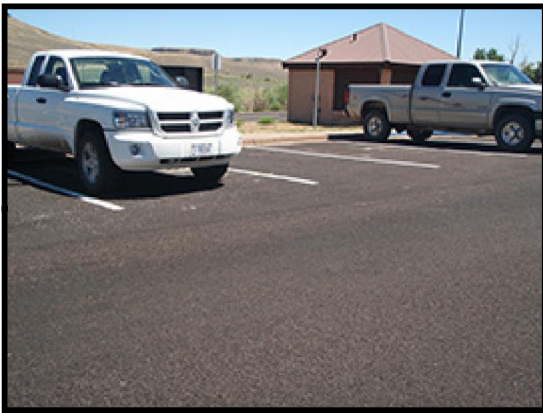
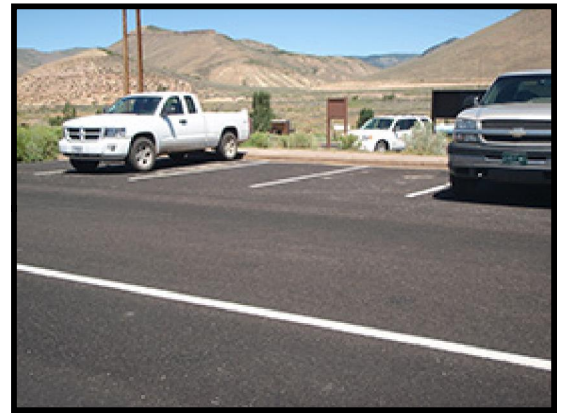
Route Number	Public / NonPublic	Date Visited	Area (sq ft)	Lane Miles *	Surface Type
0909A	NONPUBLIC	8/9/2011	1,225	0.02	AS
Culverts	Drop Inlets	Gates	Curb & Gutter	Curb	PCR
0	0	0	CONCRETE CURB AND GUTTER	NO CURB	GOOD/90

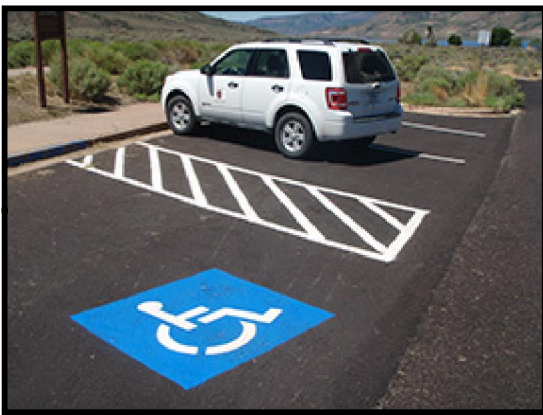
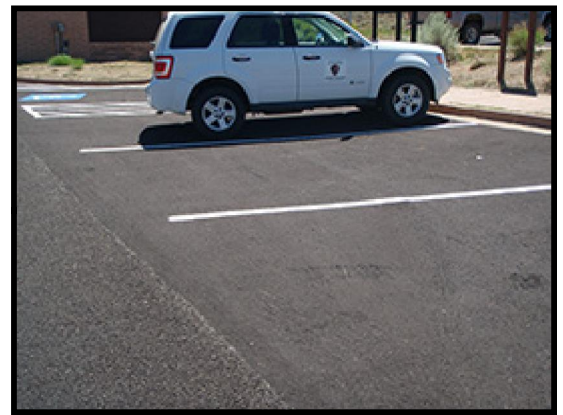
Route Number	Public / NonPublic	Date Visited	Area (sq ft)	Lane Miles *	Surface Type
0909B	NONPUBLIC	8/9/2011	866	0.02	AS
Culverts	Drop Inlets	Gates	Curb & Gutter	Curb	PCR
0	0	0	CONCRETE CURB AND GUTTER	NO CURB	GOOD/90

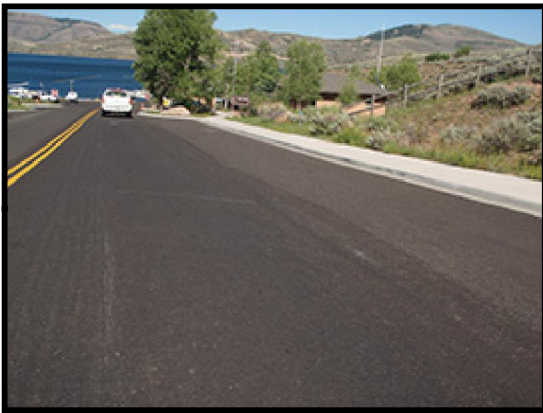
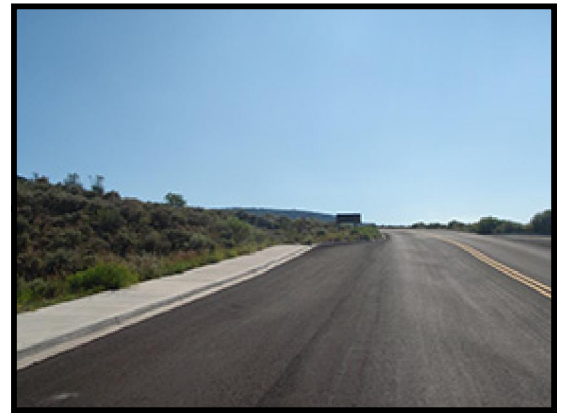
Route Number	Public / NonPublic	Date Visited	Area (sq ft)	Lane Miles *	Surface Type
0910A	PUBLIC	8/9/2011	1,864	0.03	AS
Culverts	Drop Inlets	Gates	Curb & Gutter	Curb	PCR
0	0	0	CONCRETE CURB AND GUTTER	NO CURB	GOOD/90

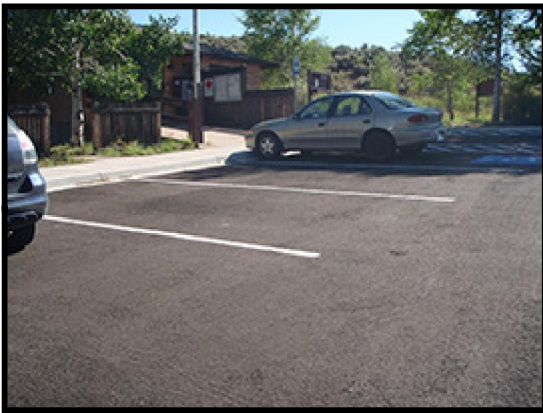
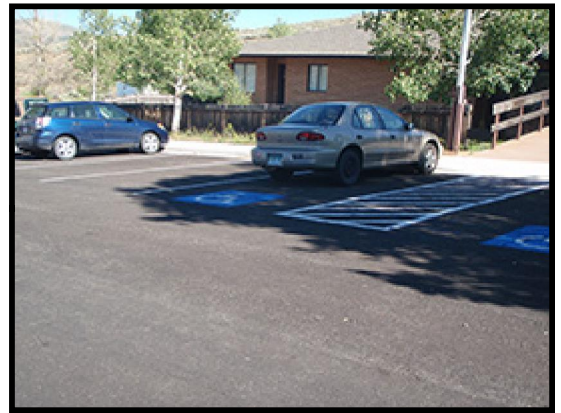
Route Number	Public / NonPublic	Date Visited	Area (sq ft)	Lane Miles *	Surface Type
0910B	PUBLIC	8/9/2011	2,044	0.04	AS
Culverts	Drop Inlets	Gates	Curb & Gutter	Curb	PCR
0	0	0	CONCRETE CURB AND GUTTER	NO CURB	GOOD/90

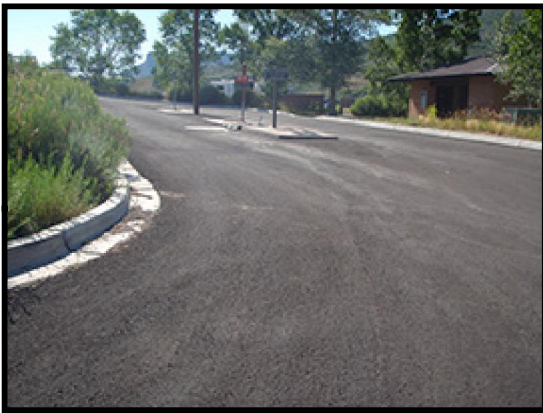
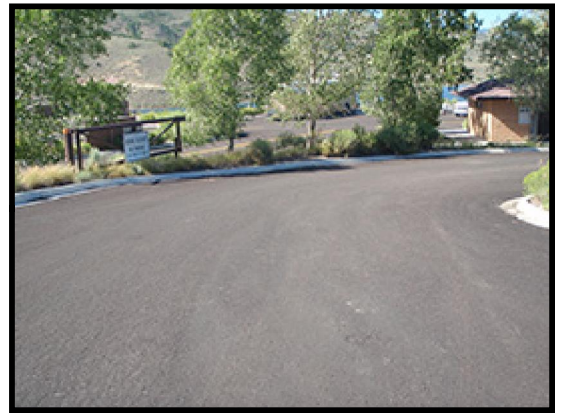
Route Number	Public / NonPublic	Date Visited	Area (sq ft)	Lane Miles *	Surface Type
0911	PUBLIC	8/9/2011	6,740	0.12	AS
Culverts	Drop Inlets	Gates	Curb & Gutter	Curb	PCR
0	0	2	CONCRETE CURB AND GUTTER	NO CURB	GOOD/90

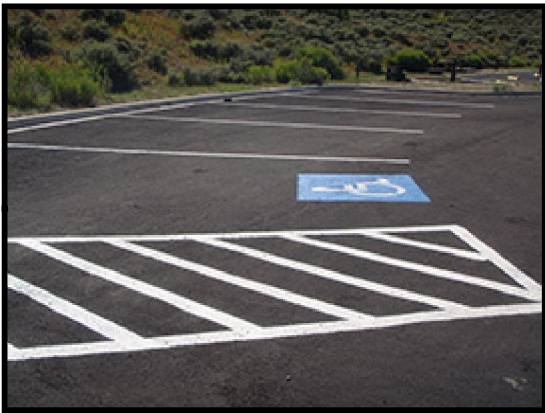
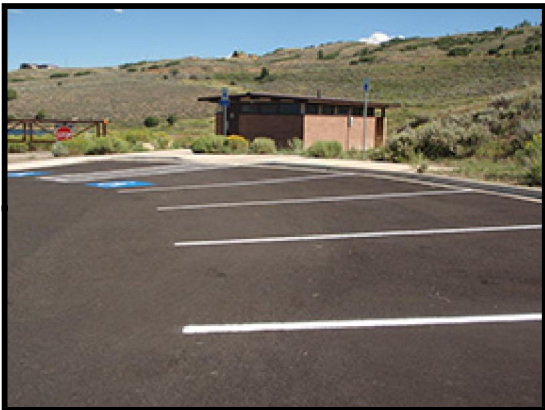
Route Number	Public / NonPublic	Date Visited	Area (sq ft)	Lane Miles *	Surface Type
0912	PUBLIC	8/9/2011	1,702	0.03	AS
Culverts	Drop Inlets	Gates	Curb & Gutter	Curb	PCR
0	0	0	CONCRETE CURB AND GUTTER	NO CURB	GOOD/90

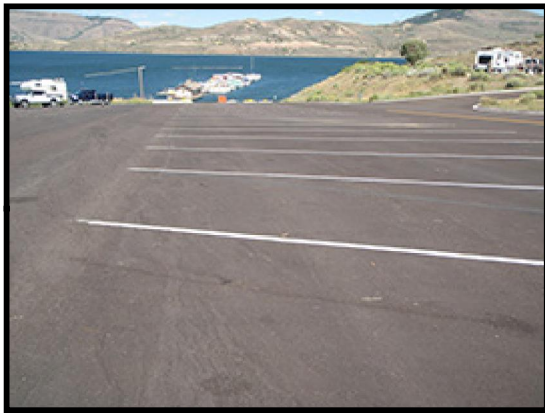
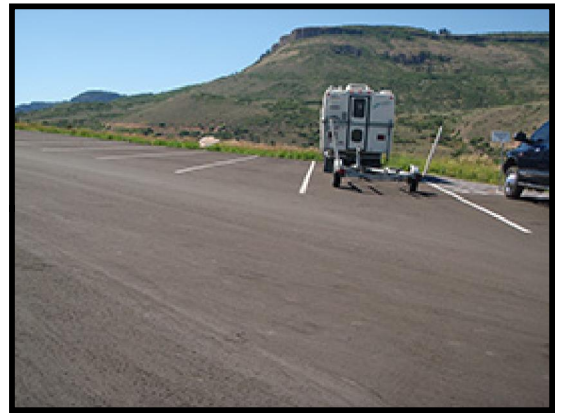
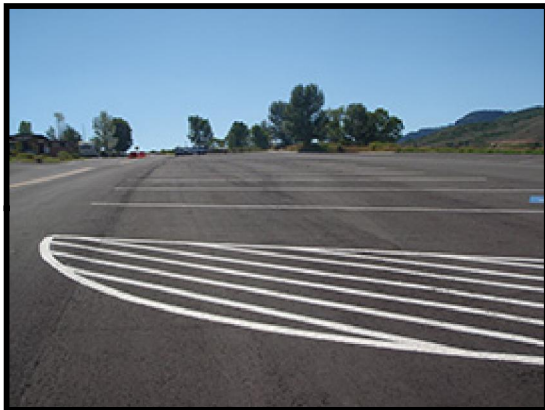
Route Number	Public / NonPublic	Date Visited	Area (sq ft)	Lane Miles *	Surface Type
0914A	PUBLIC	8/9/2011	62,296	1.07	AS
Culverts	Drop Inlets	Gates	Curb & Gutter	Curb	PCR
0	2	1	CONCRETE CURB AND GUTTER	NO CURB	GOOD/90

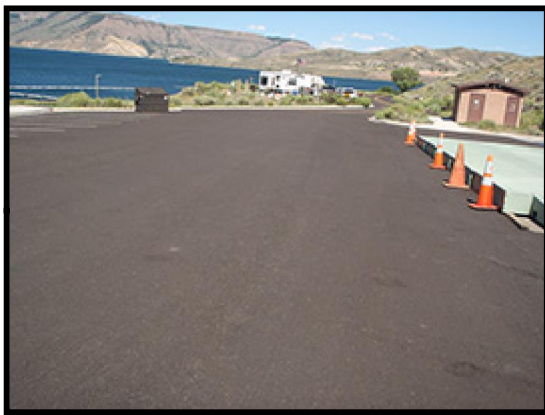
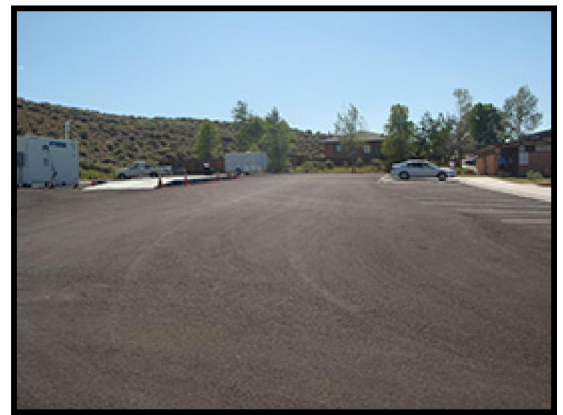
Route Number	Public / NonPublic	Date Visited	Area (sq ft)	Lane Miles *	Surface Type
0914B	PUBLIC	8/9/2011	18,574	0.32	AS
Culverts	Drop Inlets	Gates	Curb & Gutter	Curb	PCR
0	2	0	CONCRETE CURB AND GUTTER	NO CURB	GOOD/90

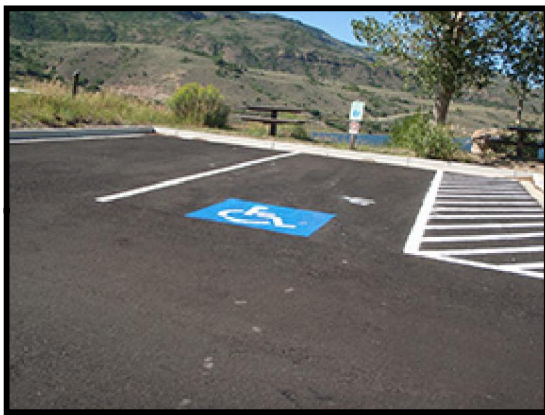
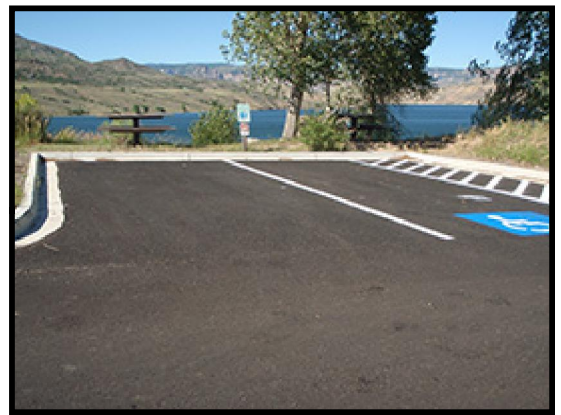
Route Number	Public / NonPublic	Date Visited	Area (sq ft)	Lane Miles *	Surface Type
0915	PUBLIC	8/9/2011	783	0.01	AS
Culverts	Drop Inlets	Gates	Curb & Gutter	Curb	PCR
0	0	0	CONCRETE CURB AND GUTTER	NO CURB	GOOD/90

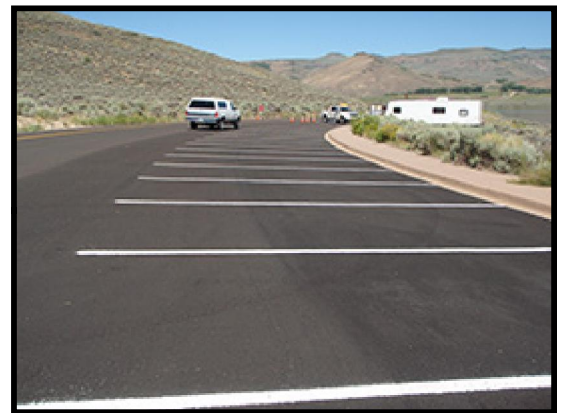
Route Number	Public / NonPublic	Date Visited	Area (sq ft)	Lane Miles *	Surface Type
0916A	PUBLIC	8/9/2011	5,322	0.09	AS
Culverts	Drop Inlets	Gates	Curb & Gutter	Curb	PCR
0	1	0	CONCRETE CURB AND GUTTER	NO CURB	GOOD/90

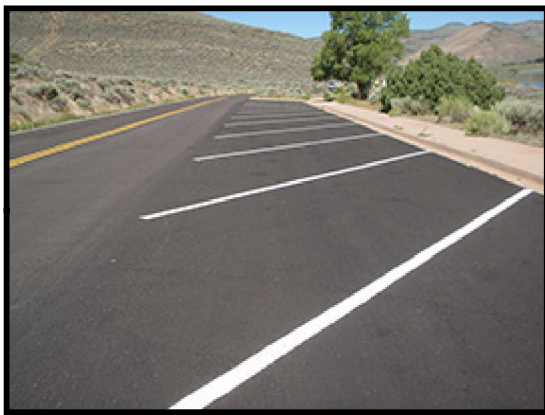
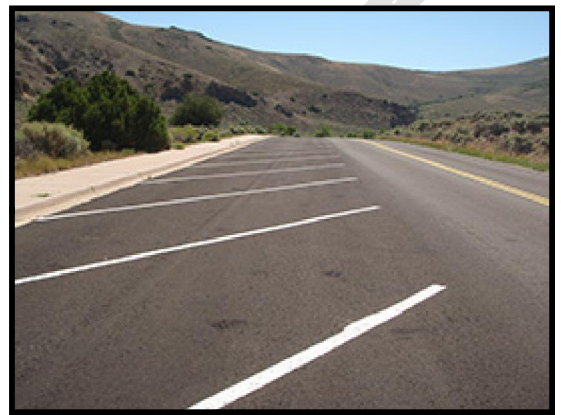
Route Number	Public / NonPublic	Date Visited	Area (sq ft)	Lane Miles *	Surface Type
0916B	PUBLIC	8/9/2011	4,158	0.07	AS
Culverts	Drop Inlets	Gates	Curb & Gutter	Curb	PCR
0	1	0	CONCRETE CURB AND GUTTER	NO CURB	GOOD/90

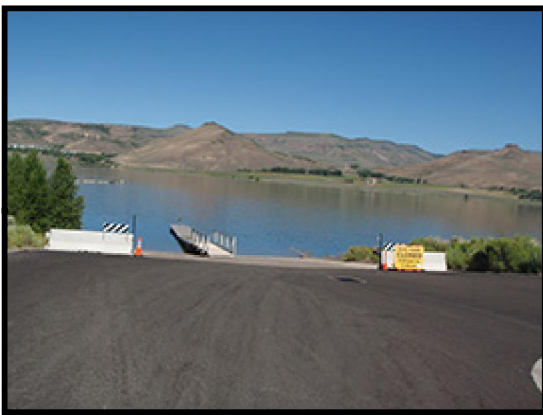
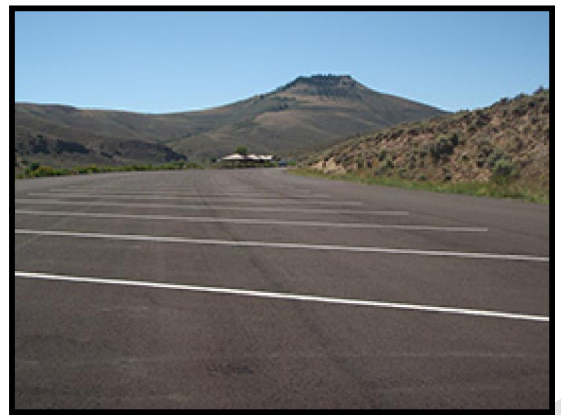
Route 0917

Route Number	Public / NonPublic	Date Visited	Area (sq ft)	Lane Miles *	Surface Type
0917	PUBLIC	8/9/2011	59,850	1.03	AS
Culverts	Drop Inlets	Gates	Curb & Gutter	Curb	PCR
0	1	0	NO CURB AND GUTTER	NO CURB	GOOD/90

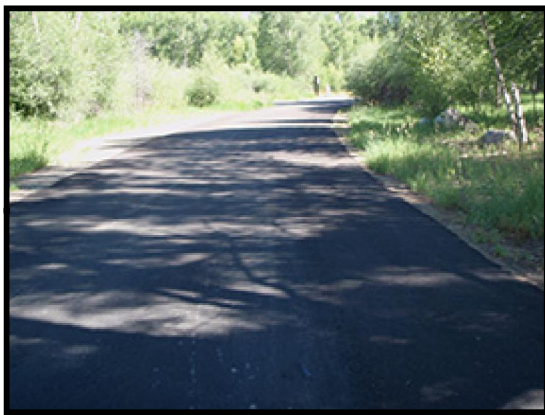
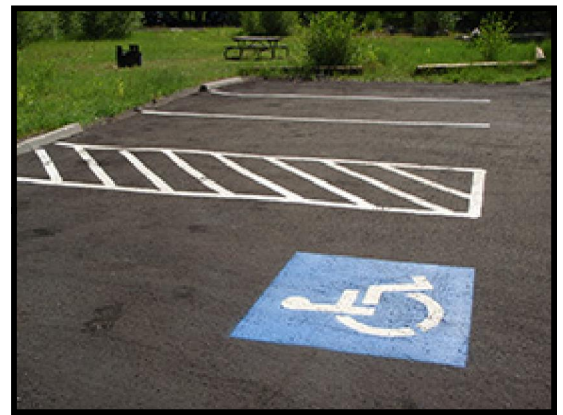
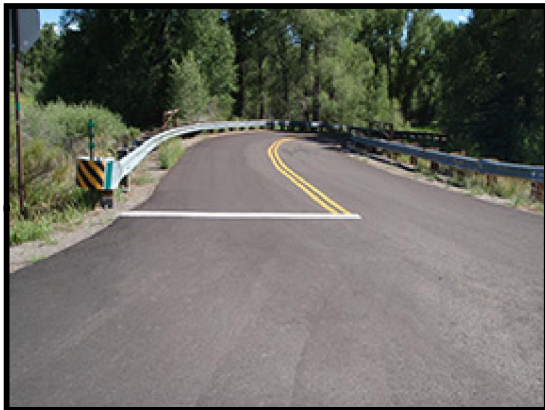
Route 0918

Route Number	Public / NonPublic	Date Visited	Area (sq ft)	Lane Miles *	Surface Type
0918	PUBLIC	8/8/2011	20,544	0.35	AS
Culverts	Drop Inlets	Gates	Curb & Gutter	Curb	PCR
1	0	1	NO CURB AND GUTTER	NO CURB	GOOD/90

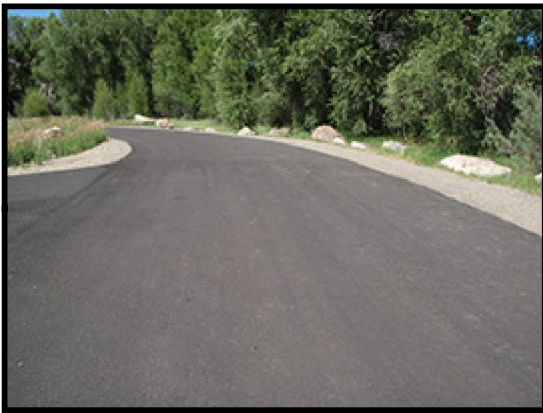
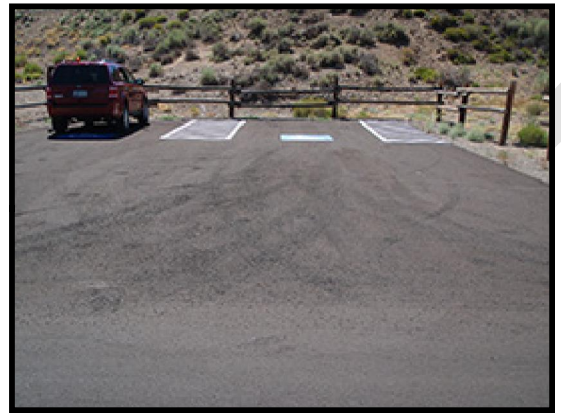
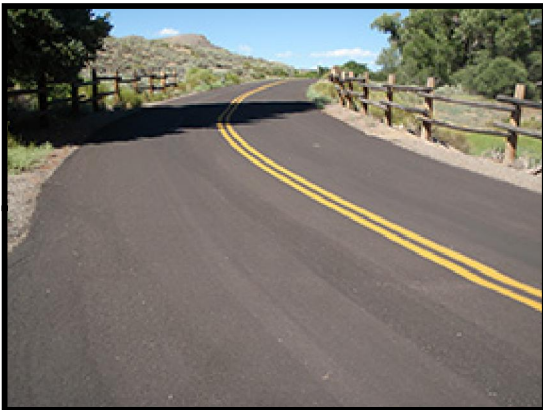
Route Number	Public / NonPublic	Date Visited	Area (sq ft)	Lane Miles *	Surface Type
0919	PUBLIC	8/8/2011	36,095	0.62	AS
Culverts	Drop Inlets	Gates	Curb & Gutter	Curb	PCR
0	0	1	NO CURB AND GUTTER	NO CURB	GOOD/90

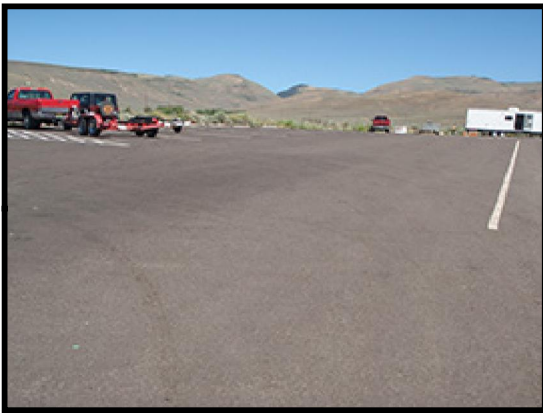
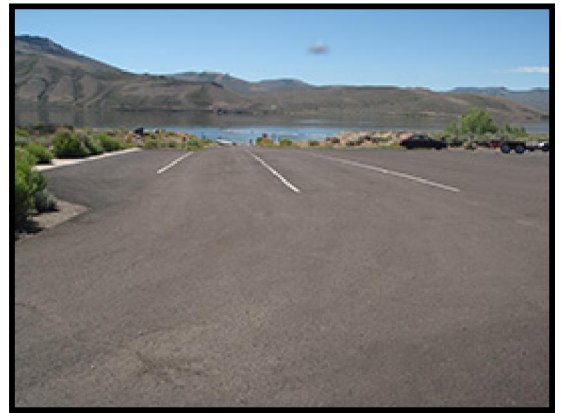
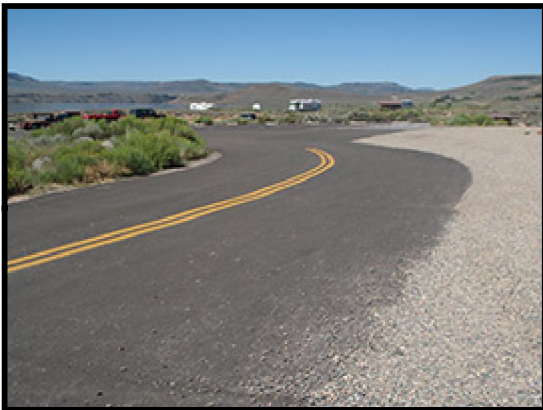
Route Number	Public / NonPublic	Date Visited	Area (sq ft)	Lane Miles *	Surface Type
0920	PUBLIC	8/9/2011	27,830	0.48	AS
Culverts	Drop Inlets	Gates	Curb & Gutter	Curb	PCR
0	0	1	NO CURB AND GUTTER	NO CURB	GOOD/90

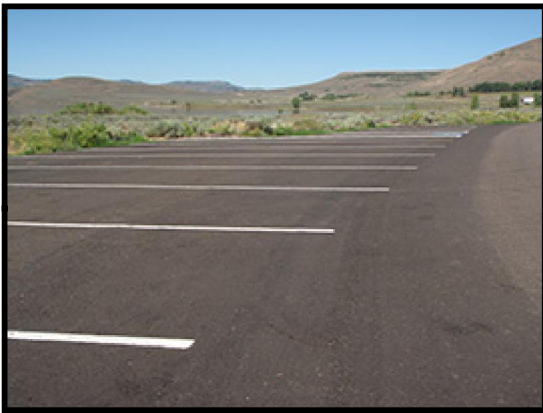
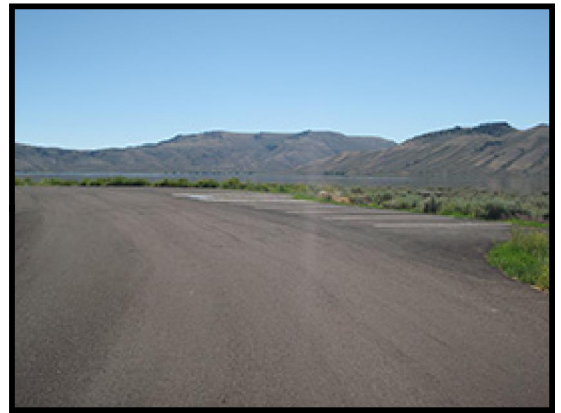
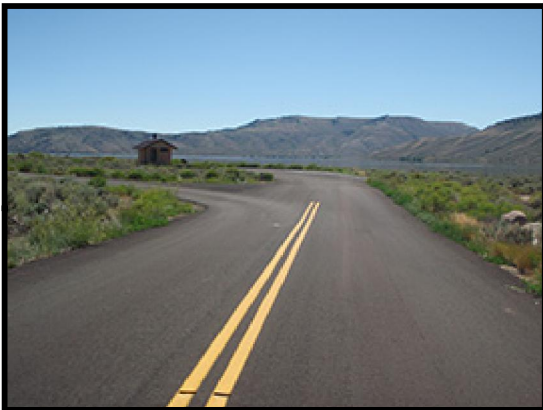
Route 0921

Route Number	Public / NonPublic	Date Visited	Area (sq ft)	Lane Miles *	Surface Type
0921	PUBLIC	8/9/2011	44,066	0.76	AS
Culverts	Drop Inlets	Gates	Curb & Gutter	Curb	PCR
0	0	0	NO CURB AND GUTTER	NO CURB	GOOD/90
