Federal Lands Highway Road Inventory Program

Road Inventory and Condition Assessment

Curecanti National Recreation Area
CURE - 1379

Cycle 5 Report

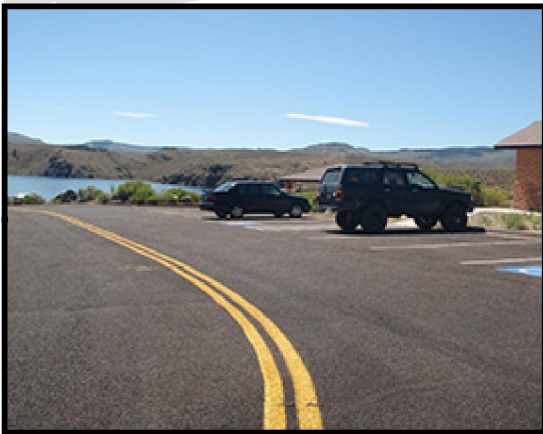
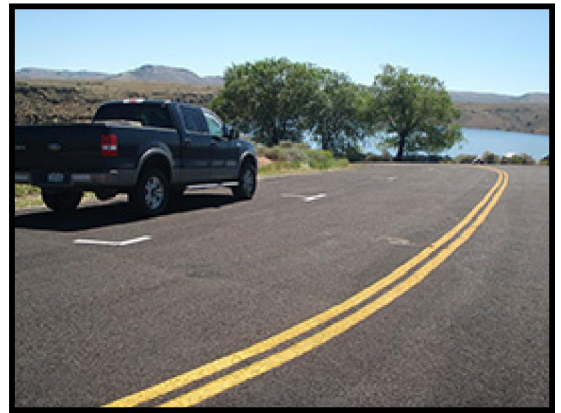
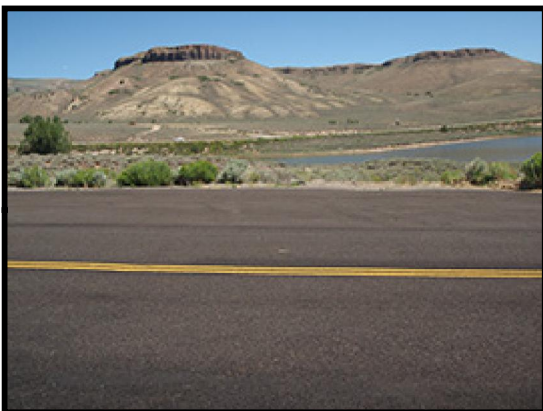
Route Number	Public / NonPublic	Date Visited	Area (sq ft)	Lane Miles *	Surface Type
0922	PUBLIC	8/9/2011	26,359	0.45	AS
Culverts	Drop Inlets	Gates	Curb & Gutter	Curb	PCR
0	0	0	CONCRETE CURB AND GUTTER	NO CURB	GOOD/90

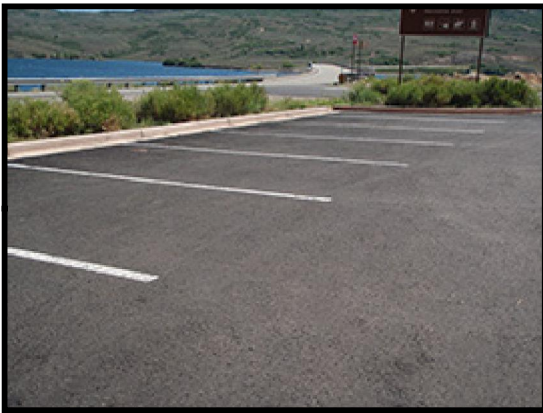
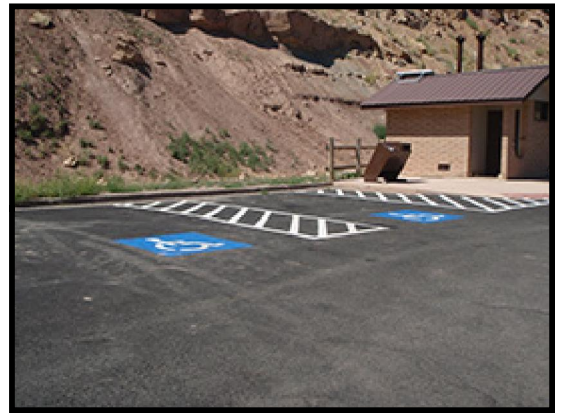
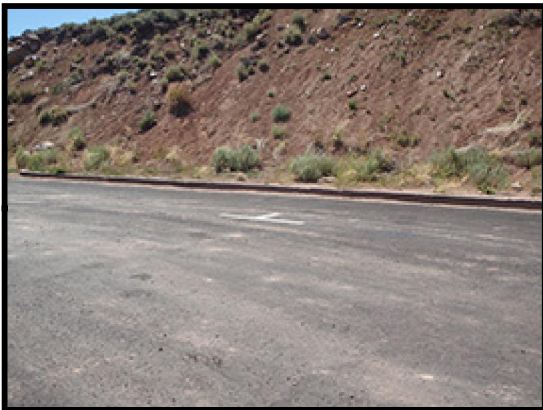
Route Number	Public / NonPublic	Date Visited	Area (sq ft)	Lane Miles *	Surface Type
0923	PUBLIC	8/9/2011	21,776	0.38	AS
Culverts	Drop Inlets	Gates	Curb & Gutter	Curb	PCR
0	0	0	CONCRETE CURB AND GUTTER	NO CURB	GOOD/90

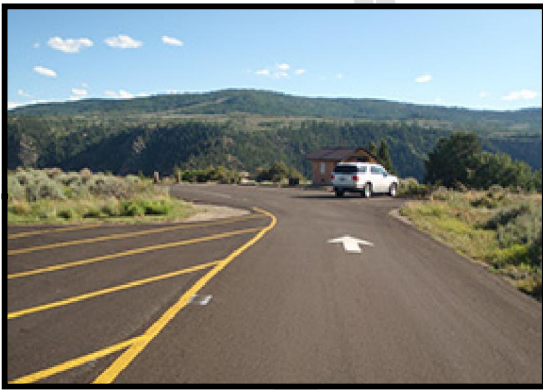
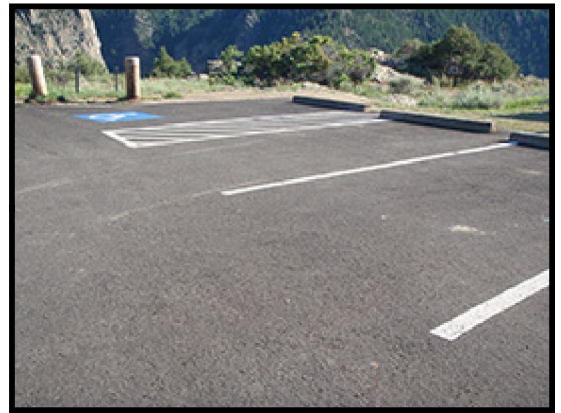
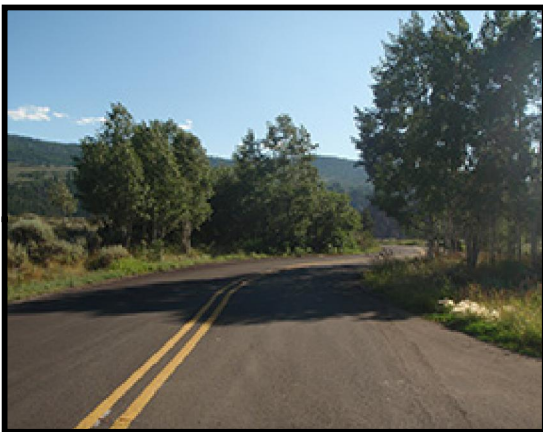
Route Number	Public / NonPublic	Date Visited	Area (sq ft)	Lane Miles *	Surface Type
0924	PUBLIC	8/9/2011	20,629	0.36	AS
Culverts	Drop Inlets	Gates	Curb & Gutter	Curb	PCR
1	0	1	NO CURB AND GUTTER	NO CURB	GOOD/90

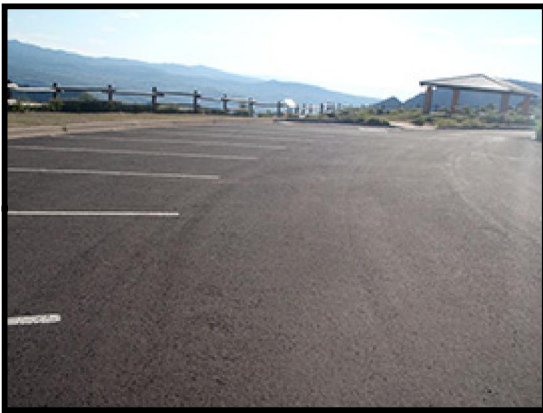
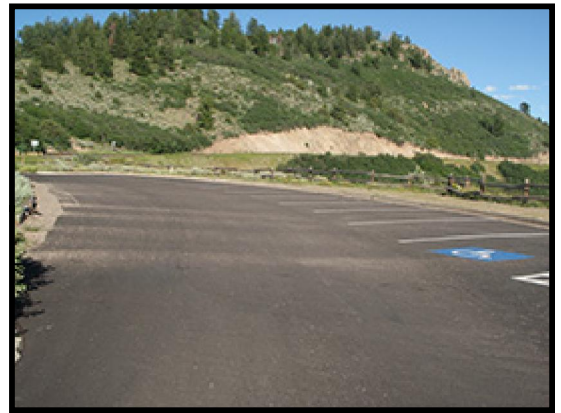
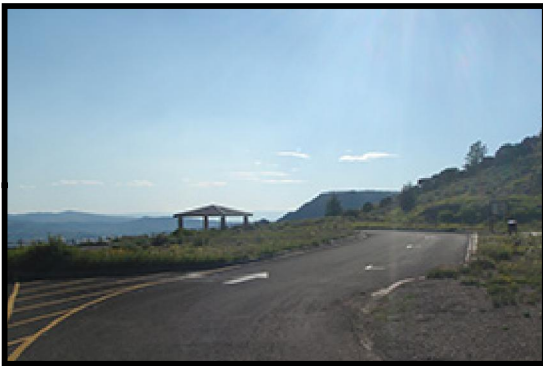
Route Number	Public / NonPublic	Date Visited	Area (sq ft)	Lane Miles *	Surface Type
0925	PUBLIC	8/9/2011	12,847	0.22	AS
Culverts	Drop Inlets	Gates	Curb & Gutter	Curb	PCR
0	1	0	CONCRETE CURB AND GUTTER	NO CURB	GOOD/90

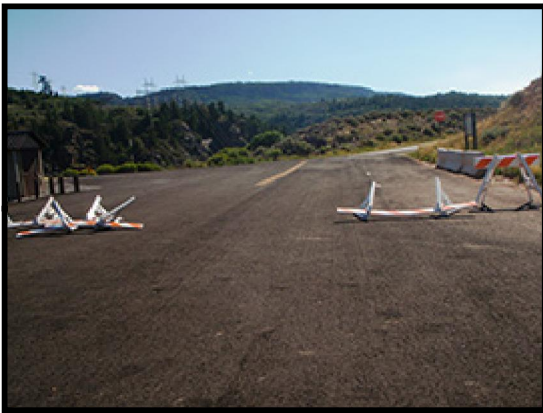
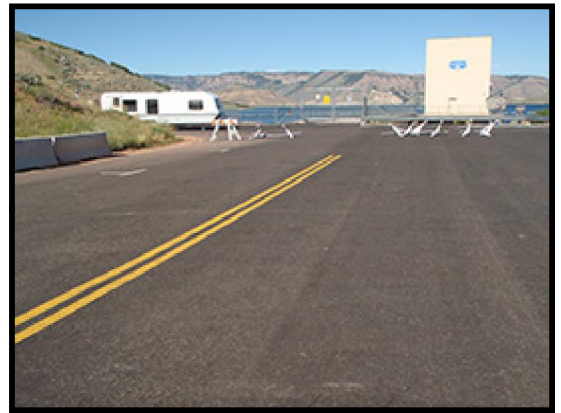
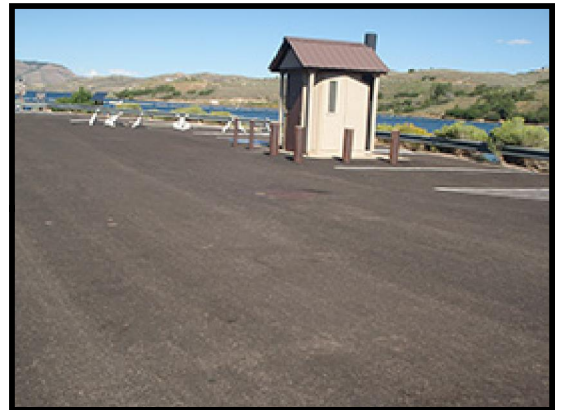
Route Number	Public / NonPublic	Date Visited	Area (sq ft)	Lane Miles *	Surface Type
0926	PUBLIC	8/9/2011	13,350	0.23	AS
Culverts	Drop Inlets	Gates	Curb & Gutter	Curb	PCR
0	0	0	NO CURB AND GUTTER	NO CURB	GOOD/90

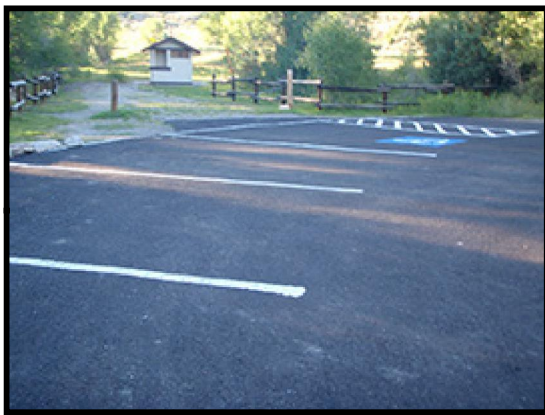
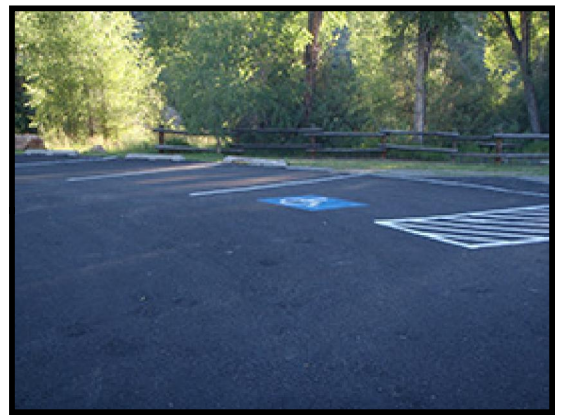
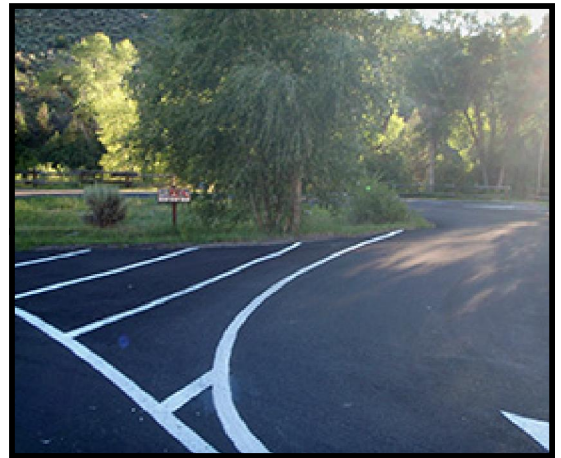
Route Number	Public / NonPublic	Date Visited	Area (sq ft)	Lane Miles *	Surface Type
0927	PUBLIC	8/9/2011	9,646	0.17	AS
Culverts	Drop Inlets	Gates	Curb & Gutter	Curb	PCR
0	0	2	NO CURB AND GUTTER	CONCRETE CURB	GOOD/90

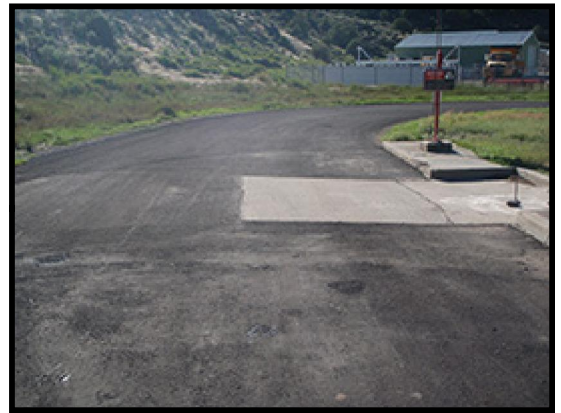
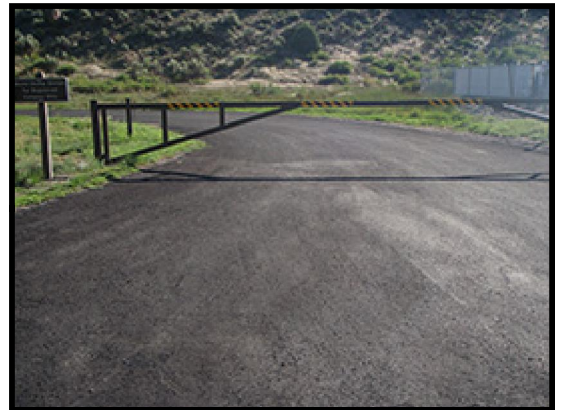
Route Number	Public / NonPublic	Date Visited	Area (sq ft)	Lane Miles *	Surface Type
0929	PUBLIC	8/10/2011	7,219	0.12	AS
Culverts	Drop Inlets	Gates	Curb & Gutter	Curb	PCR
0	0	2	NO CURB AND GUTTER	CONCRETE CURB	GOOD/90

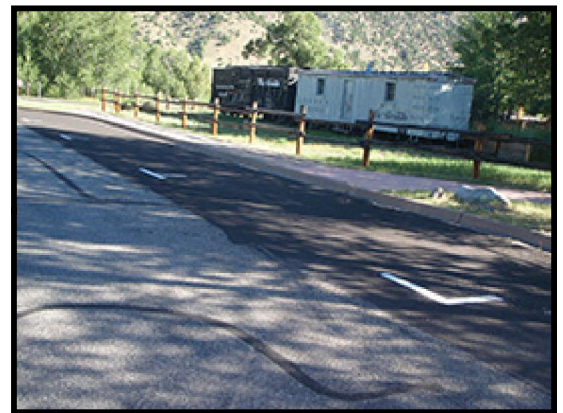
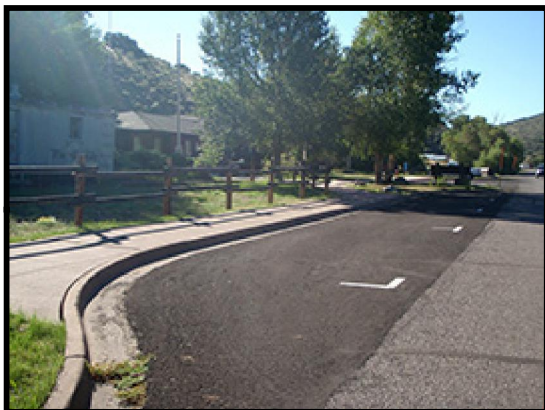
Route Number	Public / NonPublic	Date Visited	Area (sq ft)	Lane Miles *	Surface Type
0930A	PUBLIC	8/10/2011	1,161	0.02	AS
Culverts	Drop Inlets	Gates	Curb & Gutter	Curb	PCR
0	0	0	CONCRETE CURB AND GUTTER	NO CURB	GOOD/90

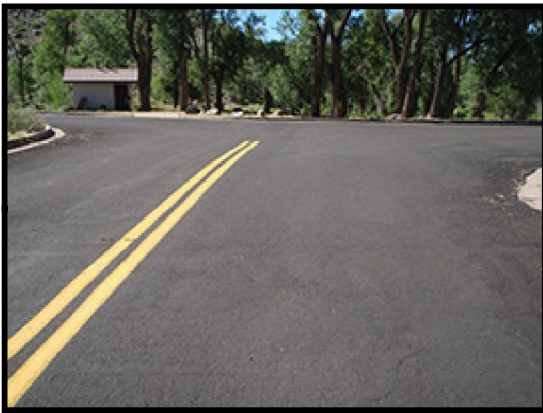
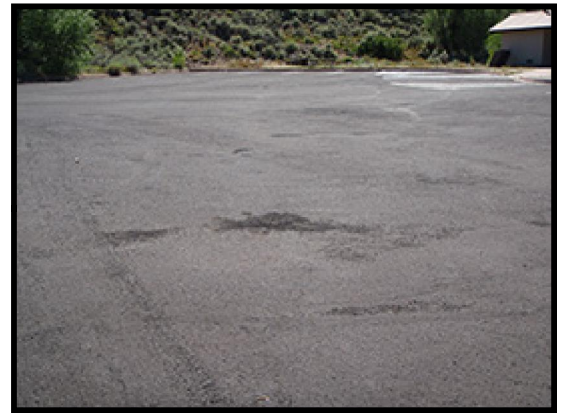
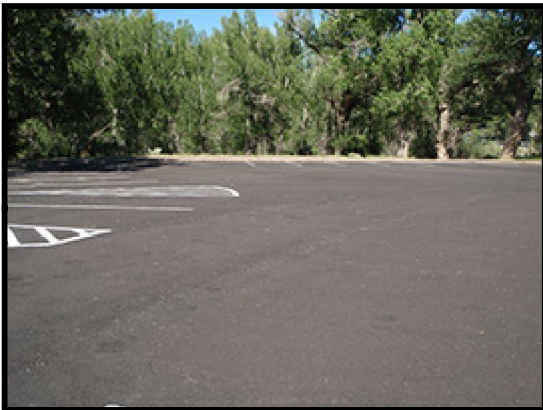
Route 0933

Route Number	Public / NonPublic	Date Visited	Area (sq ft)	Lane Miles *	Surface Type
0932	PUBLIC	8/8/2011	14,613	0.25	AS
Culverts	Drop Inlets	Gates	Curb & Gutter	Curb	PCR
0	0	1	CONCRETE CURB AND GUTTER	NO CURB	GOOD/90

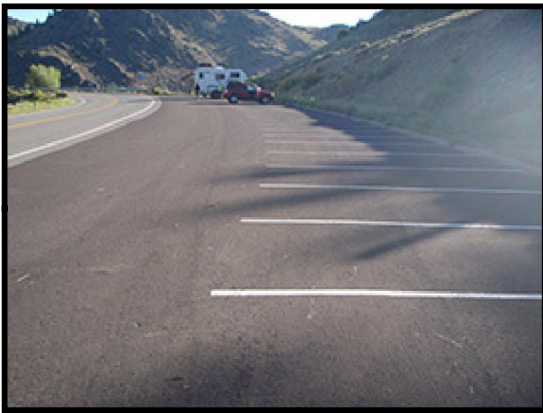
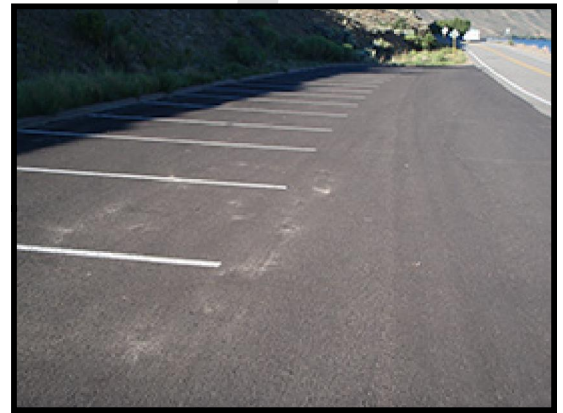
Route Number	Public / NonPublic	Date Visited	Area (sq ft)	Lane Miles *	Surface Type
0933	PUBLIC	8/9/2011	9,389	0.16	AS
Culverts	Drop Inlets	Gates	Curb & Gutter	Curb	PCR
0	0	0	NO CURB AND GUTTER	CONCRETE CURB	GOOD/90

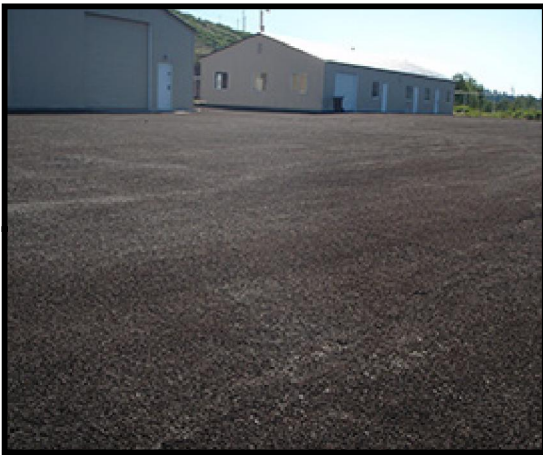
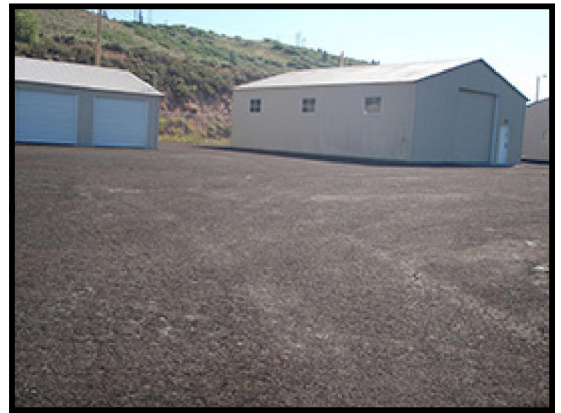
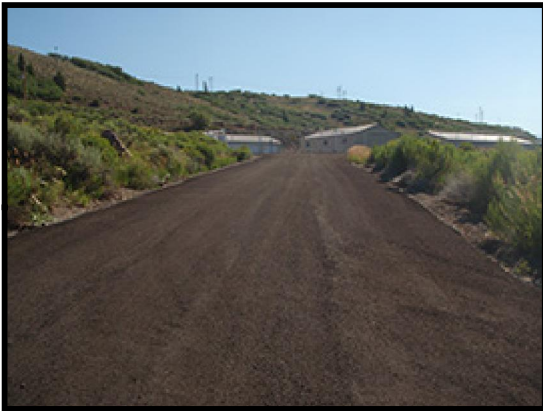
Route 0938

Route Number	Public / NonPublic	Date Visited	Area (sq ft)	Lane Miles *	Surface Type
0937	NONPUBLIC	8/8/2011	41,884	0.72	AS
Culverts	Drop Inlets	Gates	Curb & Gutter	Curb	PCR
0	0	1	NO CURB AND GUTTER	NO CURB	GOOD/90

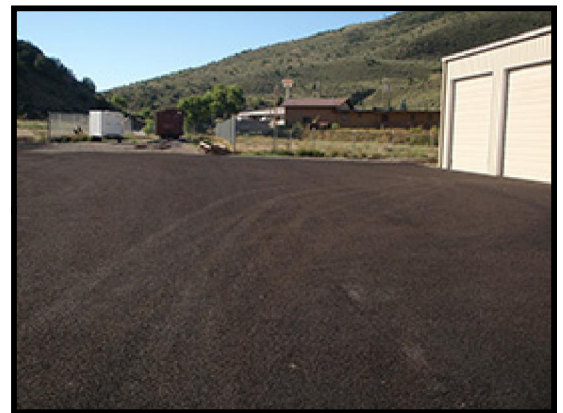
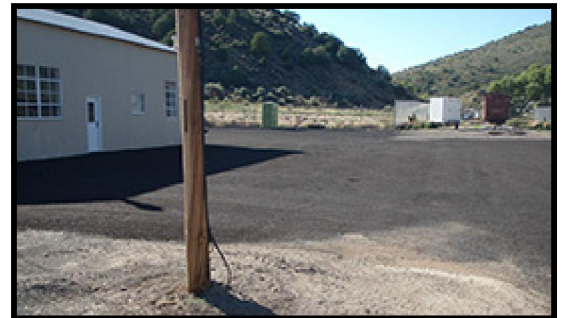
Route Number	Public / NonPublic	Date Visited	Area (sq ft)	Lane Miles *	Surface Type
0938	NONPUBLIC	8/10/2011	22,435	0.39	AS
Culverts	Drop Inlets	Gates	Curb & Gutter	Curb	PCR
0	0	1	NO CURB AND GUTTER	NO CURB	GOOD/90

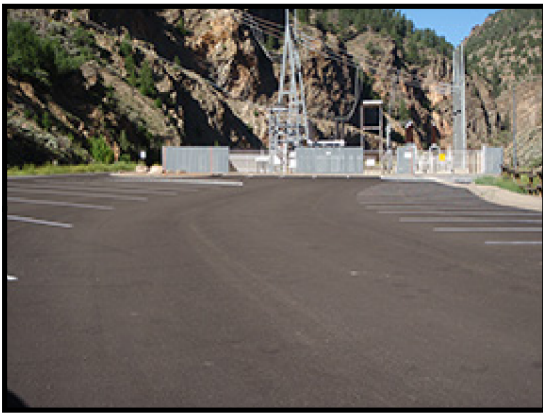
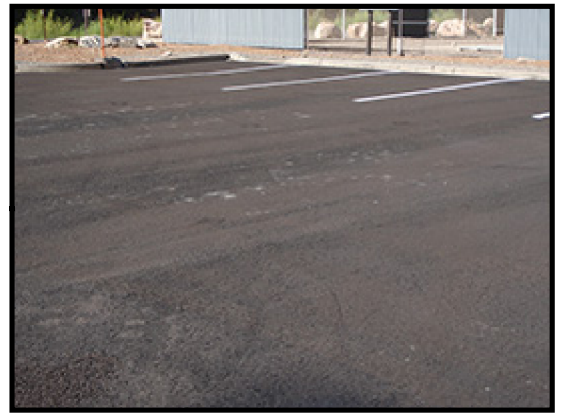
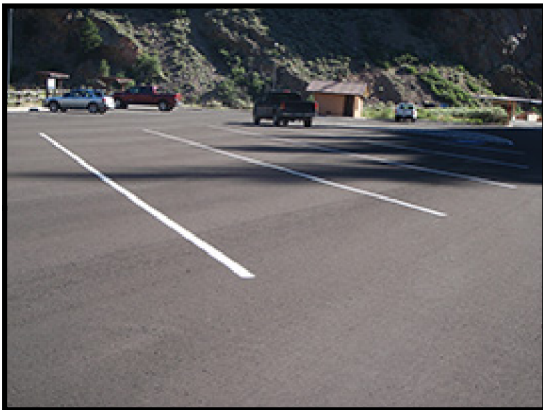
Route Number	Public / NonPublic	Date Visited	Area (sq ft)	Lane Miles *	Surface Type
0939	PUBLIC	8/10/2011	31,312	0.54	AS
Culverts	Drop Inlets	Gates	Curb & Gutter	Curb	PCR
0	1	0	CONCRETE CURB AND GUTTER	NO CURB	GOOD/90

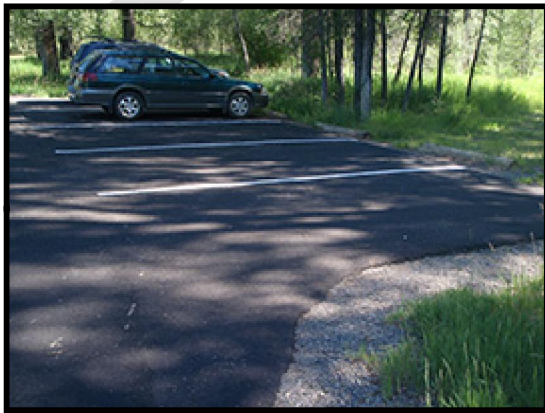
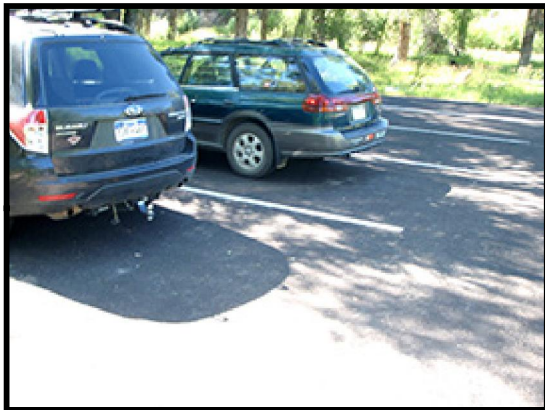
Route Number	Public / NonPublic	Date Visited	Area (sq ft)	Lane Miles *	Surface Type
0941AZ	PUBLIC	8/8/2011	935	0.02	AS
Culverts	Drop Inlets	Gates	Curb & Gutter	Curb	PCR
0	0	0	NO CURB AND GUTTER	NO CURB	GOOD/90

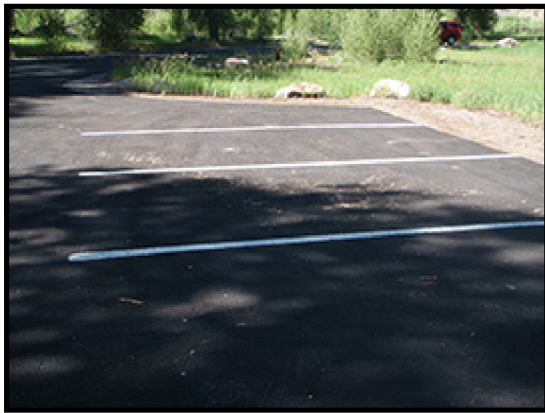
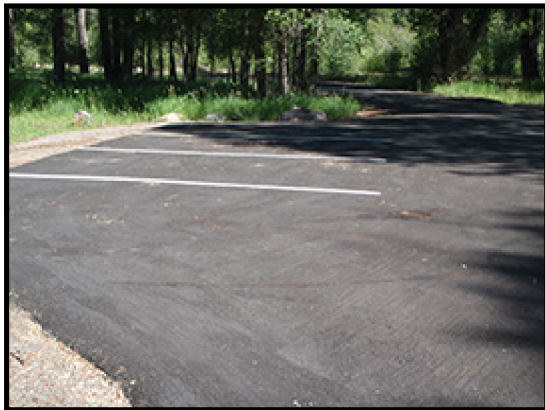
Route Number	Public / NonPublic	Date Visited	Area (sq ft)	Lane Miles *	Surface Type
0941BZ	PUBLIC	8/8/2011	886	0.02	AS
Culverts	Drop Inlets	Gates	Curb & Gutter	Curb	PCR
0	0	0	NO CURB AND GUTTER	NO CURB	GOOD/90

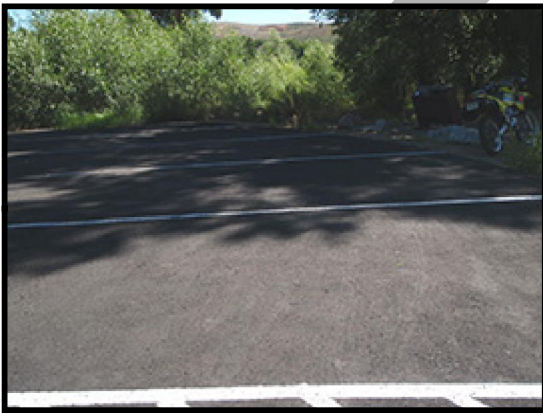
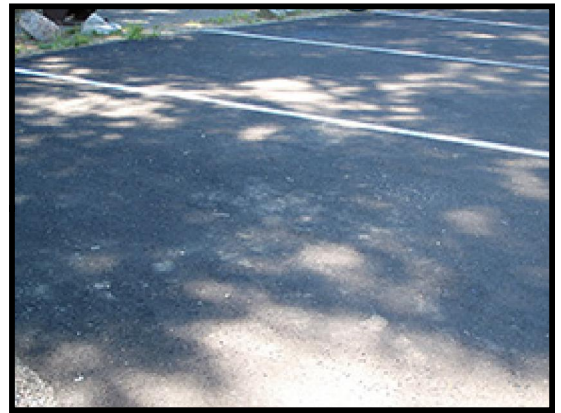
Route Number	Public / NonPublic	Date Visited	Area (sq ft)	Lane Miles *	Surface Type
0943	PUBLIC	8/8/2011	1,340	0.02	AS
Culverts	Drop Inlets	Gates	Curb & Gutter	Curb	PCR
0	0	0	NO CURB AND GUTTER	NO CURB	GOOD/90

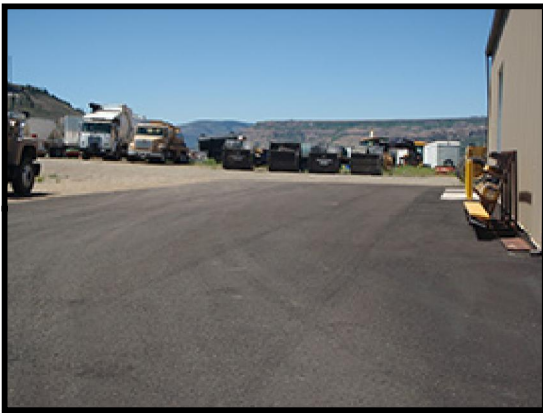
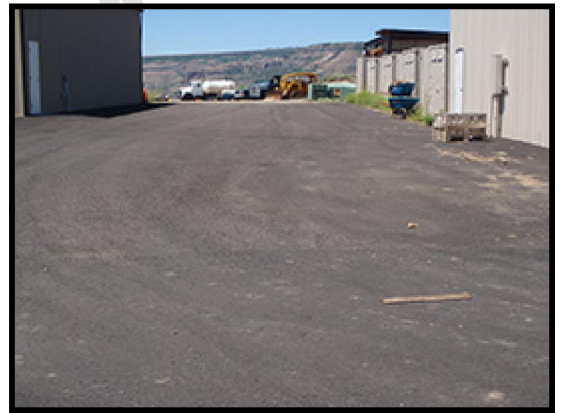
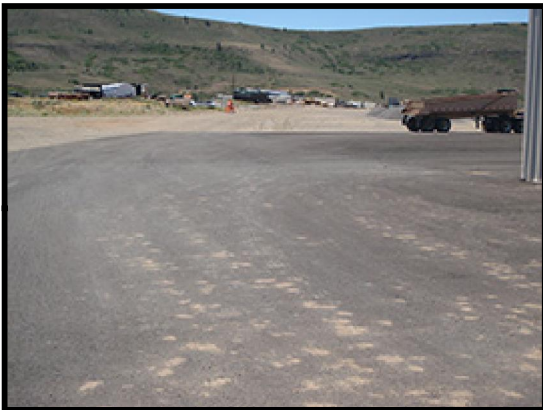
Route Number	Public / NonPublic	Date Visited	Area (sq ft)	Lane Miles *	Surface Type
0960	PUBLIC	8/9/2011	21,237	0.37	AS
Culverts	Drop Inlets	Gates	Curb & Gutter	Curb	PCR
0	0	0	NO CURB AND GUTTER	NO CURB	GOOD/90

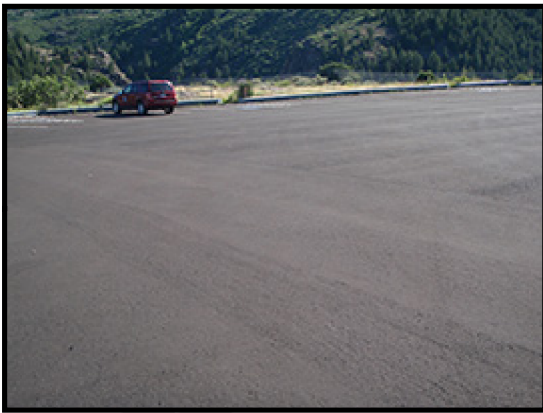
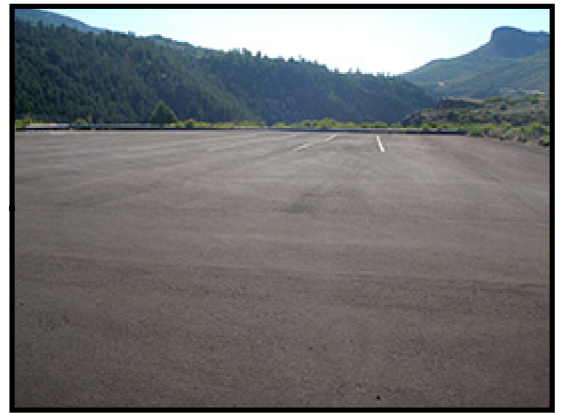
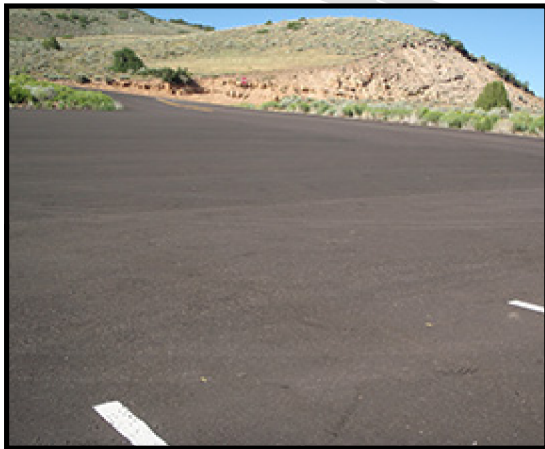
Route Number	Public / NonPublic	Date Visited	Area (sq ft)	Lane Miles *	Surface Type
0963	PUBLIC	8/9/2011	35,702	0.62	AS
Culverts	Drop Inlets	Gates	Curb & Gutter	Curb	PCR
0	0	0	NO CURB AND GUTTER	NO CURB	GOOD/90
