Federal Lands Highway Road Inventory Program

Road Inventory and Condition Assessment

Cuyahoga Valley National Park CUVA

Cycle 5 Report

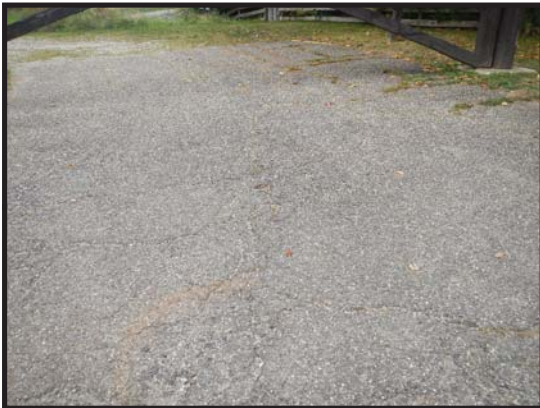
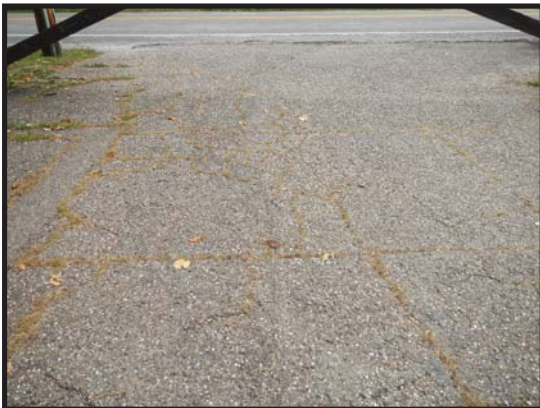
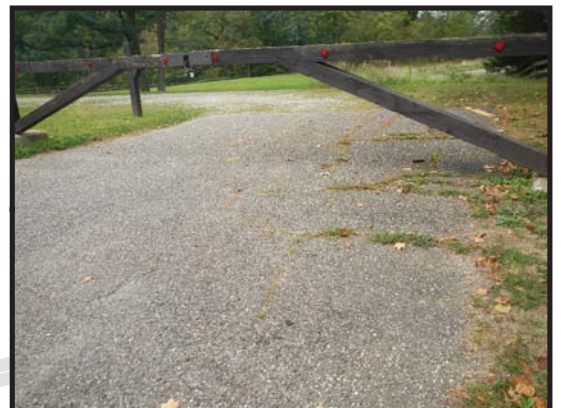
Rte 0434

Route Number	Public / NonPublic	Date Visited	Area (sq ft)	Lane Miles *	Surface Type
0434	PUBLIC	9/19/2013	751	0.01	AS
Culverts	Drop Inlets	Gates	Curb & Gutter	Curb	PCR
0	0	1	NO CURB AND GUTTER	NO CURB	POOR/45

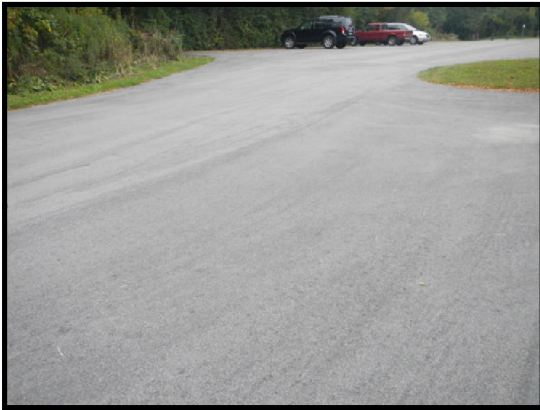
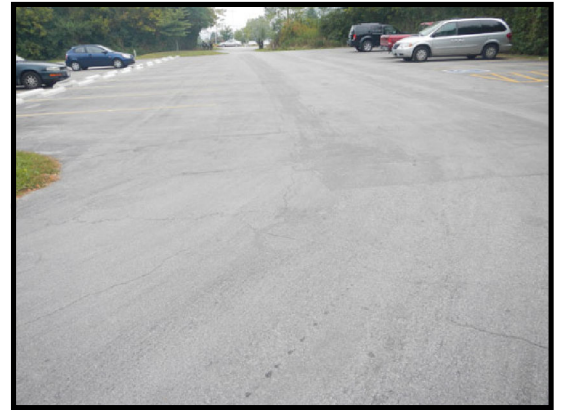
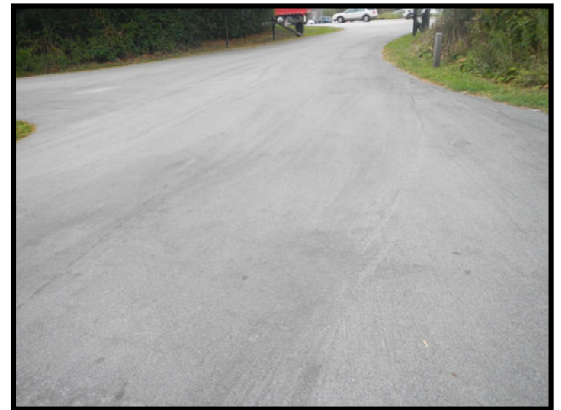
Route Number	Public / NonPublic	Date Visited	Area (sq ft)	Lane Miles *	Surface Type
0900	PUBLIC	9/19/2013	21,324	0.37	AS
Culverts	Drop Inlets	Gates	Curb & Gutter	Curb	PCR
0	0	1	NO CURB AND GUTTER	NO CURB	FAIR/73

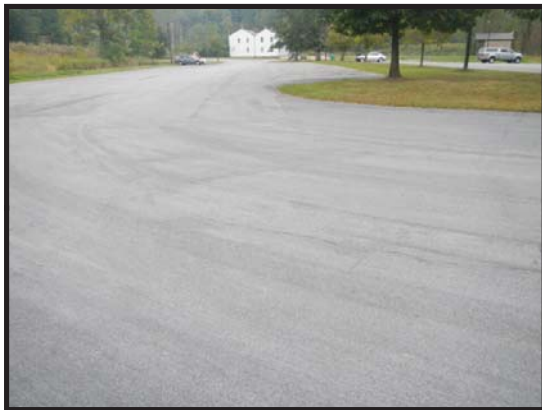
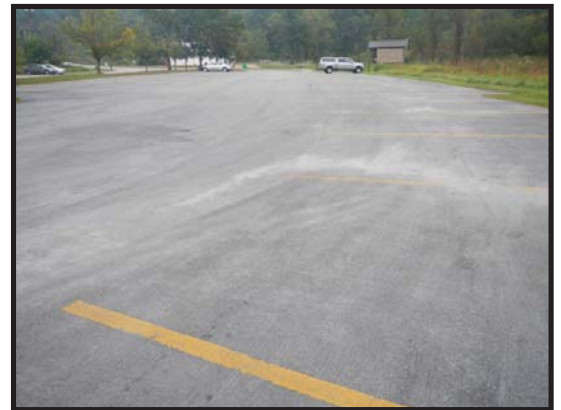
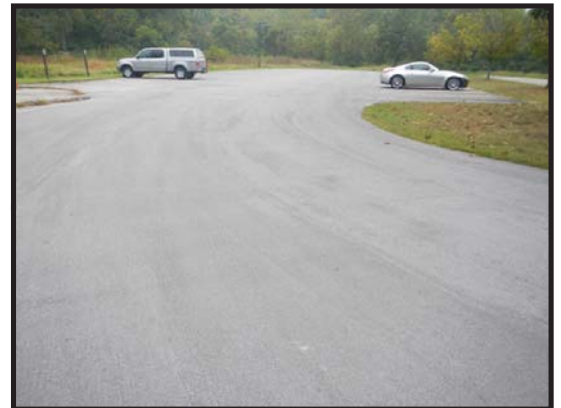
Route 0902

Route Number	Public / NonPublic	Date Visited	Area (sq ft)	Lane Miles *	Surface Type
0902	PUBLIC	9/19/2013	45,828	0.79	AS
Culverts	Drop Inlets	Gates	Curb & Gutter	Curb	PCR
0	0	0	NO CURB AND GUTTER	CONCRETE CURB	FAIR/73

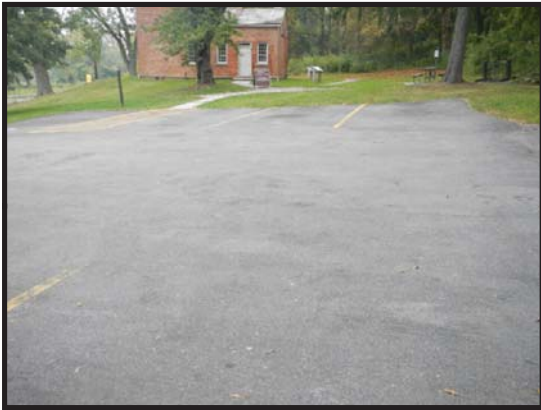
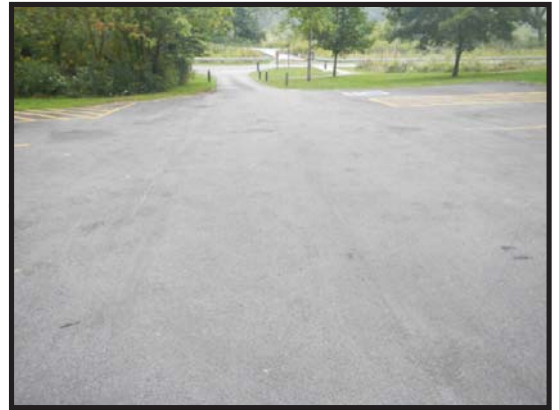
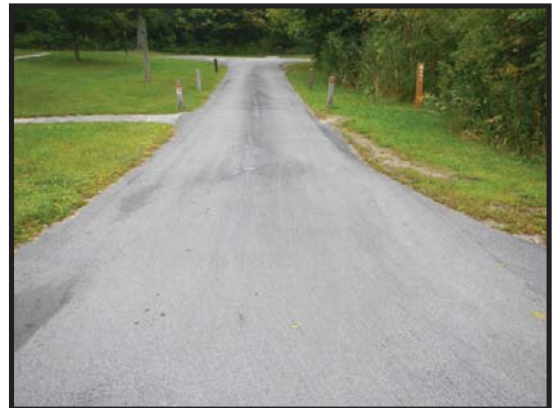
Route 0904

Route Number	Public / NonPublic	Date Visited	Area (sq ft)	Lane Miles *	Surface Type
0904	PUBLIC	9/19/2013	5,021	0.09	AS
Culverts	Drop Inlets	Gates	Curb & Gutter	Curb	PCR
0	0	1	NO CURB AND GUTTER	NO CURB	GOOD/90

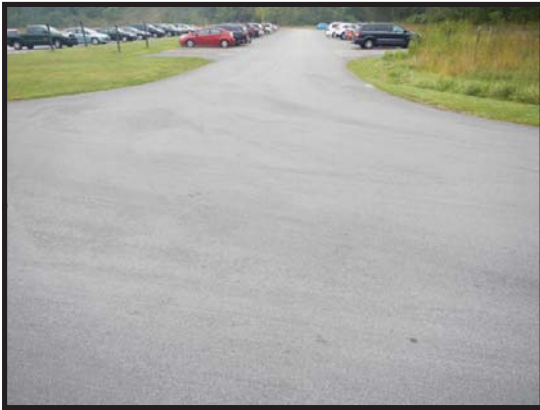
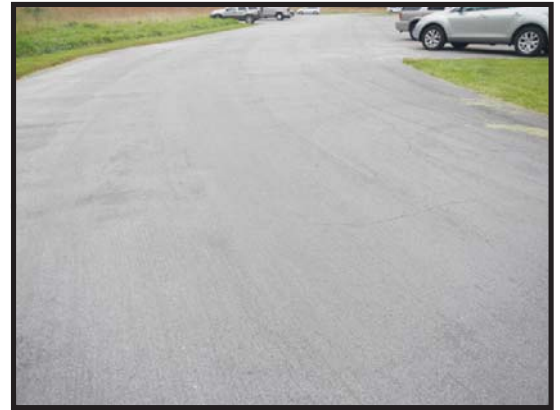
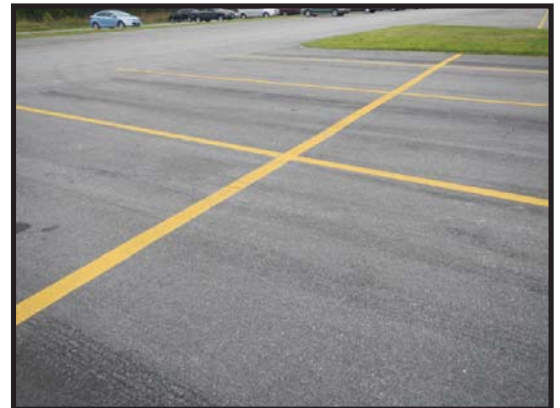
Route 0905

Route Number	Public / NonPublic	Date Visited	Area (sq ft)	Lane Miles *	Surface Type
0905	PUBLIC	9/19/2013	76,550	1.32	AS
Culverts	Drop Inlets	Gates	Curb & Gutter	Curb	PCR
0	1	0	NO CURB AND GUTTER	ASPHALT CURB	GOOD/90

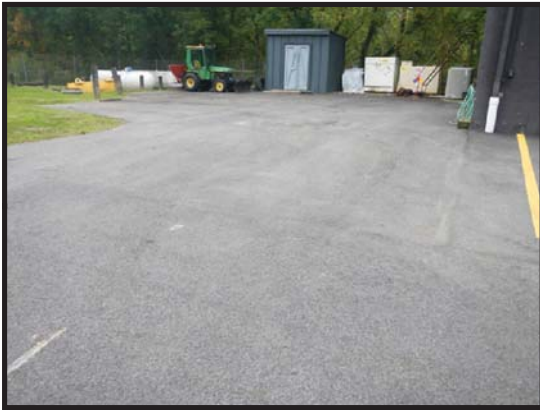
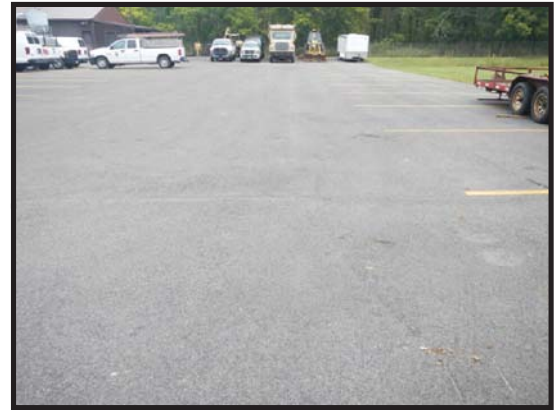
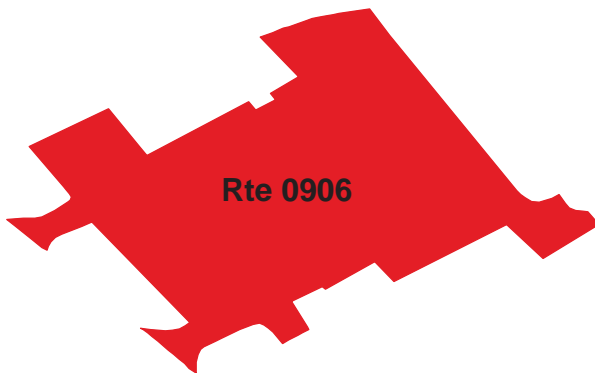
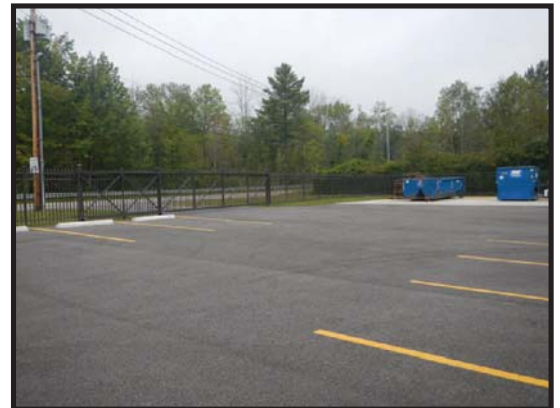
Route 0906

Route Number	Public / NonPublic	Date Visited	Area (sq ft)	Lane Miles *	Surface Type
0906	NONPUBLIC	9/19/2013	51,212	0.88	AS
Culverts	Drop Inlets	Gates	Curb & Gutter	Curb	PCR
0	7	2	NO CURB AND GUTTER	NO CURB	EXCELLENT/97

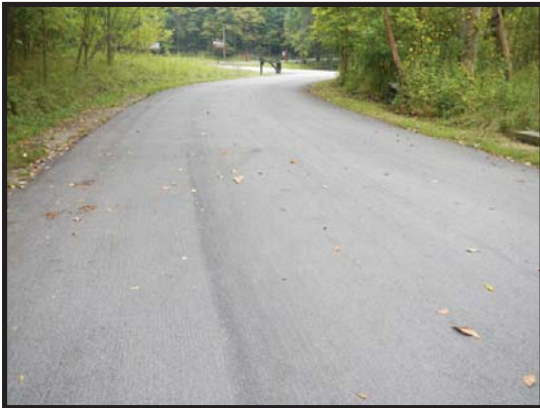
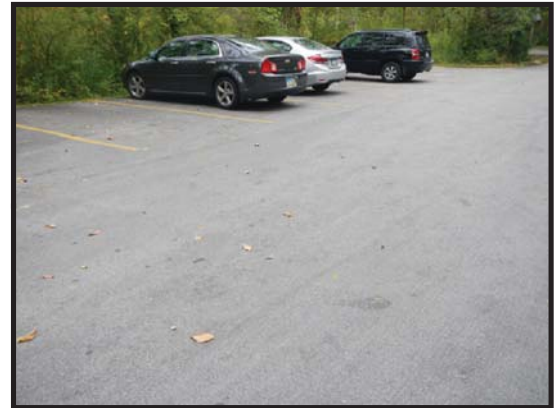
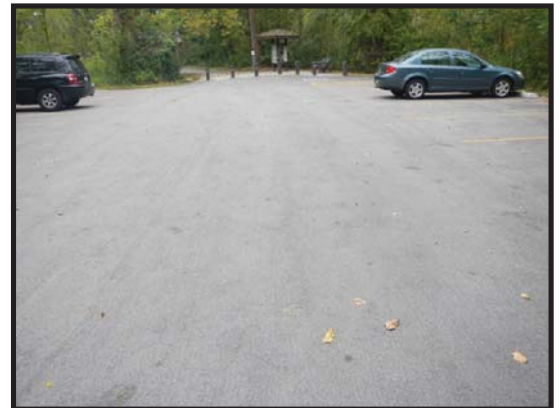
Route 0907

Route Number	Public / NonPublic	Date Visited	Area (sq ft)	Lane Miles *	Surface Type
0907	PUBLIC	9/19/2013	8,255	0.14	AS
Culverts	Drop Inlets	Gates	Curb & Gutter	Curb	PCR
0	0	1	NO CURB AND GUTTER	NO CURB	GOOD/90

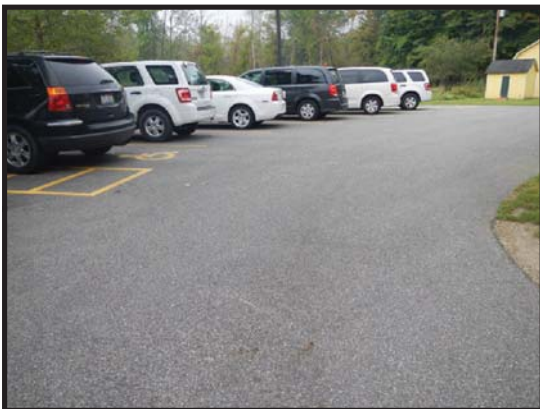
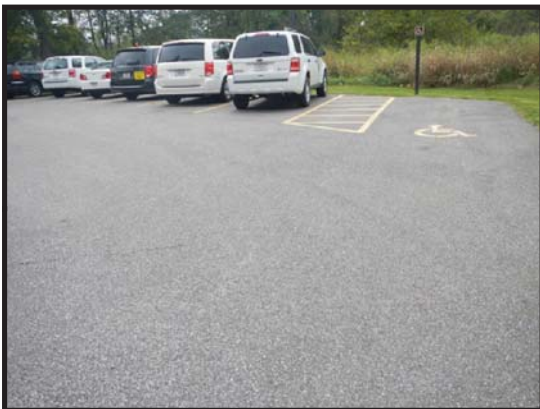
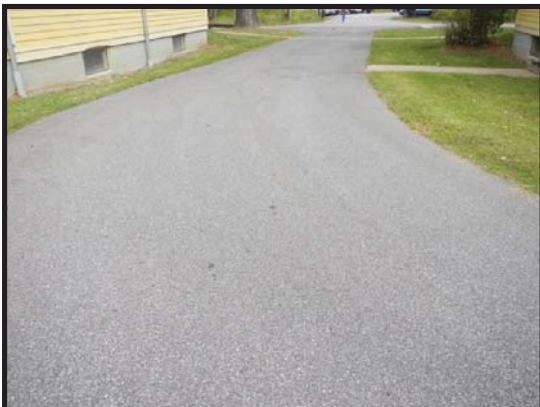
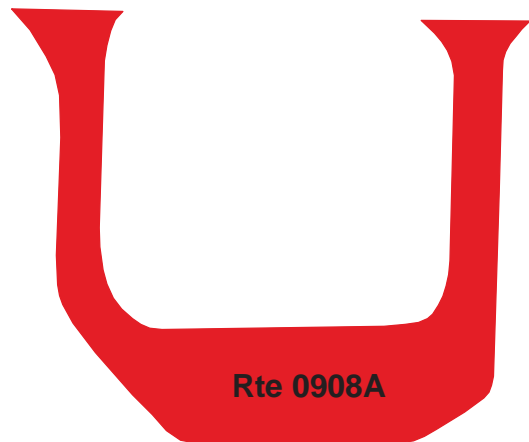
Route 0908A

Route Number	Public / NonPublic	Date Visited	Area (sq ft)	Lane Miles *	Surface Type
0908A	PUBLIC	9/19/2013	6,602	0.11	AS
Culverts	Drop Inlets	Gates	Curb & Gutter	Curb	PCR
0	0	0	NO CURB AND GUTTER	NO CURB	GOOD/90

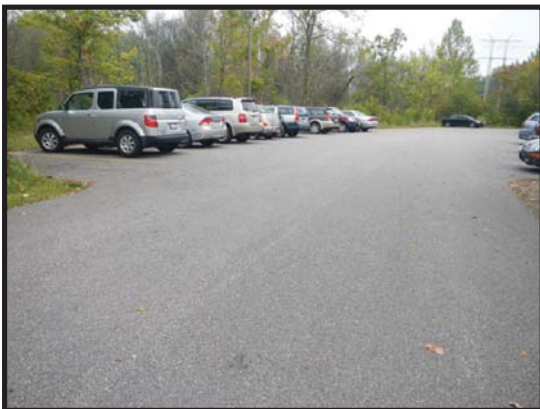
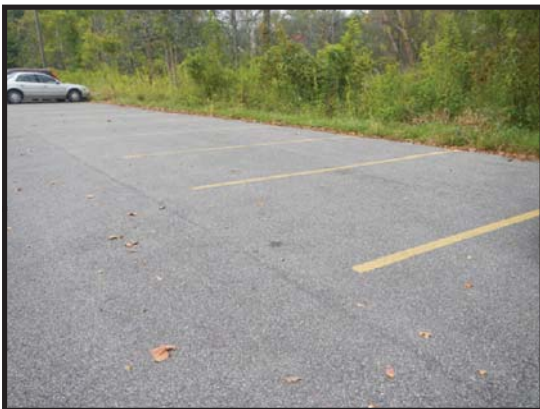
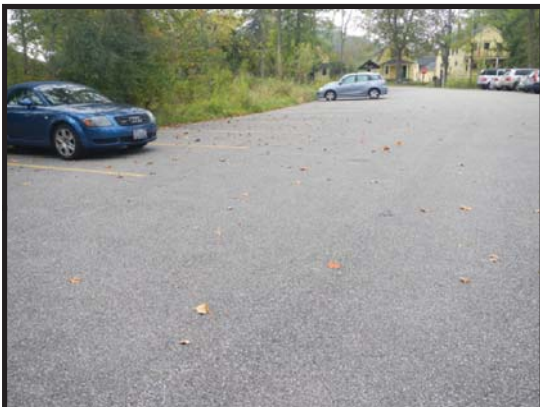
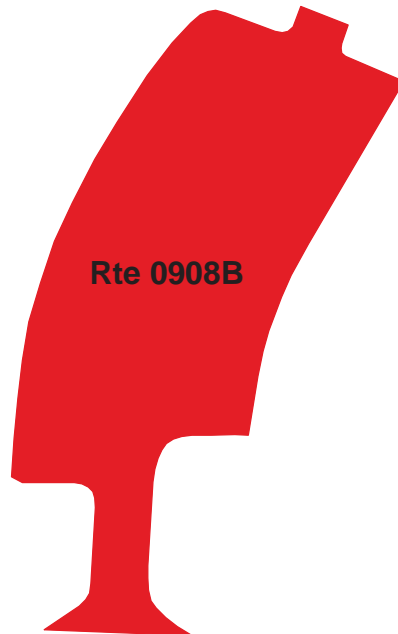
Route Number	Public / NonPublic	Date Visited	Area (sq ft)	Lane Miles *	Surface Type
0908B	PUBLIC	9/19/2013	10,641	0.18	AS
Culverts	Drop Inlets	Gates	Curb & Gutter	Curb	PCR
0	0	0	NO CURB AND GUTTER	NO CURB	GOOD/90

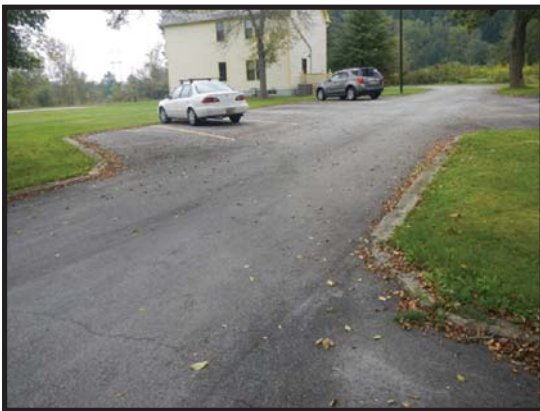
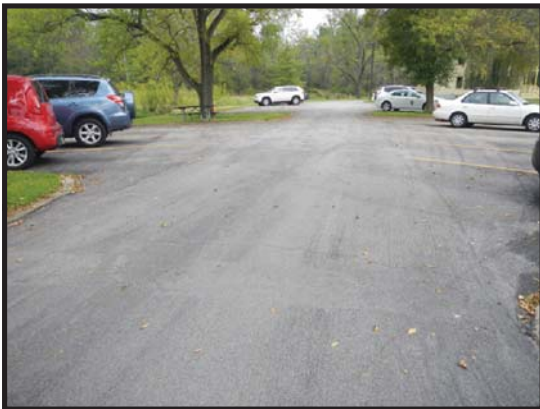
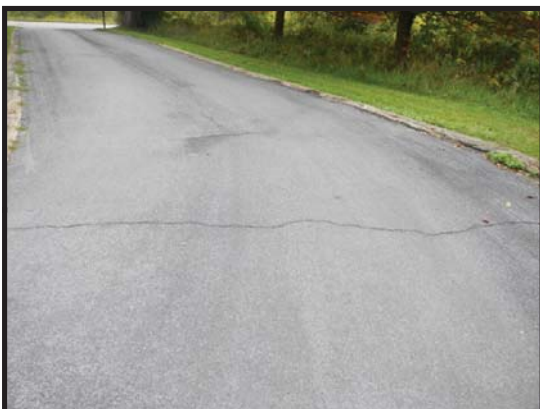
Route 0909

Route Number	Public / NonPublic	Date Visited	Area (sq ft)	Lane Miles *	Surface Type
0909	NONPUBLIC	9/19/2013	11,716	0.20	AS
Culverts	Drop Inlets	Gates	Curb & Gutter	Curb	PCR
0	0	0	NO CURB AND GUTTER	WOOD CURB	FAIR/73

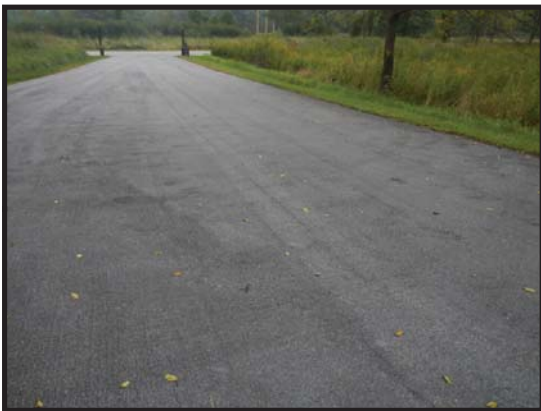
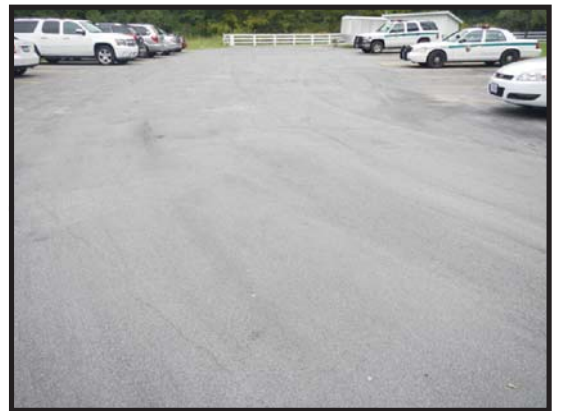
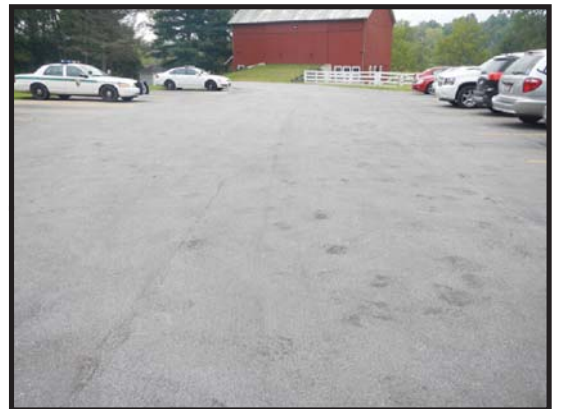
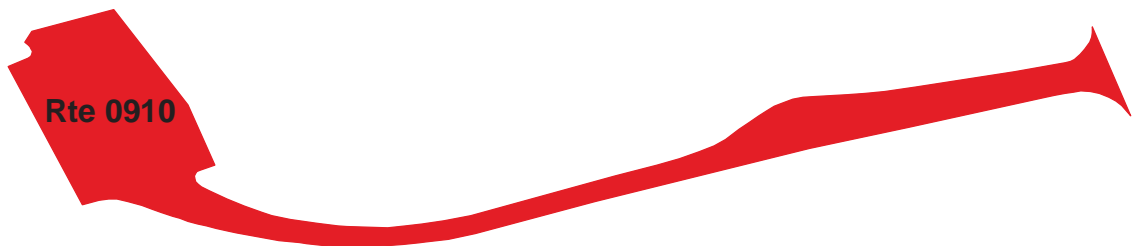
Route 0910

Route Number	Public / NonPublic	Date Visited	Area (sq ft)	Lane Miles *	Surface Type
0910	PUBLIC	9/19/2013	16,982	0.29	AS
Culverts	Drop Inlets	Gates	Curb & Gutter	Curb	PCR
1	0	2	NO CURB AND GUTTER	NO CURB	FAIR/73

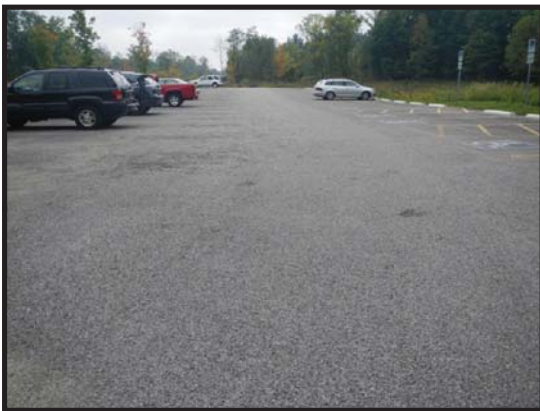
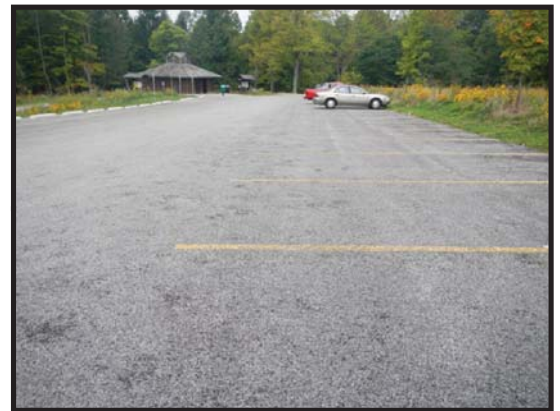
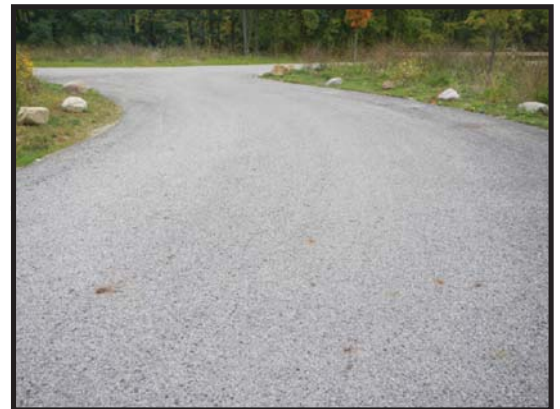
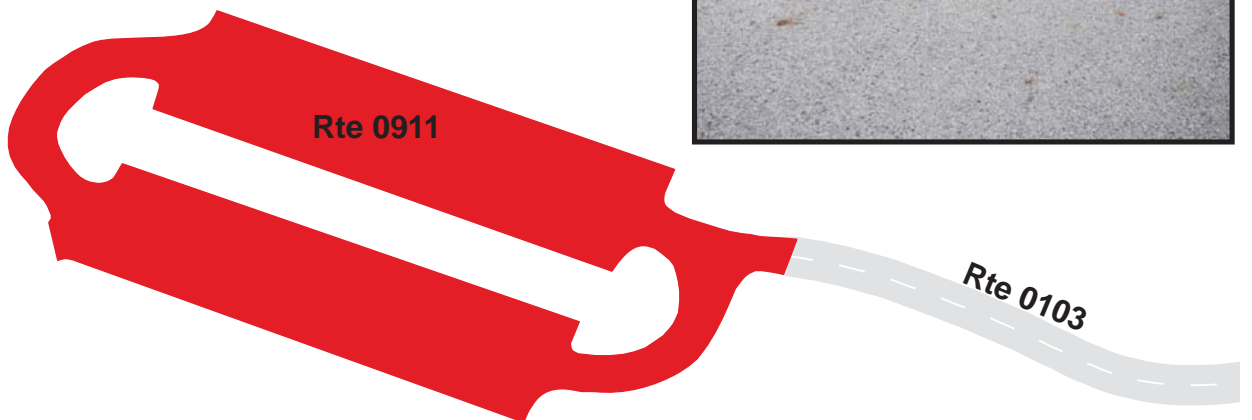
Route 0911

Route Number	Public / NonPublic	Date Visited	Area (sq ft)	Lane Miles *	Surface Type
0911	PUBLIC	9/19/2013	30,768	0.53	AS
Culverts	Drop Inlets	Gates	Curb & Gutter	Curb	PCR
0	1	0	NO CURB AND GUTTER	NO CURB	GOOD/90

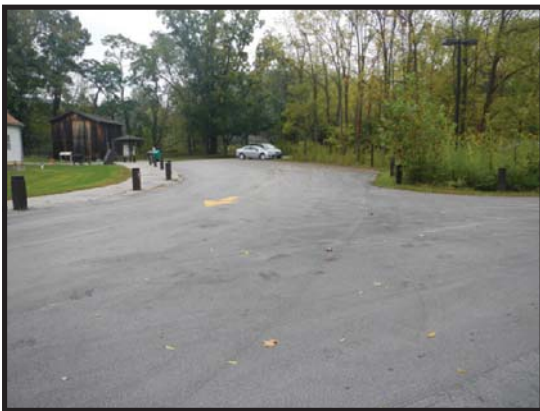
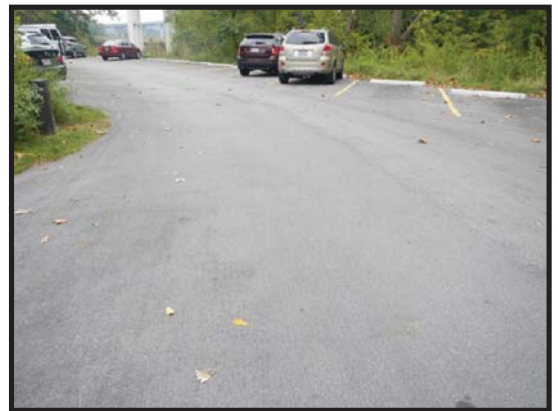
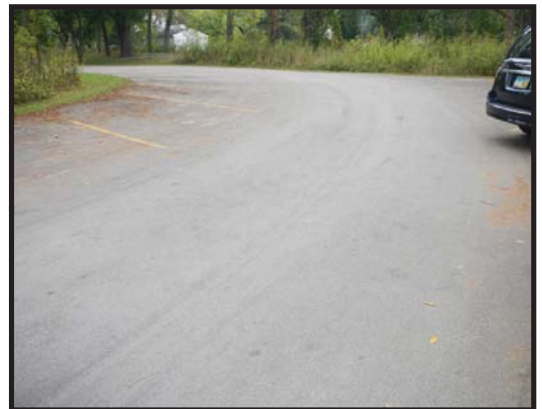
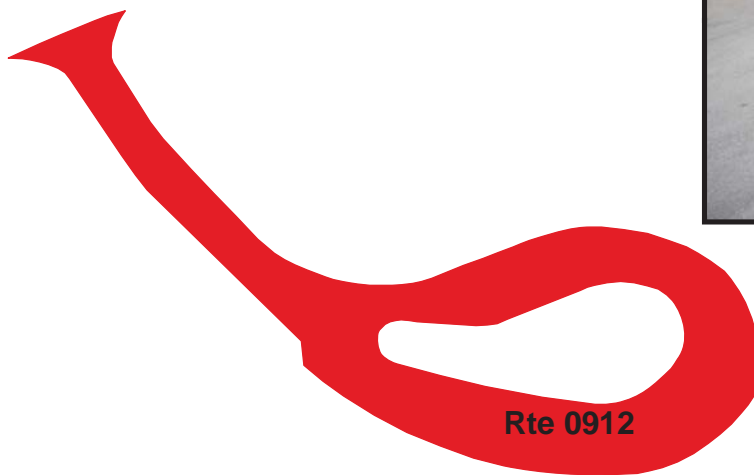
Route 0912

Route Number	Public / NonPublic	Date Visited	Area (sq ft)	Lane Miles *	Surface Type
0912	PUBLIC	9/19/2013	24,845	0.43	AS
Culverts	Drop Inlets	Gates	Curb & Gutter	Curb	PCR
0	0	1	NO CURB AND GUTTER	NO CURB	GOOD/90

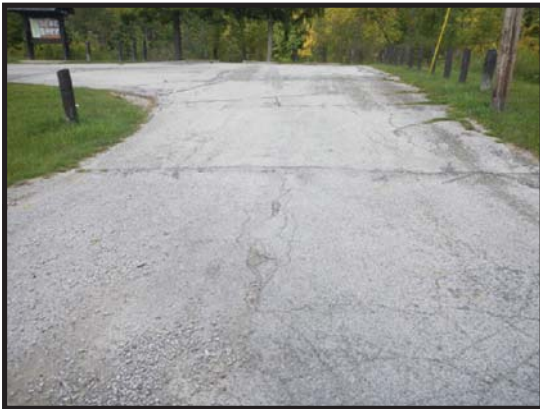
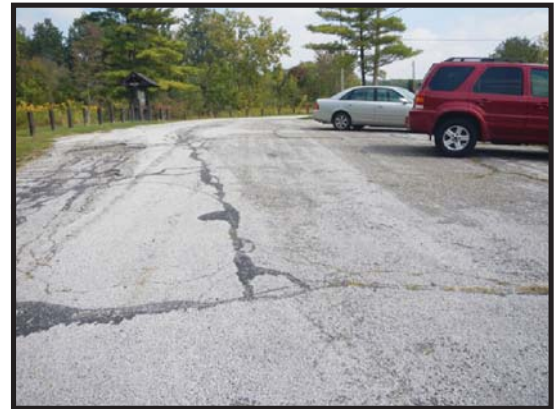
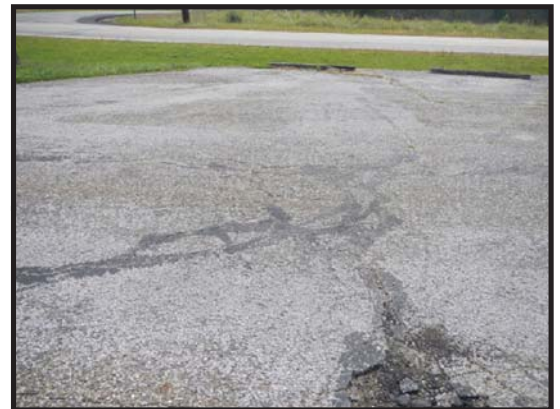
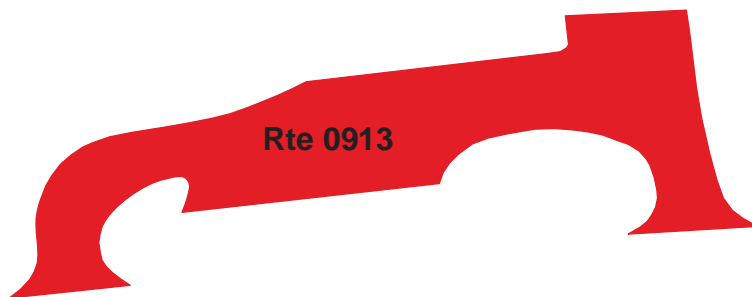
Route 0913

Route Number	Public / NonPublic	Date Visited	Area (sq ft)	Lane Miles *	Surface Type
0913	PUBLIC	9/19/2013	6,781	0.12	AS
Culverts	Drop Inlets	Gates	Curb & Gutter	Curb	PCR
2	0	1	NO CURB AND GUTTER	NO CURB	POOR/45

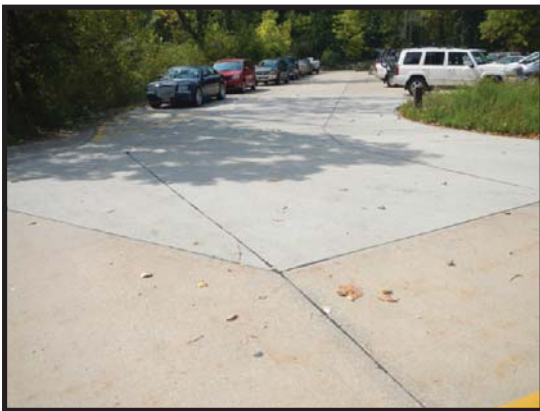
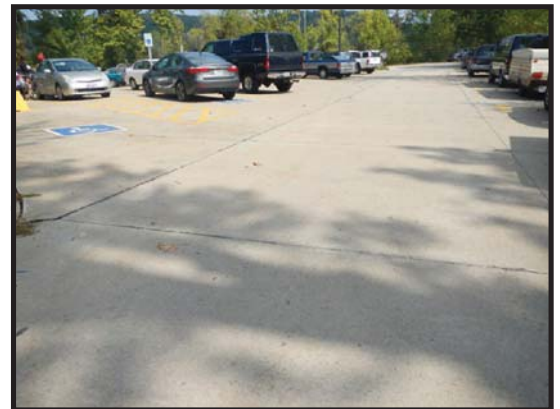
Route 0914

Route Number	Public / NonPublic	Date Visited	Area (sq ft)	Lane Miles *	Surface Type
0914	PUBLIC	9/19/2013	26,439	0.46	CO
Culverts	Drop Inlets	Gates	Curb & Gutter	Curb	PCR
0	0	1	NO CURB AND GUTTER	NO CURB	GOOD/90

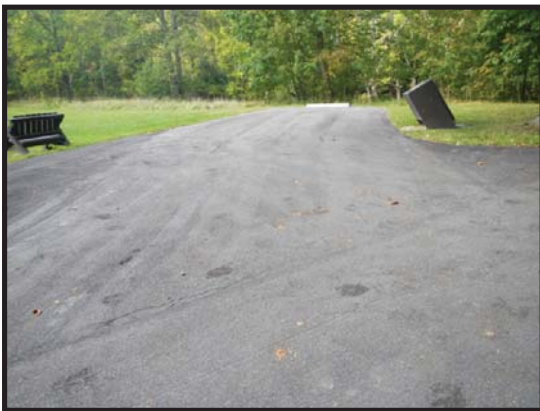
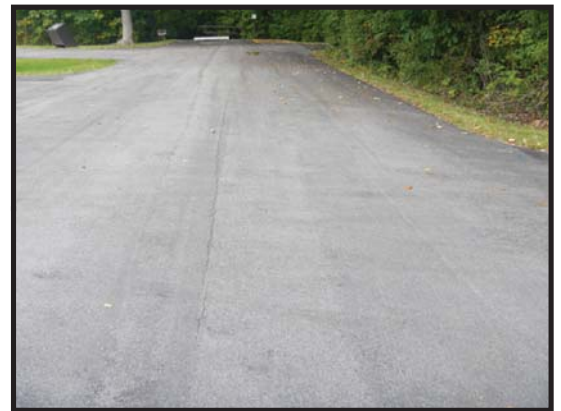
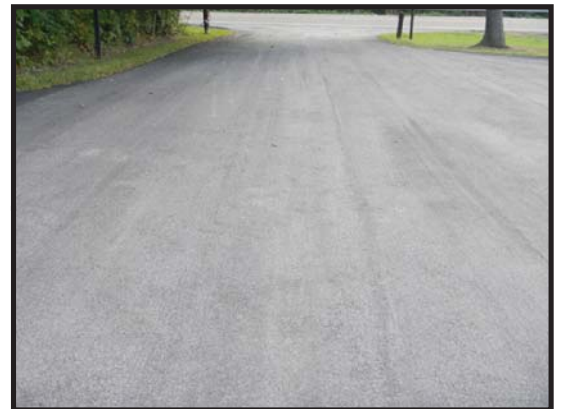
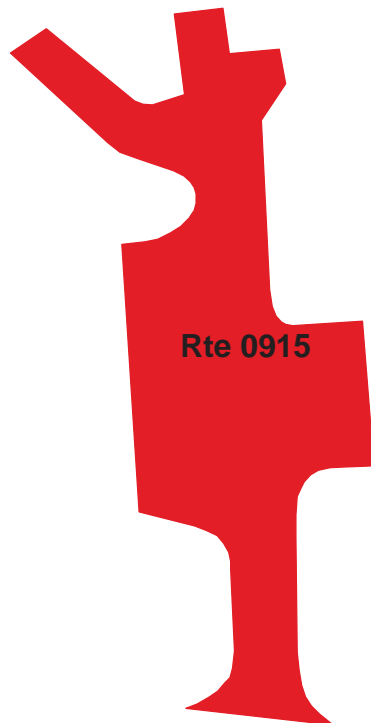
Route 0915

Route Number	Public / NonPublic	Date Visited	Area (sq ft)	Lane Miles *	Surface Type
0915	PUBLIC	9/19/2013	8,793	0.15	AS
Culverts	Drop Inlets	Gates	Curb & Gutter	Curb	PCR
0	0	1	NO CURB AND GUTTER	NO CURB	GOOD/90

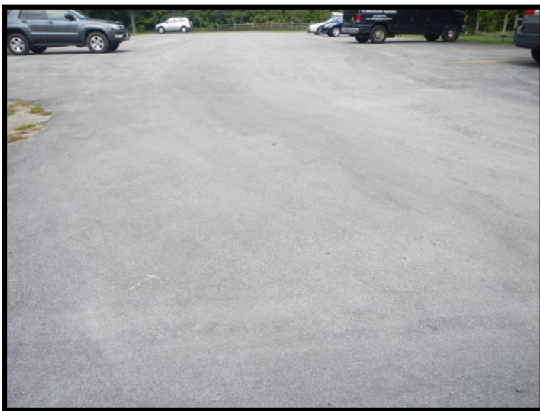
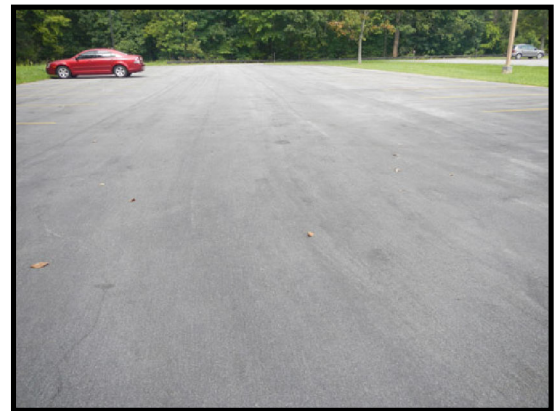
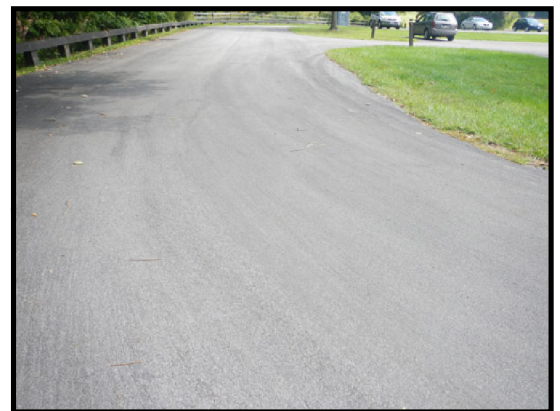
Route 0916

Route Number	Public / NonPublic	Date Visited	Area (sq ft)	Lane Miles *	Surface Type
0916	PUBLIC	9/19/2013	45,591	0.78	AS
Culverts	Drop Inlets	Gates	Curb & Gutter	Curb	PCR
0	0	0	NO CURB AND GUTTER	NO CURB	GOOD/90

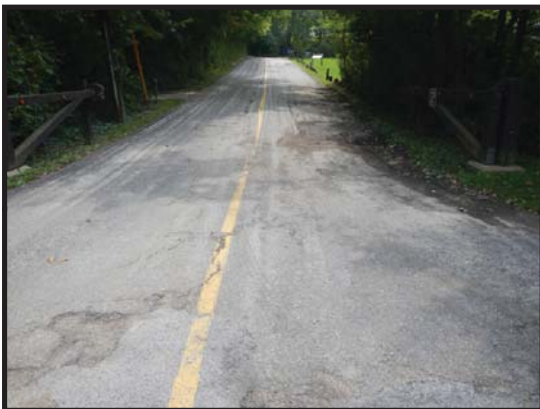
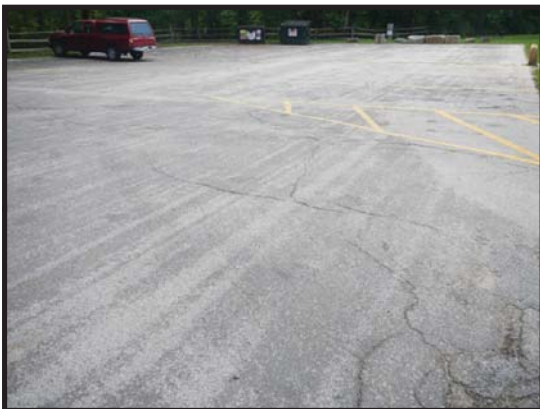
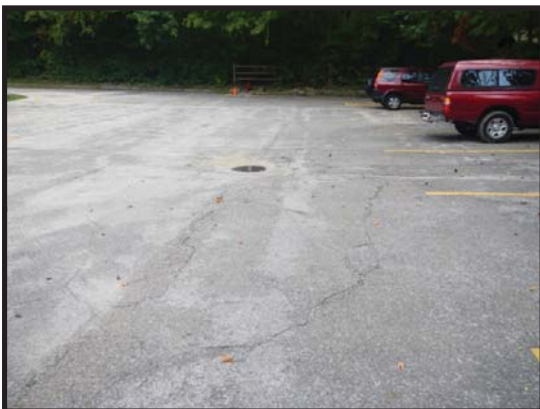
Route 0917

Route Number	Public / NonPublic	Date Visited	Area (sq ft)	Lane Miles *	Surface Type
0917	PUBLIC	9/19/2013	13,687	0.24	AS
Culverts	Drop Inlets	Gates	Curb & Gutter	Curb	PCR
1	1	1	NO CURB AND GUTTER	STONE CURB	POOR/45

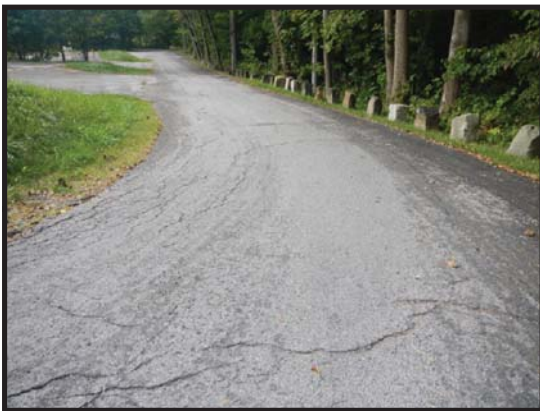
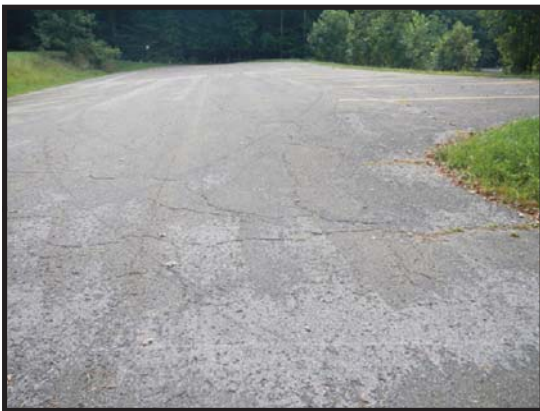
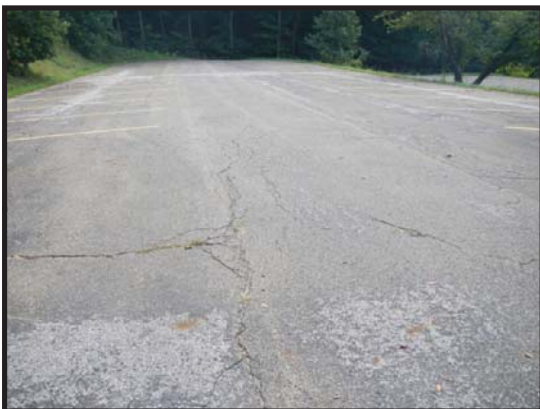
Route 0918

Route Number	Public / NonPublic	Date Visited	Area (sq ft)	Lane Miles *	Surface Type
0918	PUBLIC	9/19/2013	50,843	0.88	AS
Culverts	Drop Inlets	Gates	Curb & Gutter	Curb	PCR
0	8	1	NO CURB AND GUTTER	NO CURB	POOR/45

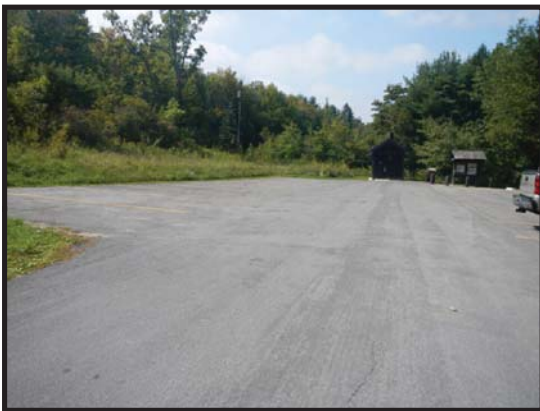
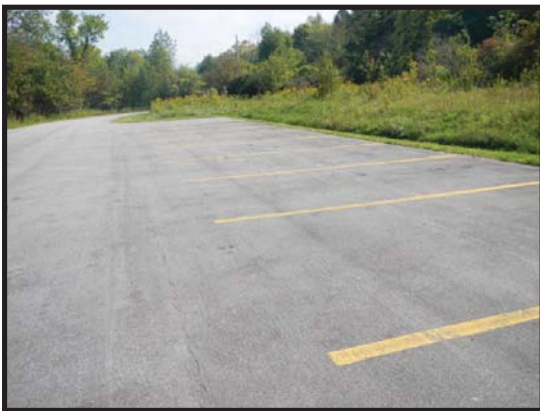
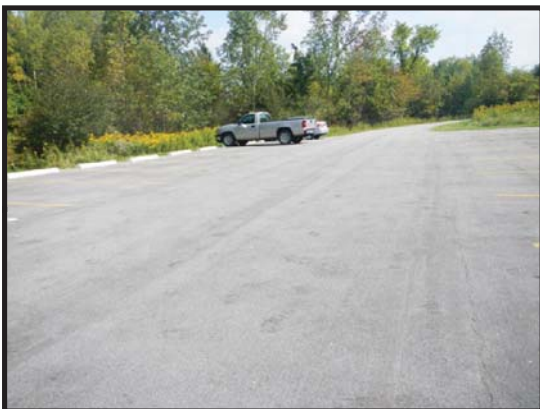
Route Number	Public / NonPublic	Date Visited	Area (sq ft)	Lane Miles *	Surface Type
0919	PUBLIC	9/19/2013	9,032	0.16	AS
Culverts	Drop Inlets	Gates	Curb & Gutter	Curb	PCR
0	0	1	NO CURB AND GUTTER	NO CURB	GOOD/90

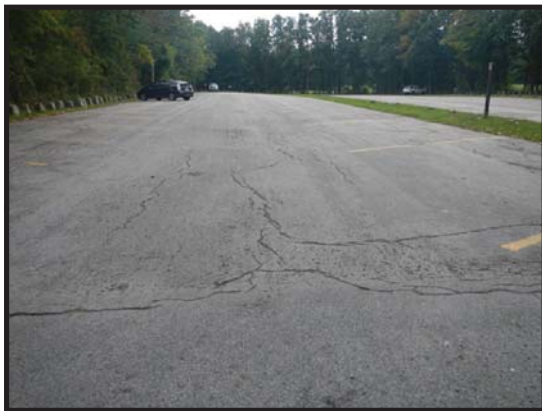
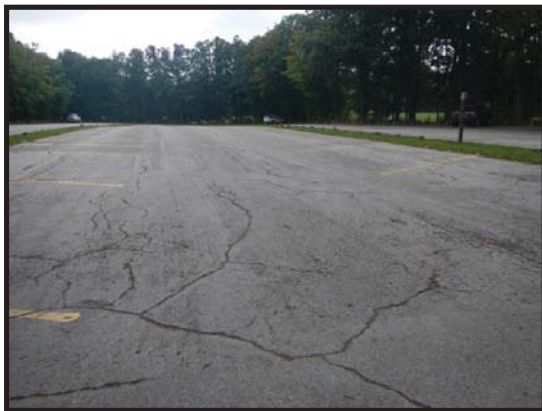
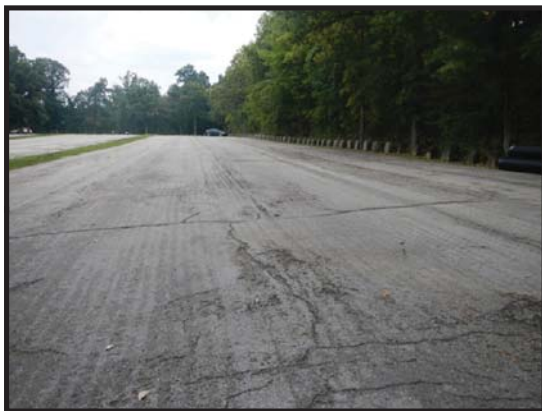
Route 0920

Route Number	Public / NonPublic	Date Visited	Area (sq ft)	Lane Miles *	Surface Type
0920	PUBLIC	9/19/2013	60,797	1.05	AS
Culverts	Drop Inlets	Gates	Curb & Gutter	Curb	PCR
1	4	0	NO CURB AND GUTTER	NO CURB	POOR/45

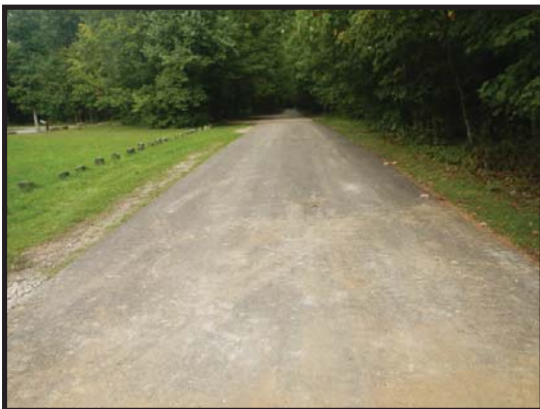
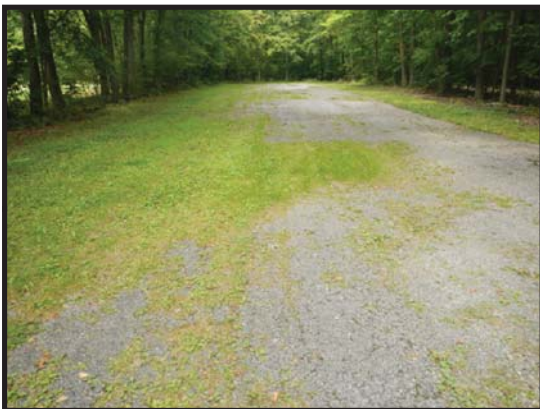
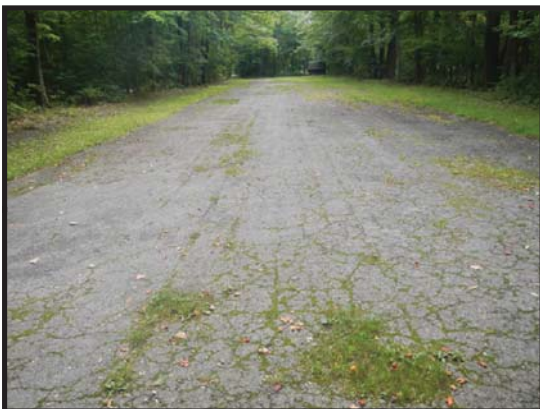
Route 0921

Route Number	Public / NonPublic	Date Visited	Area (sq ft)	Lane Miles *	Surface Type
0921	NONPUBLIC	9/19/2013	19,972	0.34	AS
Culverts	Drop Inlets	Gates	Curb & Gutter	Curb	PCR
0	0	1	NO CURB AND GUTTER	NO CURB	POOR/45

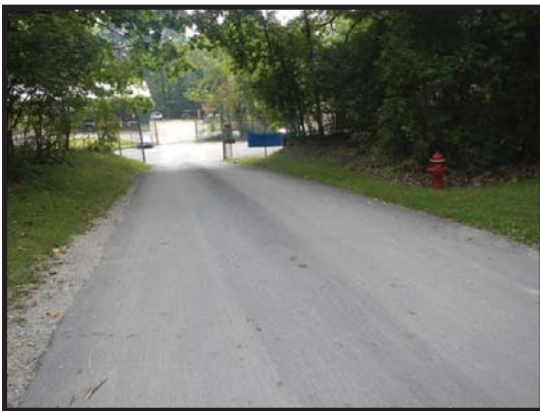
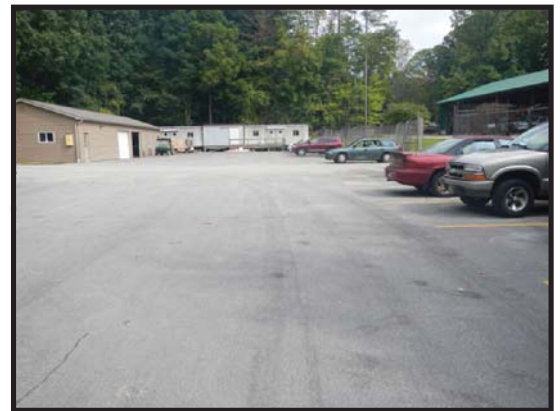
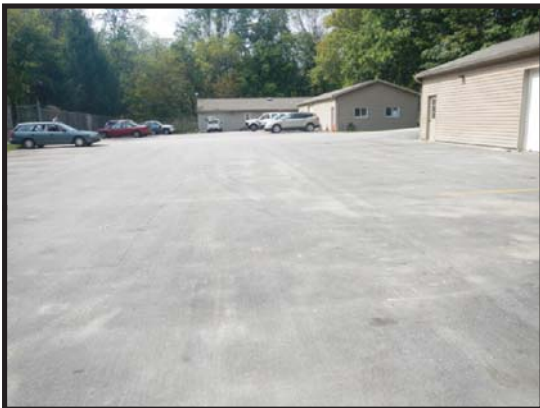
Route 0922

Route Number	Public / NonPublic	Date Visited	Area (sq ft)	Lane Miles *	Surface Type
0922	NONPUBLIC	9/19/2013	17,855	0.31	AS
Culverts	Drop Inlets	Gates	Curb & Gutter	Curb	PCR
0	3	2	NO CURB AND GUTTER	NO CURB	FAIR/73

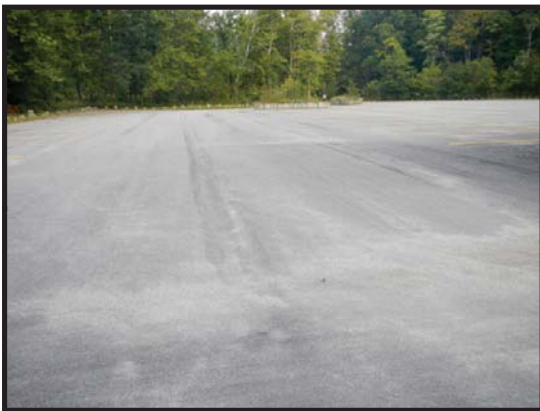
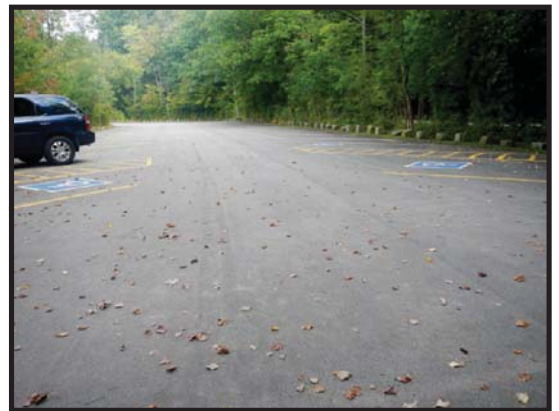
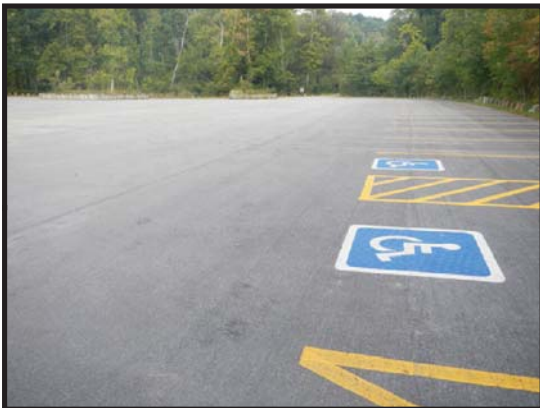
Route 0923

Route Number	Public / NonPublic	Date Visited	Area (sq ft)	Lane Miles *	Surface Type
0923	PUBLIC	9/19/2013	81,263	1.40	AS
Culverts	Drop Inlets	Gates	Curb & Gutter	Curb	PCR
0	2	2	NO CURB AND GUTTER	NO CURB	GOOD/90

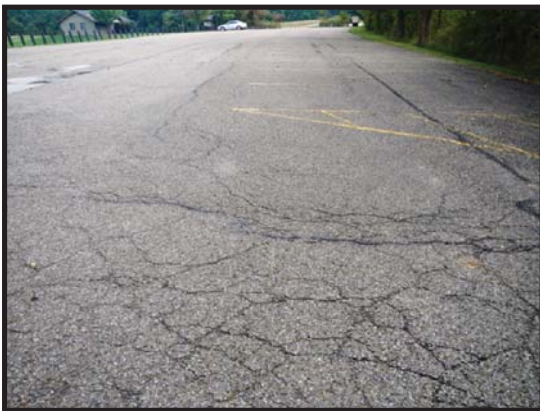
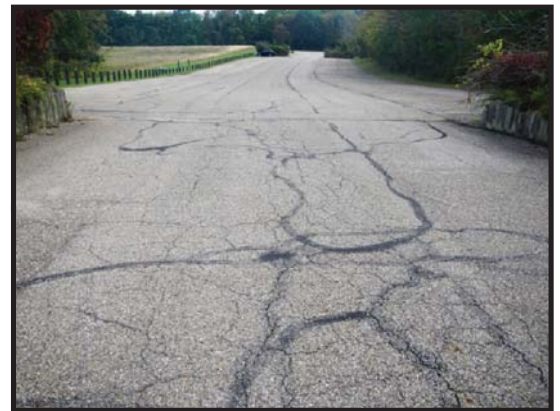
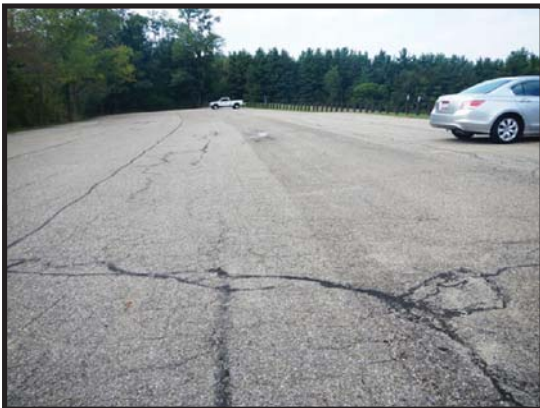
Route 0924

Route Number	Public / NonPublic	Date Visited	Area (sq ft)	Lane Miles *	Surface Type
0924	PUBLIC	9/19/2013	75,670	1.30	AS
Culverts	Drop Inlets	Gates	Curb & Gutter	Curb	PCR
2	0	2	NO CURB AND GUTTER	NO CURB	POOR/45

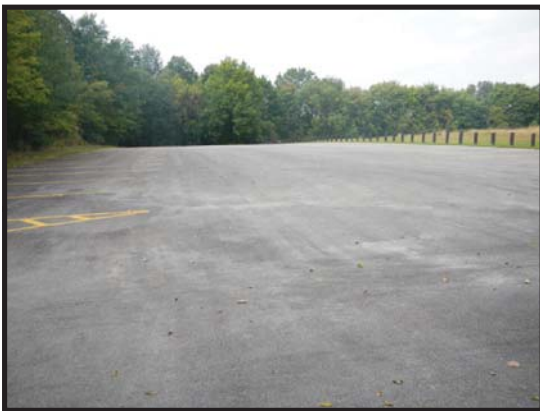
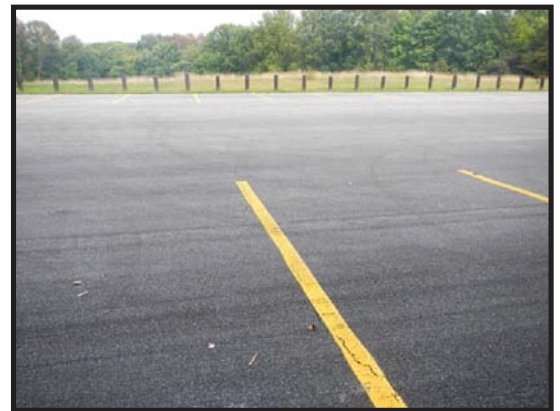
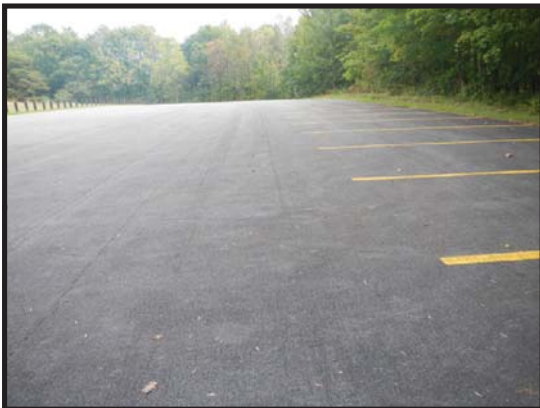
Route 0925

Route Number	Public / NonPublic	Date Visited	Area (sq ft)	Lane Miles *	Surface Type
0925	PUBLIC	9/19/2013	23,710	0.41	AS
Culverts	Drop Inlets	Gates	Curb & Gutter	Curb	PCR
1	0	1	NO CURB AND GUTTER	NO CURB	FAIR/73

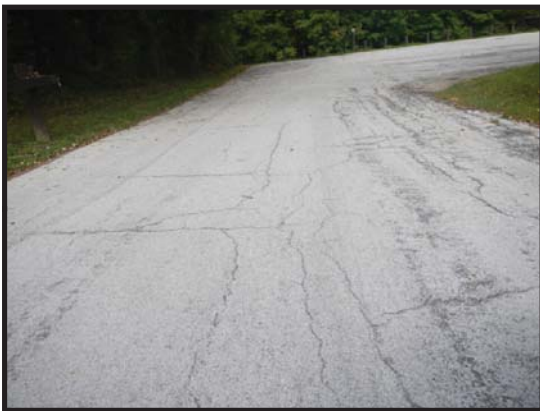
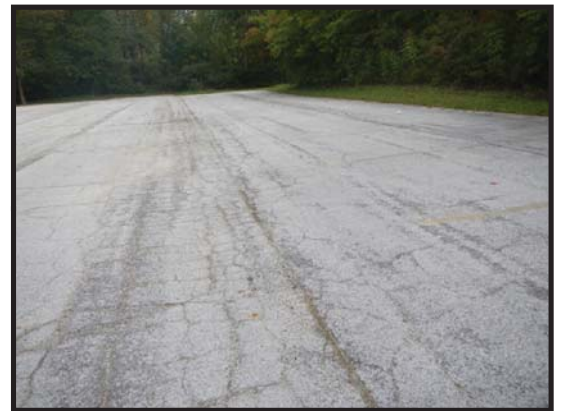
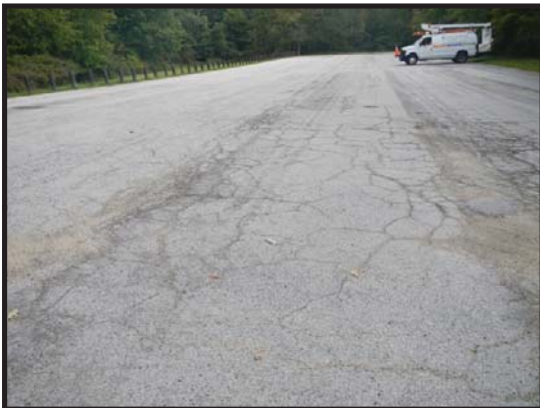
Route 0926

Route Number	Public / NonPublic	Date Visited	Area (sq ft)	Lane Miles *	Surface Type
0926	PUBLIC	9/19/2013	21,186	0.36	AS
Culverts	Drop Inlets	Gates	Curb & Gutter	Curb	PCR
1	0	1	NO CURB AND GUTTER	NO CURB	POOR/45

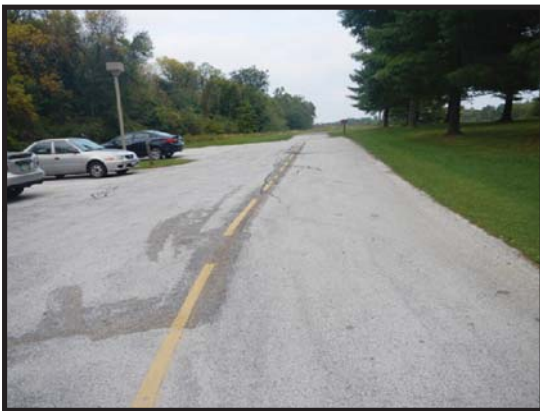
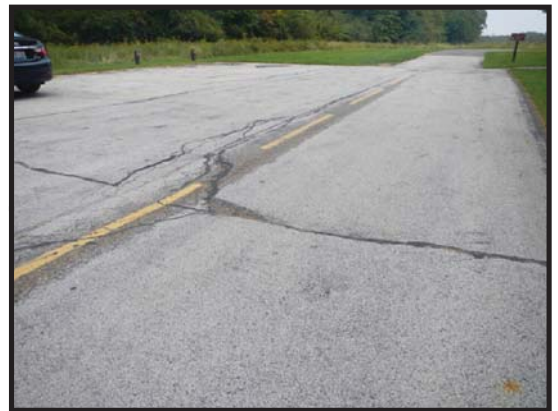
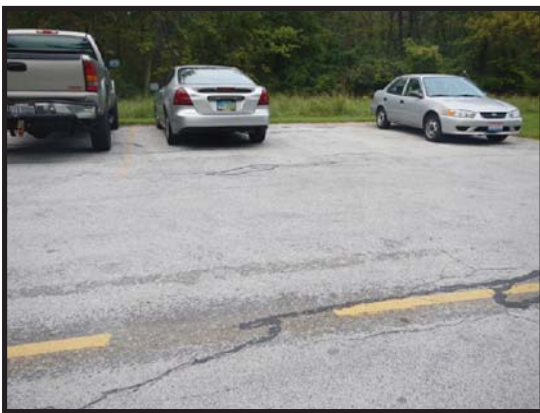
Route 0927

Route Number	Public / NonPublic	Date Visited	Area (sq ft)	Lane Miles *	Surface Type
0927	PUBLIC	9/19/2013	4,293	0.07	AS
Culverts	Drop Inlets	Gates	Curb & Gutter	Curb	PCR
0	0	0	NO CURB AND GUTTER	NO CURB	POOR/45
