Federal Lands Highway Road Inventory Program

Road Inventory and Condition Assessment

Cuyahoga Valley National Park CUVA

Cycle 5 Report

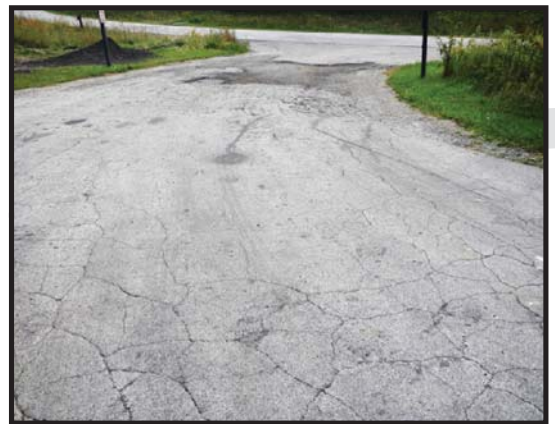
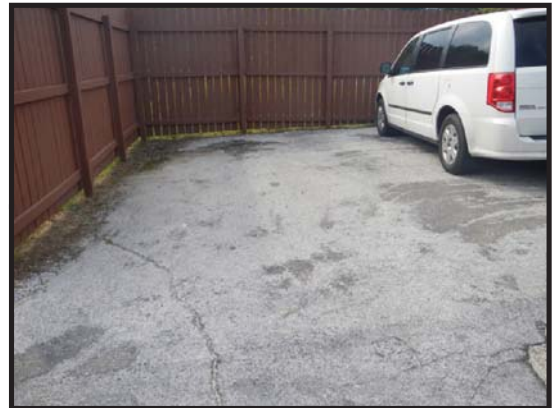
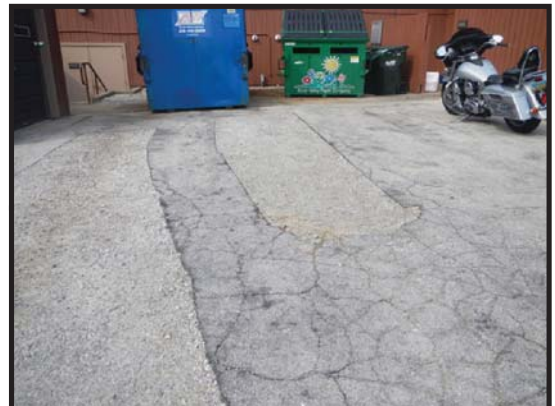
Route 0929

Route Number	Public / NonPublic	Date Visited	Area (sq ft)	Lane Miles *	Surface Type
0929	NONPUBLIC	9/19/2013	3,223	0.06	AS
Culverts	Drop Inlets	Gates	Curb & Gutter	Curb	PCR
1	0	0	NO CURB AND GUTTER	NO CURB	POOR/45

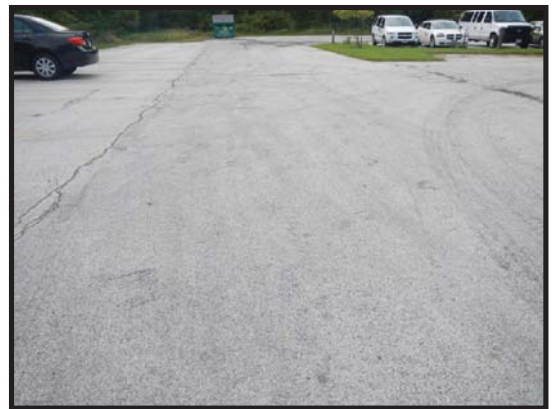
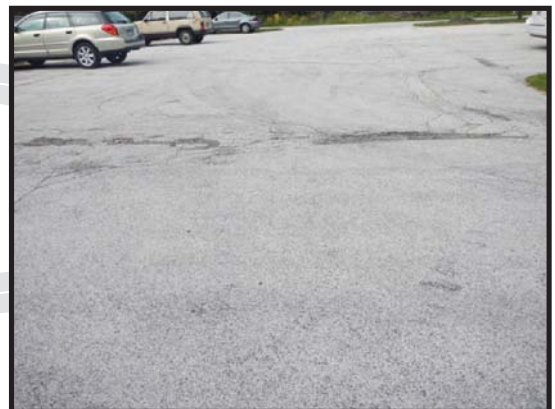
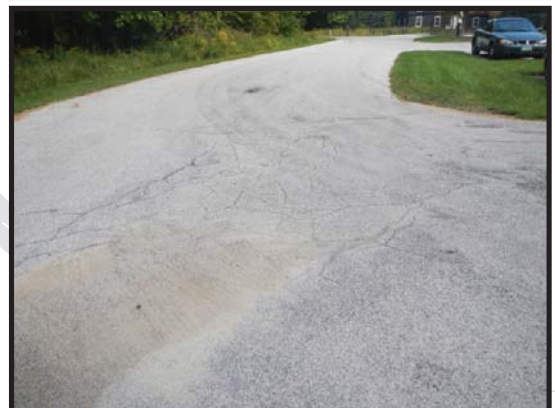
Route 0931

Route Number	Public / NonPublic	Date Visited	Area (sq ft)	Lane Miles *	Surface Type
0931	PUBLIC	9/19/2013	22,323	0.38	AS
Culverts	Drop Inlets	Gates	Curb & Gutter	Curb	PCR
0	0	0	NO CURB AND GUTTER	NO CURB	POOR/45

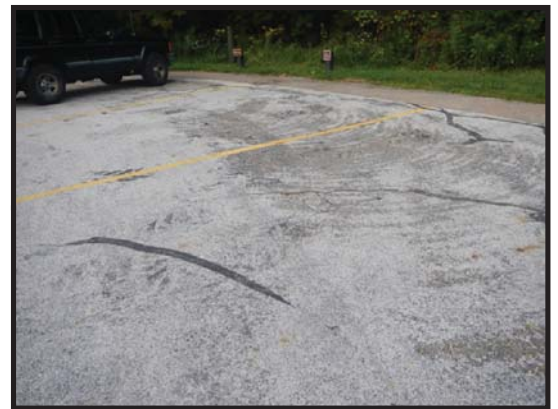
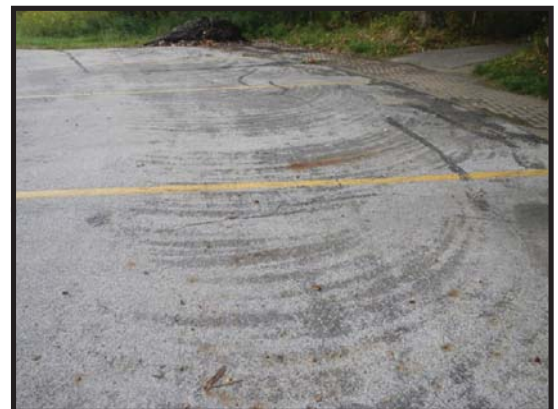
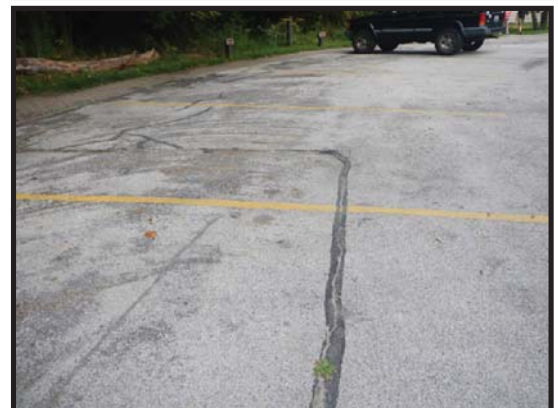
Route 0933

Route Number	Public / NonPublic	Date Visited	Area (sq ft)	Lane Miles *	Surface Type
0933	PUBLIC	9/19/2013	2,217	0.04	AS
Culverts	Drop Inlets	Gates	Curb & Gutter	Curb	PCR
0	0	0	NO CURB AND GUTTER	NO CURB	FAIR/73

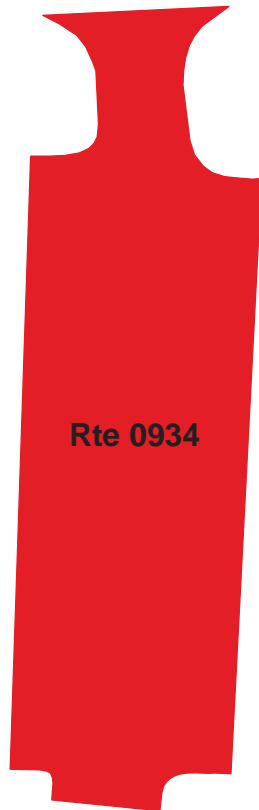
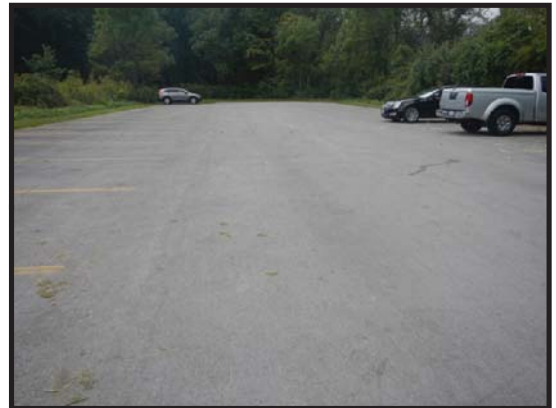
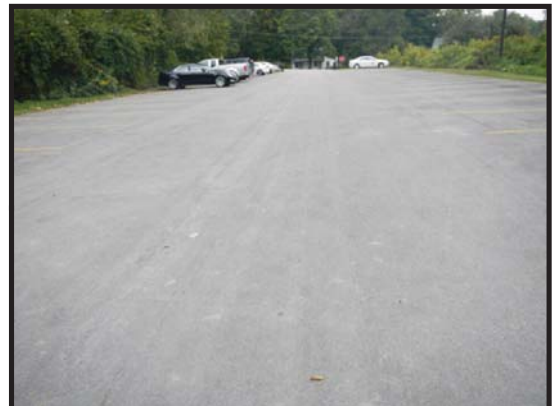
Route Number	Public / NonPublic	Date Visited	Area (sq ft)	Lane Miles *	Surface Type
0934	PUBLIC	9/19/2013	14,253	0.25	AS
Culverts	Drop Inlets	Gates	Curb & Gutter	Curb	PCR
0	0	1	NO CURB AND GUTTER	NO CURB	FAIR/73

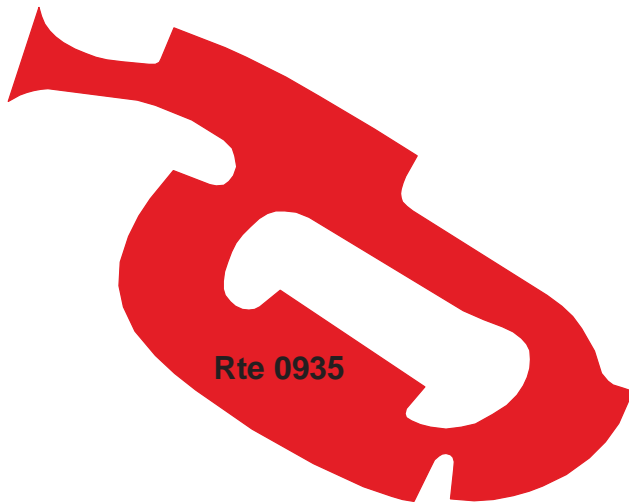
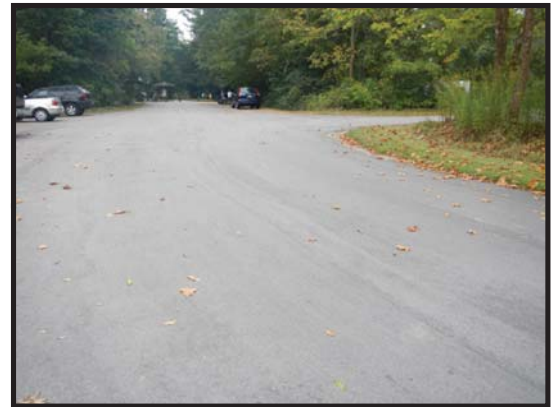
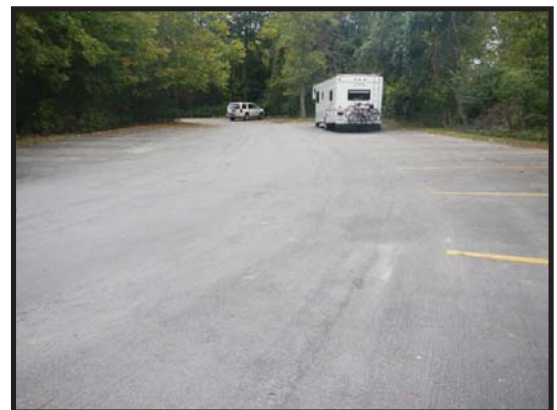
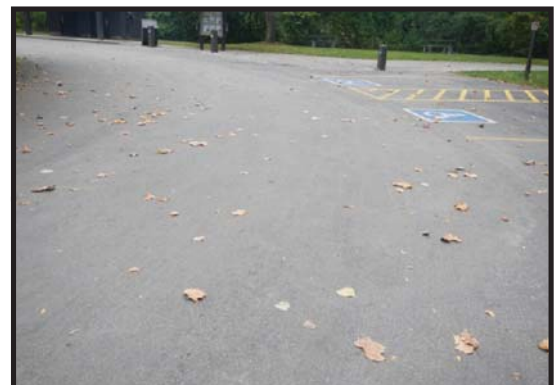
Route 0935

Route Number	Public / NonPublic	Date Visited	Area (sq ft)	Lane Miles *	Surface Type
0935	PUBLIC	9/19/2013	24,319	0.42	AS
Culverts	Drop Inlets	Gates	Curb & Gutter	Curb	PCR
0	0	1	NO CURB AND GUTTER	NO CURB	GOOD/90

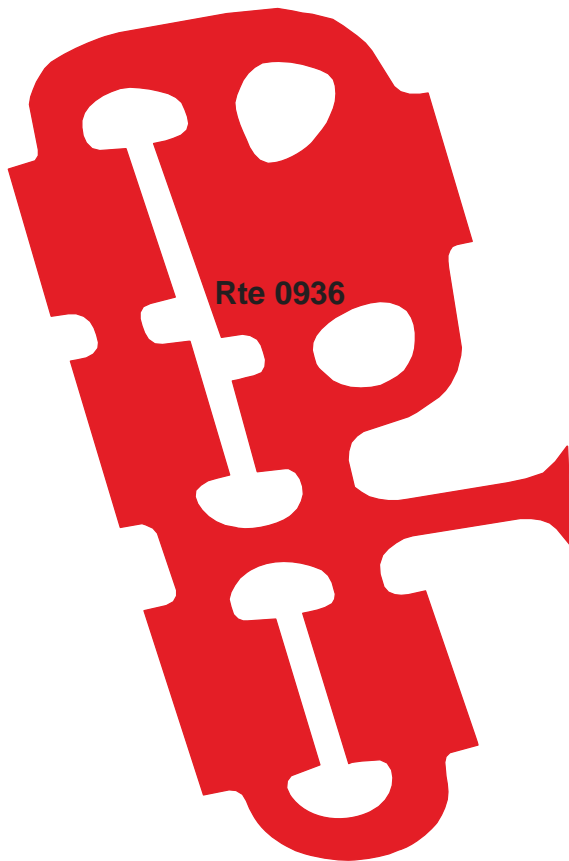
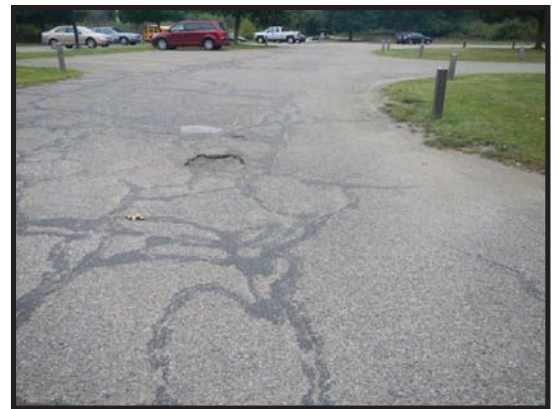
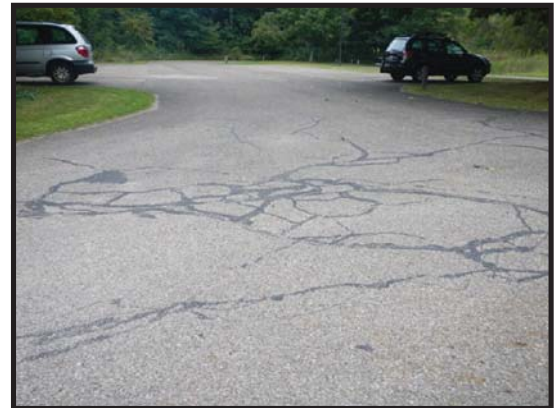
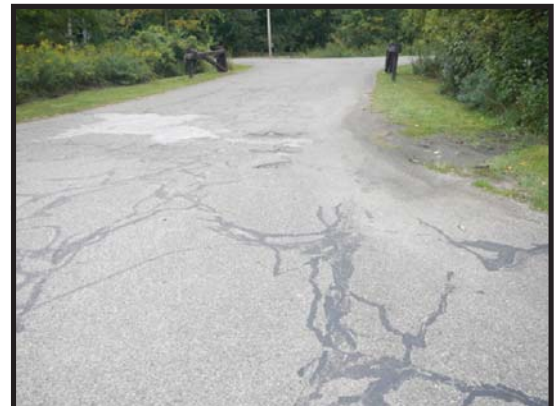
Route 0936

Route Number	Public / NonPublic	Date Visited	Area (sq ft)	Lane Miles *	Surface Type
0936	PUBLIC	9/19/2013	69,737	1.20	AS
Culverts	Drop Inlets	Gates	Curb & Gutter	Curb	PCR
1	3	1	NO CURB AND GUTTER	CONCRETE CURB	POOR/45

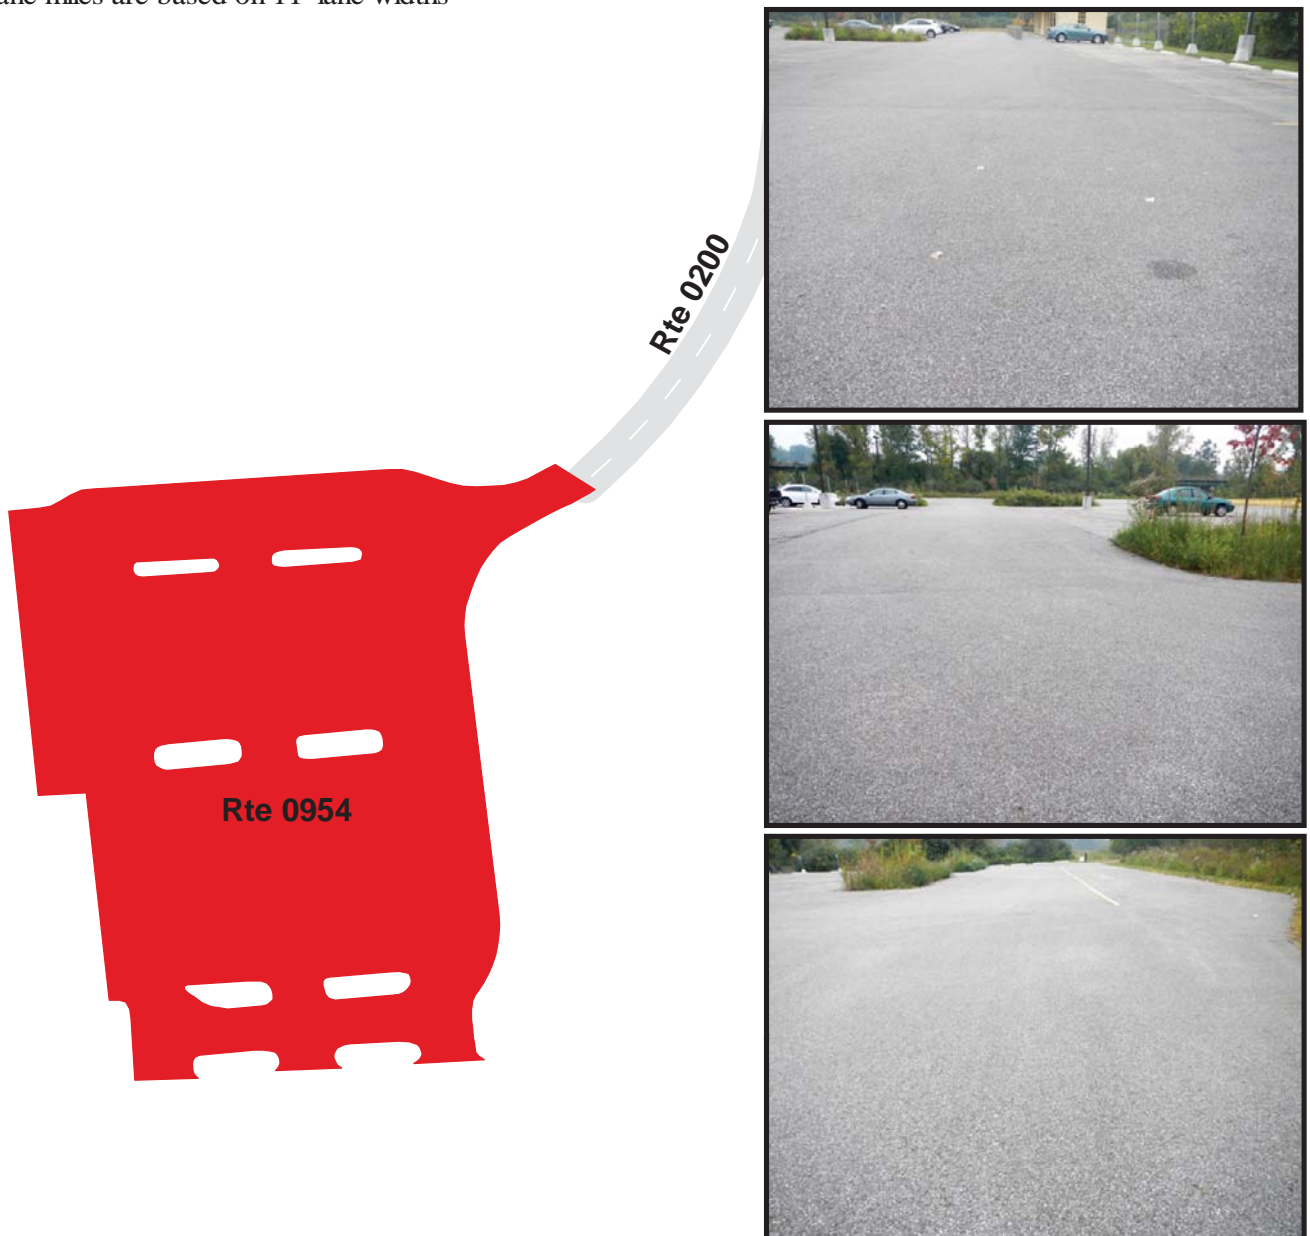
Route 0954

Route Number	Public / NonPublic	Date Visited	Area (sq ft)	Lane Miles *	Surface Type
0954	PUBLIC	9/19/2013	52,133	0.90	AS
Culverts	Drop Inlets	Gates	Curb & Gutter	Curb	PCR
0	0	4	NO CURB AND GUTTER	NO CURB	GOOD/90

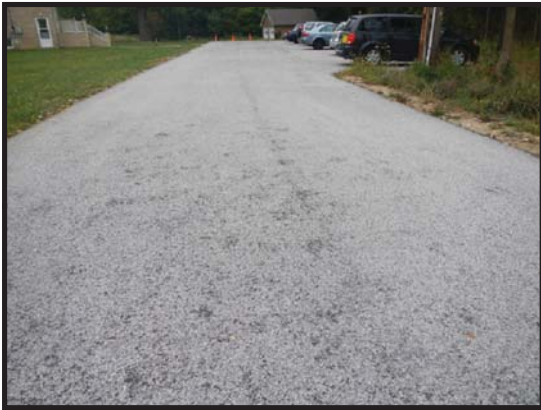
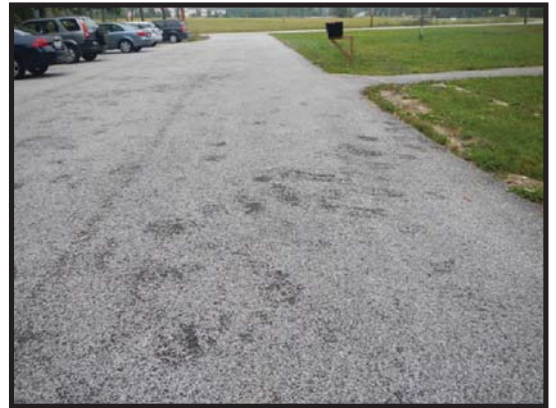
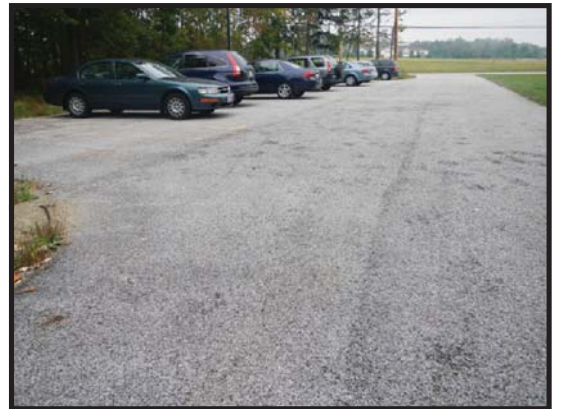
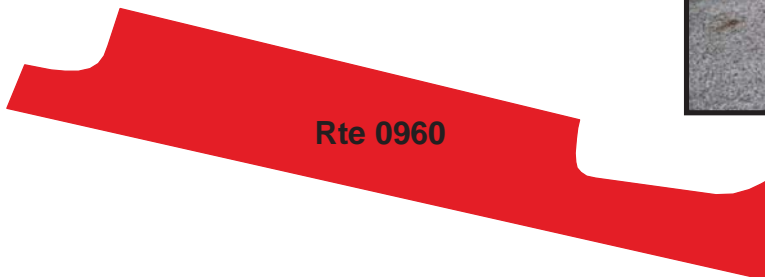
Route 0960

Route Number	Public / NonPublic	Date Visited	Area (sq ft)	Lane Miles *	Surface Type
0960	PUBLIC	9/19/2013	6,890	0.12	AS
Culverts	Drop Inlets	Gates	Curb & Gutter	Curb	PCR
0	0	0	NO CURB AND GUTTER	NO CURB	FAIR/73

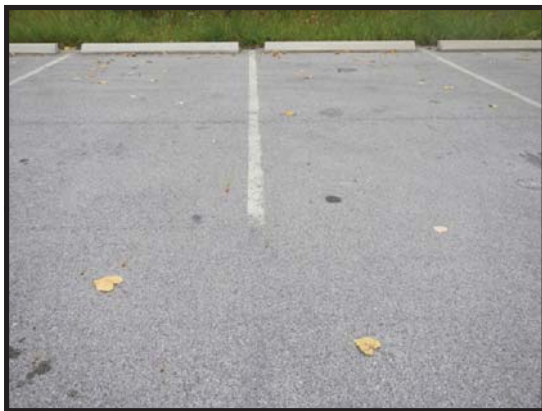
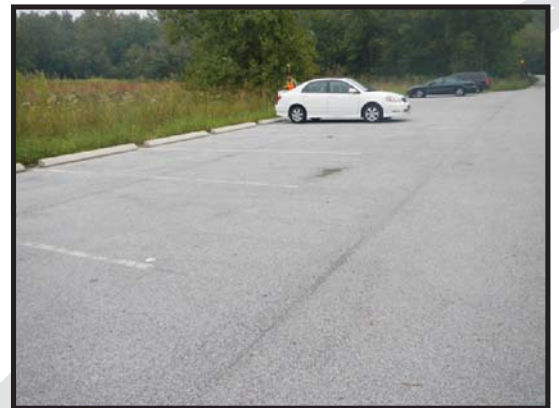
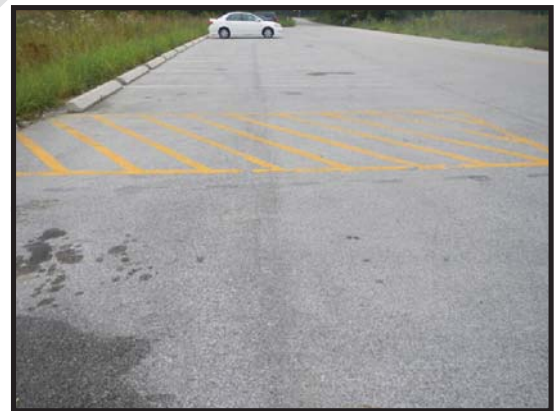
Route 0963

Route Number	Public / NonPublic	Date Visited	Area (sq ft)	Lane Miles *	Surface Type
0963	PUBLIC	9/19/2013	4,808	0.08	AS
Culverts	Drop Inlets	Gates	Curb & Gutter	Curb	PCR
0	0	0	NO CURB AND GUTTER	NO CURB	GOOD/90
