Federal Lands Highway Road Inventory Program

Road Inventory and Condition Assessment

Devils Tower National Monument DETO - 1390

Cycle 5 Report

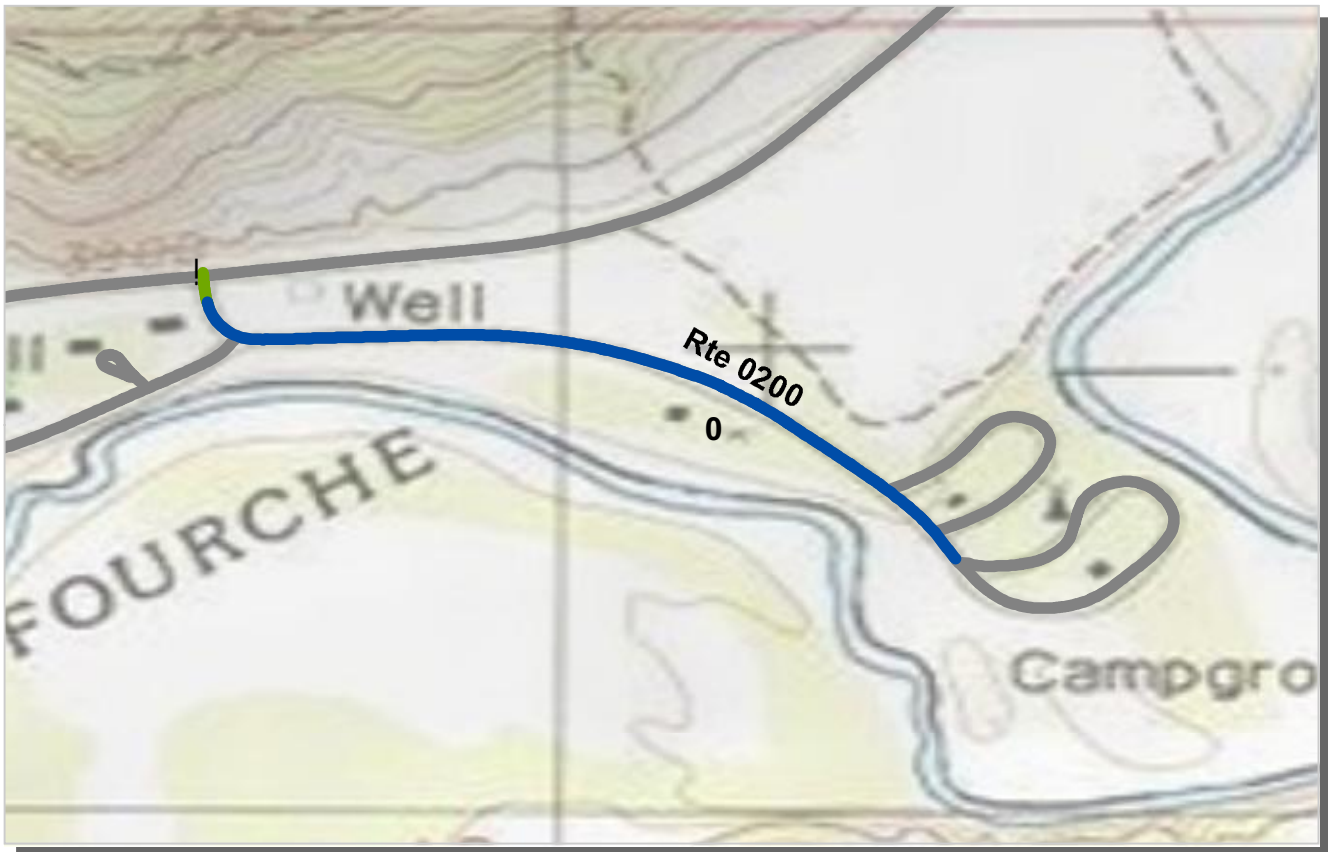
ROUTE: 0200 CAMPGROUND ROAD

Section Number	0				
Section Length (mi)	0.44				
Cross Section Information					
Number of Lanes	2				
Paved Width (ft)	19				
Lane Width (ft)	10				
Roadway Condition Information					
SCR (Surface Condition Rating)	98				
PCR (Pavement Condition Rating)	98				
Distress Index Values					
Structural Crack Index	100				
Transverse Cracking Index	100				
Patching Index	100				
Rutting Index	98				
Roughness Condition Index (RCI)	NC

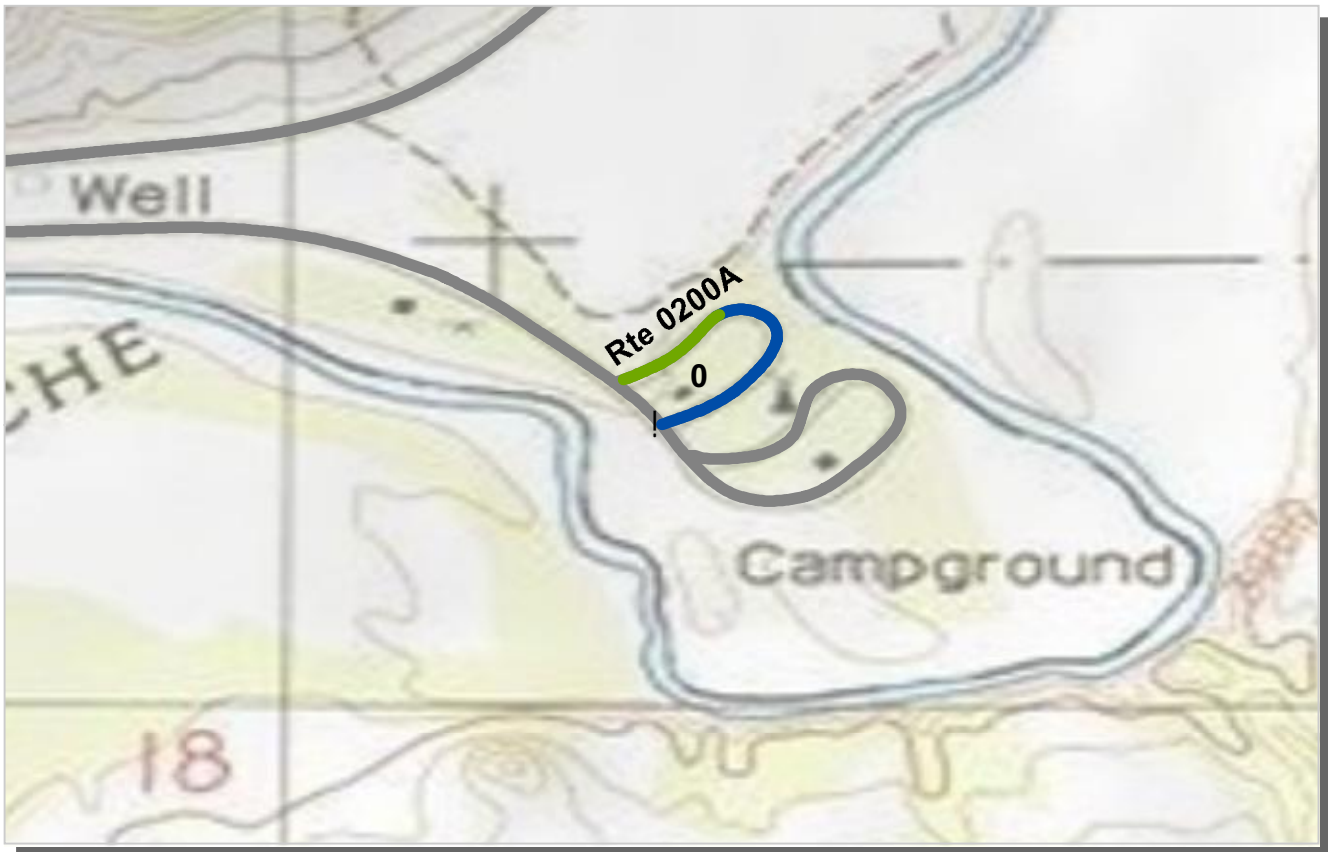
ROUTE: 0200A CAMPGROUND LOOP A

Section Number	0				
Section Length (mi)	0.18				
Cross Section Information					
Number of Lanes	1				
Paved Width (ft)	13				
Lane Width (ft)	13				
Roadway Condition Information					
SCR (Surface Condition Rating)	95				
PCR (Pavement Condition Rating)	95				
Distress Index Values					
Structural Crack Index	100				
Transverse Cracking Index	100				
Patching Index	100				
Rutting Index	95				
Roughness Condition Index (RCI)	NC

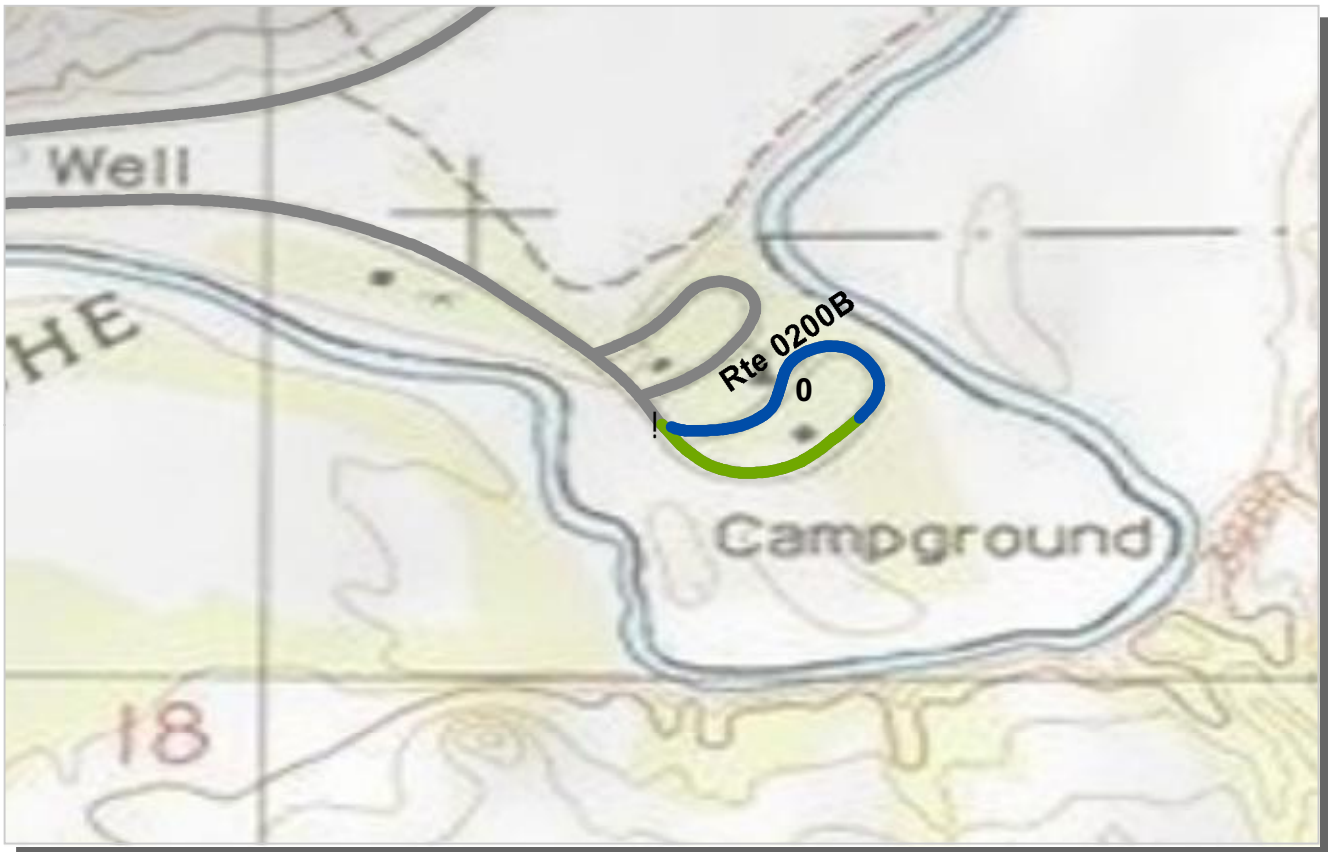
ROUTE: 0200B CAMPGROUND LOOP B

Section Number	0				
Section Length (mi)	0.29				
Cross Section Information					
Number of Lanes	1				
Paved Width (ft)	13				
Lane Width (ft)	13				
Roadway Condition Information					
SCR (Surface Condition Rating)	94				
PCR (Pavement Condition Rating)	94				
Distress Index Values					
Structural Crack Index	100				
Transverse Cracking Index	100				
Patching Index	100				
Rutting Index	94				
Roughness Condition Index (RCI)	NC

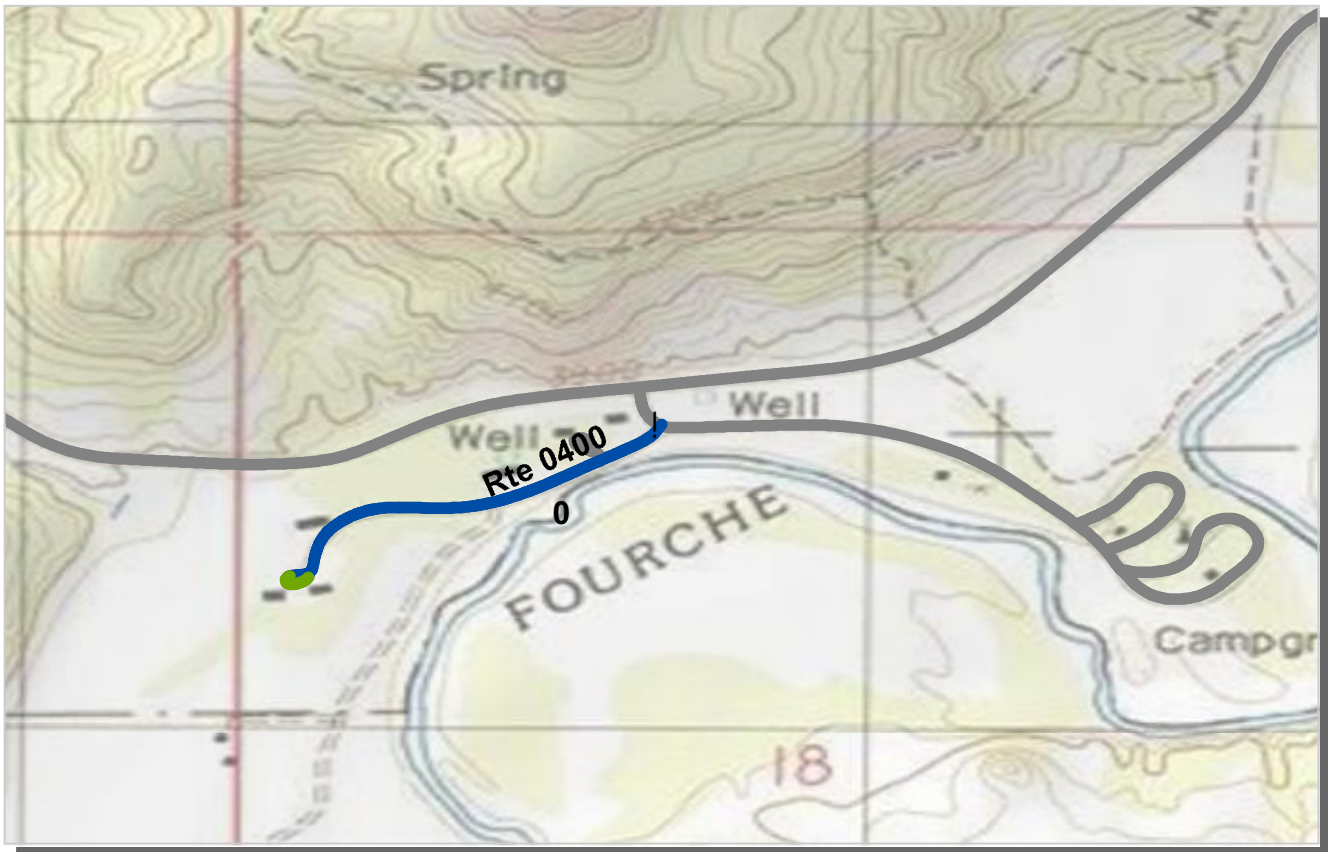
ROUTE: 0400 RESIDENCE ROAD

Section Number	0				
Section Length (mi)	0.36				
Cross Section Information					
Number of Lanes	2				
Paved Width (ft)	19				
Lane Width (ft)	9				
Roadway Condition Information					
SCR (Surface Condition Rating)	99				
PCR (Pavement Condition Rating)	99				
Distress Index Values					
Structural Crack Index	100				
Transverse Cracking Index	100				
Patching Index	100				
Rutting Index	99				
Roughness Condition Index (RCI)	NC

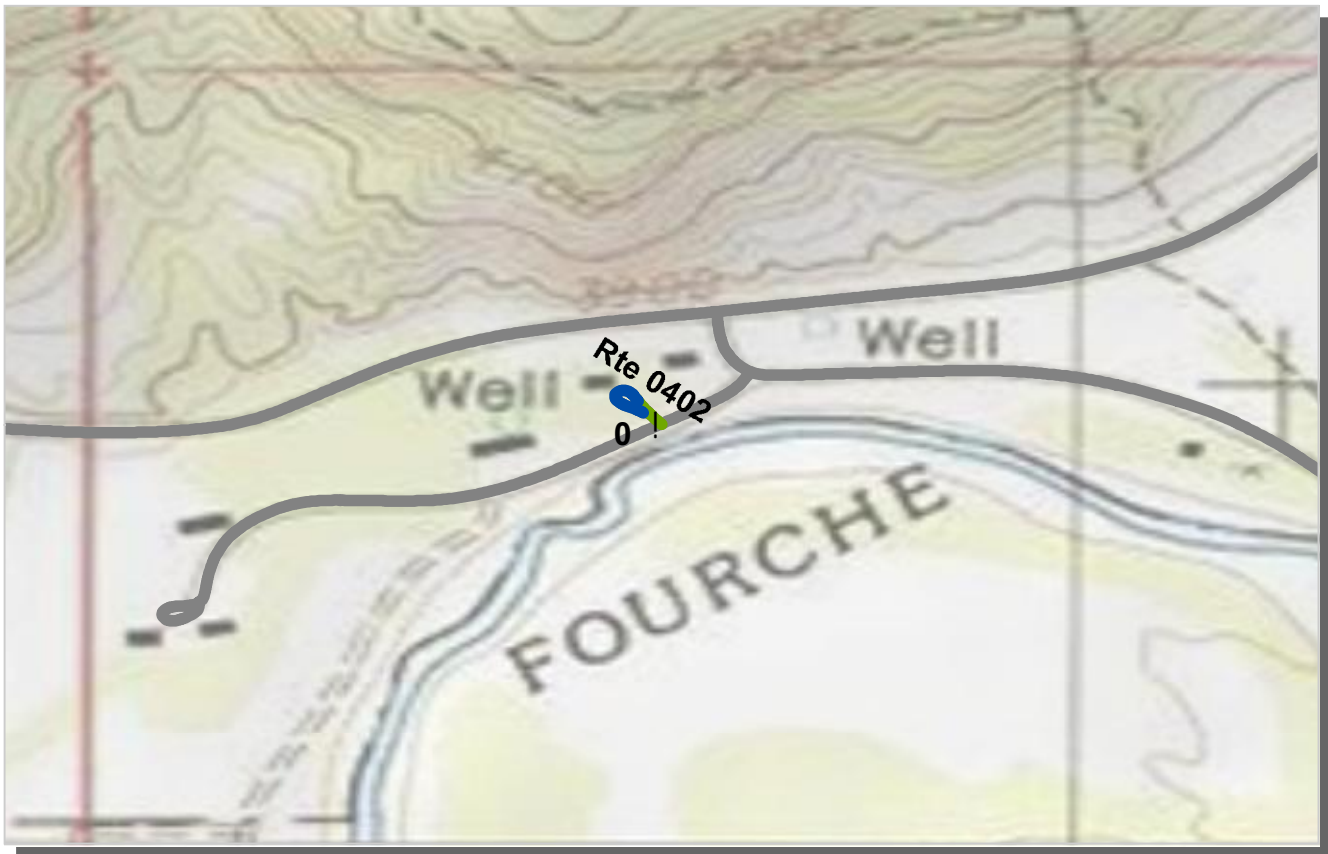
ROUTE: 0402 DRIVEWAY LOOP ROAD

Section Number	0				
Section Length (mi)	0.05				
Cross Section Information					
Number of Lanes	2				
Paved Width (ft)	18				
Lane Width (ft)	9				
Roadway Condition Information					
SCR (Surface Condition Rating)	93				
PCR (Pavement Condition Rating)	93				
Distress Index Values					
Structural Crack Index	100				
Transverse Cracking Index	99				
Patching Index	100				
Rutting Index	93				
Roughness Condition Index (RCI)	NC
