# Federal Lands Highway Road Inventory Program

Road Inventory and Condition Assessment

## Delaware Water Gap National Recreation Area DEWA

### Cycle 5 Report

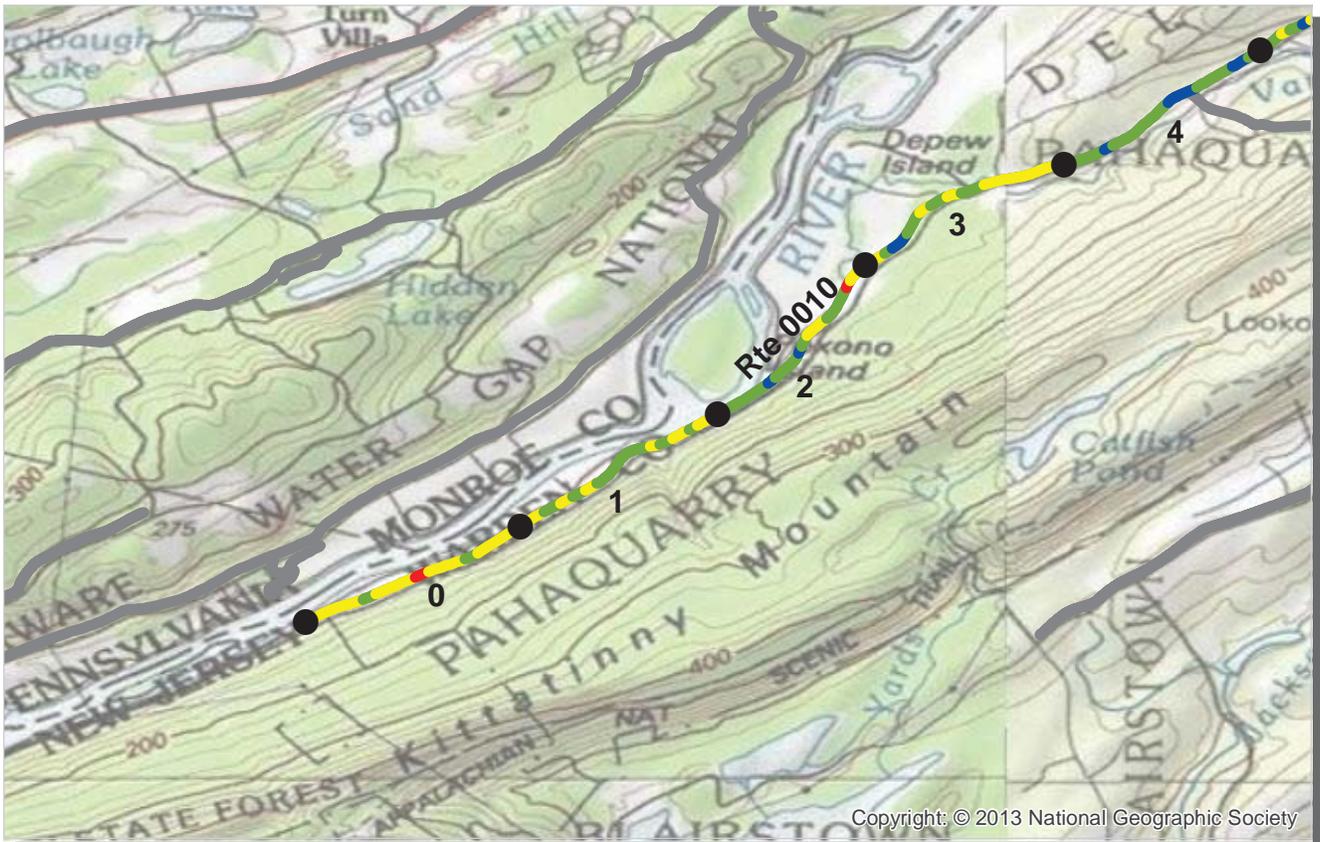
**ROUTE: 0010 OLD MINE ROAD (SOUTH SECTION)**

<i>Section Number</i>	0	1	2	3	4
<i>Section Length (mi)</i>	1.00	1.00	1.00	1.00	1.00
<i>Cross Section Information</i>					
Number of Lanes	2	2	2	2	2
Paved Width (ft)	20	20	20	21	20
Lane Width (ft)	9	9	8	8	8
<i>Roadway Condition Information</i>					
SCR (Surface Condition Rating)	80	88	89	92	94
PCR (Pavement Condition Rating)	72	83	87	86	93
<i>Distress Index Values</i>					
Structural Crack Index	80	88	89	92	96
Transverse Cracking Index	100	100	100	99	100
Patching Index	98	100	100	100	100
Rutting Index	89	91	91	94	94
Roughness Condition Index (RCI)	59	76	84	76	91

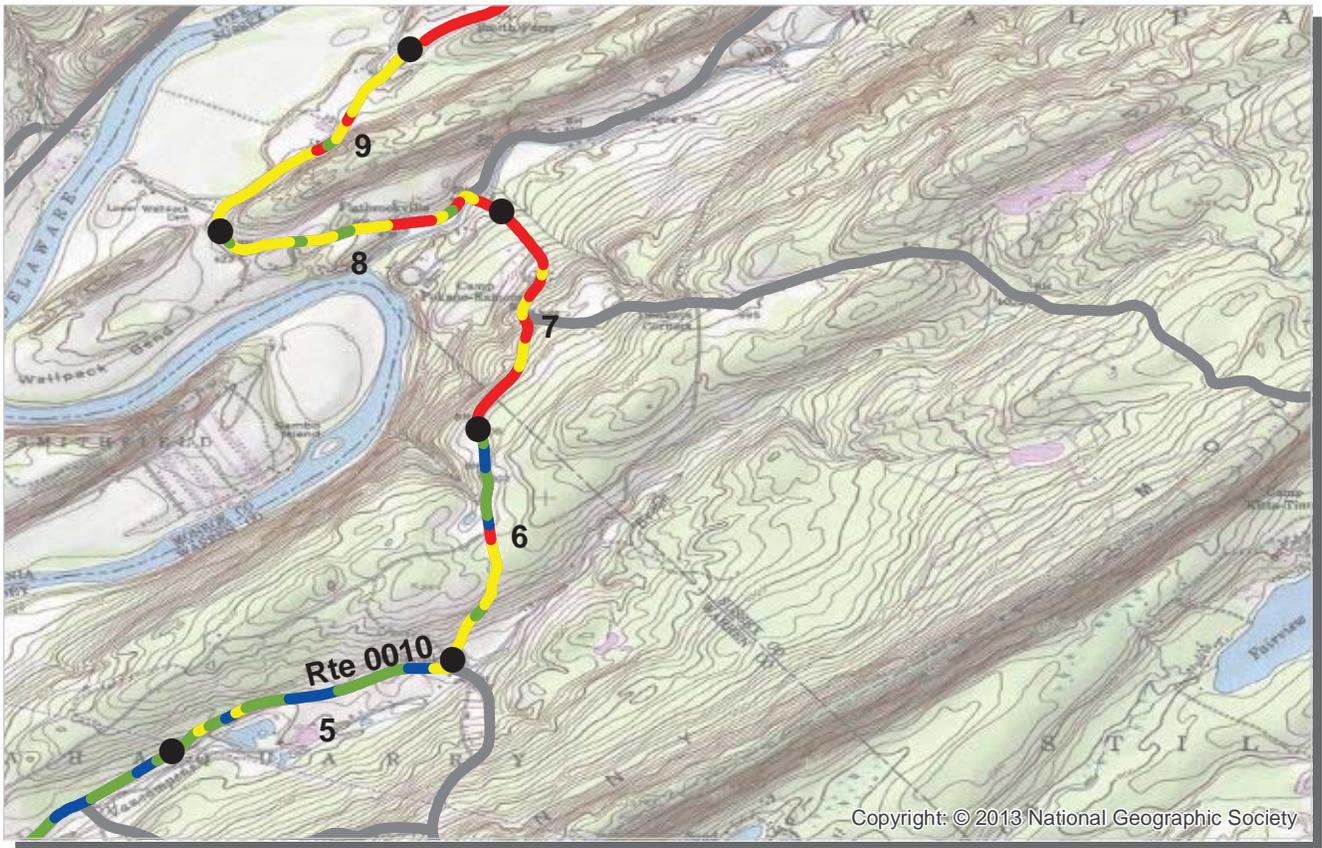
**ROUTE: 0010 OLD MINE ROAD (SOUTH SECTION)**

<i>Section Number</i>	5	6	7	8	9
<i>Section Length (mi)</i>	1.00	1.00	1.00	1.00	1.00
<i>Cross Section Information</i>					
Number of Lanes	2	2	2	2	2
Paved Width (ft)	20	22	21	20	20
Lane Width (ft)	8	9	8	9	10
<i>Roadway Condition Information</i>					
SCR (Surface Condition Rating)	95	91	72	67	54
PCR (Pavement Condition Rating)	88	83	56	69	65
<i>Distress Index Values</i>					
Structural Crack Index	95	91	72	67	54
Transverse Cracking Index	100	100	99	99	99
Patching Index	100	100	93	100	100
Rutting Index	96	92	82	95	92
Roughness Condition Index (RCI)	78	72	33	72	82

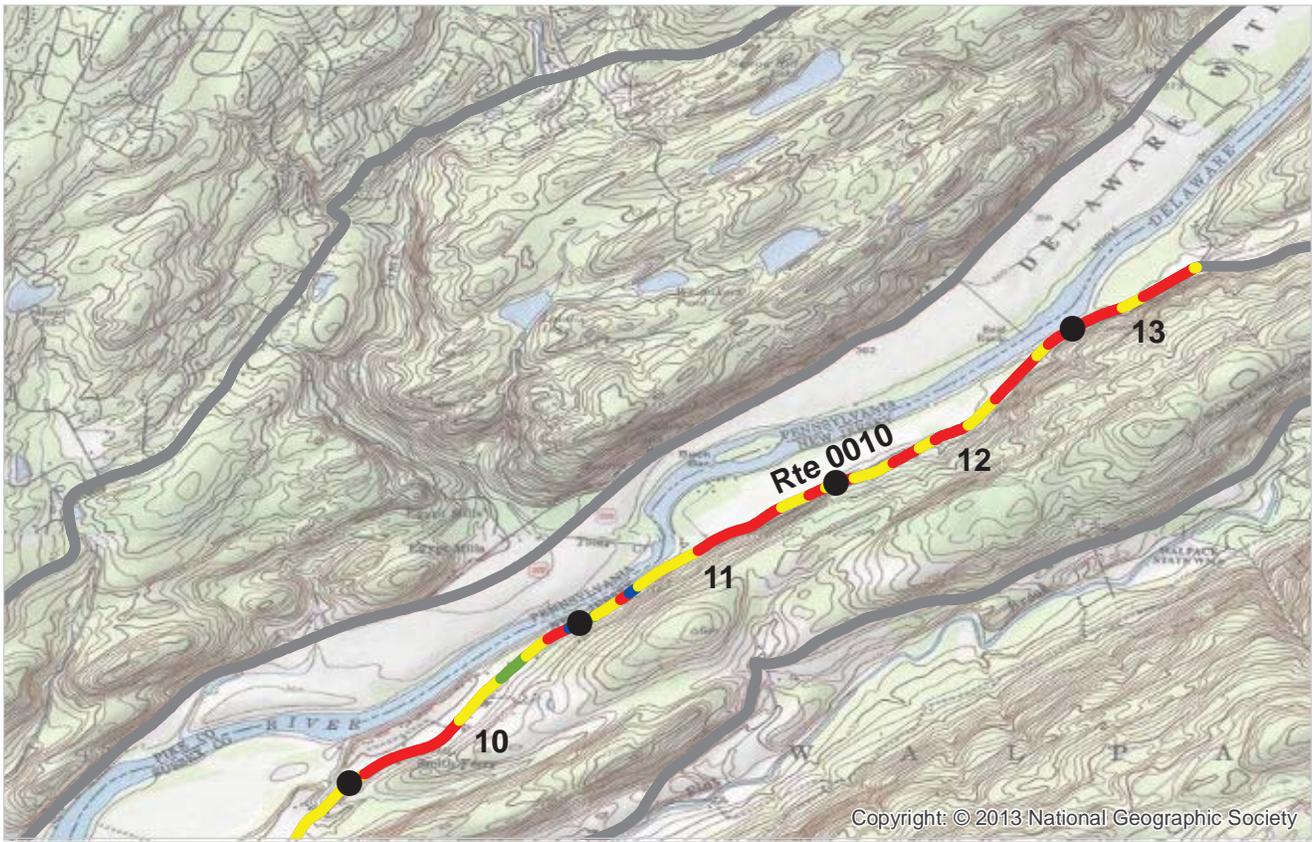
**ROUTE: 0010 OLD MINE ROAD (SOUTH SECTION)**

Section Number	10	11	12	13
Section Length (mi)	1.00	1.00	1.00	0.47
<b>Cross Section Information</b>				
Number of Lanes	2	2	2	2
Paved Width (ft)	20	19	19	20
Lane Width (ft)	10	9	10	10
<b>Roadway Condition Information</b>				
SCR (Surface Condition Rating)	49	66	53	54
PCR (Pavement Condition Rating)	57	65	58	60
<b>Distress Index Values</b>				
Structural Crack Index	49	66	53	54
Transverse Cracking Index	99	98	98	98
Patching Index	100	100	100	100
Rutting Index	91	96	93	95
Roughness Condition Index (RCI)	68	64	65	68

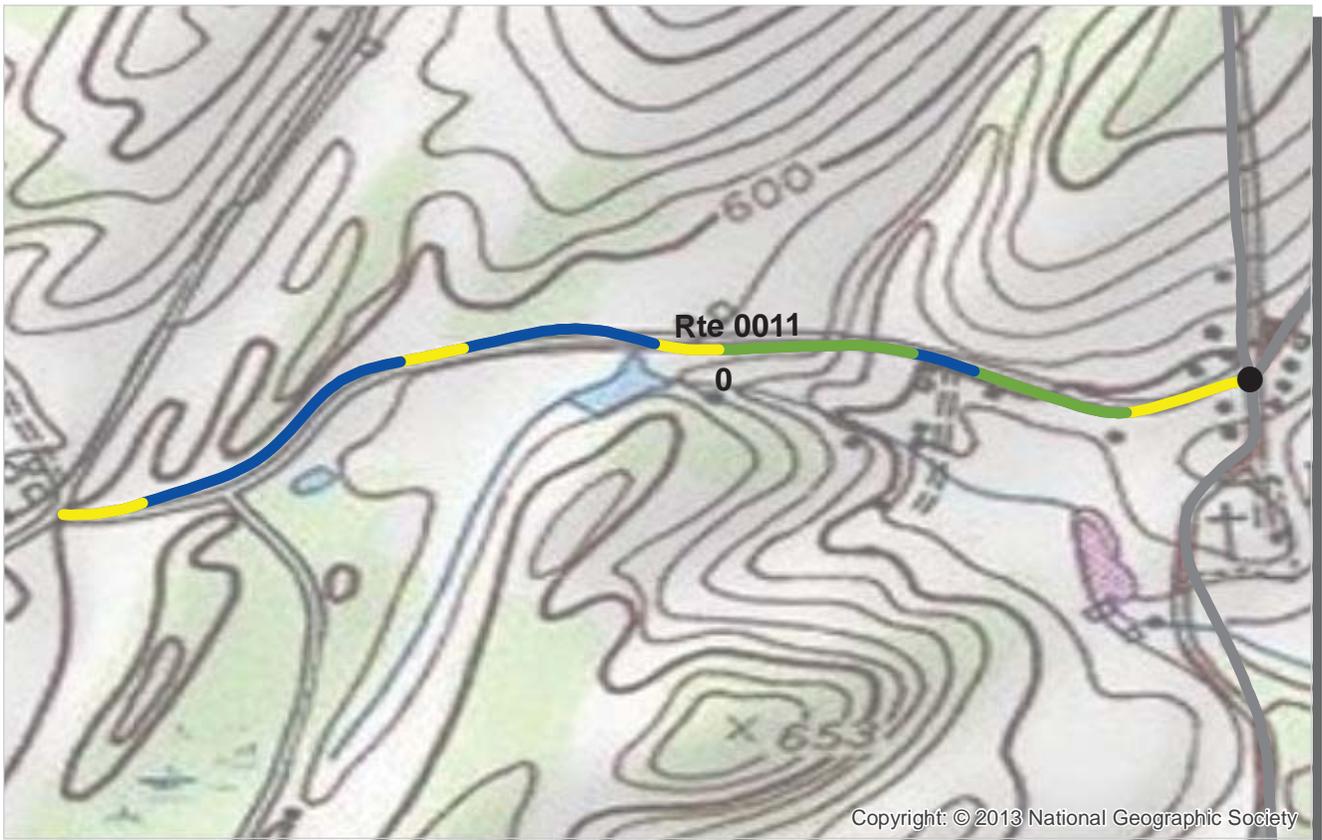
**ROUTE: 0011 KUHN ROAD**

<b>Section Number</b>	0				
<b>Section Length (mi)</b>	0.79				
<b>Cross Section Information</b>					
Number of Lanes	2				
Paved Width (ft)	19				
Lane Width (ft)	9				
<b>Roadway Condition Information</b>					
SCR (Surface Condition Rating)	93				
PCR (Pavement Condition Rating)	93				
<b>Distress Index Values</b>					
Structural Crack Index	93				
Transverse Cracking Index	98				
Patching Index	100				
Rutting Index	96				
Roughness Condition Index (RCI)	92

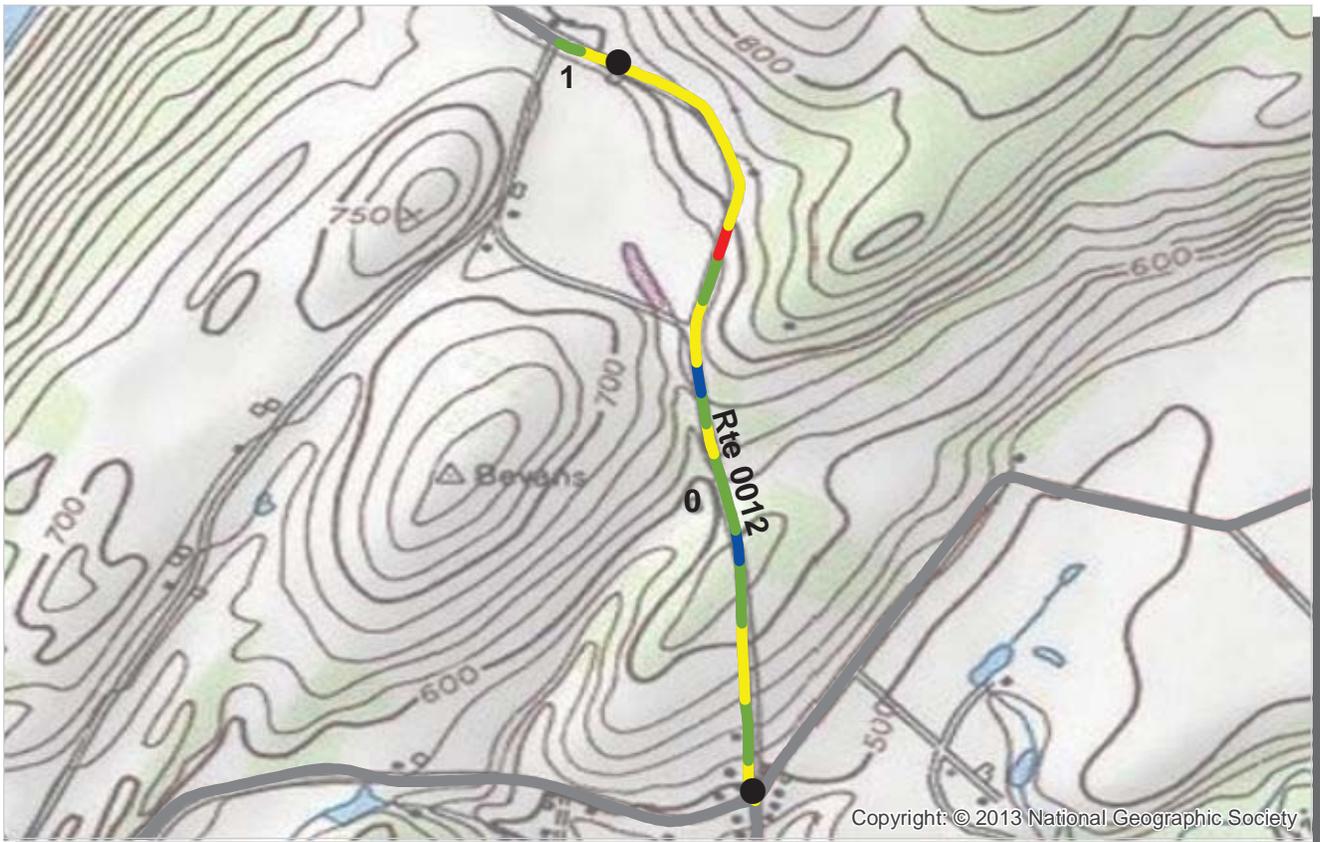
**ROUTE: 0012 PETERS VALLEY - WAGONWHEEL ROAD**

<b>Section Number</b>	0	1			
<b>Section Length (mi)</b>	1.00	0.08			
<b>Cross Section Information</b>					
Number of Lanes	2	2			
Paved Width (ft)	19	19			
Lane Width (ft)	9	9			
<b>Roadway Condition Information</b>					
SCR (Surface Condition Rating)	76	82			
PCR (Pavement Condition Rating)	80	87			
<b>Distress Index Values</b>					
Structural Crack Index	76	82			
Transverse Cracking Index	100	95			
Patching Index	100	100			
Rutting Index	98	99			
Roughness Condition Index (RCI)	87	94

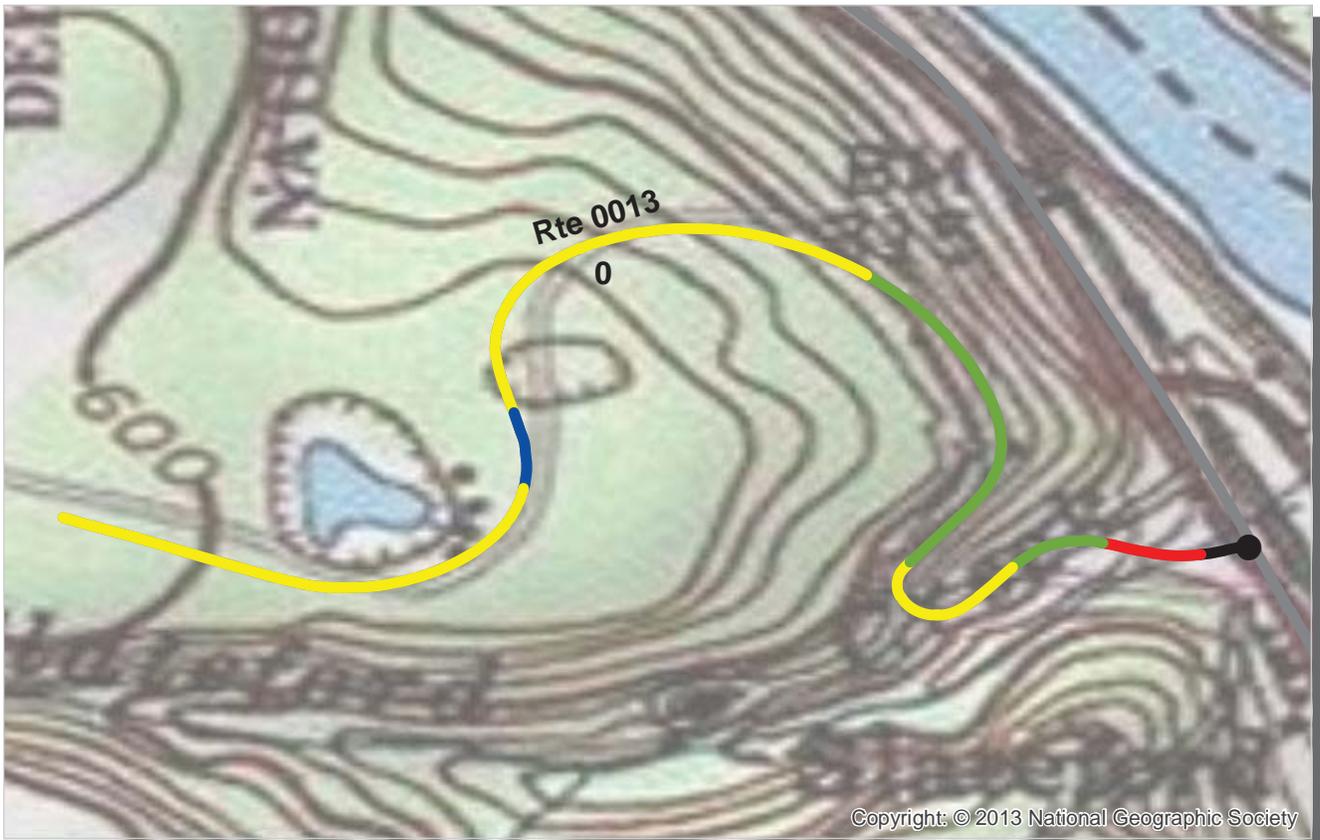
ROUTE: 0013 NATIONAL PARK DRIVE

<b>Section Number</b>	0				
<b>Section Length (mi)</b>	0.83				
<b>Cross Section Information</b>					
Number of Lanes	2				
Paved Width (ft)	26				
Lane Width (ft)	11				
<b>Roadway Condition Information</b>					
SCR (Surface Condition Rating)	88				
PCR (Pavement Condition Rating)	82				
<b>Distress Index Values</b>					
Structural Crack Index	88				
Transverse Cracking Index	99				
Patching Index	100				
Rutting Index	94				
Roughness Condition Index (RCI)	73

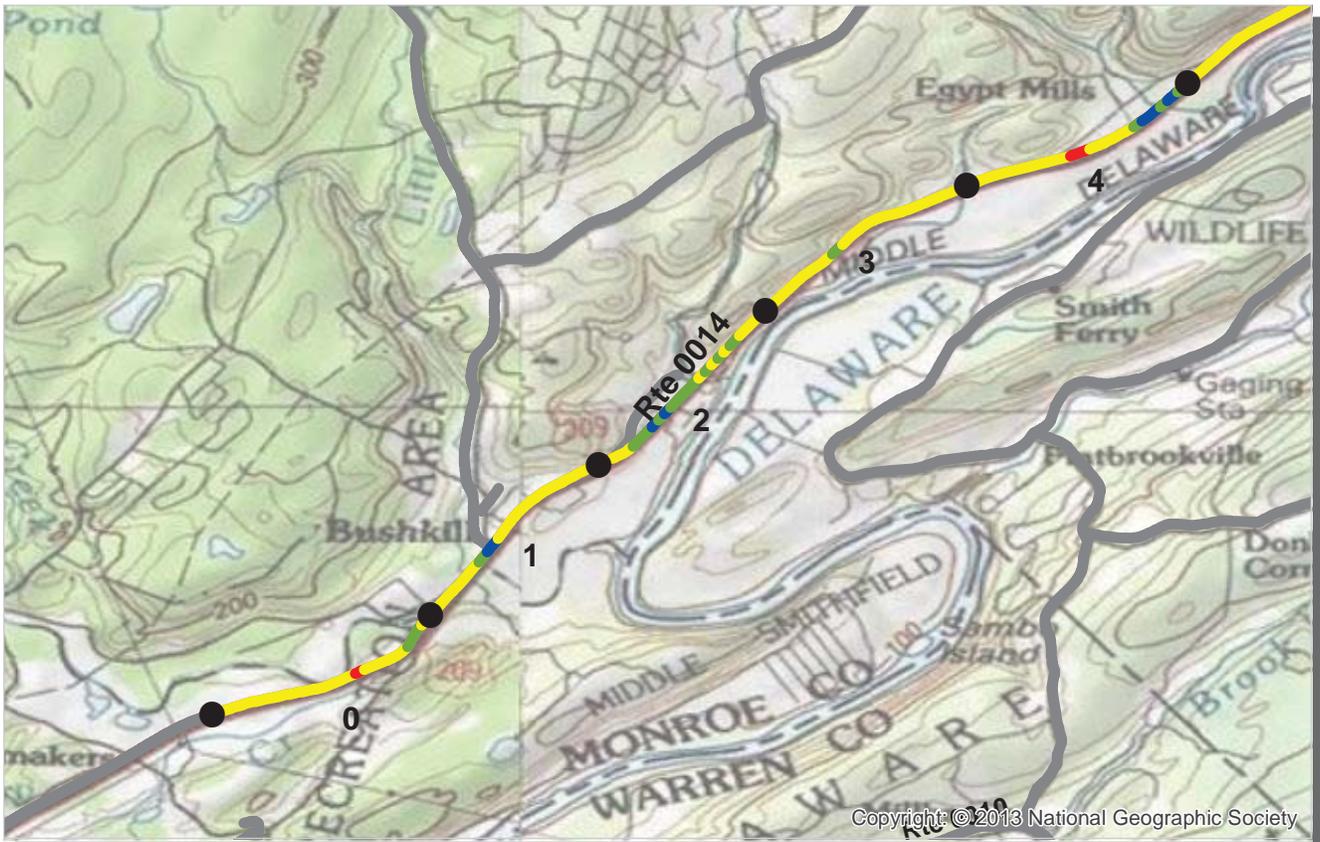
**ROUTE: 0014 US ROUTE 209**

<i>Section Number</i>	0	1	2	3	4
<i>Section Length (mi)</i>	1.00	1.00	1.00	1.00	1.00
<i>Cross Section Information</i>					
Number of Lanes	2	2	2	2	2
Paved Width (ft)	39	32	28	28	29
Lane Width (ft)	11	11	11	10	11
<i>Roadway Condition Information</i>					
SCR (Surface Condition Rating)	63	60	75	55	60
PCR (Pavement Condition Rating)	73	74	85	73	76
<i>Distress Index Values</i>					
Structural Crack Index	63	60	75	55	60
Transverse Cracking Index	78	75	84	73	72
Patching Index	100	100	100	100	100
Rutting Index	99	99	100	99	100
Roughness Condition Index (RCI)	88	96	100	100	100

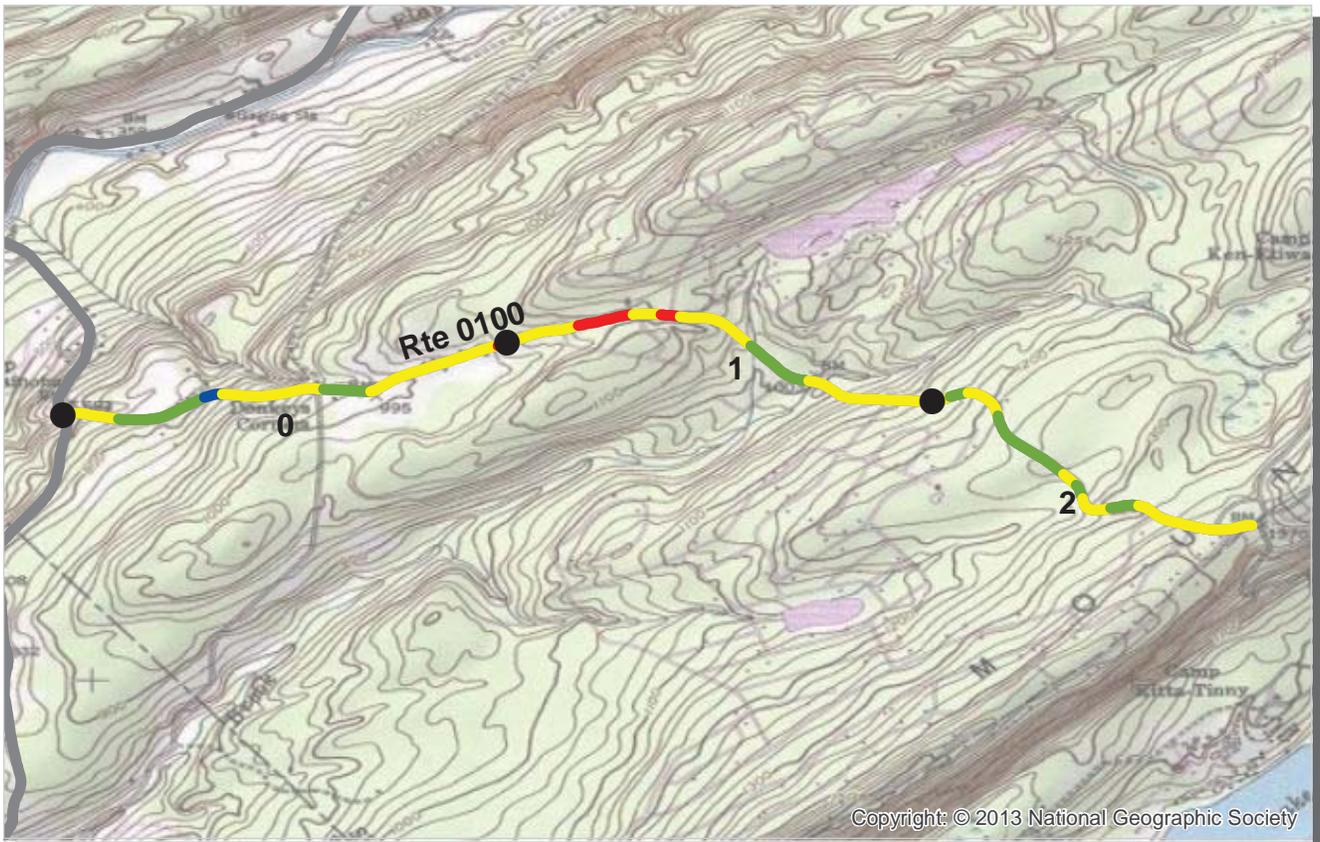
ROUTE: 0015 OLD MINE ROAD (NORTH SECTION)

PCR    Poor ■    Fair ■    Good ■    Excellent ■    No Data ■  
           (0 - 60)           (61 - 84)           (85 - 94)           (95 - 100)

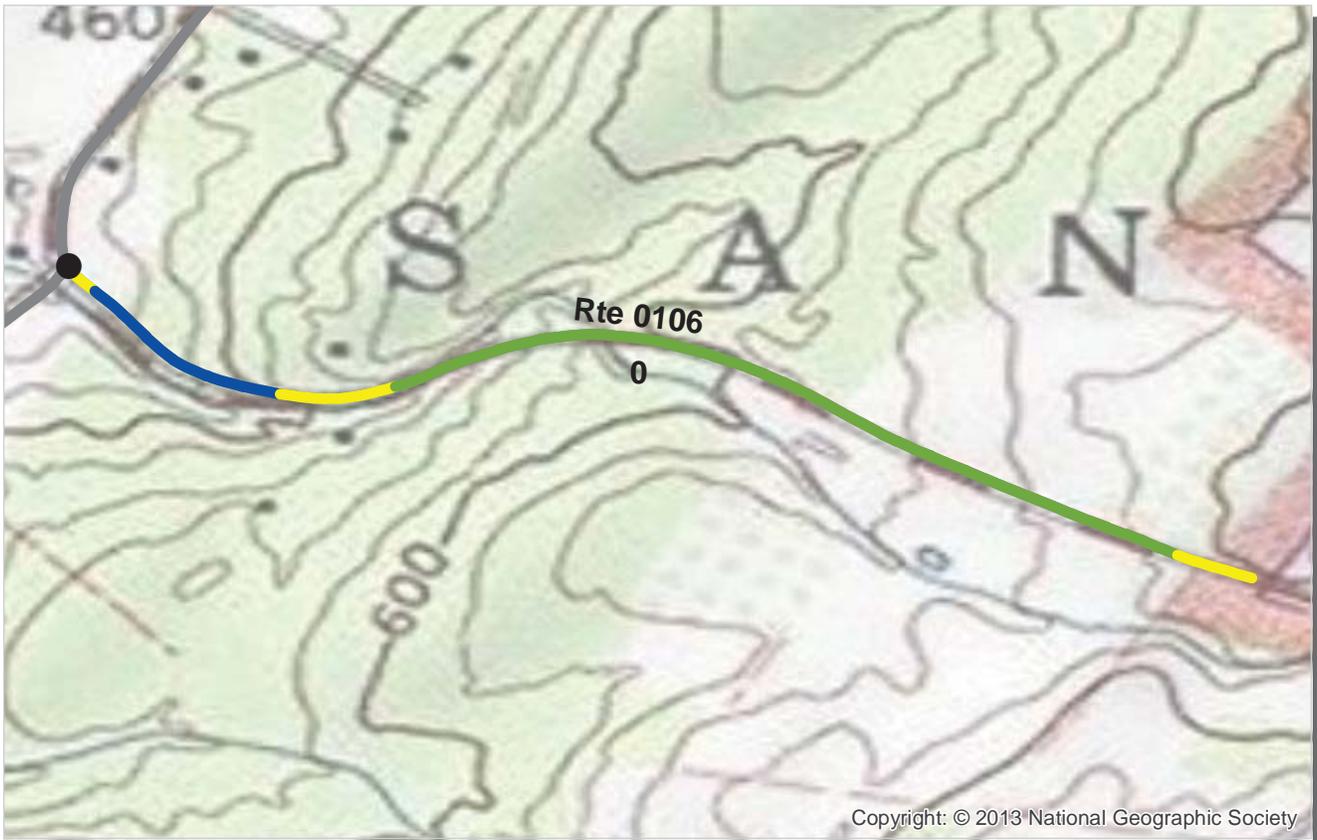
**ROUTE: 0105 RIVER ROAD**

PCR    Poor ■    Fair ■    Good ■    Excellent ■    No Data ■  
           (0 - 60)           (61 - 84)           (85 - 94)           (95 - 100)

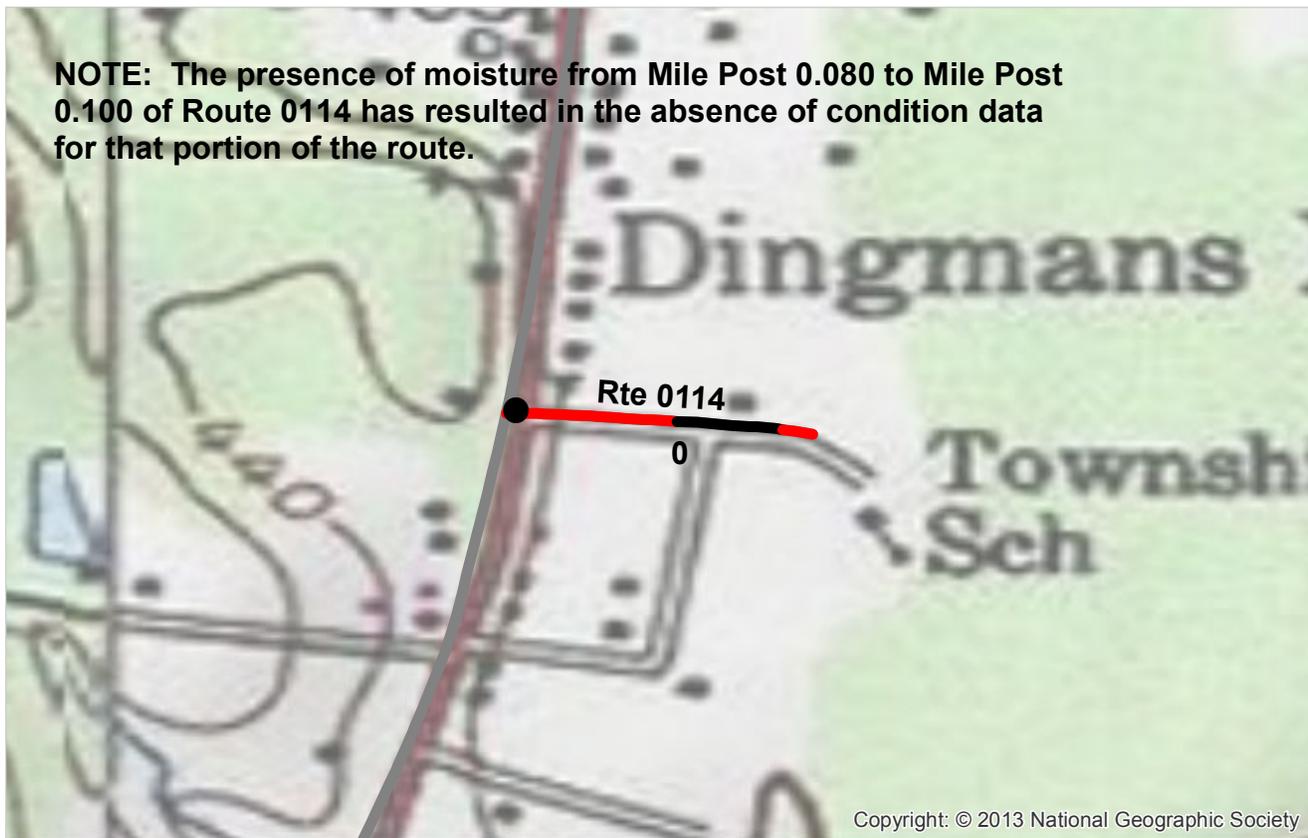
**ROUTE: 0114 SCHOOL HOUSE ROAD**

**NOTE: The presence of moisture from Mile Post 0.080 to Mile Post 0.100 of Route 0114 has resulted in the absence of condition data for that portion of the route.**

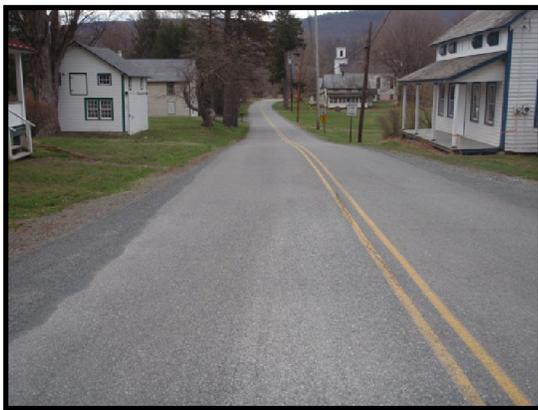
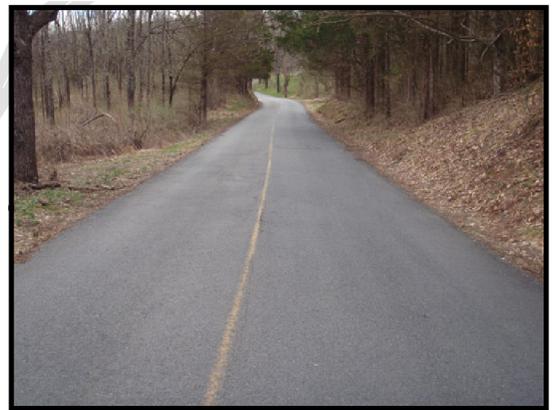
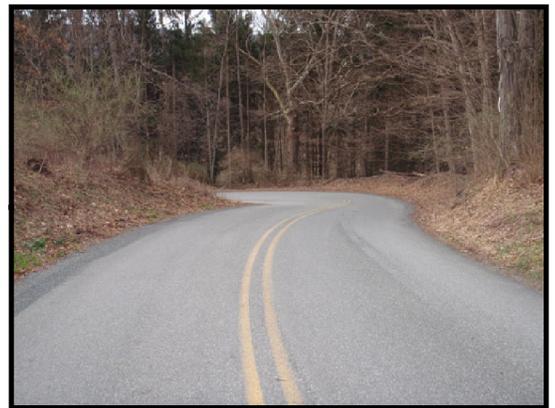
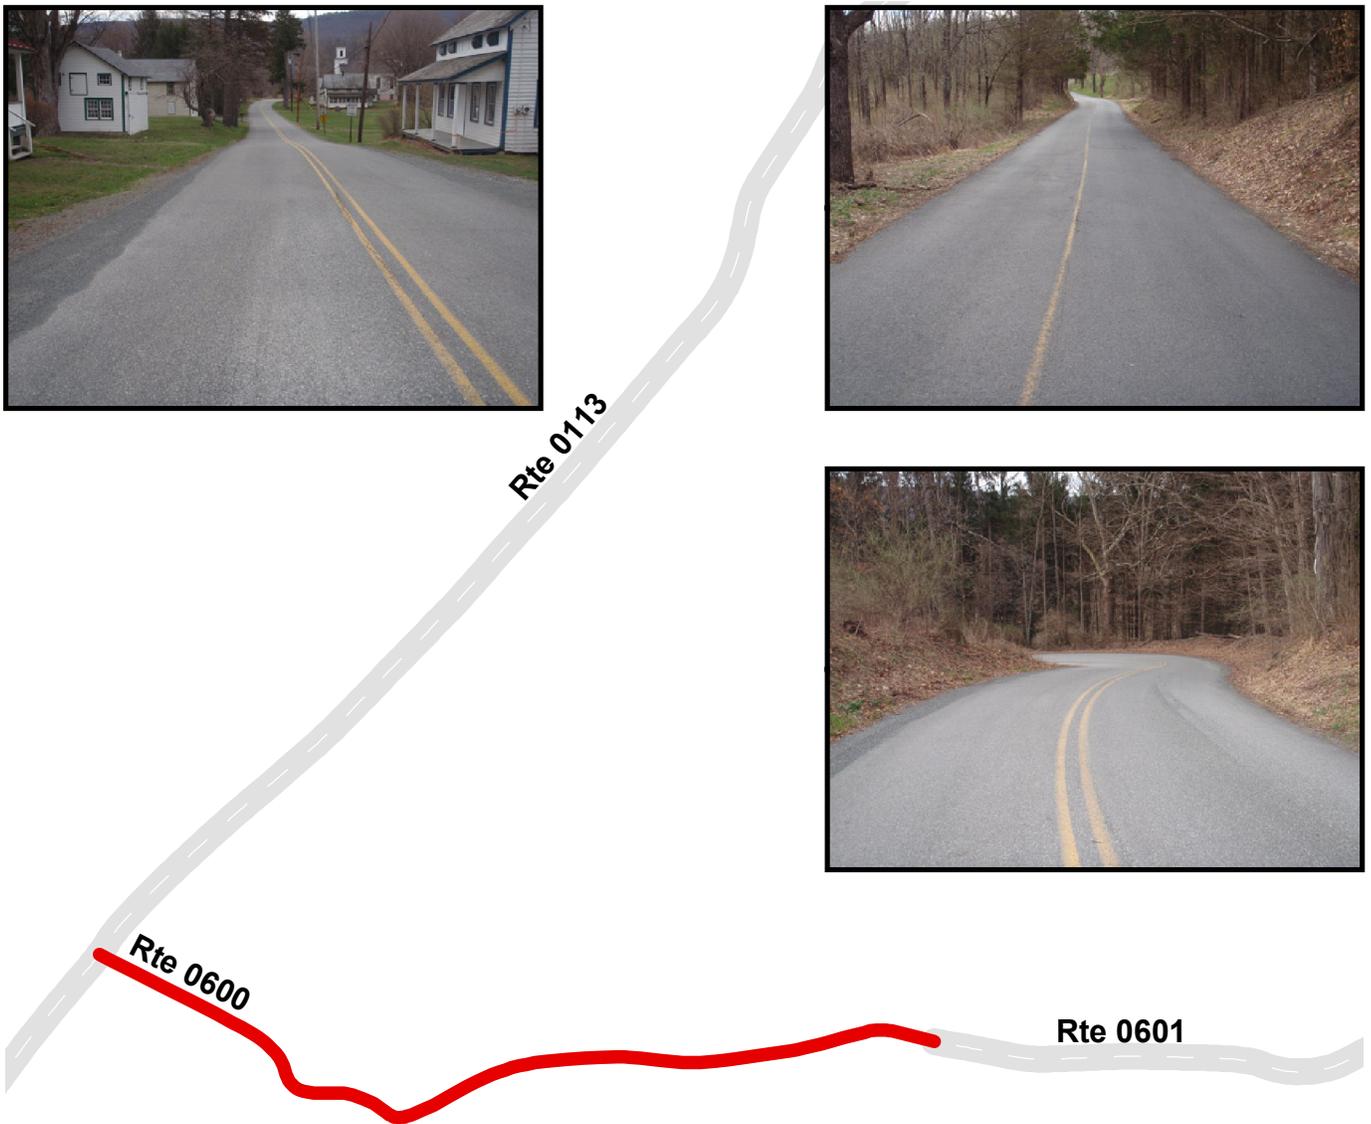
Route Number	Public / NonPublic	Date Visited	Area (sq ft)	Lane Miles *	Paved Length (mi)	Paved Width (ft)
0600	PUBLIC	4/14/2013	60,720	1.05	0.58	20
Culverts	Drop Inlets	Gates	Curb & Gutter	Curb	PCR	Surface Type
0	0	0	NO CURB AND GUTTER	NO CURB	GOOD/90	AS

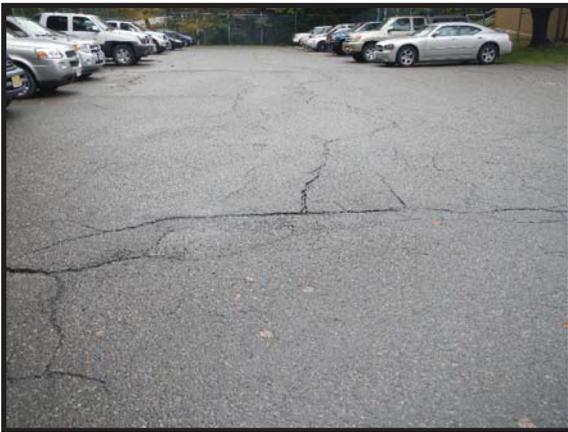
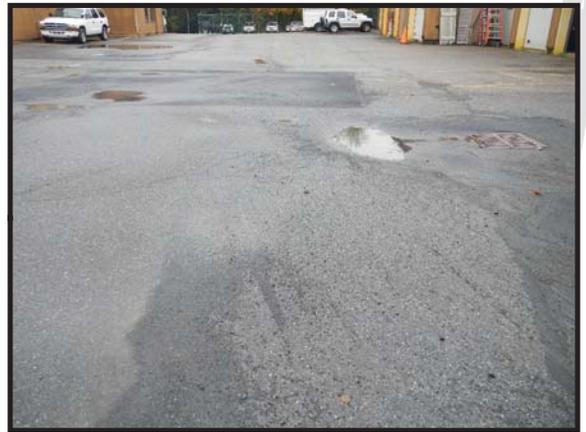
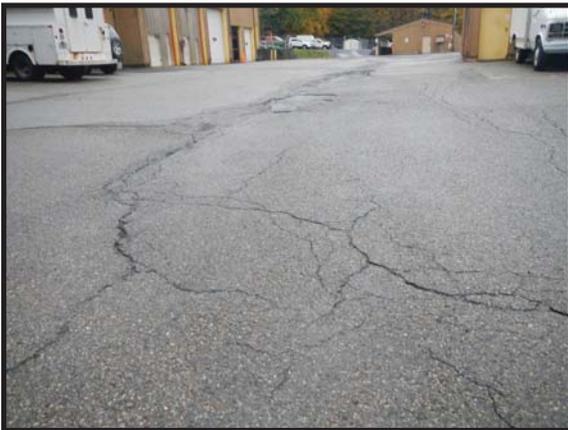
Route Number	Public / NonPublic	Date Visited	Area (sq ft)	Lane Miles *	Surface Type
0915	NONPUBLIC	10/4/2012	30,412	0.52	AS
Culverts	Drop Inlets	Gates	Curb & Gutter	Curb	PCR
0	2	1	NO CURB AND GUTTER	NO CURB	POOR/45

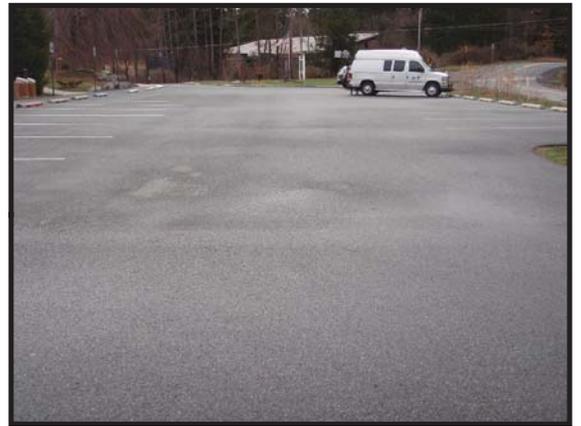
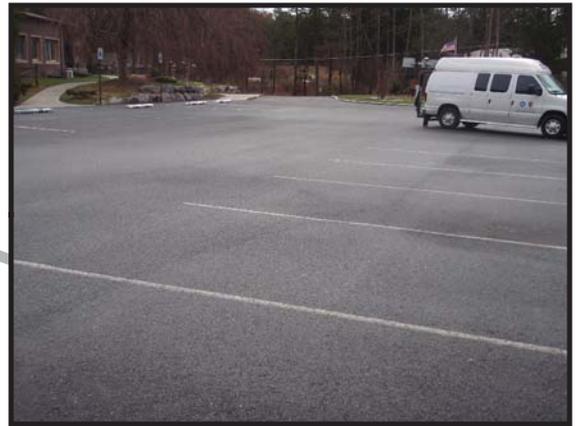
Route Number	Public / NonPublic	Date Visited	Area (sq ft)	Lane Miles *	Surface Type
0931AZ	PUBLIC	4/13/2013	14,702	0.25	AS
Culverts	Drop Inlets	Gates	Curb & Gutter	Curb	PCR
1	1	0	NO CURB AND GUTTER	CONCRETE CURB	GOOD/90

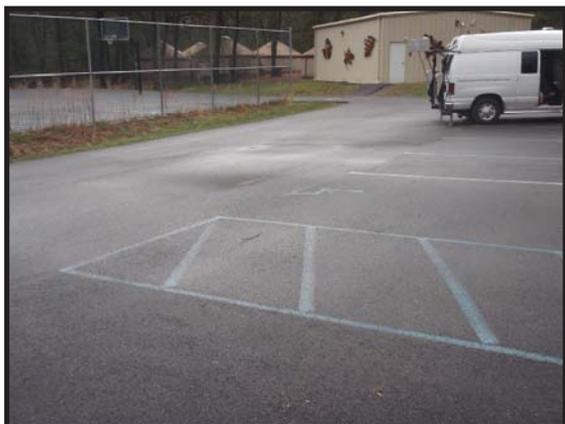
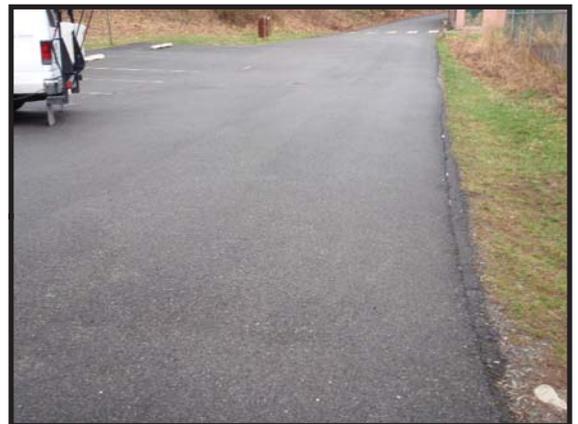
Route Number	Public / NonPublic	Date Visited	Area (sq ft)	Lane Miles *	Surface Type
0931BZ	PUBLIC	4/13/2013	9,205	0.16	AS
Culverts	Drop Inlets	Gates	Curb & Gutter	Curb	PCR
0	1	0	NO CURB AND GUTTER	NO CURB	GOOD/90

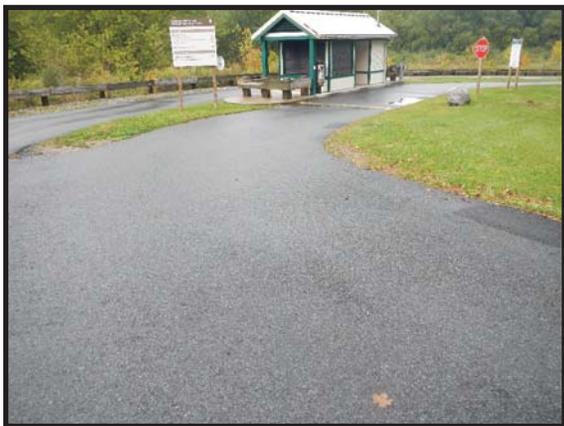
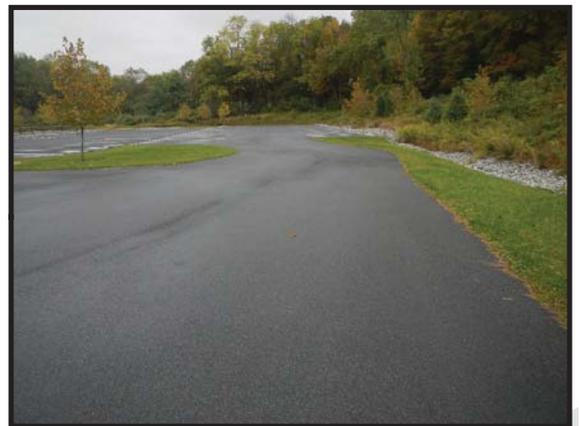
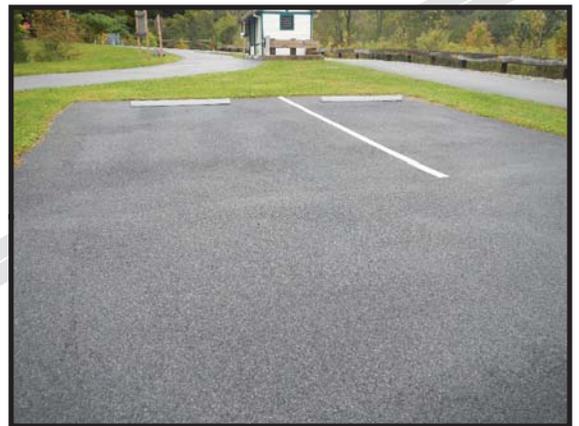
Route Number	Public / NonPublic	Date Visited	Area (sq ft)	Lane Miles *	Surface Type
0980	PUBLIC	10/3/2012	63,193	1.09	AS
Culverts	Drop Inlets	Gates	Curb & Gutter	Curb	PCR
0	2	4	NO CURB AND GUTTER	NO CURB	GOOD/90
