Federal Lands Highway Road Inventory Program

Road Inventory and Condition Assessment

Dinosaur National Monument DINO - 1400

Cycle 5 Report

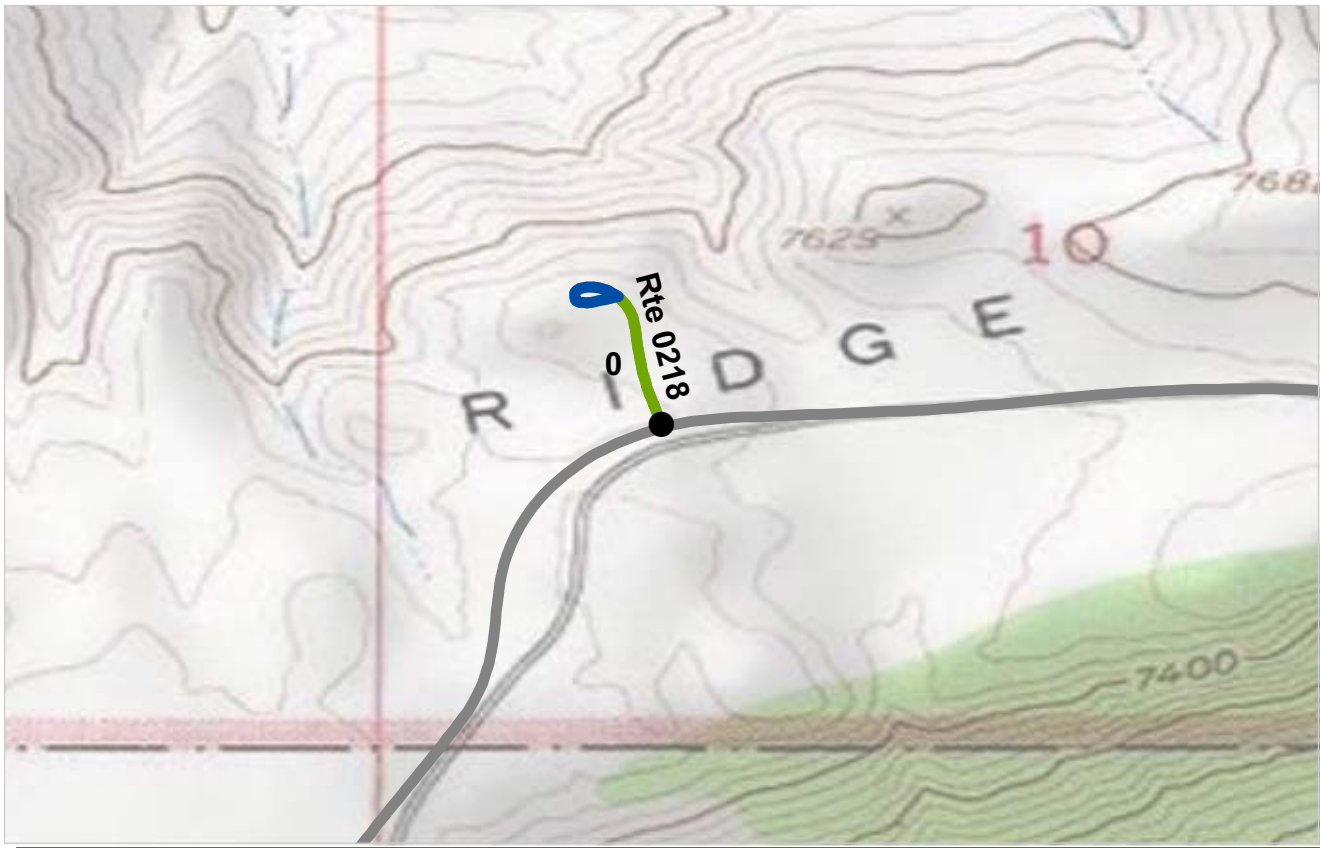
ROUTE: 0218 ISLAND PARK OVERLOOK ROAD

Section Number	0				
Section Length (mi)	0.20				
Cross Section Information					
Number of Lanes	2				
Paved Width (ft)	19				
Lane Width (ft)	10				
Roadway Condition Information					
SCR (Surface Condition Rating)	90				
PCR (Pavement Condition Rating)	90				
Distress Index Values					
Structural Crack Index	100				
Transverse Cracking Index	100				
Patching Index	100				
Rutting Index	90				
Roughness Condition Index (RCI)	NC

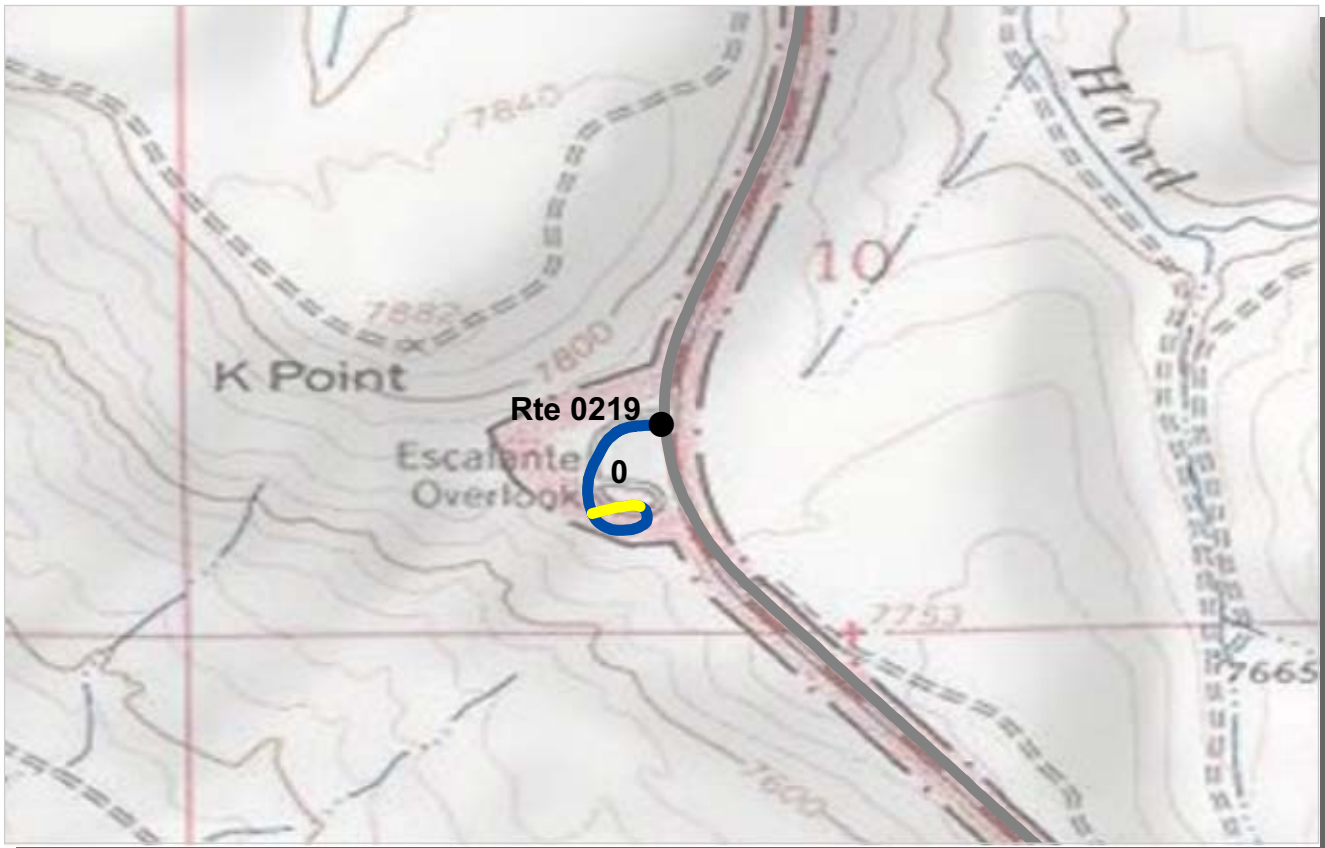
ROUTE: 0219 ESCALANTE OVERLOOK ROAD

Section Number	0				
Section Length (mi)	0.22				
Cross Section Information					
Number of Lanes	2				
Paved Width (ft)	22				
Lane Width (ft)	12				
Roadway Condition Information					
SCR (Surface Condition Rating)	98				
PCR (Pavement Condition Rating)	98				
Distress Index Values					
Structural Crack Index	98				
Transverse Cracking Index	100				
Patching Index	100				
Rutting Index	98				
Roughness Condition Index (RCI)	NC
