Federal Lands Highway Road Inventory Program

Road Inventory and Condition Assessment

Thomas Edison National Historical Park EDIS

Cycle 5 Report

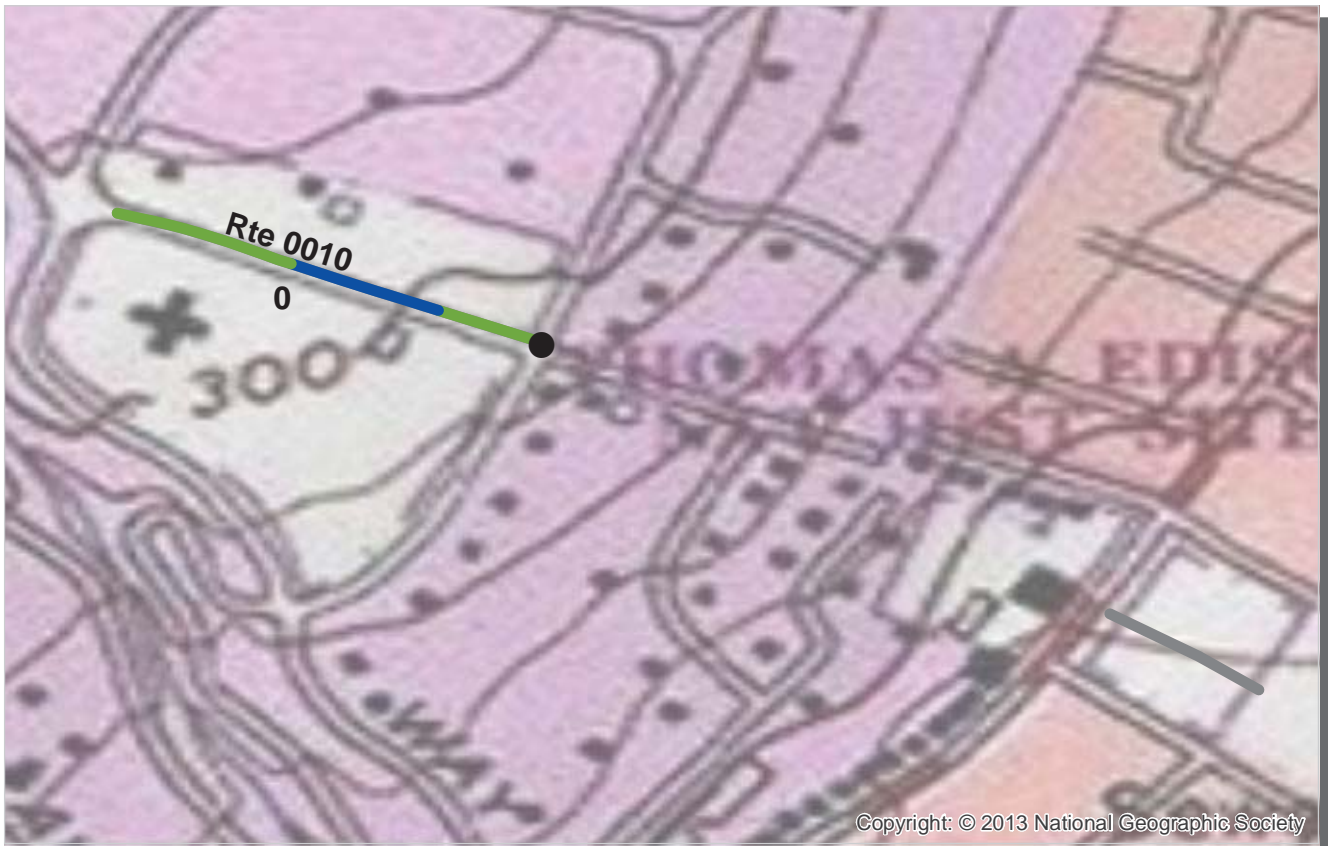
ROUTE: 0010 HONEYSUCKLE AVENUE

Section Number	0				
Section Length (mi)	0.18				
Cross Section Information					
Number of Lanes	1				
Paved Width (ft)	14				
Lane Width (ft)	14				
Roadway Condition Information					
SCR (Surface Condition Rating)	95				
PCR (Pavement Condition Rating)	95				
Distress Index Values					
Structural Crack Index	95				
Transverse Cracking Index	99				
Patching Index	97				
Rutting Index	98				
Roughness Condition Index (RCI)	NC

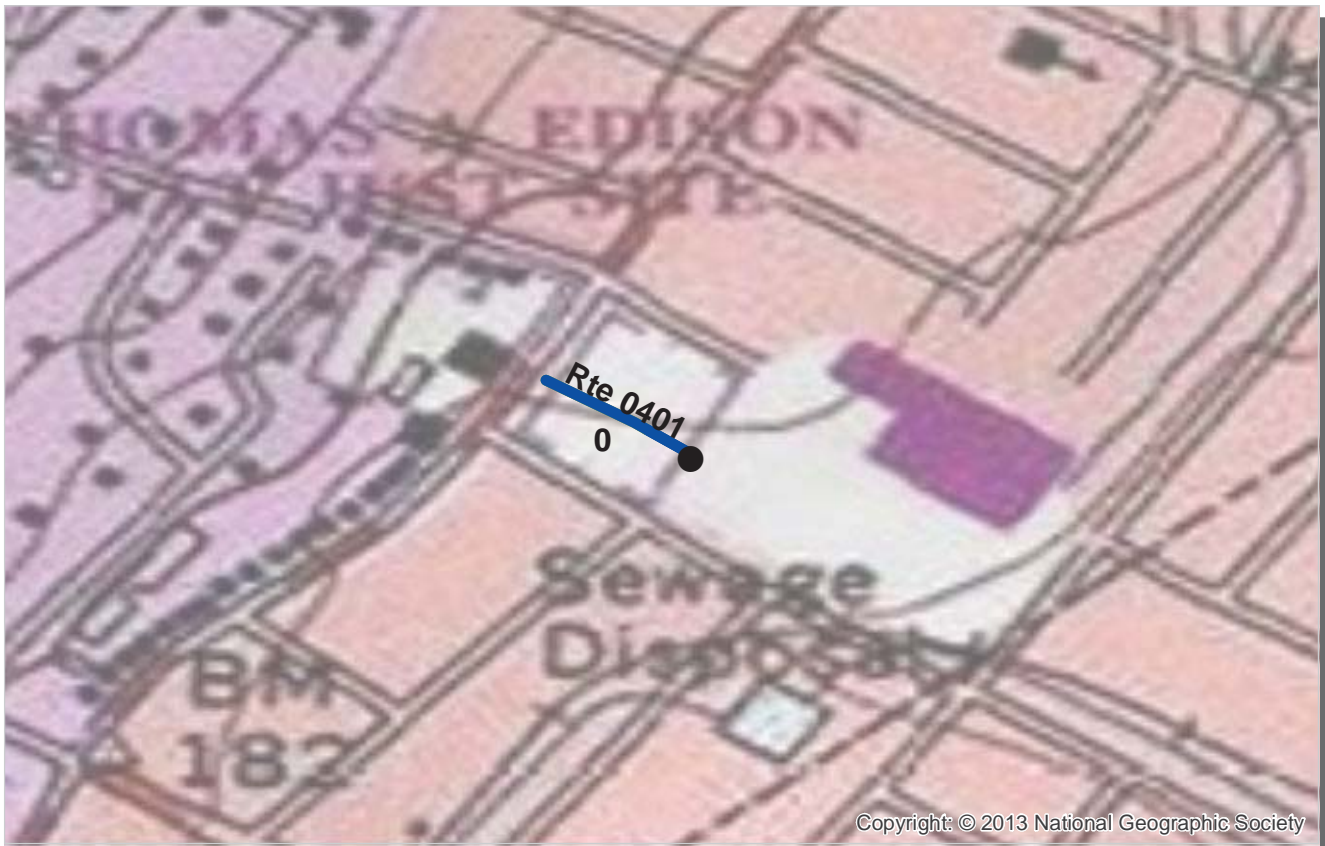
ROUTE: 0401 LABORATORY COURTYARD SERVICE ROAD

Section Number	0				
Section Length (mi)	0.06				
Cross Section Information					
Number of Lanes	2				
Paved Width (ft)	20				
Lane Width (ft)	10				
Roadway Condition Information					
SCR (Surface Condition Rating)	95				
PCR (Pavement Condition Rating)	95				
Distress Index Values					
Structural Crack Index	97				
Transverse Cracking Index	99				
Patching Index	100				
Rutting Index	95				
Roughness Condition Index (RCI)	NC

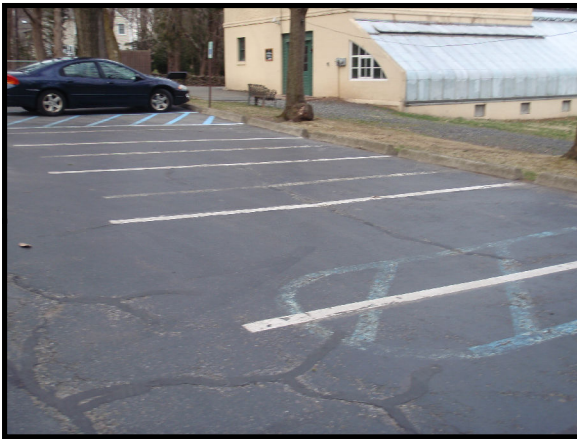
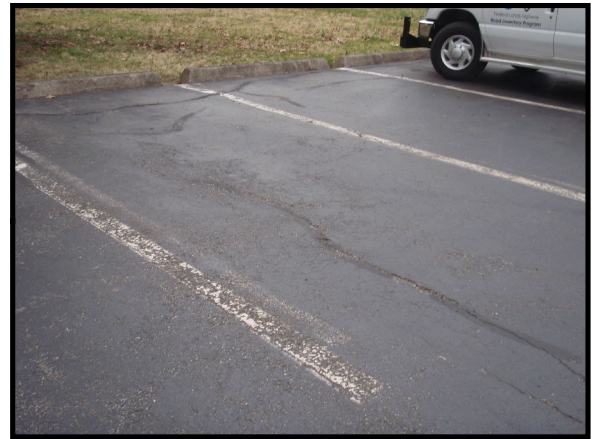
Route Number	Public / NonPublic	Date Visited	Area (sq ft)	Lane Miles *	Surface Type
0900	PUBLIC	4/4/2013	5,178	0.09	AS
Culverts	Drop Inlets	Gates	Curb & Gutter	Curb	PCR
0	0	0	NO CURB AND GUTTER	NO CURB	POOR/45

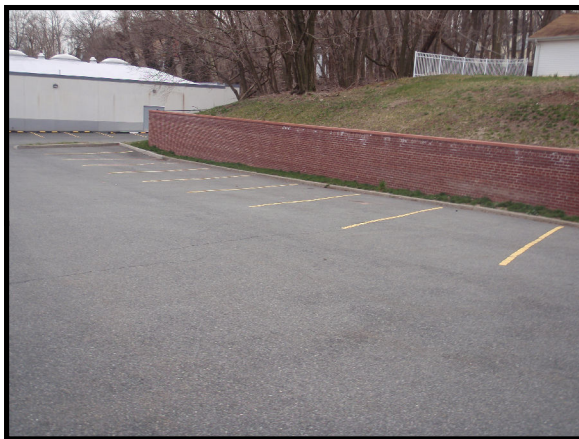
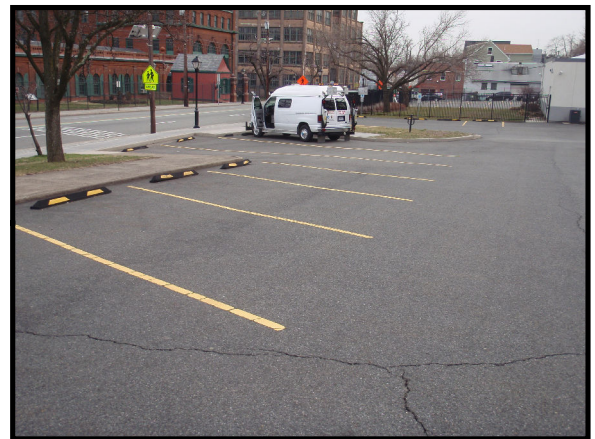
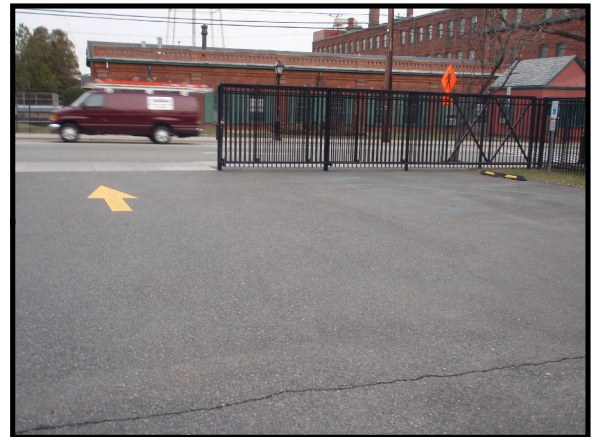
Route 0901

Route Number	Public / NonPublic	Date Visited	Area (sq ft)	Lane Miles *	Surface Type
0901	PUBLIC	4/4/2013	15,983	0.28	AS
Culverts	Drop Inlets	Gates	Curb & Gutter	Curb	PCR
0	2	3	NO CURB AND GUTTER	CONCRETE CURB	GOOD/90

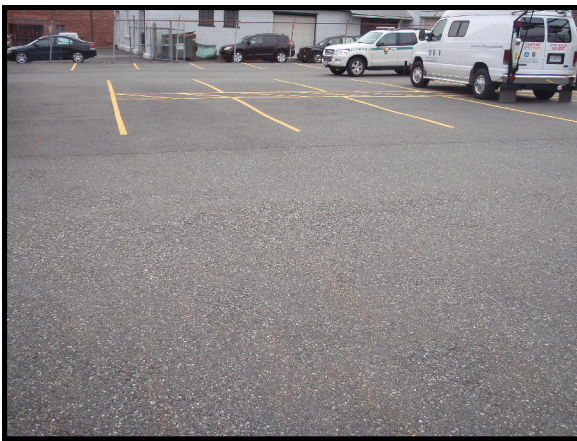
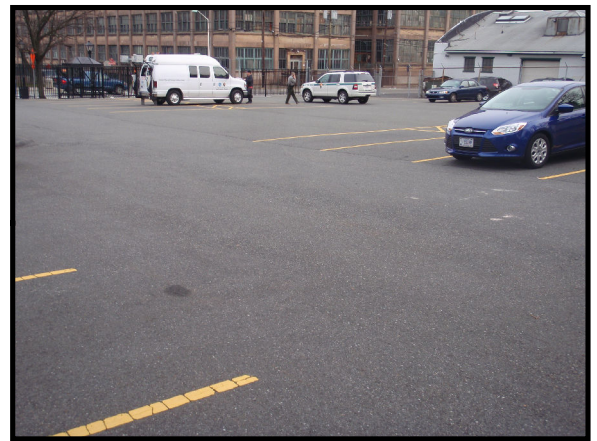
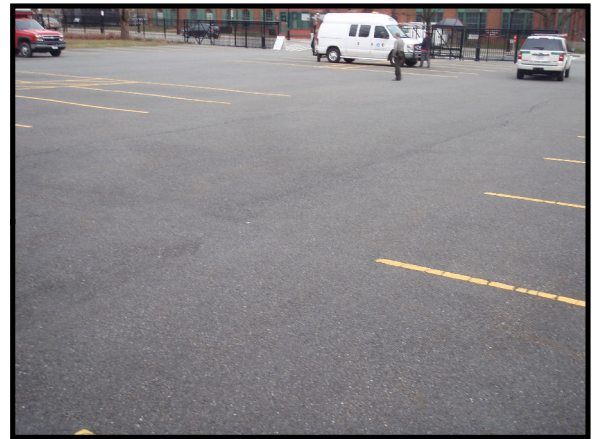
Route 0902

Route Number	Public / NonPublic	Date Visited	Area (sq ft)	Lane Miles *	Surface Type
0902	NONPUBLIC	4/4/2013	20,373	0.35	AS
Culverts	Drop Inlets	Gates	Curb & Gutter	Curb	PCR
0	0	2	NO CURB AND GUTTER	NO CURB	GOOD/90
