Federal Lands Highway Road Inventory Program

Road Inventory and Condition Assessment

Eisenhower National Historic Site EISE

Cycle 5 Report

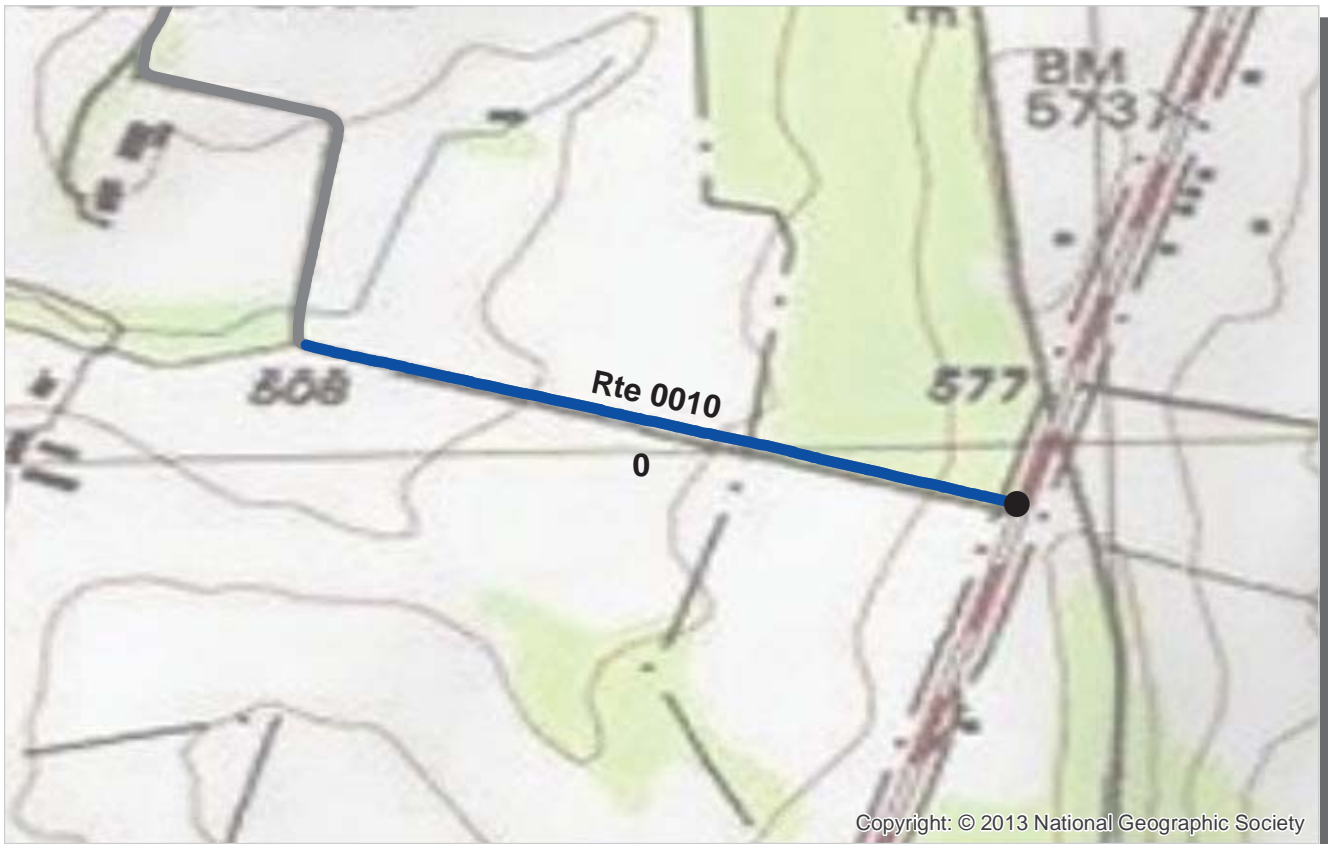
ROUTE: 0010 EISENHOWER FARM LANE

PCR Poor ■ Fair ■ Good ■ Excellent ■ No Data ■
 (0 - 60) (61 - 84) (85 - 94) (95 - 100)

<i>Section Number</i>	0				
<i>Section Length (mi)</i>	0.38				
<i>Cross Section Information</i>					
Number of Lanes	2				
Paved Width (ft)	18				
Lane Width (ft)	9				
<i>Roadway Condition Information</i>					
SCR (Surface Condition Rating)	99				
PCR (Pavement Condition Rating)	99				
<i>Distress Index Values</i>					
Structural Crack Index	100				
Transverse Cracking Index	99				
Patching Index	100				
Rutting Index	100				
Roughness Condition Index (RCI)	NC

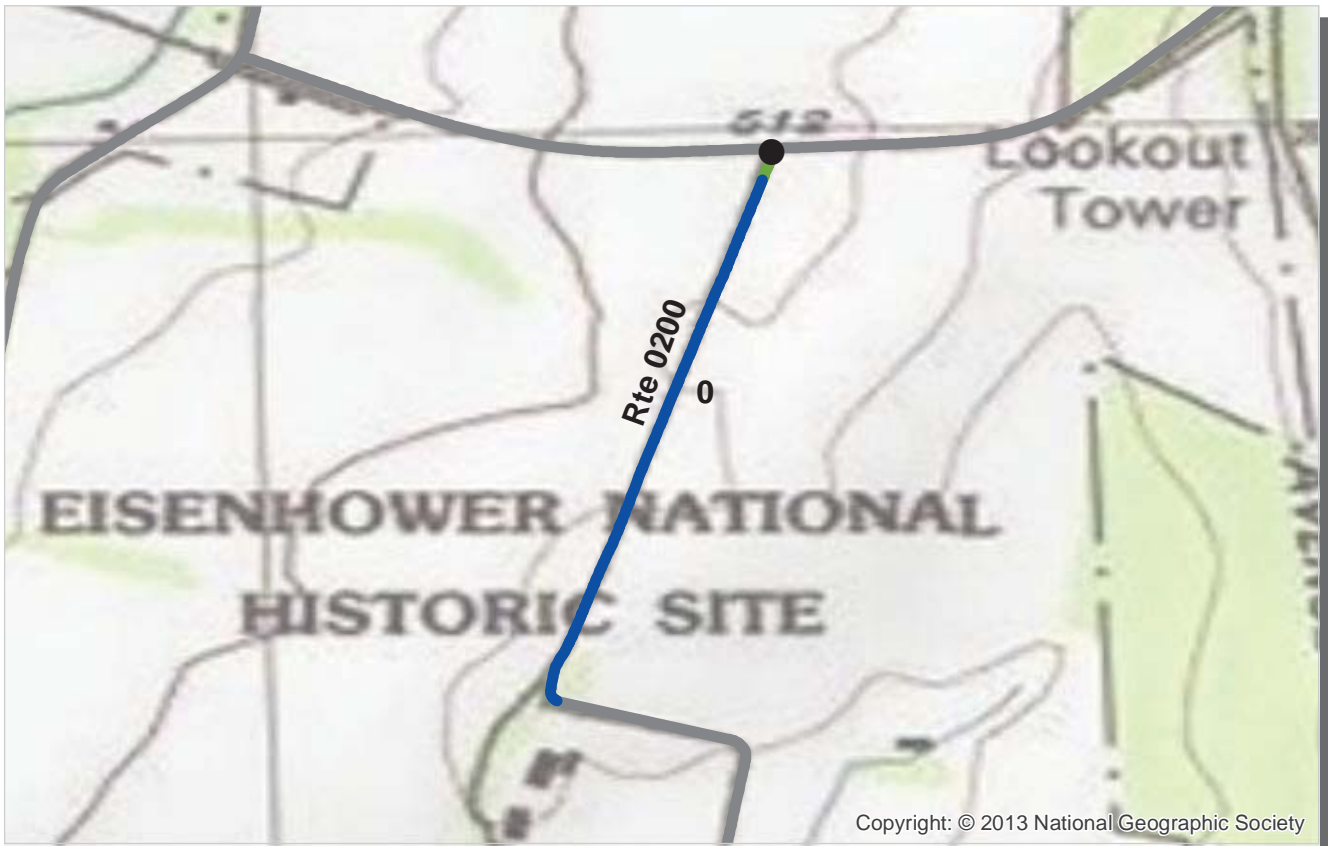
ROUTE: 0200 EISENHOWER DRIVE FARM 1

PCR Poor ■ Fair ■ Good ■ Excellent ■ No Data ■
 (0 - 60) (61 - 84) (85 - 94) (95 - 100)

Section Number	0				
Section Length (mi)	0.38				
Cross Section Information					
Number of Lanes	1				
Paved Width (ft)	11				
Lane Width (ft)	11				
Roadway Condition Information					
SCR (Surface Condition Rating)	100				
PCR (Pavement Condition Rating)	100				
Distress Index Values					
Structural Crack Index	100				
Transverse Cracking Index	100				
Patching Index	100				
Rutting Index	100				
Roughness Condition Index (RCI)	NC

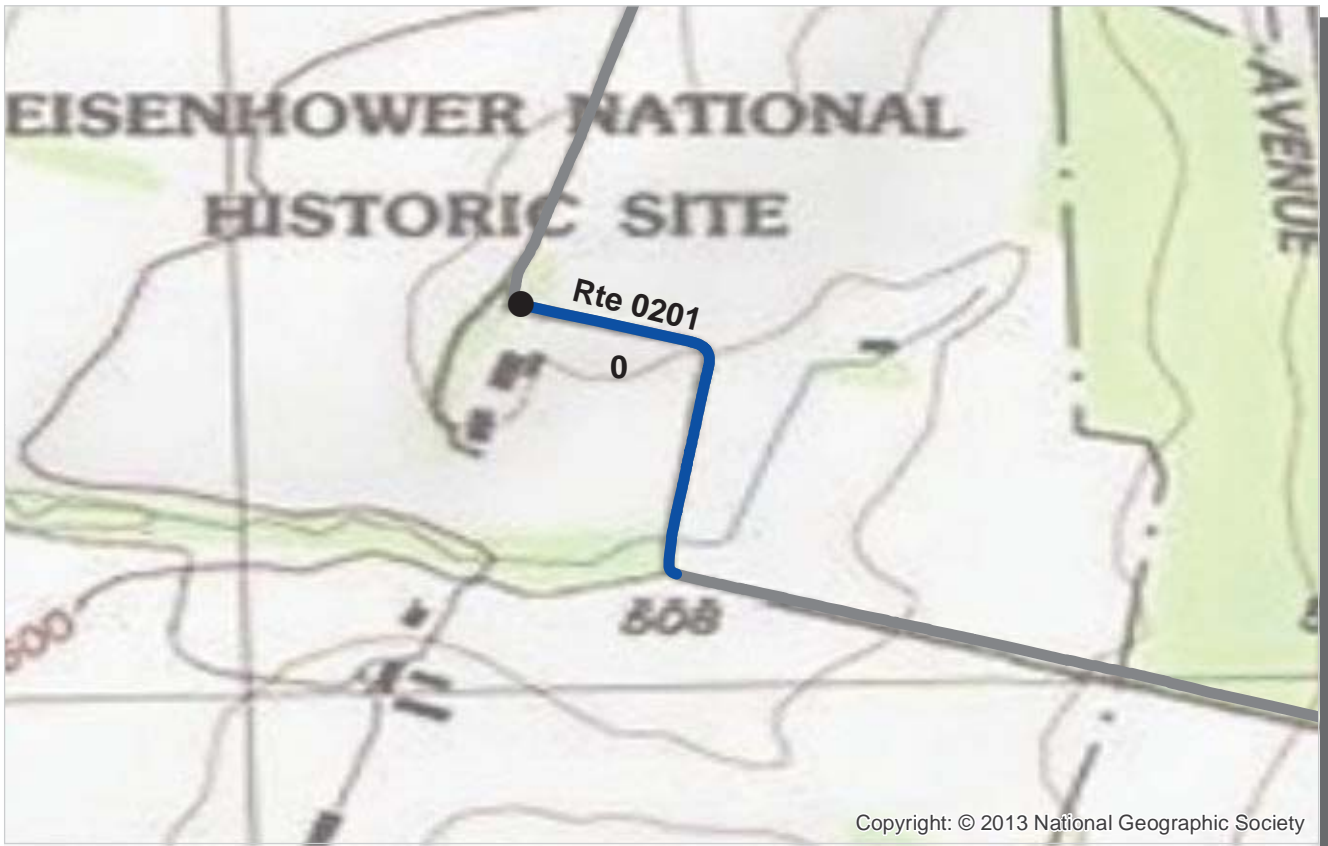
ROUTE: 0201 EISENHOWER FARM NEVINS LANE

PCR Poor ■ Fair ■ Good ■ Excellent ■ No Data ■
 (0 - 60) (61 - 84) (85 - 94) (95 - 100)

Section Number	0				
Section Length (mi)	0.25				
Cross Section Information					
Number of Lanes	1				
Paved Width (ft)	13				
Lane Width (ft)	13				
Roadway Condition Information					
SCR (Surface Condition Rating)	98				
PCR (Pavement Condition Rating)	98				
Distress Index Values					
Structural Crack Index	100				
Transverse Cracking Index	99				
Patching Index	100				
Rutting Index	98				
Roughness Condition Index (RCI)	NC

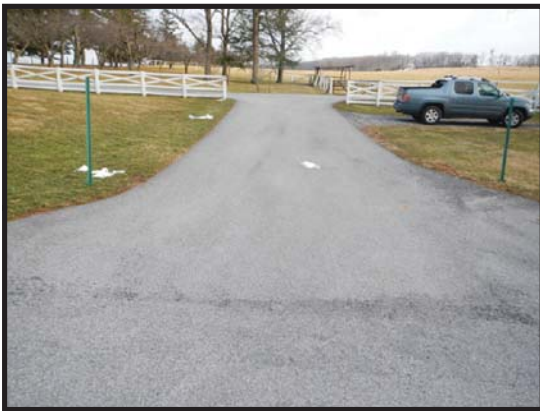
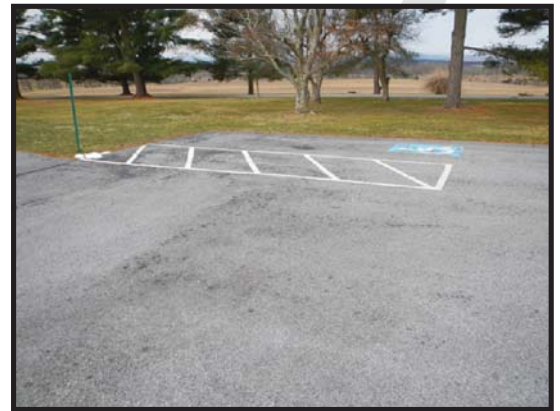
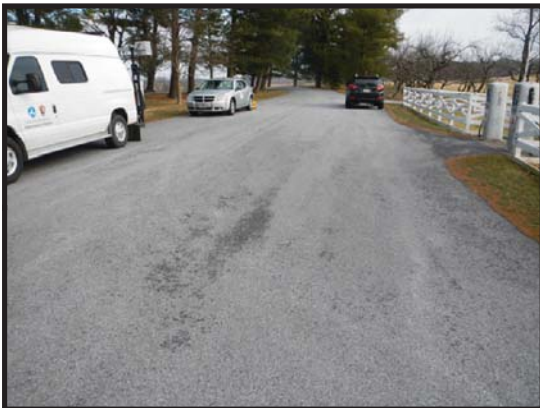
Route 0901

Route Number	Public / NonPublic	Date Visited	Area (sq ft)	Lane Miles *	Surface Type
0901	NONPUBLIC	2/20/2013	14,331	0.25	AS
Culverts	Drop Inlets	Gates	Curb & Gutter	Curb	PCR
0	2	0	NO CURB AND GUTTER	NO CURB	GOOD/90

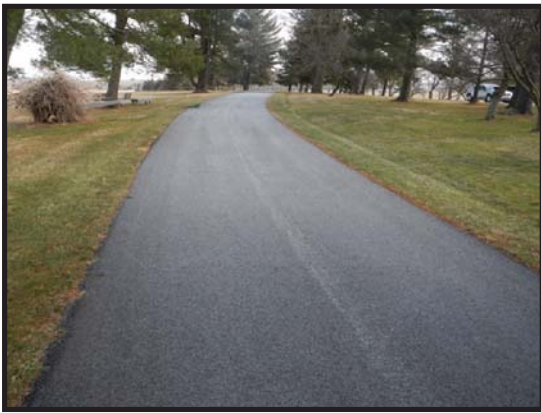
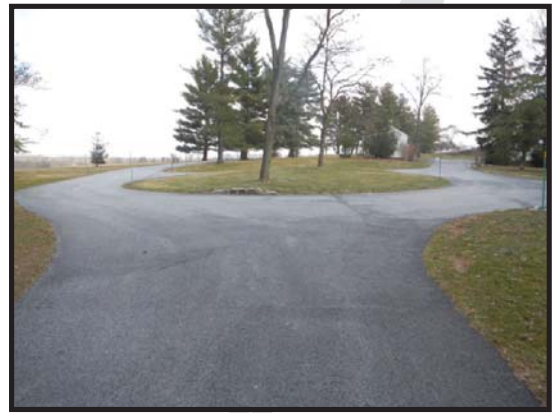
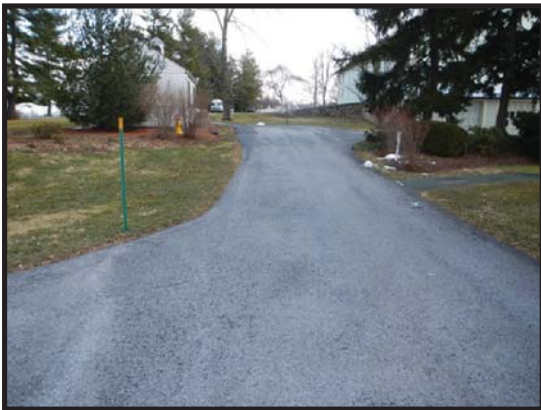
Route 0902

Route Number	Public / NonPublic	Date Visited	Area (sq ft)	Lane Miles *	Surface Type
0902	NONPUBLIC	2/20/2013	1,973	0.03	AS
Culverts	Drop Inlets	Gates	Curb & Gutter	Curb	PCR
0	0	0	NO CURB AND GUTTER	NO CURB	GOOD/90
