# Federal Lands Highway Road Inventory Program

Road Inventory and Condition Assessment

## El Malpais National Monument ELMA

### Cycle 5 Report

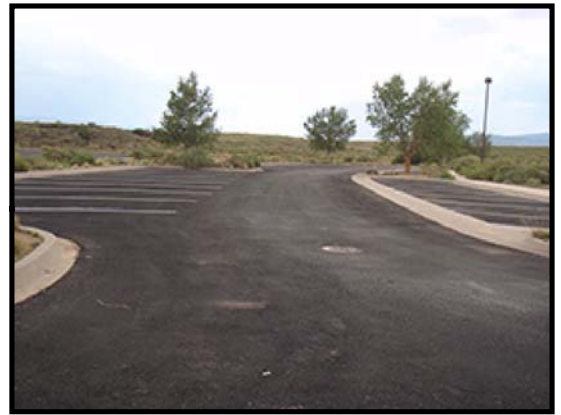
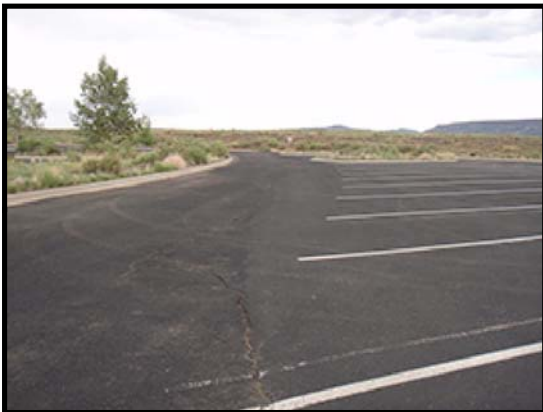
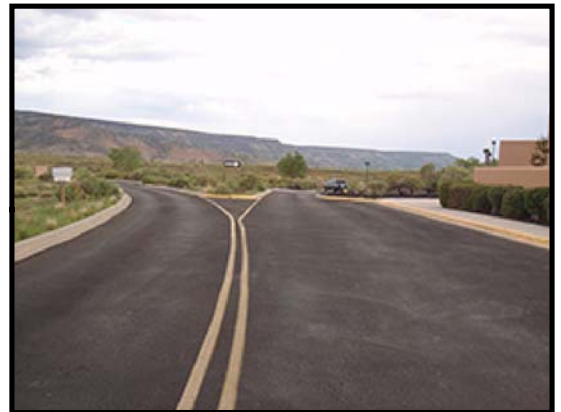
Route Number	Public / NonPublic	Date Visited	Area (sq ft)	Lane Miles *	Surface Type
0900	PUBLIC	9/3/2011	68,688	1.18	AS
Culverts	Drop Inlets	Gates	Curb & Gutter	Curb	PCR
0	2	0	CONCRETE CURB AND GUTTER	NO CURB	FAIR/73

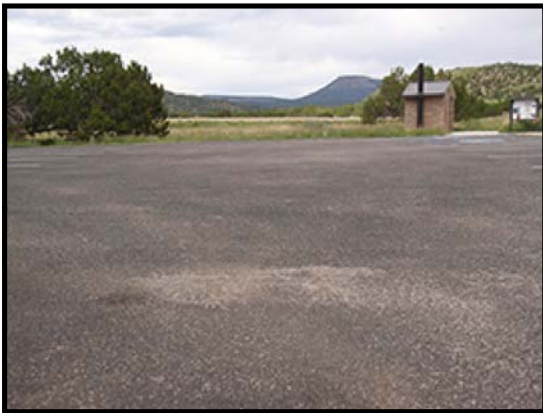
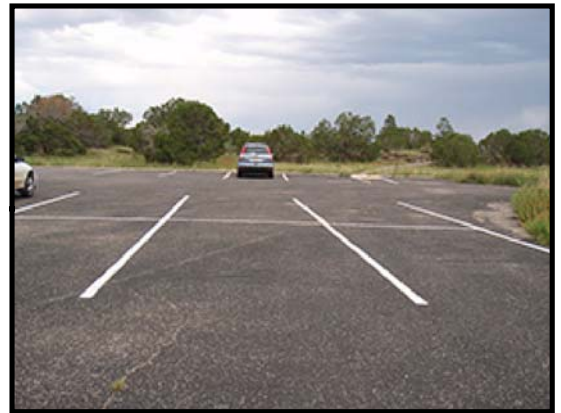
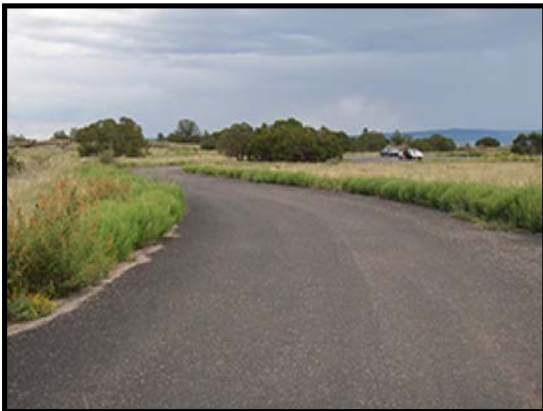
## Route 0901

Route Number	Public / NonPublic	Date Visited	Area (sq ft)	Lane Miles *	Surface Type
0901	PUBLIC	9/3/2011	23,652	0.41	AS
Culverts	Drop Inlets	Gates	Curb & Gutter	Curb	PCR
0	0	1	NO CURB AND GUTTER	NO CURB	FAIR/73

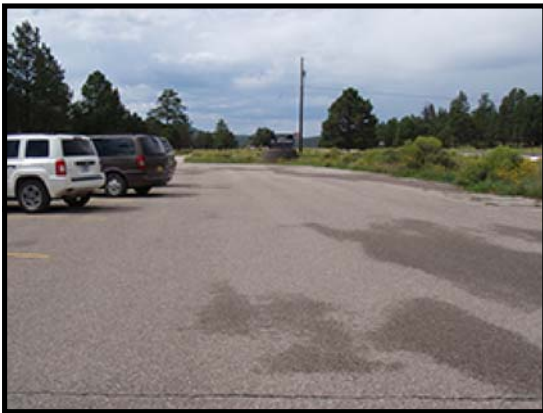
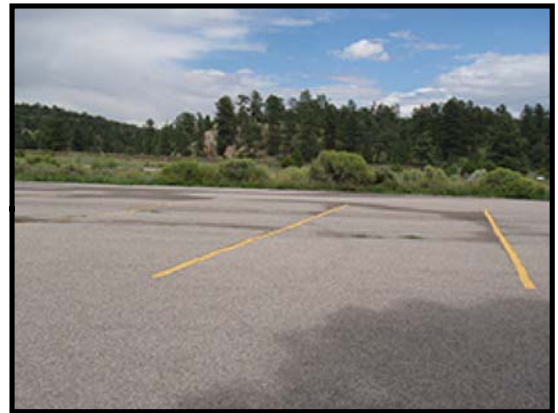
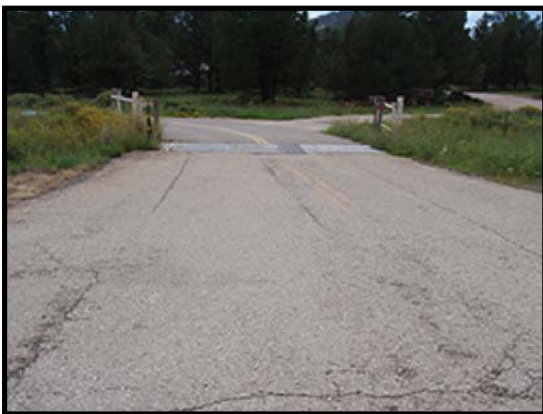
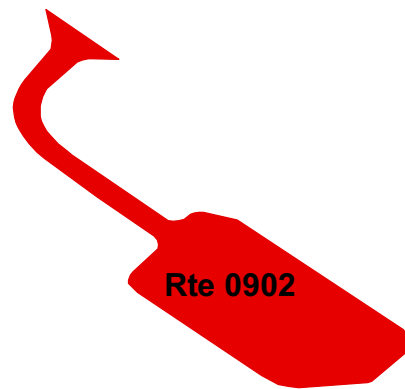
## Route 0902

Route Number	Public / NonPublic	Date Visited	Area (sq ft)	Lane Miles *	Surface Type
0902	PUBLIC	9/3/2011	30,131	0.52	AS
Culverts	Drop Inlets	Gates	Curb & Gutter	Curb	PCR
0	0	1	NO CURB AND GUTTER	NO CURB	FAIR/73
