# Federal Lands Highway Road Inventory Program

Road Inventory and Condition Assessment

## El Morro National Monument ELMO

### Cycle 5 Report

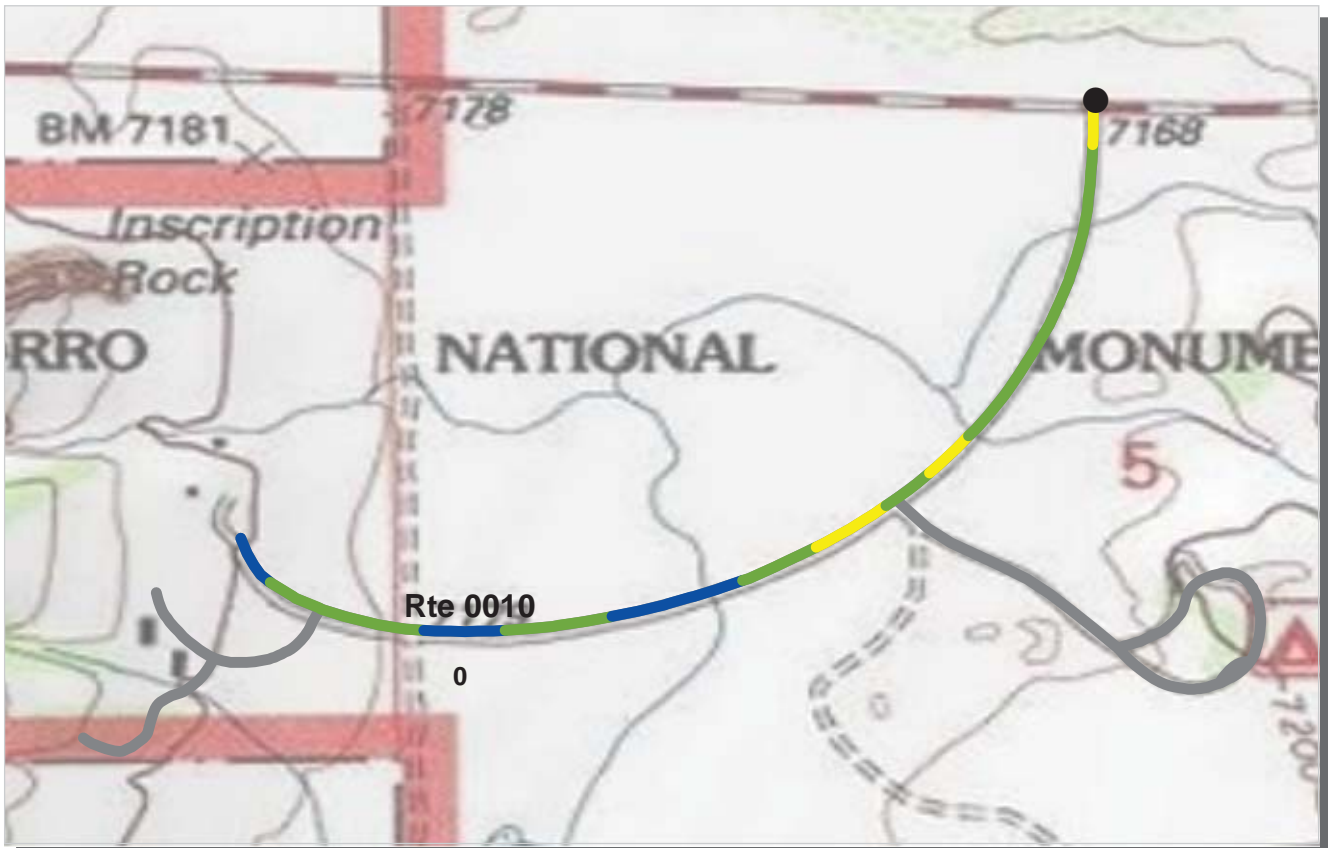
**ROUTE: 0010 ENTRANCE ROAD**

<i>Section Number</i>	0				
<i>Section Length (mi)</i>	0.87				
<i>Cross Section Information</i>					
Number of Lanes	2				
Paved Width (ft)	21				
Lane Width (ft)	10				
<i>Roadway Condition Information</i>					
SCR (Surface Condition Rating)	96				
PCR (Pavement Condition Rating)	87				
<i>Distress Index Values</i>					
Structural Crack Index	97				
Transverse Cracking Index	99				
Patching Index	100				
Rutting Index	96				
Roughness Condition Index (RCI)	74

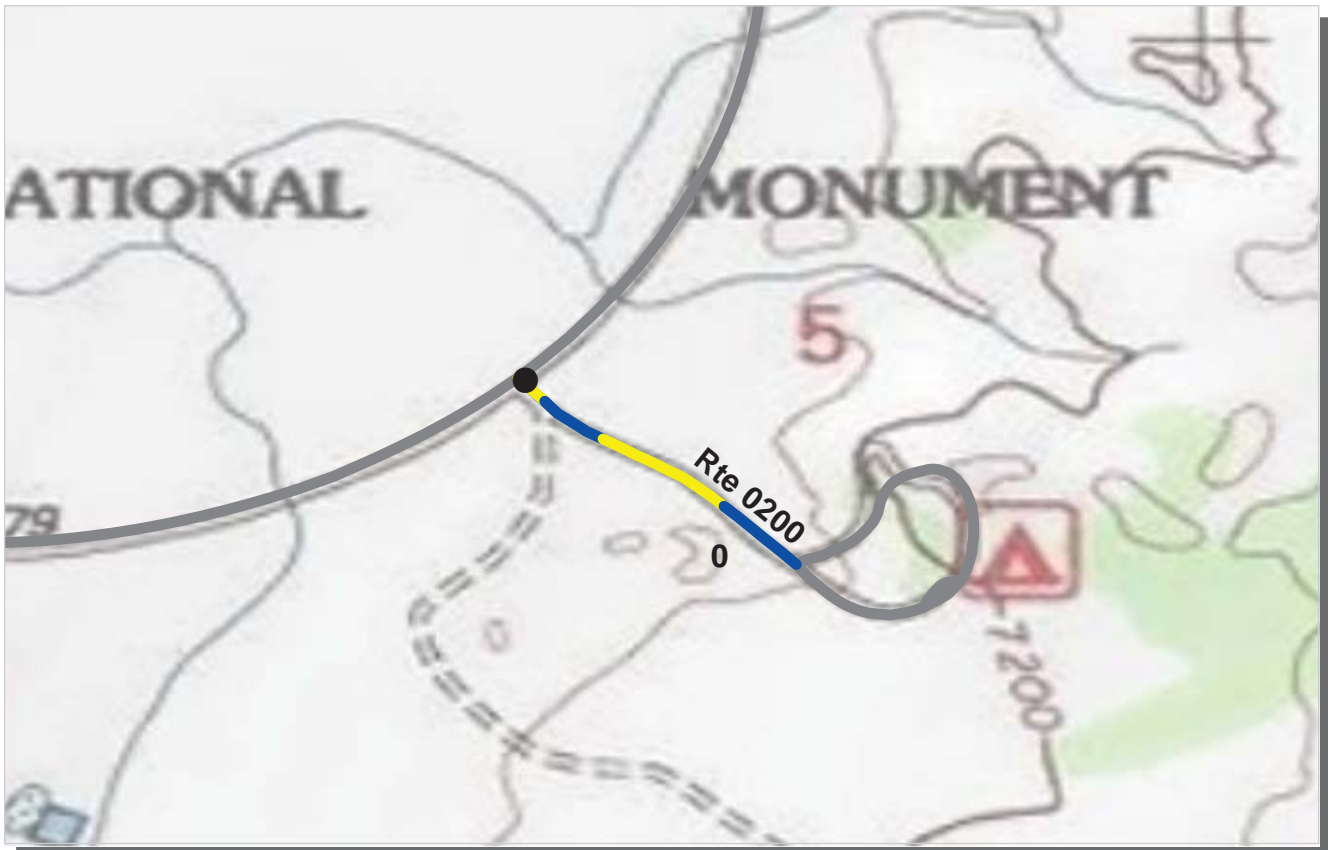
**ROUTE: 0200 CAMPGROUND LOOP ACCESS**

<b>Section Number</b>	0				
<b>Section Length (mi)</b>	0.19				
<b>Cross Section Information</b>					
Number of Lanes	2				
Paved Width (ft)	15				
Lane Width (ft)	7				
<b>Roadway Condition Information</b>					
SCR (Surface Condition Rating)	82				
PCR (Pavement Condition Rating)	82				
<b>Distress Index Values</b>					
Structural Crack Index	82				
Transverse Cracking Index	99				
Patching Index	100				
Rutting Index	96				
Roughness Condition Index (RCI)	NC

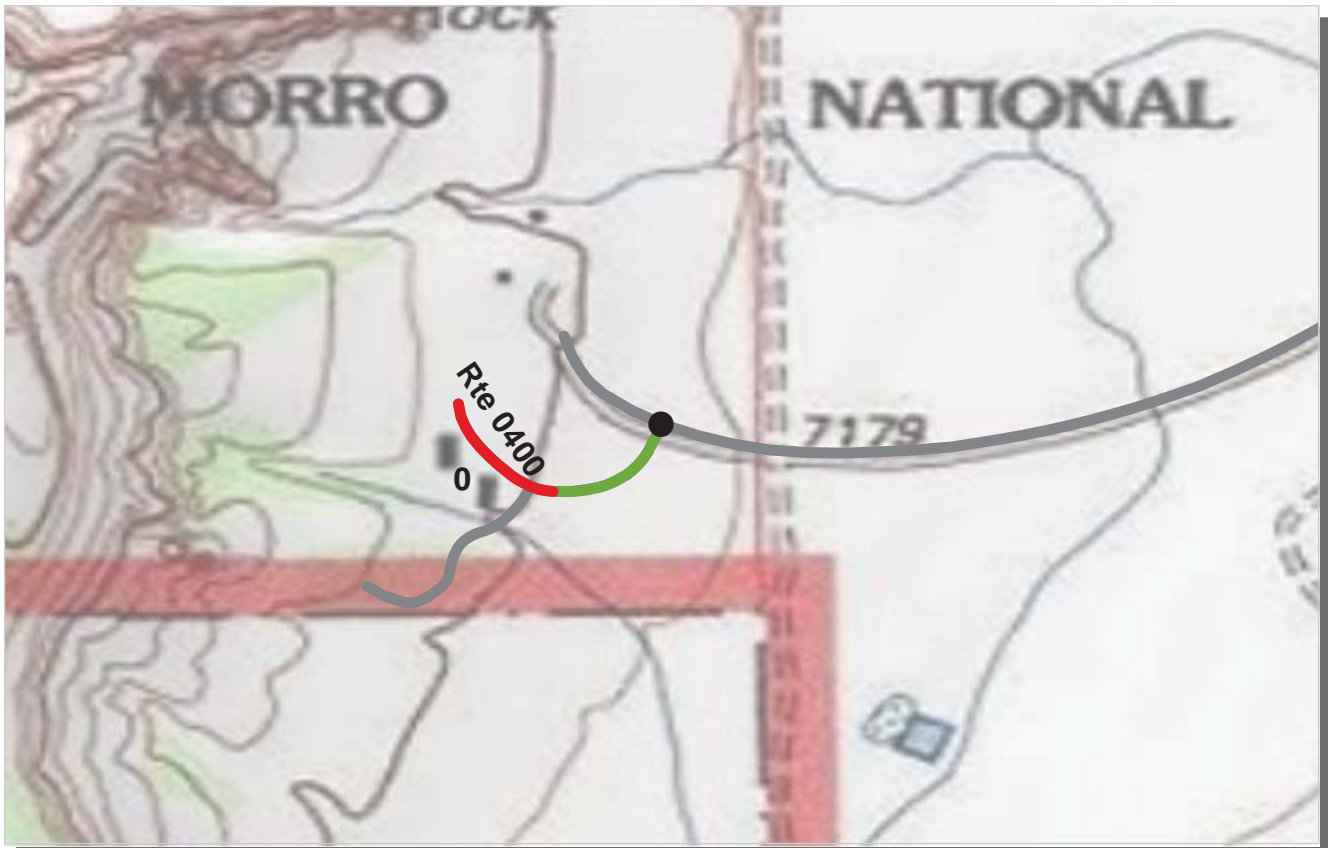
**ROUTE: 0400 RESIDENCE ROAD**

<b>Section Number</b>	0				
<b>Section Length (mi)</b>	0.16				
<b>Cross Section Information</b>					
Number of Lanes	2				
Paved Width (ft)	17				
Lane Width (ft)	8				
<b>Roadway Condition Information</b>					
SCR (Surface Condition Rating)	65				
PCR (Pavement Condition Rating)	65				
<b>Distress Index Values</b>					
Structural Crack Index	65				
Transverse Cracking Index	80				
Patching Index	100				
Rutting Index	99				
Roughness Condition Index (RCI)	NC

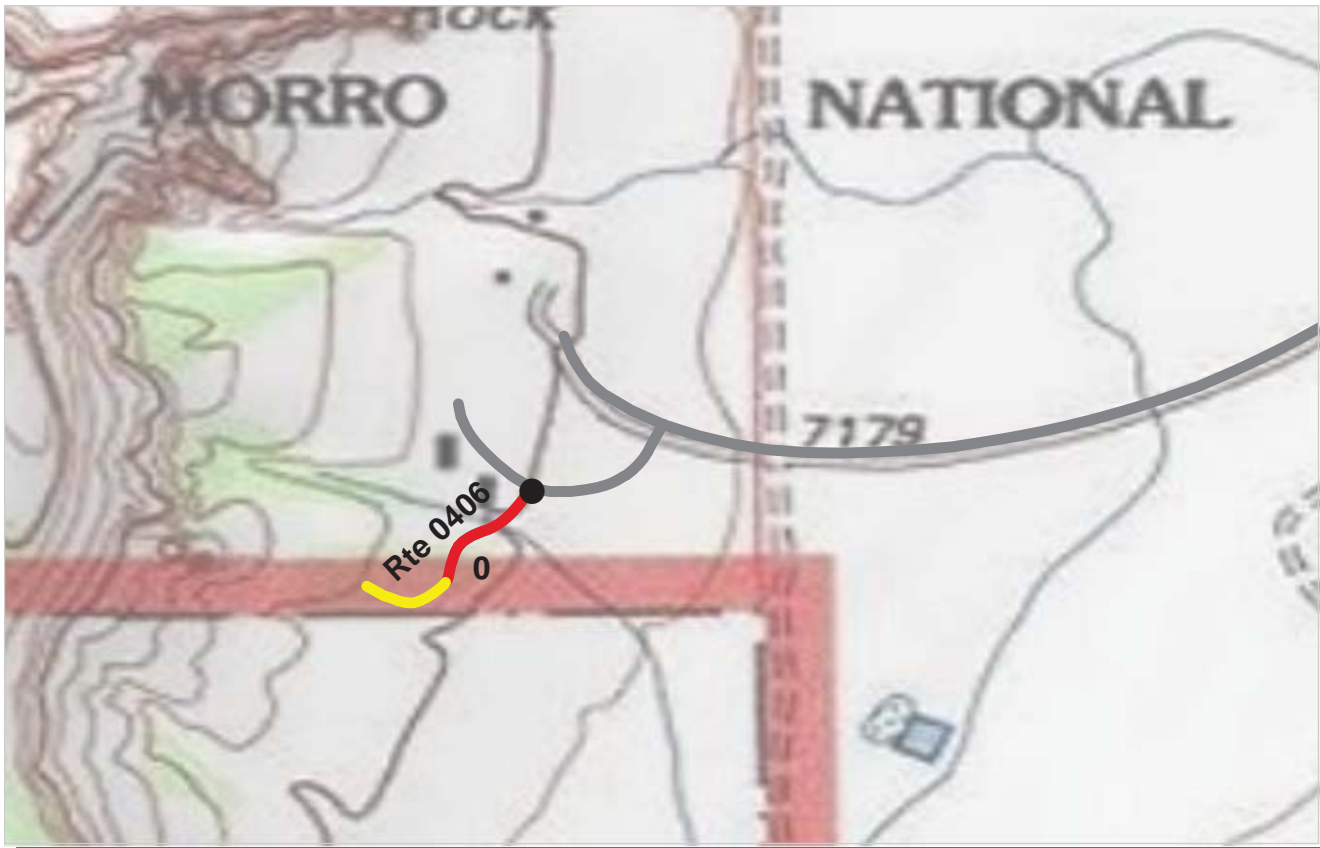
**ROUTE: 0406 RESIDENCE ROAD A**

<b>Section Number</b>	0				
<b>Section Length (mi)</b>	0.12				
<b>Cross Section Information</b>					
Number of Lanes	2				
Paved Width (ft)	18				
Lane Width (ft)	9				
<b>Roadway Condition Information</b>					
SCR (Surface Condition Rating)	58				
PCR (Pavement Condition Rating)	58				
<b>Distress Index Values</b>					
Structural Crack Index	94				
Transverse Cracking Index	58				
Patching Index	99				
Rutting Index	94				
Roughness Condition Index (RCI)	NC

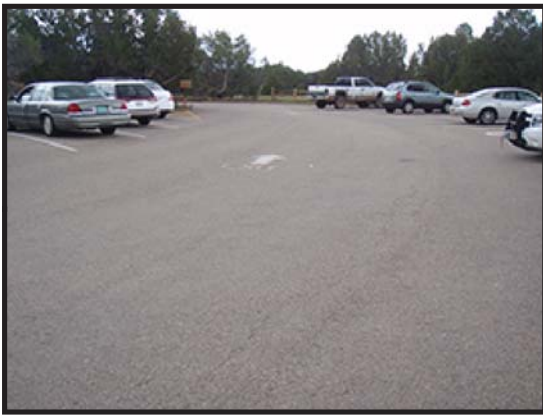
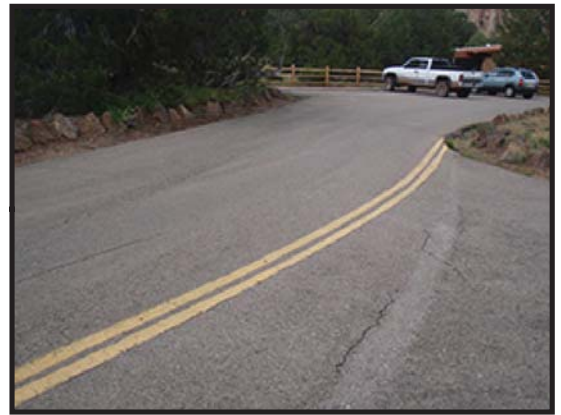
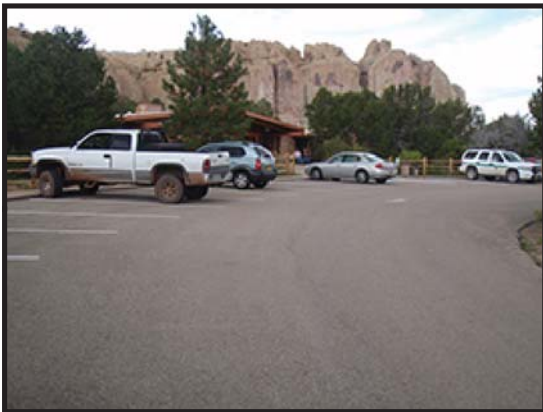
Route Number	Public / NonPublic	Date Visited	Area (sq ft)	Lane Miles *	Surface Type
0902	PUBLIC	9/3/2011	20,601	0.36	AS
Culverts	Drop Inlets	Gates	Curb & Gutter	Curb	PCR
0	0	0	NO CURB AND GUTTER	STONE CURB	GOOD/90

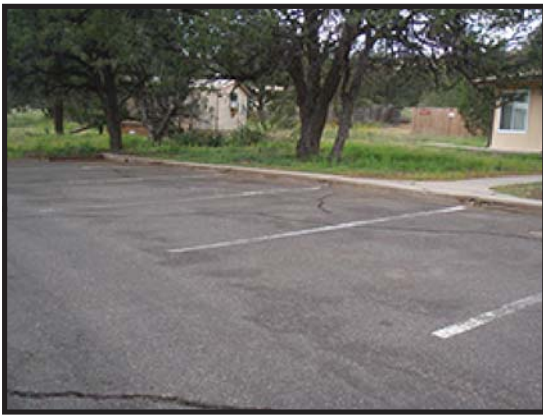
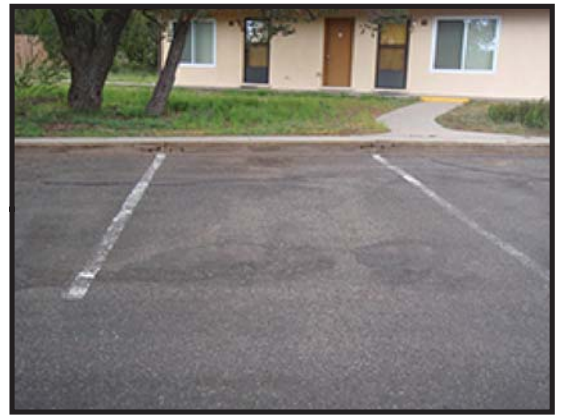
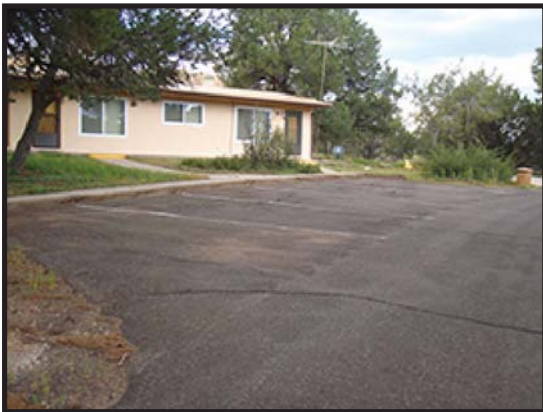
**EL MORRO NATIONAL MONUMENT**  
**Route 0905**  
**HOUSING PARKING**  
 ADJACENT TO ROUTE 0406 (RESIDENCE ROAD A)

Route Number	Public / NonPublic	Date Visited	Area (sq ft)	Lane Miles *	Surface Type
0905	PUBLIC	9/3/2011	1,455	0.03	AS
Culverts	Drop Inlets	Gates	Curb & Gutter	Curb	PCR
0	0	0	NO CURB AND GUTTER	WOOD CURB	POOR/45
