# Federal Lands Highway Road Inventory Program

Road Inventory and Condition Assessment

**Eugene O'Neill National Historic Site**

**Cycle 5 Report**

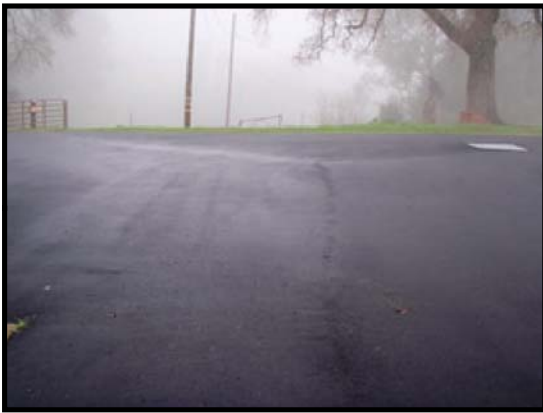
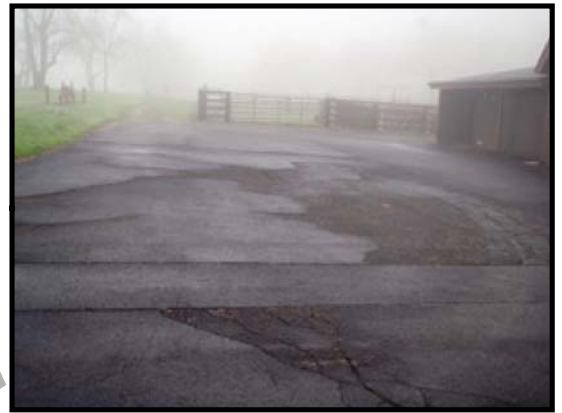
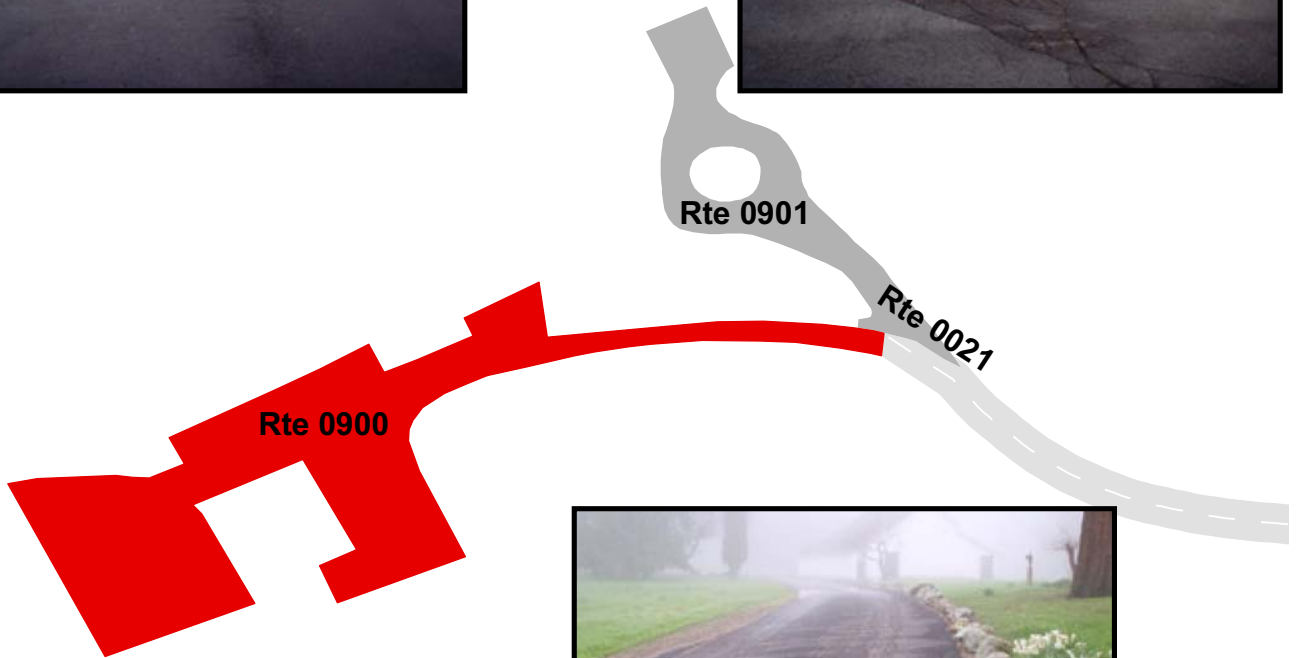
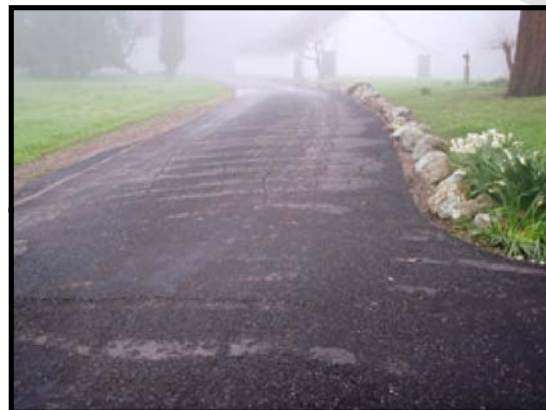
## Route 0900

Route Number	Public / NonPublic	Date Visited	Area (sq ft)	Lane Miles *	Surface Type
0900	PUBLIC	1/27/2010	17,845	0.31	AS
Culverts	Drop Inlets	Gates	Curb & Gutter	Curb	PCR
0	0	0	NO CURB AND GUTTER	NO CURB	POOR/45

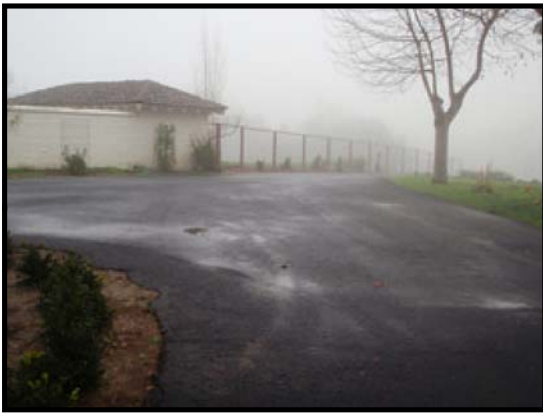
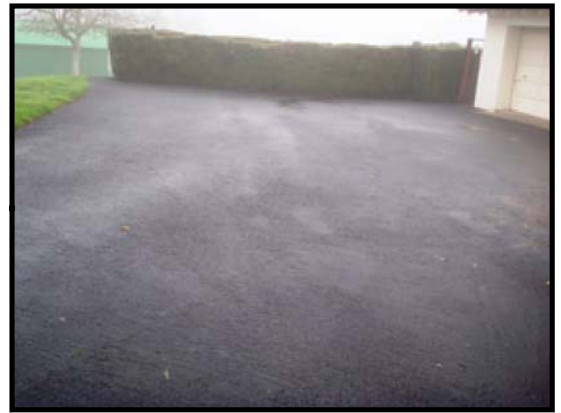
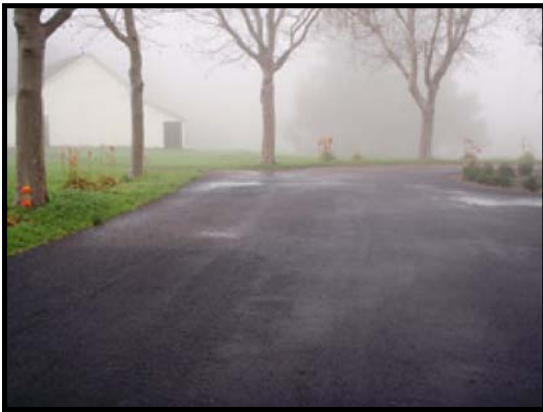
## Route 0901

Route Number	Public / NonPublic	Date Visited	Area (sq ft)	Lane Miles *	Surface Type
0901	NONPUBLIC	1/27/2010	5,837	0.10	AS
Culverts	Drop Inlets	Gates	Curb & Gutter	Curb	PCR
0	0	0	NO CURB AND GUTTER	NO CURB	GOOD/90

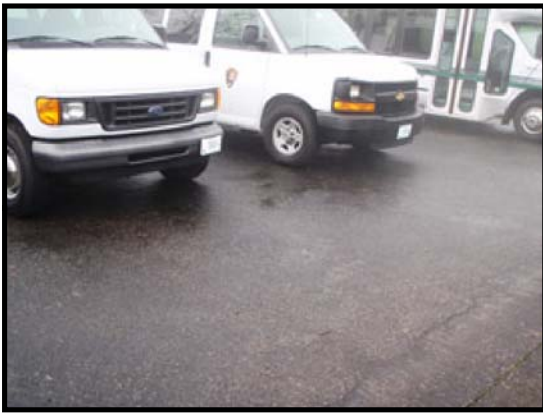
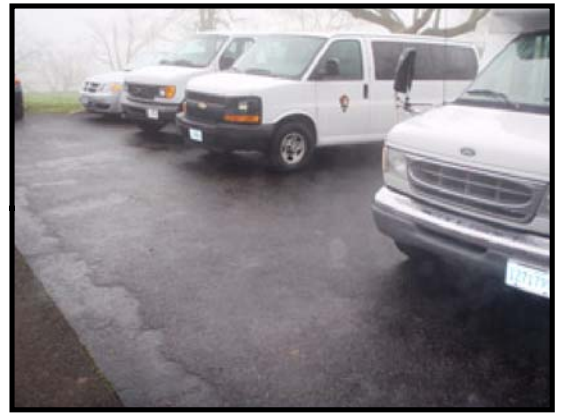
## Route 0902

Route Number	Public / NonPublic	Date Visited	Area (sq ft)	Lane Miles *	Surface Type
0902	PUBLIC	1/27/2010	1,349	0.02	AS
Culverts	Drop Inlets	Gates	Curb & Gutter	Curb	PCR
0	0	0	NO CURB AND GUTTER	CONCRETE CURB	GOOD/90

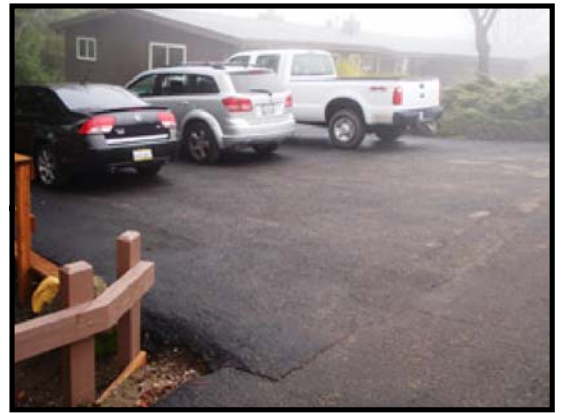
## Route 0903

Route Number	Public / NonPublic	Date Visited	Area (sq ft)	Lane Miles *	Surface Type
0903	NONPUBLIC	1/27/2010	1,013	0.02	AS
Culverts	Drop Inlets	Gates	Curb & Gutter	Curb	PCR
0	0	0	NO CURB AND GUTTER	NO CURB	GOOD/90
