Federal Lands Highway Road Inventory Program

Road Inventory and Condition Assessment

Fossil Butte National Monument FOBU - 1468

Cycle 5 Report

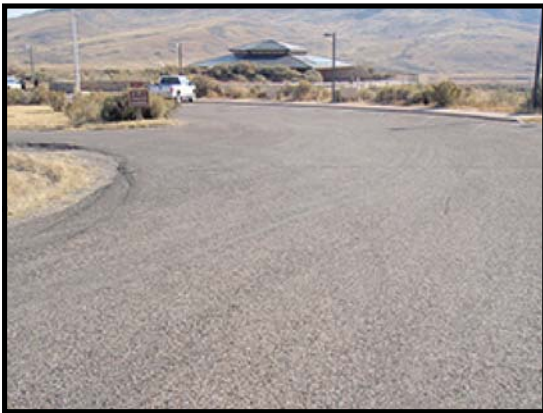
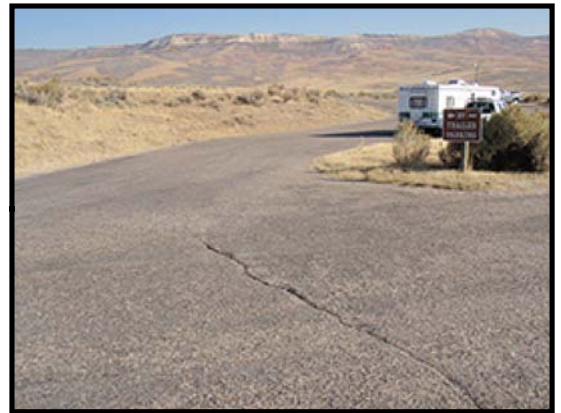
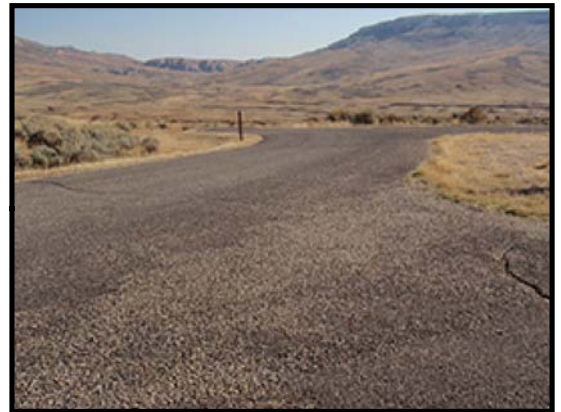
Route 0900

Route Number	Public / NonPublic	Date Visited	Area (sq ft)	Lane Miles *	Surface Type
0900	PUBLIC	10/3/2010	39,496	0.68	AS
Culverts	Drop Inlets	Gates	Curb & Gutter	Curb	PCR
1	1	0	CONCRETE CURB AND GUTTER	NO CURB	FAIR/73

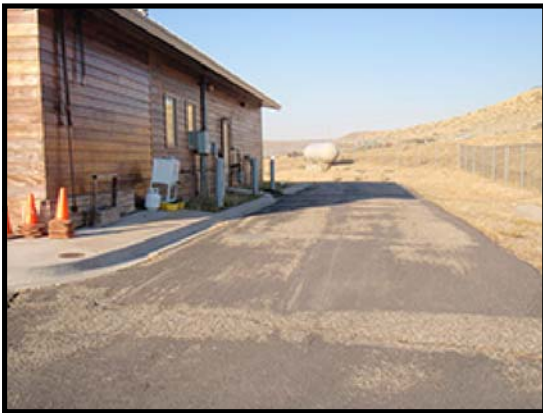
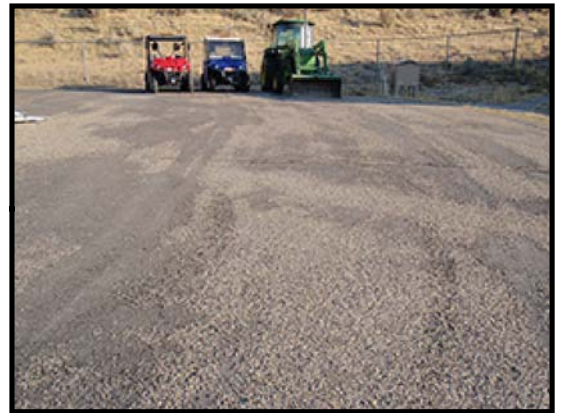
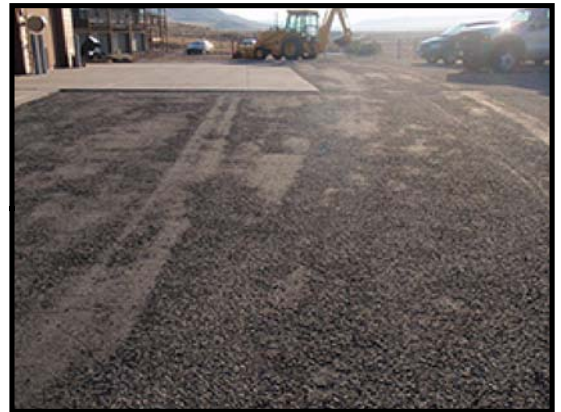
Route 0901

Route Number	Public / NonPublic	Date Visited	Area (sq ft)	Lane Miles *	Surface Type
0901	PUBLIC	10/3/2010	23,087	0.40	AS
Culverts	Drop Inlets	Gates	Curb & Gutter	Curb	PCR
0	0	1	CONCRETE CURB AND GUTTER	NO CURB	POOR/45

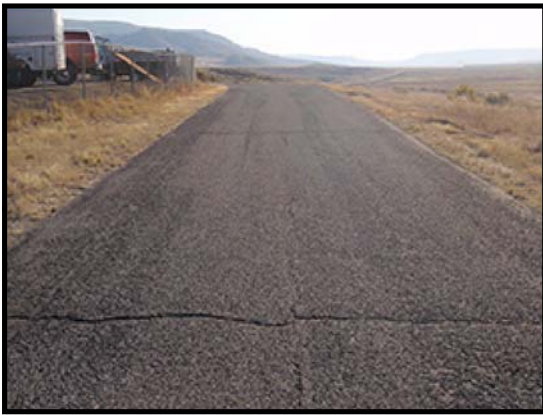
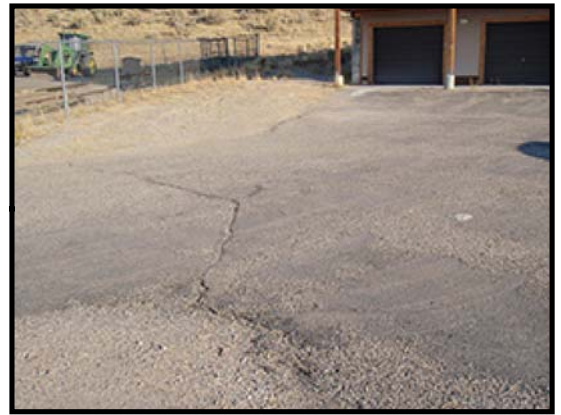
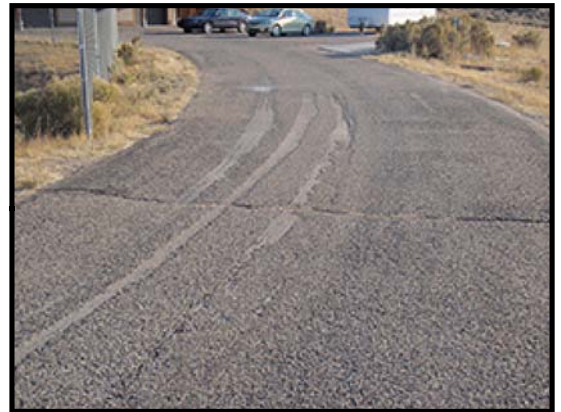
Route 0902

Route Number	Public / NonPublic	Date Visited	Area (sq ft)	Lane Miles *	Surface Type
0902	PUBLIC	10/3/2010	9,128	0.16	AS
Culverts	Drop Inlets	Gates	Curb & Gutter	Curb	PCR
2	0	0	NO CURB AND GUTTER	NO CURB	POOR/45

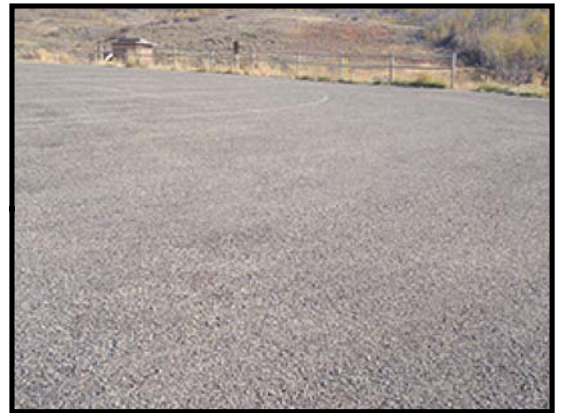
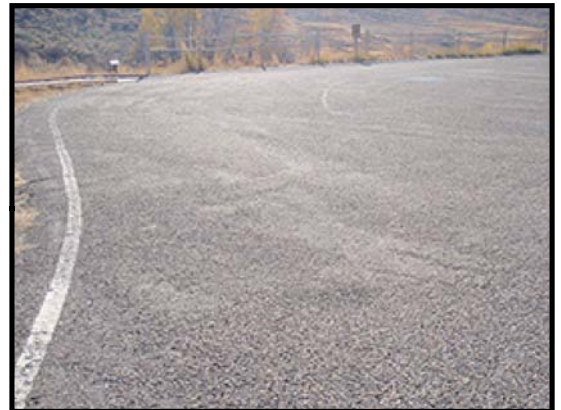
Route 0903

Route Number	Public / NonPublic	Date Visited	Area (sq ft)	Lane Miles *	Surface Type
0903	PUBLIC	10/3/2010	9,456	0.16	AS
Culverts	Drop Inlets	Gates	Curb & Gutter	Curb	PCR
0	0	0	NO CURB AND GUTTER	NO CURB	FAIR/73

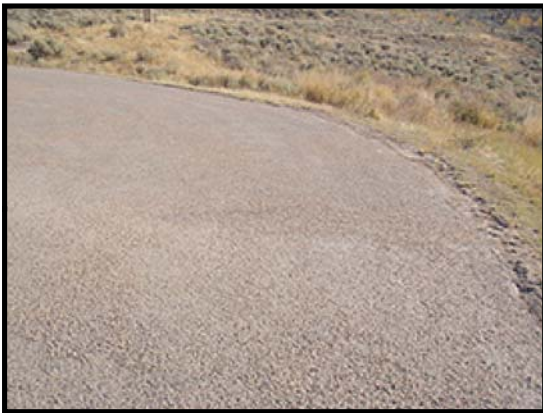
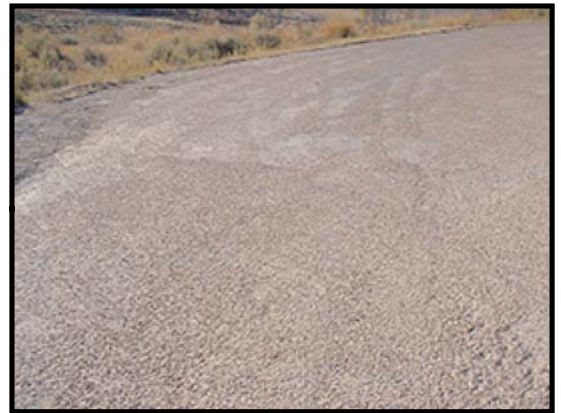
Route 0904

Route Number	Public / NonPublic	Date Visited	Area (sq ft)	Lane Miles *	Surface Type
0904	PUBLIC	10/3/2010	4,009	0.07	AS
Culverts	Drop Inlets	Gates	Curb & Gutter	Curb	PCR
0	0	0	NO CURB AND GUTTER	NO CURB	FAIR/73

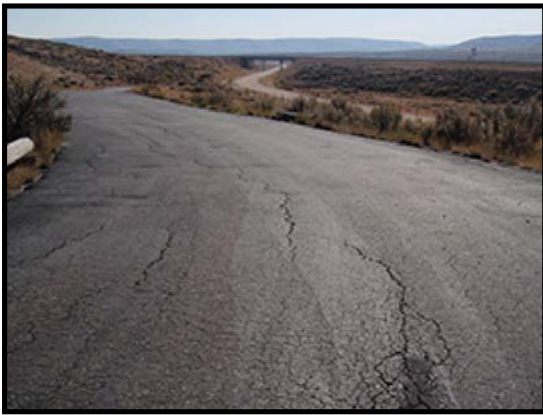
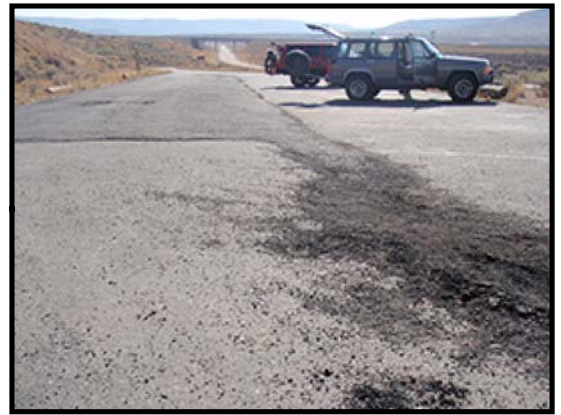
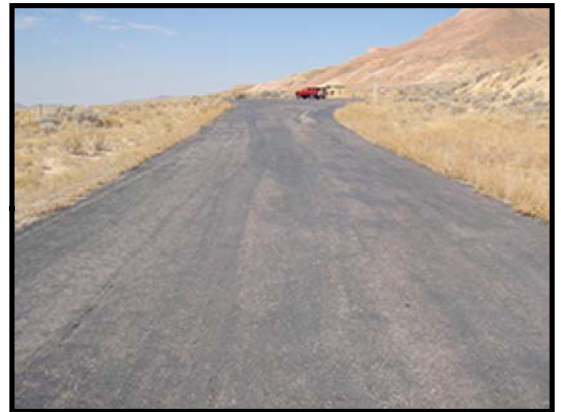
Route 0905

Route Number	Public / NonPublic	Date Visited	Area (sq ft)	Lane Miles *	Surface Type
0905	PUBLIC	10/3/2010	22,903	0.39	AS
Culverts	Drop Inlets	Gates	Curb & Gutter	Curb	PCR
0	0	0	NO CURB AND GUTTER	NO CURB	POOR/45
