Federal Lands Highway Road Inventory Program

Road Inventory and Condition Assessment

Fort Davis National Historic Site FODA - 7220

Cycle 5 Report

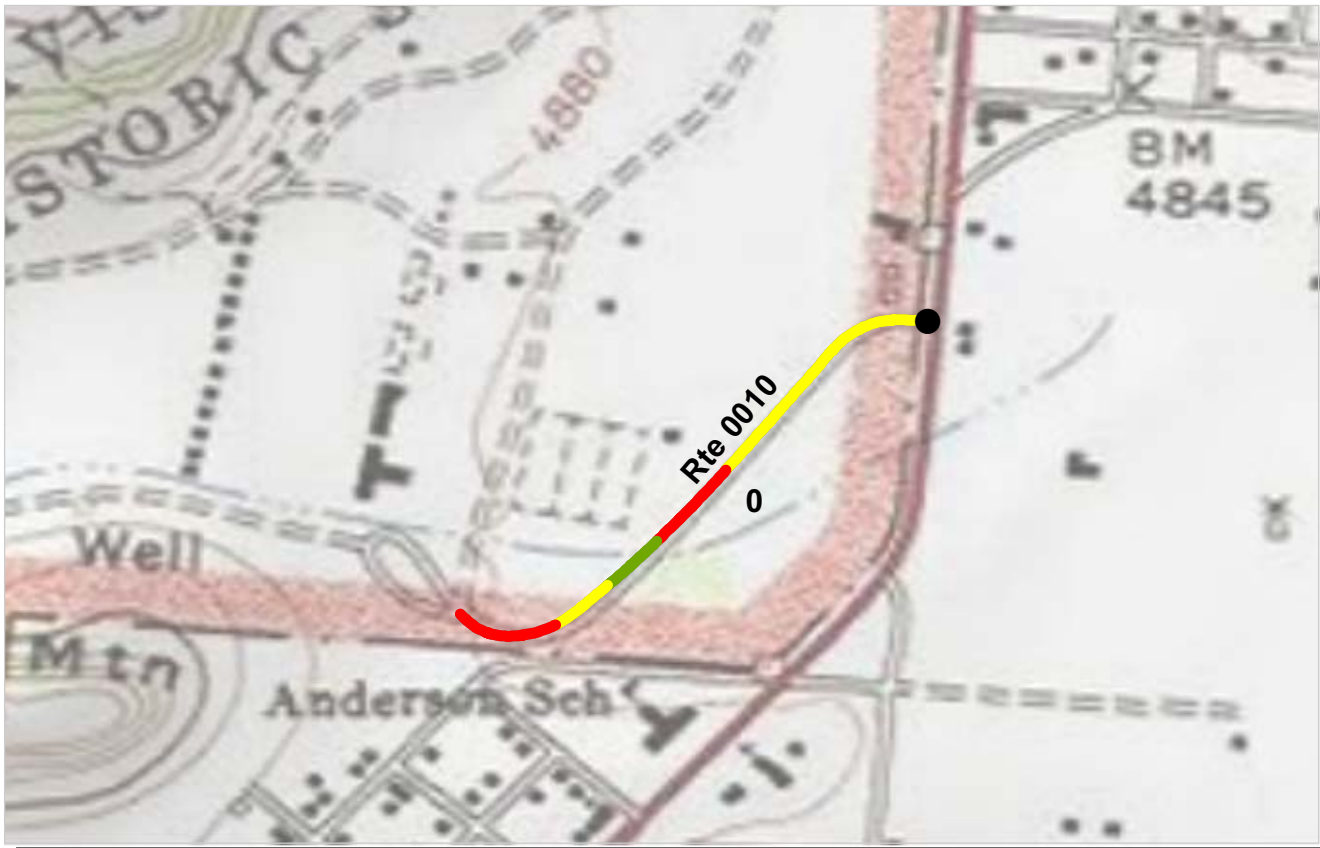
ROUTE: 0010 ENTRANCE ROAD

| SCR (Surface Condition Rating) | 71 | | | | |
| PCR (Pavement Condition Rating) | 71 | | | | |
| Structural Crack Index | 79 | | | | |
| Transverse Cracking Index | 71 | | | | |

Structural Crack Index is a combination of the Longitudinal Cracking Index and Alligator Cracking Index.
 See Section 10 for explanation of SCR, PCR, & all Distress Index Values.

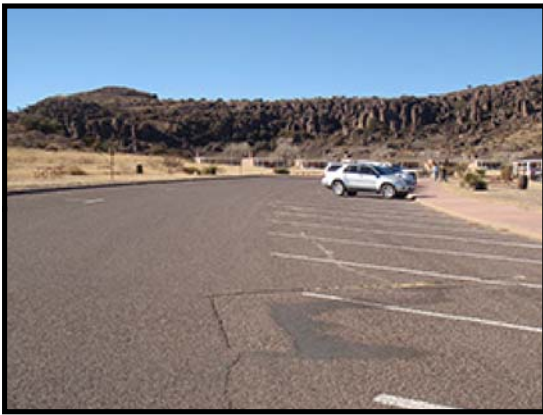
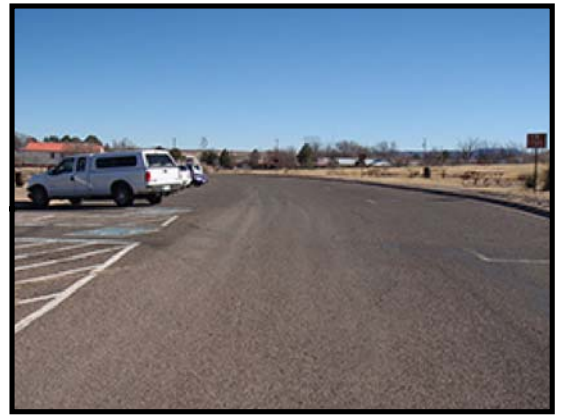
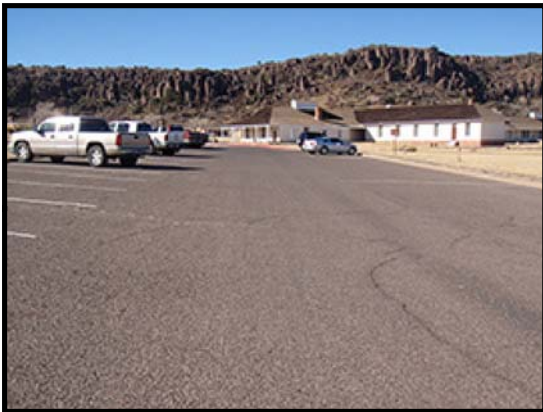
Route 0900

| Route Number | Public / NonPublic | Date Visited | Area (sq ft) | Lane Miles * | Surface Type |
|---|---|---|---|---|---|
| 0 | 2 | 0 | CONCRETE CURB AND GUTTER | NO CURB | FAIR/73 |

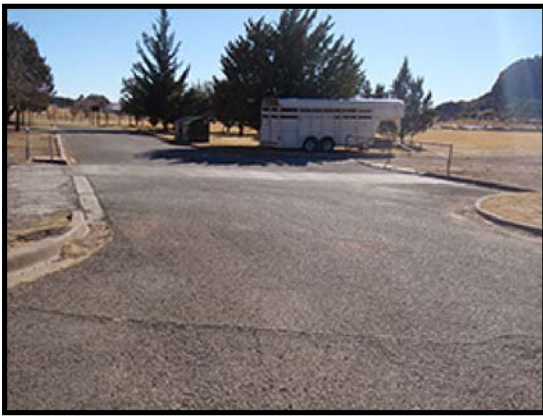
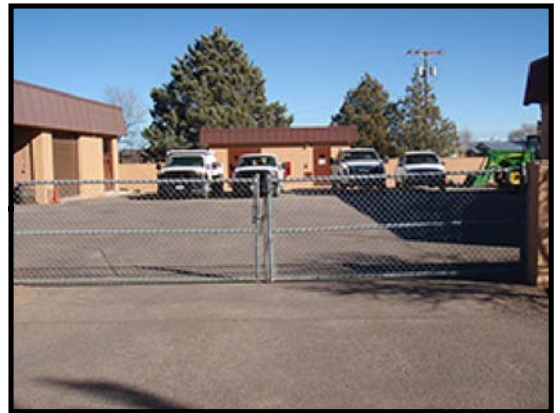
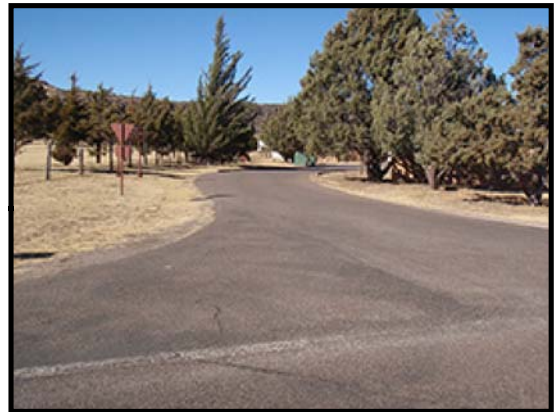
Route 0901

| Route Number | Public / NonPublic | Date Visited | Area (sq ft) | Lane Miles * | Surface Type |
|---|---|---|---|---|---|
| 0 | 0 | 2 | CONCRETE CURB AND GUTTER | NO CURB | GOOD/90 |

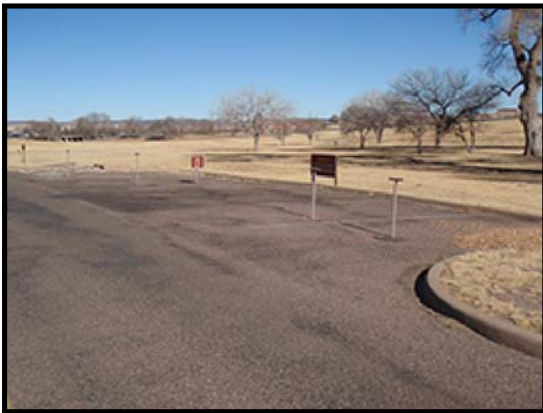
Route 0904

| Route Number | Public / NonPublic | Date Visited | Area (sq ft) | Lane Miles * | Surface Type |
|---|---|---|---|---|---|
| 0 | 0 | 0 | CONCRETE CURB AND GUTTER | NO CURB | FAIR/73 |
