Federal Lands Highway Road Inventory Program

Road Inventory and Condition Assessment

Fort Frederica National Monument FOFR

Cycle 5 Report

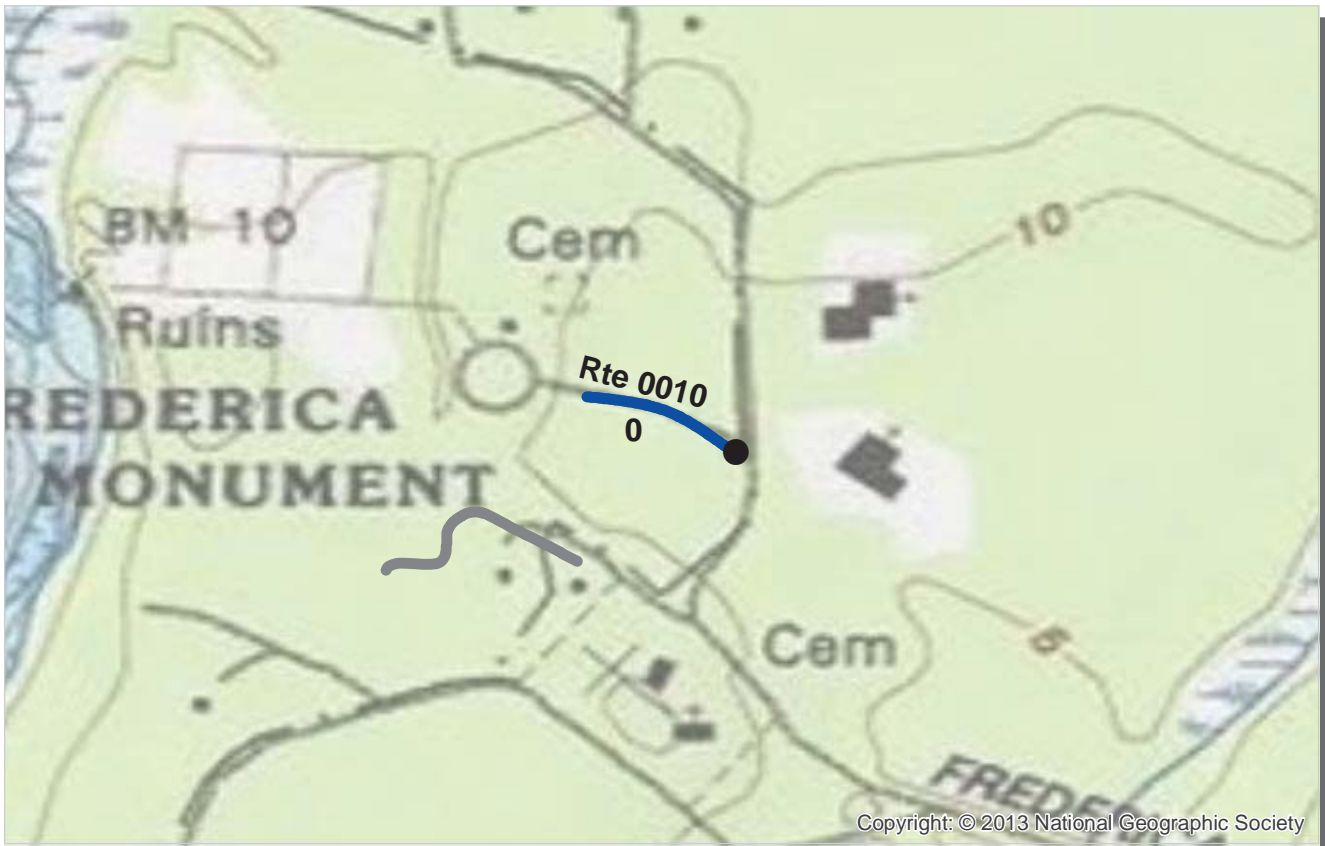
ROUTE: 0010 HQVCC ENTRANCE ROAD

Section Number	0				
Section Length (mi)	0.09				
Cross Section Information					
Number of Lanes	2				
Paved Width (ft)	19				
Lane Width (ft)	9				
Roadway Condition Information					
SCR (Surface Condition Rating)	97				
PCR (Pavement Condition Rating)	97				
Distress Index Values					
Structural Crack Index	100				
Transverse Cracking Index	99				
Patching Index	100				
Rutting Index	97				
Roughness Condition Index (RCI)	NC

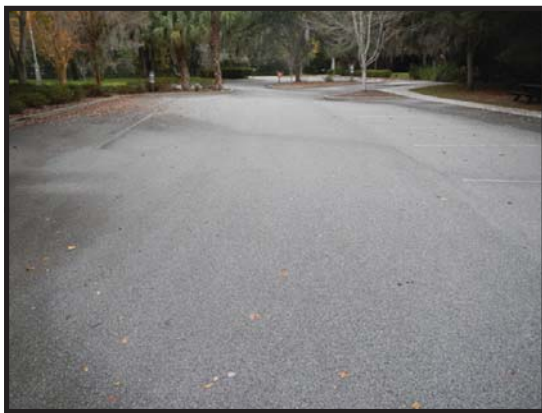
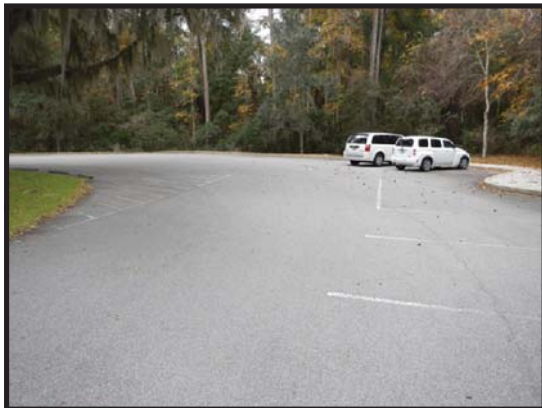
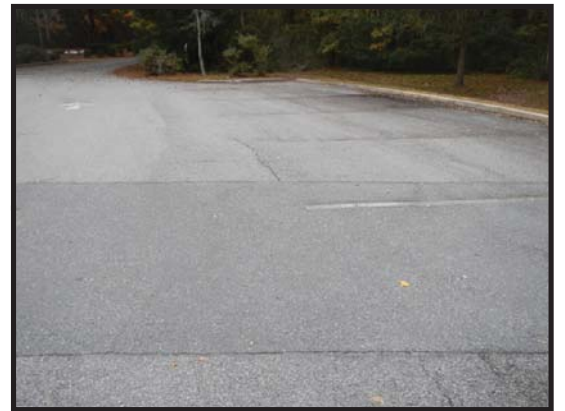
Route Number	Public / NonPublic	Date Visited	Area (sq ft)	Lane Miles *	Surface Type
0900	PUBLIC	12/6/2012	39,720	0.68	AS
Culverts	Drop Inlets	Gates	Curb & Gutter	Curb	PCR
0	0	0	NO CURB AND GUTTER	CONCRETE CURB	FAIR/73

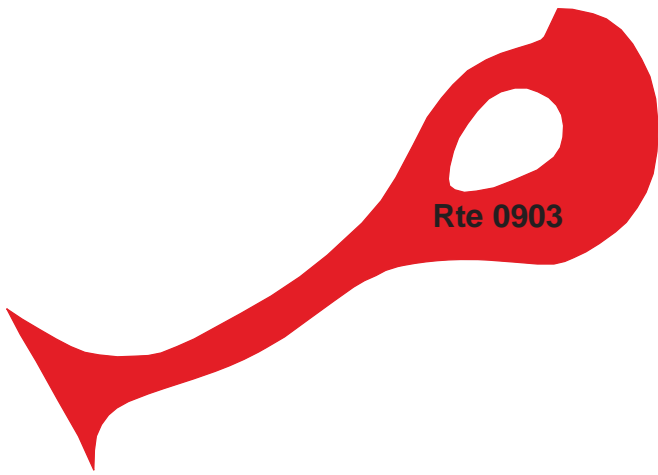
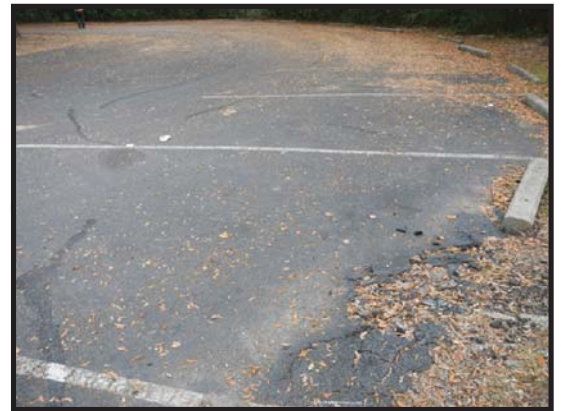
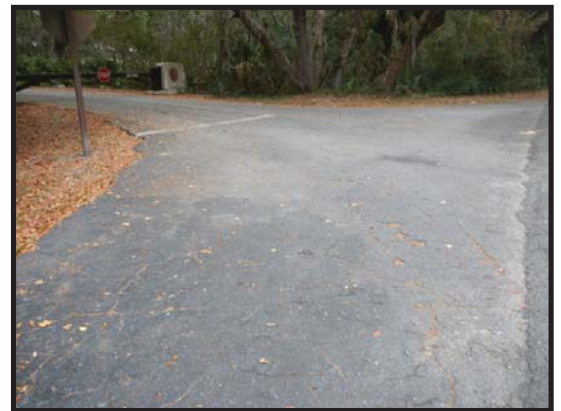
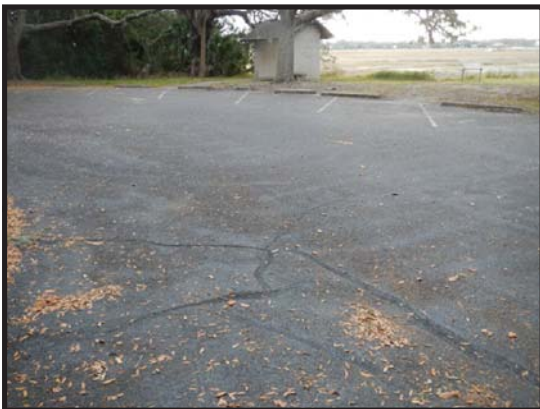
Route 0903

Route Number	Public / NonPublic	Date Visited	Area (sq ft)	Lane Miles *	Surface Type
0903	PUBLIC	12/6/2012	15,377	0.27	AS
Culverts	Drop Inlets	Gates	Curb & Gutter	Curb	PCR
0	0	1	NO CURB AND GUTTER	NO CURB	POOR/45
