Federal Lands Highway Road Inventory Program

Road Inventory and Condition Assessment

Fort McHenry National Monument & Historic Shrine FOMC

Cycle 5 Report

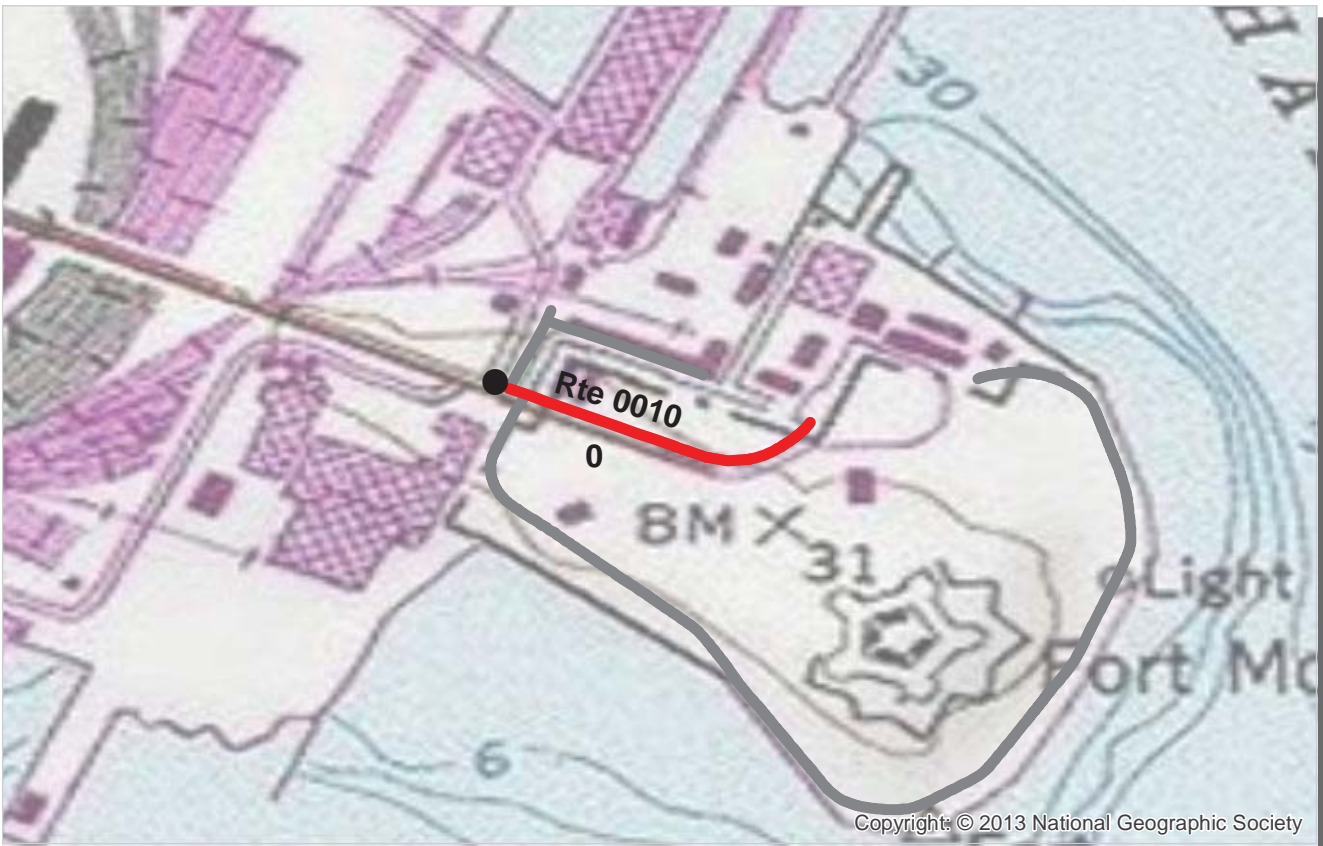
ROUTE: 0010 FORT AVENUE

Section Number	0				
Section Length (mi)	0.18				
Cross Section Information					
Number of Lanes	2				
Paved Width (ft)	32				
Lane Width (ft)	19				
Roadway Condition Information					
SCR (Surface Condition Rating)	52				
PCR (Pavement Condition Rating)	52				
Distress Index Values					
Structural Crack Index	52				
Transverse Cracking Index	90				
Patching Index	100				
Rutting Index	98				
Roughness Condition Index (RCI)	NC

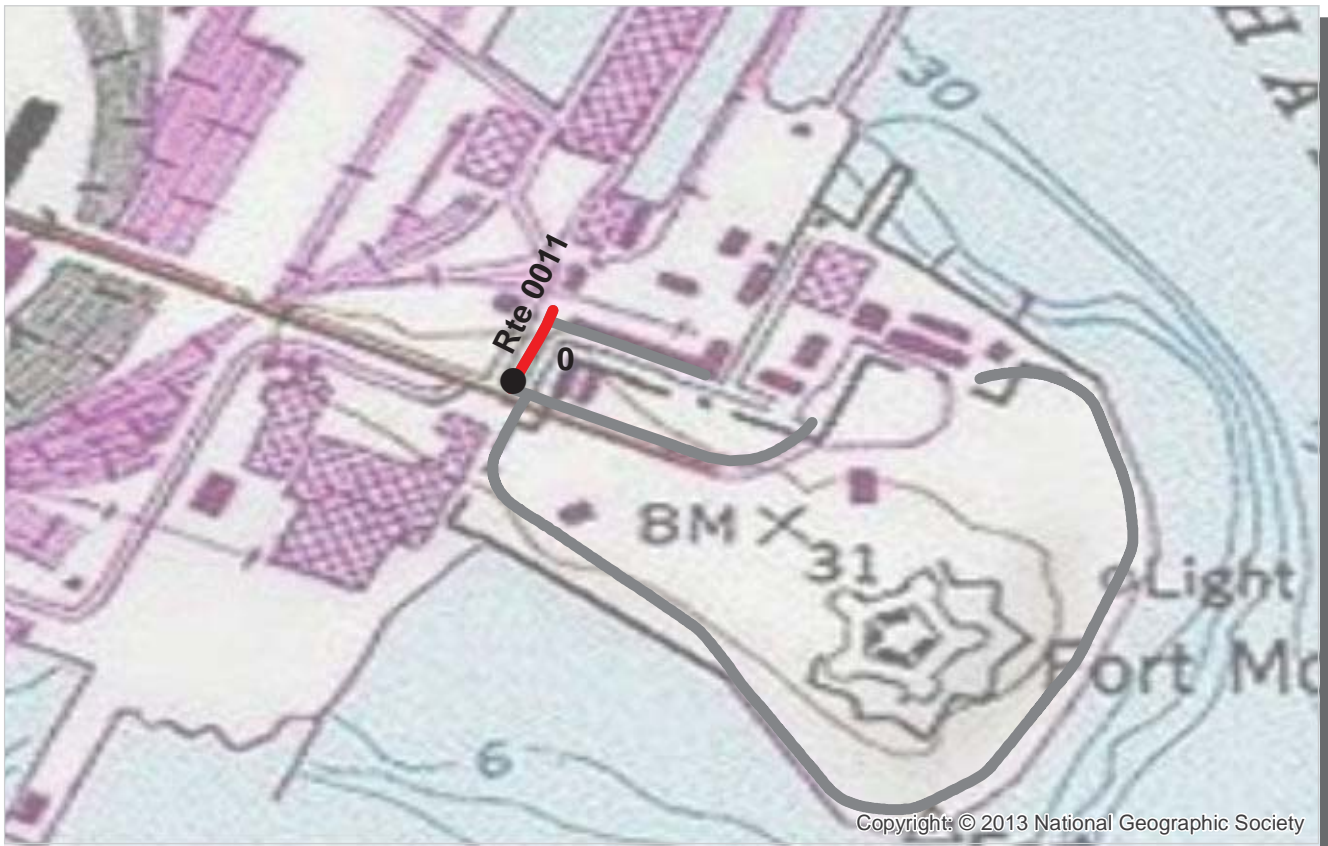
ROUTE: 0011 WALLACE STREET

<i>Section Number</i>	0				
<i>Section Length (mi)</i>	0.05				
<i>Cross Section Information</i>					
Number of Lanes	2				
Paved Width (ft)	21				
Lane Width (ft)	11				
<i>Roadway Condition Information</i>					
SCR (Surface Condition Rating)	0				
PCR (Pavement Condition Rating)	0				
<i>Distress Index Values</i>					
Structural Crack Index	0				
Transverse Cracking Index	78				
Patching Index	100				
Rutting Index	97				
Roughness Condition Index (RCI)	NC

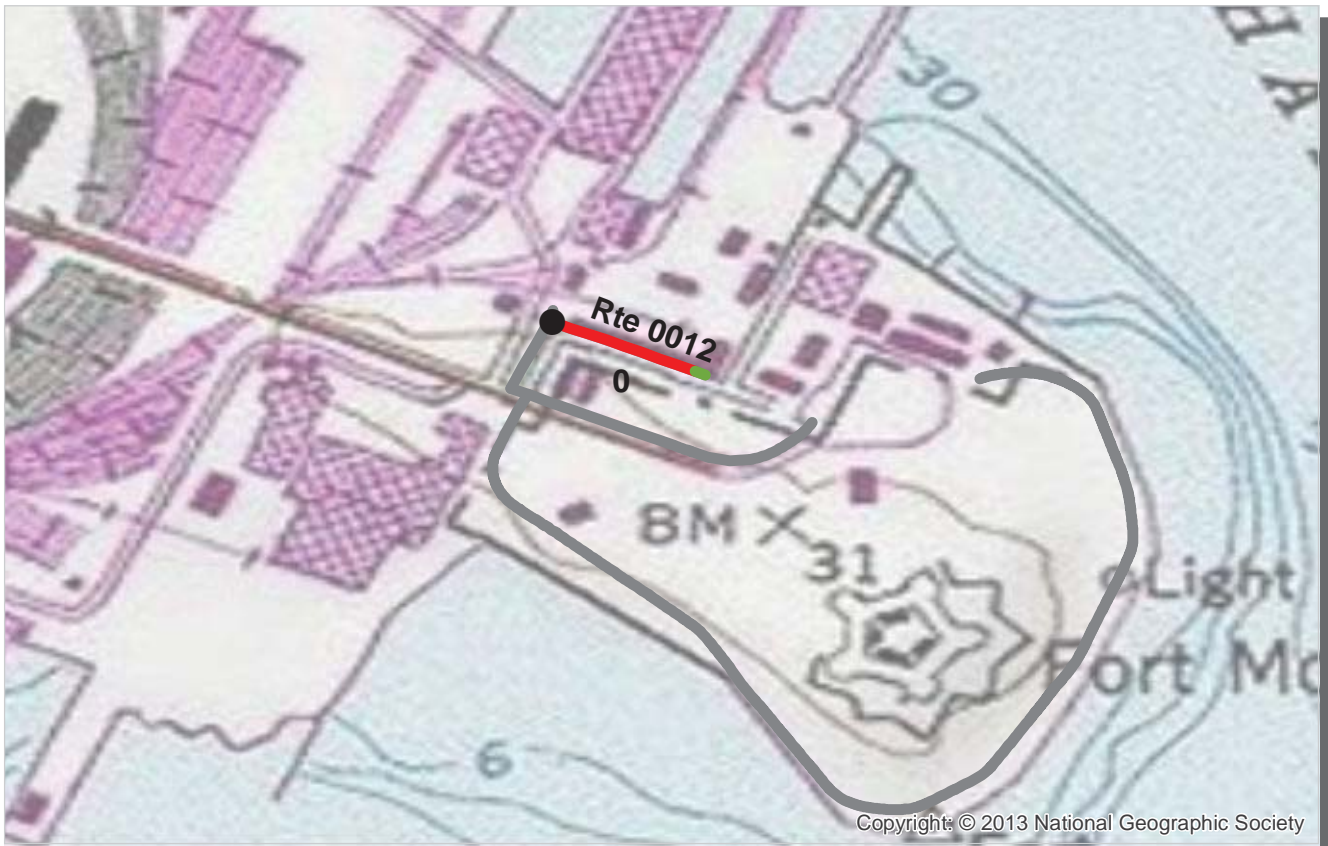
ROUTE: 0012 NIMITZ DRIVE

Section Number	0				
Section Length (mi)	0.09				
Cross Section Information					
Number of Lanes	2				
Paved Width (ft)	24				
Lane Width (ft)	12				
Roadway Condition Information					
SCR (Surface Condition Rating)	21				
PCR (Pavement Condition Rating)	21				
Distress Index Values					
Structural Crack Index	21				
Transverse Cracking Index	97				
Patching Index	100				
Rutting Index	97				
Roughness Condition Index (RCI)	NC

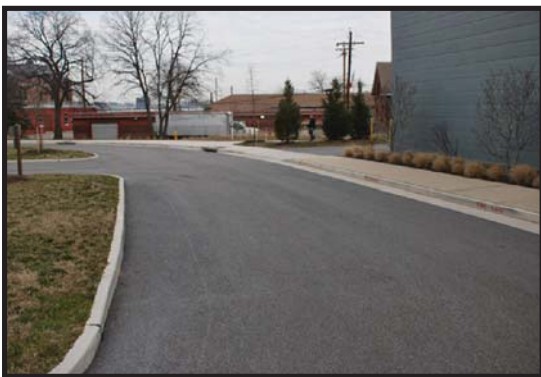
Route Number	Public / NonPublic	Date Visited	Area (sq ft)	Lane Miles *	Surface Type
0900	PUBLIC	2/13/2013	52,678	0.91	AS
Culverts	Drop Inlets	Gates	Curb & Gutter	Curb	PCR
0	8	0	CONCRETE CURB AND GUTTER	CONCRETE CURB	FAIR/73

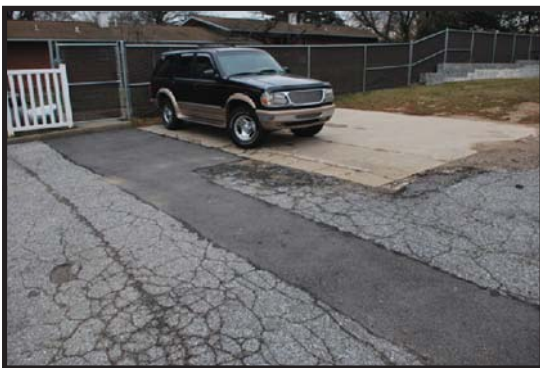
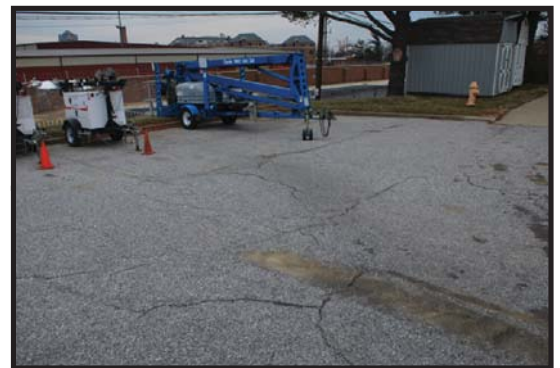
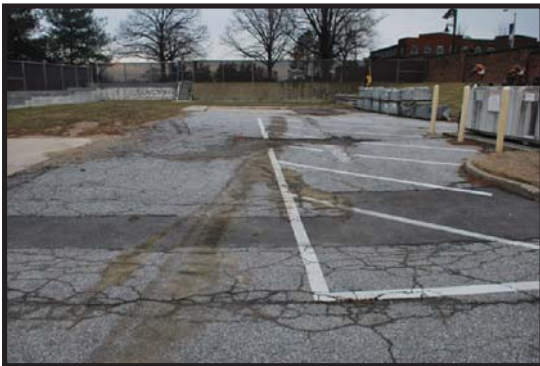
Route 0901

Route Number	Public / NonPublic	Date Visited	Area (sq ft)	Lane Miles *	Surface Type
0901	NONPUBLIC	2/13/2013	7,160	0.12	AS
Culverts	Drop Inlets	Gates	Curb & Gutter	Curb	PCR
0	1	3	NO CURB AND GUTTER	CONCRETE CURB	POOR/45

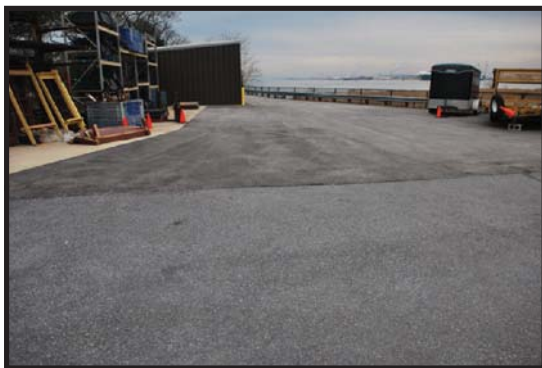
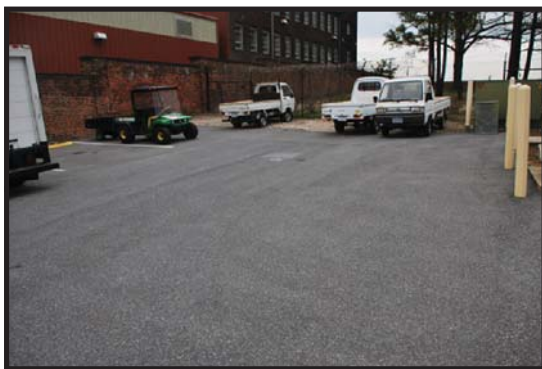
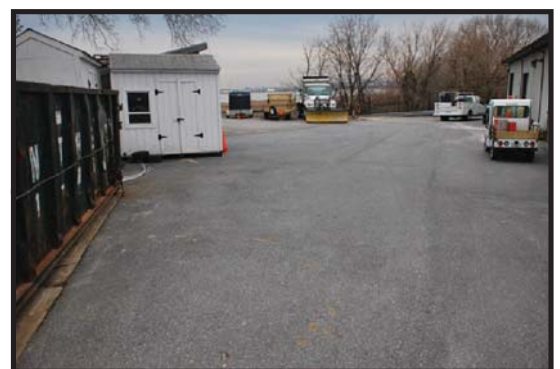
Route 0902

Route Number	Public / NonPublic	Date Visited	Area (sq ft)	Lane Miles *	Surface Type
0902	NONPUBLIC	2/13/2013	18,275	0.32	AS
Culverts	Drop Inlets	Gates	Curb & Gutter	Curb	PCR
0	2	2	NO CURB AND GUTTER	CONCRETE CURB	GOOD/90

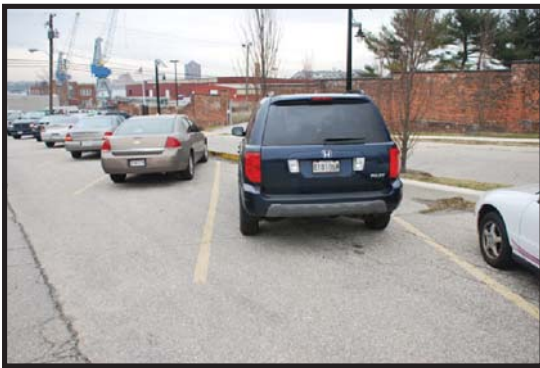
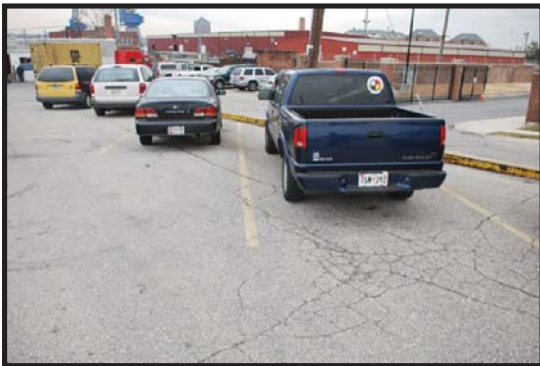
Route 0905

Route Number	Public / NonPublic	Date Visited	Area (sq ft)	Lane Miles *	Surface Type
0905	PUBLIC	2/13/2013	4,181	0.07	AS
Culverts	Drop Inlets	Gates	Curb & Gutter	Curb	PCR
0	0	0	NO CURB AND GUTTER	CONCRETE CURB	POOR/45
