Federal Lands Highway Road Inventory Program

Road Inventory and Condition Assessment

Fort Pulaski National Monument FOPU

Cycle 5 Report

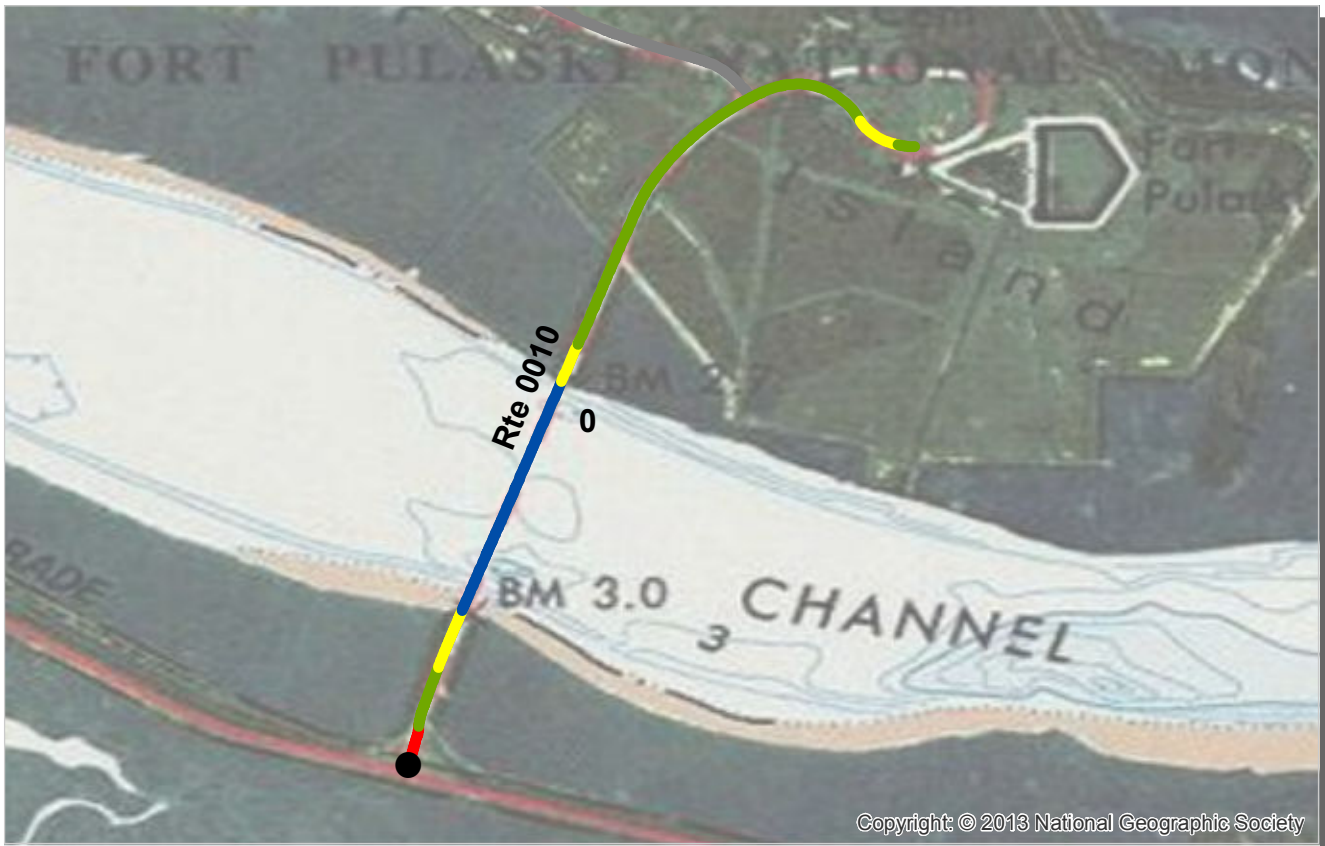
ROUTE: 0010 ENTRANCE ROAD

Section Number	0				
Section Length (mi)	0.89				
Cross Section Information					
Number of Lanes	2				
Paved Width (ft)	21				
Lane Width (ft)	10				
Roadway Condition Information					
SCR (Surface Condition Rating)	92				
PCR (Pavement Condition Rating)	86				
Distress Index Values					
Structural Crack Index	92				
Transverse Cracking Index	97				
Patching Index	100				
Rutting Index	99				
Roughness Condition Index (RCI)	78

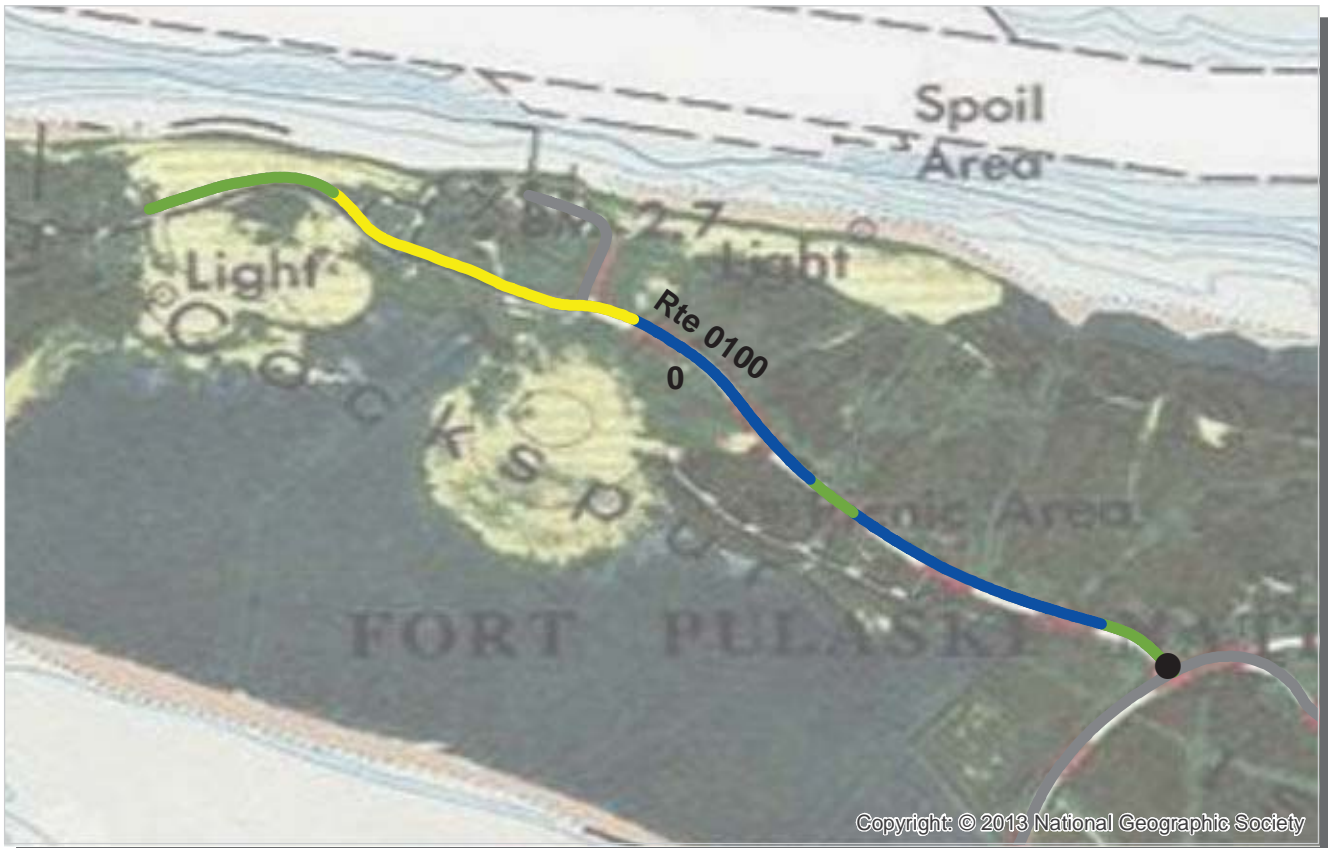
ROUTE: 0100 WEST ROAD

Section Number	0				
Section Length (mi)	0.86				
Cross Section Information					
Number of Lanes	2				
Paved Width (ft)	20				
Lane Width (ft)	10				
Roadway Condition Information					
SCR (Surface Condition Rating)	91				
PCR (Pavement Condition Rating)	91				
Distress Index Values					
Structural Crack Index	93				
Transverse Cracking Index	91				
Patching Index	100				
Rutting Index	94				
Roughness Condition Index (RCI)	NC

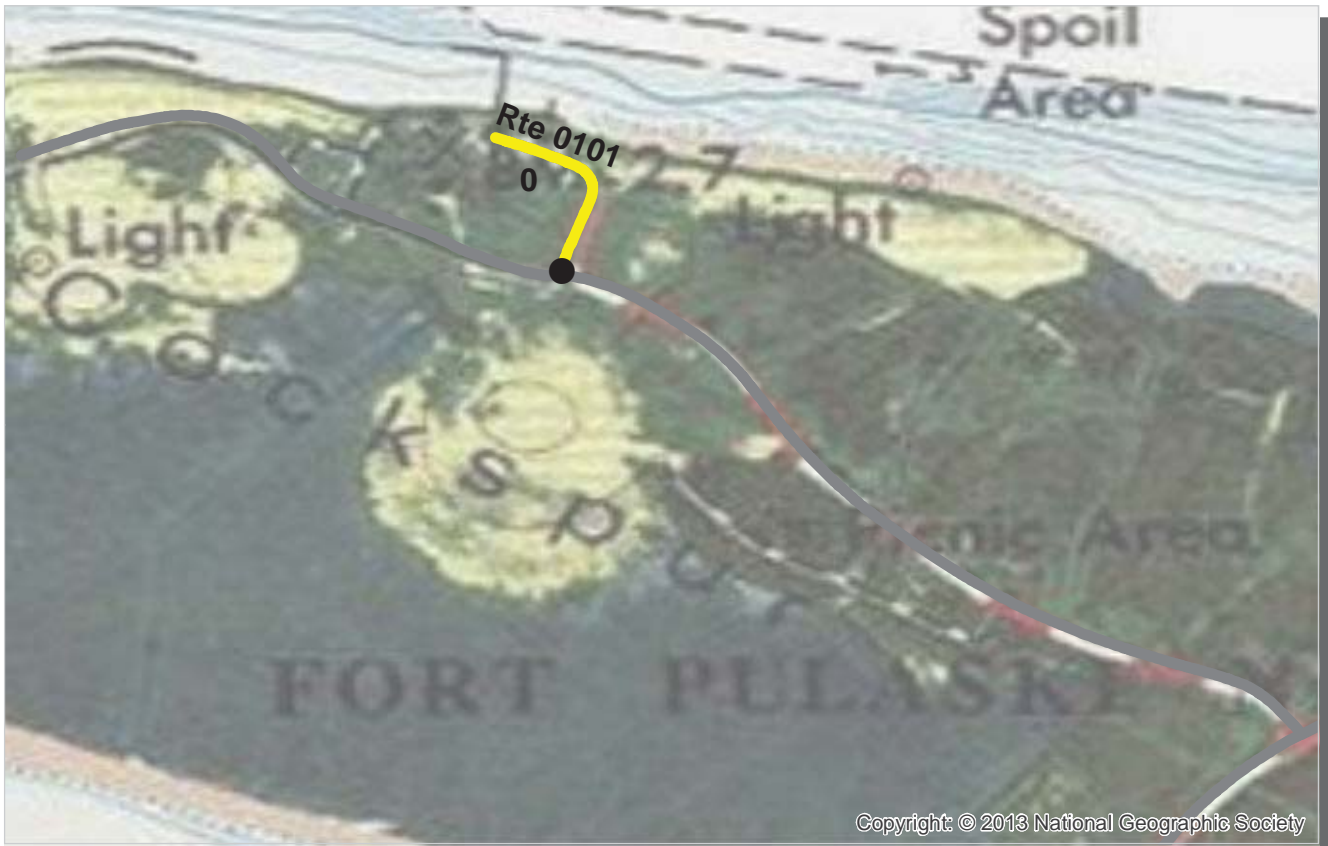
ROUTE: 0101 PILOT ROAD

Section Number	0				
Section Length (mi)	0.12				
Cross Section Information					
Number of Lanes	1				
Paved Width (ft)	13				
Lane Width (ft)	13				
Roadway Condition Information					
SCR (Surface Condition Rating)	80				
PCR (Pavement Condition Rating)	80				
Distress Index Values					
Structural Crack Index	80				
Transverse Cracking Index	81				
Patching Index	100				
Rutting Index	91				
Roughness Condition Index (RCI)	NC

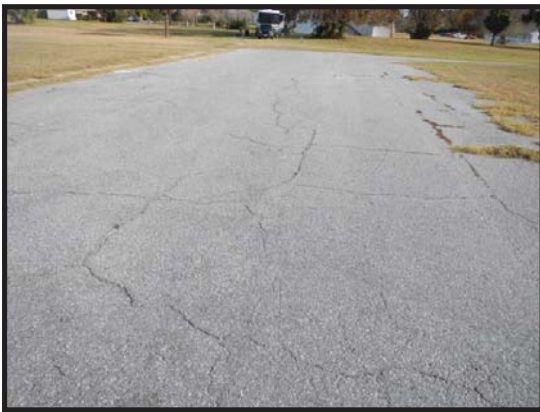
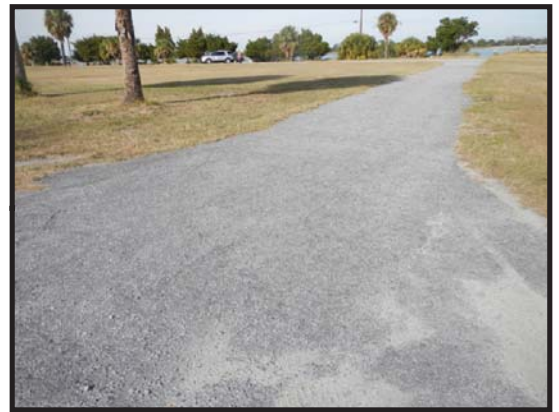
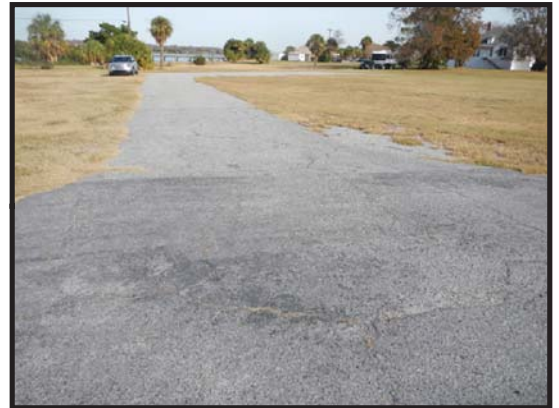
Route Number	Public / NonPublic	Date Visited	Area (sq ft)	Lane Miles *	Surface Type
0200	PUBLIC	12/5/2012	8,523	0.15	AS
Culverts	Drop Inlets	Gates	Curb & Gutter	Curb	PCR
0	0	0	NO CURB AND GUTTER	NO CURB	POOR/45

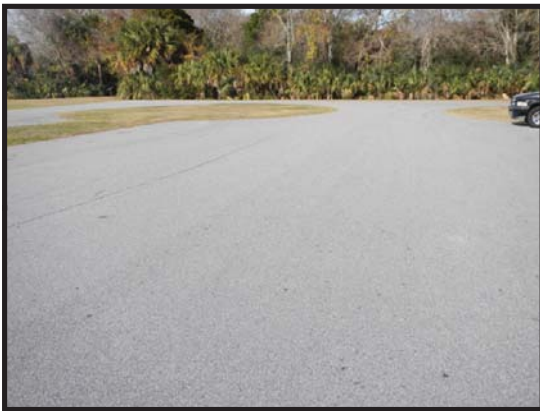
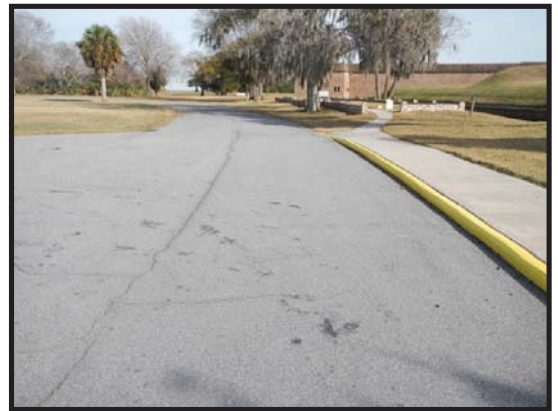
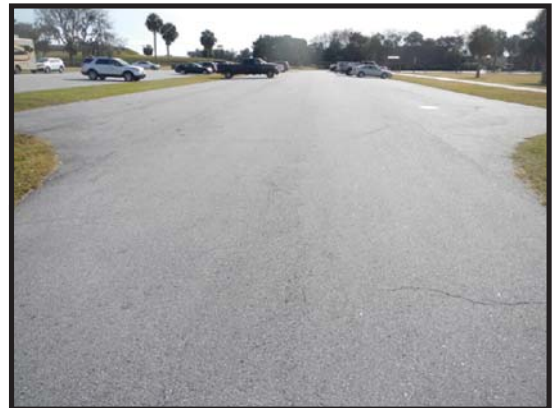
Route Number	Public / NonPublic	Date Visited	Area (sq ft)	Lane Miles *	Surface Type
0900	PUBLIC	12/5/2012	53,168	0.92	AS
Culverts	Drop Inlets	Gates	Curb & Gutter	Curb	PCR
0	3	0	NO CURB AND GUTTER	CONCRETE CURB	FAIR/73

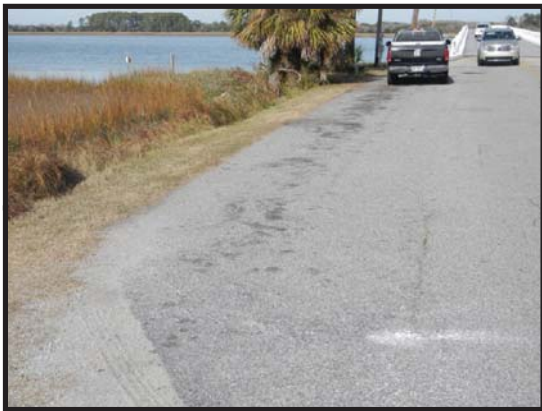
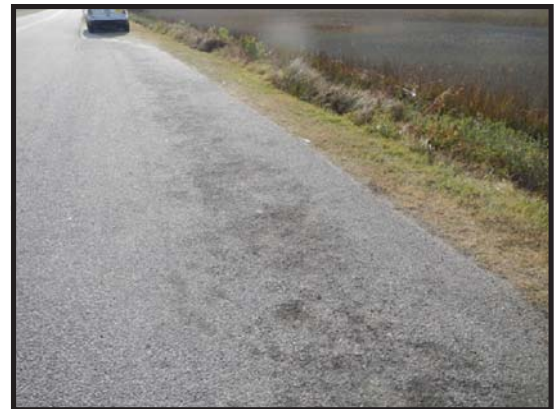
Route 0901AZ

Route Number	Public / NonPublic	Date Visited	Area (sq ft)	Lane Miles *	Surface Type
0901AZ	PUBLIC	12/5/2012	851	0.02	AS
Culverts	Drop Inlets	Gates	Curb & Gutter	Curb	PCR
0	0	0	NO CURB AND GUTTER	NO CURB	GOOD/90

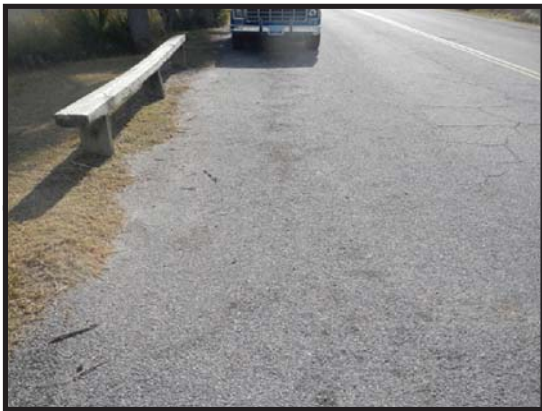
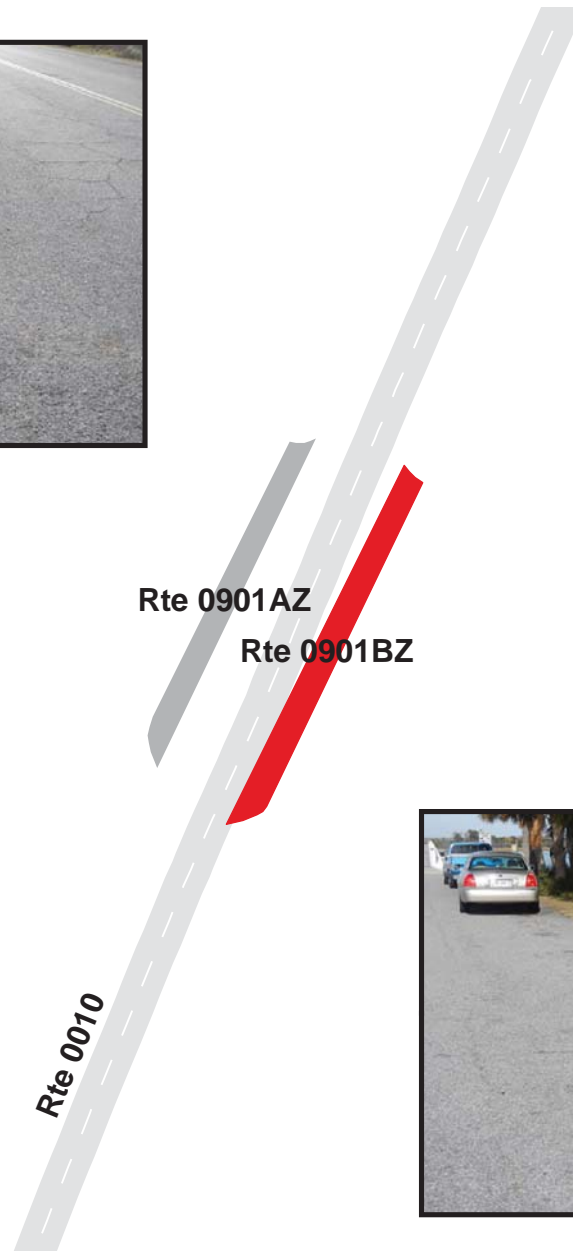
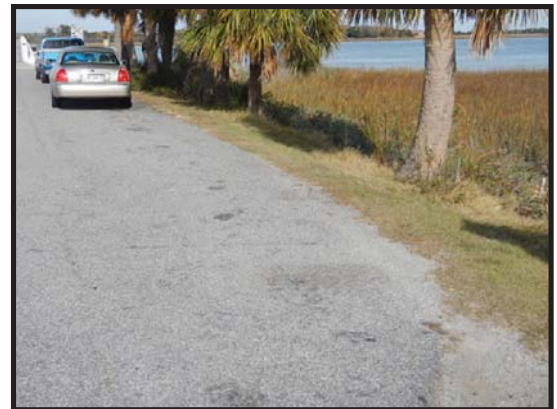
Route 0901BZ

Route Number	Public / NonPublic	Date Visited	Area (sq ft)	Lane Miles *	Surface Type
0901BZ	PUBLIC	12/5/2012	1,023	0.02	AS
Culverts	Drop Inlets	Gates	Curb & Gutter	Curb	PCR
0	0	0	NO CURB AND GUTTER	NO CURB	GOOD/90

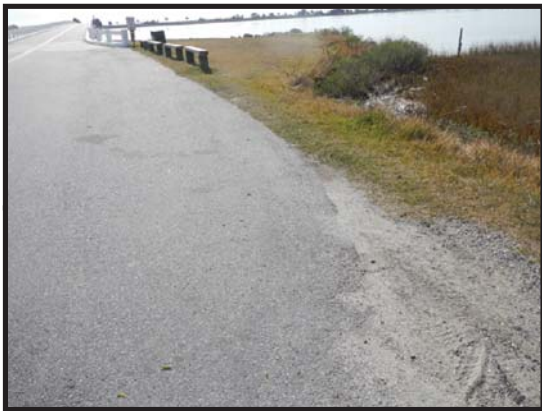
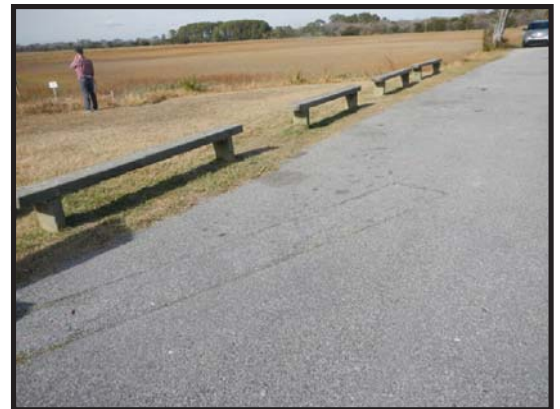
Route 0901CZ

Route Number	Public / NonPublic	Date Visited	Area (sq ft)	Lane Miles *	Surface Type
0901CZ	PUBLIC	12/5/2012	1,053	0.02	AS
Culverts	Drop Inlets	Gates	Curb & Gutter	Curb	PCR
0	0	0	NO CURB AND GUTTER	NO CURB	GOOD/90

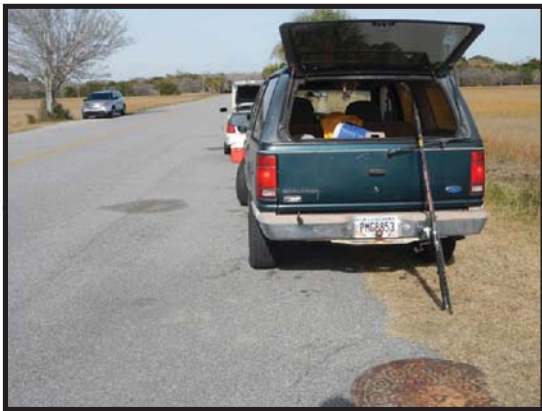
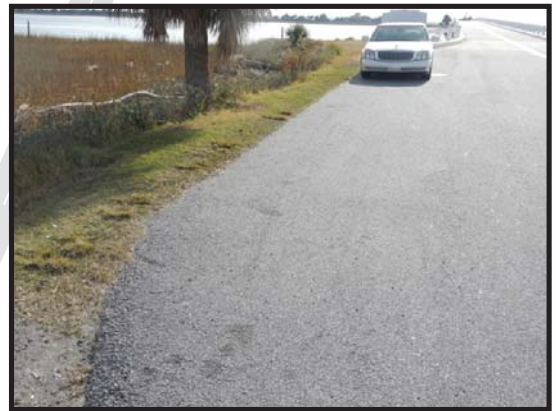
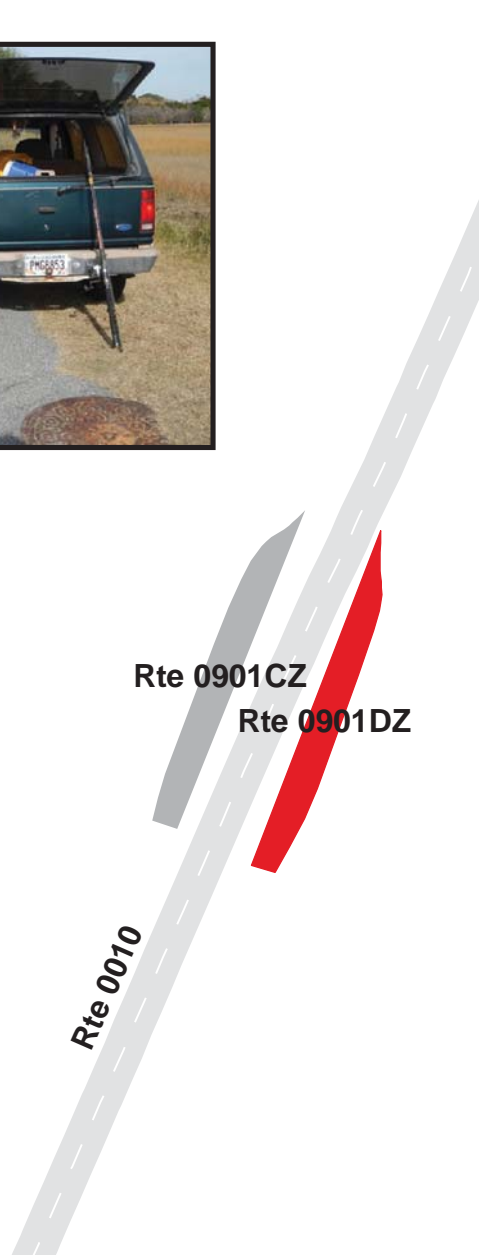
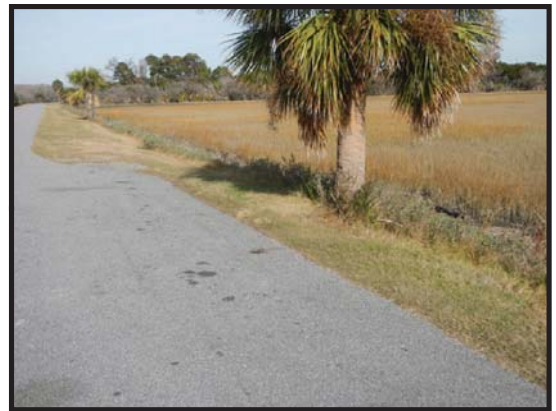
Route 0901DZ

Route Number	Public / NonPublic	Date Visited	Area (sq ft)	Lane Miles *	Surface Type
0901DZ	PUBLIC	12/5/2012	1,008	0.02	AS
Culverts	Drop Inlets	Gates	Curb & Gutter	Curb	PCR
0	0	0	NO CURB AND GUTTER	NO CURB	GOOD/90

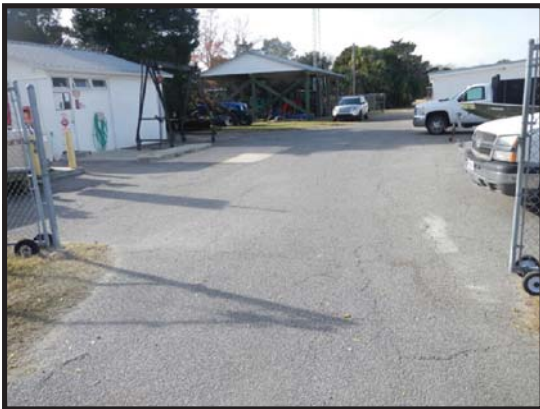
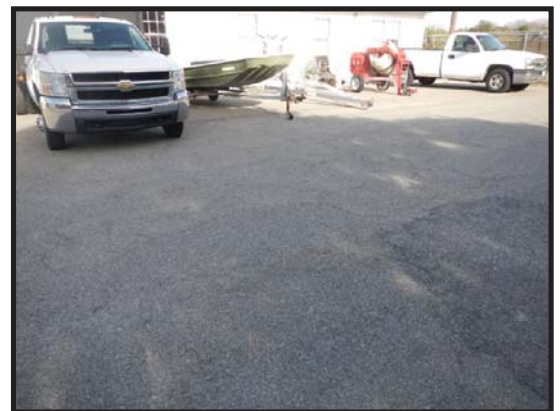
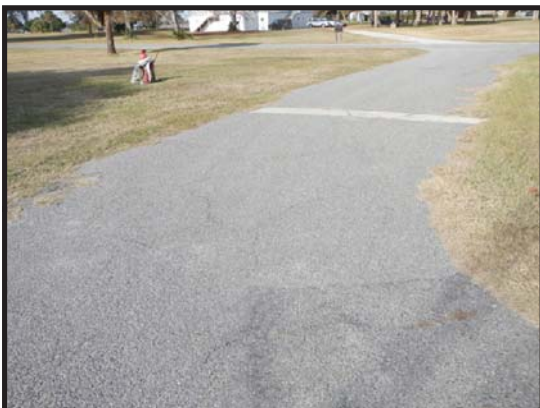
Route 0903

Route Number	Public / NonPublic	Date Visited	Area (sq ft)	Lane Miles *	Surface Type
0903	NONPUBLIC	12/5/2012	7,977	0.14	AS
Culverts	Drop Inlets	Gates	Curb & Gutter	Curb	PCR
1	0	2	NO CURB AND GUTTER	NO CURB	POOR/45

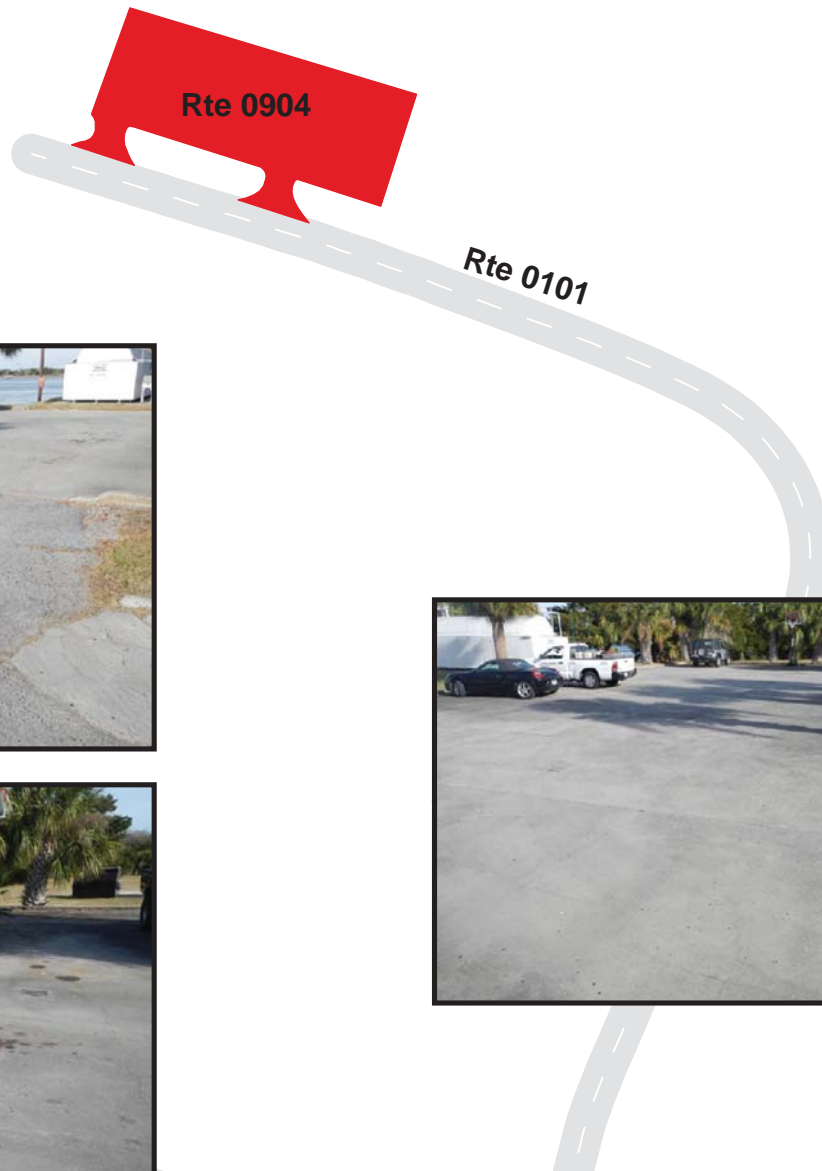
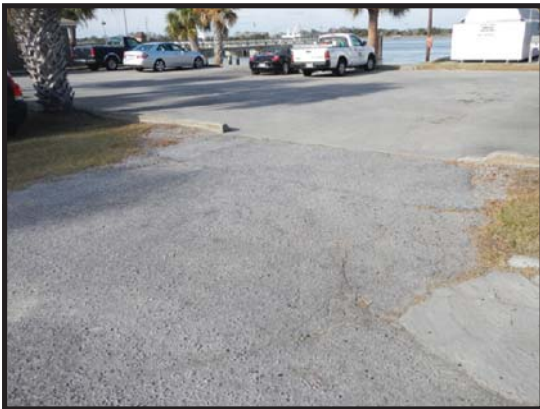
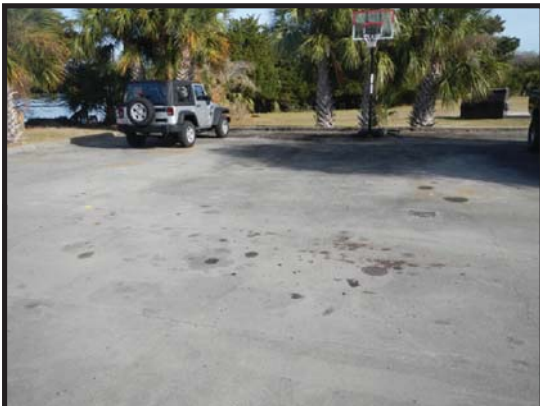
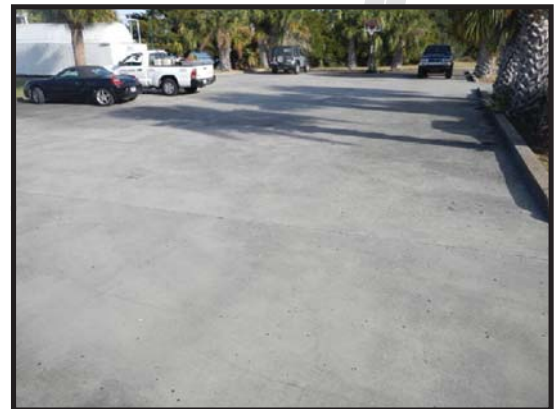
Route 0904

Route Number	Public / NonPublic	Date Visited	Area (sq ft)	Lane Miles *	Surface Type
0904	NONPUBLIC	12/5/2012	5,988	0.10	CO
Culverts	Drop Inlets	Gates	Curb & Gutter	Curb	PCR
0	0	0	NO CURB AND GUTTER	CONCRETE CURB	POOR/45
