# Federal Lands Highway Road Inventory Program

Road Inventory and Condition Assessment

**Fort Scott National Historic Site**  
**FOSC - 6350**

**Cycle 5 Report**

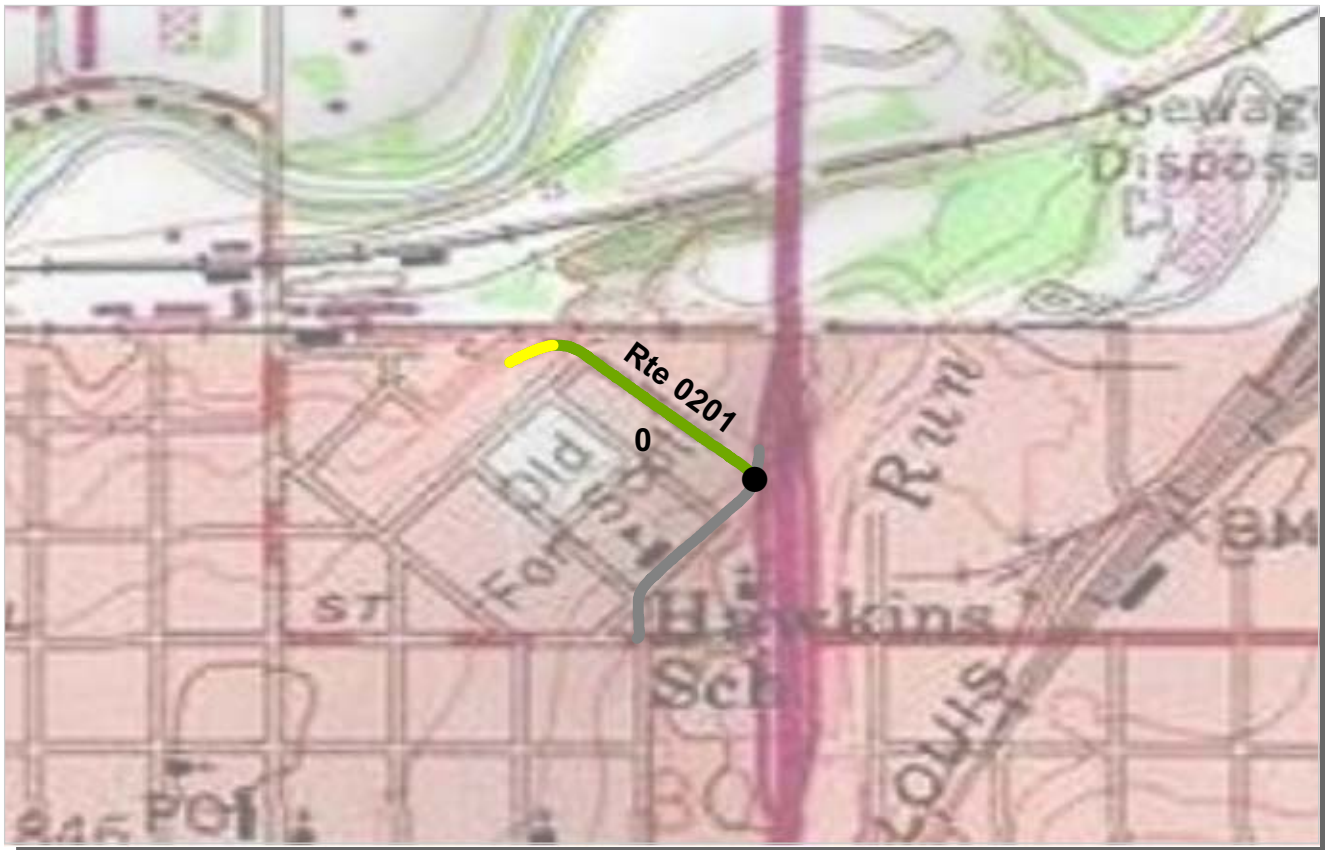
**ROUTE: 0201 SITE ACCESS ROAD**

<b>Section Number</b>	0				
<b>Section Length (mi)</b>	0.17				
<b>Cross Section Information</b>					
Number of Lanes	1				
Paved Width (ft)	11				
Lane Width (ft)	11				
<b>Roadway Condition Information</b>					
SCR (Surface Condition Rating)	85				
PCR (Pavement Condition Rating)	85				
<b>Distress Index Values</b>					
Structural Crack Index	100				
Transverse Cracking Index	96				
Patching Index	100				
Rutting Index	85				
Roughness Condition Index (RCI)	NC

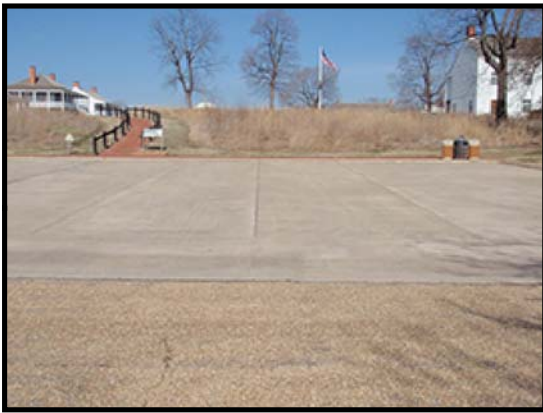
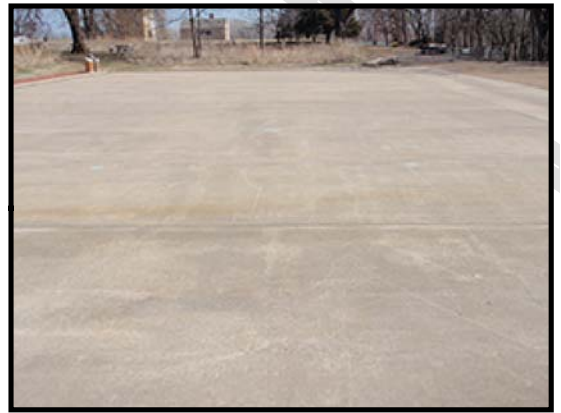
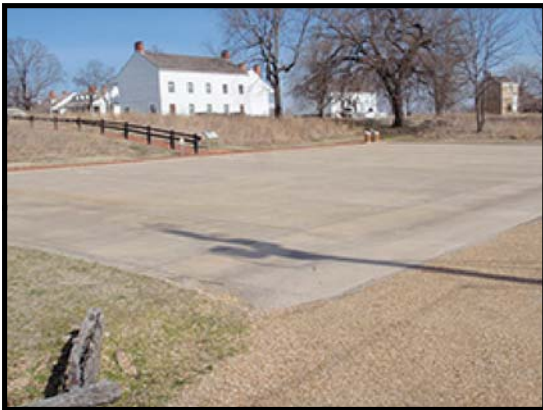
Route Number	Public / NonPublic	Date Visited	Area (sq ft)	Lane Miles *	Surface Type
0900	PUBLIC	3/16/2011	10,174	0.18	CO
Culverts	Drop Inlets	Gates	Curb & Gutter	Curb	PCR
0	0	0	CONCRETE CURB AND GUTTER	NO CURB	GOOD/90

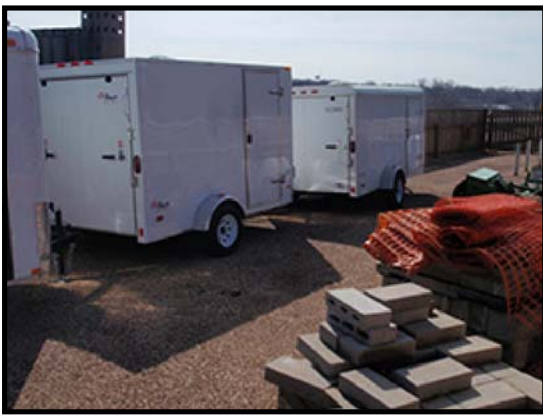
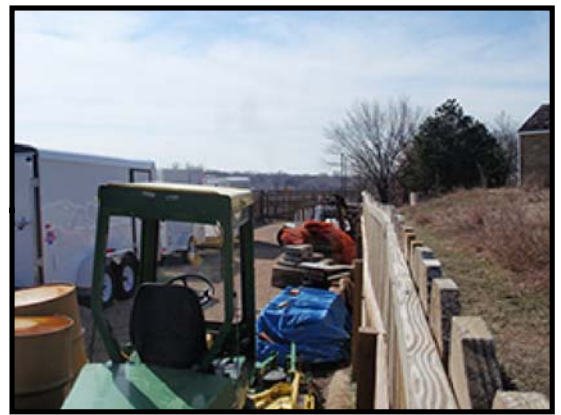
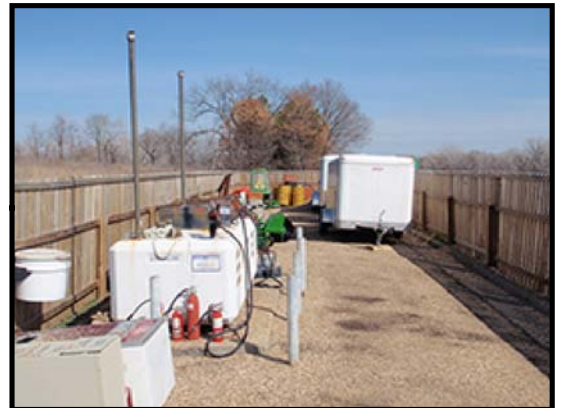
## Route 0901

Route Number	Public / NonPublic	Date Visited	Area (sq ft)	Lane Miles *	Surface Type
0901	NONPUBLIC	3/16/2011	2,697	0.05	AS
Culverts	Drop Inlets	Gates	Curb & Gutter	Curb	PCR
0	0	1	CONCRETE CURB AND GUTTER	NO CURB	GOOD/90
