Federal Lands Highway Road Inventory Program

Road Inventory and Condition Assessment

Fort Union National Monument FOUN

Cycle 5 Report

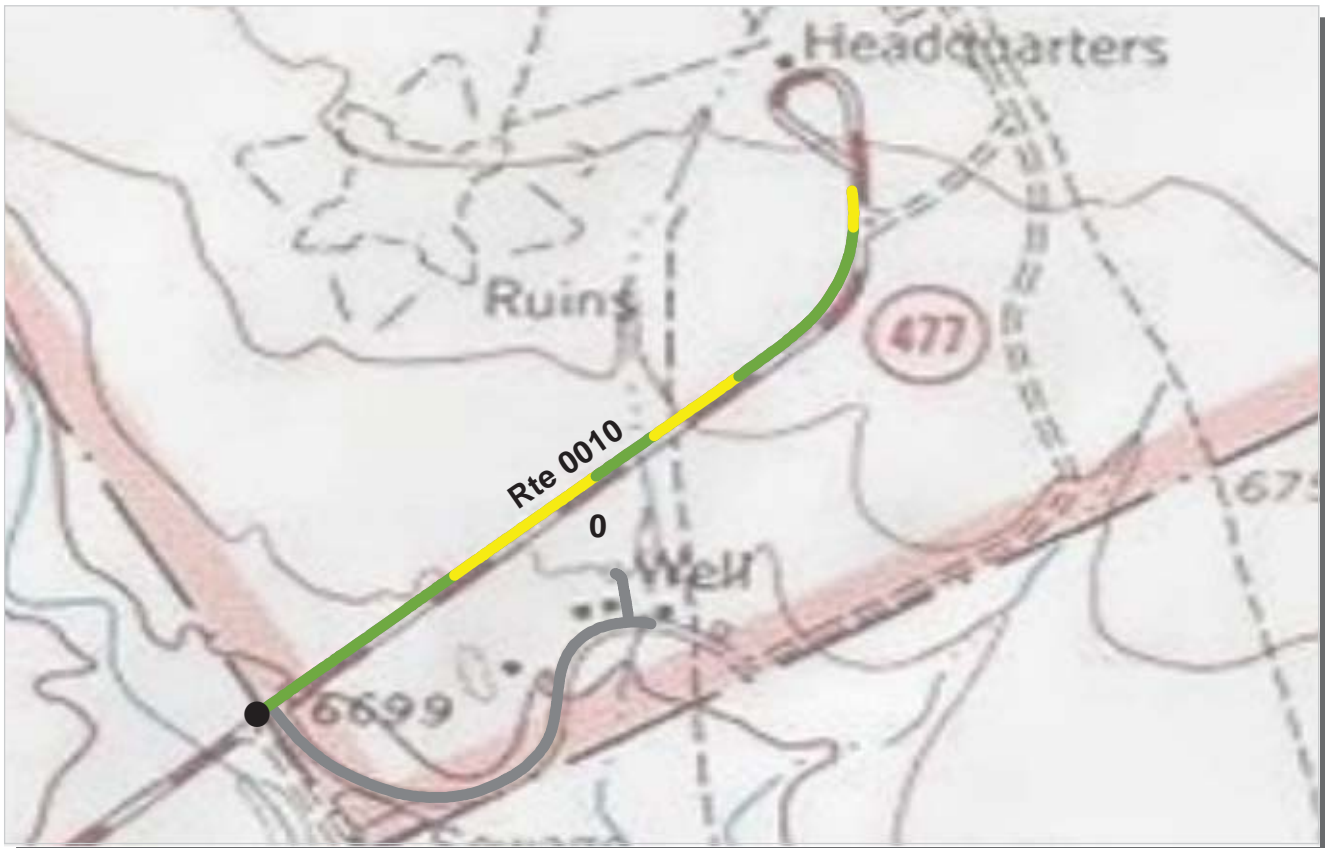
Section Number	0				
Section Length (mi)	0.48				
Cross Section Information					
Number of Lanes	2				
Paved Width (ft)	21				
Lane Width (ft)	10				
Roadway Condition Information					
SCR (Surface Condition Rating)	85				
PCR (Pavement Condition Rating)	85				
Distress Index Values					
Structural Crack Index	85				
Transverse Cracking Index	89				
Patching Index	99				
Rutting Index	94				
Roughness Condition Index (RCI)	NC

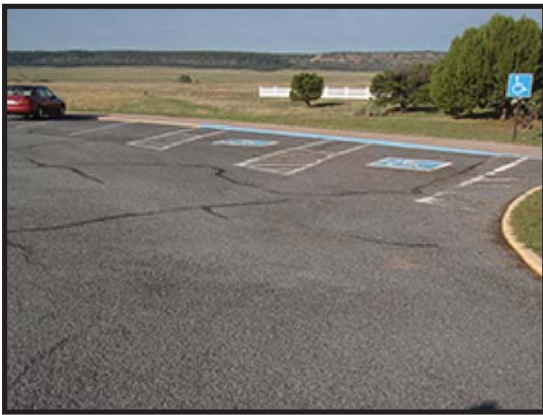
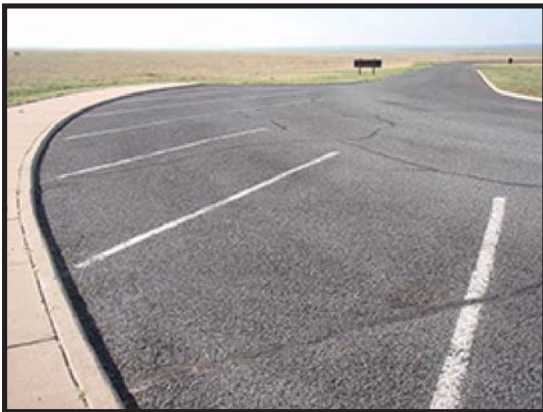
Route Number	Public / NonPublic	Date Visited	Area (sq ft)	Lane Miles *	Surface Type
0900	PUBLIC	9/5/2011	35,547	0.61	AS
Culverts	Drop Inlets	Gates	Curb & Gutter	Curb	PCR
0	0	0	NO CURB AND GUTTER	CONCRETE CURB	FAIR/73

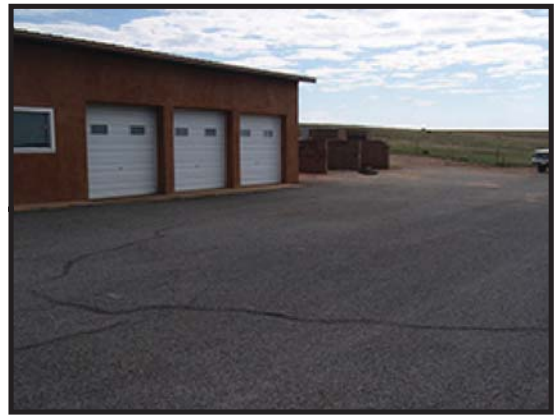
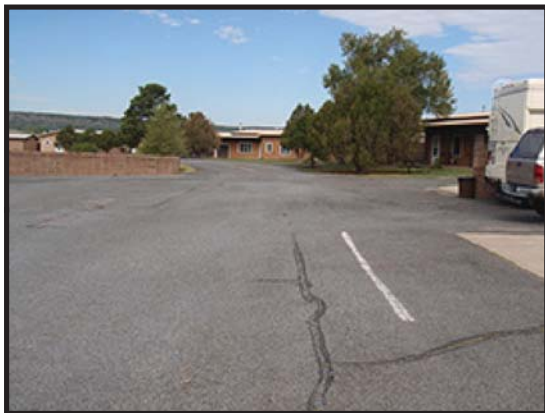
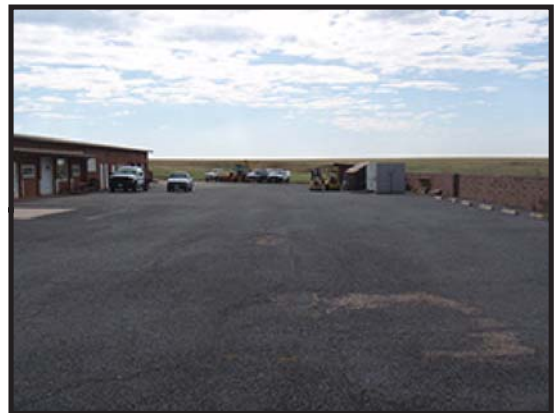
Route 0901

Route Number	Public / NonPublic	Date Visited	Area (sq ft)	Lane Miles *	Surface Type
0901	NONPUBLIC	9/5/2011	26,837	0.46	AS
Culverts	Drop Inlets	Gates	Curb & Gutter	Curb	PCR
0	0	0	NO CURB AND GUTTER	NO CURB	POOR/45
