# Federal Lands Highway Road Inventory Program

Road Inventory and Condition Assessment

## Fort Union Trading Post National Historic Site FOUS - 1549

### Cycle 5 Report

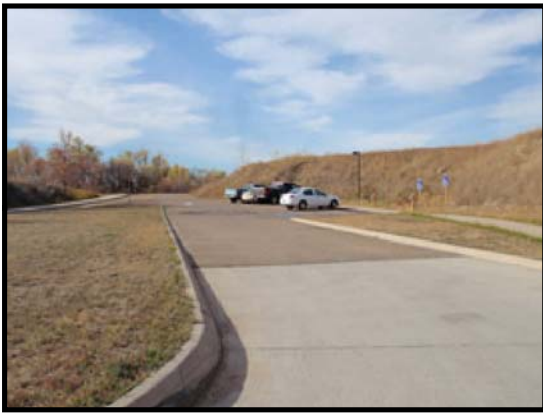
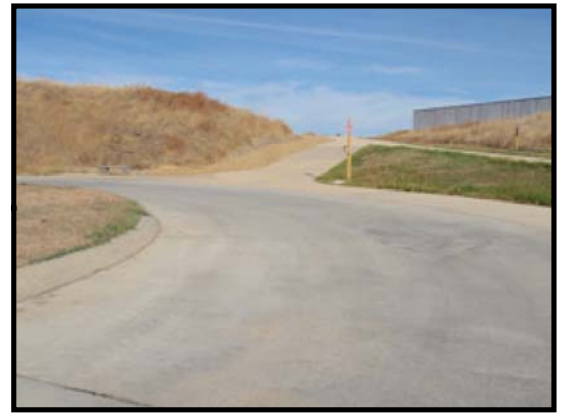
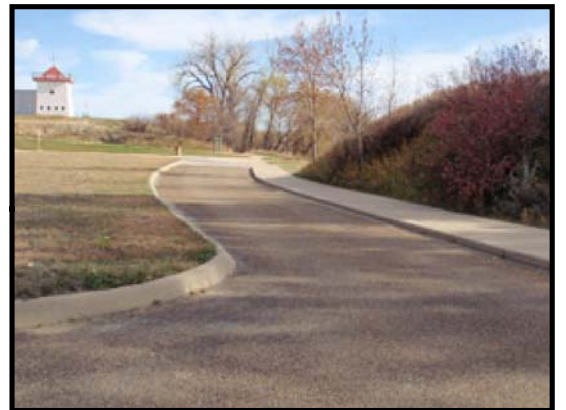
## Route 0903

Route Number	Public / NonPublic	Date Visited	Area (sq ft)	Lane Miles *	Surface Type
0901	PUBLIC	10/20/2010	12,156	0.21	AS
Culverts	Drop Inlets	Gates	Curb & Gutter	Curb	PCR
0	1	0	NO CURB AND GUTTER	CONCRETE CURB	GOOD/90

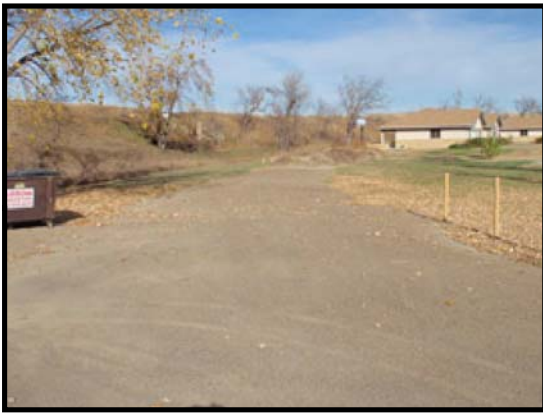
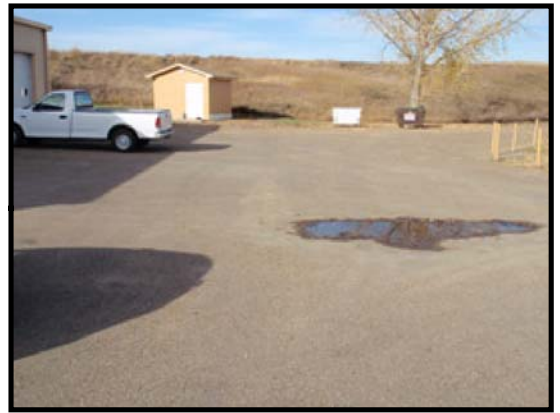
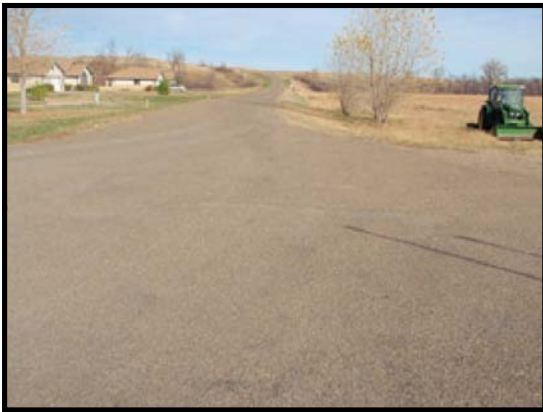
Route Number	Public / NonPublic	Date Visited	Area (sq ft)	Lane Miles *	Surface Type
0903	NONPUBLIC	10/20/2010	12,583	0.22	AS
Culverts	Drop Inlets	Gates	Curb & Gutter	Curb	PCR
0	0	0	NO CURB AND GUTTER	NO CURB	GOOD/90
