# Federal Lands Highway Road Inventory Program

Road Inventory and Condition Assessment

## Fort Vancouver National Historic Site FOVA - 9430

### Cycle 5 Report

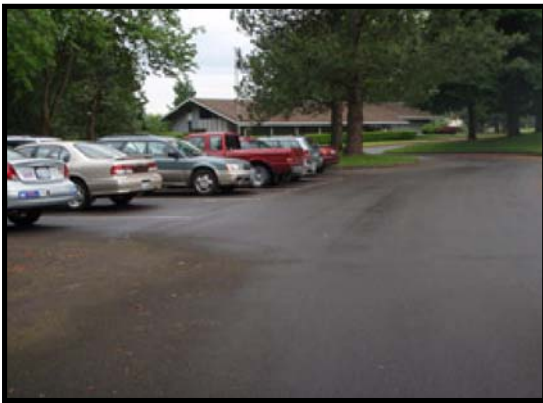
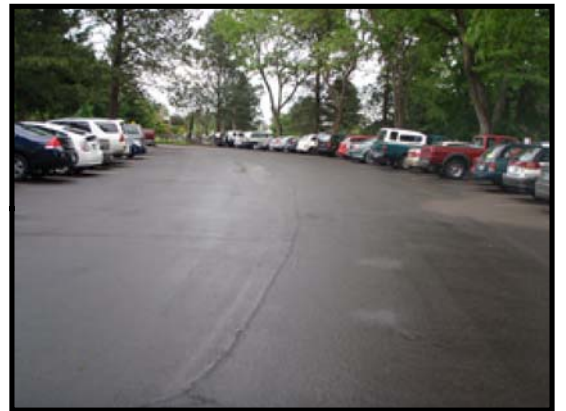
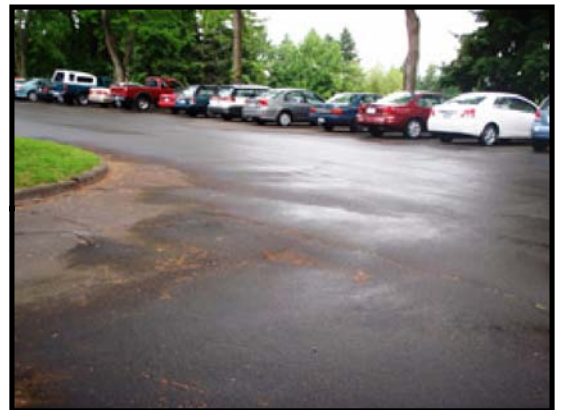
Route Number	Public / NonPublic	Date Visited	Area (sq ft)	Lane Miles *	Surface Type
0900	PUBLIC	6/15/2010	25,939	0.45	AS
Culverts	Drop Inlets	Gates	Curb & Gutter	Curb	PCR
0	1	0	NO CURB AND GUTTER	CONCRETE CURB	FAIR/73

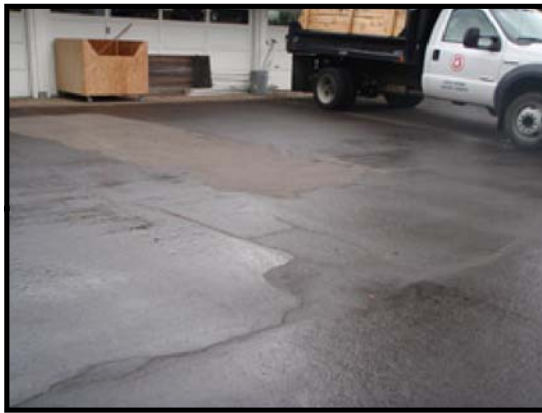
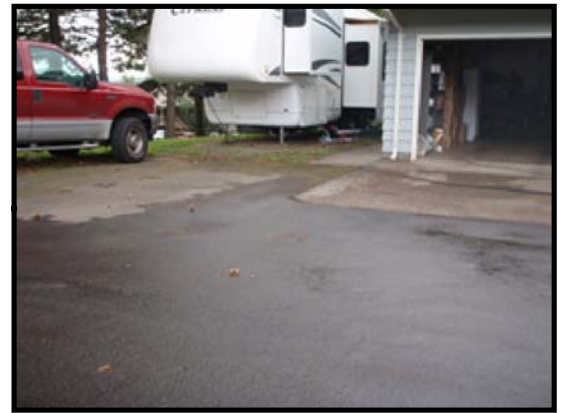
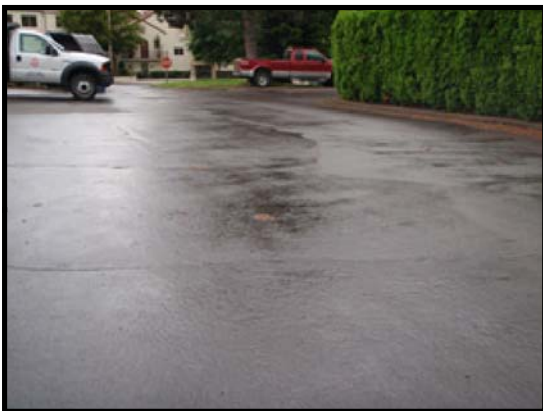
## Route 0901

Route Number	Public / NonPublic	Date Visited	Area (sq ft)	Lane Miles *	Surface Type
0901	NONPUBLIC	6/15/2010	7,405	0.13	AS
Culverts	Drop Inlets	Gates	Curb & Gutter	Curb	PCR
0	0	0	NO CURB AND GUTTER	CONCRETE CURB	FAIR/73

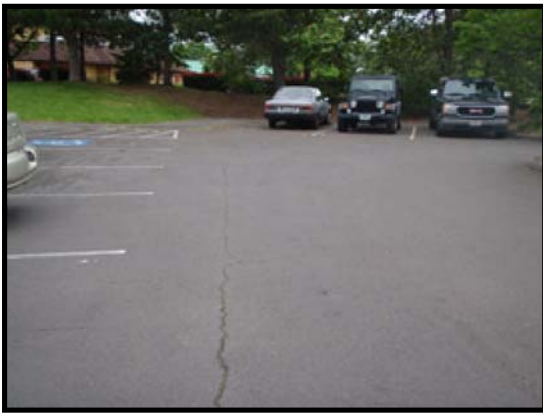
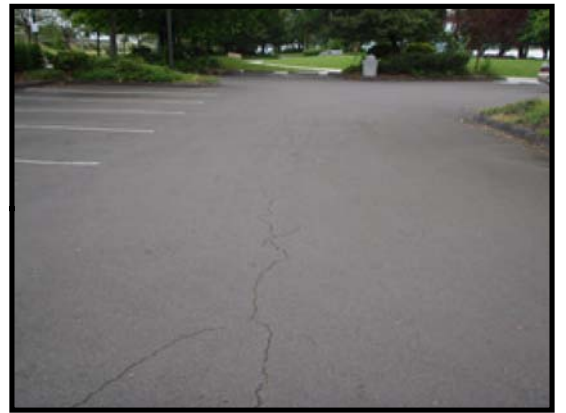
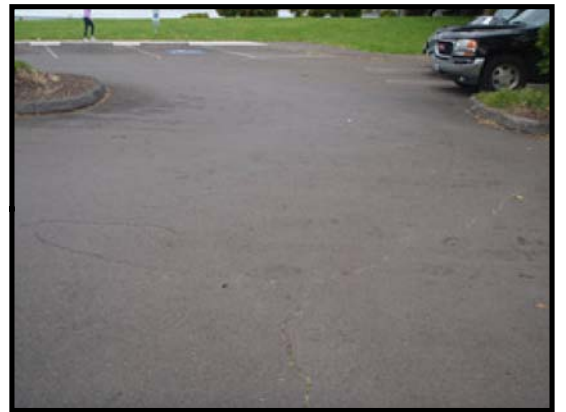
## Route 0903A

Route Number	Public / NonPublic	Date Visited	Area (sq ft)	Lane Miles *	Surface Type
0903A	PUBLIC	6/15/2010	10,183	0.18	AS
Culverts	Drop Inlets	Gates	Curb & Gutter	Curb	PCR
0	0	0	NO CURB AND GUTTER	CONCRETE CURB	FAIR/73

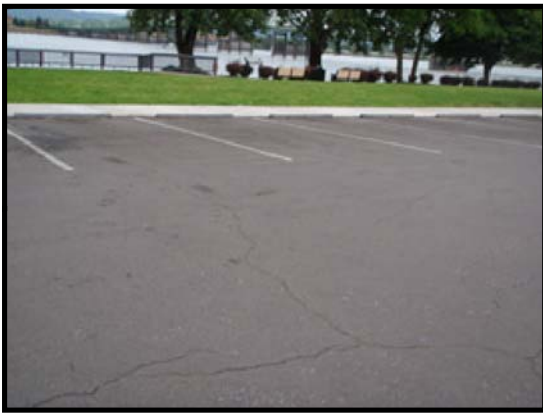
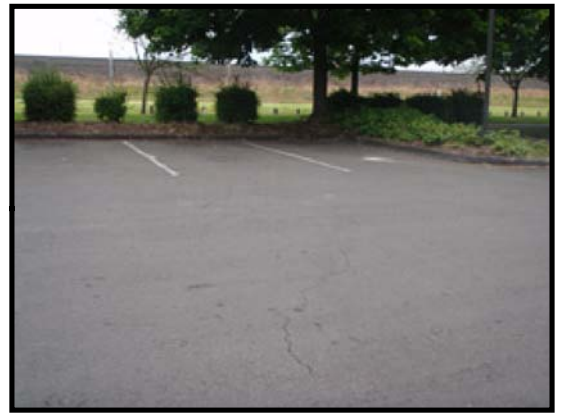
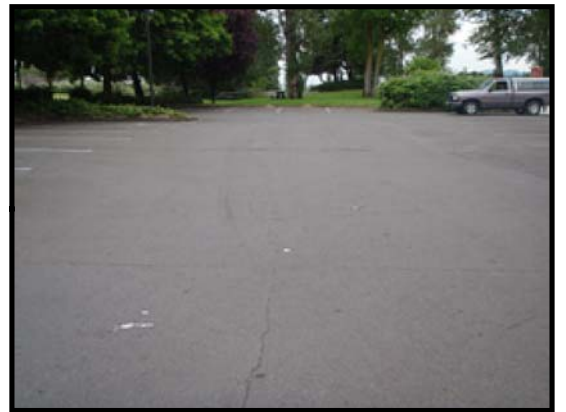
## Route 0903B

Route Number	Public / NonPublic	Date Visited	Area (sq ft)	Lane Miles *	Surface Type
0903B	PUBLIC	6/15/2010	9,448	0.16	AS
Culverts	Drop Inlets	Gates	Curb & Gutter	Curb	PCR
0	0	0	NO CURB AND GUTTER	CONCRETE CURB	FAIR/73

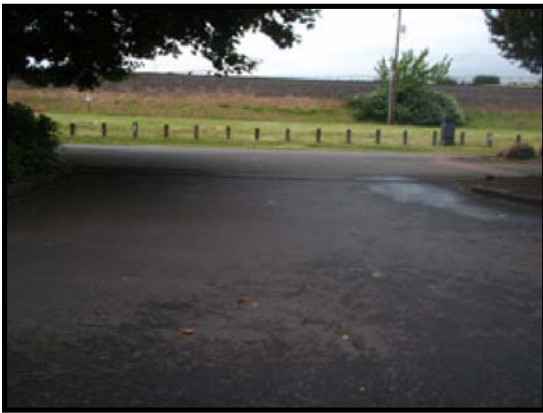
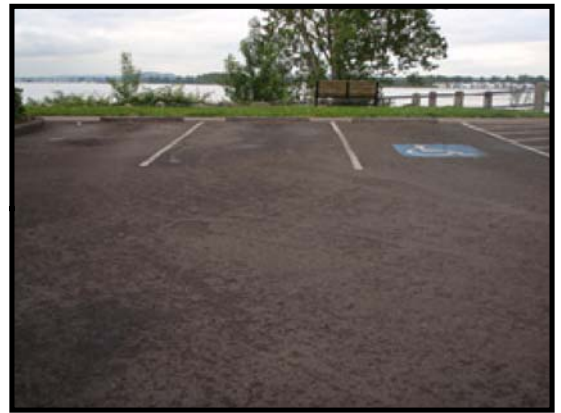
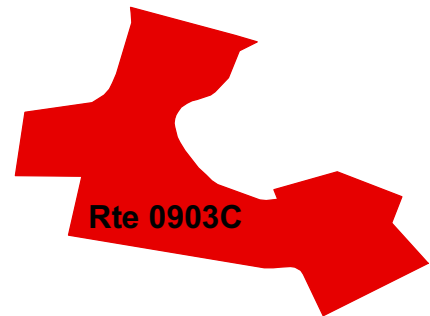
## Route 0903C

Route Number	Public / NonPublic	Date Visited	Area (sq ft)	Lane Miles *	Surface Type
0903C	PUBLIC	6/15/2010	6,948	0.12	AS
Culverts	Drop Inlets	Gates	Curb & Gutter	Curb	PCR
0	1	0	NO CURB AND GUTTER	CONCRETE CURB	FAIR/73

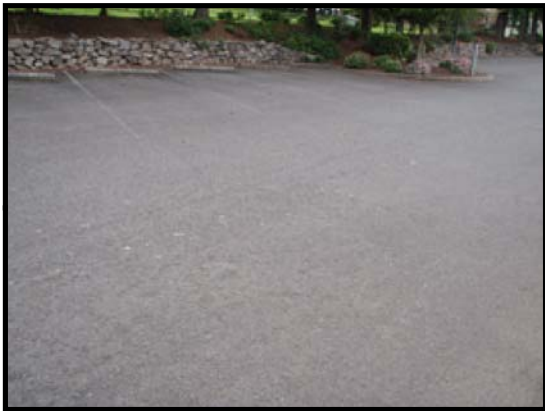
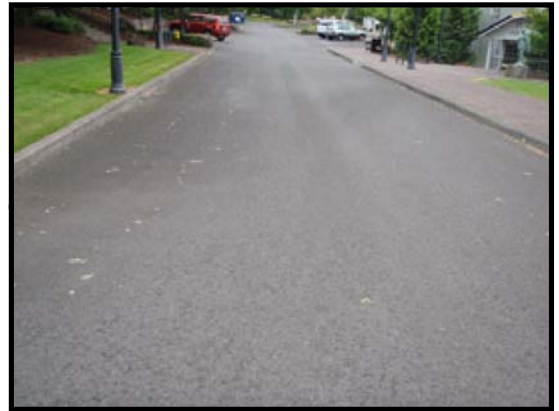
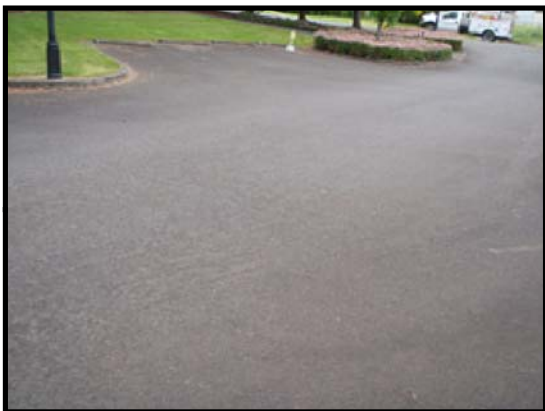
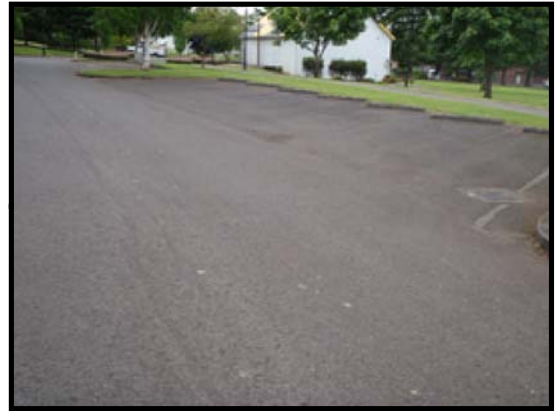
## Route 0904

Route Number	Public / NonPublic	Date Visited	Area (sq ft)	Lane Miles *	Surface Type
0904	PUBLIC	6/15/2010	23,867	0.41	AS
Culverts	Drop Inlets	Gates	Curb & Gutter	Curb	PCR
0	3	0	NO CURB AND GUTTER	CONCRETE CURB	FAIR/73
