Federal Lands Highway Road Inventory Program

Road Inventory and Condition Assessment

Friendship Hill National Historic Site FRHI

Cycle 5 Report

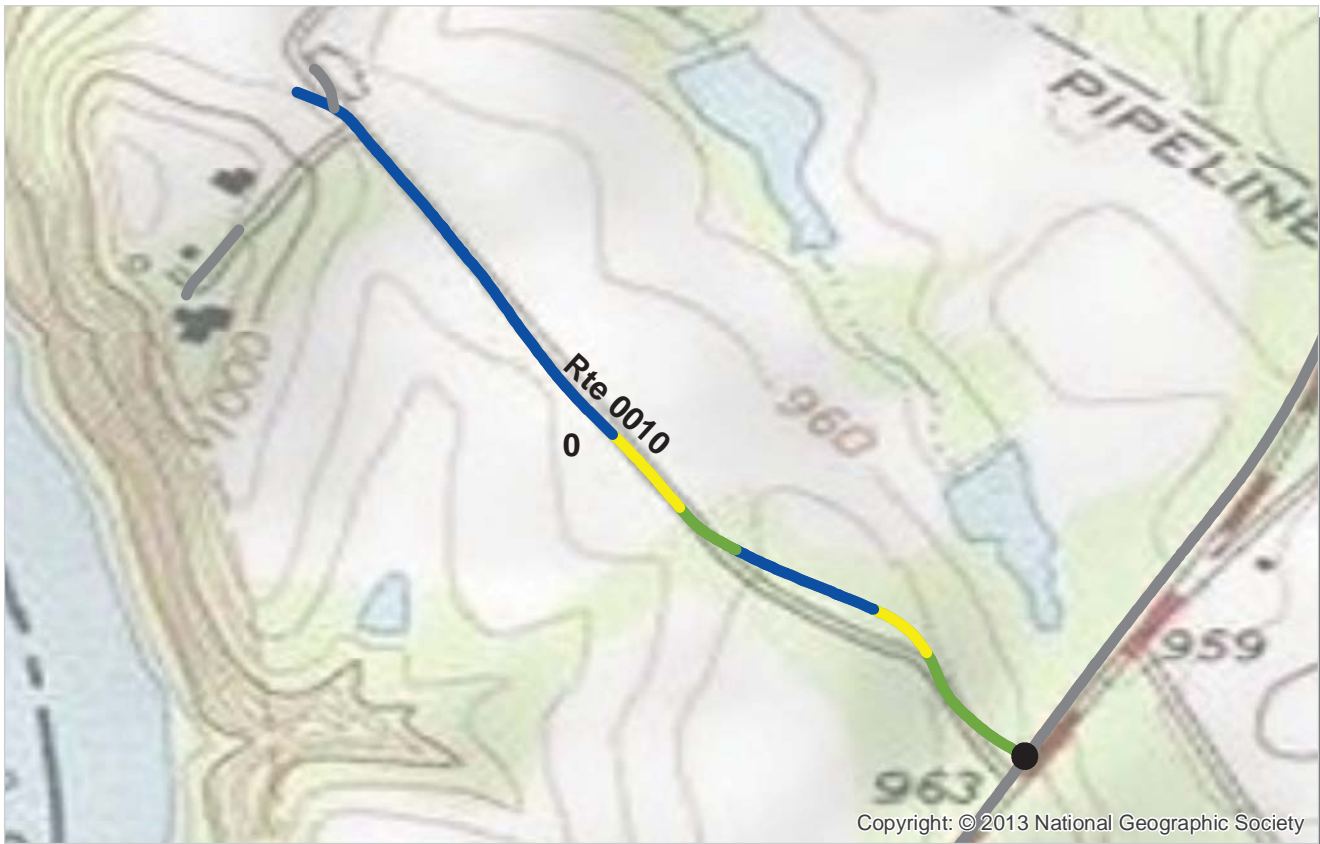
PCR	Poor	Fair	Good	Excellent	No Data
	(0 - 60)	(61 - 84)	(85 - 94)	(95 - 100)

Section Number	0				
Section Length (mi)	0.58				
Cross Section Information					
Number of Lanes	2				
Paved Width (ft)	19				
Lane Width (ft)	9				
Roadway Condition Information					
SCR (Surface Condition Rating)	94				
PCR (Pavement Condition Rating)	94				
Distress Index Values					
Structural Crack Index	94				
Transverse Cracking Index	100				
Patching Index	100				
Rutting Index	99				
Roughness Condition Index (RCI)	NC

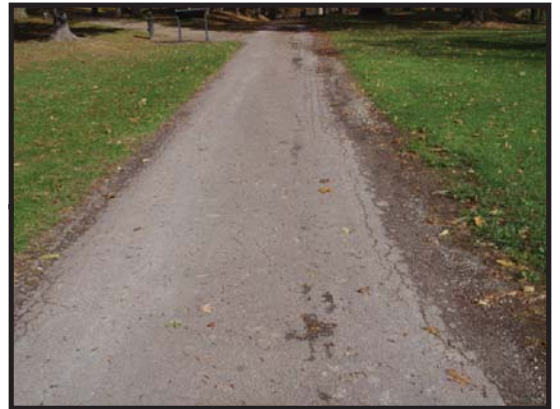
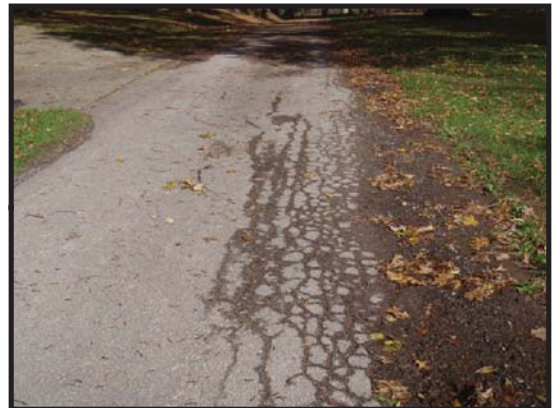
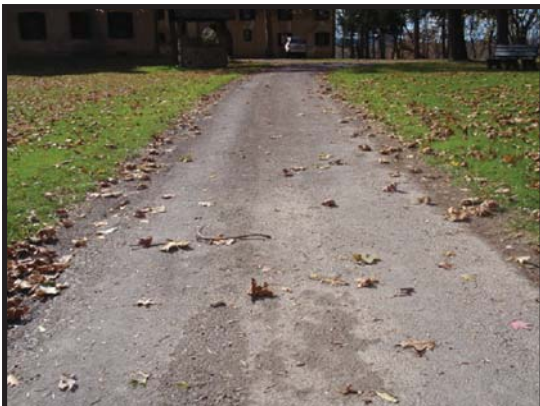
Route 0401

Route Number	Public / NonPublic	Date Visited	Area (sq ft)	Lane Miles *	Paved Length (mi)	Paved Width (ft)
0401	PUBLIC	9/18/2013	1,531	0.03	0.03	10
Culverts	Drop Inlets	Gates	Curb & Gutter	Curb	PCR	Surface Type
0	0	1	NO CURB AND GUTTER	NO CURB	GOOD/90	AS

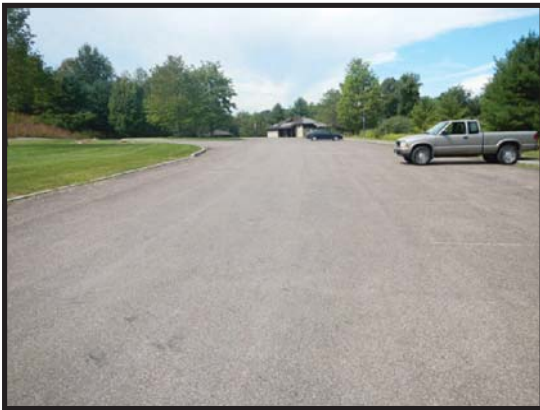
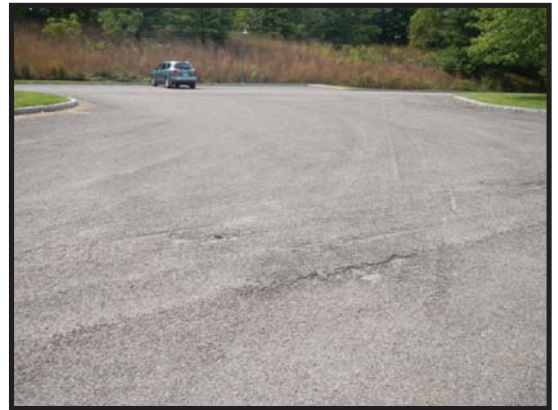
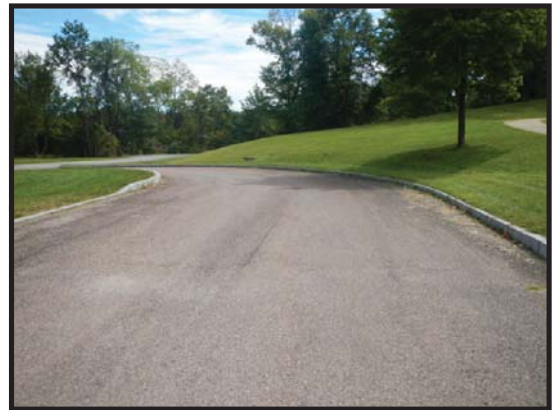
Route Number	Public / NonPublic	Date Visited	Area (sq ft)	Lane Miles *	Surface Type
0900	PUBLIC	9/18/2013	33,164	0.57	AS
Culverts	Drop Inlets	Gates	Curb & Gutter	Curb	PCR
1	1	0	NO CURB AND GUTTER	STONE CURB	GOOD/90

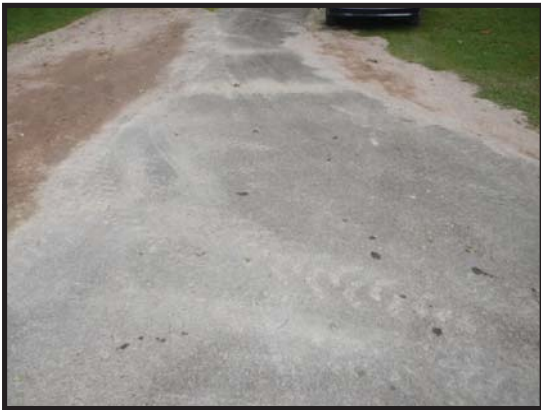
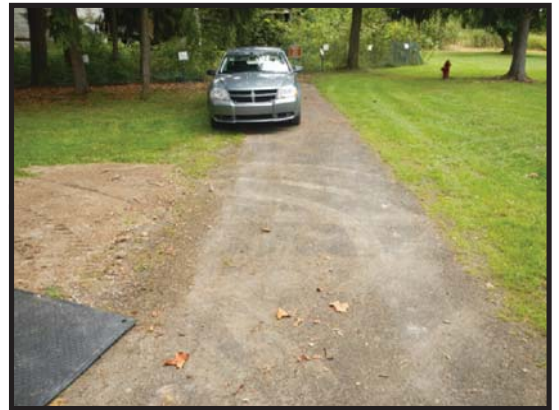
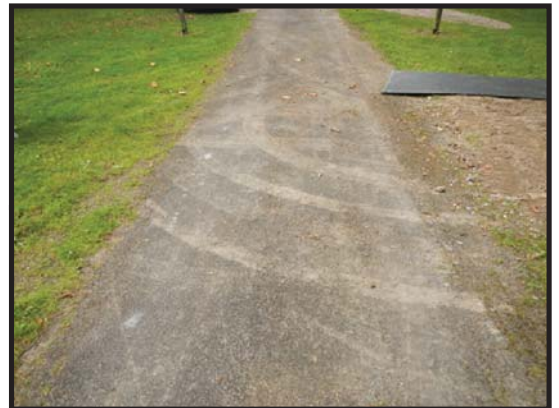
Route 0904

Route Number	Public / NonPublic	Date Visited	Area (sq ft)	Lane Miles *	Surface Type
0904	PUBLIC	9/18/2013	1,420	0.02	AS
Culverts	Drop Inlets	Gates	Curb & Gutter	Curb	PCR
0	0	0	NO CURB AND GUTTER	NO CURB	FAIR/73
