# Federal Lands Highway Road Inventory Program

Road Inventory and Condition Assessment

## Fredericksburg and Spotsylvania National Military Park FRSP

### Cycle 5 Report

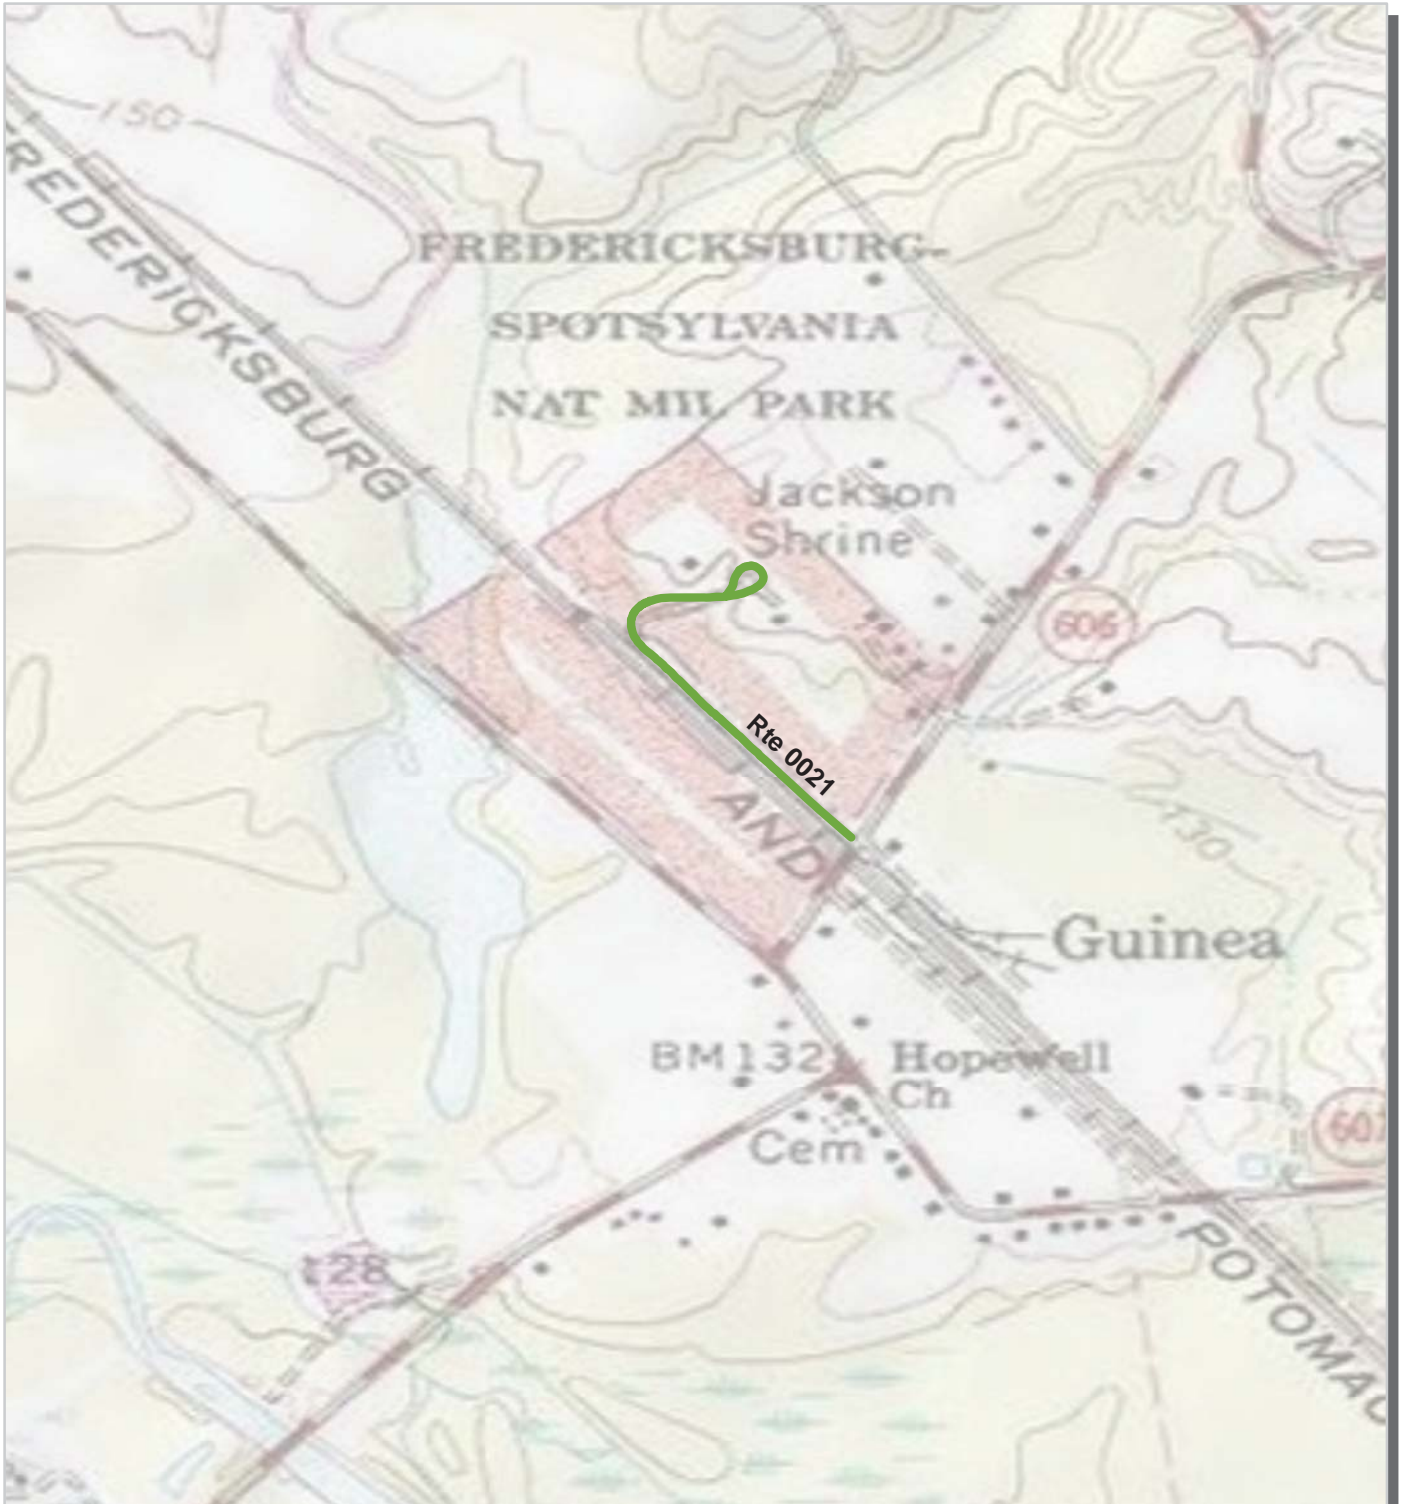
**Fredericksburg And Spotsylvania National Military Park  
Route Condition Map  
PCR - Mile by Mile  
Area 5**

PCR	Poor	Fair	Good	Excellent	No Data
	(0 - 60)	(61 - 84)	(85 - 94)	(95 - 100)

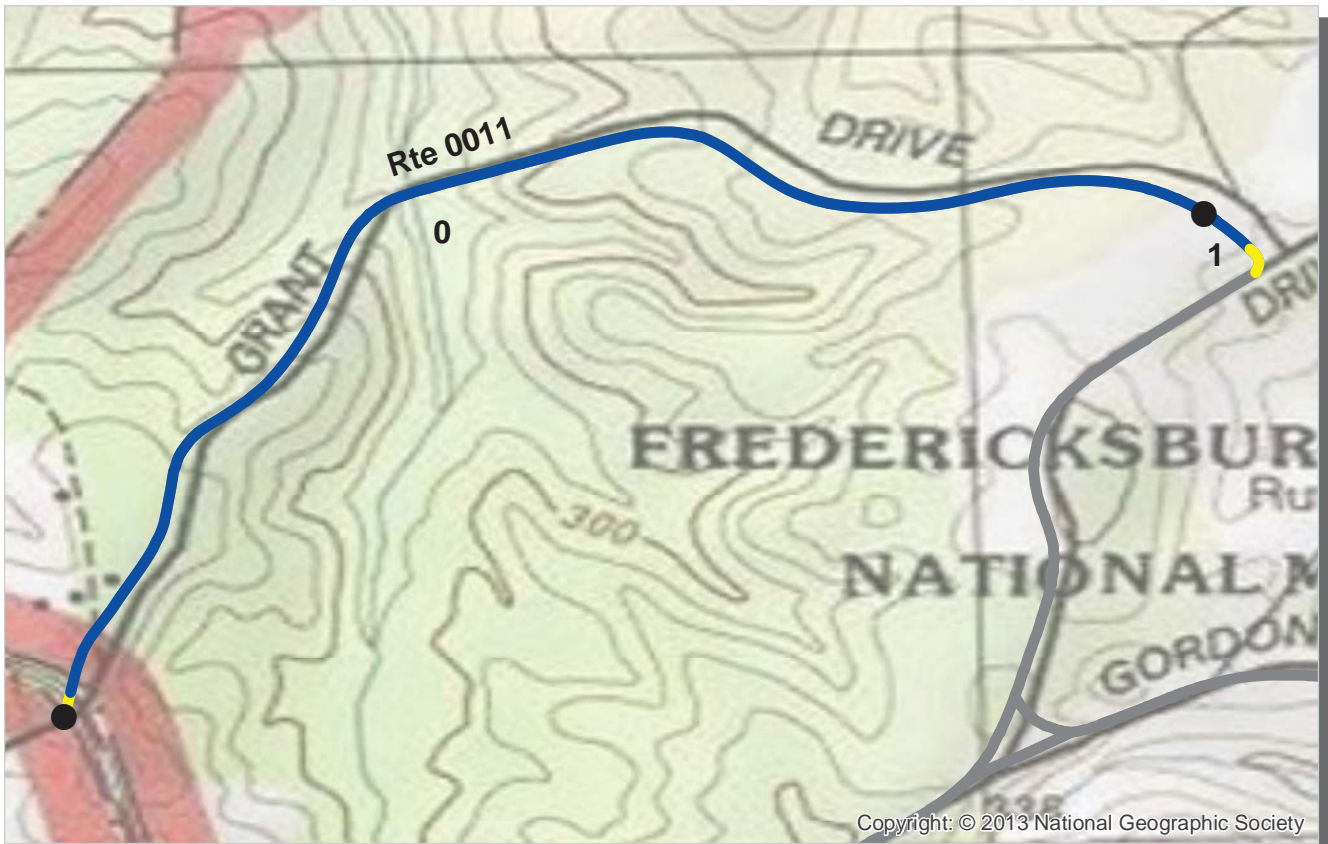
**ROUTE: 0011 GRANT DRIVE WEST**

<i>Section Number</i>	0	1			
<i>Section Length (mi)</i>	1.00	0.06			
<i>Cross Section Information</i>					
Number of Lanes	2	2			
Paved Width (ft)	20	20			
Lane Width (ft)	10	10			
<i>Roadway Condition Information</i>					
SCR (Surface Condition Rating)	99	100			
PCR (Pavement Condition Rating)	99	95			
<i>Distress Index Values</i>					
Structural Crack Index	100	100			
Transverse Cracking Index	100	100			
Patching Index	100	100			
Rutting Index	99	100			
Roughness Condition Index (RCI)	100	88

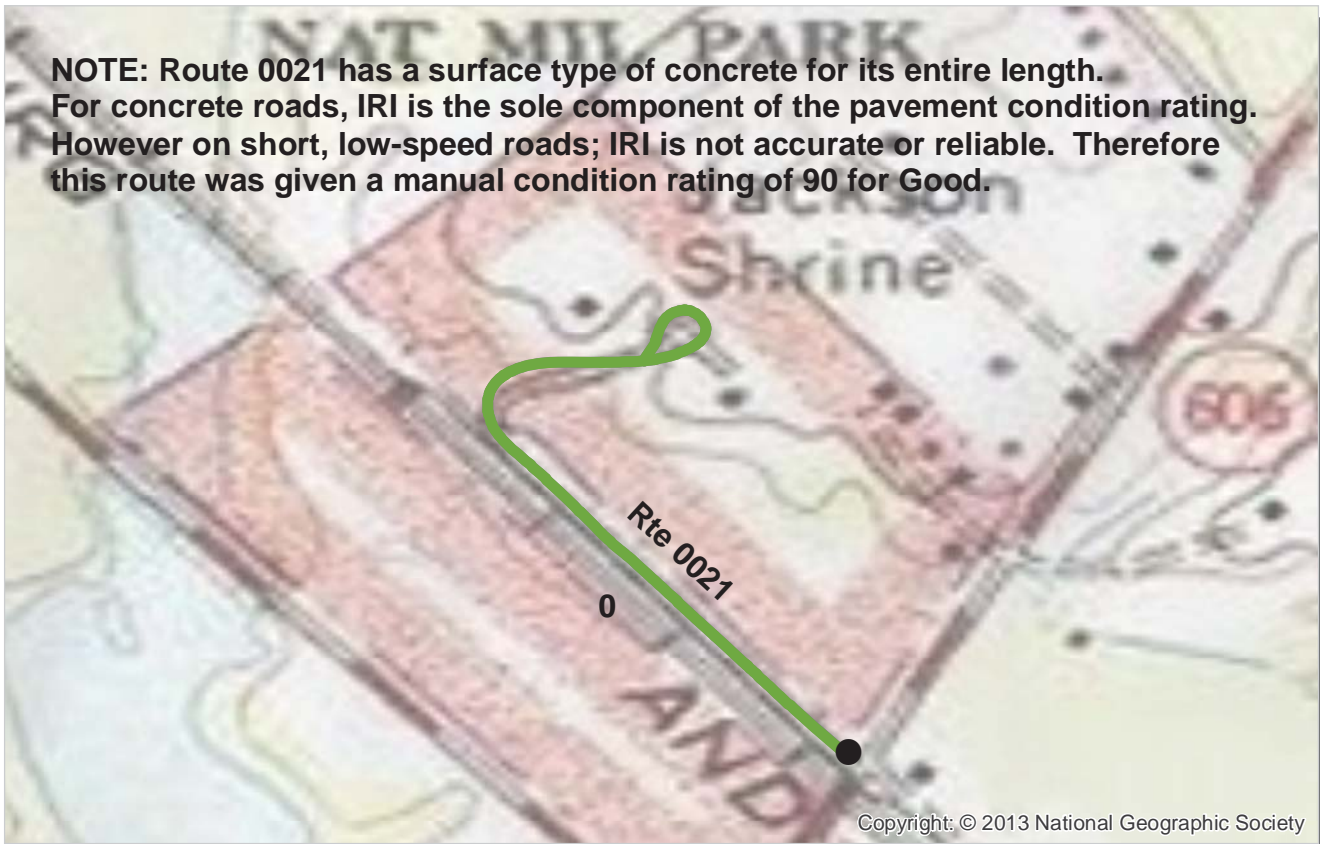
**ROUTE: 0021 JACKSON SHRINE**

**NOTE: Route 0021 has a surface type of concrete for its entire length. For concrete roads, IRI is the sole component of the pavement condition rating. However on short, low-speed roads; IRI is not accurate or reliable. Therefore this route was given a manual condition rating of 90 for Good.**

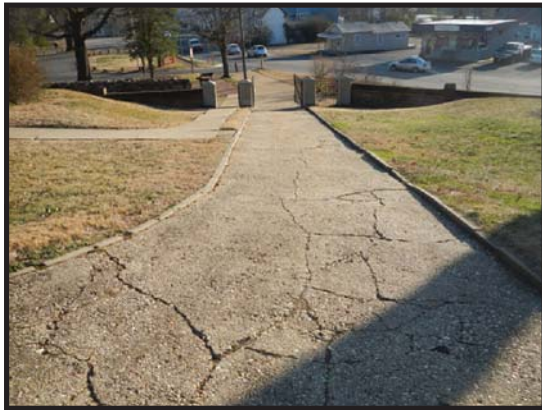
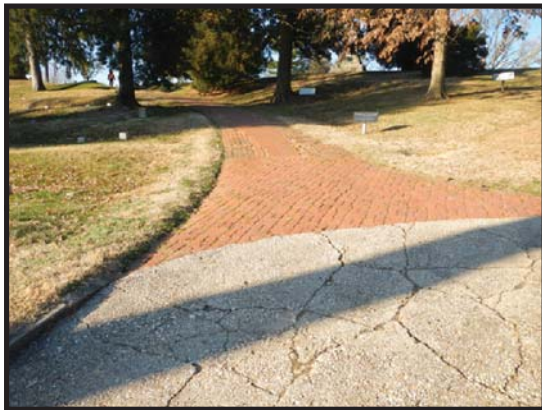
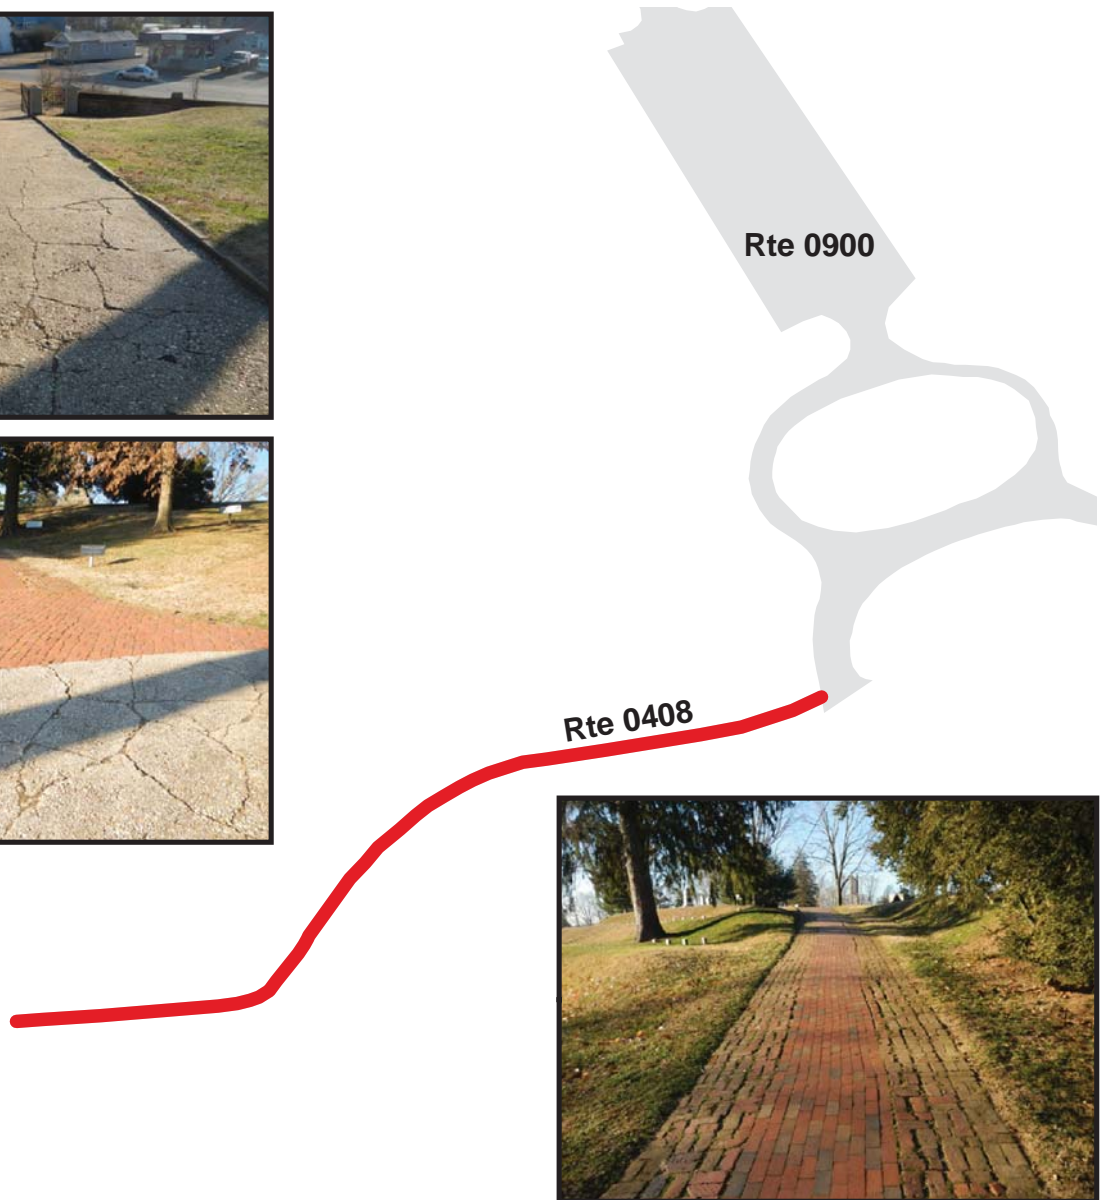
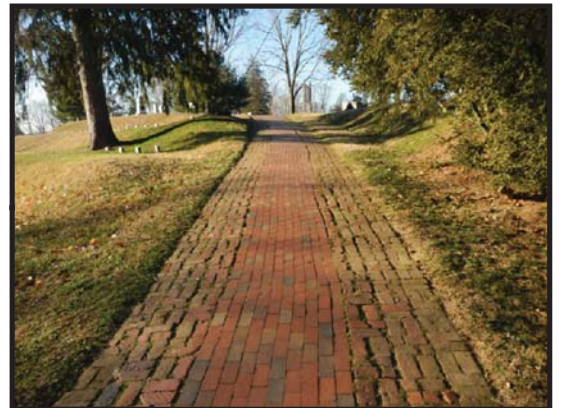
Route Number	Public / NonPublic	Date Visited	Area (sq ft)	Lane Miles *	Paved Length (mi)	Paved Width (ft)
0408	PUBLIC	1/23/2013	4,419	0.08	0.09	9
Culverts	Drop Inlets	Gates	Curb & Gutter	Curb	PCR	Surface Type
0	4	1	NO CURB AND GUTTER	CONCRETE CURB	POOR/45	CO

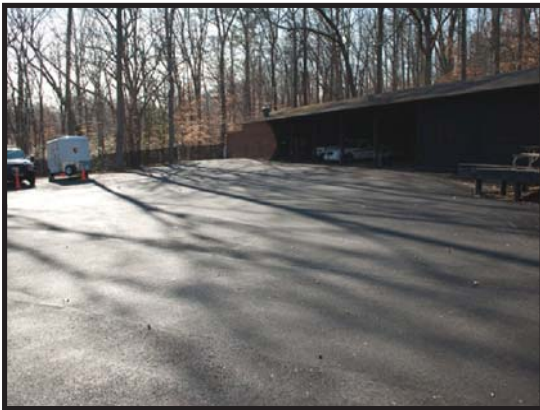
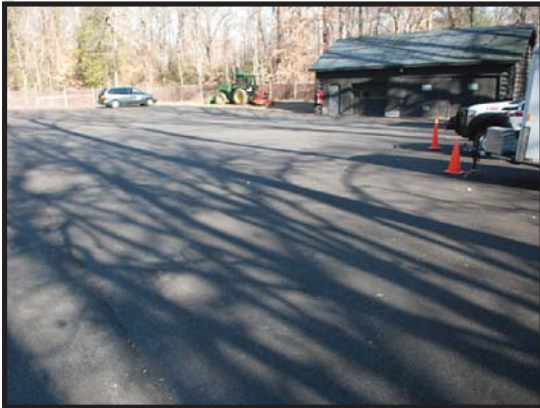
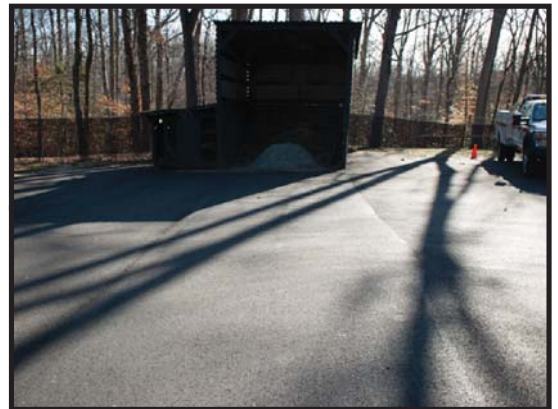
Route Number	Public / NonPublic	Date Visited	Area (sq ft)	Lane Miles *	Surface Type
0908A	NONPUBLIC	1/23/2013	14,028	0.24	AS
Culverts	Drop Inlets	Gates	Curb & Gutter	Curb	PCR
0	0	2	NO CURB AND GUTTER	NO CURB	EXCELLENT/97

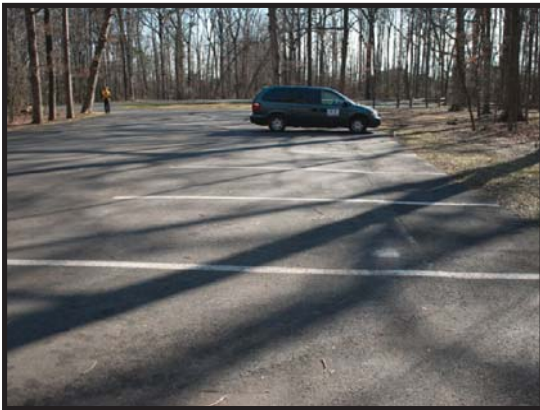
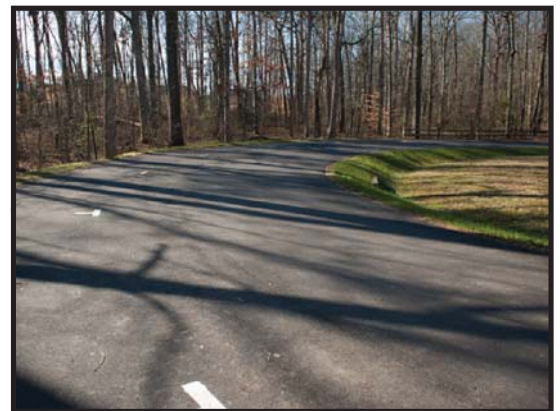
## Route 0910

Route Number	Public / NonPublic	Date Visited	Area (sq ft)	Lane Miles *	Surface Type
0910	PUBLIC	1/23/2013	19,673	0.34	AS
Culverts	Drop Inlets	Gates	Curb & Gutter	Curb	PCR
2	1	1	NO CURB AND GUTTER	NO CURB	GOOD/90

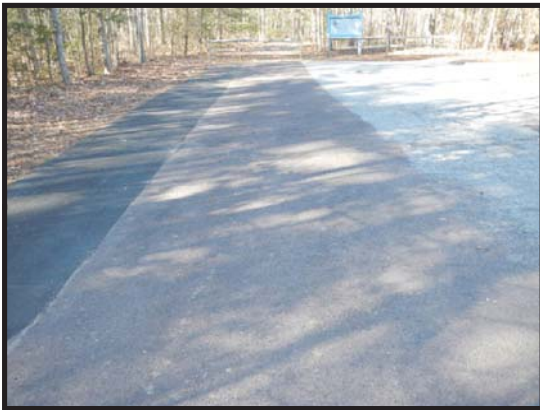
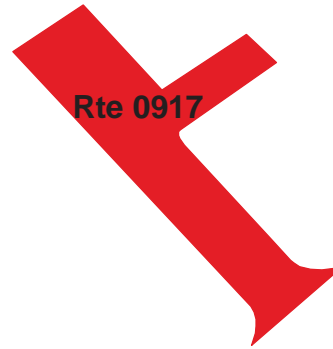
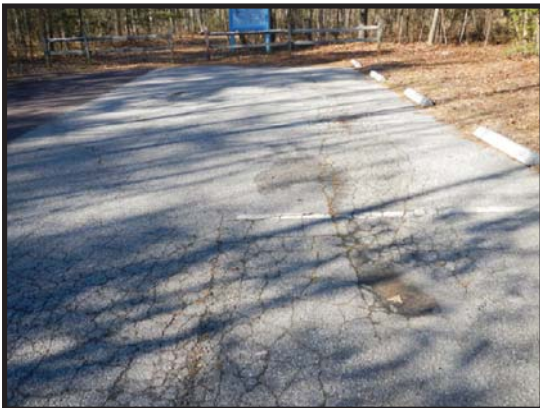
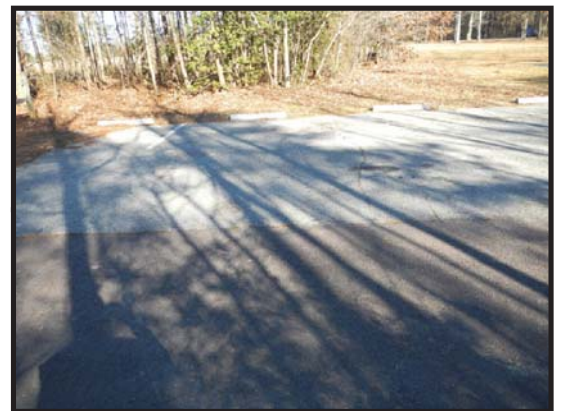
## Route 0917

Route Number	Public / NonPublic	Date Visited	Area (sq ft)	Lane Miles *	Surface Type
0917	PUBLIC	1/22/2013	4,636	0.08	AS
Culverts	Drop Inlets	Gates	Curb & Gutter	Curb	PCR
1	0	0	NO CURB AND GUTTER	NO CURB	POOR/45

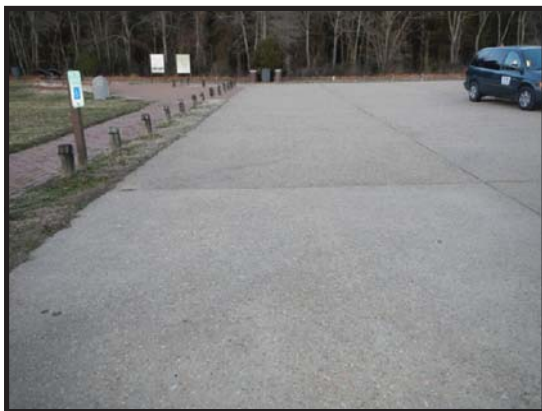
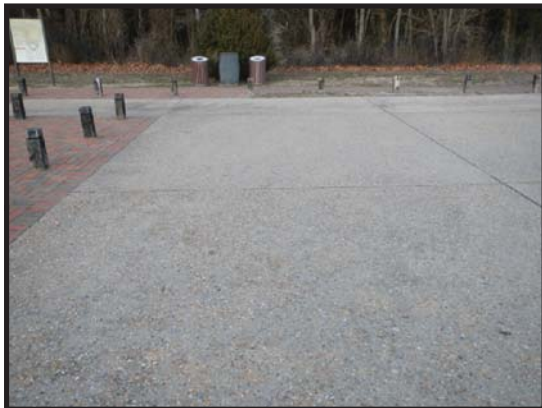
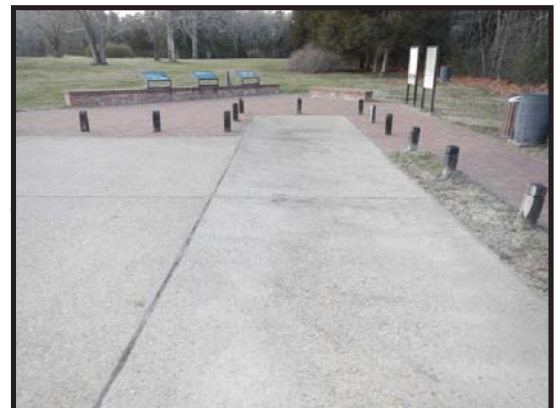
## Route 0919

Route Number	Public / NonPublic	Date Visited	Area (sq ft)	Lane Miles *	Surface Type
0919	PUBLIC	1/22/2013	3,309	0.06	AS
Culverts	Drop Inlets	Gates	Curb & Gutter	Curb	PCR
0	0	0	NO CURB AND GUTTER	NO CURB	GOOD/90

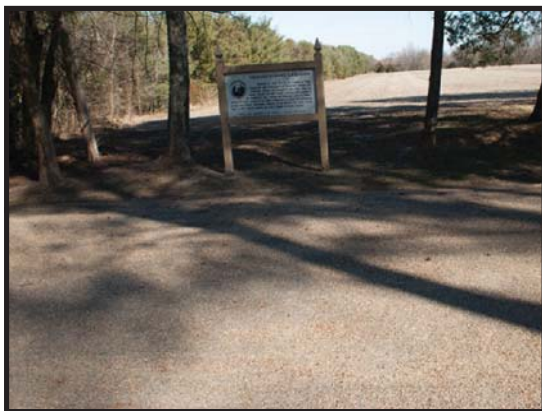
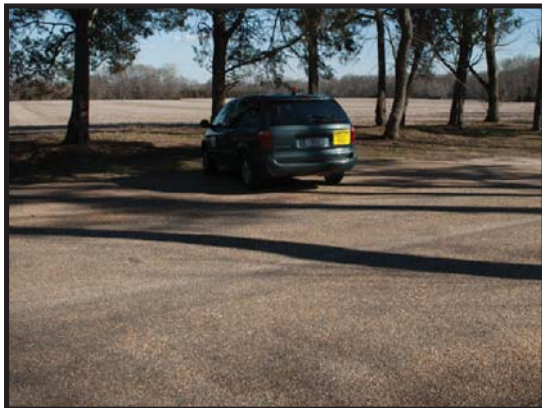
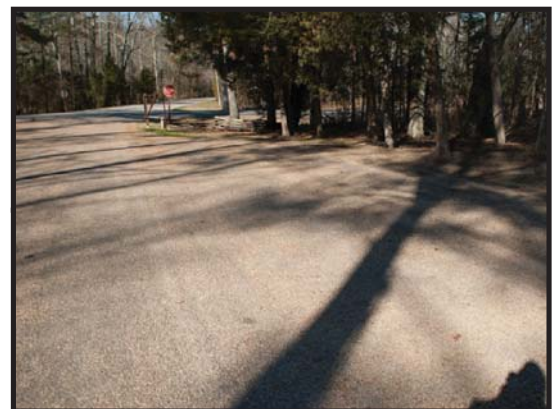
## Route 0933

Route Number	Public / NonPublic	Date Visited	Area (sq ft)	Lane Miles *	Surface Type
0933	PUBLIC	1/22/2013	1,613	0.03	AS
Culverts	Drop Inlets	Gates	Curb & Gutter	Curb	PCR
0	0	0	NO CURB AND GUTTER	NO CURB	FAIR/73

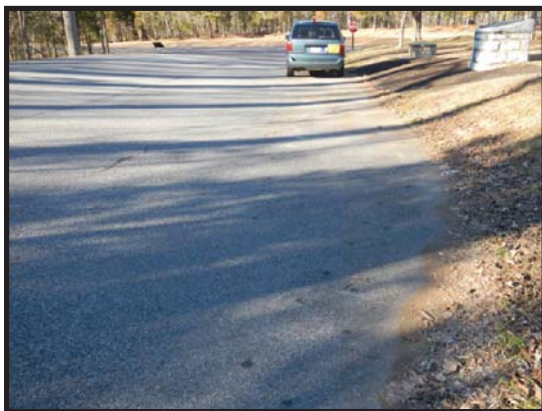
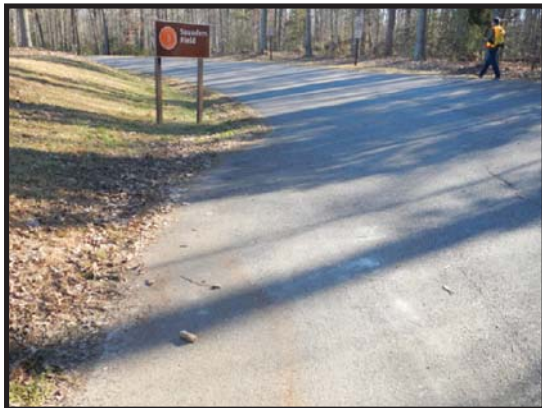
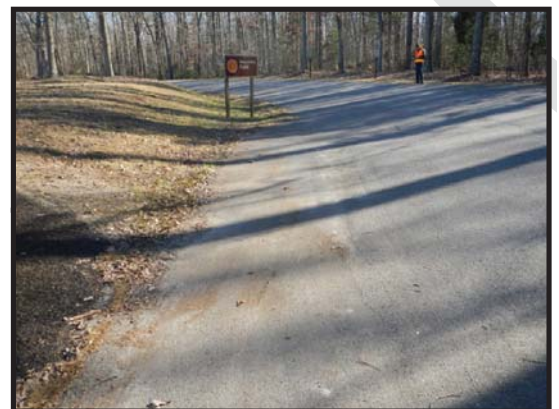
## Route 0936A

Route Number	Public / NonPublic	Date Visited	Area (sq ft)	Lane Miles *	Surface Type
0936A	PUBLIC	1/22/2013	557	0.01	AS
Culverts	Drop Inlets	Gates	Curb & Gutter	Curb	PCR
0	0	0	NO CURB AND GUTTER	NO CURB	GOOD/90

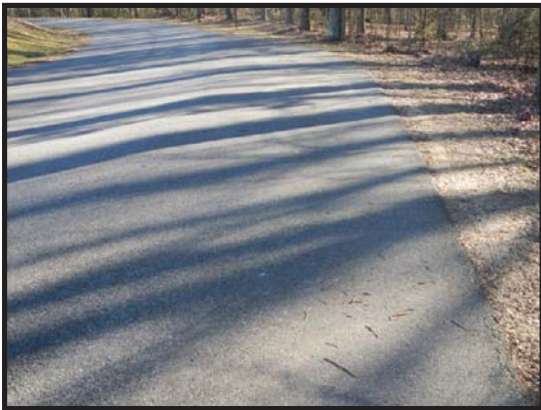
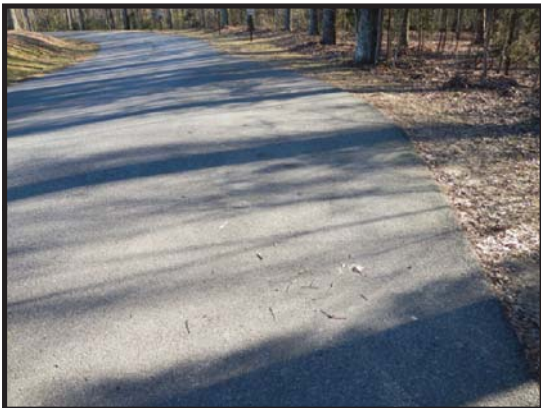
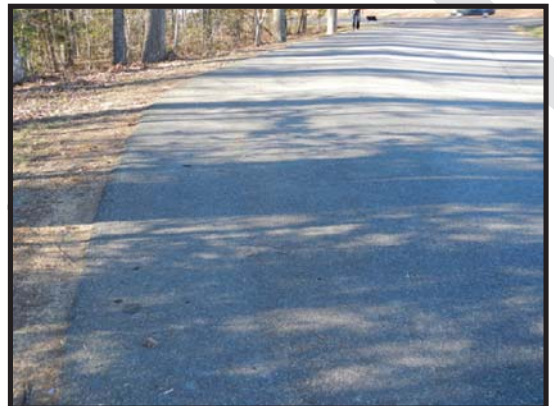
## Route 0936B

Route Number	Public / NonPublic	Date Visited	Area (sq ft)	Lane Miles *	Surface Type
0936B	PUBLIC	1/22/2013	510	0.01	AS
Culverts	Drop Inlets	Gates	Curb & Gutter	Curb	PCR
0	0	0	NO CURB AND GUTTER	NO CURB	GOOD/90
