Federal Lands Highway Road Inventory Program

Road Inventory and Condition Assessment

Gettysburg National Military Park GETT

Cycle 5 Report

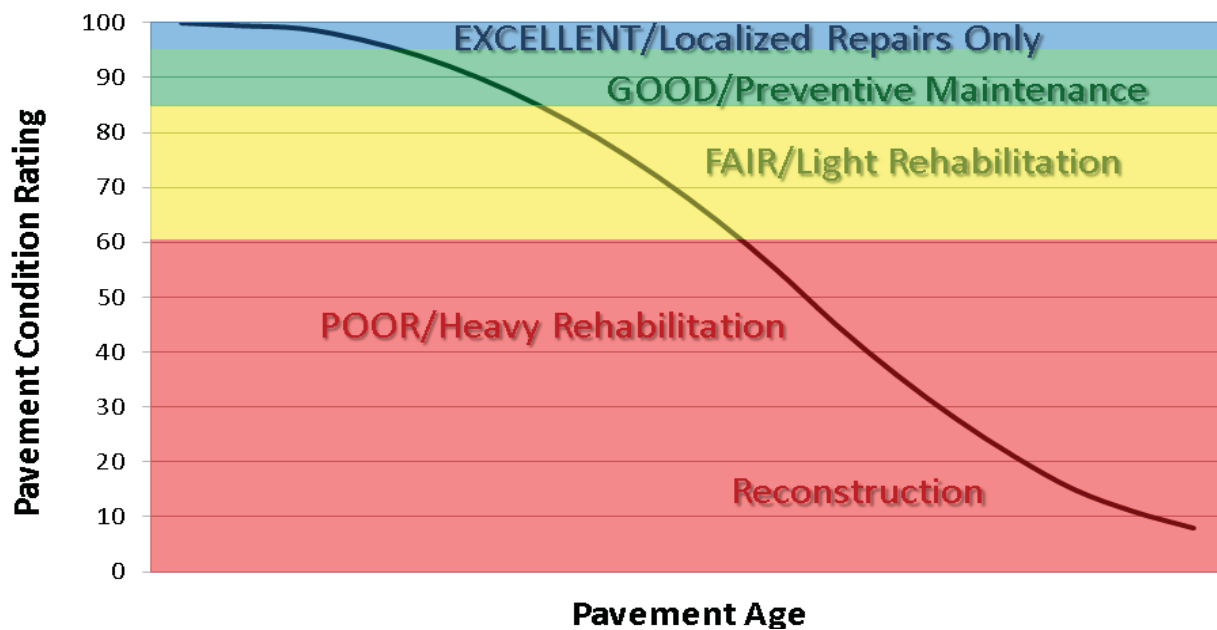
Condition Categories and Treatments

- Excellent/New: PCR of 95-100. Pavements in this range will require only spot repairs
- Good: PCR of 85-94. Pavements in this range will likely be candidates for Preventive Maintenance. Examples include Chip and Slurry Seals, Micro Surfacing and Thin Overlays.
- Fair: PCR of 61-84. Pavements in this range will likely be candidates of Light Rehabilitation (L3R). Examples include single-lift overlays up to 2.5 inches in total thickness, milling and overlays.
- Poor: PCR of 0-60. Pavements in this range will likely be candidates of Heavy Rehabilitation or Reconstruction (H3R or 4R). Examples include Pulverization, Multiple Lift Overlays, and Reconstruction.

At this time, specific Maintenance and Rehabilitation activities should be evaluated and recommended at the project level. Site-specific conditions that influence treatment type should be determined based on performing a subsurface investigation and/or pavement condition survey, and not be based solely on RIP data. Additionally, RIP produces a snapshot of conditions the year in which the data was collected. For further information or to obtain additional Pavement Management System's data from our Highway Pavement Management Application (HPMA) please contact the Eastern Federal Lands pavement team.

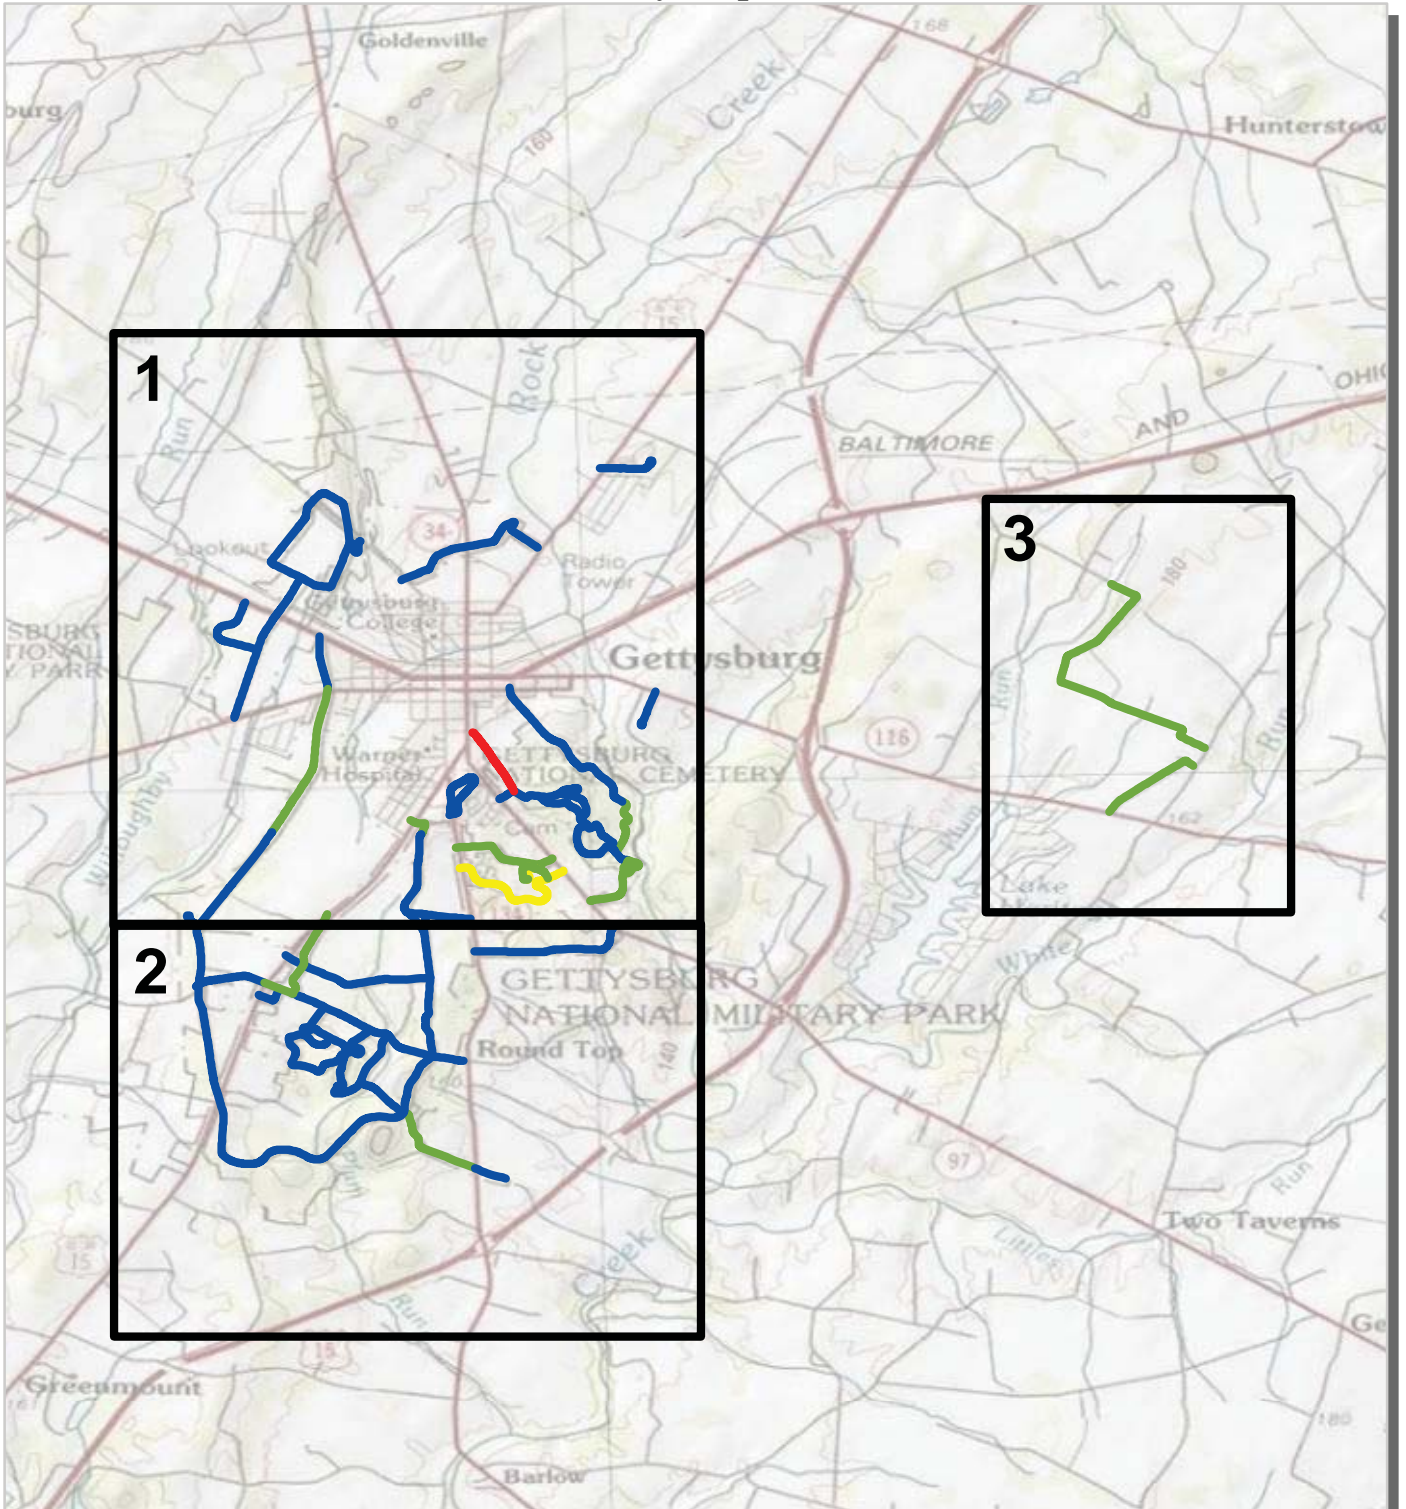
Gettysburg National Military Park Route Condition Map PCR - Mile by Mile Key Map

PCR	<div style="display: inline-block; width: 20px; height: 10px; background-color: red; border: 1px solid black;"></div>	<div style="display: inline-block; width: 20px; height: 10px; background-color: yellow; border: 1px solid black;"></div>	<div style="display: inline-block; width: 20px; height: 10px; background-color: green; border: 1px solid black;"></div>	<div style="display: inline-block; width: 20px; height: 10px; background-color: blue; border: 1px solid black;"></div>	<div style="display: inline-block; width: 20px; height: 10px; background-color: black; border: 1px solid black;"></div>
	Poor	Fair	Good	Excellent	No Data
	(0 - 60)	(61 - 84)	(85 - 94)	(95 - 100)

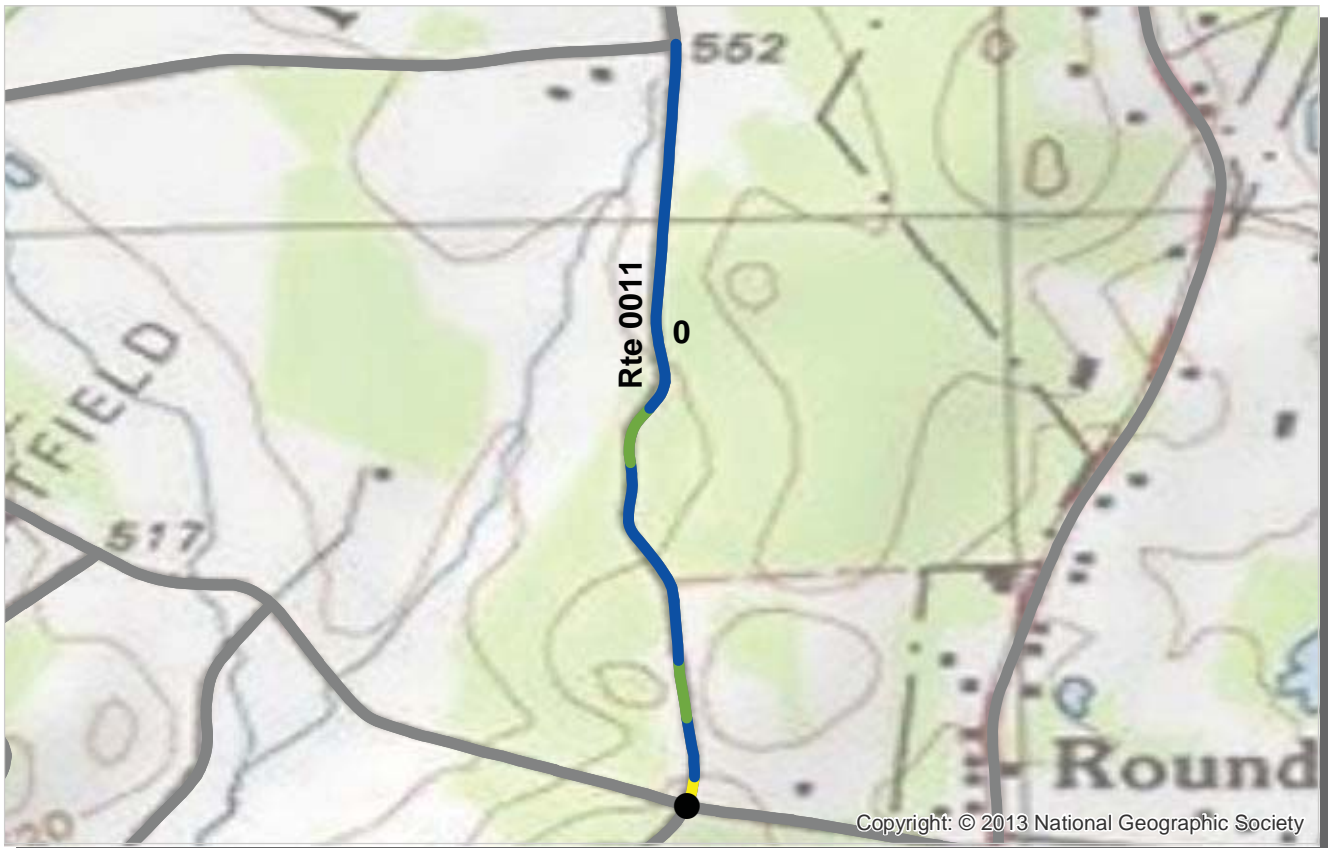
ROUTE: 0010 HANCOCK AVENUE

Section Number	0				
Section Length (mi)	0.53				
Cross Section Information					
Number of Lanes	1				
Paved Width (ft)	19				
Lane Width (ft)	19				
Roadway Condition Information					
SCR (Surface Condition Rating)	100				
PCR (Pavement Condition Rating)	96				
Distress Index Values					
Structural Crack Index	100				
Transverse Cracking Index	100				
Patching Index	100				
Rutting Index	100				
Roughness Condition Index (RCI)	90

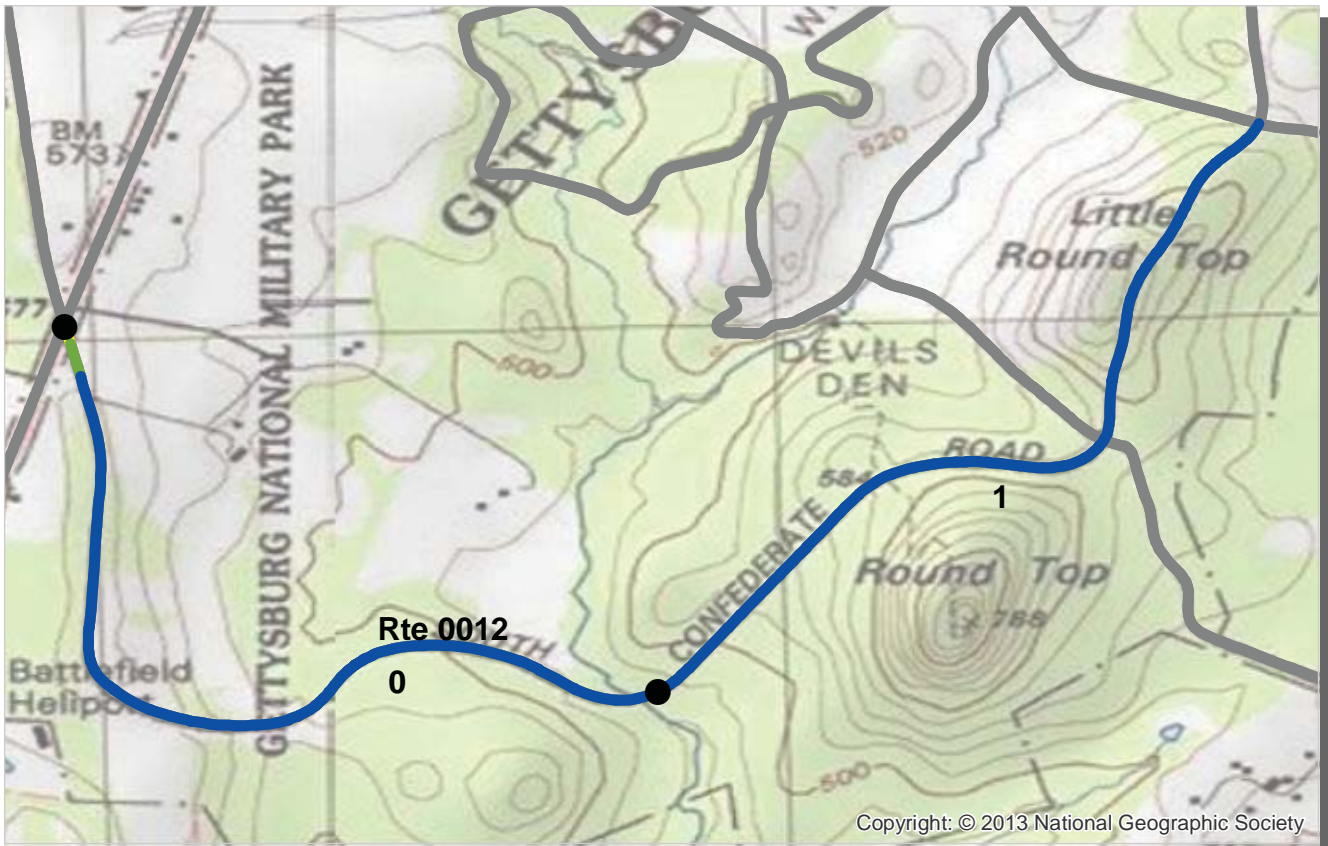
ROUTE: 0011 SEDGWICK AVENUE

<i>Section Number</i>	0	1			
<i>Section Length (mi)</i>	1.00	0.96			
<i>Cross Section Information</i>					
Number of Lanes	1	1			
Paved Width (ft)	19	18			
Lane Width (ft)	17	18			
<i>Roadway Condition Information</i>					
SCR (Surface Condition Rating)	100	99			
PCR (Pavement Condition Rating)	100	99			
<i>Distress Index Values</i>					
Structural Crack Index	100	100			
Transverse Cracking Index	100	100			
Patching Index	100	100			
Rutting Index	100	99			
Roughness Condition Index (RCI)	100	100

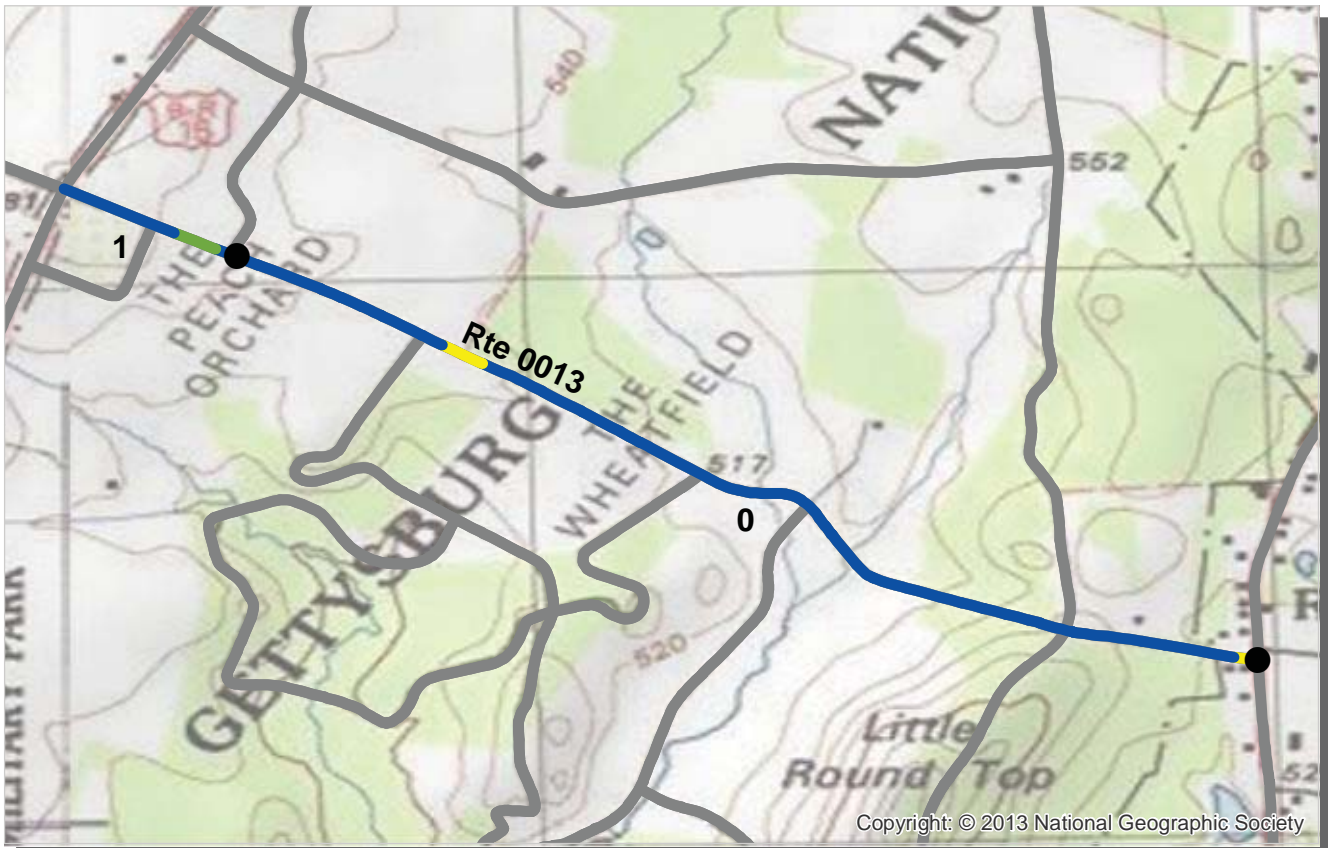
ROUTE: 0012 SOUTH CONFEDERATE-SYKES AVENUE

<i>Section Number</i>	0	1			
<i>Section Length (mi)</i>	1.00	0.16			
<i>Cross Section Information</i>					
Number of Lanes	2	2			
Paved Width (ft)	19	20			
Lane Width (ft)	10	10			
<i>Roadway Condition Information</i>					
SCR (Surface Condition Rating)	99	95			
PCR (Pavement Condition Rating)	97	92			
<i>Distress Index Values</i>					
Structural Crack Index	99	95			
Transverse Cracking Index	100	100			
Patching Index	100	100			
Rutting Index	100	100			
Roughness Condition Index (RCI)	93	88

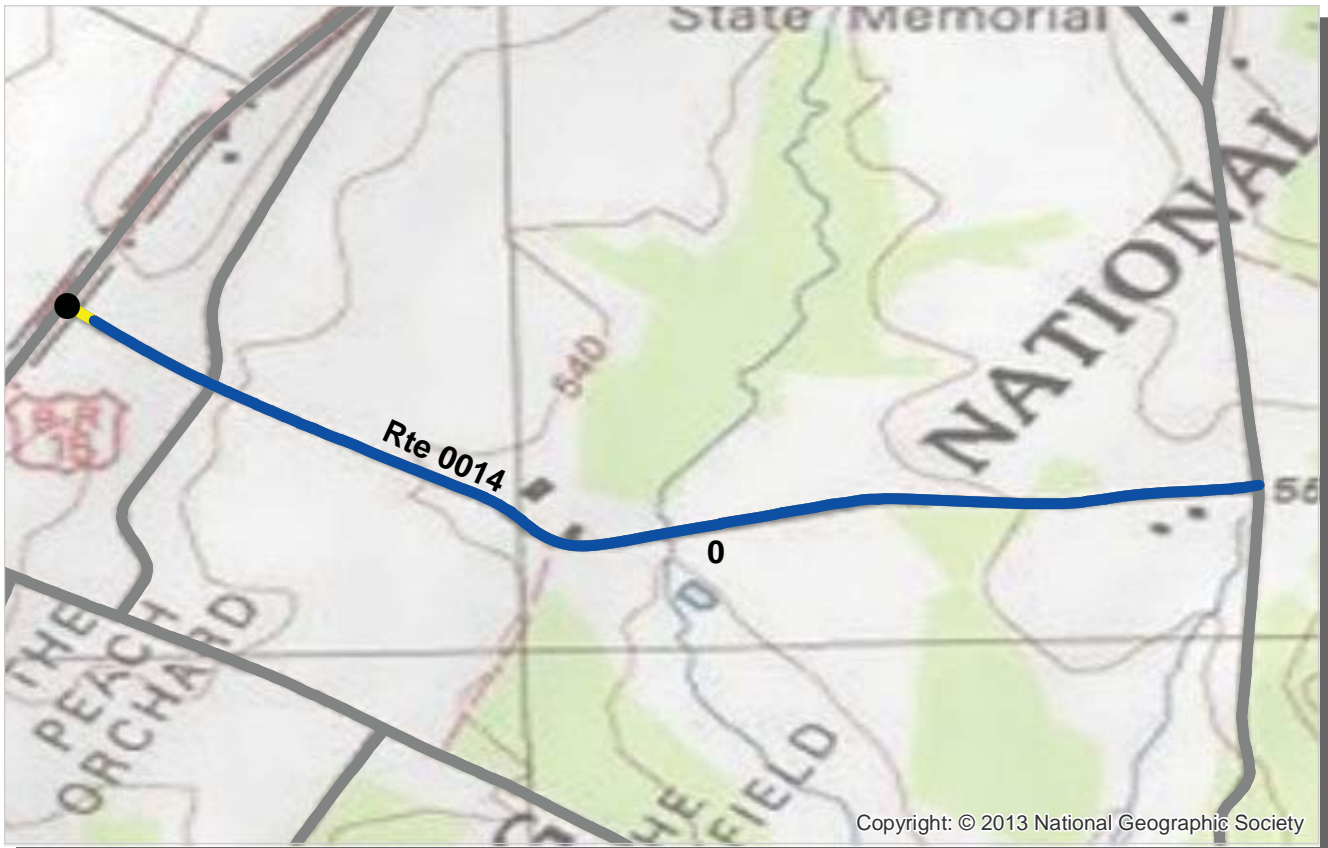
ROUTE: 0013 WHEATFIELD ROAD

Section Number	0				
Section Length (mi)	0.79				
Cross Section Information					
Number of Lanes	1				
Paved Width (ft)	18				
Lane Width (ft)	18				
Roadway Condition Information					
SCR (Surface Condition Rating)	100				
PCR (Pavement Condition Rating)	99				
Distress Index Values					
Structural Crack Index	100				
Transverse Cracking Index	100				
Patching Index	100				
Rutting Index	100				
Roughness Condition Index (RCI)	97

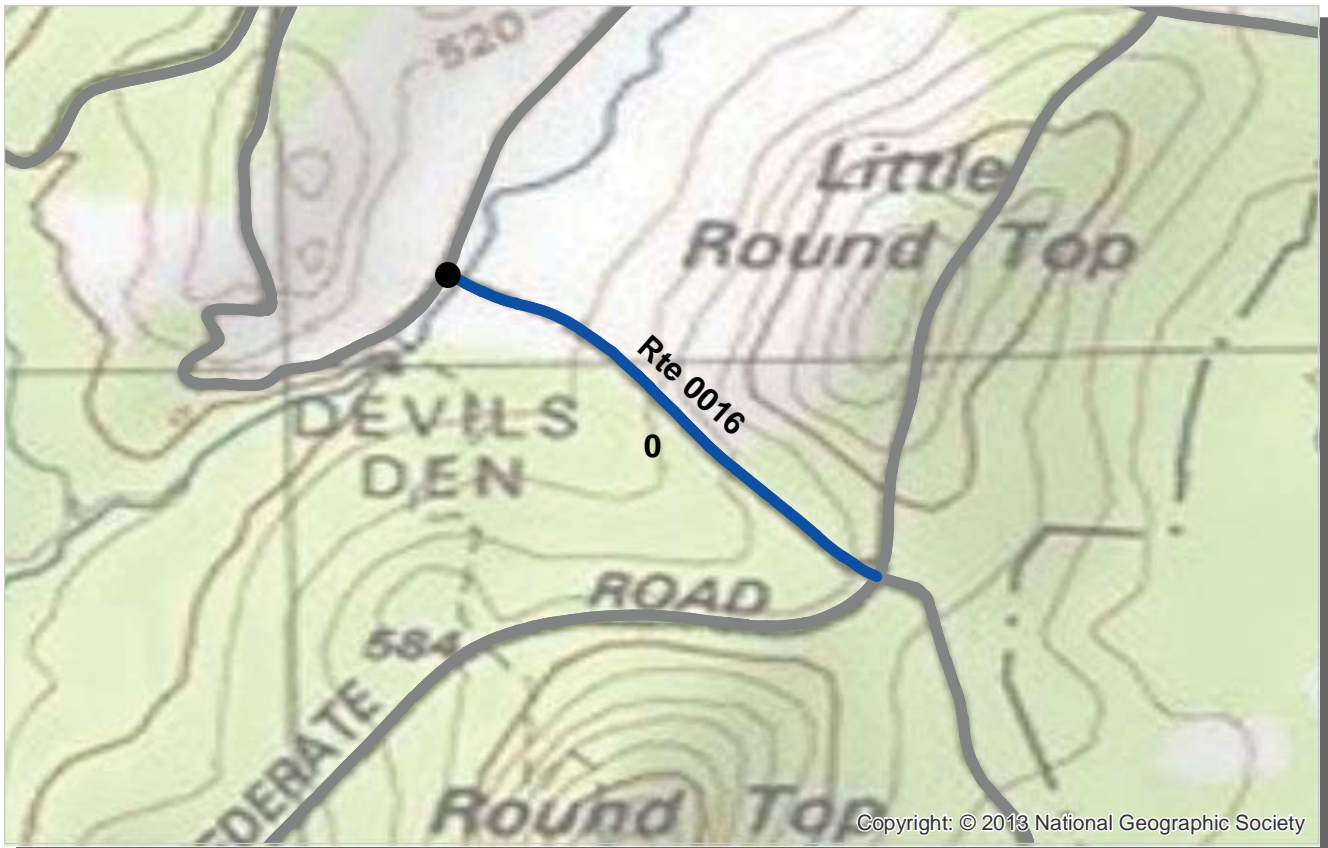
ROUTE: 0015 NORTH SICKLES AVENUE

Section Number	0				
Section Length (mi)	0.30				
Cross Section Information					
Number of Lanes	2				
Paved Width (ft)	17				
Lane Width (ft)	9				
Roadway Condition Information					
SCR (Surface Condition Rating)	100				
PCR (Pavement Condition Rating)	100				
Distress Index Values					
Structural Crack Index	100				
Transverse Cracking Index	100				
Patching Index	100				
Rutting Index	100				
Roughness Condition Index (RCI)	NC

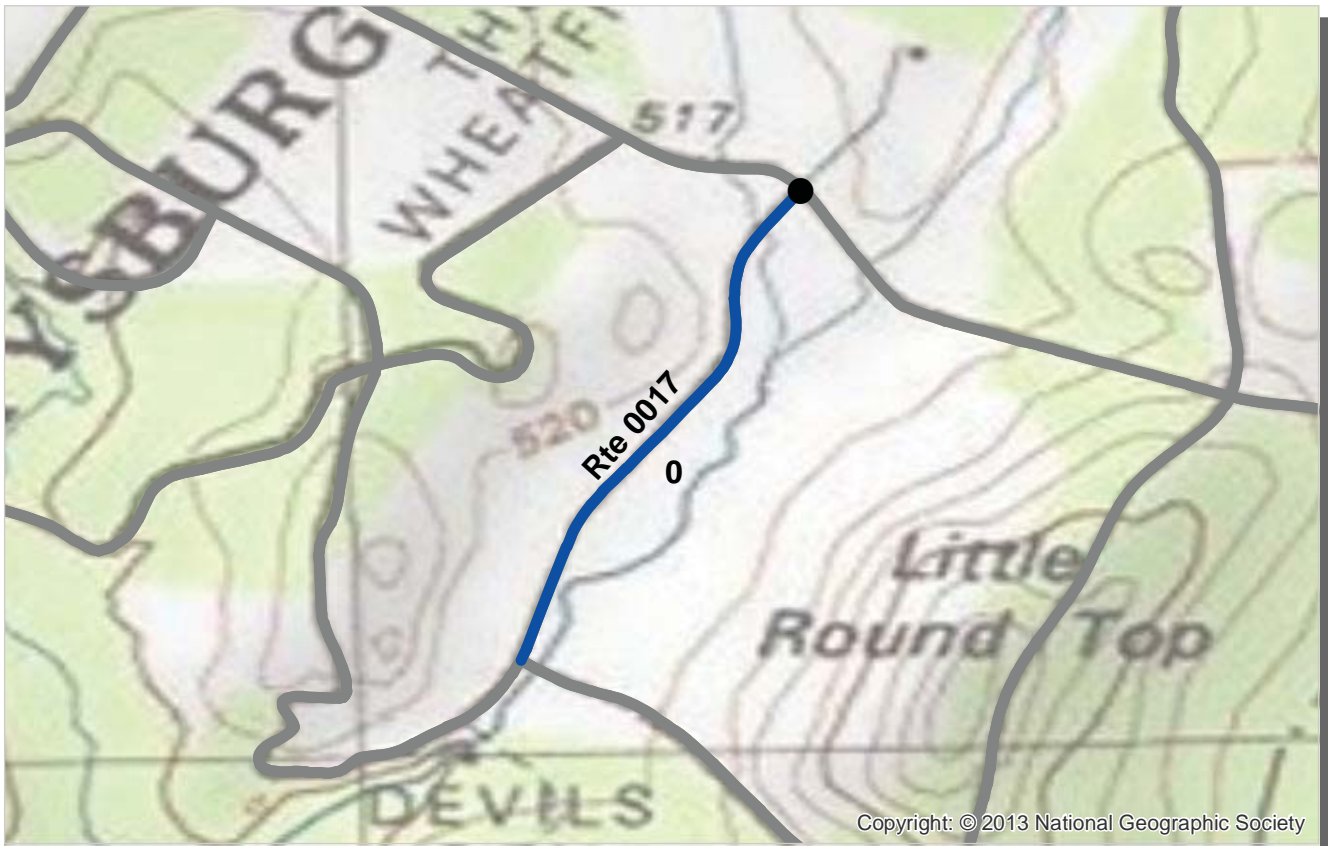
ROUTE: 0016 WARREN AVENUE

Section Number	0				
Section Length (mi)	0.35				
Cross Section Information					
Number of Lanes	1				
Paved Width (ft)	18				
Lane Width (ft)	18				
Roadway Condition Information					
SCR (Surface Condition Rating)	100				
PCR (Pavement Condition Rating)	100				
Distress Index Values					
Structural Crack Index	100				
Transverse Cracking Index	100				
Patching Index	100				
Rutting Index	100				
Roughness Condition Index (RCI)	NC

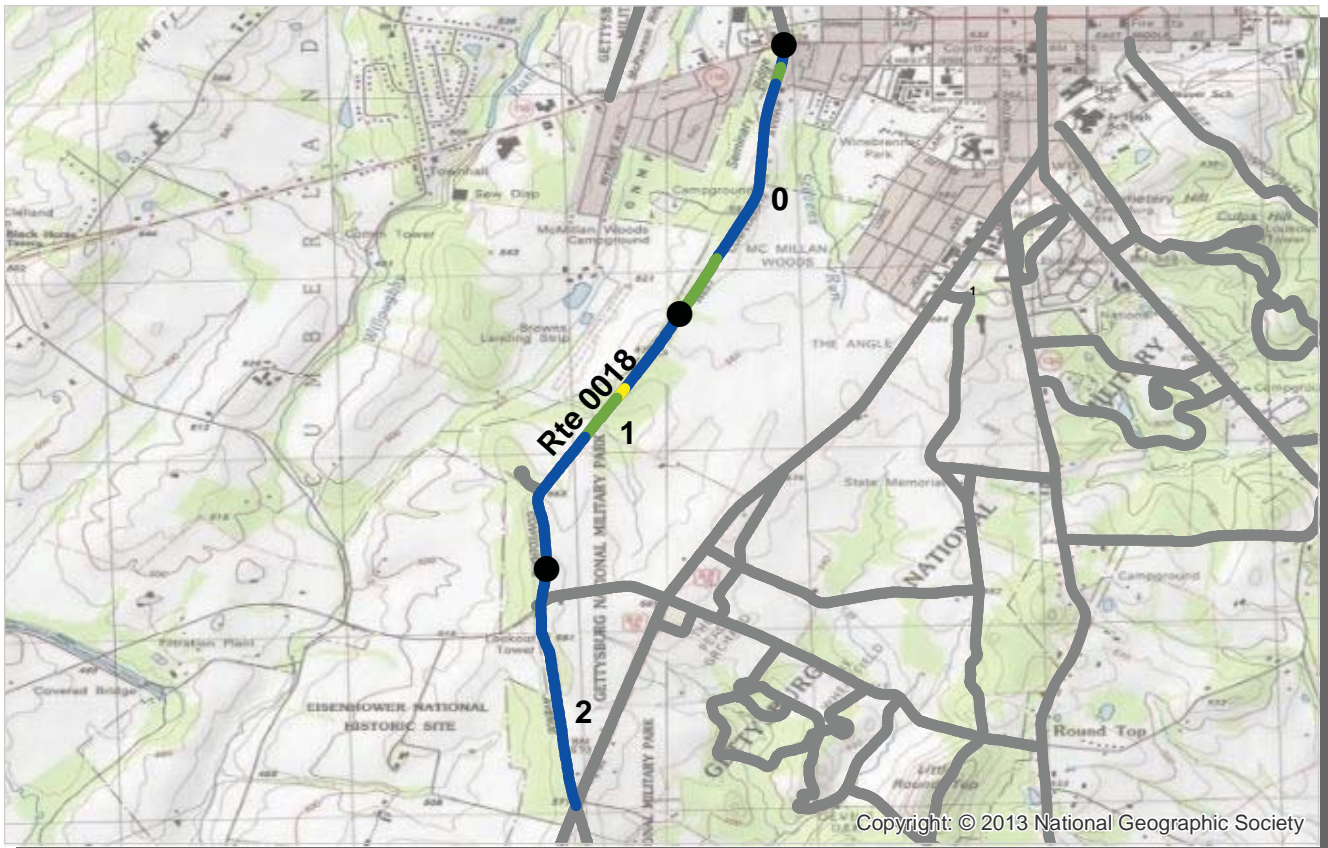
ROUTE: 0017 CRAWFORD AVENUE

Section Number	0	1	2		
Section Length (mi)	1.00	1.00	0.83		
Cross Section Information					
Number of Lanes	1	1	1		
Paved Width (ft)	19	20	18		
Lane Width (ft)	14	20	18		
Roadway Condition Information					
SCR (Surface Condition Rating)	99	100	100		
PCR (Pavement Condition Rating)	94	96	100		
Distress Index Values					
Structural Crack Index	100	100	100		
Transverse Cracking Index	100	100	100		
Patching Index	100	100	100		
Rutting Index	99	100	100		
Roughness Condition Index (RCI)	86	89	100

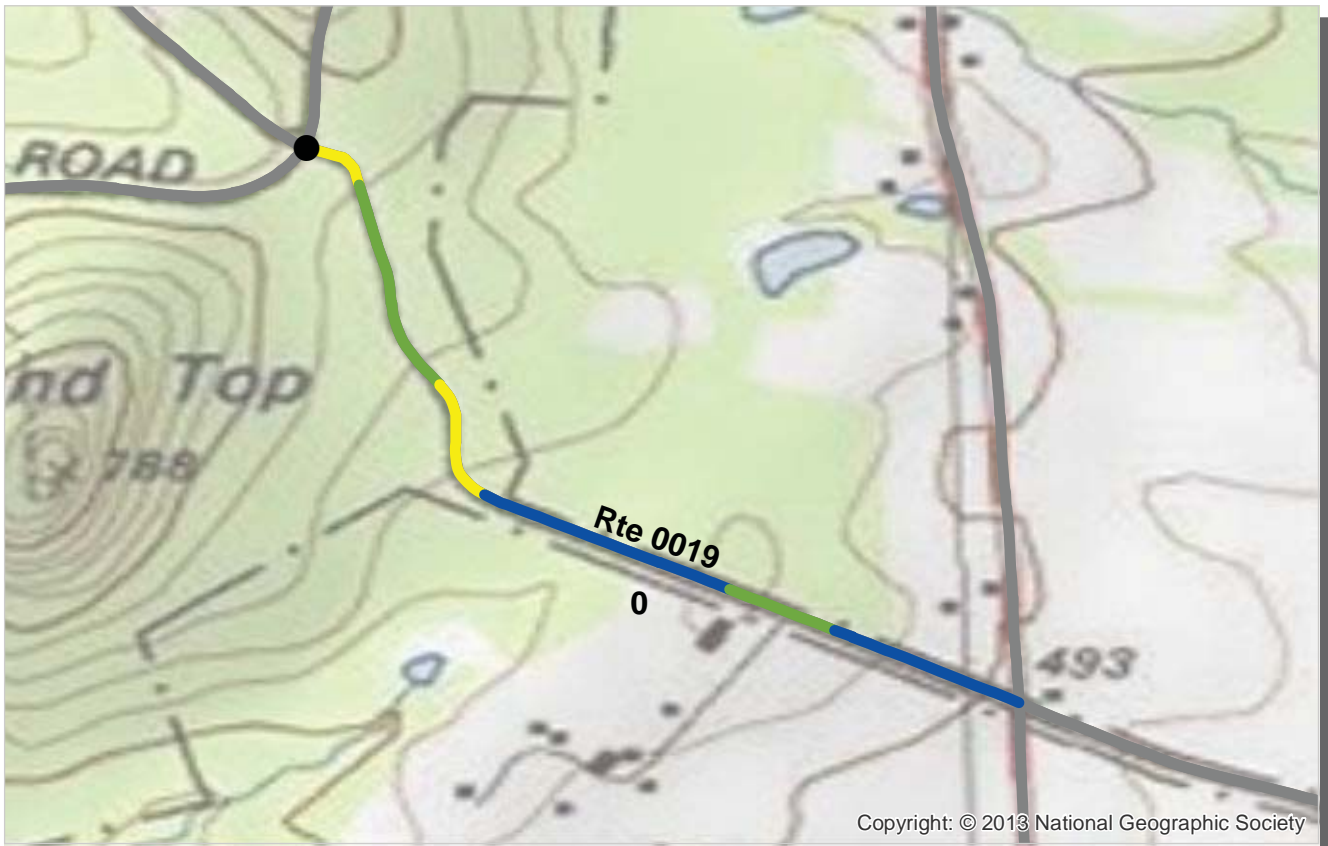
ROUTE: 0018 WEST CONFEDERATE AVENUE

Section Number	0				
Section Length (mi)	0.56				
Cross Section Information					
Number of Lanes	2				
Paved Width (ft)	14				
Lane Width (ft)	7				
Roadway Condition Information					
SCR (Surface Condition Rating)	100				
PCR (Pavement Condition Rating)	88				
Distress Index Values					
Structural Crack Index	100				
Transverse Cracking Index	100				
Patching Index	100				
Rutting Index	100				
Roughness Condition Index (RCI)	70

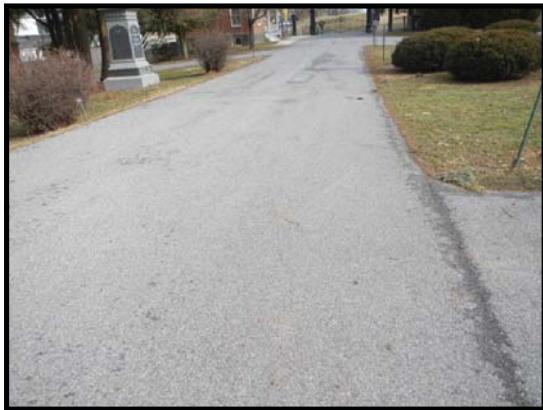
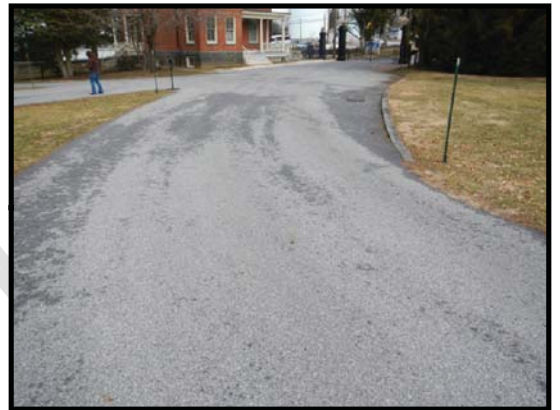
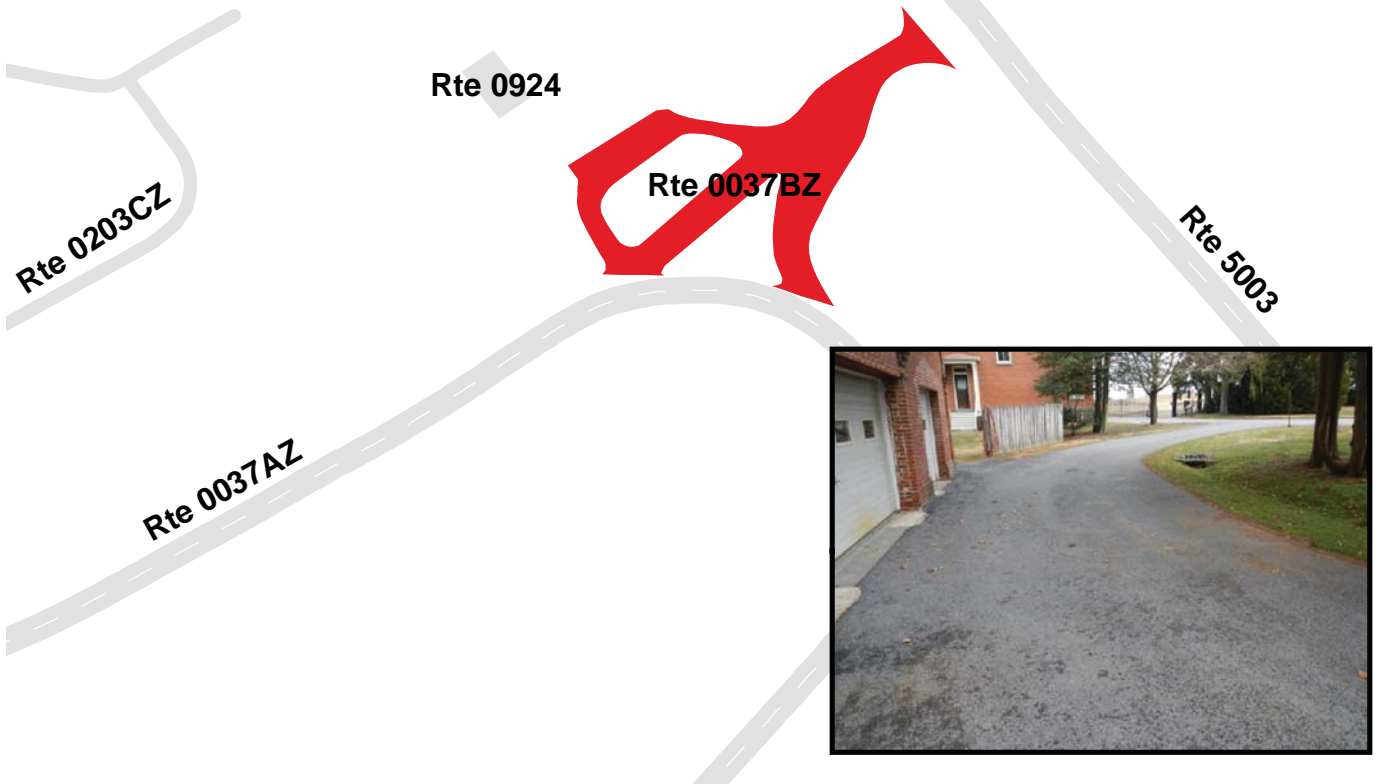
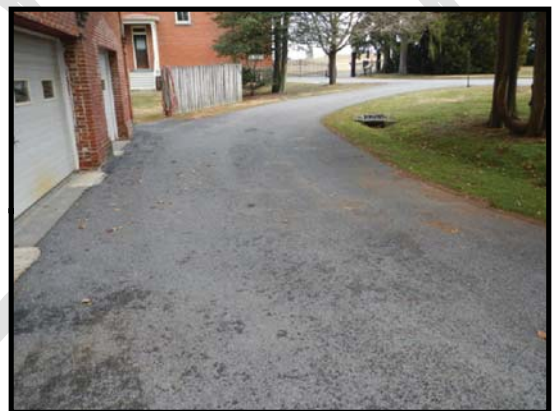
Route Number	Public / NonPublic	Date Visited	Area (sq ft)	Lane Miles *	Surface Type
0037BZ	PUBLIC	2/20/2013	8,885	0.15	AS
Culverts	Drop Inlets	Gates	Curb & Gutter	Curb	PCR
0	4	1	NO CURB AND GUTTER	STONE CURB	GOOD/90

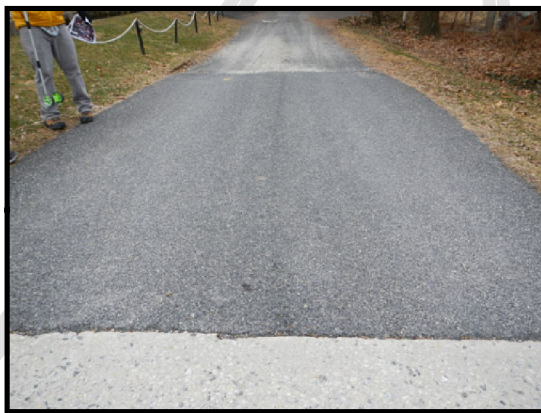
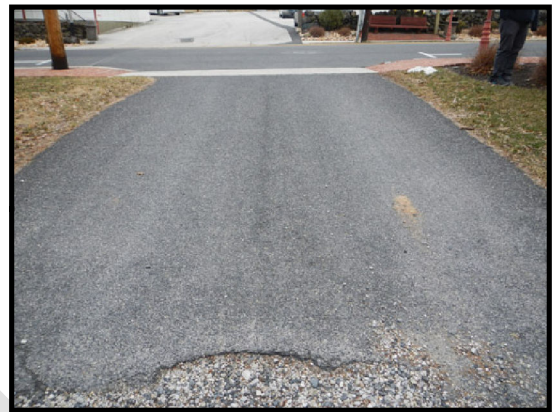
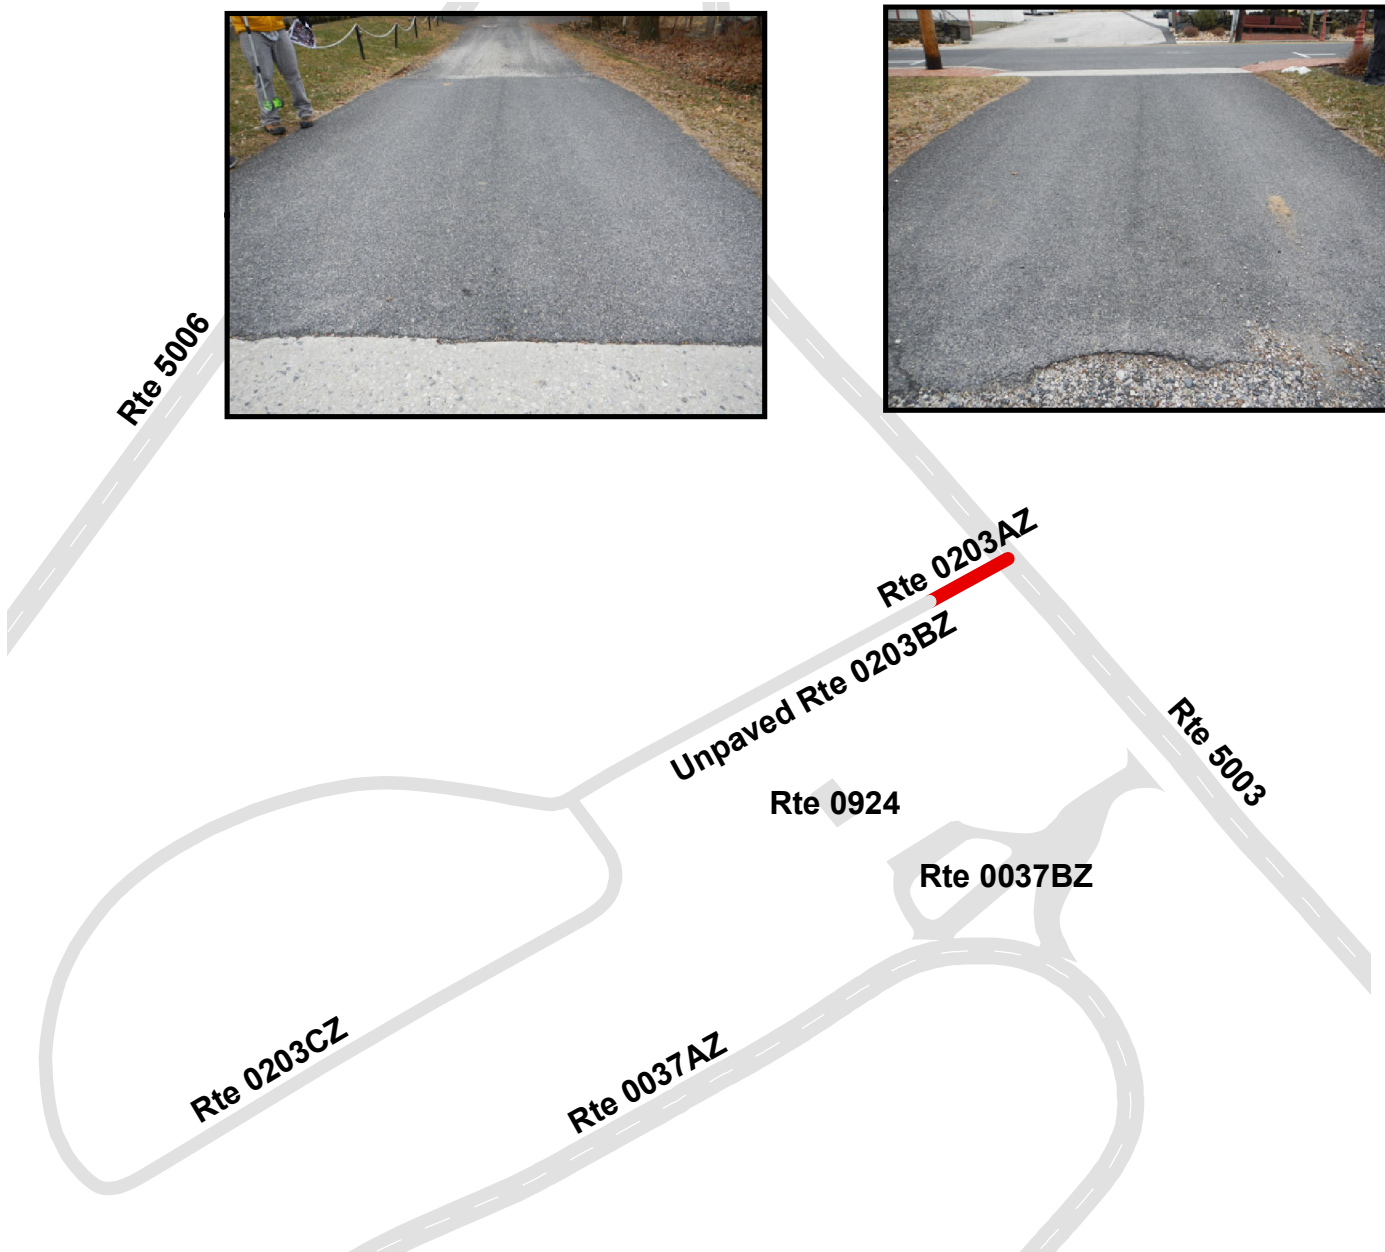
Route Number	Public / NonPublic	Date Visited	Area (sq ft)	Lane Miles *	Paved Length (mi)	Paved Width (ft)
0203AZ	PUBLIC	2/20/2013	444	0.01	0.01	12
Culverts	Drop Inlets	Gates	Curb & Gutter	Curb	PCR	Surface Type
0	0	0	NO CURB AND GUTTER	NO CURB	GOOD/90	AS

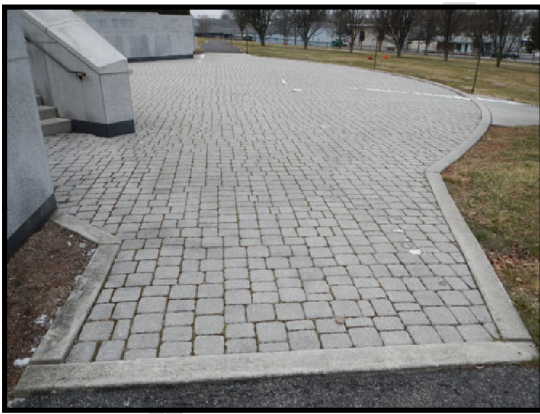
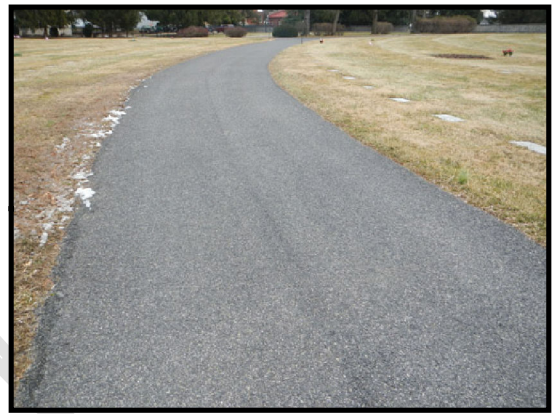
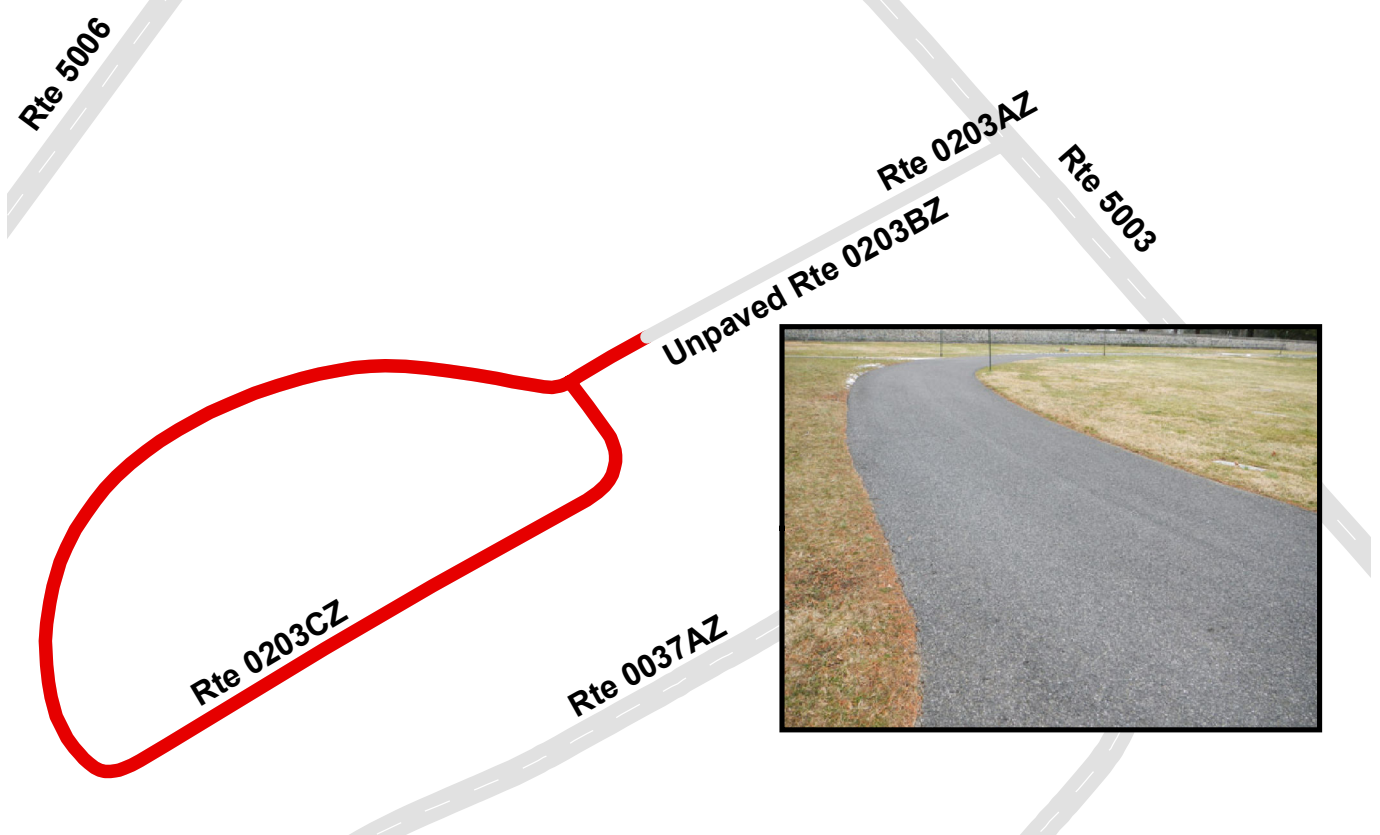
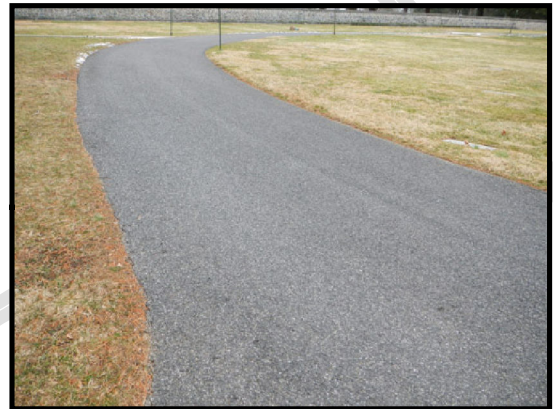
Route 0203CZ

Route Number	Public / NonPublic	Date Visited	Area (sq ft)	Lane Miles *	Paved Length (mi)	Paved Width (ft)
0203CZ	PUBLIC	2/20/2013	14,081	0.24	0.23	11.8
Culverts	Drop Inlets	Gates	Curb & Gutter	Curb	PCR	Surface Type
0	0	1	NO CURB AND GUTTER	NO CURB	GOOD/90	AS

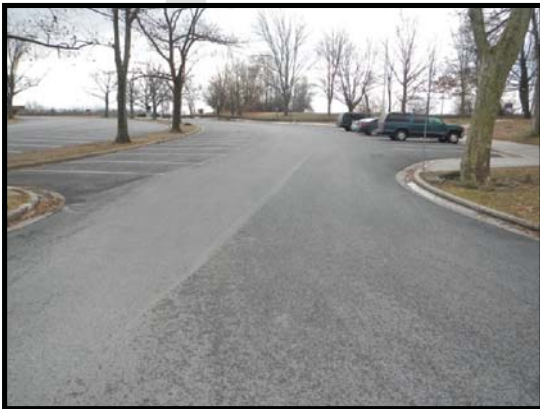
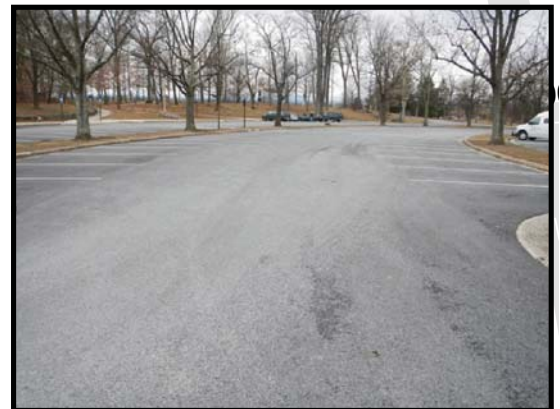
Route Number	Public / NonPublic	Date Visited	Area (sq ft)	Lane Miles *	Surface Type
0904	PUBLIC	2/20/2013	76,442	1.32	AS
Culverts	Drop Inlets	Gates	Curb & Gutter	Curb	PCR
0	7	0	CONCRETE CURB AND GUTTER	NO CURB	GOOD/90

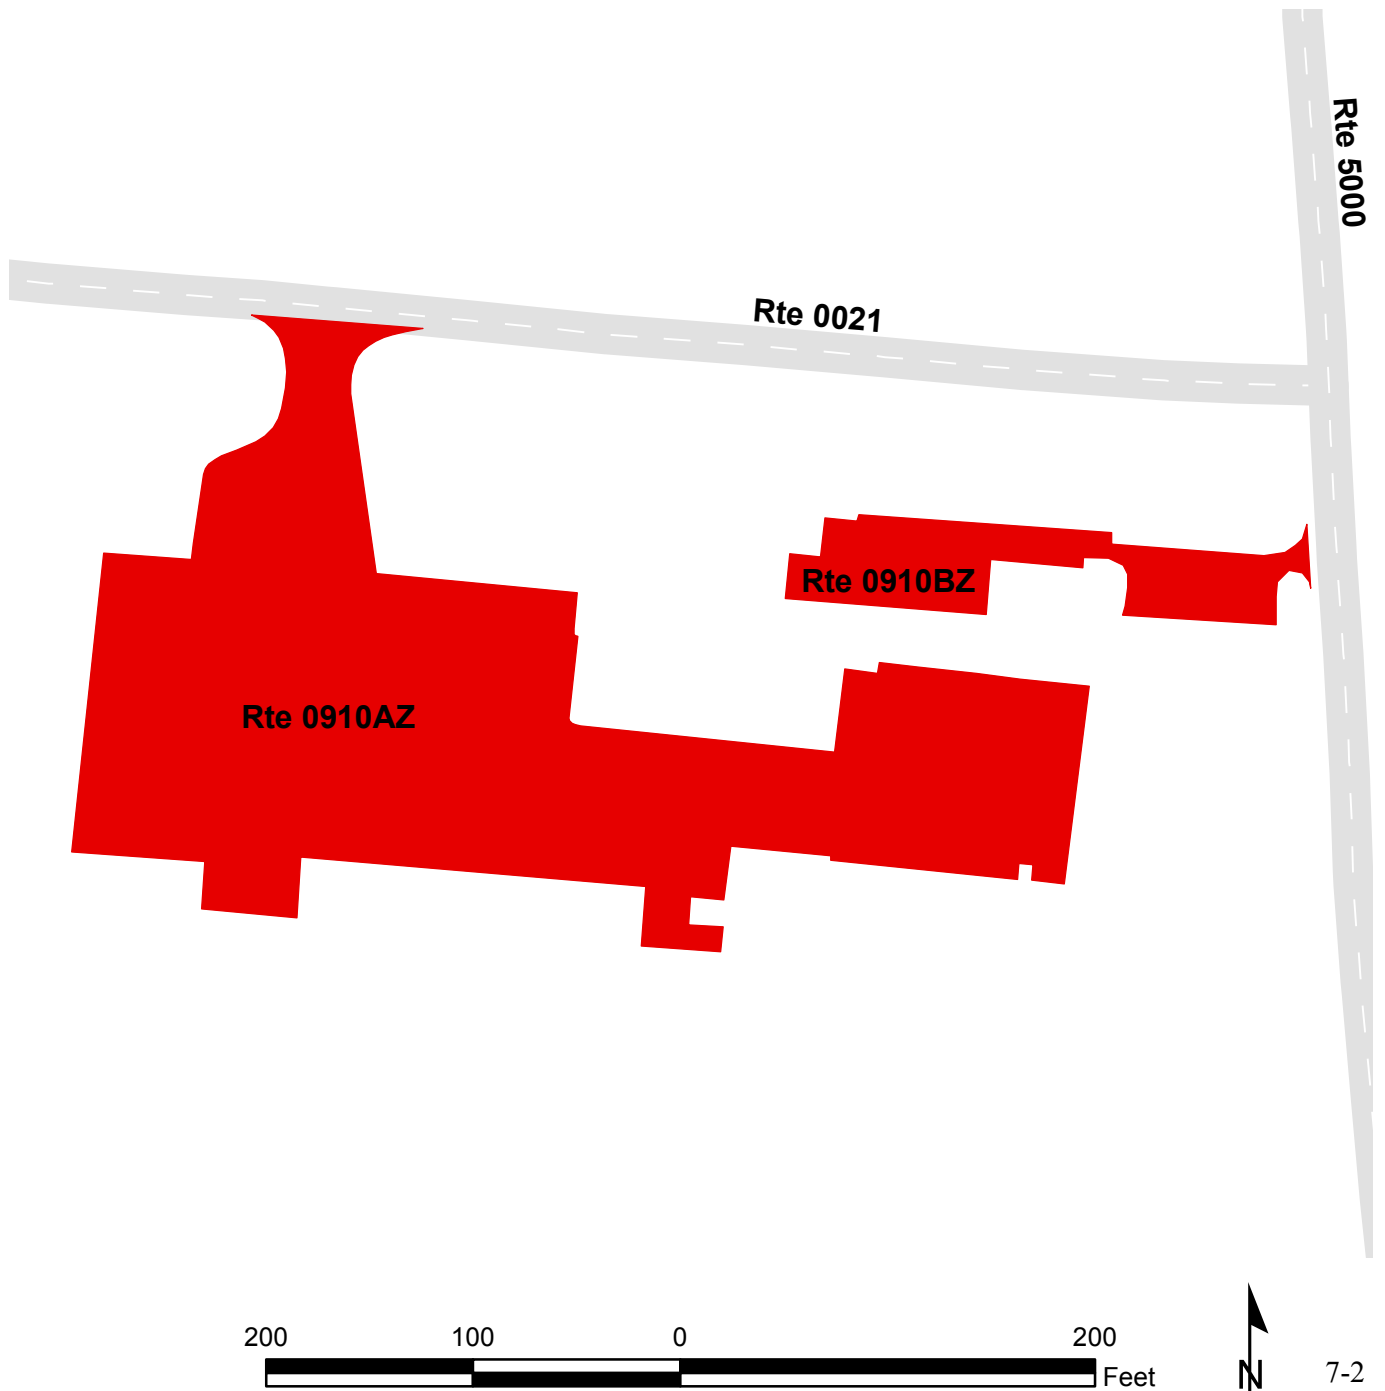
Route 0910ZZ

Route Number	Public / NonPublic	Date Visited	Area (sq ft)	Lane Miles *	Surface Type
0910ZZ	PUBLIC	2/20/2013	53,104	0.91	AS
Culverts	Drop Inlets	Gates	Curb & Gutter	Curb	PCR
-1	-1	-1	N/A	N/A	SUMMARY/90
