Federal Lands Highway Road Inventory Program

Road Inventory and Condition Assessment

Gettysburg National Military Park GETT

Cycle 5 Report

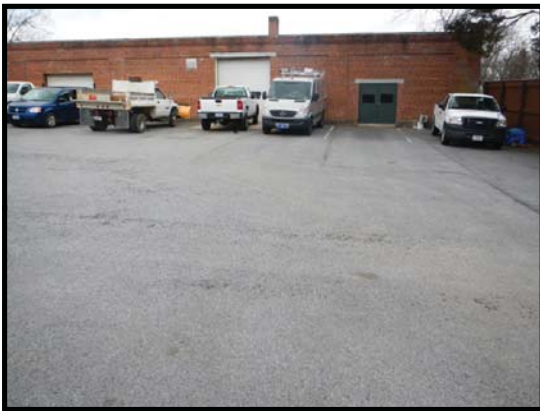
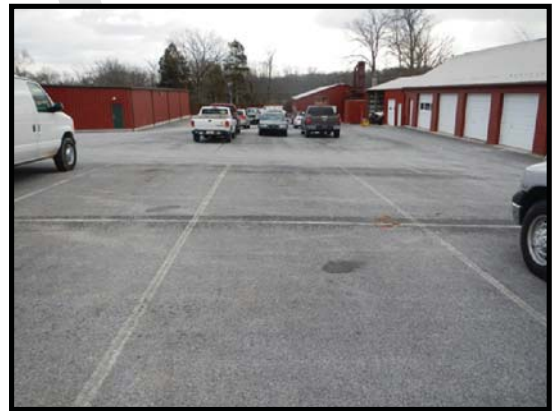
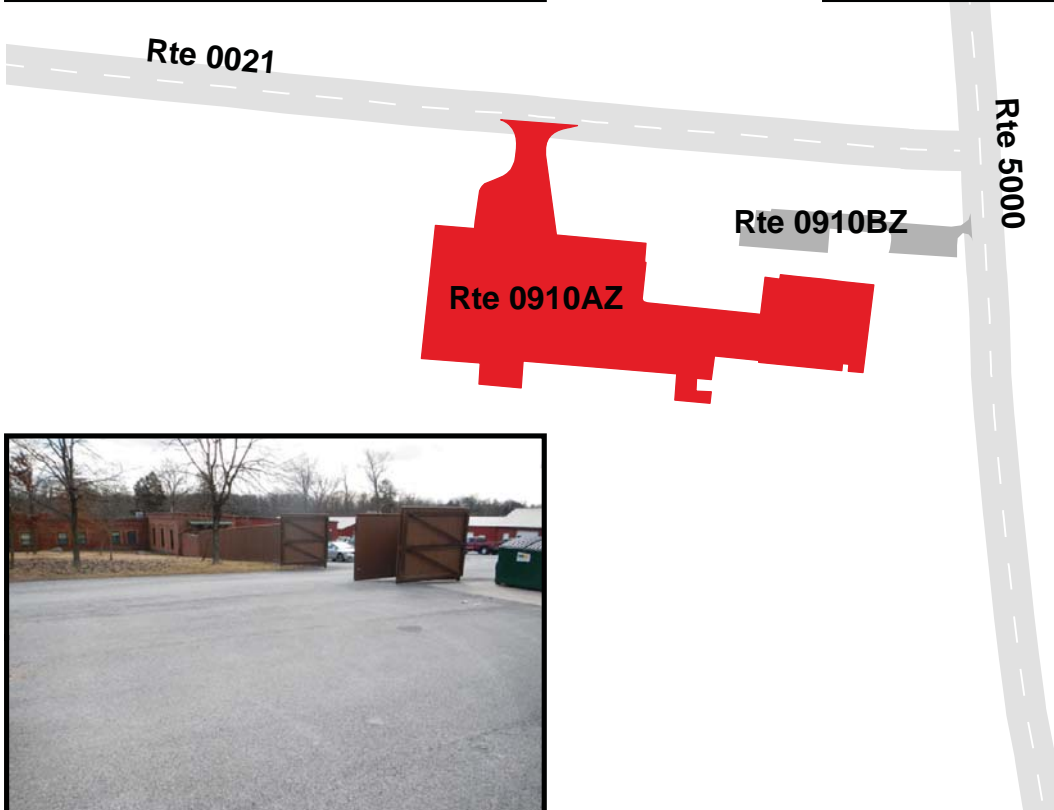
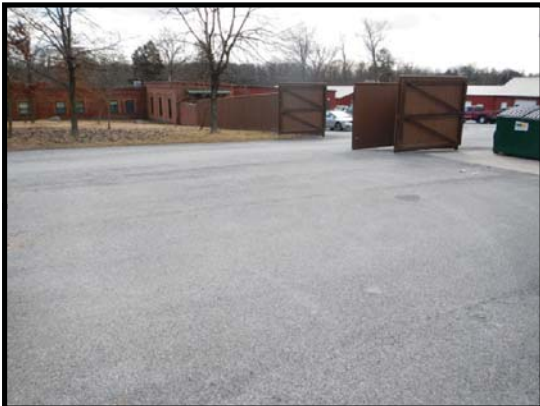
Route 0910AZ

Route Number	Public / NonPublic	Date Visited	Area (sq ft)	Lane Miles *	Surface Type
0910AZ	PUBLIC	2/20/2013	47,352	0.82	AS
Culverts	Drop Inlets	Gates	Curb & Gutter	Curb	PCR
1	4	6	NO CURB AND GUTTER	CONCRETE CURB	GOOD/90

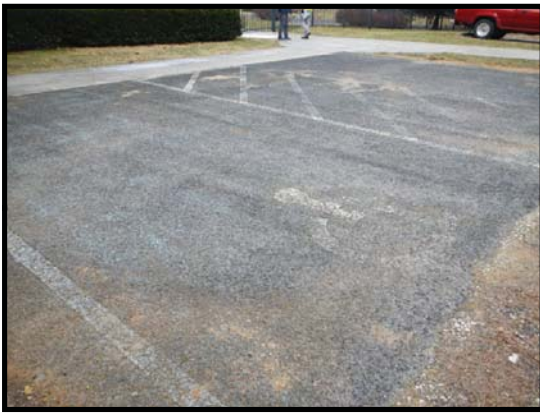
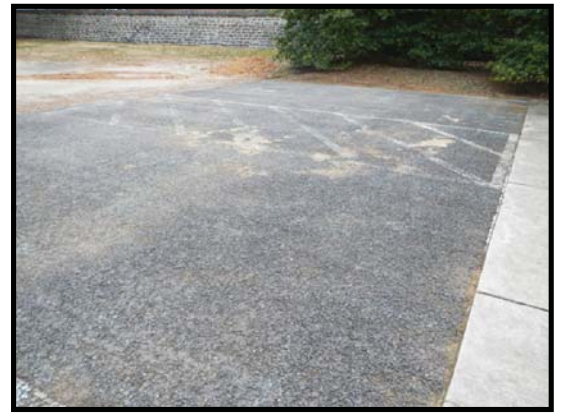
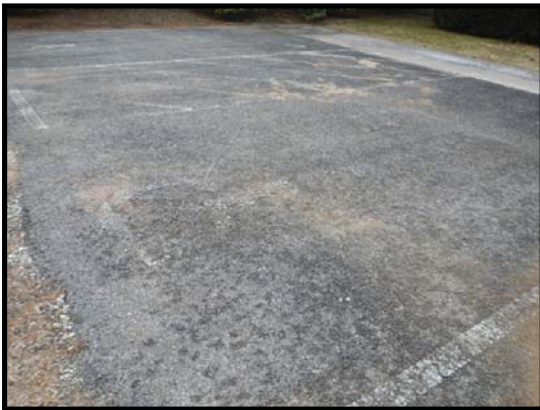
Route 0924

Route Number	Public / NonPublic	Date Visited	Area (sq ft)	Lane Miles *	Surface Type
0924	PUBLIC	2/20/2013	686	0.01	AS
Culverts	Drop Inlets	Gates	Curb & Gutter	Curb	PCR
0	0	0	NO CURB AND GUTTER	NO CURB	GOOD/90
