# Federal Lands Highway Road Inventory Program

Road Inventory and Condition Assessment

## George Washington Birthplace National Monument GEWA

### Cycle 5 Report

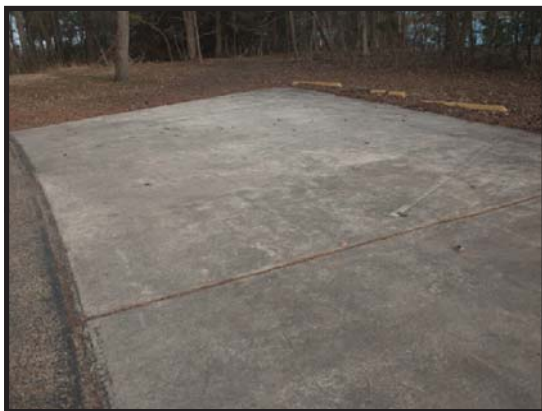
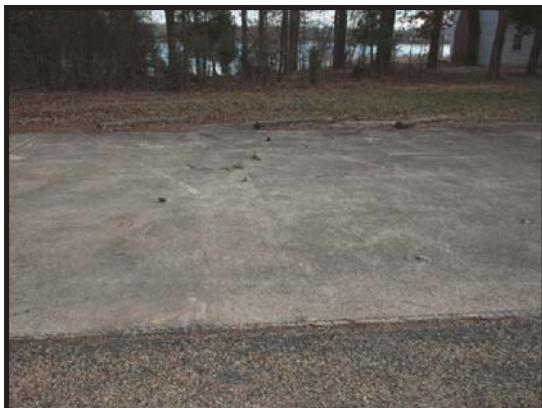
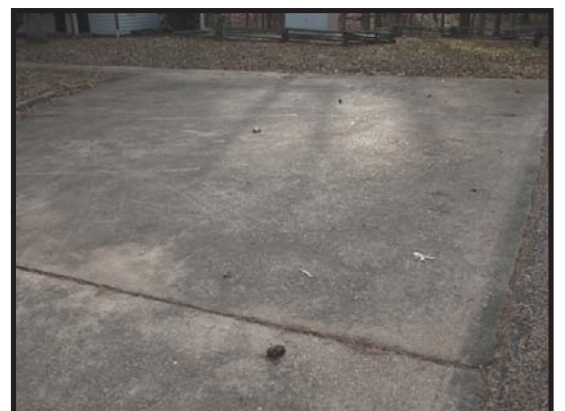
## Route 0903

Route Number	Public / NonPublic	Date Visited	Area (sq ft)	Lane Miles *	Surface Type
0903	PUBLIC	1/23/2013	16,536	0.29	AS
Culverts	Drop Inlets	Gates	Curb & Gutter	Curb	PCR
1	0	0	NO CURB AND GUTTER	NO CURB	POOR/45

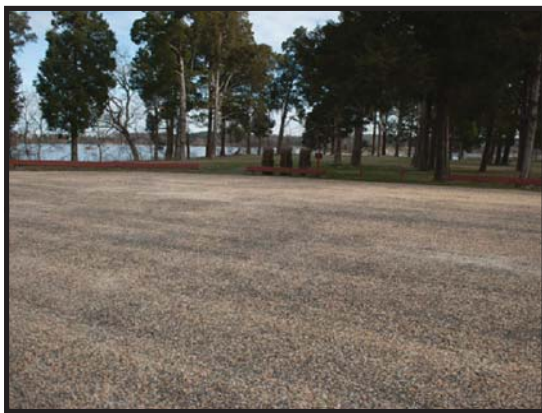
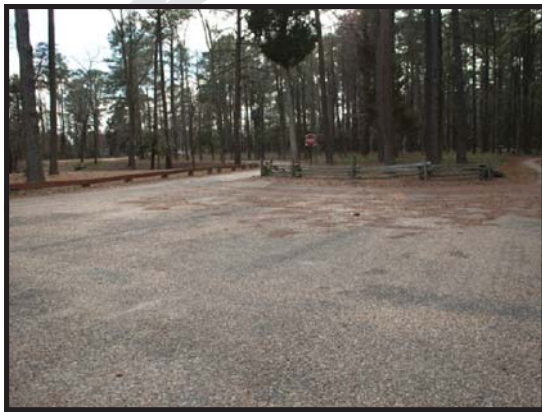
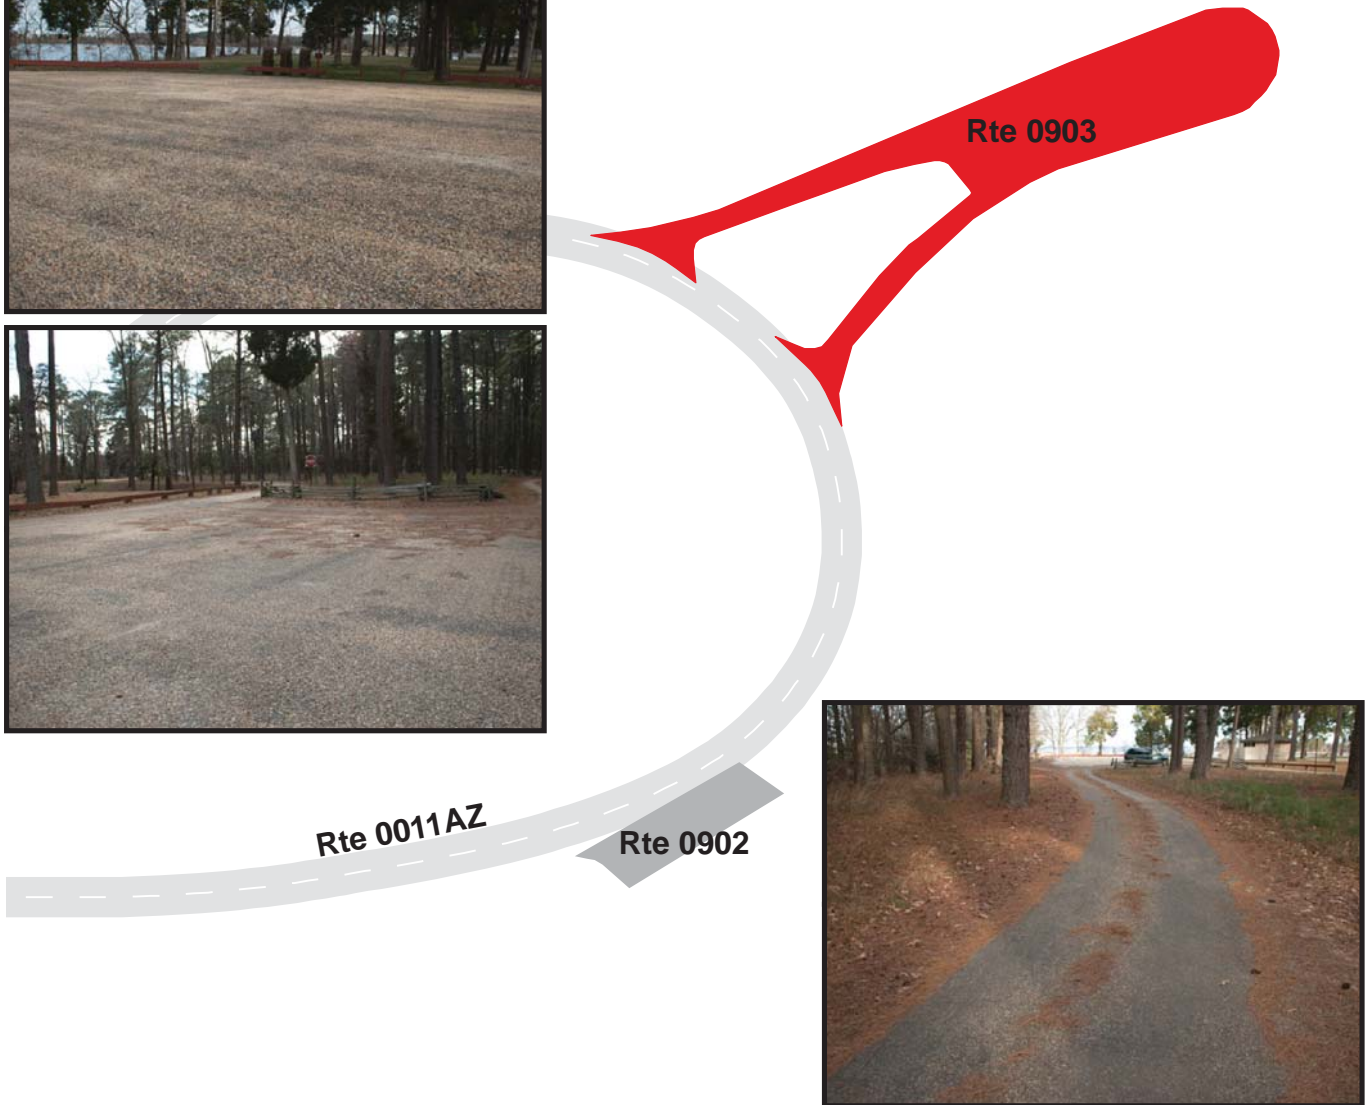
## Route 0904

Route Number	Public / NonPublic	Date Visited	Area (sq ft)	Lane Miles *	Surface Type
0904	NONPUBLIC	1/23/2013	8,086	0.14	AS
Culverts	Drop Inlets	Gates	Curb & Gutter	Curb	PCR
0	0	0	NO CURB AND GUTTER	NO CURB	POOR/45

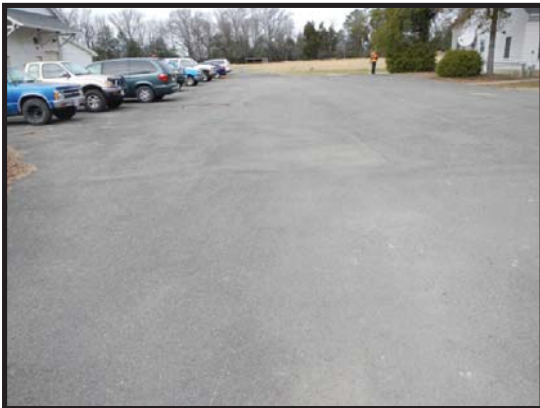
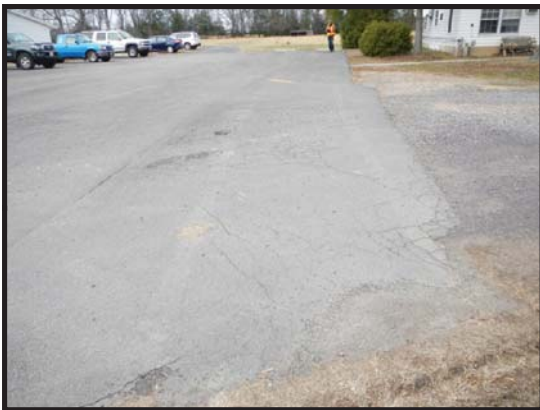
## Route 0905

Route Number	Public / NonPublic	Date Visited	Area (sq ft)	Lane Miles *	Surface Type
0905	PUBLIC	1/23/2013	7,034	0.12	AS
Culverts	Drop Inlets	Gates	Curb & Gutter	Curb	PCR
0	0	0	NO CURB AND GUTTER	NO CURB	FAIR/73

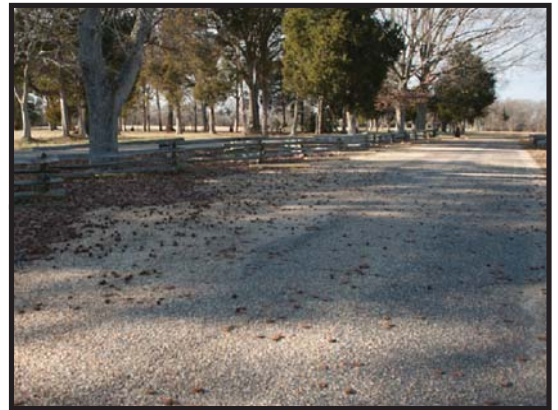
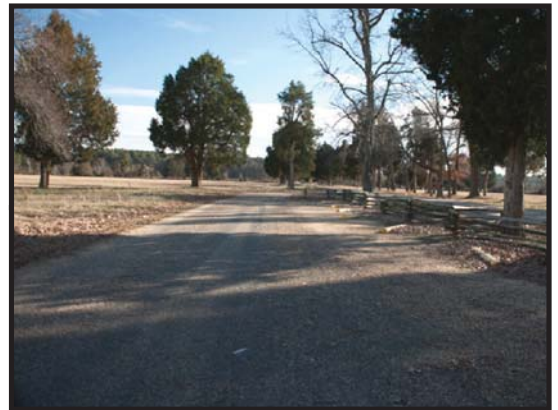
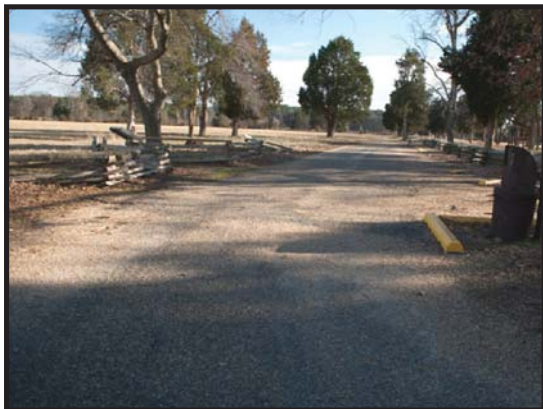
## Route 0906

Route Number	Public / NonPublic	Date Visited	Area (sq ft)	Lane Miles *	Surface Type
0906	PUBLIC	1/23/2013	7,830	0.14	AS
Culverts	Drop Inlets	Gates	Curb & Gutter	Curb	PCR
0	0	0	NO CURB AND GUTTER	NO CURB	FAIR/73
