Federal Lands Highway Road Inventory Program

Road Inventory and Condition Assessment

Gila Cliff Dwellings National Monument GICL - 7250

Cycle 5 Report

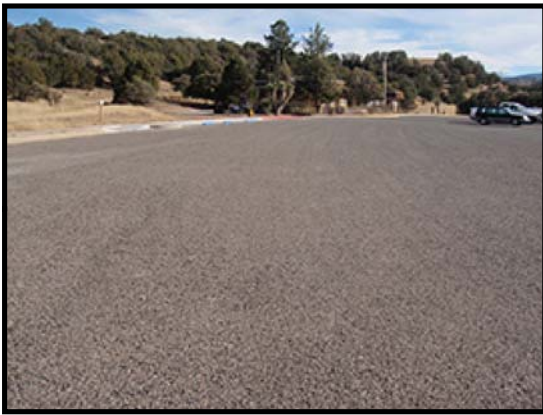
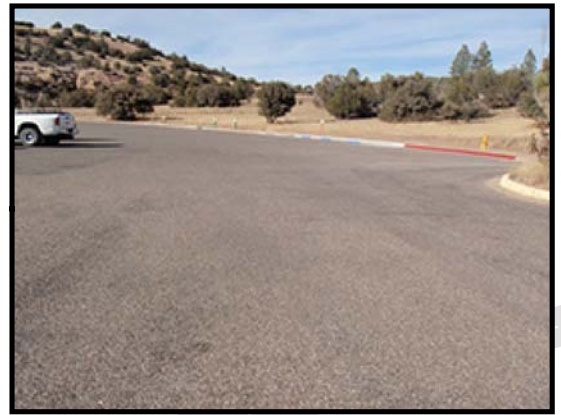
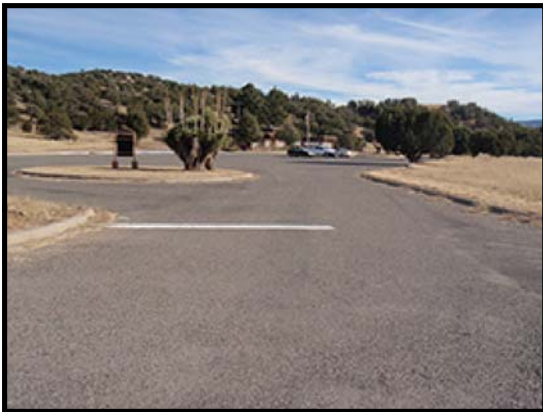
Route Number	Public / NonPublic	Date Visited	Area (sq ft)	Lane Miles *	Surface Type
0900	PUBLIC	12/5/2010	54,037	0.93	AS
Culverts	Drop Inlets	Gates	Curb & Gutter	Curb	PCR
0	1	0	CONCRETE CURB AND GUTTER	NO CURB	FAIR/73

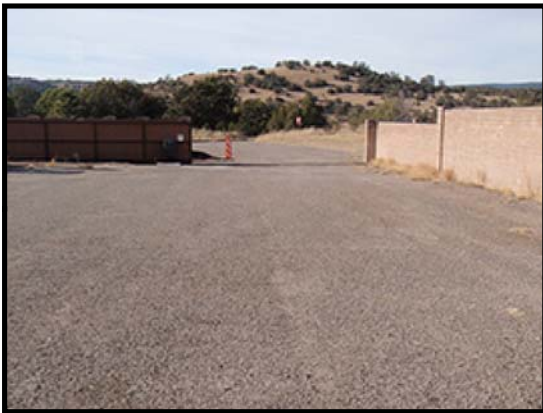
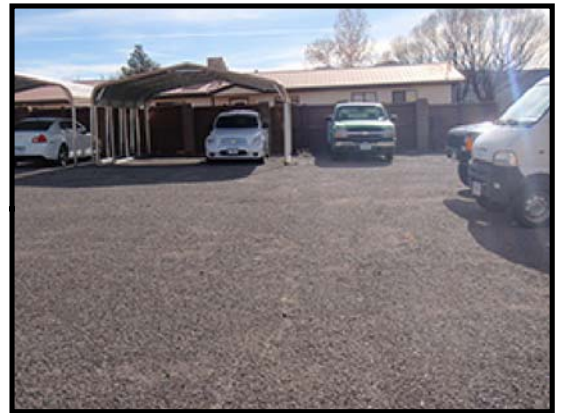
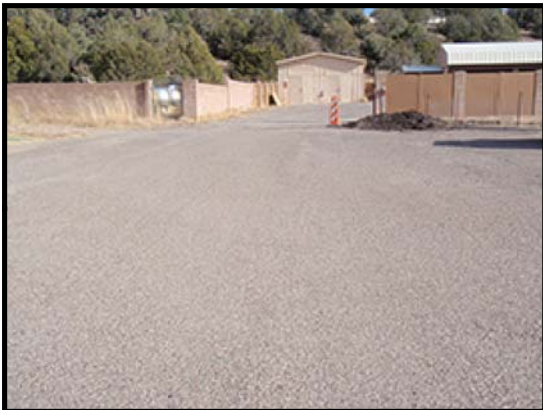
Route 0903

Route Number	Public / NonPublic	Date Visited	Area (sq ft)	Lane Miles *	Surface Type
0903	NONPUBLIC	12/5/2010	16,743	0.29	AS
Culverts	Drop Inlets	Gates	Curb & Gutter	Curb	PCR
0	0	1	CONCRETE CURB AND GUTTER	NO CURB	POOR/45

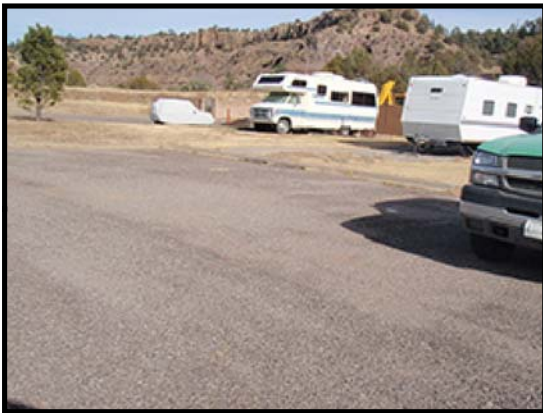
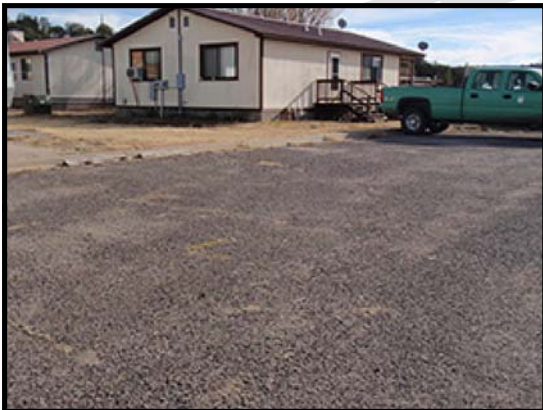
Route 0904A

Route Number	Public / NonPublic	Date Visited	Area (sq ft)	Lane Miles *	Surface Type
0904A	NONPUBLIC	12/5/2010	1,786	0.03	AS
Culverts	Drop Inlets	Gates	Curb & Gutter	Curb	PCR
0	0	0	CONCRETE CURB AND GUTTER	NO CURB	POOR/45

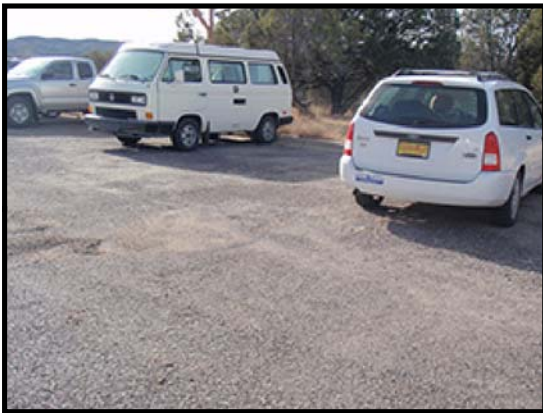
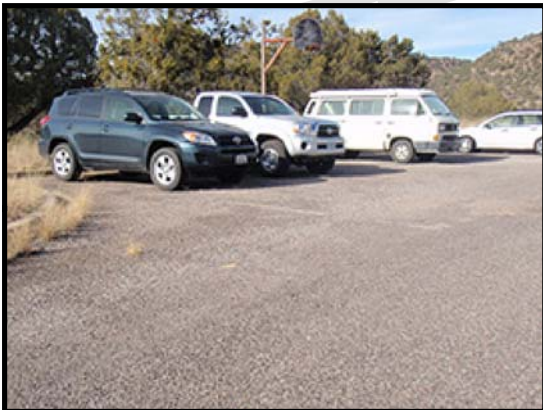
Route 0904B

Route Number	Public / NonPublic	Date Visited	Area (sq ft)	Lane Miles *	Surface Type
0904B	NONPUBLIC	12/5/2010	1,527	0.03	AS
Culverts	Drop Inlets	Gates	Curb & Gutter	Curb	PCR
0	0	0	CONCRETE CURB AND GUTTER	NO CURB	POOR/45

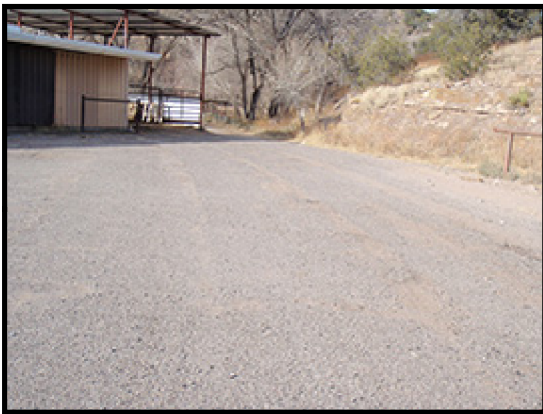
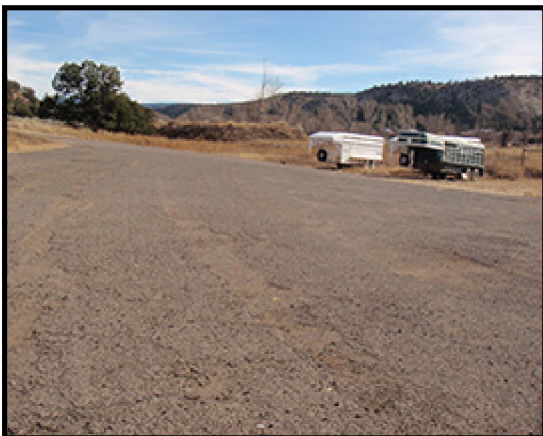
Route 0908

Route Number	Public / NonPublic	Date Visited	Area (sq ft)	Lane Miles *	Surface Type
0908	NONPUBLIC	12/5/2010	5,803	0.10	AS
Culverts	Drop Inlets	Gates	Curb & Gutter	Curb	PCR
0	0	0	NO CURB AND GUTTER	NO CURB	POOR/45

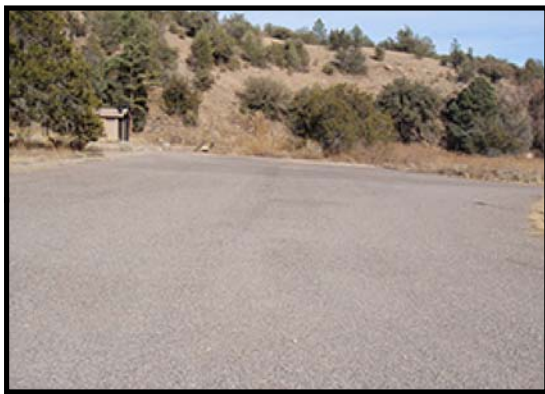
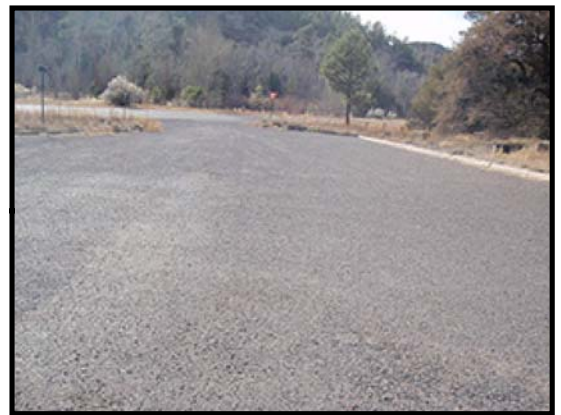
Route Number	Public / NonPublic	Date Visited	Area (sq ft)	Lane Miles *	Surface Type
0912	PUBLIC	12/5/2010	11,470	0.20	AS
Culverts	Drop Inlets	Gates	Curb & Gutter	Curb	PCR
0	0	0	CONCRETE CURB AND GUTTER	NO CURB	POOR/45

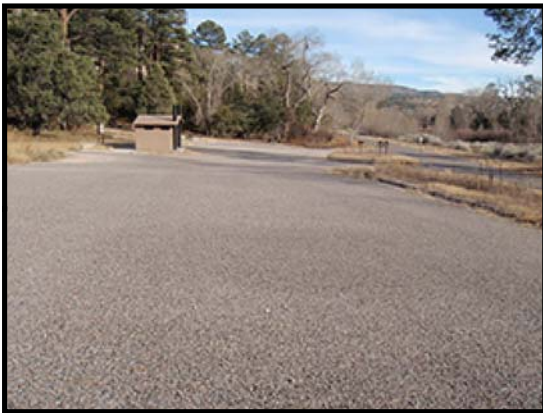
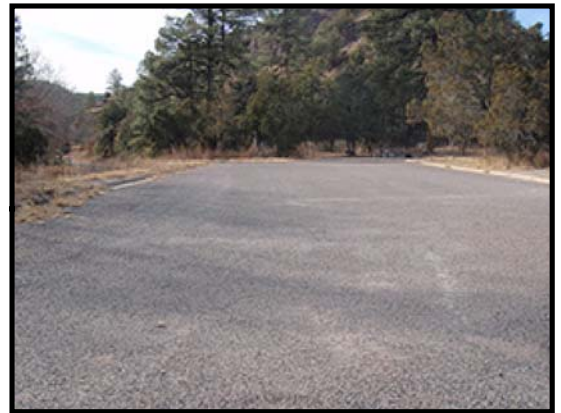
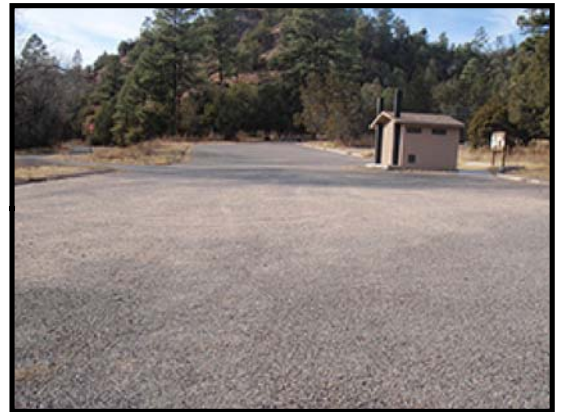
Route 0913

Route Number	Public / NonPublic	Date Visited	Area (sq ft)	Lane Miles *	Surface Type
0913	PUBLIC	12/5/2010	17,695	0.31	AS
Culverts	Drop Inlets	Gates	Curb & Gutter	Curb	PCR
0	0	0	CONCRETE CURB AND GUTTER	NO CURB	POOR/45

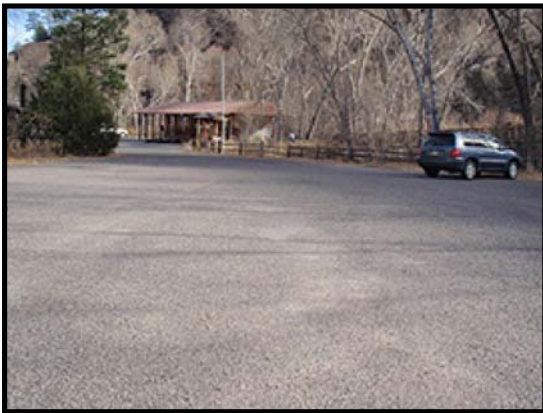
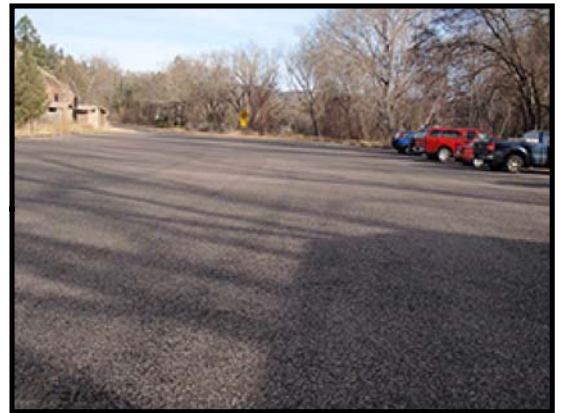
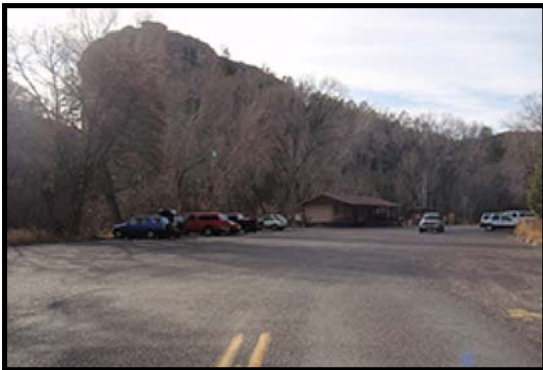
Route 0914

Route Number	Public / NonPublic	Date Visited	Area (sq ft)	Lane Miles *	Surface Type
0914	PUBLIC	12/5/2010	37,991	0.65	AS
Culverts	Drop Inlets	Gates	Curb & Gutter	Curb	PCR
0	0	0	NO CURB AND GUTTER	NO CURB	FAIR/73
