Federal Lands Highway Road Inventory Program

Road Inventory and Condition Assessment

Glen Canyon National Recreation Area GLCA

Cycle 5 Report

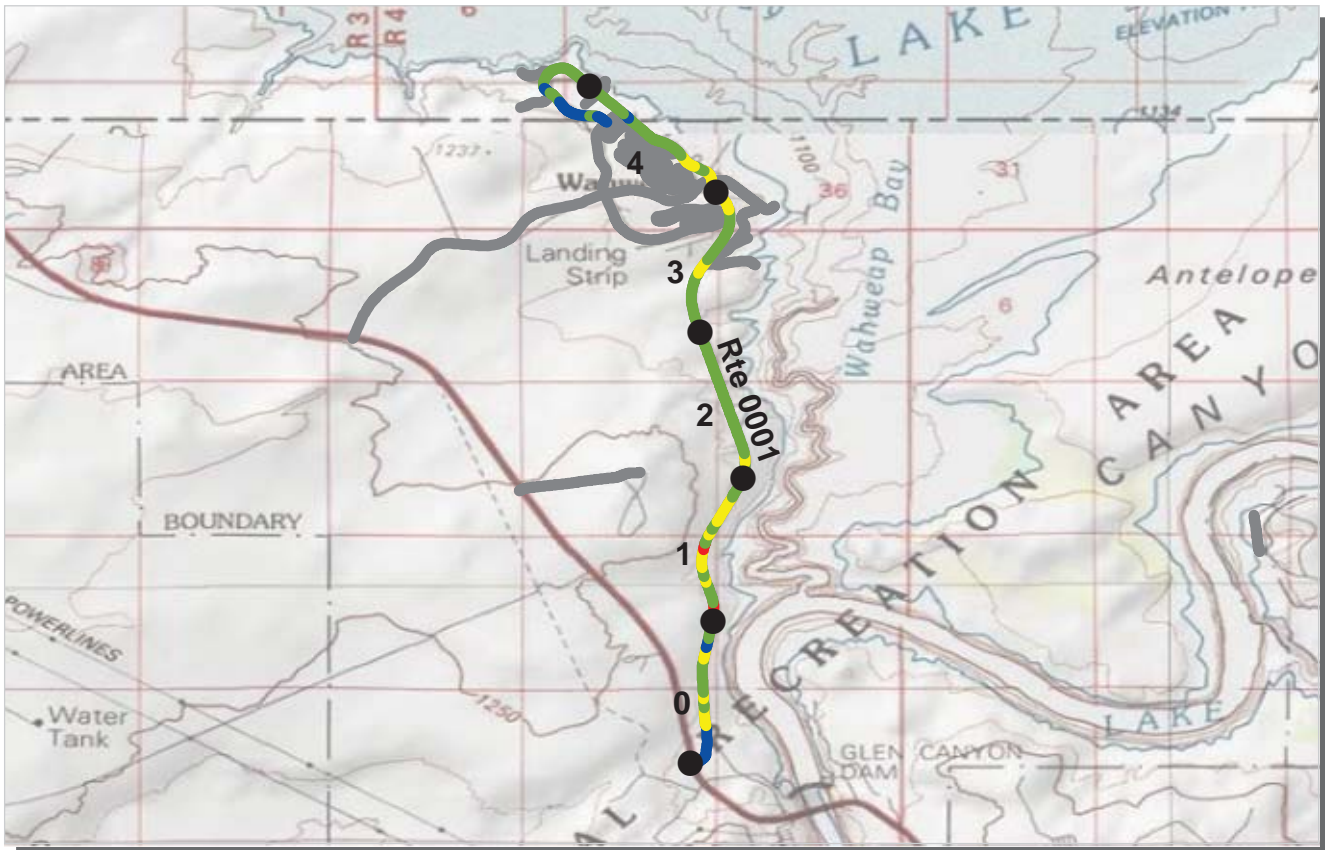
<i>Section Number</i>	0	1	2	3	4
<i>Section Length (mi)</i>	1.00	1.00	1.00	1.00	1.00
<i>Cross Section Information</i>					
Number of Lanes	2	2	2	2	2
Paved Width (ft)	41	32	33	32	37
Lane Width (ft)	17	12	12	12	16
<i>Roadway Condition Information</i>					
SCR (Surface Condition Rating)	91	75	91	89	94
PCR (Pavement Condition Rating)	90	85	93	88	91
<i>Distress Index Values</i>					
Structural Crack Index	95	75	98	96	98
Transverse Cracking Index	91	86	91	89	94
Patching Index	100	100	100	100	98
Rutting Index	93	92	91	89	95
Roughness Condition Index (RCI)	88	99	96	87	86

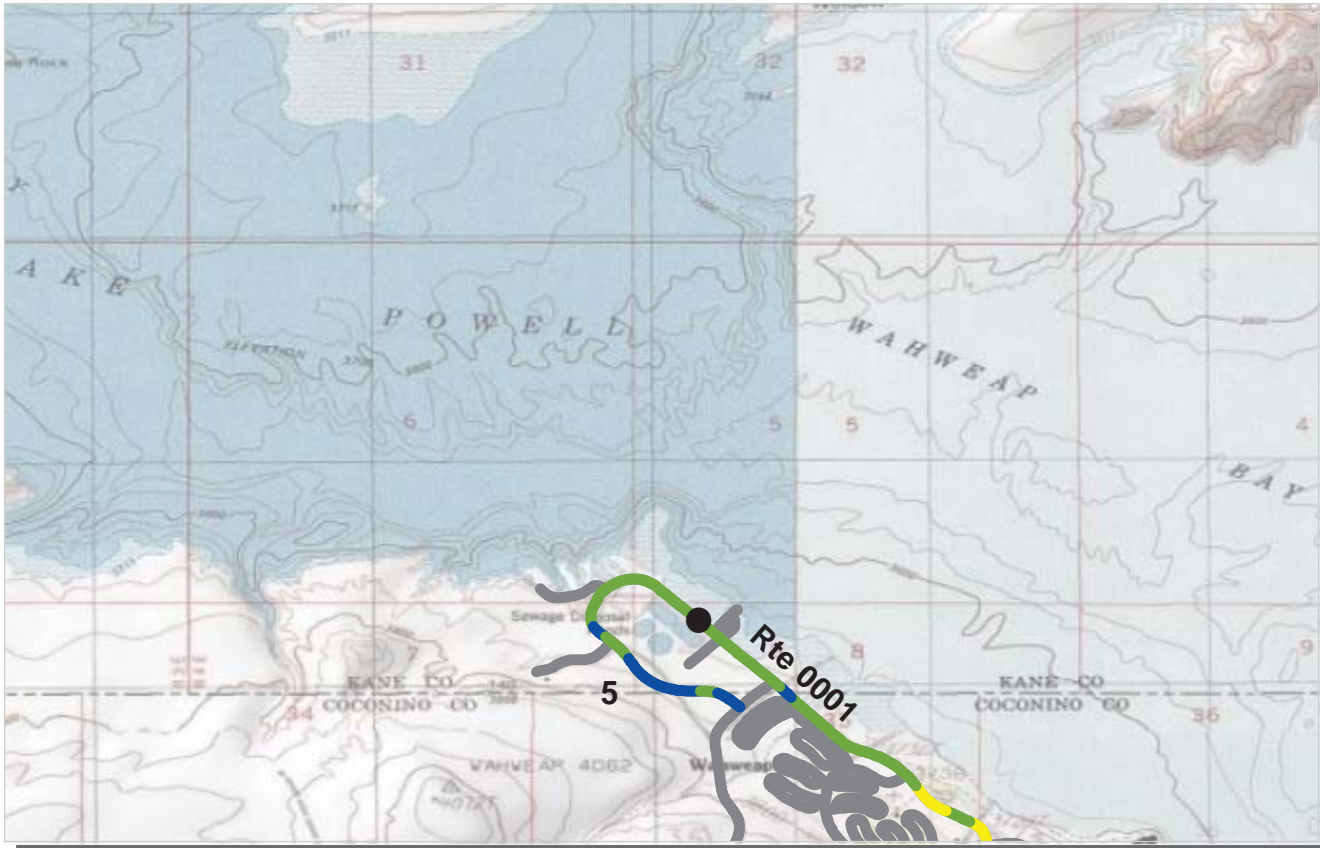
ROUTE: 0001 LAKESHORE DRIVE

Section Number	5				
Section Length (mi)	0.80				
Cross Section Information					
Number of Lanes	2				
Paved Width (ft)	33				
Lane Width (ft)	13				
Roadway Condition Information					
SCR (Surface Condition Rating)	95				
PCR (Pavement Condition Rating)	93				
Distress Index Values					
Structural Crack Index	98				
Transverse Cracking Index	95				
Patching Index	100				
Rutting Index	97				
Roughness Condition Index (RCI)	91

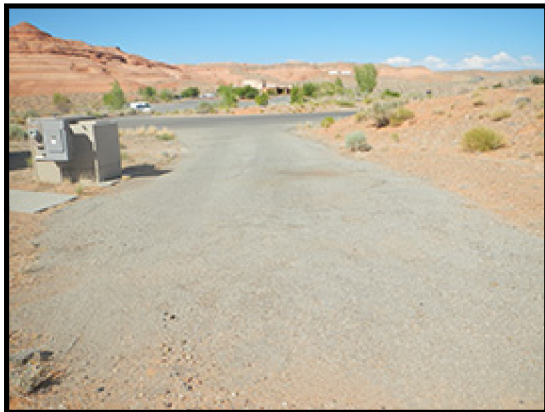
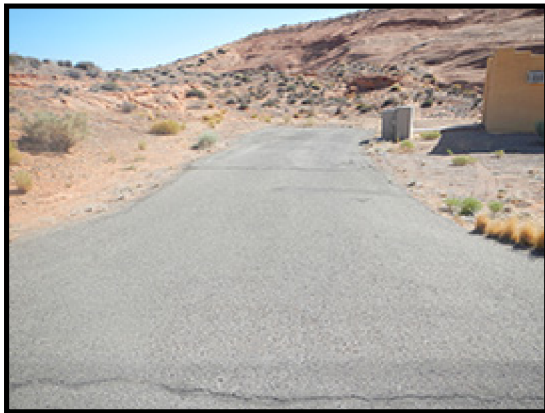
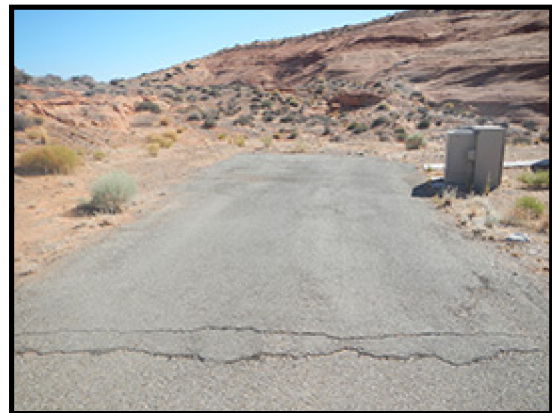
Route 0433

Route Number	Public / NonPublic	Date Visited	Area (sq ft)	Lane Miles *	Paved Length (mi)	Paved Width (ft)
0433	PUBLIC	6/16/2012	1,331	0.02	0.01	18
Culverts	Drop Inlets	Gates	Curb & Gutter	Curb	PCR	Surface Type
0	0	0	NO CURB AND GUTTER	NO CURB	POOR/45	AS

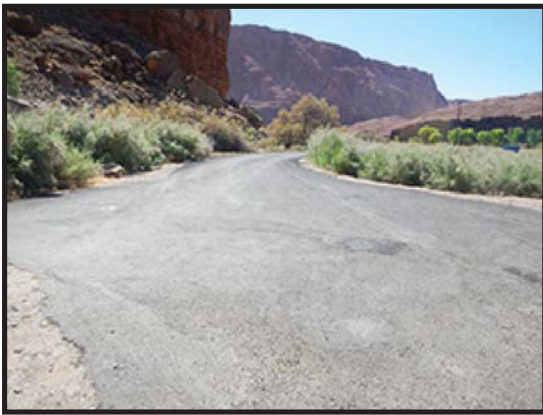
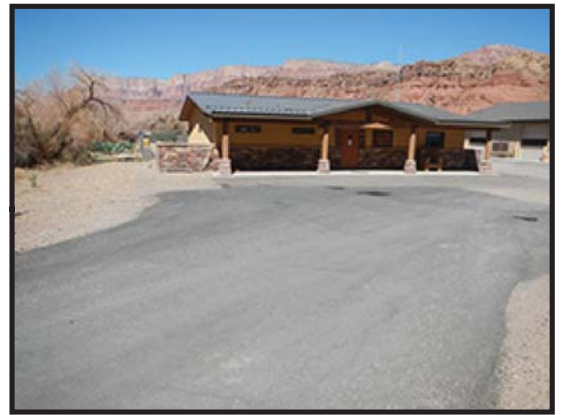
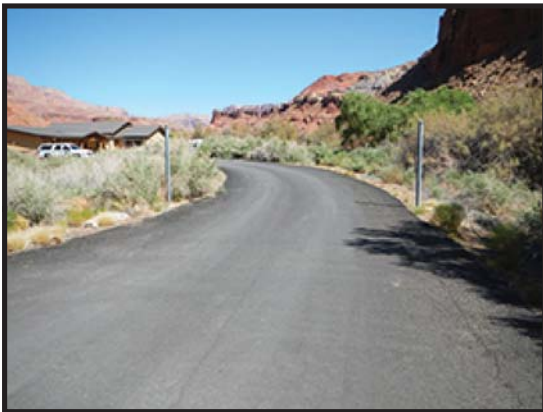
Route Number	Public / NonPublic	Date Visited	Area (sq ft)	Lane Miles *	Surface Type
0956	NONPUBLIC	6/11/2012	3,897	0.07	AS
Culverts	Drop Inlets	Gates	Curb & Gutter	Curb	PCR
1	0	0	NO CURB AND GUTTER	NO CURB	FAIR/73

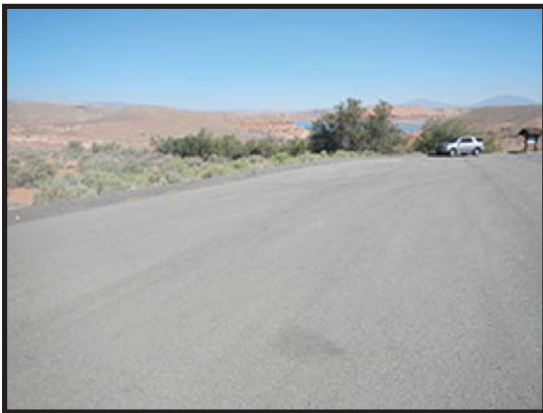
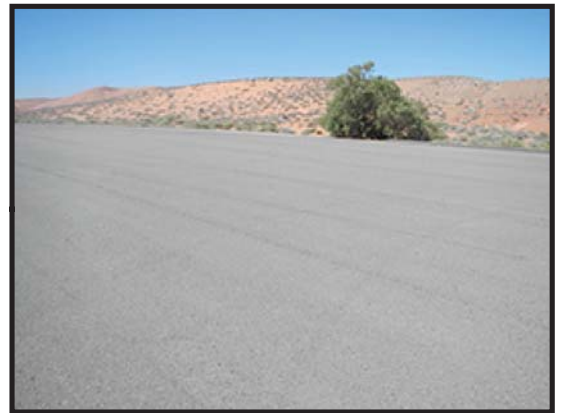
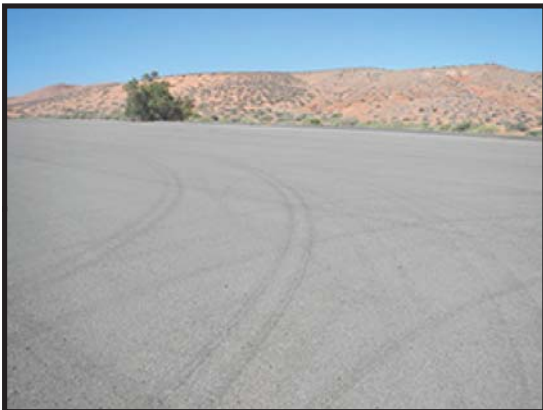
Route 0979

Route Number	Public / NonPublic	Date Visited	Area (sq ft)	Lane Miles *	Surface Type
0979	PUBLIC	6/17/2012	33,357	0.57	AS
Culverts	Drop Inlets	Gates	Curb & Gutter	Curb	PCR
0	0	0	NO CURB AND GUTTER	ASPHALT CURB	GOOD/90

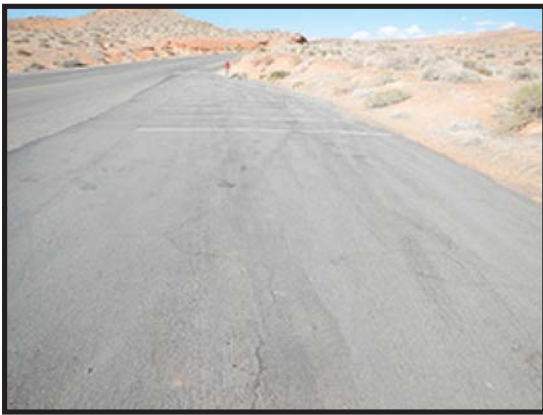
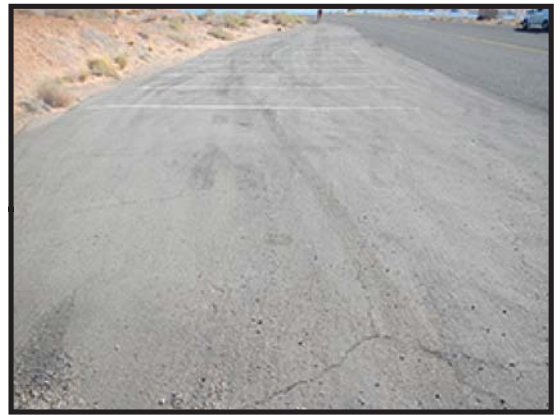
Route 0994B

Route Number	Public / NonPublic	Date Visited	Area (sq ft)	Lane Miles *	Surface Type
0994B	PUBLIC	6/16/2012	5,055	0.09	AS
Culverts	Drop Inlets	Gates	Curb & Gutter	Curb	PCR
0	0	0	NO CURB AND GUTTER	NO CURB	POOR/45

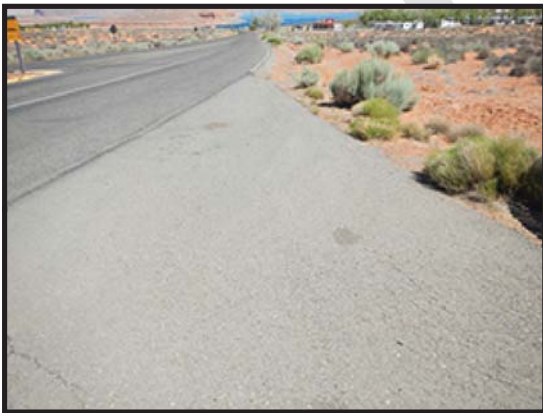
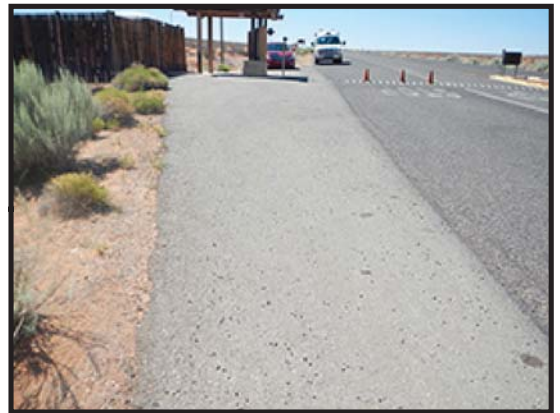
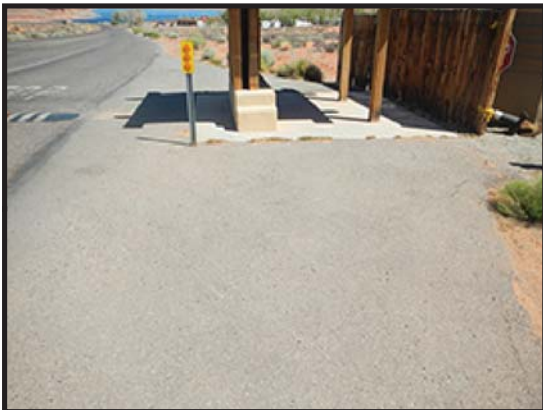
Route 1021

Route Number	Public / NonPublic	Date Visited	Area (sq ft)	Lane Miles *	Surface Type
1021	PUBLIC	6/17/2012	1,420	0.02	AS
Culverts	Drop Inlets	Gates	Curb & Gutter	Curb	PCR
1	0	0	NO CURB AND GUTTER	NO CURB	GOOD/90
