Federal Lands Highway Road Inventory Program

Road Inventory and Condition Assessment

Grand Canyon National Park
GRCA

Cycle 5 Report

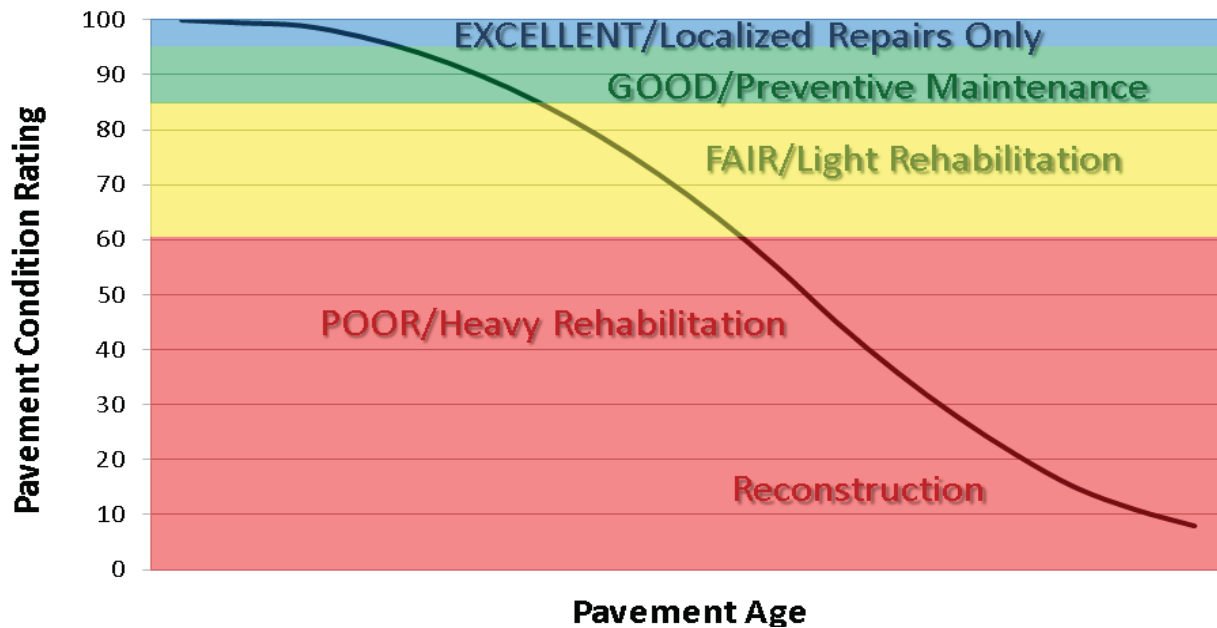
Condition Categories and Treatments

- Excellent/New: PCR of 95-100. Pavements in this range will require only spot repairs
- Good: PCR of 85-94. Pavements in this range will likely be candidates for Preventive Maintenance. Examples include Chip and Slurry Seals, Micro Surfacing and Thin Overlays.
- Fair: PCR of 61-84. Pavements in this range will likely be candidates of Light Rehabilitation (L3R). Examples include single-lift overlays up to 2.5 inches in total thickness, milling and overlays.
- Poor: PCR of 0-60. Pavements in this range will likely be candidates of Heavy Rehabilitation or Reconstruction (H3R or 4R). Examples include Pulverization, Multiple Lift Overlays, and Reconstruction.

At this time, specific Maintenance and Rehabilitation activities should be evaluated and recommended at the project level. Site-specific conditions that influence treatment type should be determined based on performing a subsurface investigation and/or pavement condition survey, and not be based solely on RIP data. Additionally, RIP produces a snapshot of conditions the year in which the data was collected. For further information or to obtain additional Pavement Management System's data from our Highway Pavement Management Application (HPMA) please contact the Eastern Federal Lands pavement team.

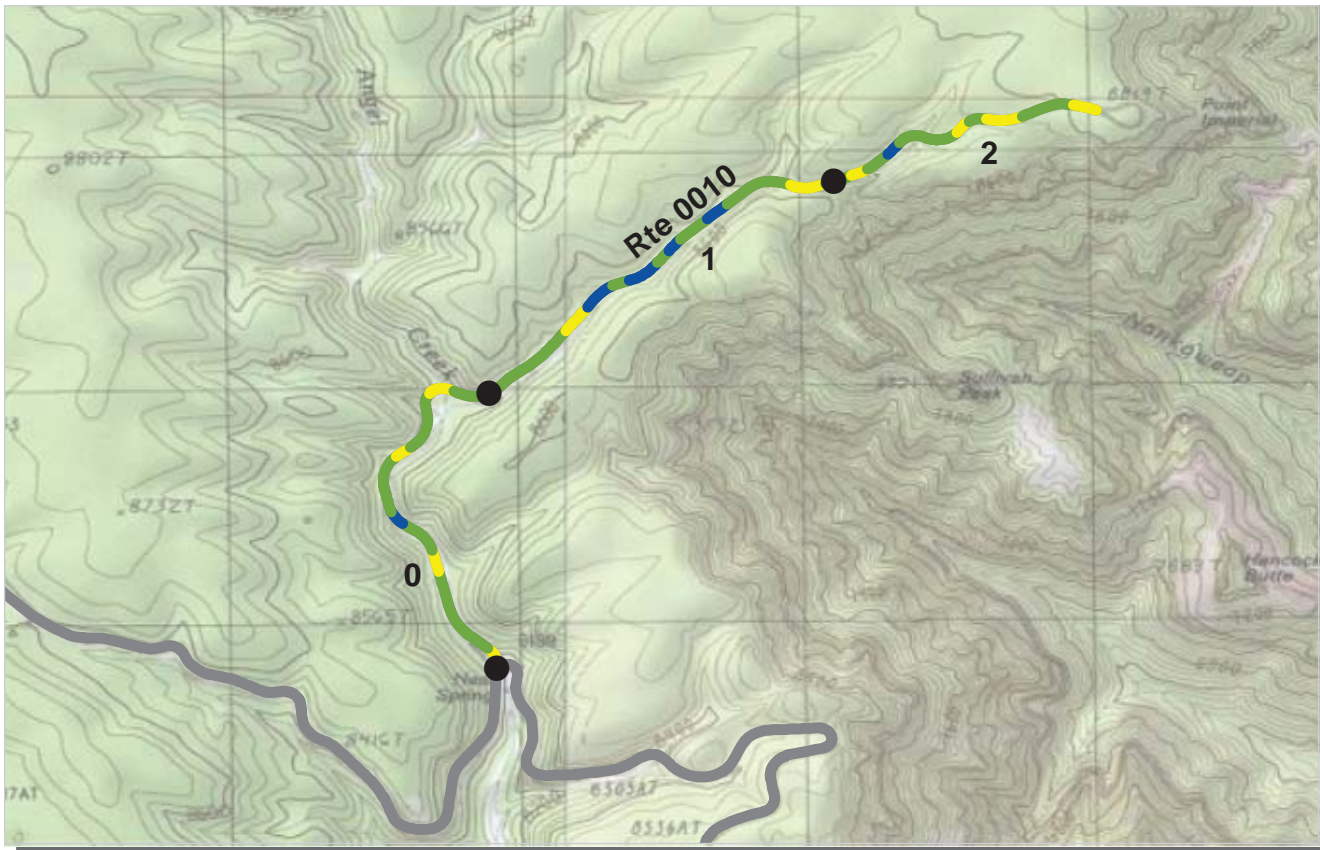
<i>Section Number</i>	0	1	2		
<i>Section Length (mi)</i>	1.00	1.00	0.65		
<i>Cross Section Information</i>					
Number of Lanes	2	2	2		
Paved Width (ft)	20	20	21		
Lane Width (ft)	9	8	9		
<i>Roadway Condition Information</i>					
SCR (Surface Condition Rating)	92	93	95		
PCR (Pavement Condition Rating)	85	89	86		
<i>Distress Index Values</i>					
Structural Crack Index	99	100	100		
Transverse Cracking Index	99	99	100		
Patching Index	100	100	100		
Rutting Index	92	93	95		
Roughness Condition Index (RCI)	75	82	73

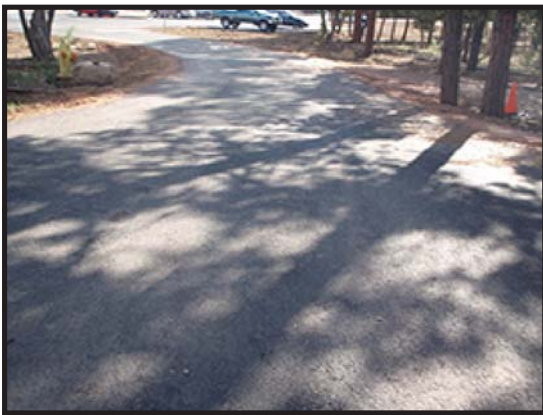
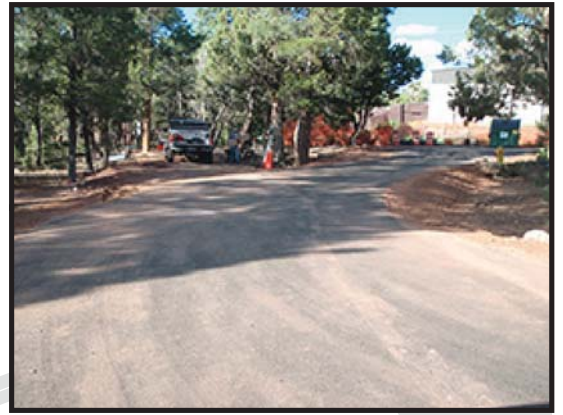
Route 0504

Route Number	Public / NonPublic	Date Visited	Area (sq ft)	Lane Miles *	Surface Type
0504	PUBLIC	6/8/2012	6,218	0.11	AS
Culverts	Drop Inlets	Gates	Curb & Gutter	Curb	PCR
0	0	0	NO CURB AND GUTTER	NO CURB	POOR/45

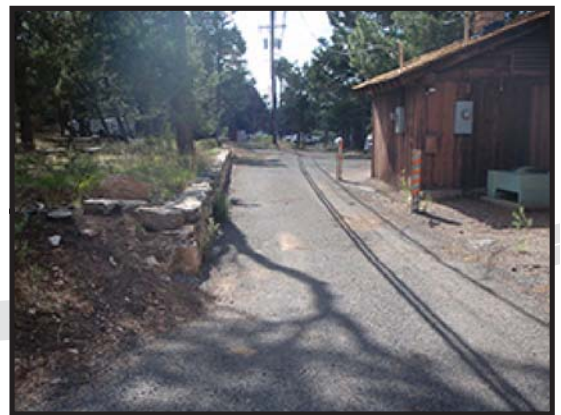
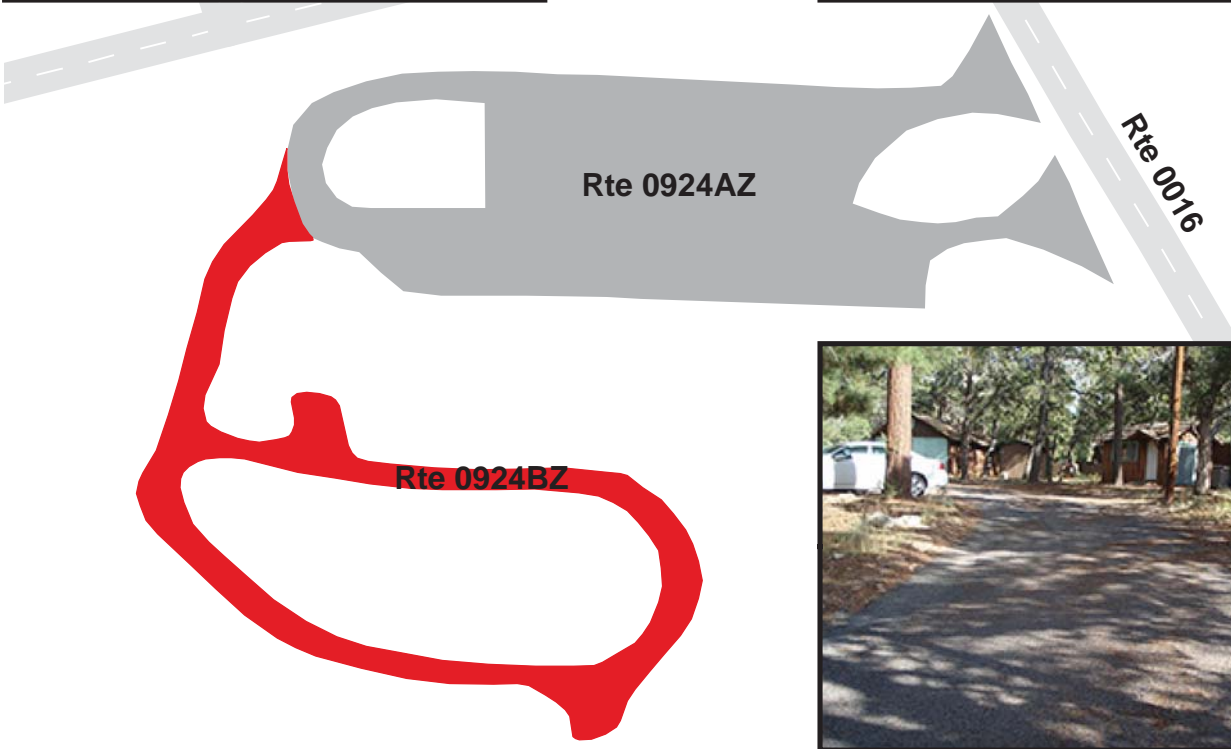
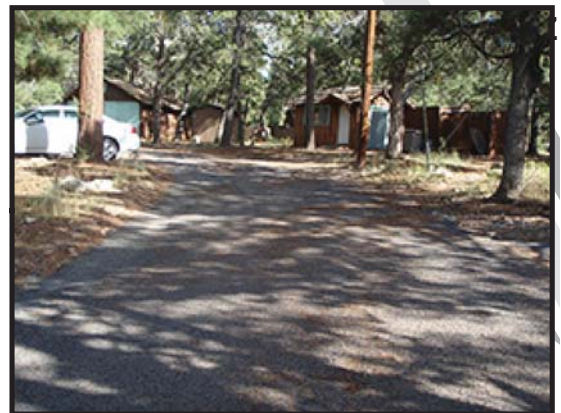
Route 0928

Route Number	Public / NonPublic	Date Visited	Area (sq ft)	Lane Miles *	Surface Type
0924BZ	PUBLIC	8/15/2011	7,206	0.12	AS
Culverts	Drop Inlets	Gates	Curb & Gutter	Curb	PCR
0	0	0	NO CURB AND GUTTER	STONE CURB	POOR/45

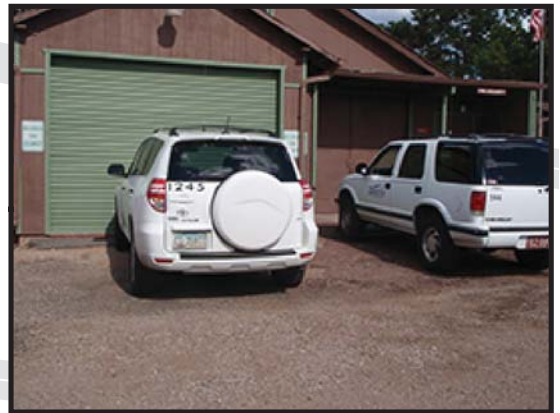
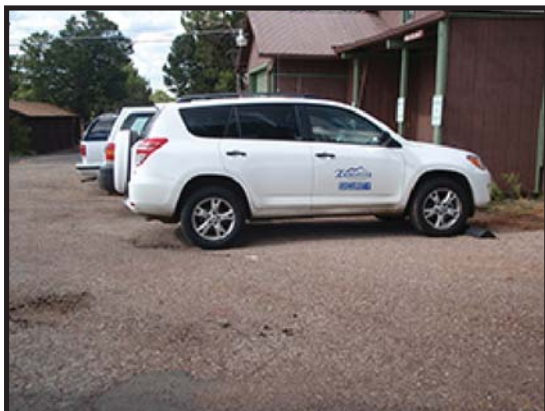
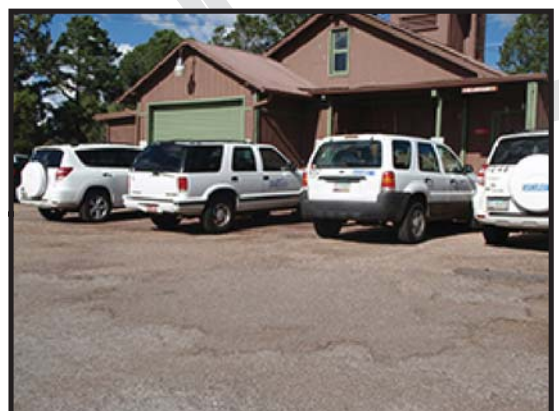
Route 0989ZZ

Route Number	Public / NonPublic	Date Visited	Area (sq ft)	Lane Miles *	Surface Type
0934BZ	PUBLIC	8/15/2011	10,223	0.18	AS
Culverts	Drop Inlets	Gates	Curb & Gutter	Curb	PCR
0	0	0	NO CURB AND GUTTER	NO CURB	POOR/45

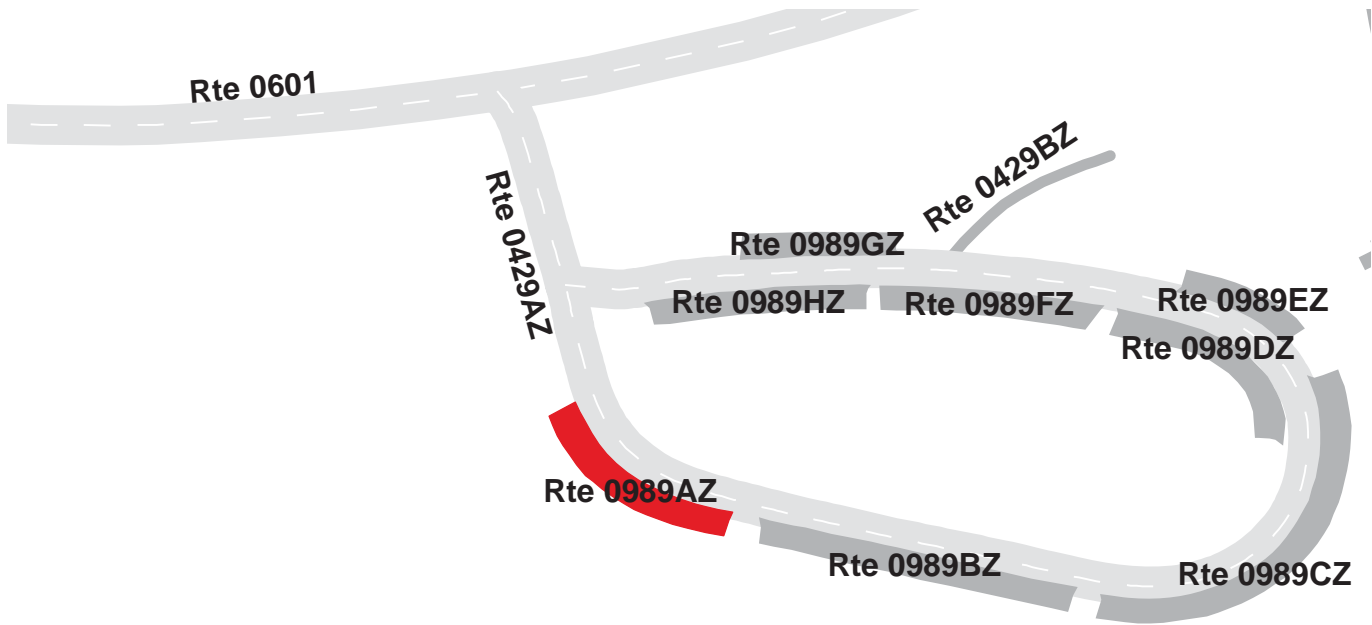
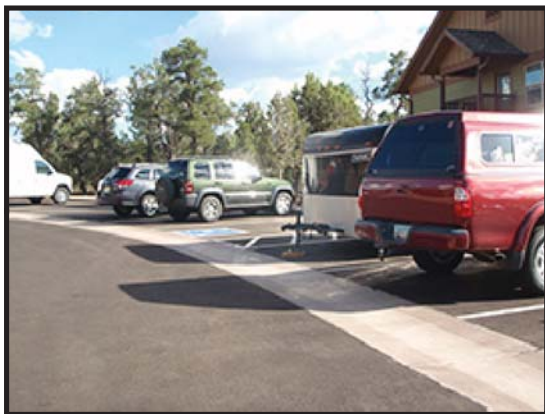
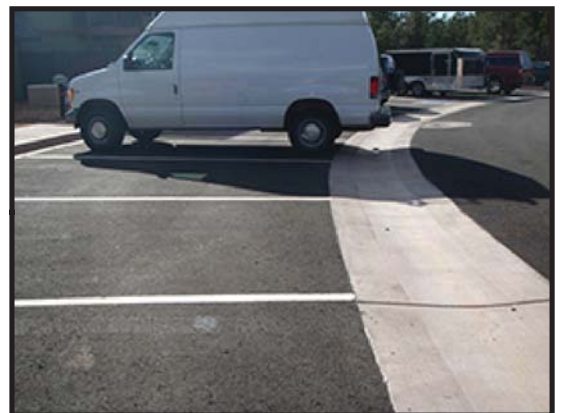
Route 0989BZ

Route Number	Public / NonPublic	Date Visited	Area (sq ft)	Lane Miles *	Surface Type
0989AZ	PUBLIC	8/15/2011	3,188	0.06	AS
Culverts	Drop Inlets	Gates	Curb & Gutter	Curb	PCR
0	0	0	CONCRETE CURB AND GUTTER	NO CURB	EXCELLENT/97

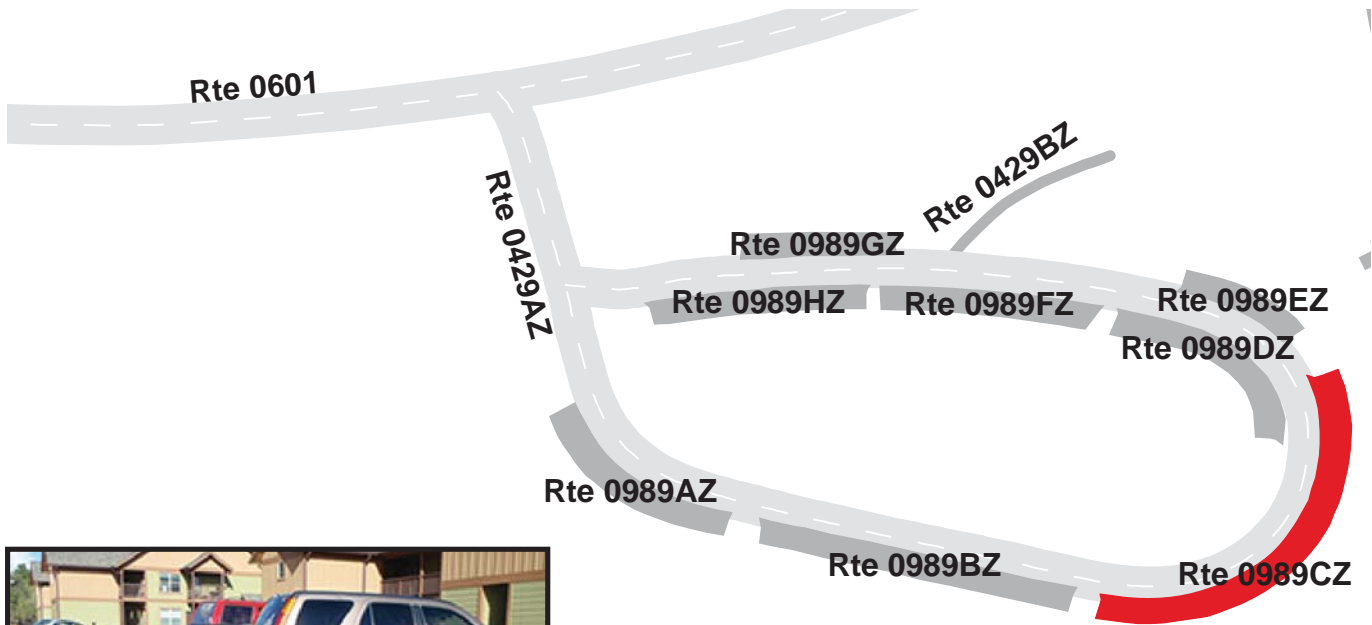
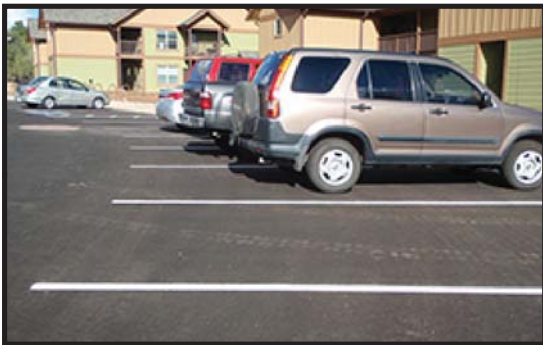
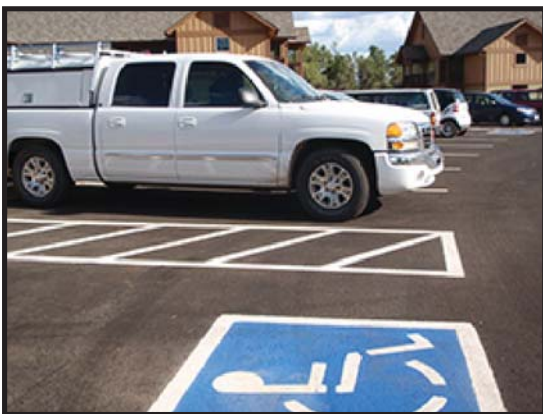
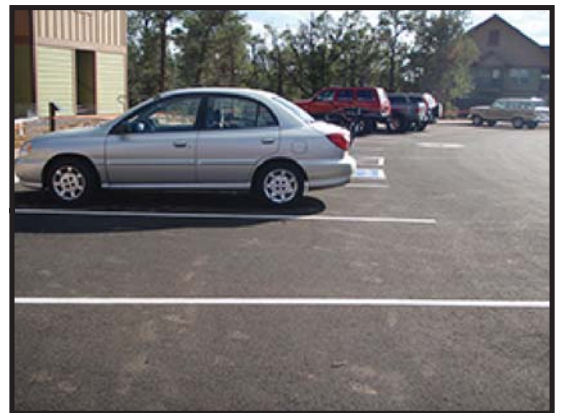
Route 0989CZ

Route Number	Public / NonPublic	Date Visited	Area (sq ft)	Lane Miles *	Surface Type
0989CZ	PUBLIC	8/15/2011	5,914	0.10	AS
Culverts	Drop Inlets	Gates	Curb & Gutter	Curb	PCR
0	0	0	CONCRETE CURB AND GUTTER	NO CURB	EXCELLENT/97

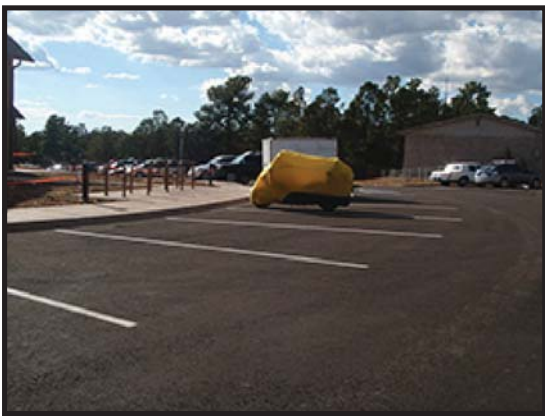
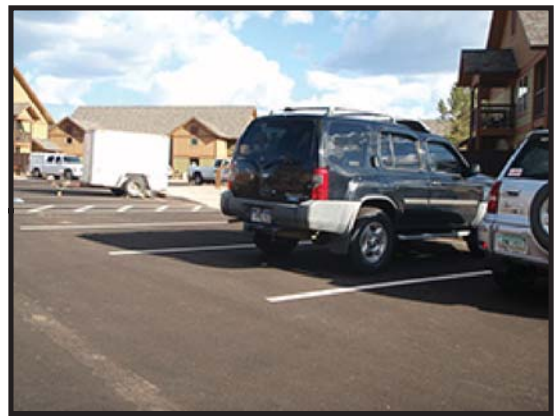
Route 0989DZ

Route Number	Public / NonPublic	Date Visited	Area (sq ft)	Lane Miles *	Surface Type
0989DZ	PUBLIC	8/15/2011	3,143	0.05	AS
Culverts	Drop Inlets	Gates	Curb & Gutter	Curb	PCR
0	0	0	CONCRETE CURB AND GUTTER	NO CURB	EXCELLENT/97

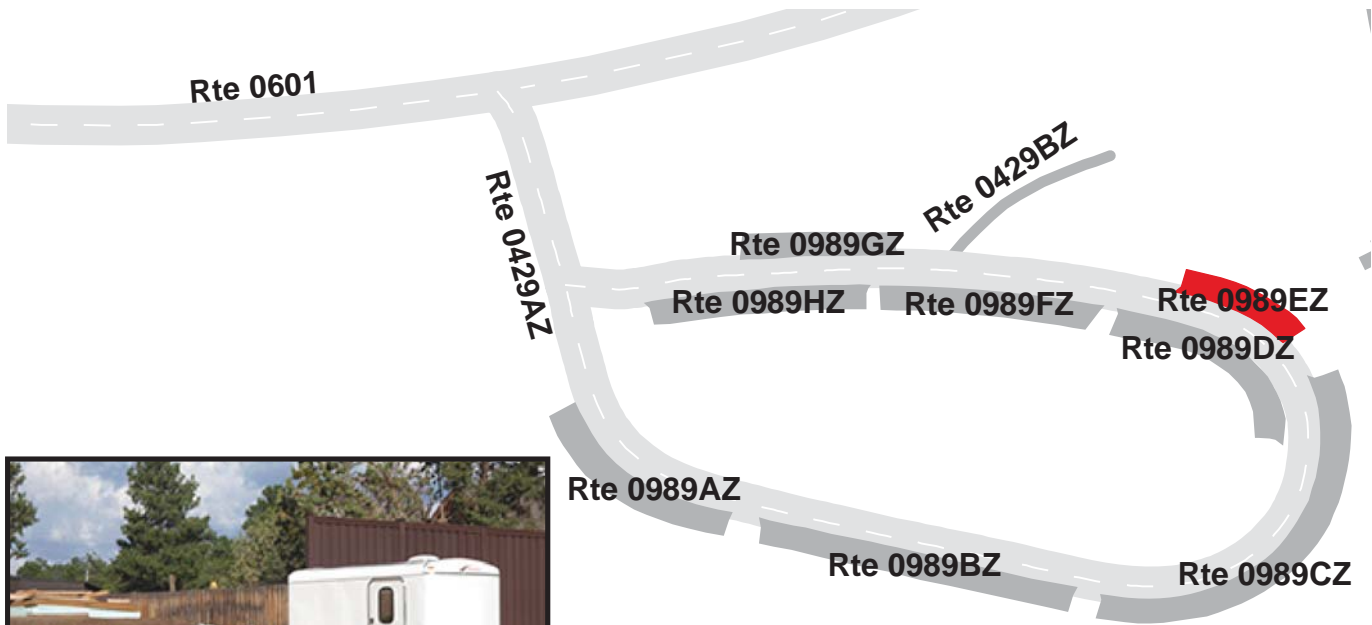
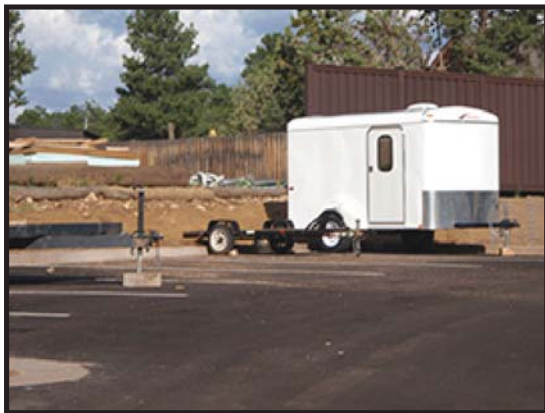
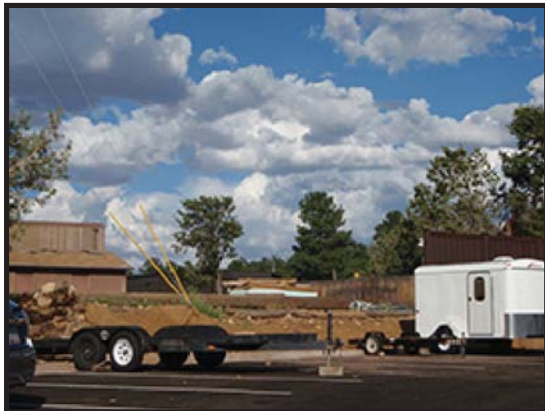
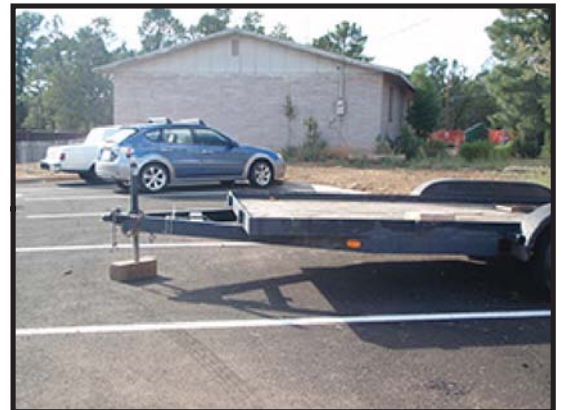
Route 0989EZ

Route Number	Public / NonPublic	Date Visited	Area (sq ft)	Lane Miles *	Surface Type
0989EZ	PUBLIC	8/15/2011	1,703	0.03	AS
Culverts	Drop Inlets	Gates	Curb & Gutter	Curb	PCR
0	0	0	CONCRETE CURB AND GUTTER	NO CURB	EXCELLENT/97

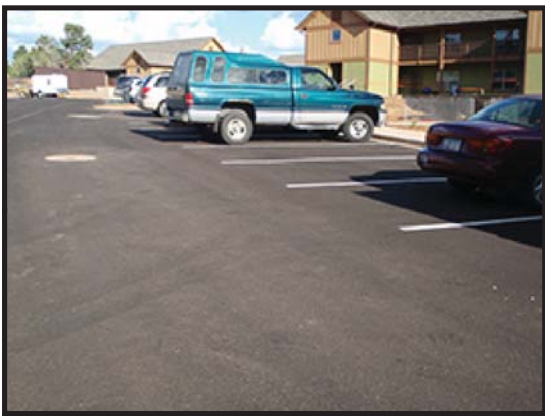
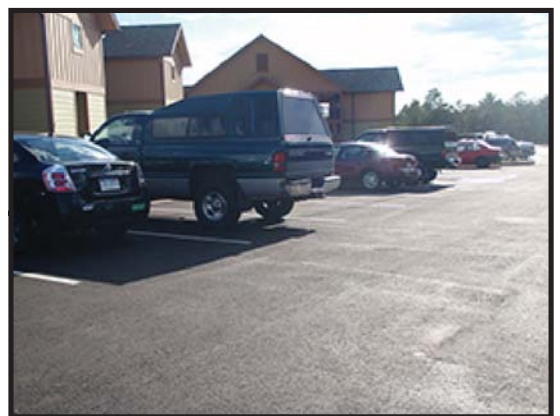
Route 0989FZ

Route Number	Public / NonPublic	Date Visited	Area (sq ft)	Lane Miles *	Surface Type
0989FZ	PUBLIC	8/15/2011	2,914	0.05	AS
Culverts	Drop Inlets	Gates	Curb & Gutter	Curb	PCR
0	0	0	CONCRETE CURB AND GUTTER	NO CURB	EXCELLENT/97

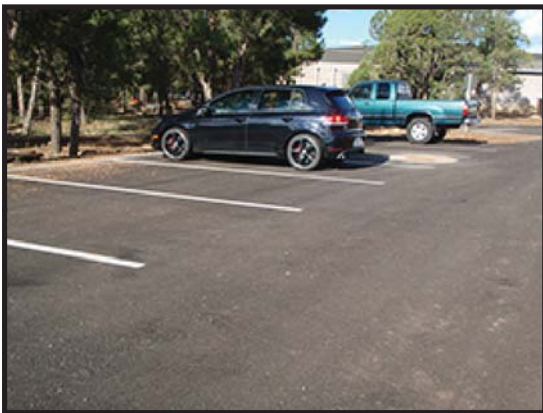
Route 0989GZ

Route Number	Public / NonPublic	Date Visited	Area (sq ft)	Lane Miles *	Surface Type
0989GZ	PUBLIC	8/15/2011	2,043	0.04	AS
Culverts	Drop Inlets	Gates	Curb & Gutter	Curb	PCR
0	0	0	NO CURB AND GUTTER	NO CURB	EXCELLENT/97

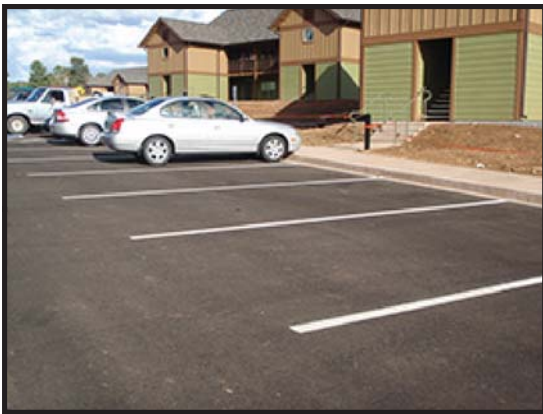
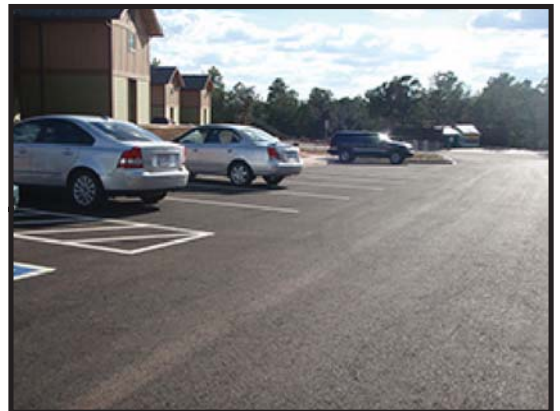
Route 0989HZ

Route Number	Public / NonPublic	Date Visited	Area (sq ft)	Lane Miles *	Surface Type
0989HZ	PUBLIC	8/15/2011	2,878	0.05	AS
Culverts	Drop Inlets	Gates	Curb & Gutter	Curb	PCR
0	0	0	CONCRETE CURB AND GUTTER	NO CURB	EXCELLENT/97

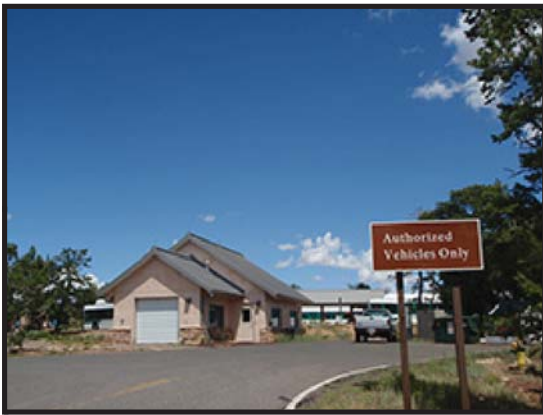
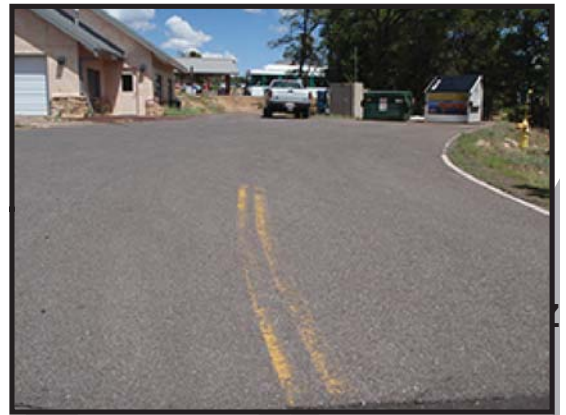
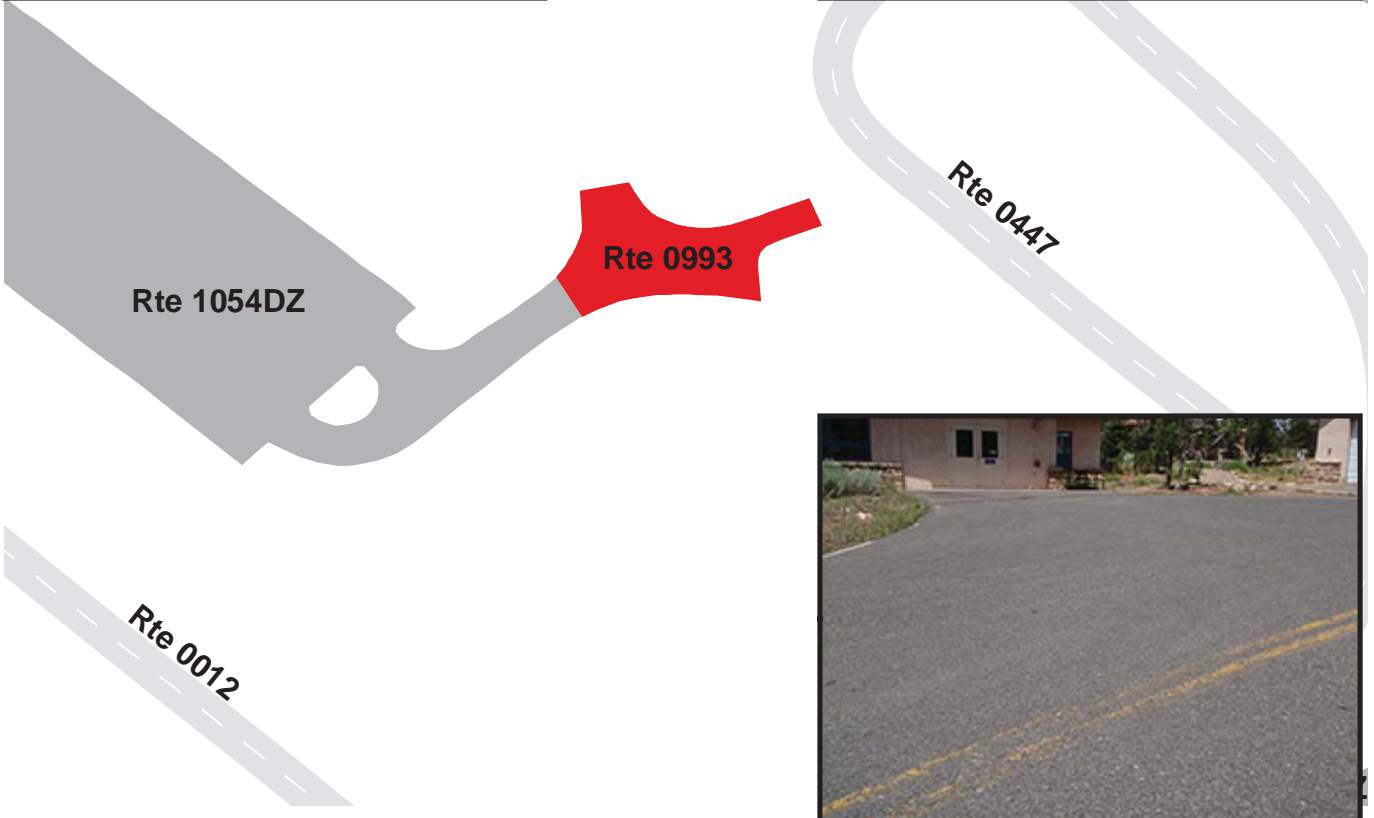
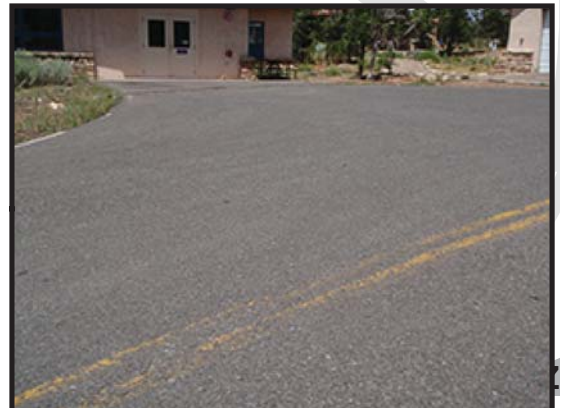
Route 0993

Route Number	Public / NonPublic	Date Visited	Area (sq ft)	Lane Miles *	Surface Type
0993	NONPUBLIC	8/15/2011	4,761	0.08	AS
Culverts	Drop Inlets	Gates	Curb & Gutter	Curb	PCR
1	0	0	NO CURB AND GUTTER	NO CURB	FAIR/73

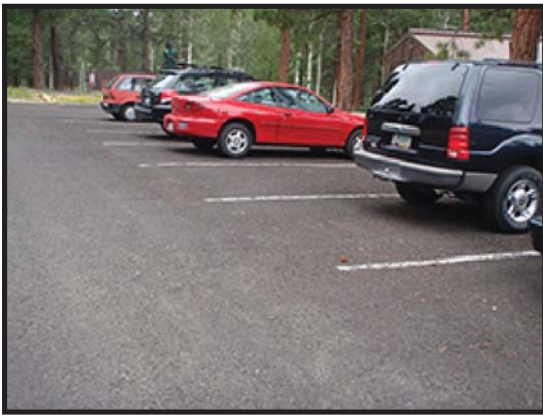
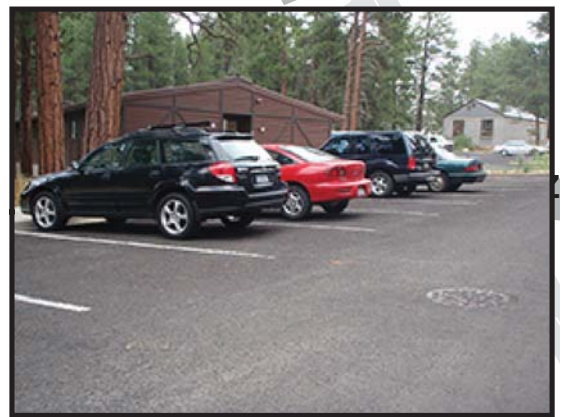
Route Number	Public / NonPublic	Date Visited	Area (sq ft)	Lane Miles *	Surface Type
1014FZ	PUBLIC	8/12/2011	2,771	0.05	AS
Culverts	Drop Inlets	Gates	Curb & Gutter	Curb	PCR
0	1	0	CONCRETE CURB AND GUTTER	CONCRETE CURB	GOOD/90

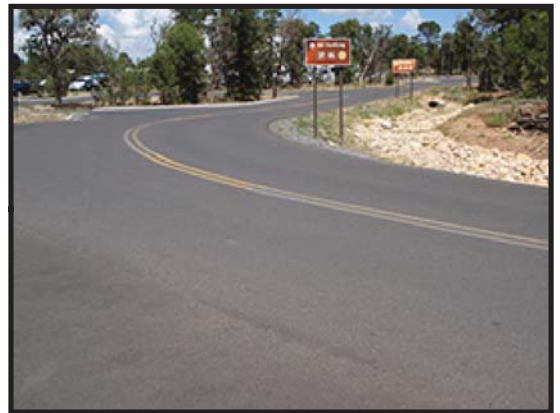
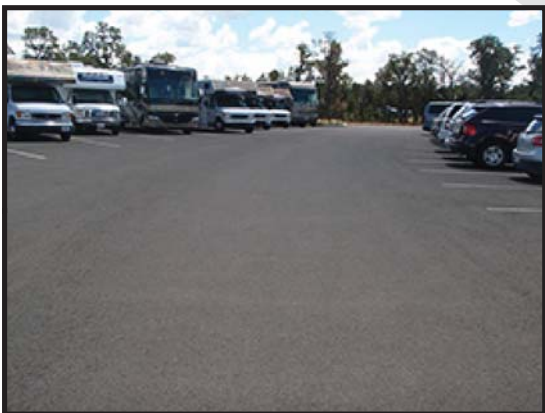
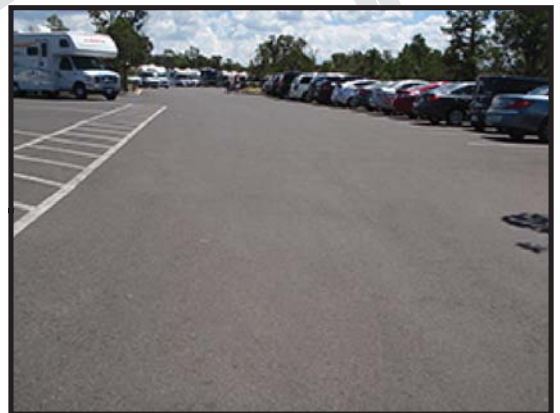
Route Number	Public / NonPublic	Date Visited	Area (sq ft)	Lane Miles *	Surface Type
1054AZ	PUBLIC	8/15/2011	131,202	2.26	AS
Culverts	Drop Inlets	Gates	Curb & Gutter	Curb	PCR
0	1	0	NO CURB AND GUTTER	CONCRETE CURB	GOOD/90

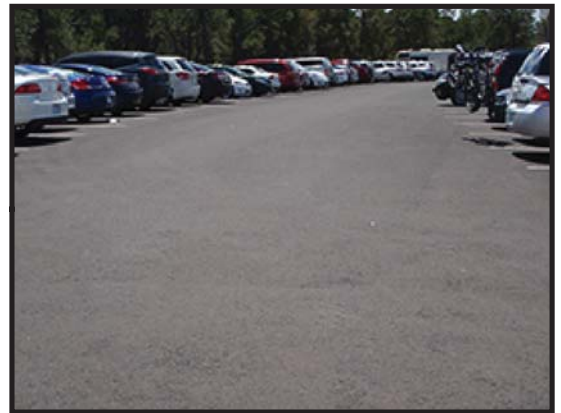
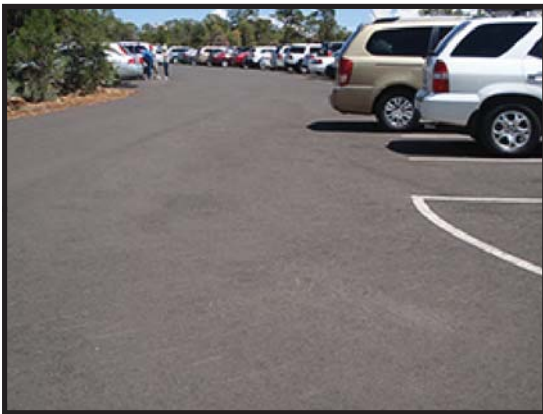
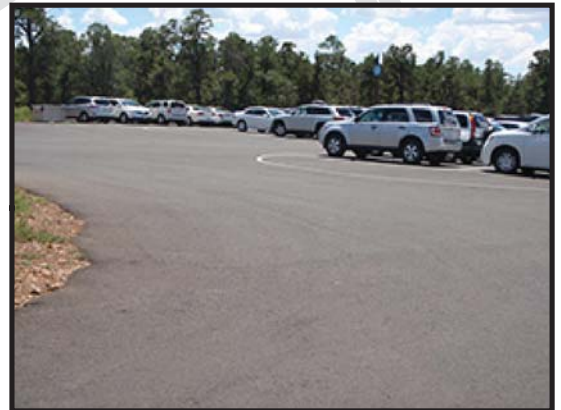
Route Number	Public / NonPublic	Date Visited	Area (sq ft)	Lane Miles *	Surface Type
1054CZ	PUBLIC	8/15/2011	74,550	1.28	AS
Culverts	Drop Inlets	Gates	Curb & Gutter	Curb	PCR
0	0	0	NO CURB AND GUTTER	CONCRETE CURB	GOOD/90

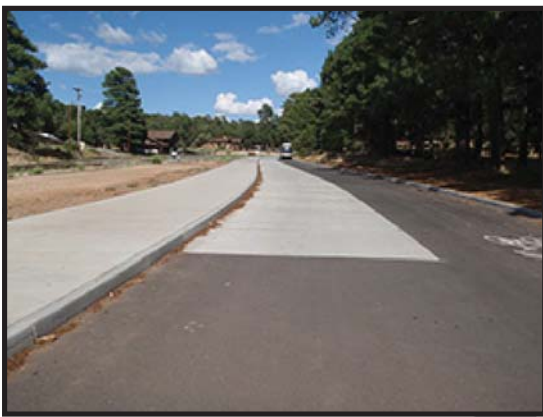
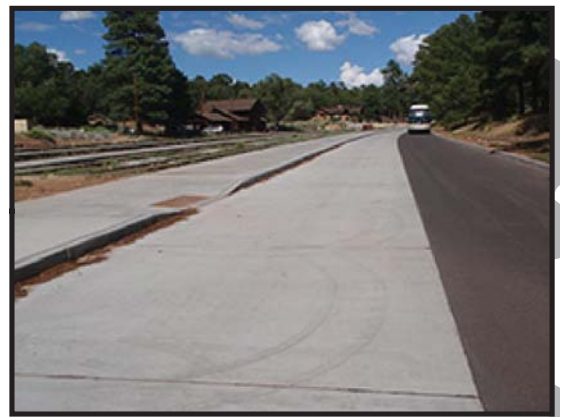
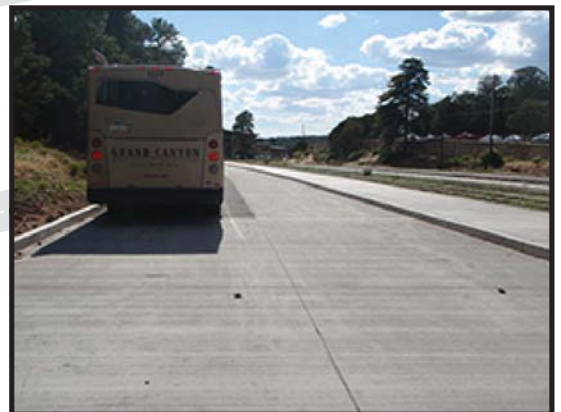
Route Number	Public / NonPublic	Date Visited	Area (sq ft)	Lane Miles *	Surface Type
1062	NONPUBLIC	8/15/2011	6,577	0.11	CO
Culverts	Drop Inlets	Gates	Curb & Gutter	Curb	PCR
0	0	0	NO CURB AND GUTTER	CONCRETE CURB	GOOD/90
