Federal Lands Highway Road Inventory Program

Road Inventory and Condition Assessment

**National Capital Parks – East
Greenbelt Park
GREE**

Cycle 5 Report

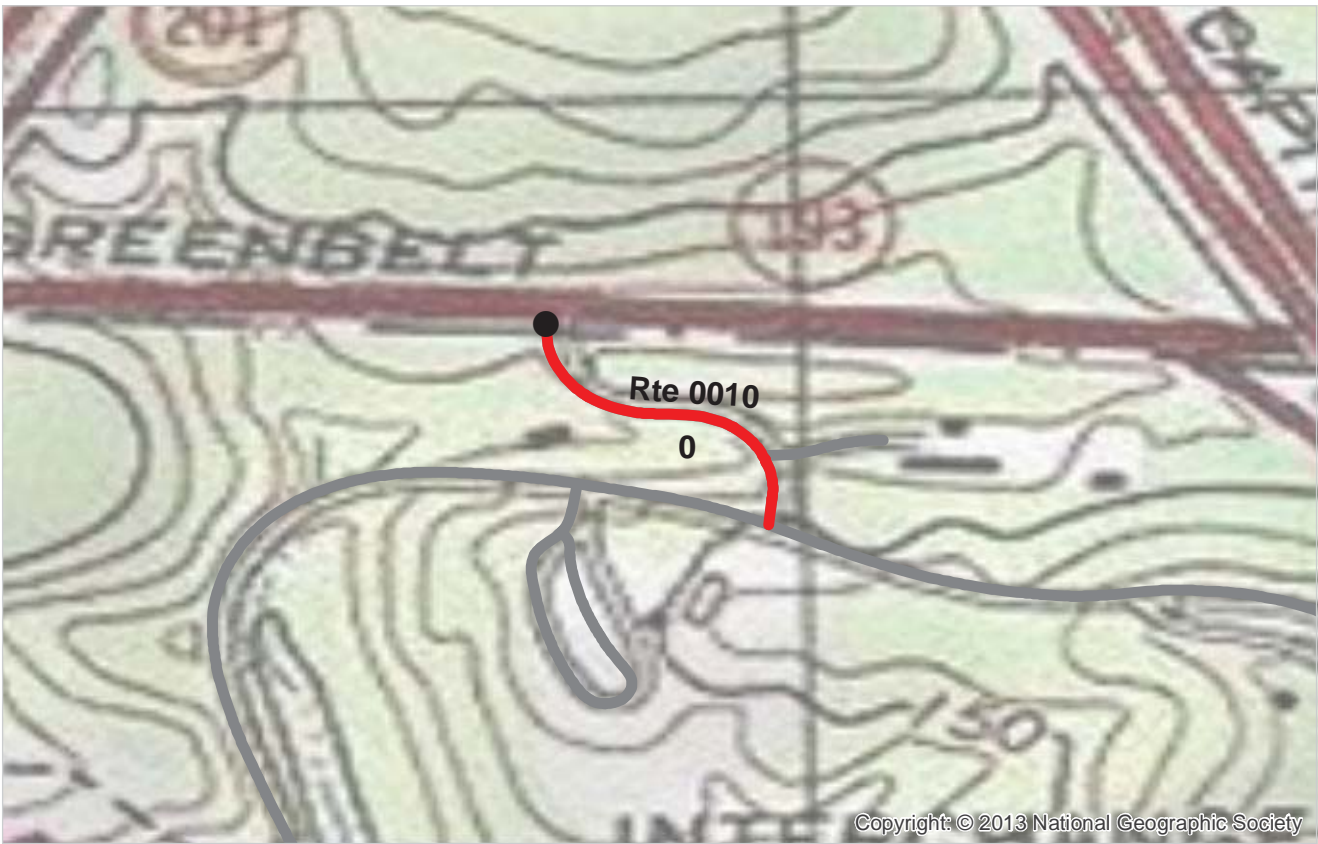
ROUTE: 0010 MAIN ENTRANCE ROAD

Section Number	0				
Section Length (mi)	0.15				
Cross Section Information					
Number of Lanes	2				
Paved Width (ft)	22				
Lane Width (ft)	12				
Roadway Condition Information					
SCR (Surface Condition Rating)	0				
PCR (Pavement Condition Rating)	0				
Distress Index Values					
Structural Crack Index	0				
Transverse Cracking Index	96				
Patching Index	100				
Rutting Index	95				
Roughness Condition Index (RCI)	NC

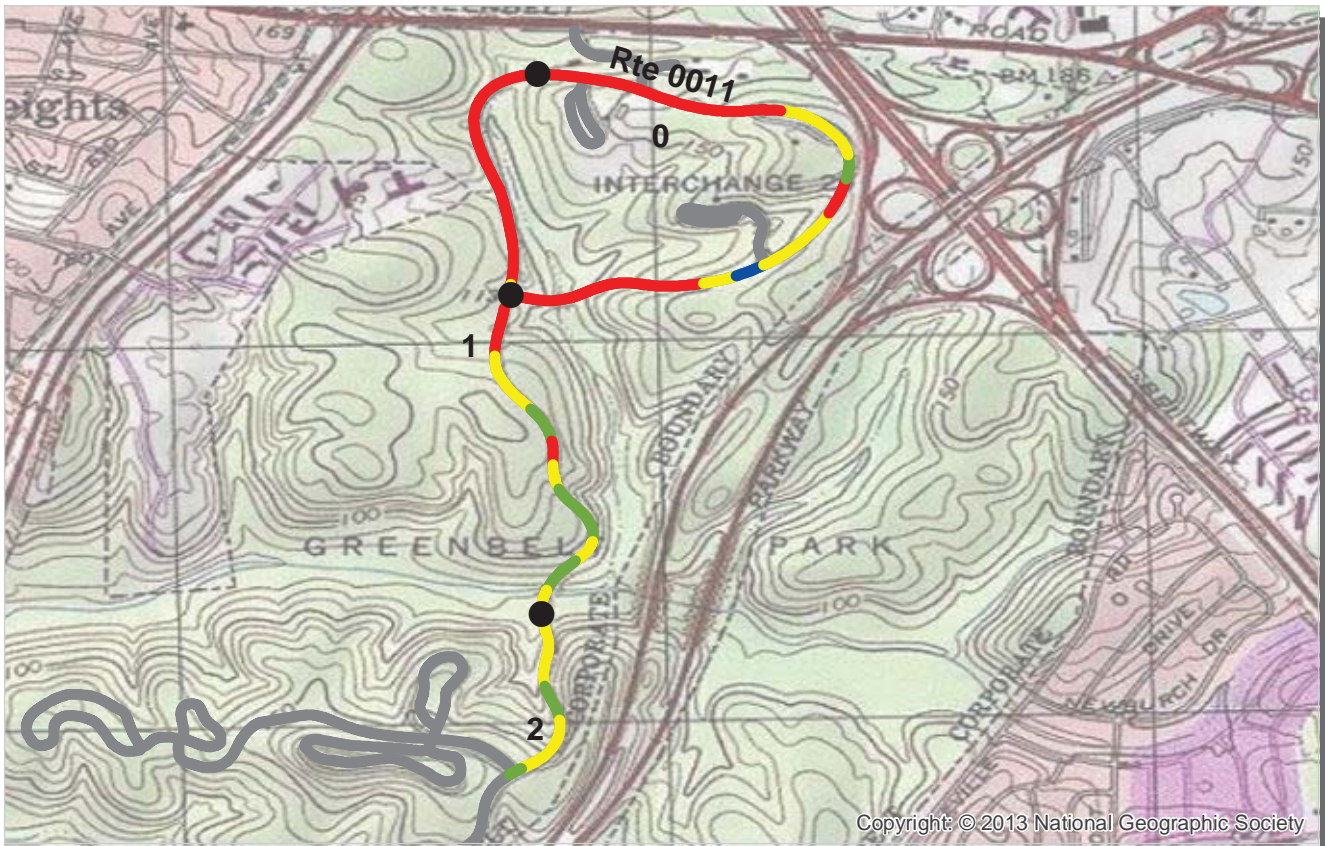
ROUTE: 0011 PARK CENTRAL ROAD

Section Number	0	1	2		
Section Length (mi)	1.00	1.00	0.30		
Cross Section Information					
Number of Lanes	2	2	2		
Paved Width (ft)	20	21	22		
Lane Width (ft)	10	10	10		
Roadway Condition Information					
SCR (Surface Condition Rating)	20	10	81		
PCR (Pavement Condition Rating)	37	35	78		
Distress Index Values					
Structural Crack Index	20	10	81		
Transverse Cracking Index	95	97	97		
Patching Index	100	100	100		
Rutting Index	96	98	96		
Roughness Condition Index (RCI)	63	72	74

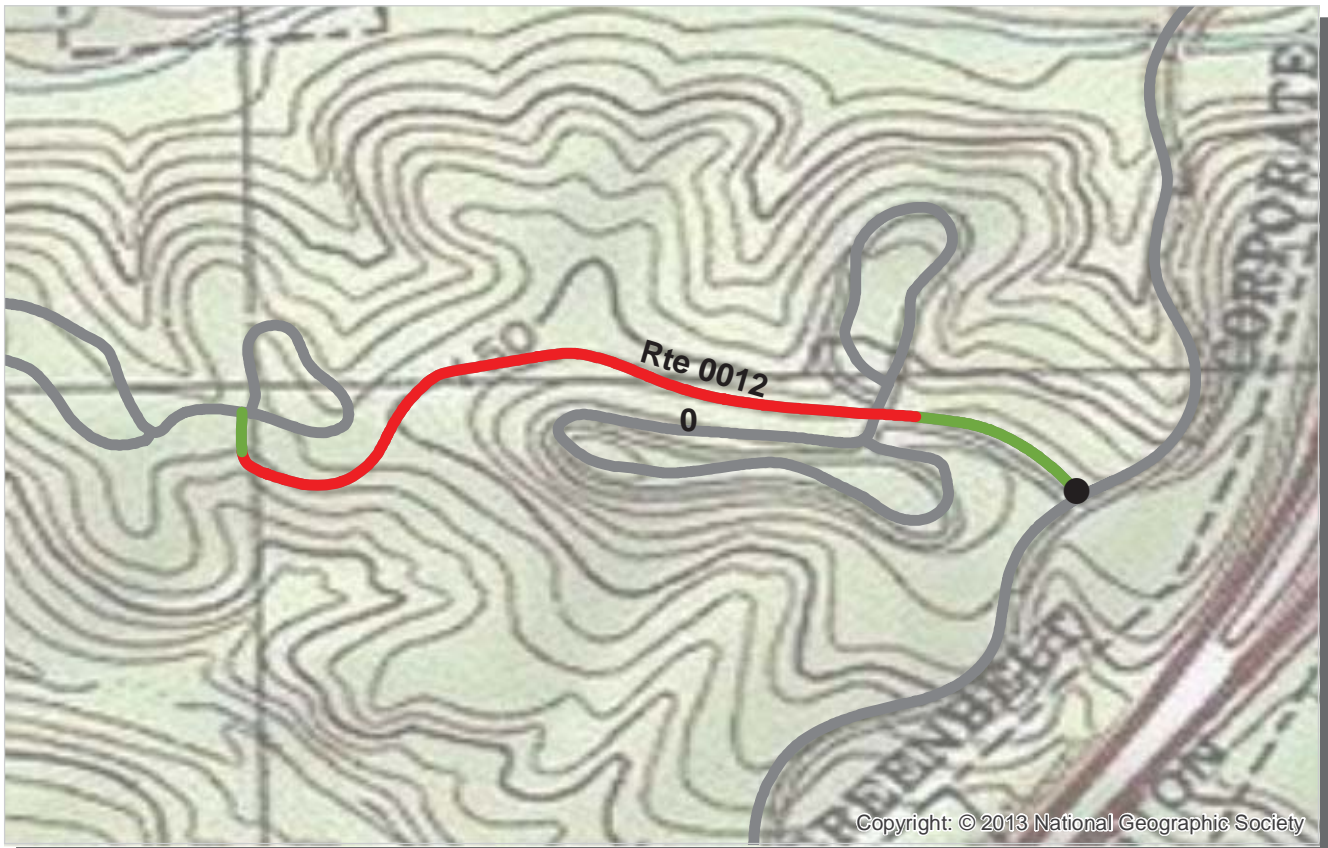
ROUTE: 0012 CAMPGROUND ACCESS

<i>Section Number</i>	0				
<i>Section Length (mi)</i>	0.52				
<i>Cross Section Information</i>					
Number of Lanes	2				
Paved Width (ft)	19				
Lane Width (ft)	9				
<i>Roadway Condition Information</i>					
SCR (Surface Condition Rating)	0				
PCR (Pavement Condition Rating)	0				
<i>Distress Index Values</i>					
Structural Crack Index	0				
Transverse Cracking Index	95				
Patching Index	99				
Rutting Index	95				
Roughness Condition Index (RCI)	NC

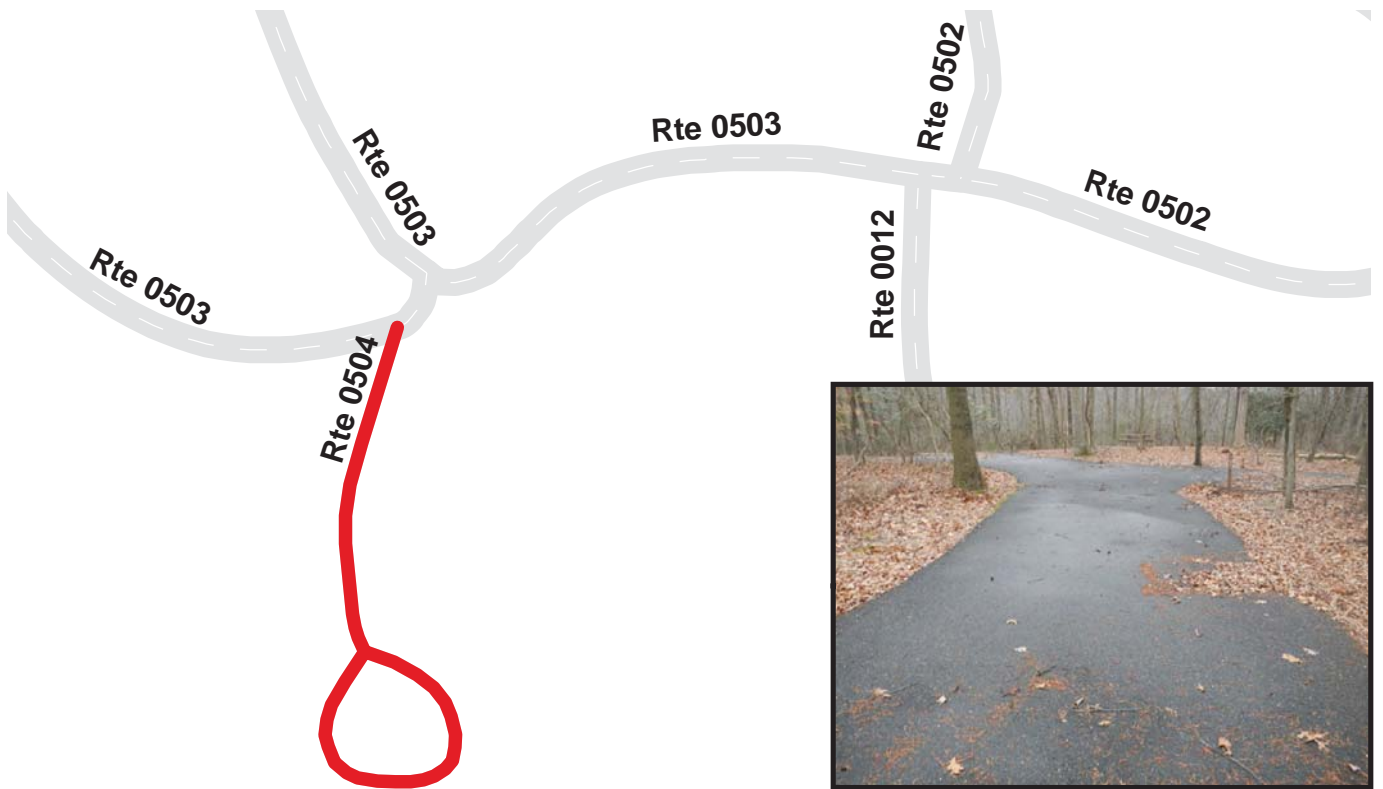
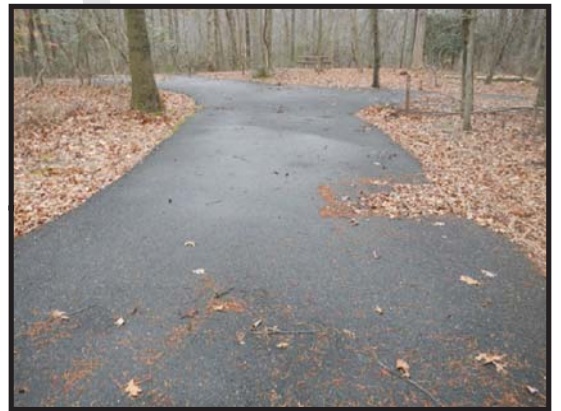
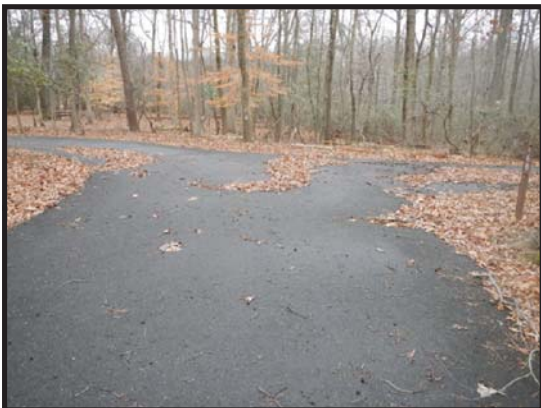
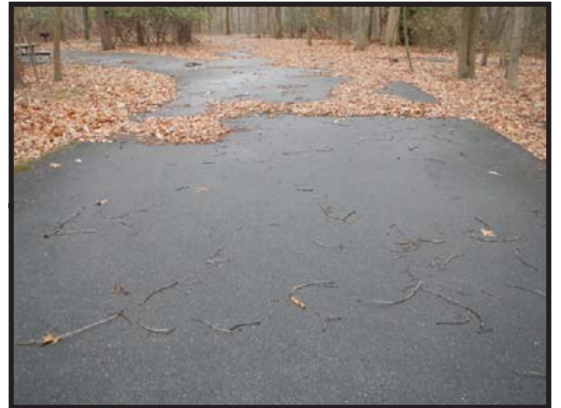
Route Number	Public / NonPublic	Date Visited	Area (sq ft)	Lane Miles *	Paved Length (mi)	Paved Width (ft)
0504	PUBLIC	1/14/2013	7,809	0.13	0.09	17
Culverts	Drop Inlets	Gates	Curb & Gutter	Curb	PCR	Surface Type
0	0	1	NO CURB AND GUTTER	NO CURB	FAIR/73	AS

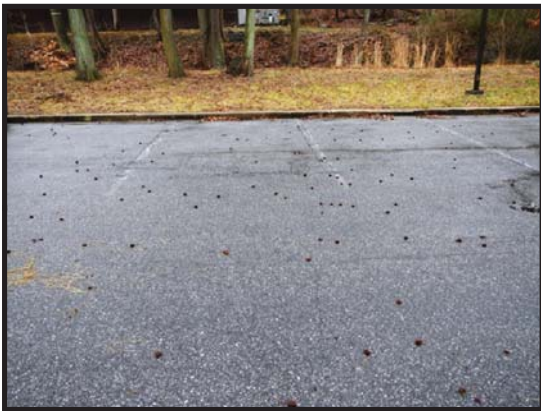
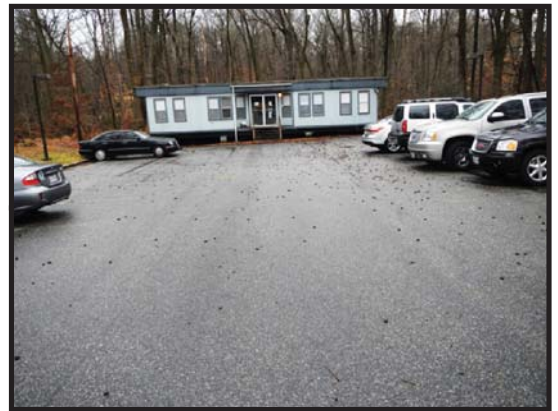
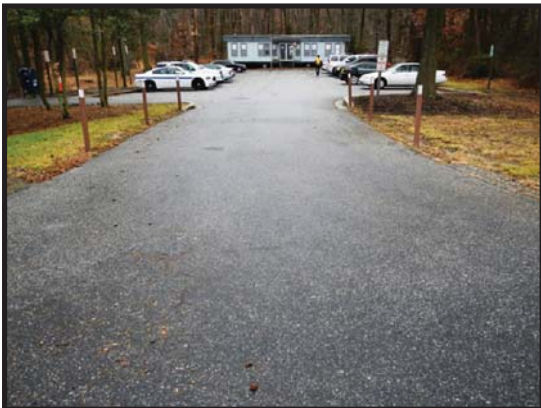
Route Number	Public / NonPublic	Date Visited	Area (sq ft)	Lane Miles *	Surface Type
0900	PUBLIC	1/14/2013	9,083	0.16	AS
Culverts	Drop Inlets	Gates	Curb & Gutter	Curb	PCR
0	0	0	CONCRETE CURB AND GUTTER	NO CURB	FAIR/73

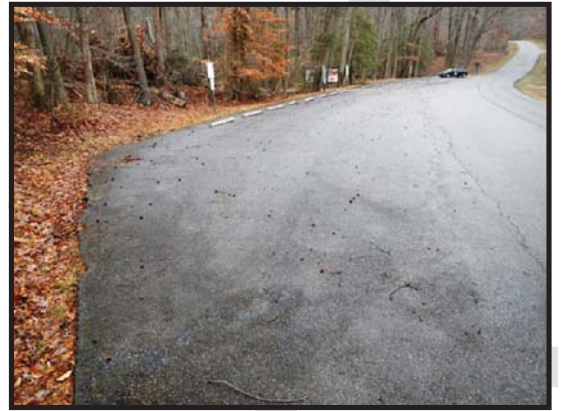
Route 0904

Route Number	Public / NonPublic	Date Visited	Area (sq ft)	Lane Miles *	Surface Type
0904	PUBLIC	1/14/2013	9,079	0.16	AS
Culverts	Drop Inlets	Gates	Curb & Gutter	Curb	PCR
0	0	0	NO CURB AND GUTTER	WOOD CURB	FAIR/73

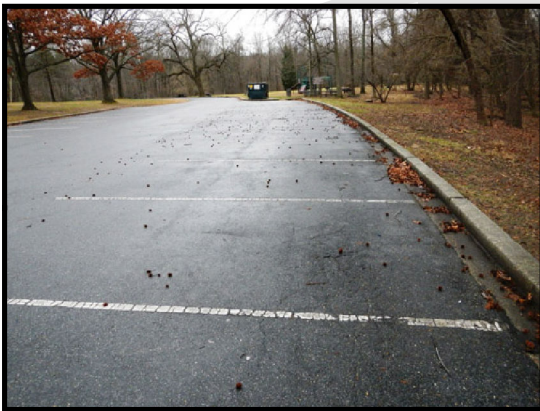
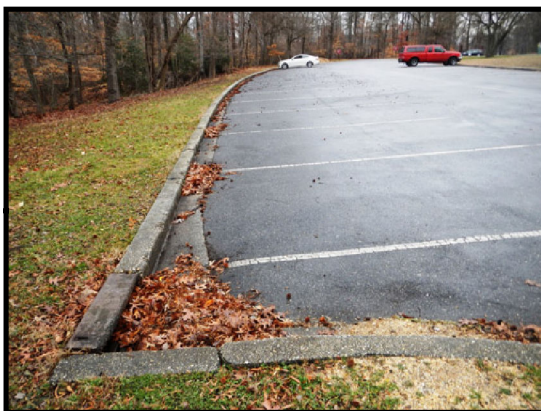
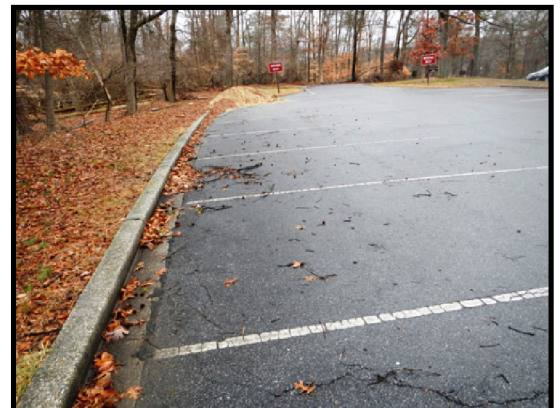
Route Number	Public / NonPublic	Date Visited	Area (sq ft)	Lane Miles *	Surface Type
0907BZ	PUBLIC	1/14/2013	5,240	0.09	AS
Culverts	Drop Inlets	Gates	Curb & Gutter	Curb	PCR
0	1	0	CONCRETE CURB AND GUTTER	NO CURB	GOOD/90

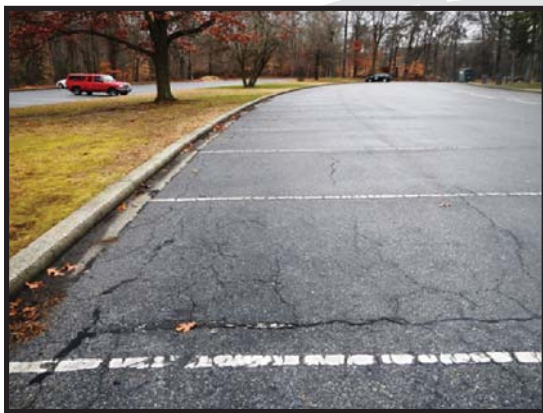
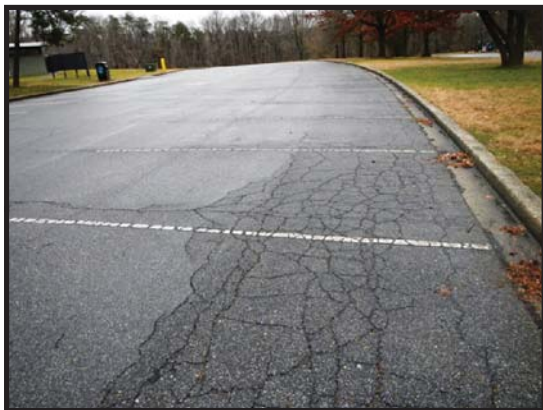
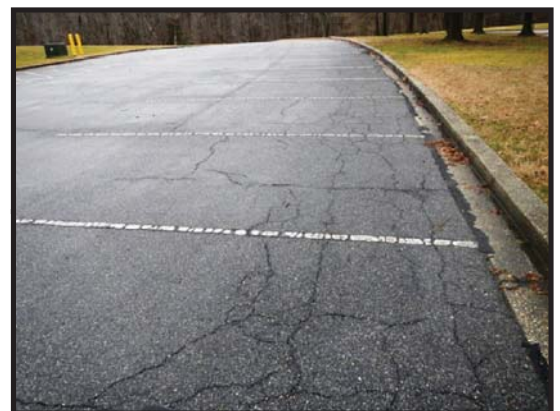
Route 0907CZ

Route Number	Public / NonPublic	Date Visited	Area (sq ft)	Lane Miles *	Surface Type
0907CZ	PUBLIC	1/14/2013	5,162	0.09	AS
Culverts	Drop Inlets	Gates	Curb & Gutter	Curb	PCR
0	1	0	CONCRETE CURB AND GUTTER	NO CURB	POOR/45

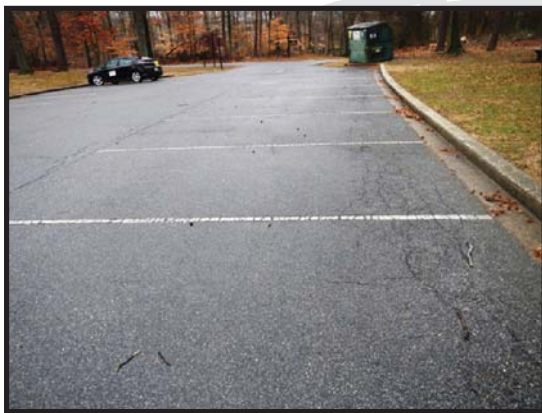
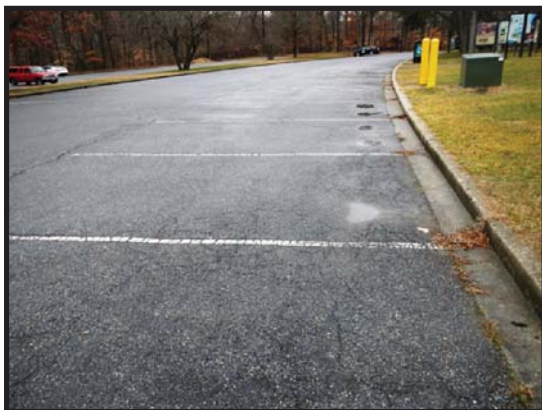
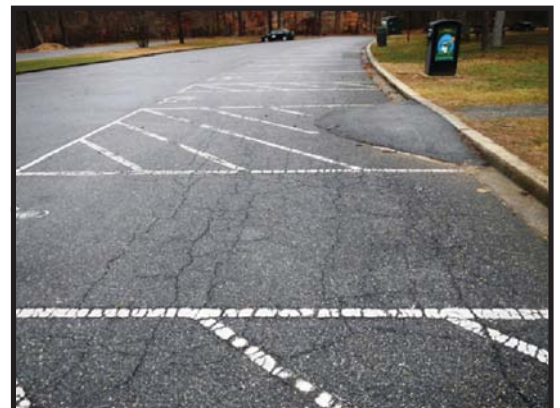
Route 0907DZ

Route Number	Public / NonPublic	Date Visited	Area (sq ft)	Lane Miles *	Surface Type
0907DZ	PUBLIC	1/14/2013	4,948	0.09	AS
Culverts	Drop Inlets	Gates	Curb & Gutter	Curb	PCR
0	0	0	CONCRETE CURB AND GUTTER	NO CURB	POOR/45

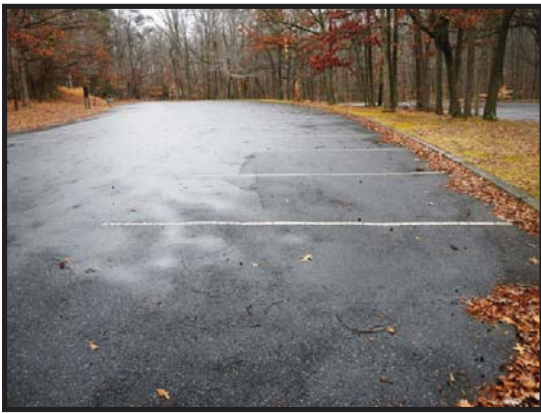
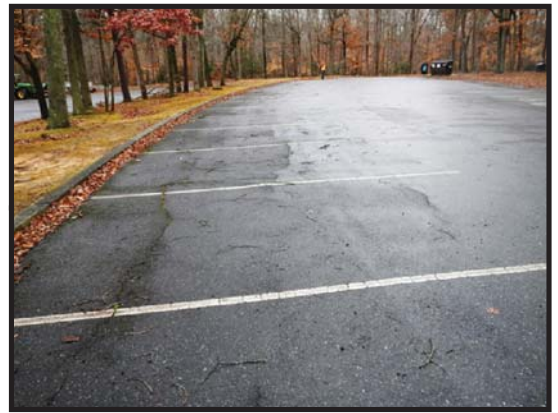
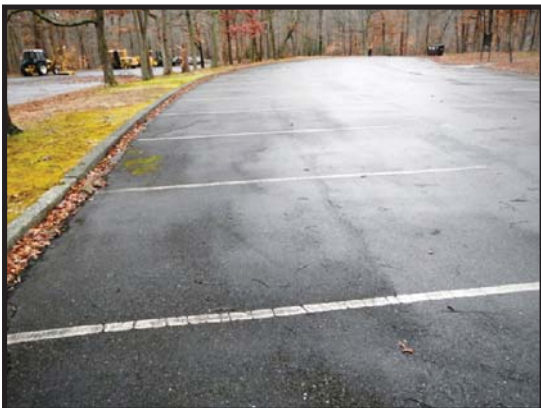
Route Number	Public / NonPublic	Date Visited	Area (sq ft)	Lane Miles *	Surface Type
0908AZ	PUBLIC	1/14/2013	4,683	0.08	AS
Culverts	Drop Inlets	Gates	Curb & Gutter	Curb	PCR
0	1	0	CONCRETE CURB AND GUTTER	NO CURB	FAIR/73

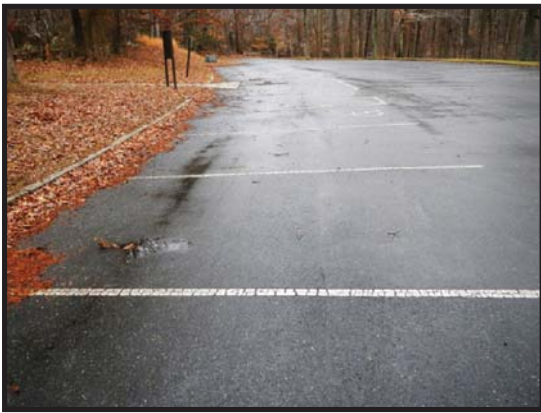
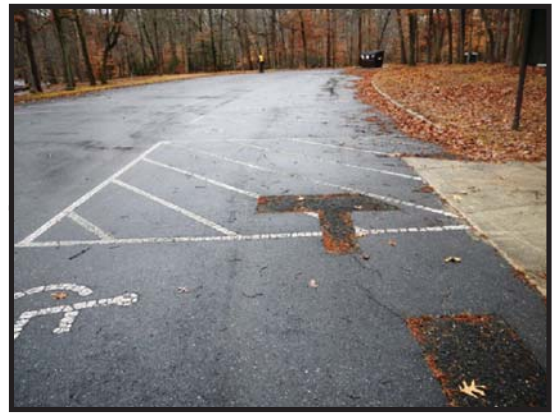
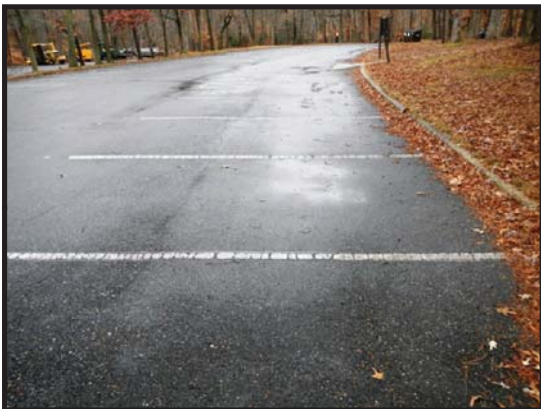
Route 0908BZ

Route Number	Public / NonPublic	Date Visited	Area (sq ft)	Lane Miles *	Surface Type
0908BZ	PUBLIC	1/14/2013	4,653	0.08	AS
Culverts	Drop Inlets	Gates	Curb & Gutter	Curb	PCR
0	0	0	CONCRETE CURB AND GUTTER	NO CURB	FAIR/73

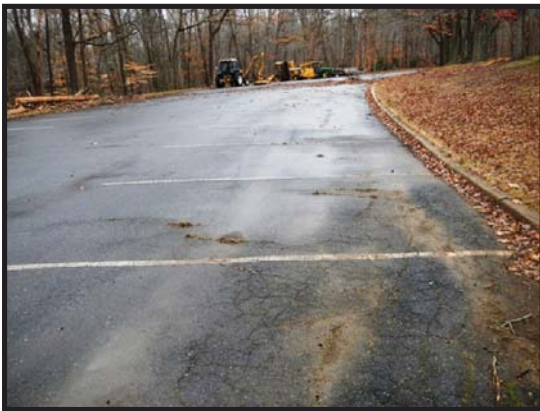
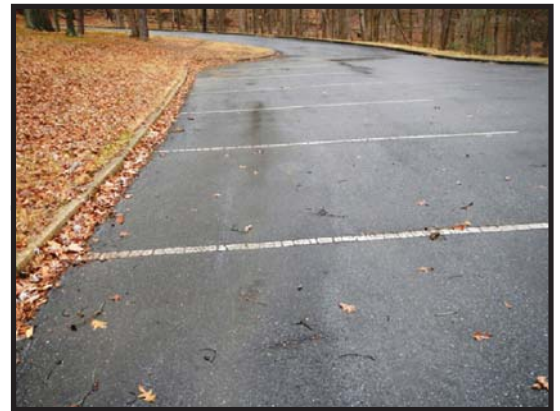
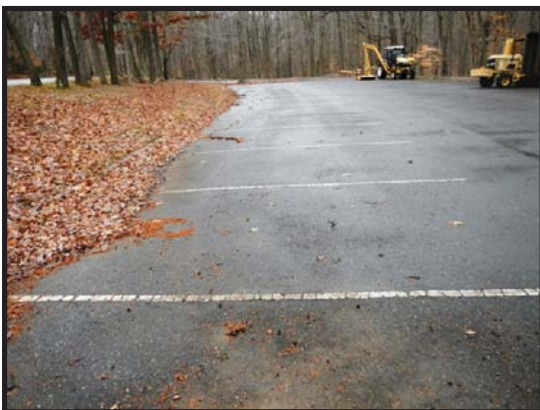
Route 0908CZ

Route Number	Public / NonPublic	Date Visited	Area (sq ft)	Lane Miles *	Surface Type
0908CZ	PUBLIC	1/14/2013	4,792	0.08	AS
Culverts	Drop Inlets	Gates	Curb & Gutter	Curb	PCR
0	0	0	CONCRETE CURB AND GUTTER	NO CURB	FAIR/73

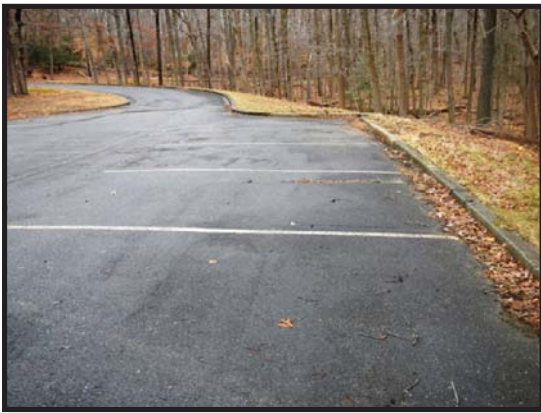
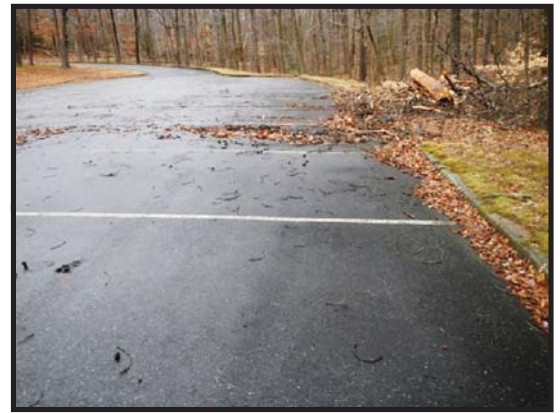
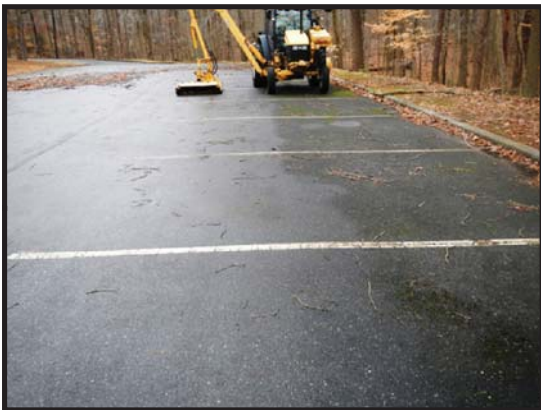
Route 0908DZ

Route Number	Public / NonPublic	Date Visited	Area (sq ft)	Lane Miles *	Surface Type
0908DZ	PUBLIC	1/14/2013	6,165	0.11	AS
Culverts	Drop Inlets	Gates	Curb & Gutter	Curb	PCR
0	2	0	CONCRETE CURB AND GUTTER	NO CURB	FAIR/73

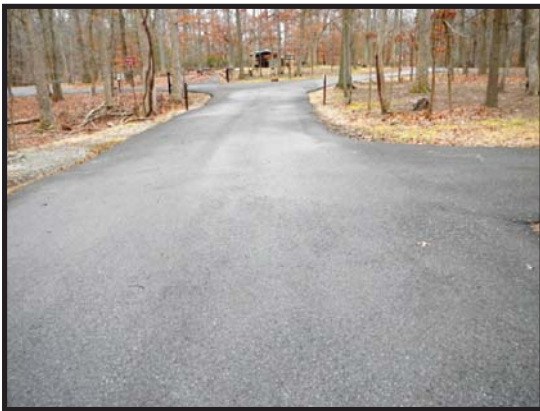
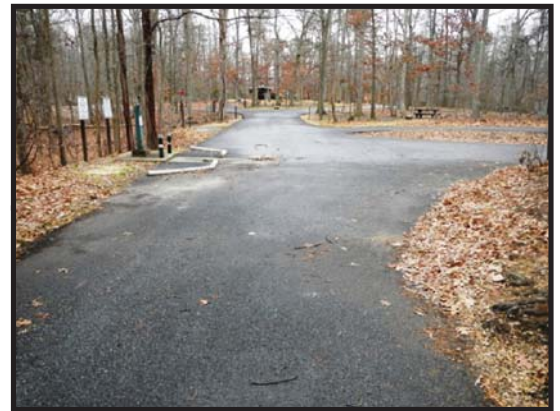
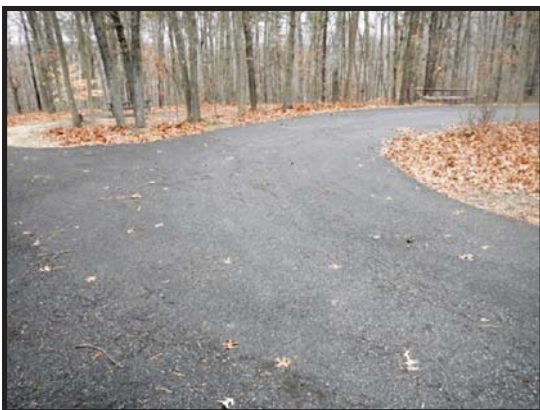
Route 0909

Route Number	Public / NonPublic	Date Visited	Area (sq ft)	Lane Miles *	Surface Type
0909	PUBLIC	1/14/2013	6,690	0.12	AS
Culverts	Drop Inlets	Gates	Curb & Gutter	Curb	PCR
0	0	0	NO CURB AND GUTTER	NO CURB	GOOD/90

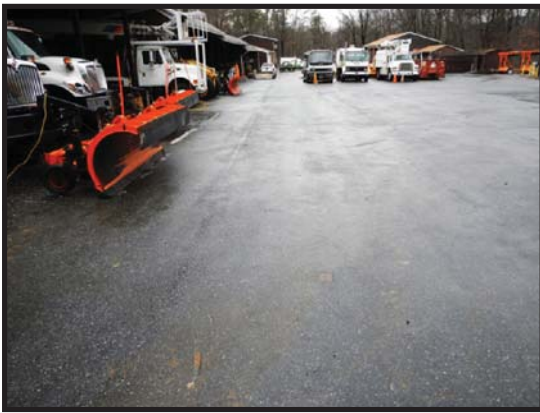
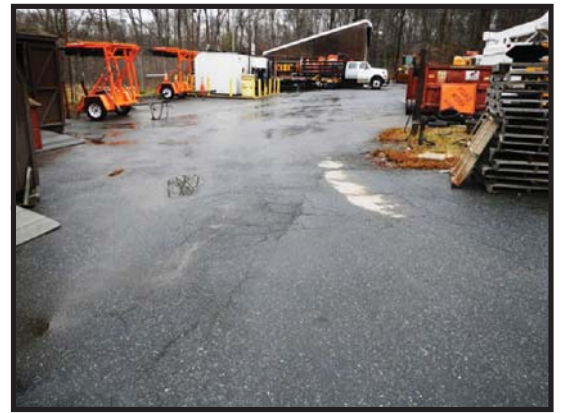
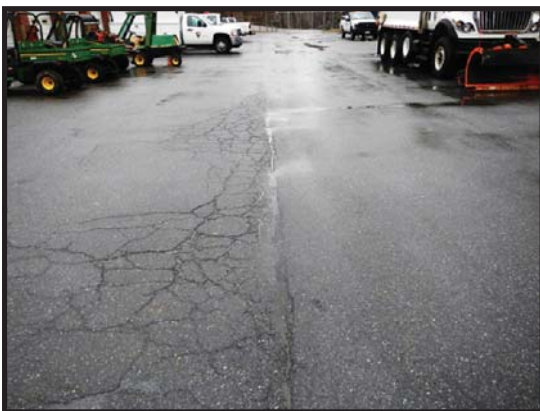
Route 0910

Route Number	Public / NonPublic	Date Visited	Area (sq ft)	Lane Miles *	Surface Type
0910	NONPUBLIC	1/14/2013	38,834	0.67	AS
Culverts	Drop Inlets	Gates	Curb & Gutter	Curb	PCR
0	2	1	NO CURB AND GUTTER	ASPHALT & CONCRETE	POOR/45

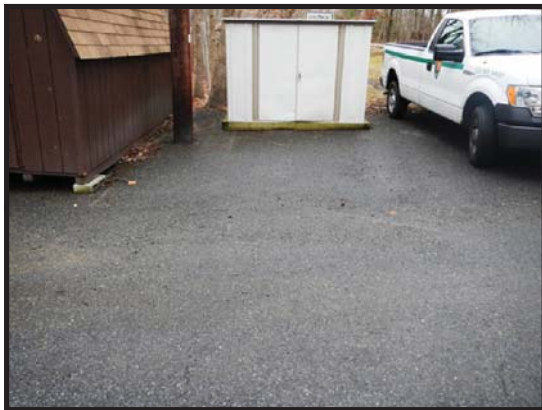
Route 0911

Route Number	Public / NonPublic	Date Visited	Area (sq ft)	Lane Miles *	Surface Type
0911	PUBLIC	1/14/2013	974	0.02	AS
Culverts	Drop Inlets	Gates	Curb & Gutter	Curb	PCR
0	0	0	NO CURB AND GUTTER	NO CURB	GOOD/90

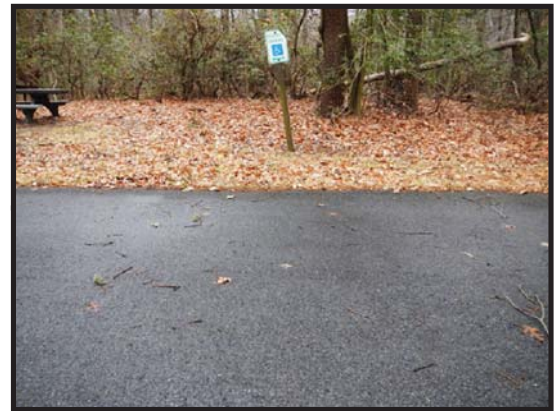
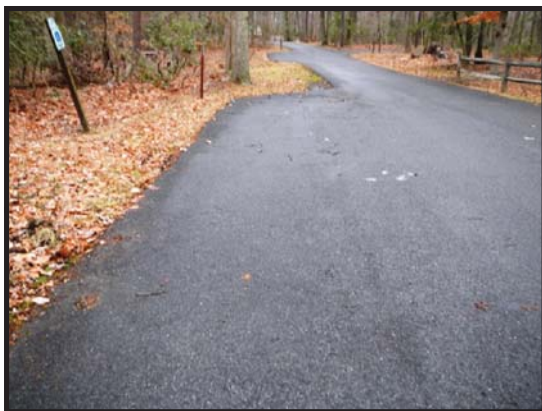
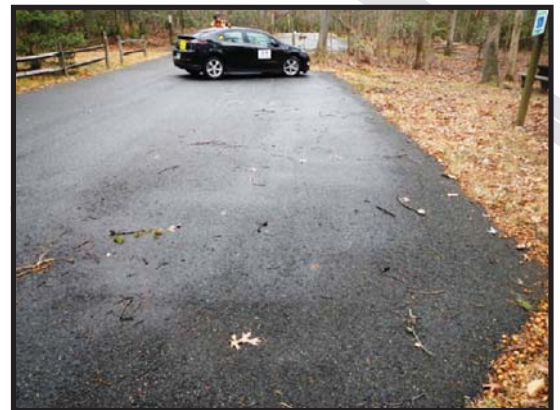
Route 0912

Route Number	Public / NonPublic	Date Visited	Area (sq ft)	Lane Miles *	Surface Type
0912	PUBLIC	1/14/2013	516	0.01	AS
Culverts	Drop Inlets	Gates	Curb & Gutter	Curb	PCR
0	0	0	NO CURB AND GUTTER	NO CURB	GOOD/90
