# Federal Lands Highway Road Inventory Program

Road Inventory and Condition Assessment

**Great Sand Dunes National Park and Preserve**

**Cycle 5 Report**

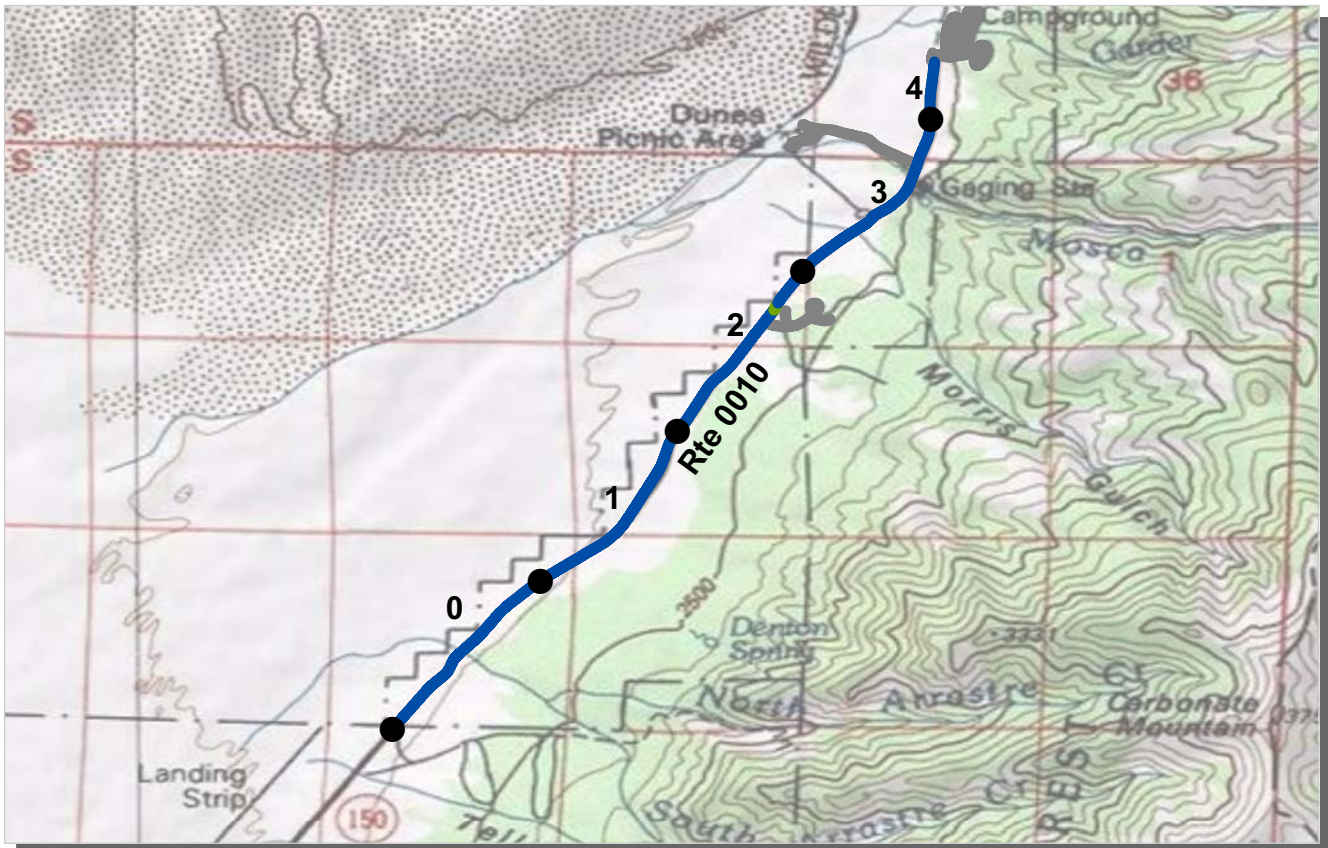
<i>Section Number</i>	0	1	2	3	4
<i>Section Length (mi)</i>	1.00	1.00	1.00	1.00	0.31
<i>Cross Section Information</i>					
Number of Lanes	2	2	2	2	2
Paved Width (ft)	25	25	25	24	25
Lane Width (ft)	11	11	11	11	11
<i>Roadway Condition Information</i>					
SCR (Surface Condition Rating)	100	100	100	100	99
PCR (Pavement Condition Rating)	100	100	100	100	99
<i>Distress Index Values</i>					
Structural Crack Index	100	100	100	100	99
Transverse Cracking Index	100	100	100	100	100
Patching Index	100	100	100	100	100
Rutting Index	100	100	100	100	100
Roughness Condition Index (RCI)	100	100	100	100	100

Structural Crack Index is a combination of the Longitudinal Cracking Index and Alligator Cracking Index.  
See Section 10 for explanation of SCR, PCR, & all Distress Index Values.

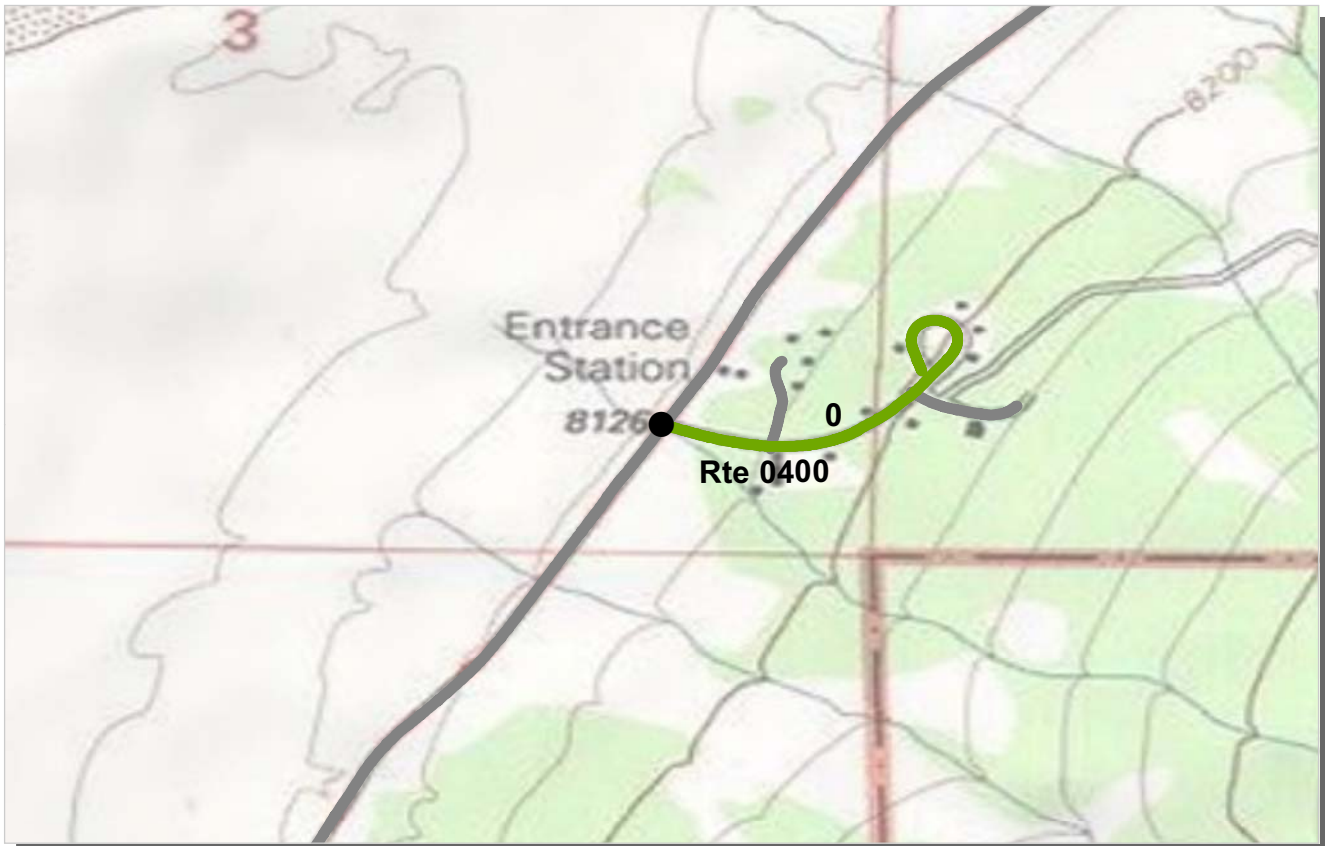
**ROUTE: 0203 MEDANO ROAD**

PCR    Poor ■    Fair ■    Good ■    Excellent ■    No Data ■  
           (0 - 60)           (61 - 84)           (85 - 94)           (95 - 100)

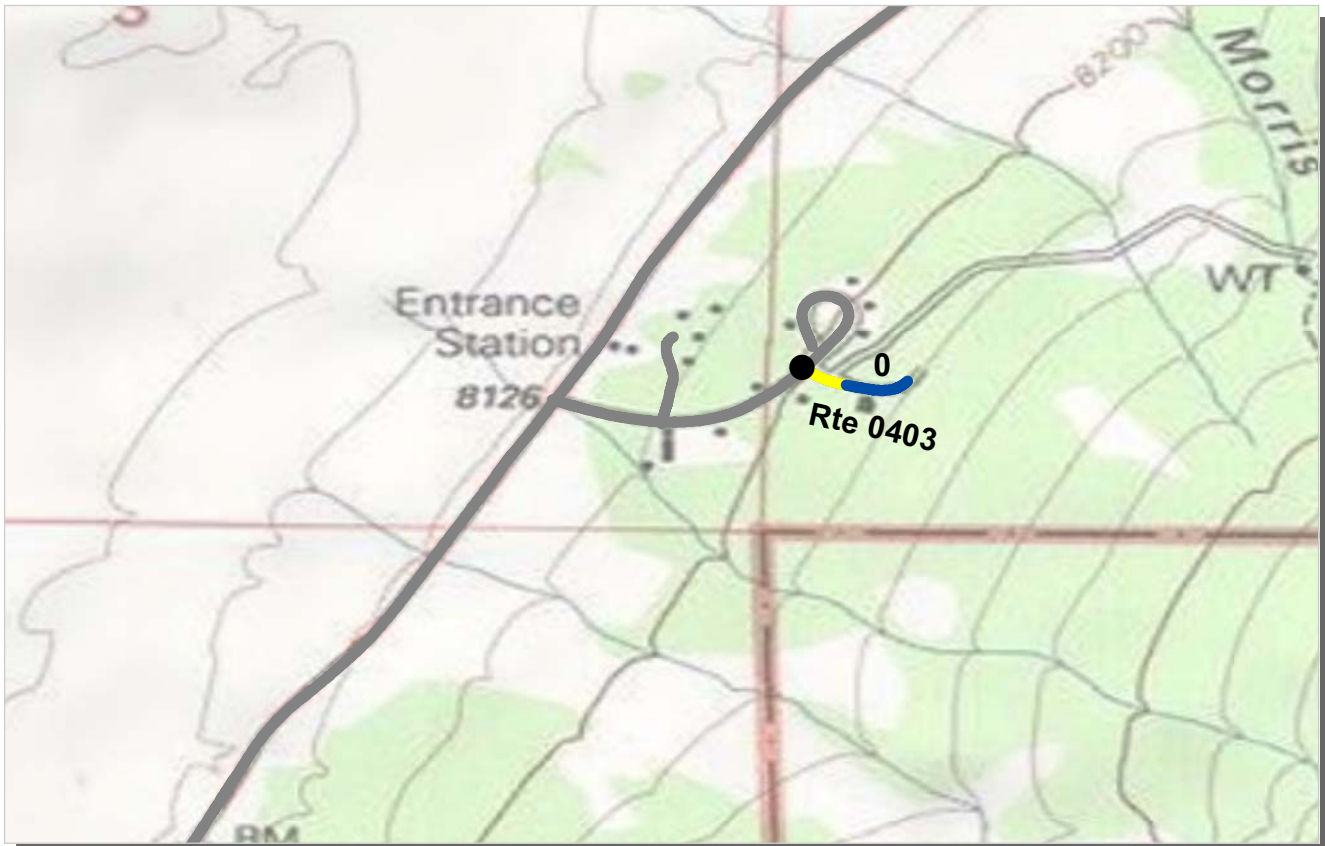
**ROUTE: 0401 TRAILER RESIDENCE ROAD**

PCR	Poor	Fair	Good	Excellent	No Data
	(0 - 60)	(61 - 84)	(85 - 94)	(95 - 100)

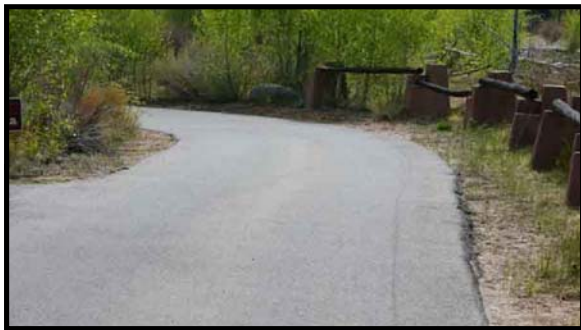
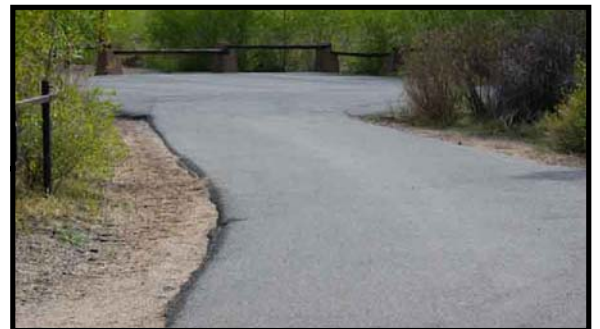
Route Number	Public / NonPublic	Date Visited	Area (sq ft)	Lane Miles *	MRL	
					Length (mi)	Width (ft)
0201A	PUBLIC	5/26/2010	2,746	0.05	0.05	10
Culverts	Drop Inlets	Gates	Curb & Gutter	Curb	PCR	Surface Type
0	0	1	NO CURB AND GUTTER	NO CURB	GOOD/90	AS

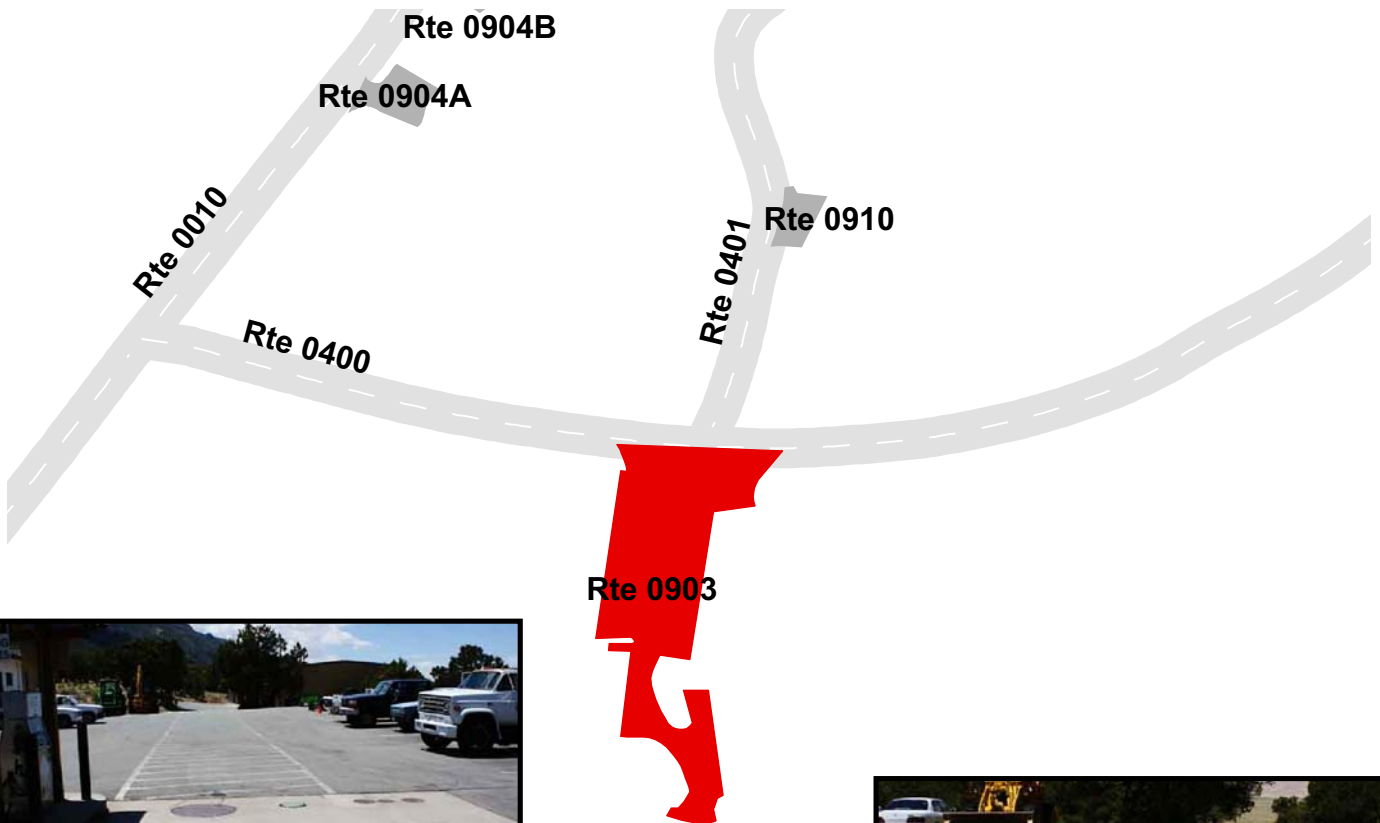
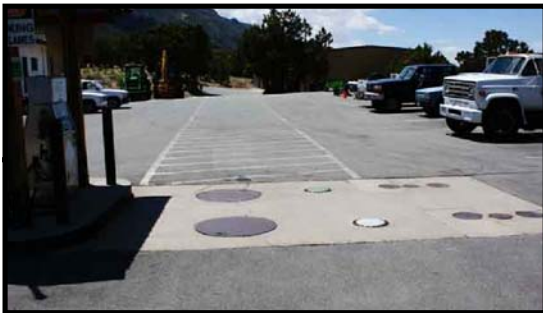
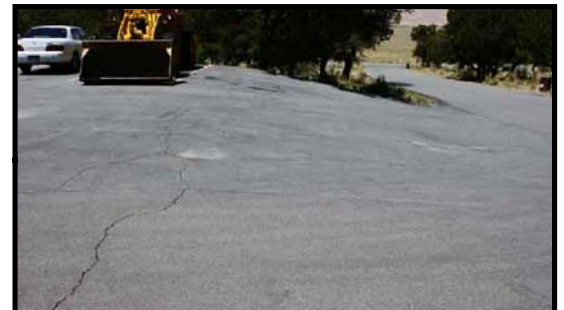
## Route 0903

Route Number	Public / NonPublic	Date Visited	Area (sq ft)	Lane Miles *	Surface Type
0903	NONPUBLIC	5/27/2010	23,071	0.40	AS
Culverts	Drop Inlets	Gates	Curb & Gutter	Curb	PCR
0	0	0	NO CURB AND GUTTER	NO CURB	GOOD/90

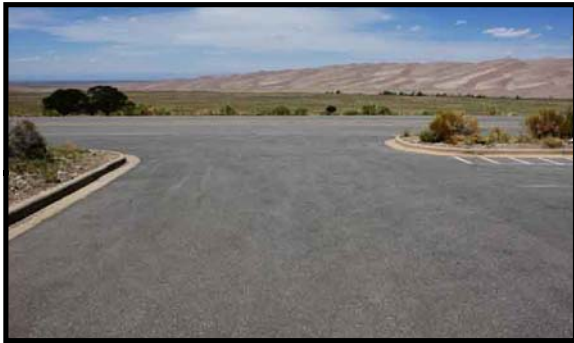
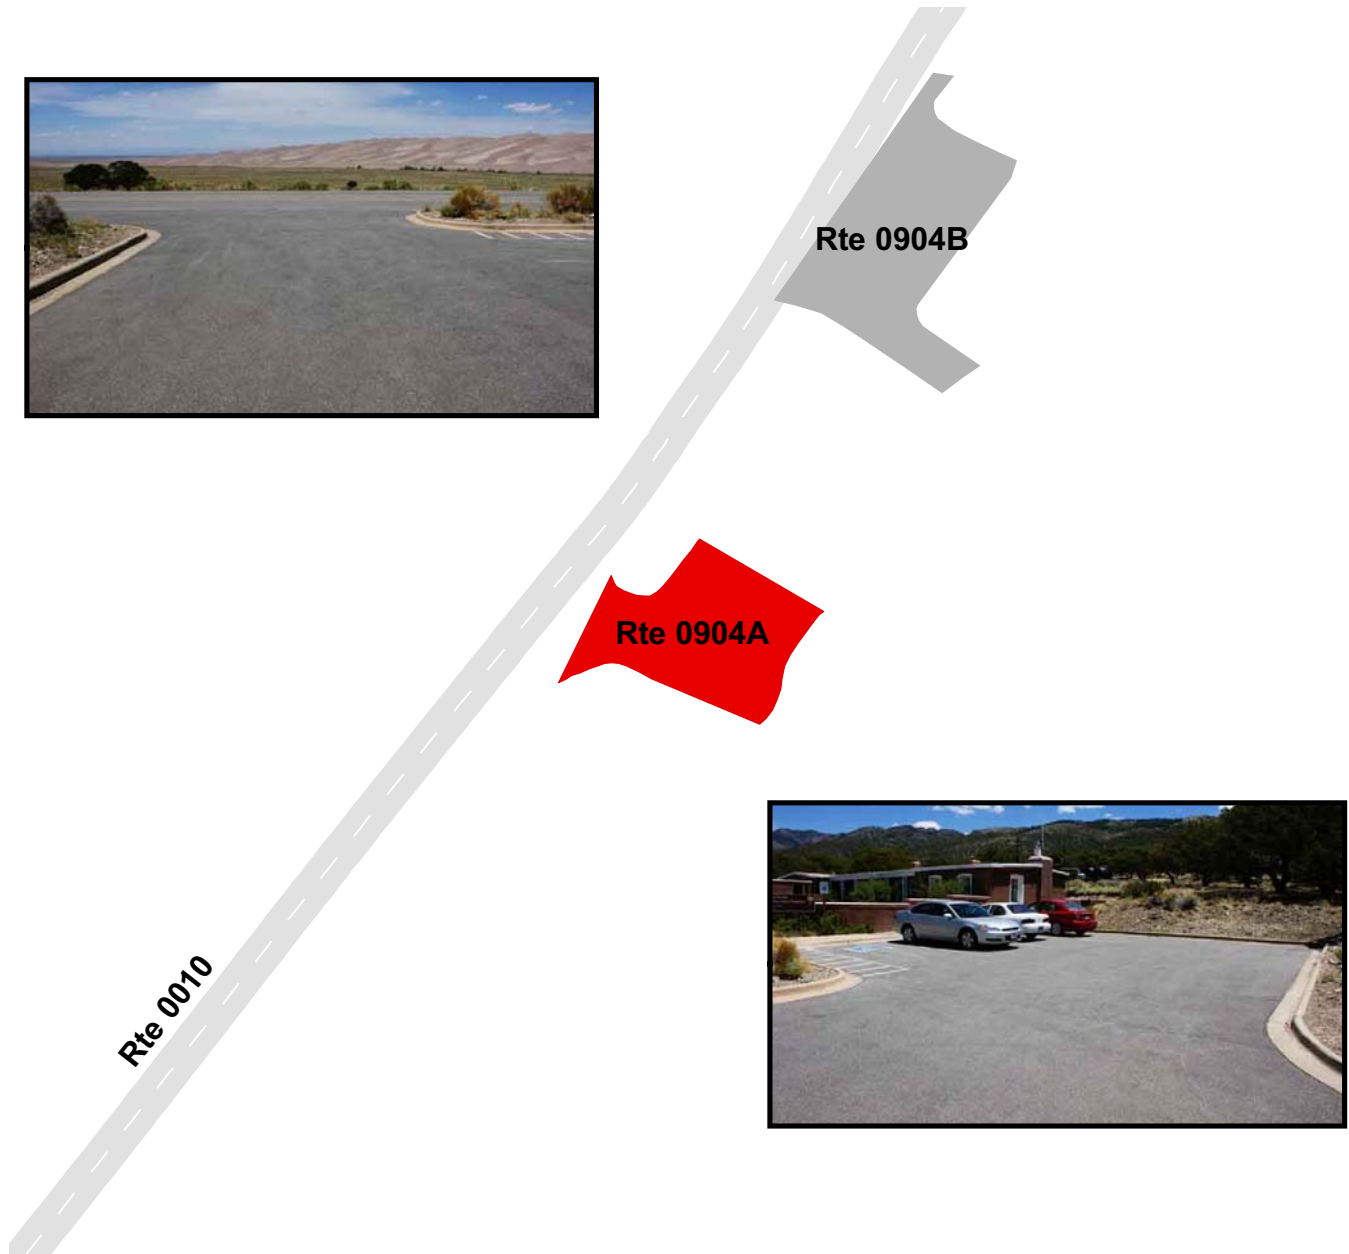
Route Number	Public / NonPublic	Date Visited	Area (sq ft)	Lane Miles *	Surface Type
0904A	PUBLIC	5/27/2010	2,253	0.04	AS
Culverts	Drop Inlets	Gates	Curb & Gutter	Curb	PCR
0	0	0	CONCRETE CURB AND GUTTER	NO CURB	GOOD/90

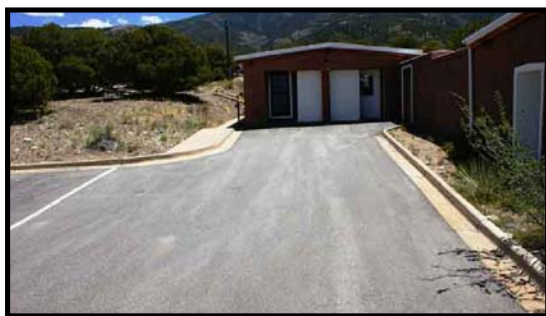
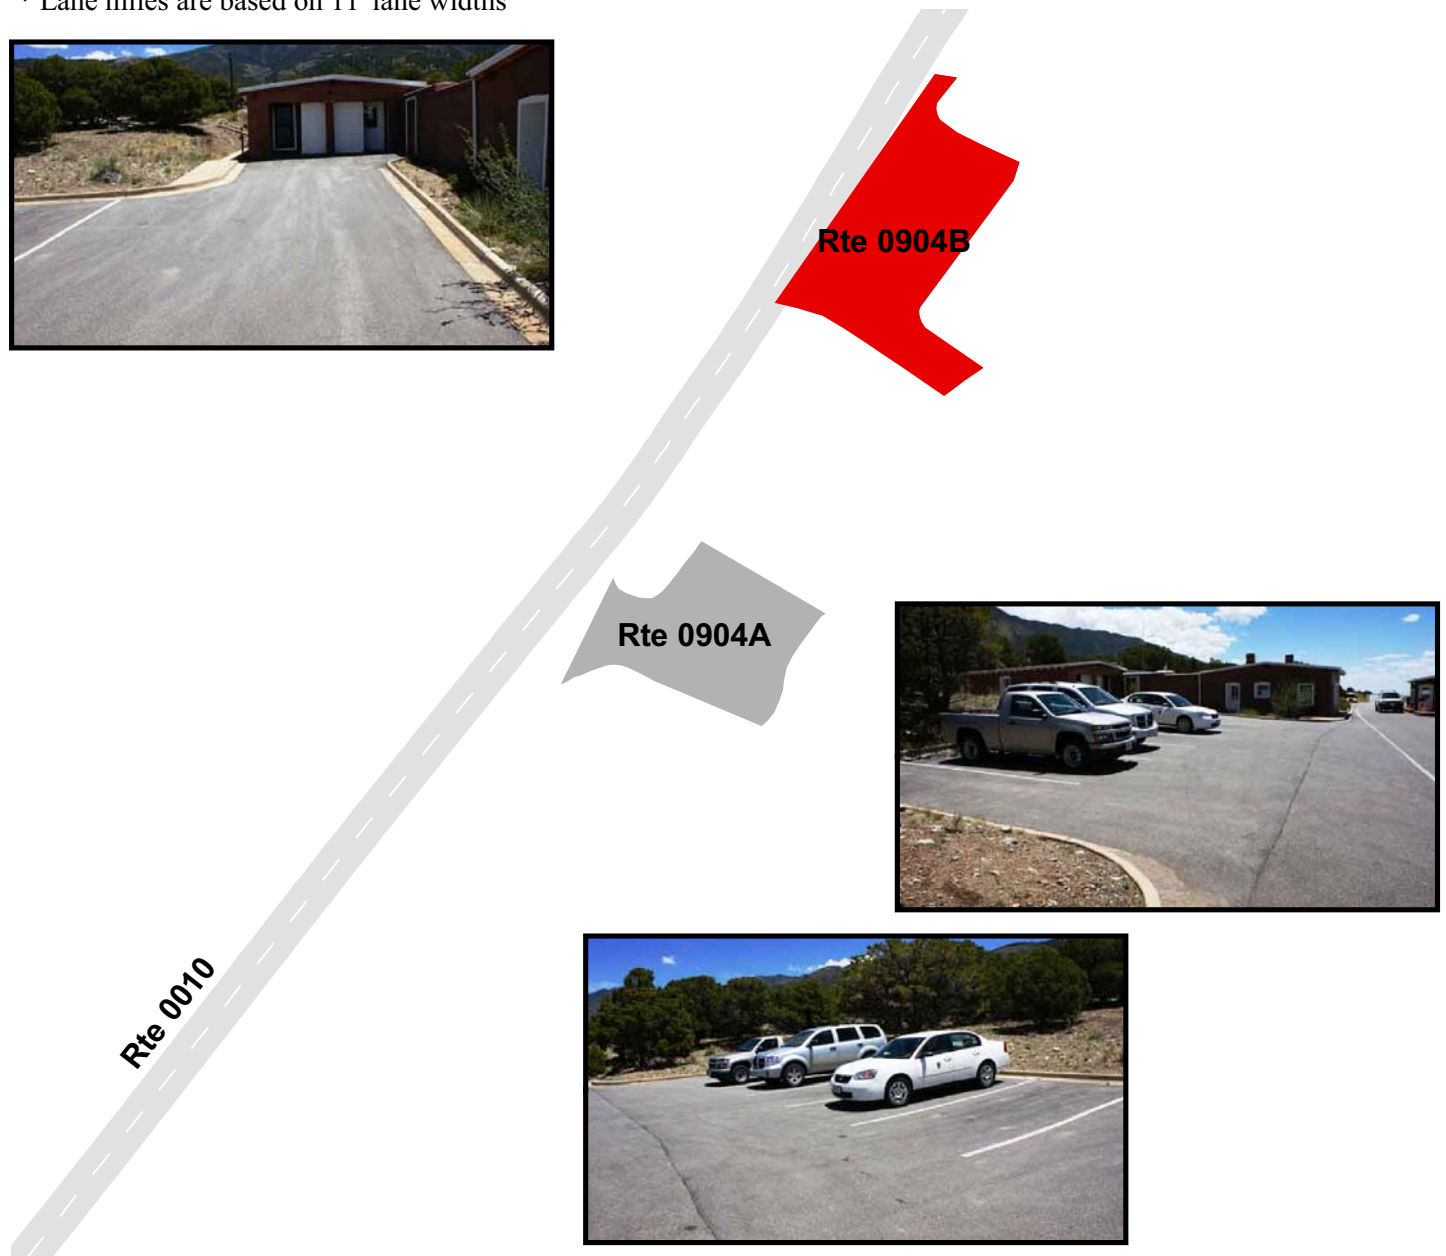
## Route 0904B

Route Number	Public / NonPublic	Date Visited	Area (sq ft)	Lane Miles *	Surface Type
0904B	PUBLIC	5/27/2010	2,965	0.05	AS
Culverts	Drop Inlets	Gates	Curb & Gutter	Curb	PCR
0	1	0	CONCRETE CURB AND GUTTER	NO CURB	GOOD/90

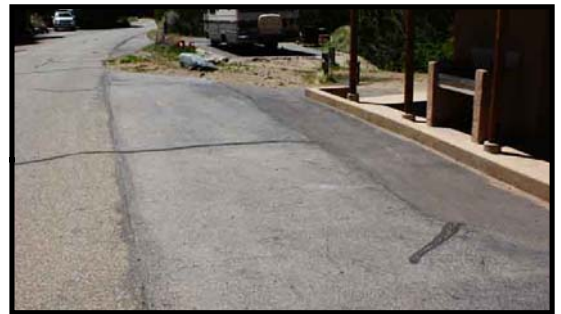
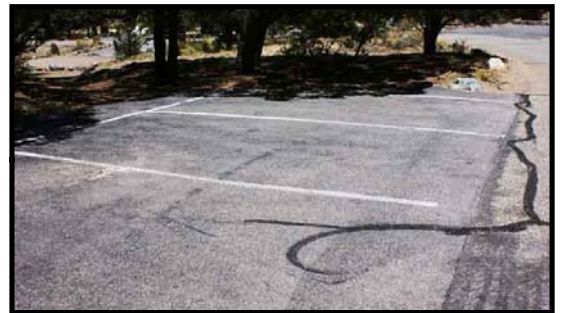
Route Number	Public / NonPublic	Date Visited	Area (sq ft)	Lane Miles *	Surface Type
0907	PUBLIC	5/26/2010	1,311	0.02	AS
Culverts	Drop Inlets	Gates	Curb & Gutter	Curb	PCR
0	0	0	NO CURB AND GUTTER	NO CURB	FAIR/73

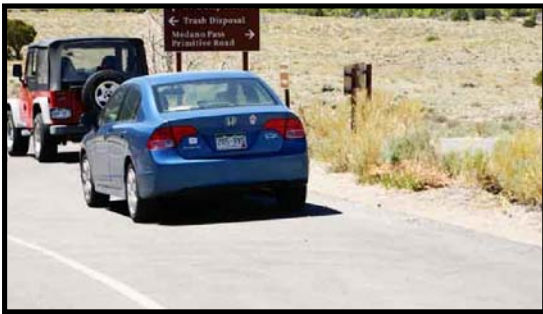
## Route 0908

Route Number	Public / NonPublic	Date Visited	Area (sq ft)	Lane Miles *	Surface Type
0908	PUBLIC	5/26/2010	2,685	0.05	AS
Culverts	Drop Inlets	Gates	Curb & Gutter	Curb	PCR
0	0	0	NO CURB AND GUTTER	NO CURB	GOOD/90

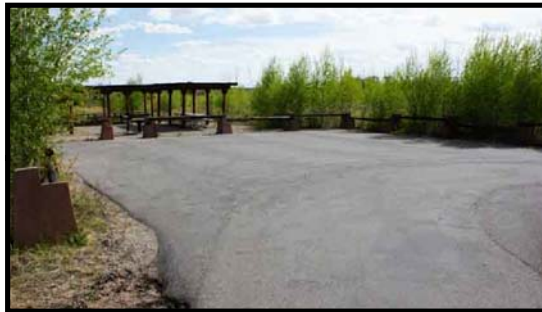
## Route 0909

Route Number	Public / NonPublic	Date Visited	Area (sq ft)	Lane Miles *	Surface Type
0909	PUBLIC	5/26/2010	2,203	0.04	AS
Culverts	Drop Inlets	Gates	Curb & Gutter	Curb	PCR
0	0	0	NO CURB AND GUTTER	NO CURB	GOOD/90

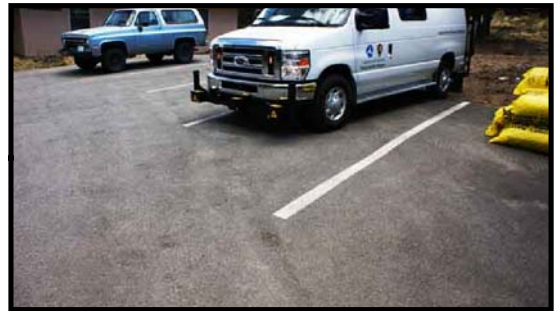
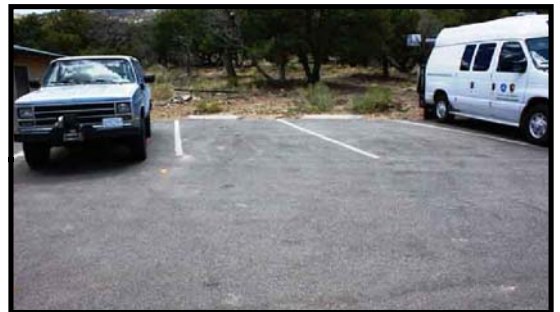
## Route 0910

Route Number	Public / NonPublic	Date Visited	Area (sq ft)	Lane Miles *	Surface Type
0910	PUBLIC	5/27/2010	1,559	0.03	AS
Culverts	Drop Inlets	Gates	Curb & Gutter	Curb	PCR
0	0	0	NO CURB AND GUTTER	NO CURB	GOOD/90
