Federal Lands Highway Road Inventory Program

Road Inventory and Condition Assessment

Grand Teton National Park
GRTE - 1460

Cycle 5 Report

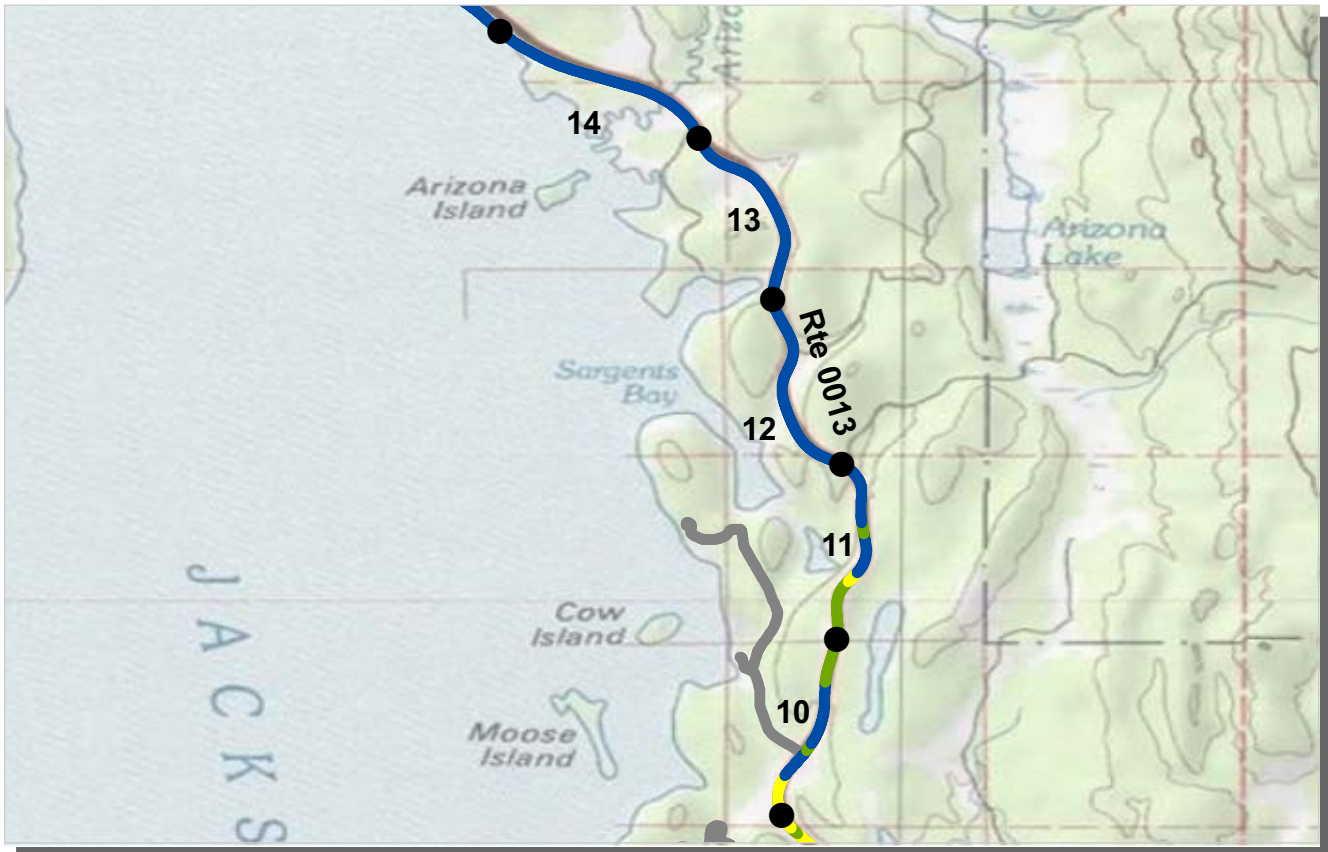
ROUTE: 0013 NORTH PARK ROAD

* If the PCR rating is not available for a section, the SCR rating will be displayed. See appendix for definitions and formulas.

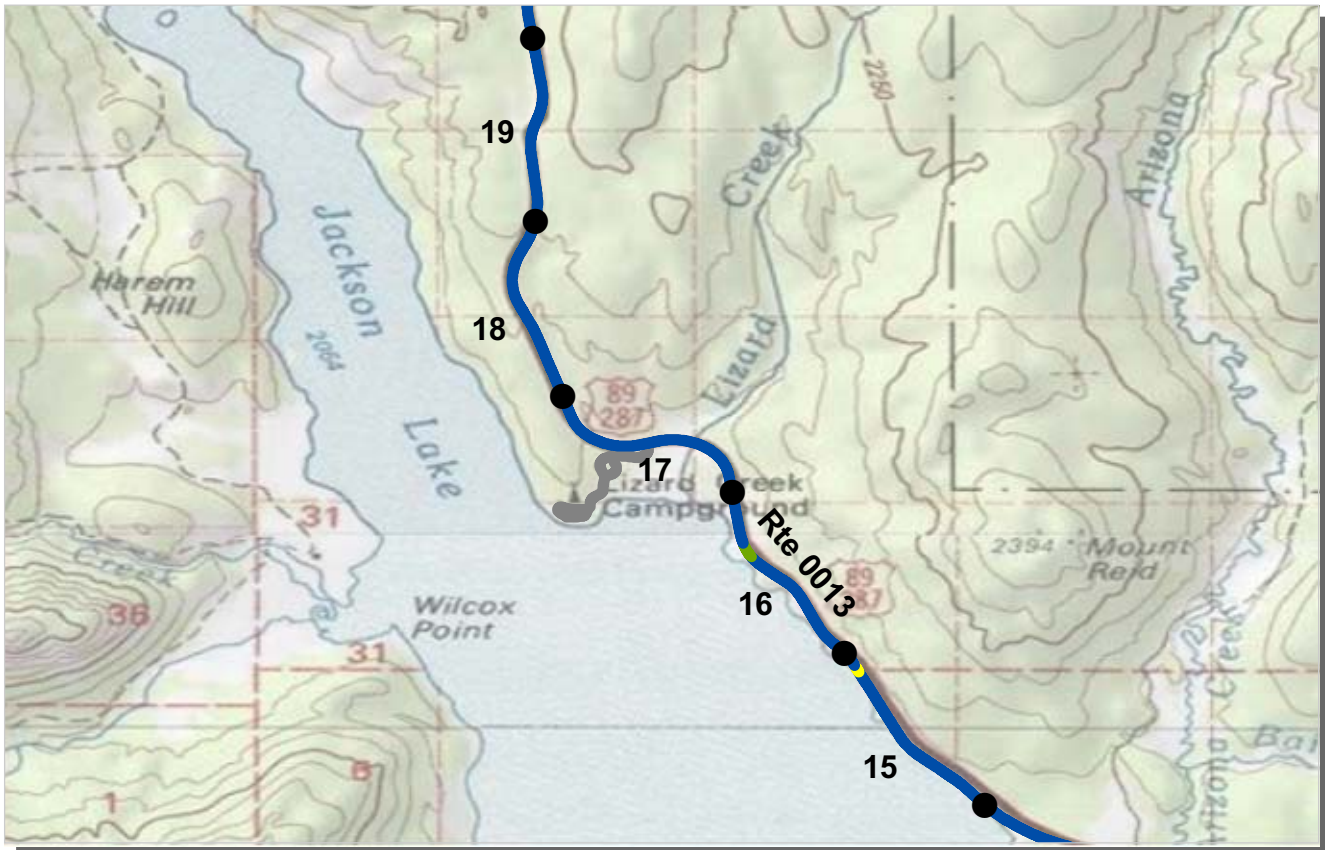
ROUTE: 0013 NORTH PARK ROAD

* If the PCR rating is not available for a section, the SCR rating will be displayed. See appendix for definitions and formulas.

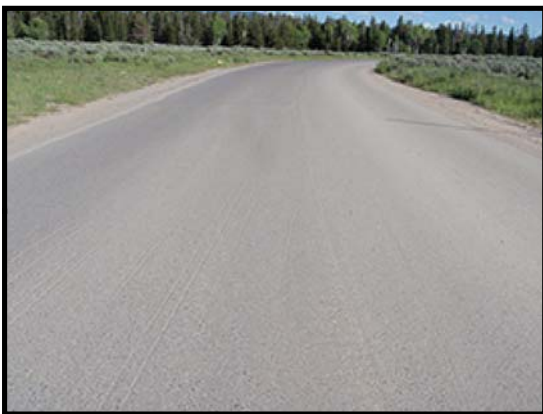
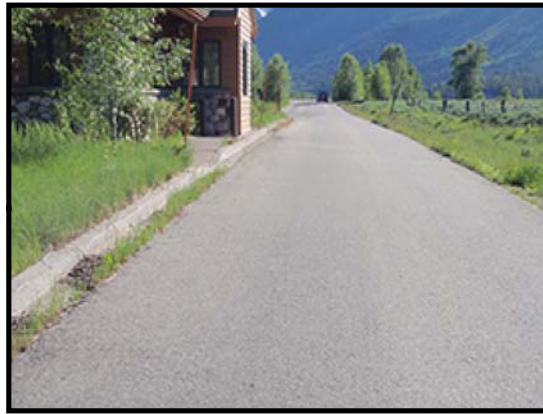
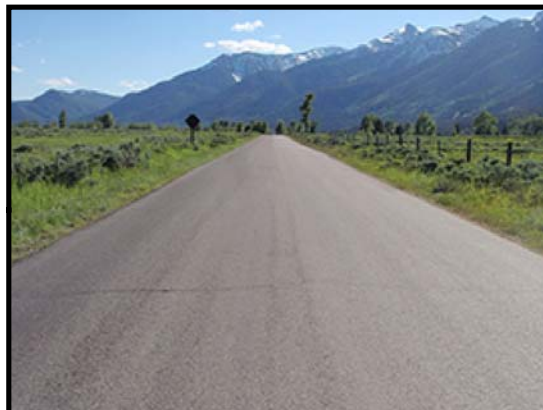
Route 0100ZZ

| Route Number | Public / NonPublic | Date Visited | Area (sq ft) | Lane Miles * | Paved Length (mi) | Paved Width (ft) |
|---|---|---|---|---|---|---|
| 0 | 0 | 0 | CURB AND GUTTER | NO CURB | GOOD/90 | AS |

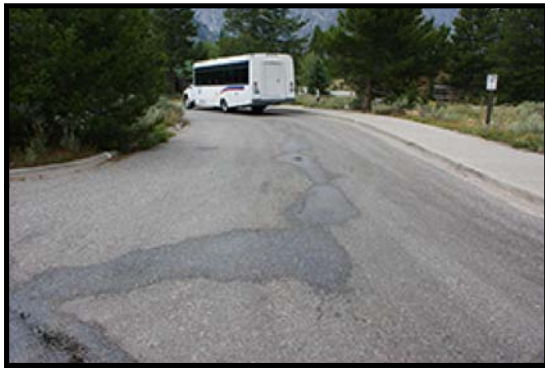
Route 0266

| Route Number | Public / NonPublic | Date Visited | Area (sq ft) | Lane Miles * | Surface Type |
|---|---|---|---|---|---|
| 0 | 0 | 0 | CONCRETE CURB AND GUTTER | NO CURB | FAIR/73 |

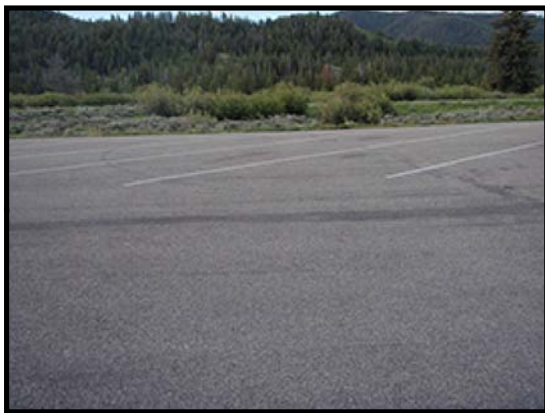
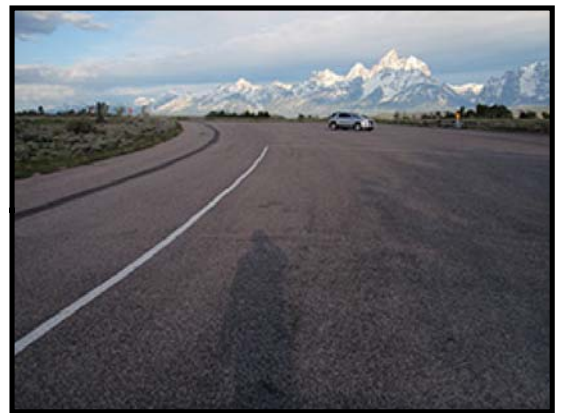
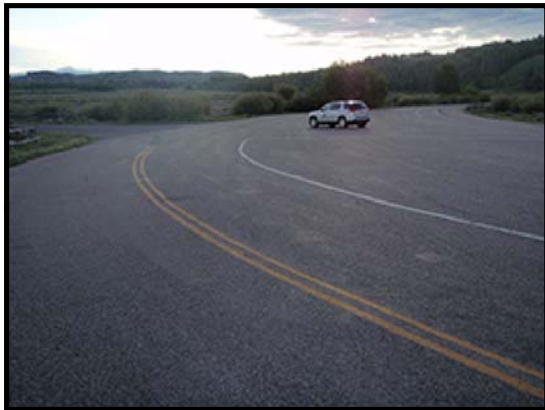
| Route Number | Public / NonPublic | Date Visited | Area (sq ft) | Lane Miles * | Surface Type |
|---|---|---|---|---|---|
| 0 | 0 | 0 | NO CURB AND GUTTER | NO CURB | FAIR/73 |

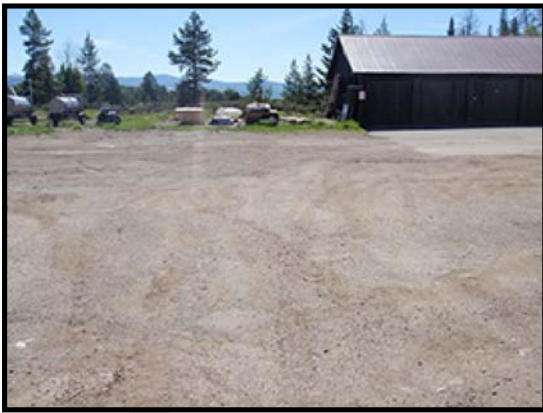
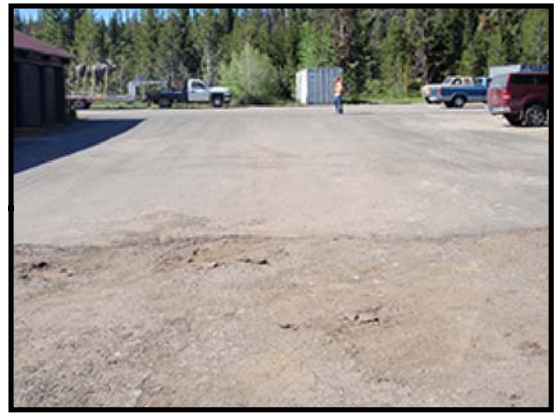
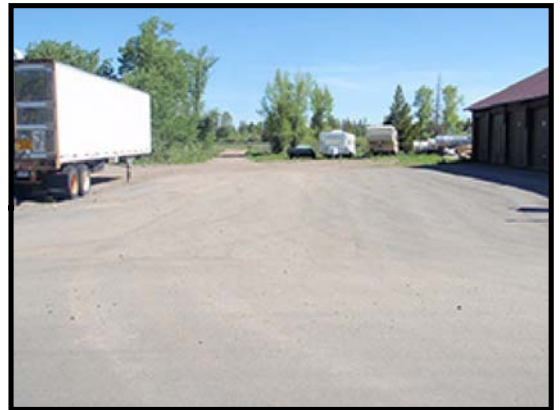
Route 0922

| Route Number | Public / NonPublic | Date Visited | Area (sq ft) | Lane Miles * | Surface Type |
|---|---|---|---|---|---|
| 0 | 0 | 0 | NO CURB AND GUTTER | NO CURB | FAIR/73 |

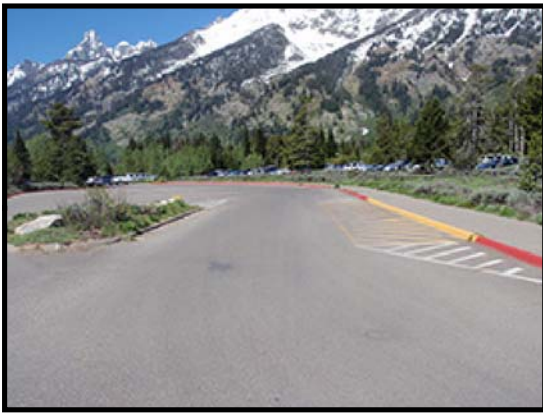
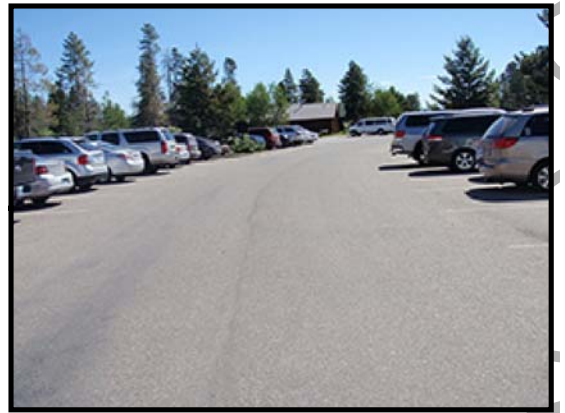
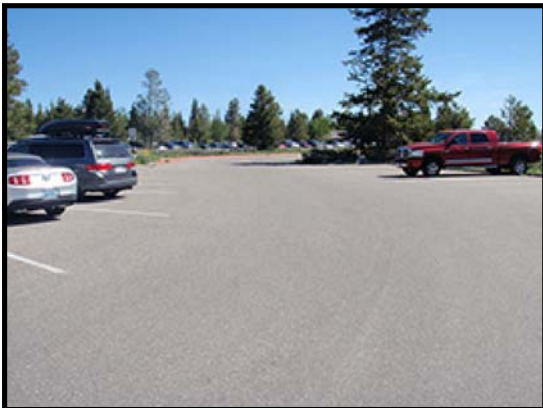
Route 0929

| Route Number | Public / NonPublic | Date Visited | Area (sq ft) | Lane Miles * | Surface Type |
|---|---|---|---|---|---|
| 0 | 5 | 0 | CONCRETE CURB AND GUTTER | NO CURB | GOOD/90 |

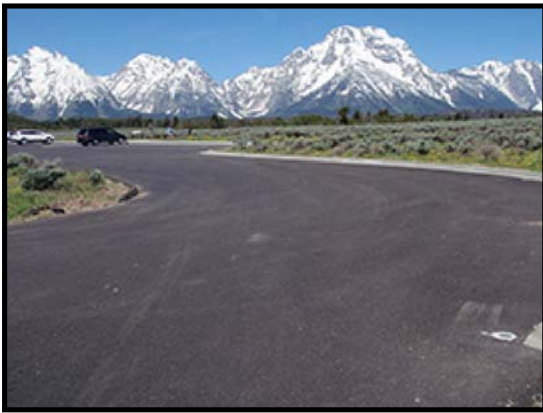
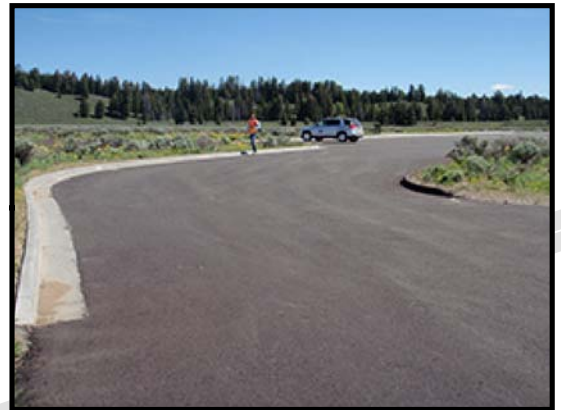
Route 0940

| Route Number | Public / NonPublic | Date Visited | Area (sq ft) | Lane Miles * | Surface Type |
|---|---|---|---|---|---|
| 0 | 0 | 0 | CONCRETE CURB AND GUTTER | ASPHALT CURB | EXCELLENT/97 |

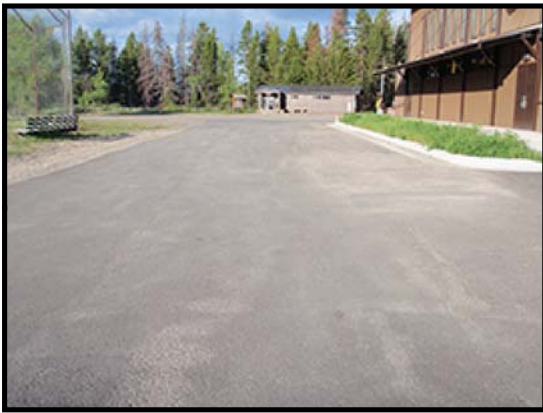
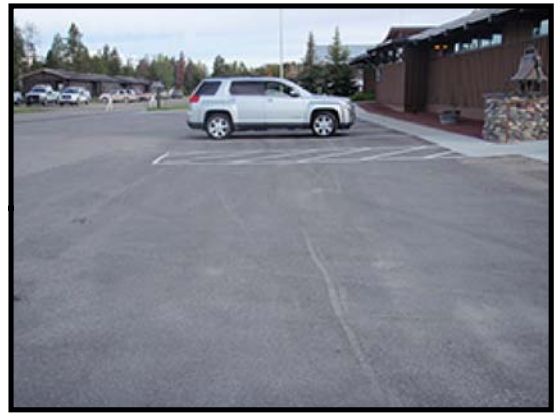
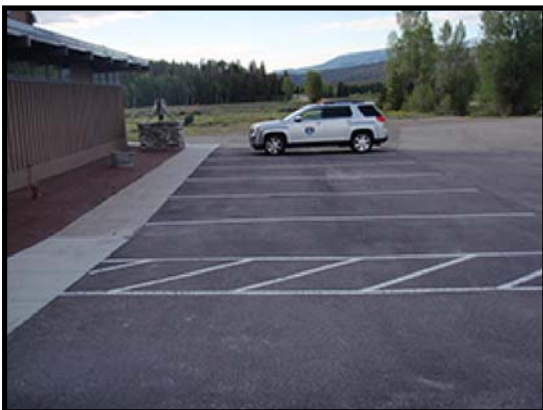
Route 0953EZ

| Route Number | Public / NonPublic | Date Visited | Area (sq ft) | Lane Miles * | Surface Type |
|---|---|---|---|---|---|
| 0 | 0 | 0 | CONCRETE CURB AND GUTTER | NO CURB | GOOD/90 |

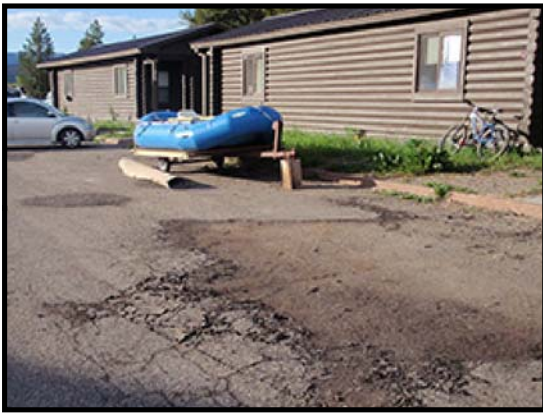
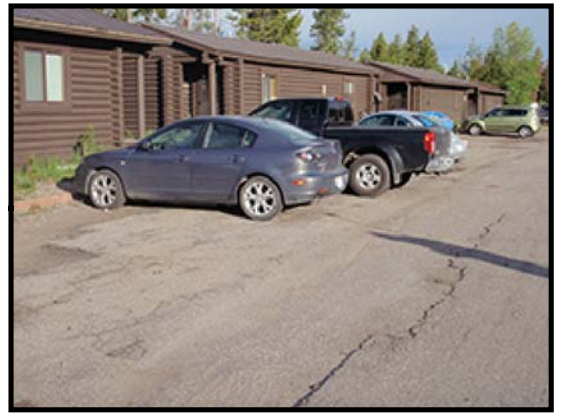
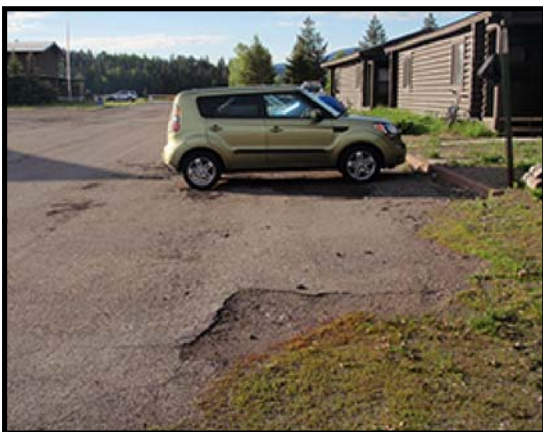
Route 0965

| Route Number | Public / NonPublic | Date Visited | Area (sq ft) | Lane Miles * | Surface Type |
|---|---|---|---|---|---|
| 0 | 0 | 0 | CONCRETE CURB AND GUTTER | NO CURB | POOR/45 |

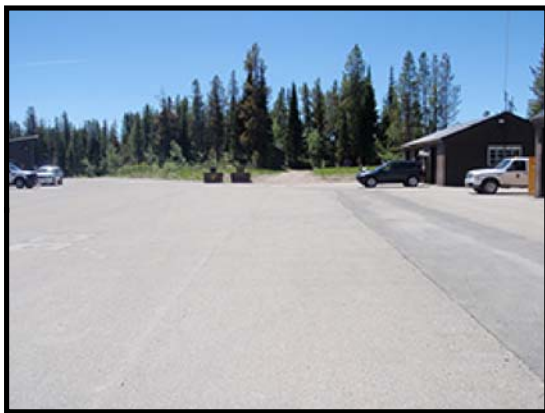
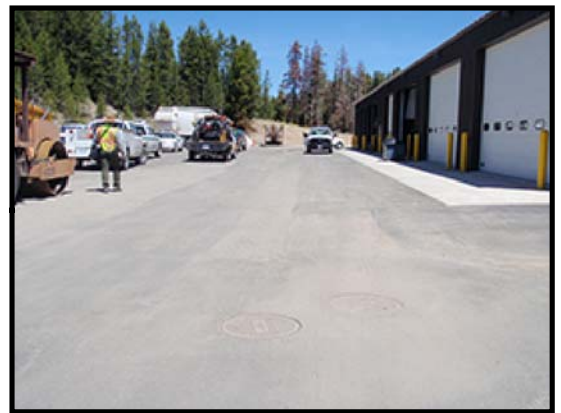
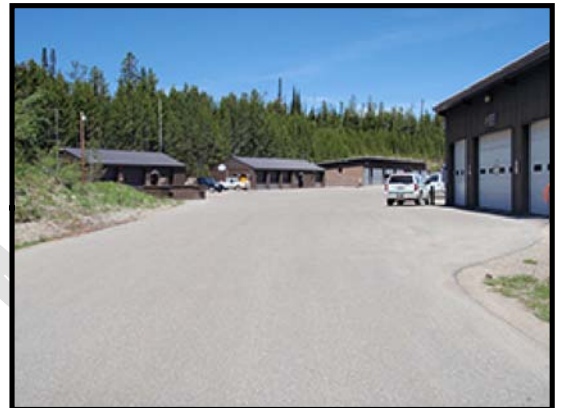
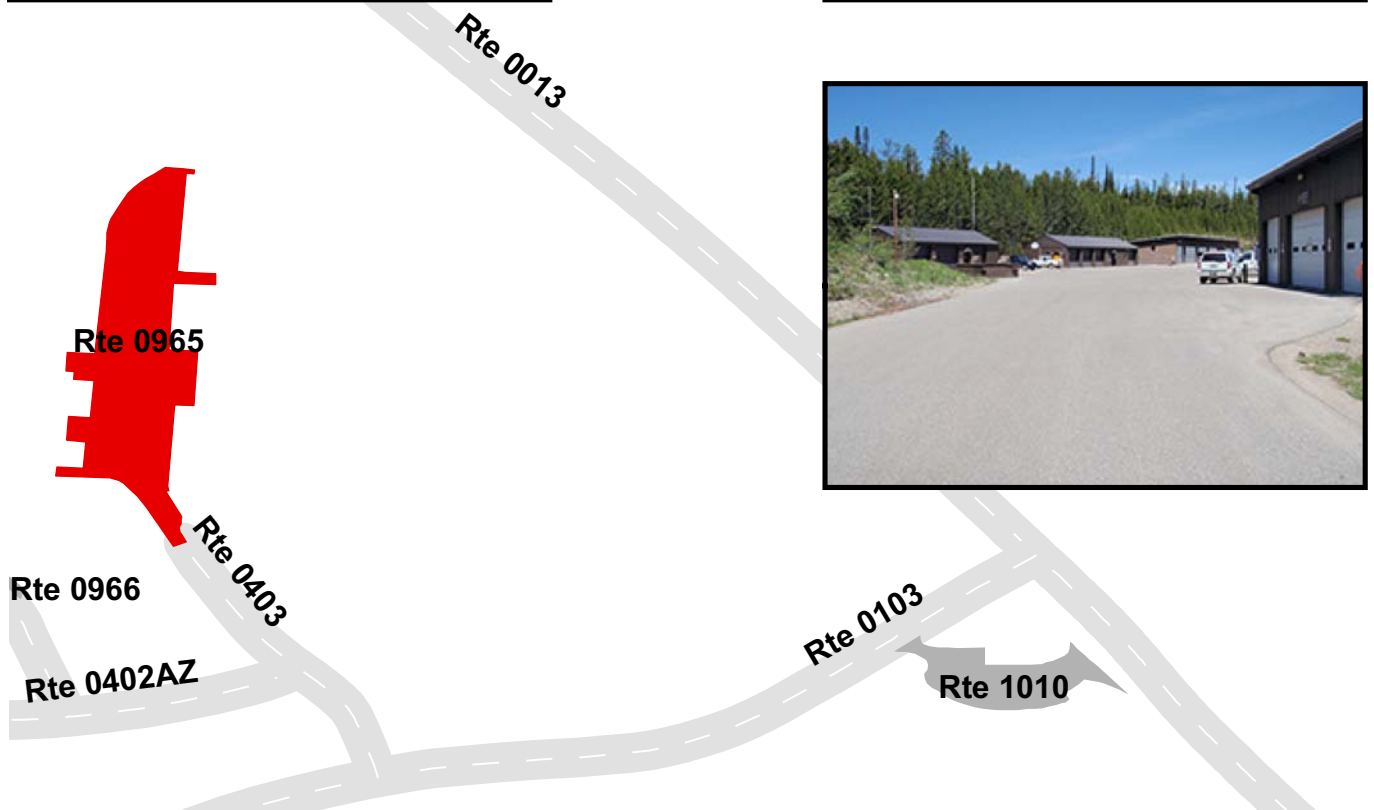
Route 0977

| Route Number | Public / NonPublic | Date Visited | Area (sq ft) | Lane Miles * | Surface Type |
|---|---|---|---|---|---|
| 0 | 2 | 0 | NO CURB AND GUTTER | NO CURB | FAIR/73 |

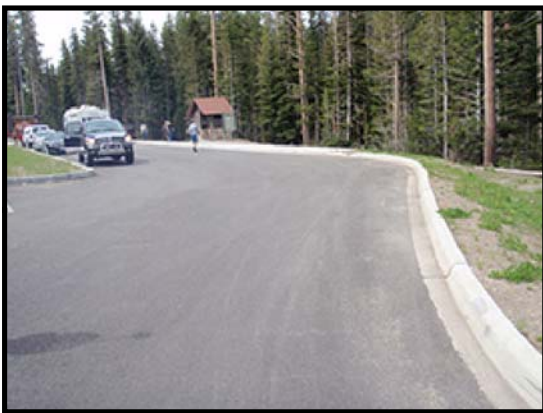
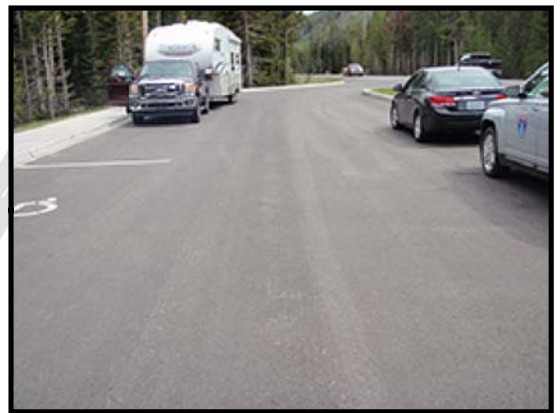
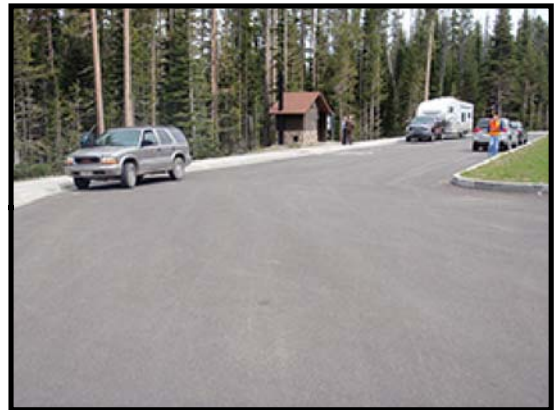
Route 1007ZZ

| Route Number | Public / NonPublic | Date Visited | Area (sq ft) | Lane Miles * | Surface Type |
|---|---|---|---|---|---|
| 0 | 0 | 0 | CONCRETE CURB AND GUTTER | CONCRETE CURB | EXCELLENT/97 |

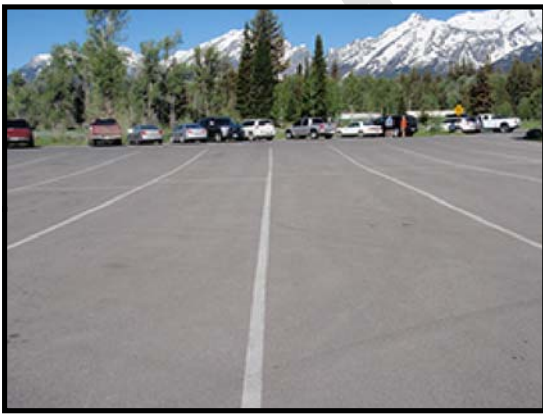
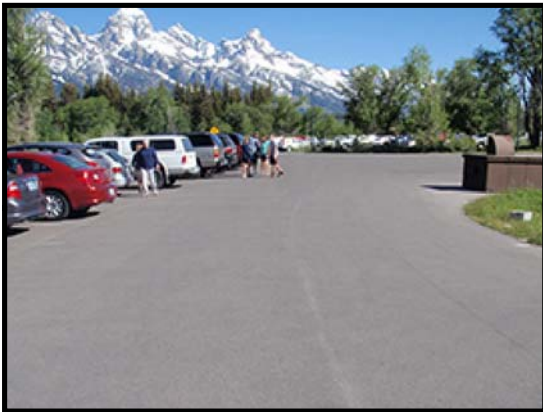
Route 1019

| Route Number | Public / NonPublic | Date Visited | Area (sq ft) | Lane Miles * | Surface Type |
|---|---|---|---|---|---|
| 0 | 0 | 0 | NO CURB AND GUTTER | NO CURB | EXCELLENT/97 |

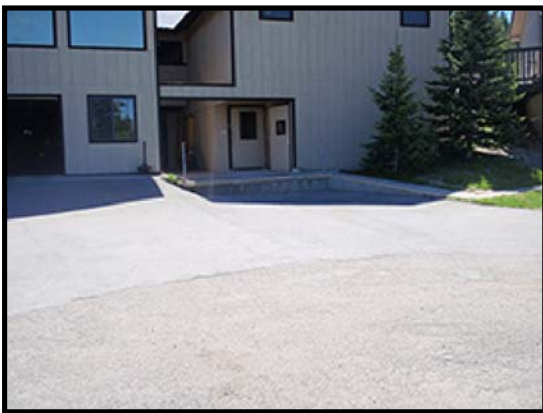
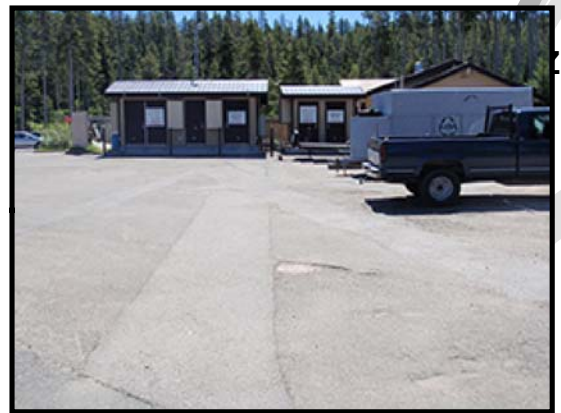
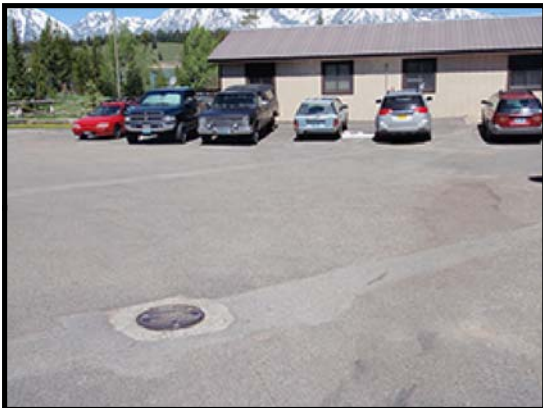
Route 1020

| Route Number | Public / NonPublic | Date Visited | Area (sq ft) | Lane Miles * | Surface Type |
|---|---|---|---|---|---|
| 0 | 1 | 0 | CONCRETE CURB AND GUTTER | NO CURB | FAIR/73 |

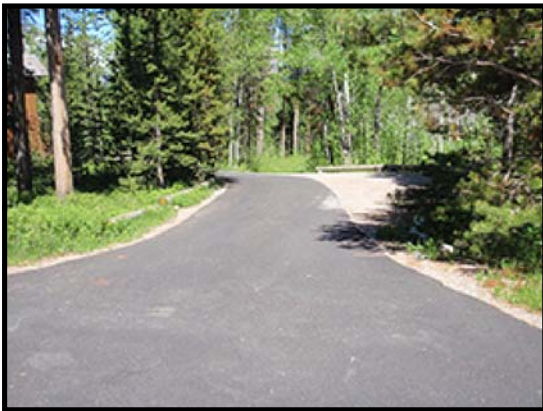
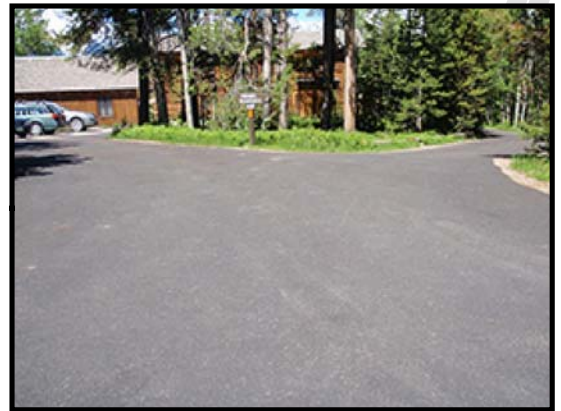
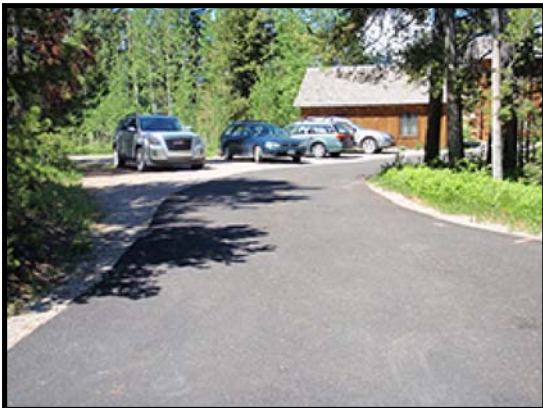
Route 1025ZZ

| Route Number | Public / NonPublic | Date Visited | Area (sq ft) | Lane Miles * | Surface Type |
|---|---|---|---|---|---|
| 0 | 0 | 0 | NO CURB AND GUTTER | NO CURB | EXCELLENT/97 |

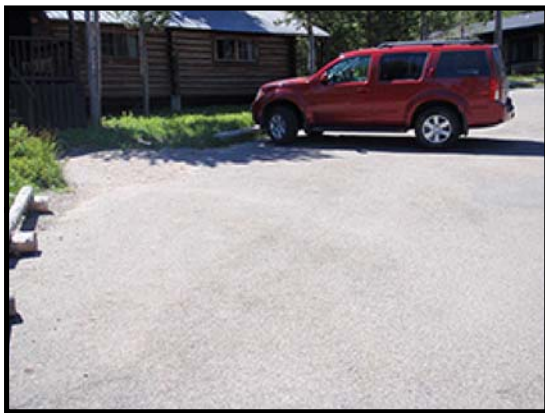
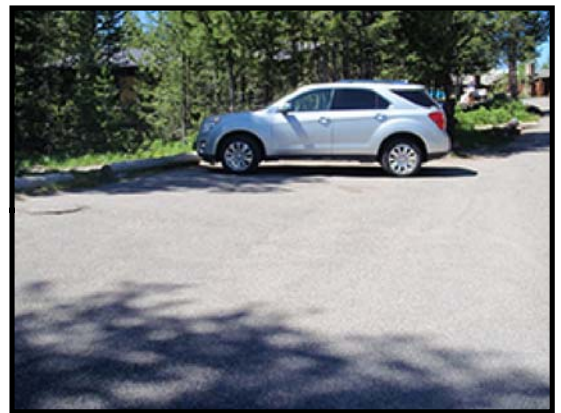
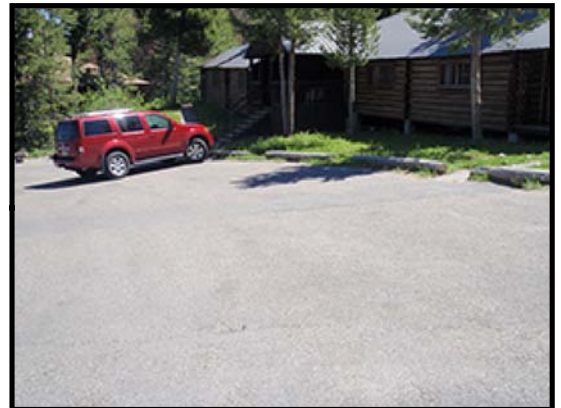
Route 1028

| Route Number | Public / NonPublic | Date Visited | Area (sq ft) | Lane Miles * | Surface Type |
|---|---|---|---|---|---|
| 0 | 0 | 0 | NO CURB AND GUTTER | NO CURB | FAIR/73 |

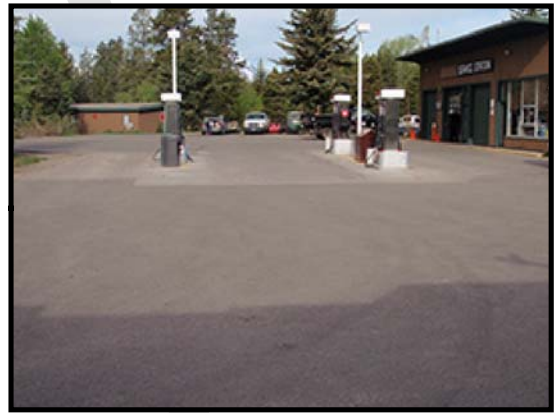
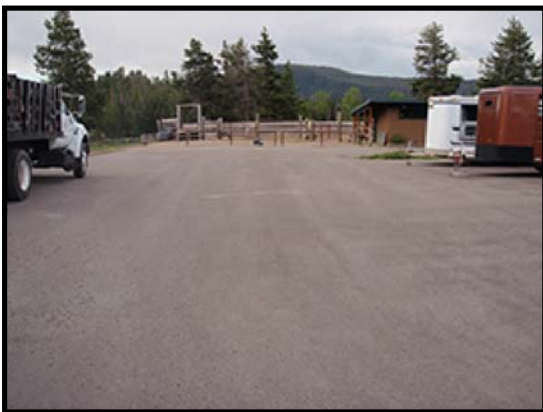
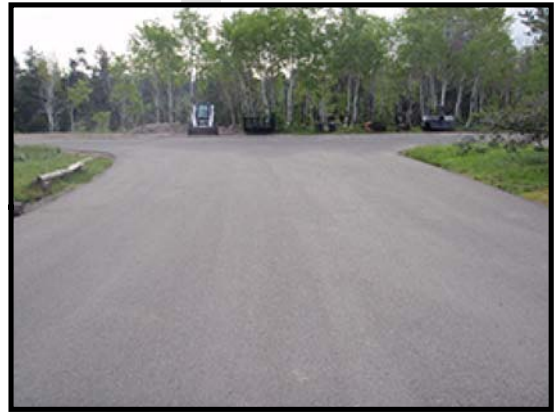
Route 1030

| Route Number | Public / NonPublic | Date Visited | Area (sq ft) | Lane Miles * | Surface Type |
|---|---|---|---|---|---|
| 0 | 1 | 0 | NO CURB AND GUTTER | CONCRETE CURB | GOOD/90 |

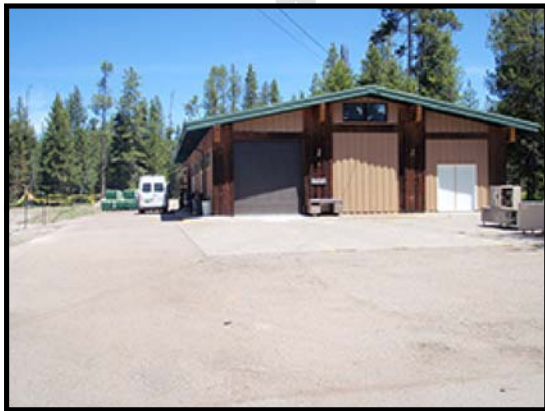
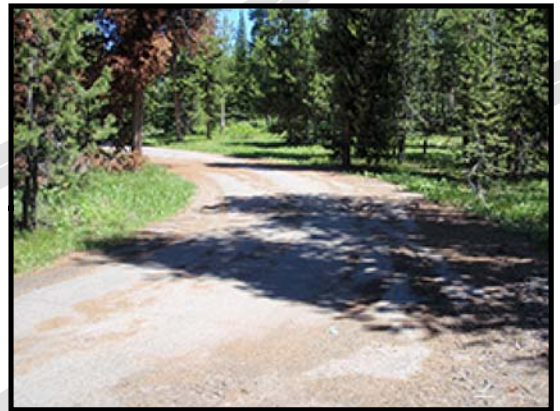
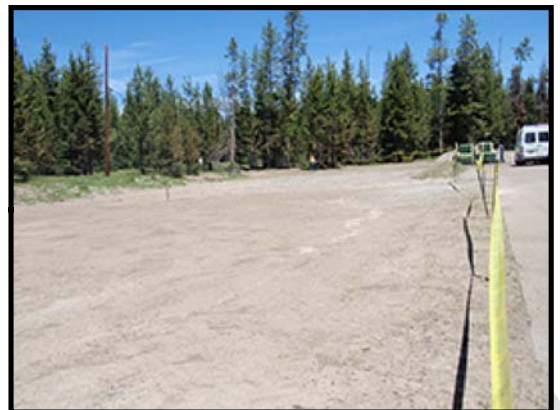
Route 1031

| Route Number | Public / NonPublic | Date Visited | Area (sq ft) | Lane Miles * | Surface Type |
|---|---|---|---|---|---|
| 0 | 0 | 0 | CONCRETE CURB AND GUTTER | NO CURB | CONSTRUCT/-1 |

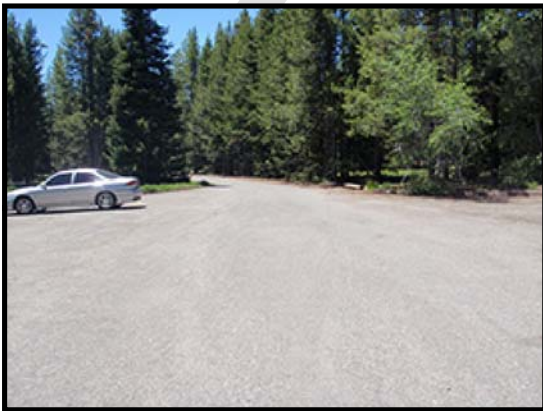
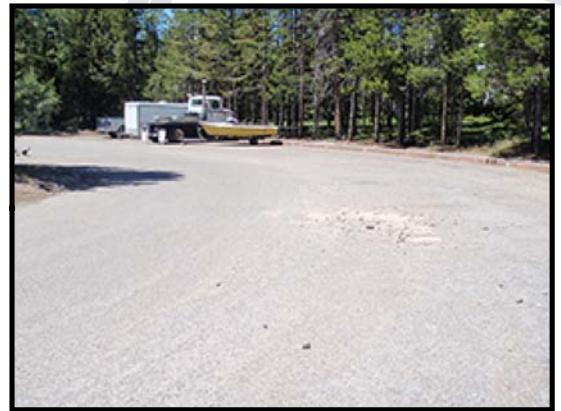
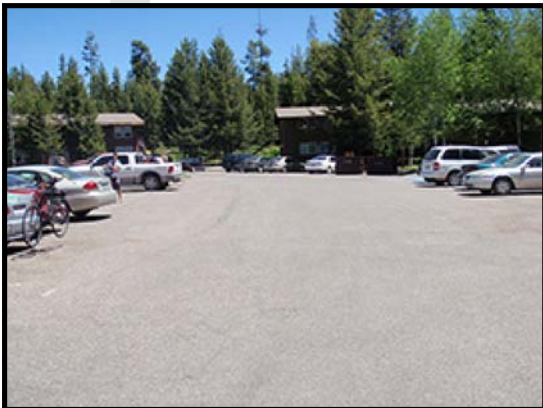
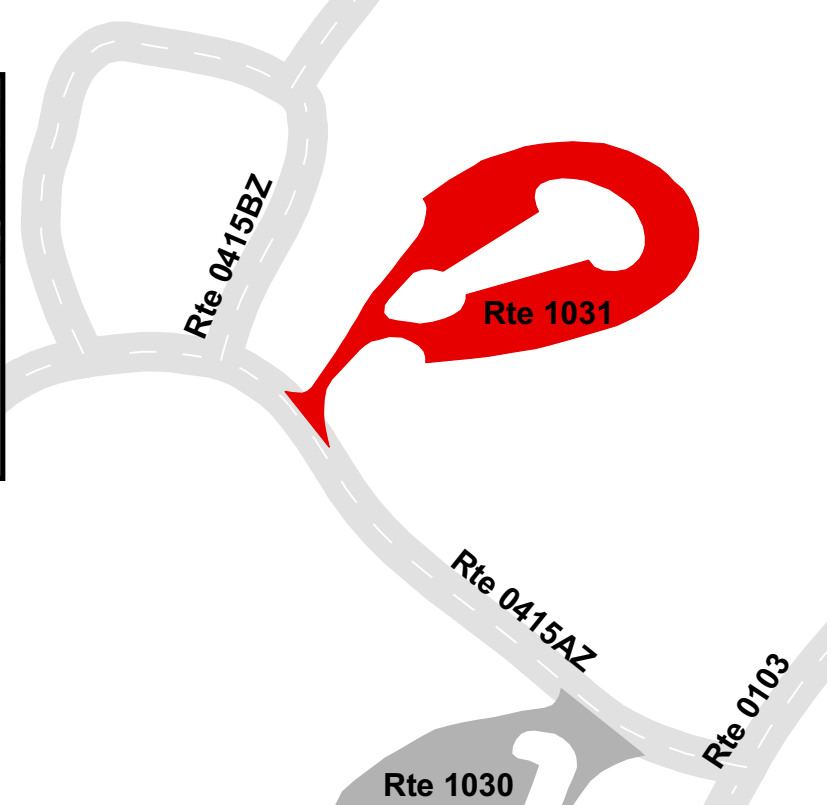
Route 1035ZZ

| Route Number | Public / NonPublic | Date Visited | Area (sq ft) | Lane Miles * | Surface Type |
|---|---|---|---|---|---|
| 0 | 0 | 0 | CONCRETE CURB AND GUTTER | NO CURB | FAIR/73 |

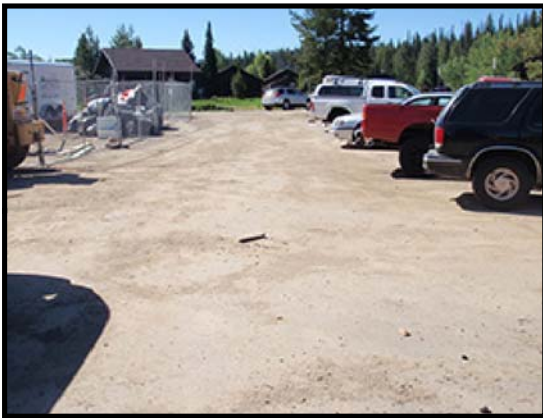
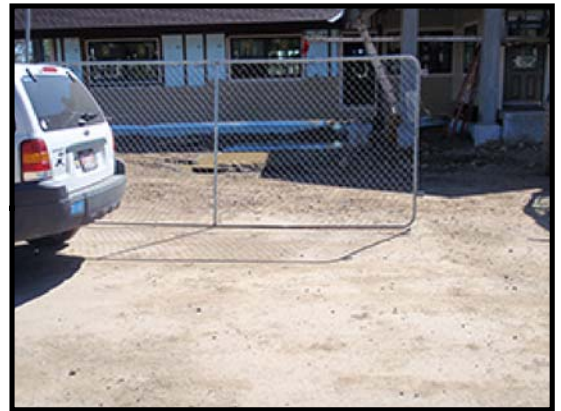
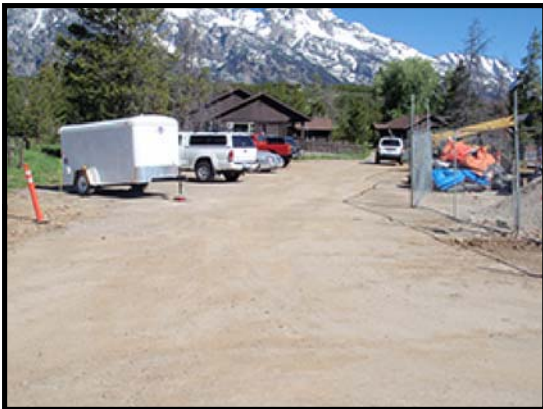
Route 1035BZ

| Route Number | Public / NonPublic | Date Visited | Area (sq ft) | Lane Miles * | Surface Type |
|---|---|---|---|---|---|
| 0 | 0 | 0 | NO CURB AND GUTTER | NO CURB | CONSTRUCT/-1 |

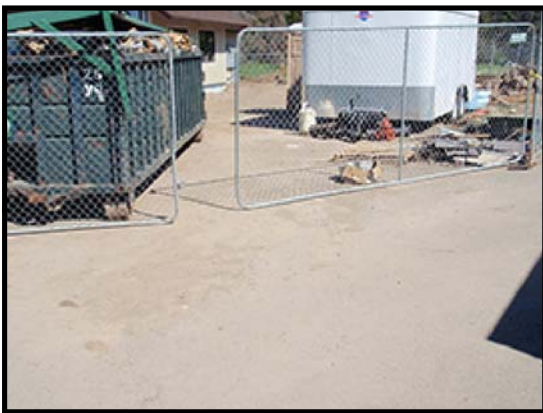
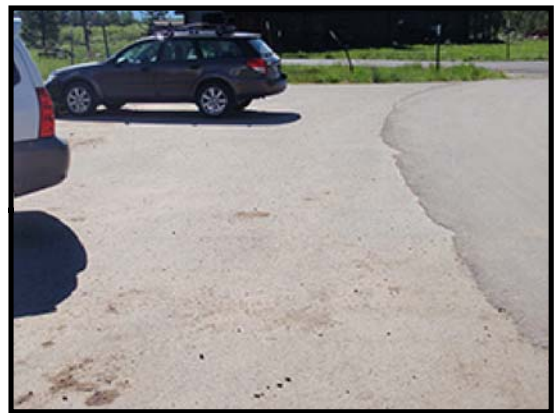
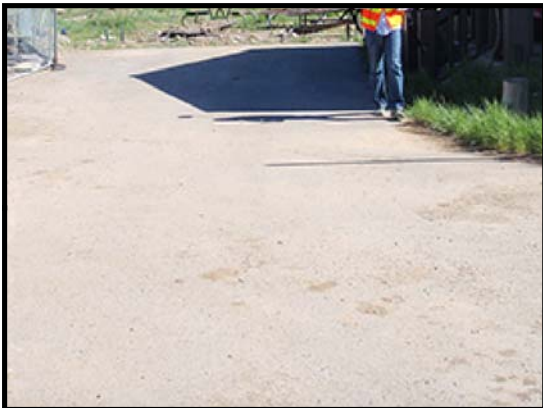
Route 1036

| Route Number | Public / NonPublic | Date Visited | Area (sq ft) | Lane Miles * | Surface Type |
|---|---|---|---|---|---|
| 0 | 0 | 0 | NO CURB AND GUTTER | NO CURB | CONSTRUCT/-1 |
