Federal Lands Highway Road Inventory Program

Road Inventory and Condition Assessment

Guilford Courthouse National Military Park GUCO

Cycle 5 Report

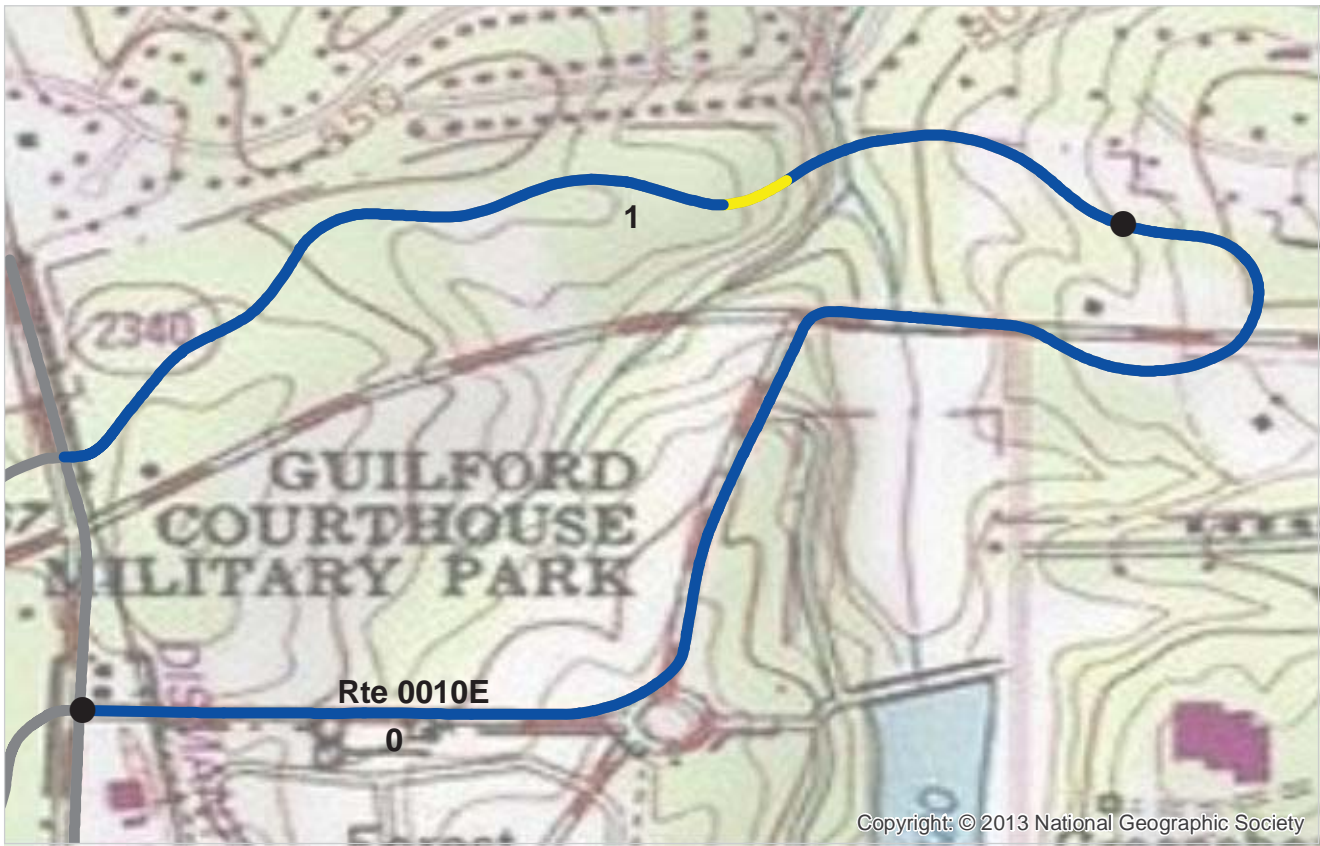
ROUTE: 0010E TOUR ROAD EAST

<i>Section Number</i>	0	1			
<i>Section Length (mi)</i>	1.00	0.73			
<i>Cross Section Information</i>					
Number of Lanes	2	2			
Paved Width (ft)	21	21			
Lane Width (ft)	10	11			
<i>Roadway Condition Information</i>					
SCR (Surface Condition Rating)	99	99			
PCR (Pavement Condition Rating)	99	99			
<i>Distress Index Values</i>					
Structural Crack Index	100	99			
Transverse Cracking Index	100	100			
Patching Index	100	100			
Rutting Index	99	100			
Roughness Condition Index (RCI)	NC	NC

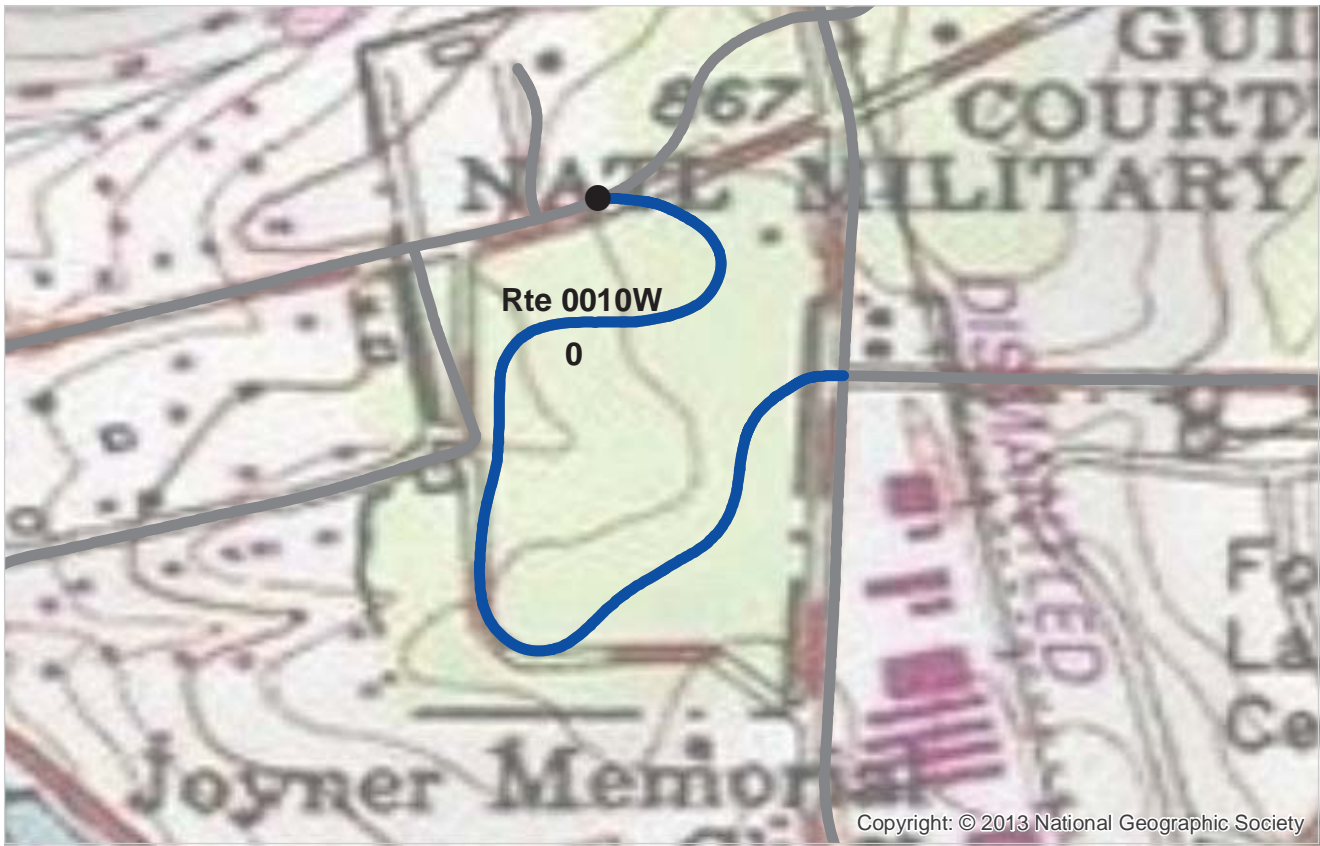
ROUTE: 0010W TOUR ROAD WEST

<i>Section Number</i>	0				
<i>Section Length (mi)</i>	0.53				
<i>Cross Section Information</i>					
Number of Lanes	2				
Paved Width (ft)	20				
Lane Width (ft)	12				
<i>Roadway Condition Information</i>					
SCR (Surface Condition Rating)	98				
PCR (Pavement Condition Rating)	98				
<i>Distress Index Values</i>					
Structural Crack Index	100				
Transverse Cracking Index	100				
Patching Index	100				
Rutting Index	98				
Roughness Condition Index (RCI)	NC

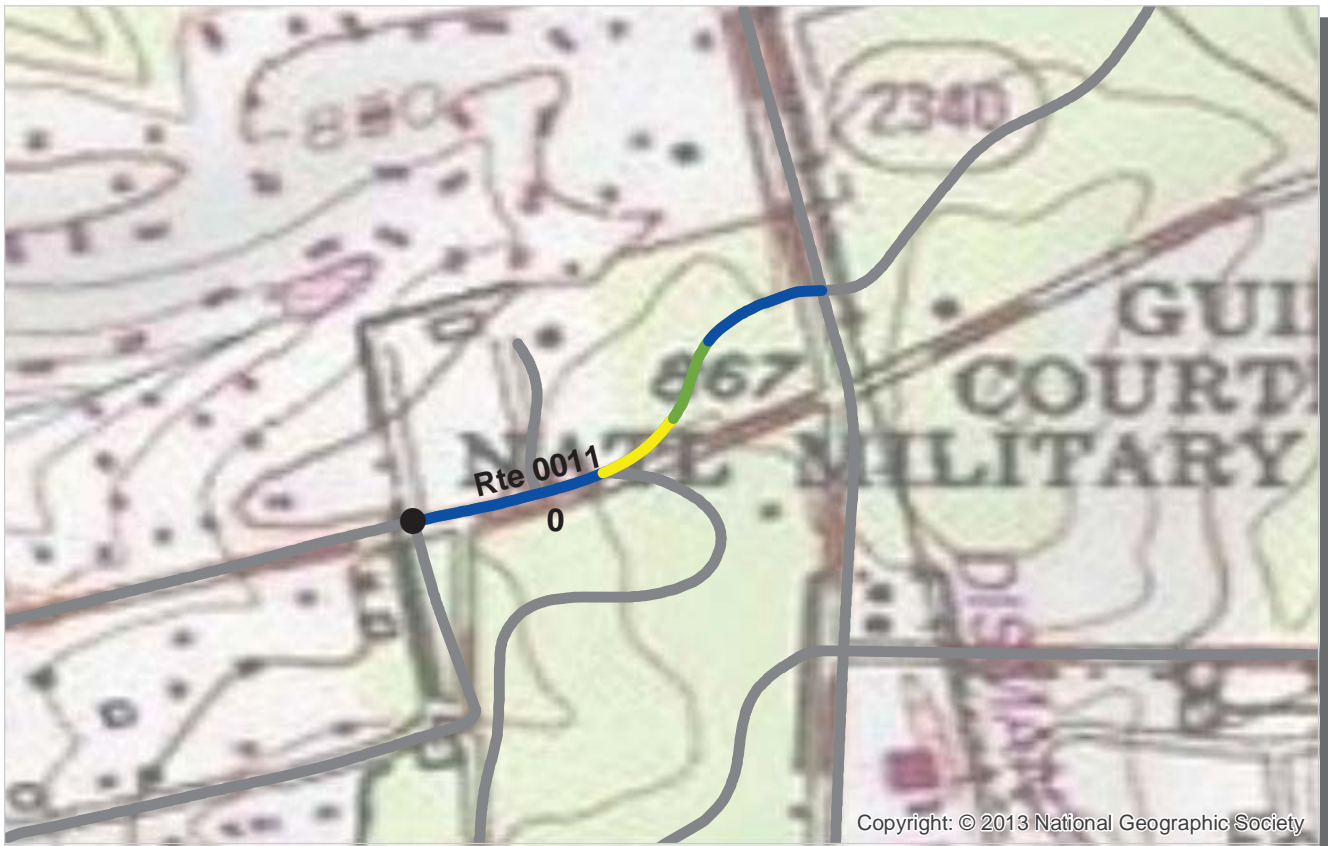
ROUTE: 0011 NEW GARDEN ROAD

Section Number	0				
Section Length (mi)	0.21				
Cross Section Information					
Number of Lanes	2				
Paved Width (ft)	21				
Lane Width (ft)	10				
Roadway Condition Information					
SCR (Surface Condition Rating)	95				
PCR (Pavement Condition Rating)	95				
Distress Index Values					
Structural Crack Index	95				
Transverse Cracking Index	100				
Patching Index	100				
Rutting Index	99				
Roughness Condition Index (RCI)	NC

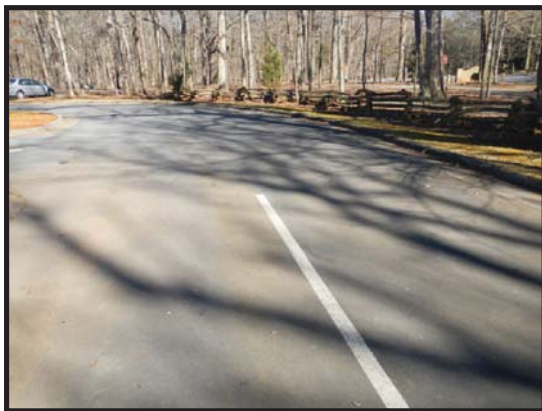
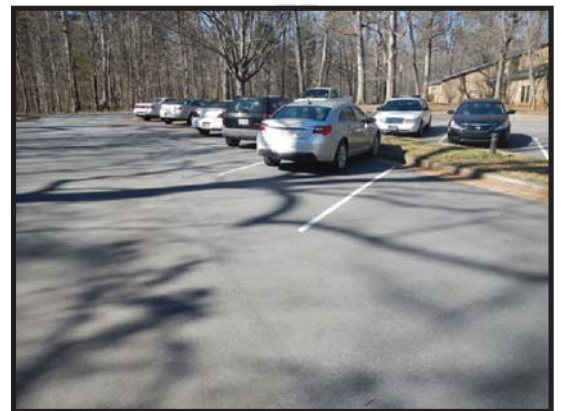
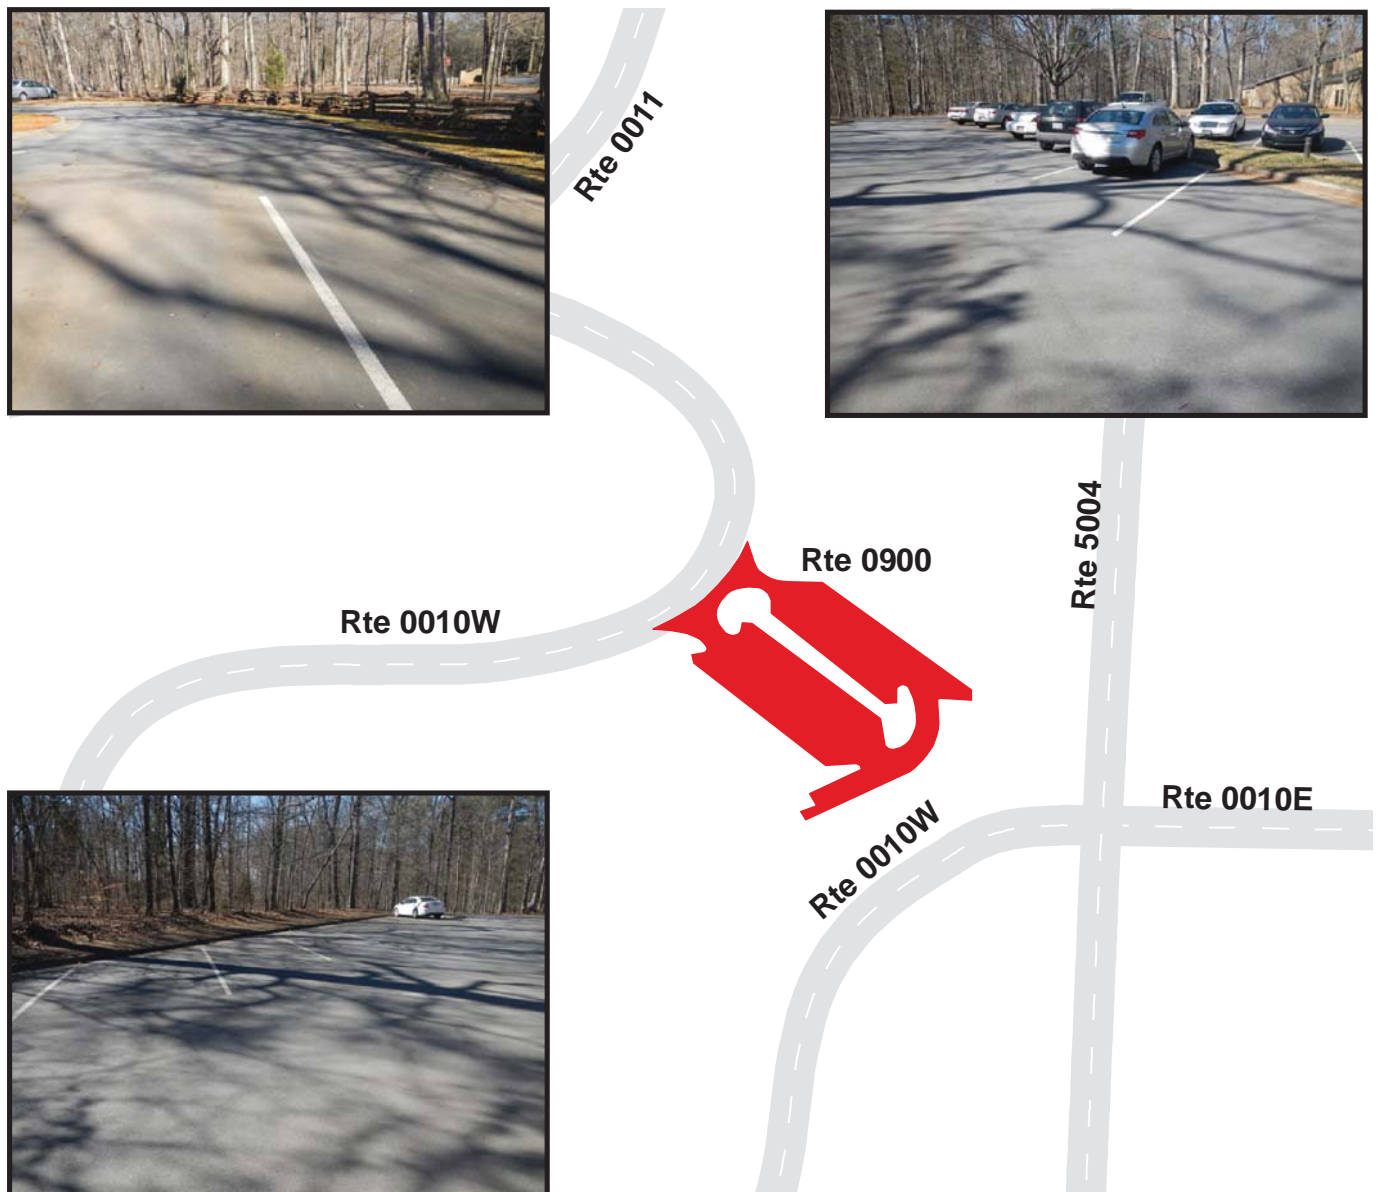
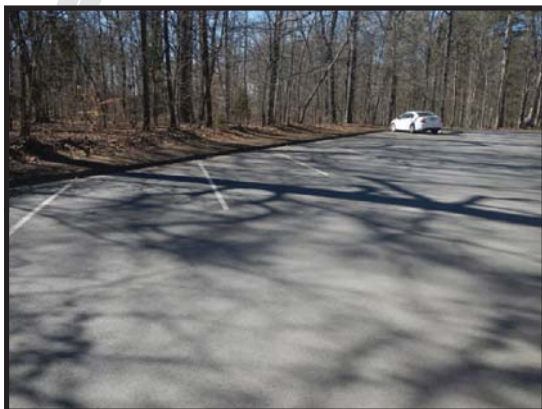
Route Number	Public / NonPublic	Date Visited	Area (sq ft)	Lane Miles *	Surface Type
0900	PUBLIC	2/21/2013	18,576	0.32	AS
Culverts	Drop Inlets	Gates	Curb & Gutter	Curb	PCR
0	3	0	CONCRETE CURB AND GUTTER	NO CURB	GOOD/90

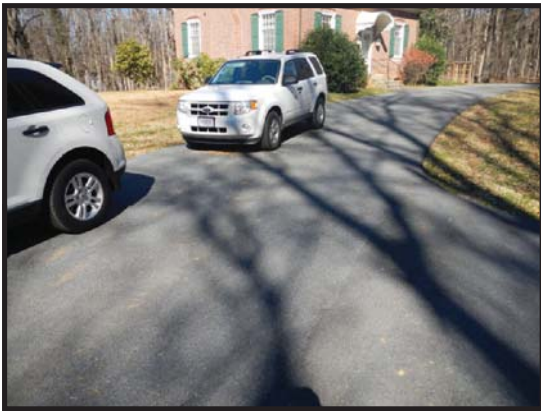
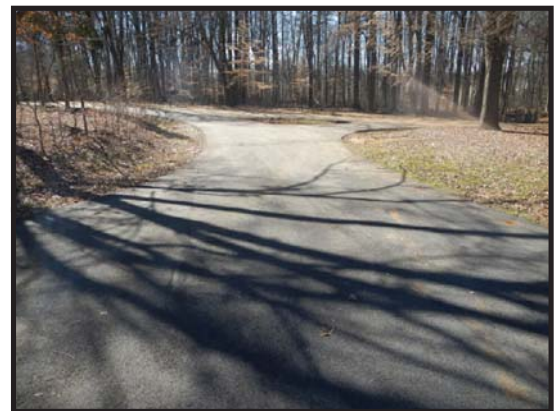
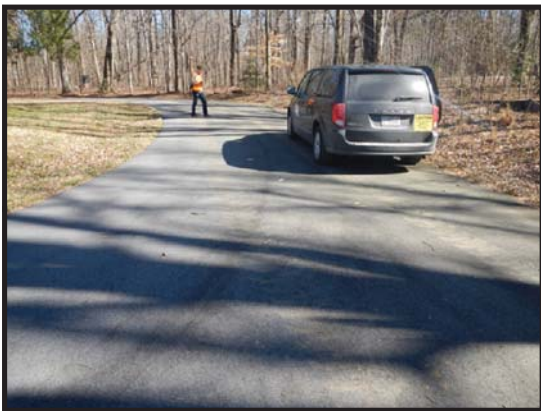
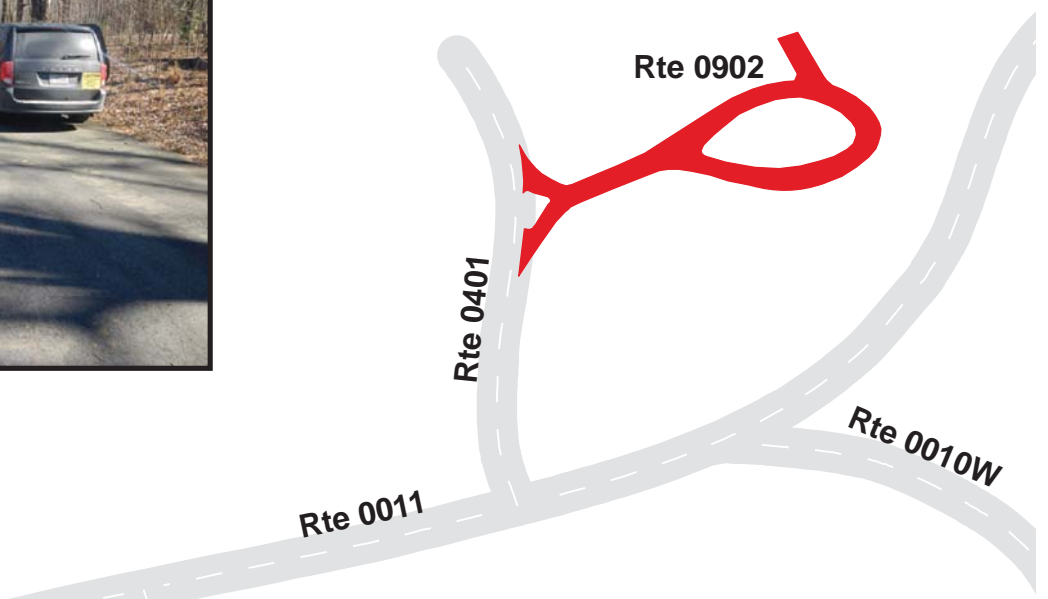
Route 0902

Route Number	Public / NonPublic	Date Visited	Area (sq ft)	Lane Miles *	Surface Type
0902	NONPUBLIC	2/21/2013	8,935	0.15	AS
Culverts	Drop Inlets	Gates	Curb & Gutter	Curb	PCR
0	2	0	NO CURB AND GUTTER	NO CURB	GOOD/90

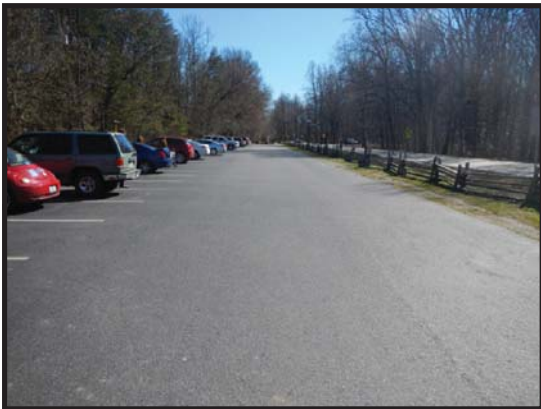
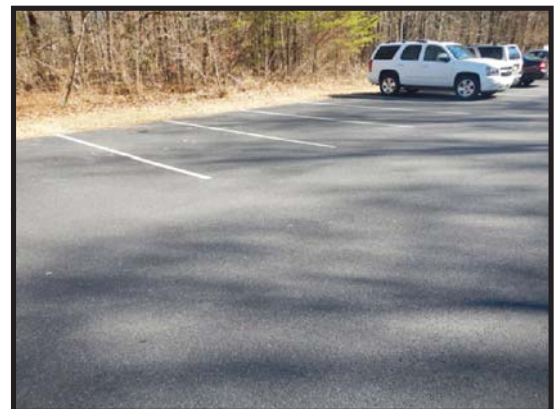
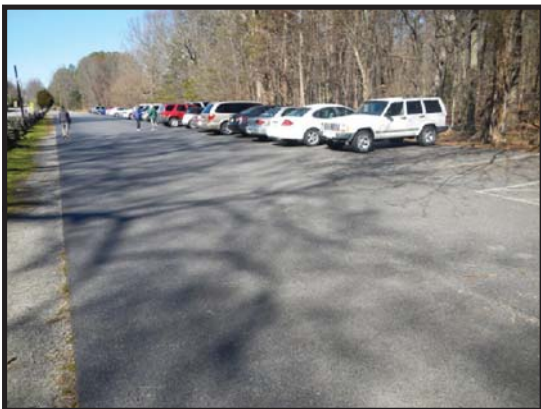
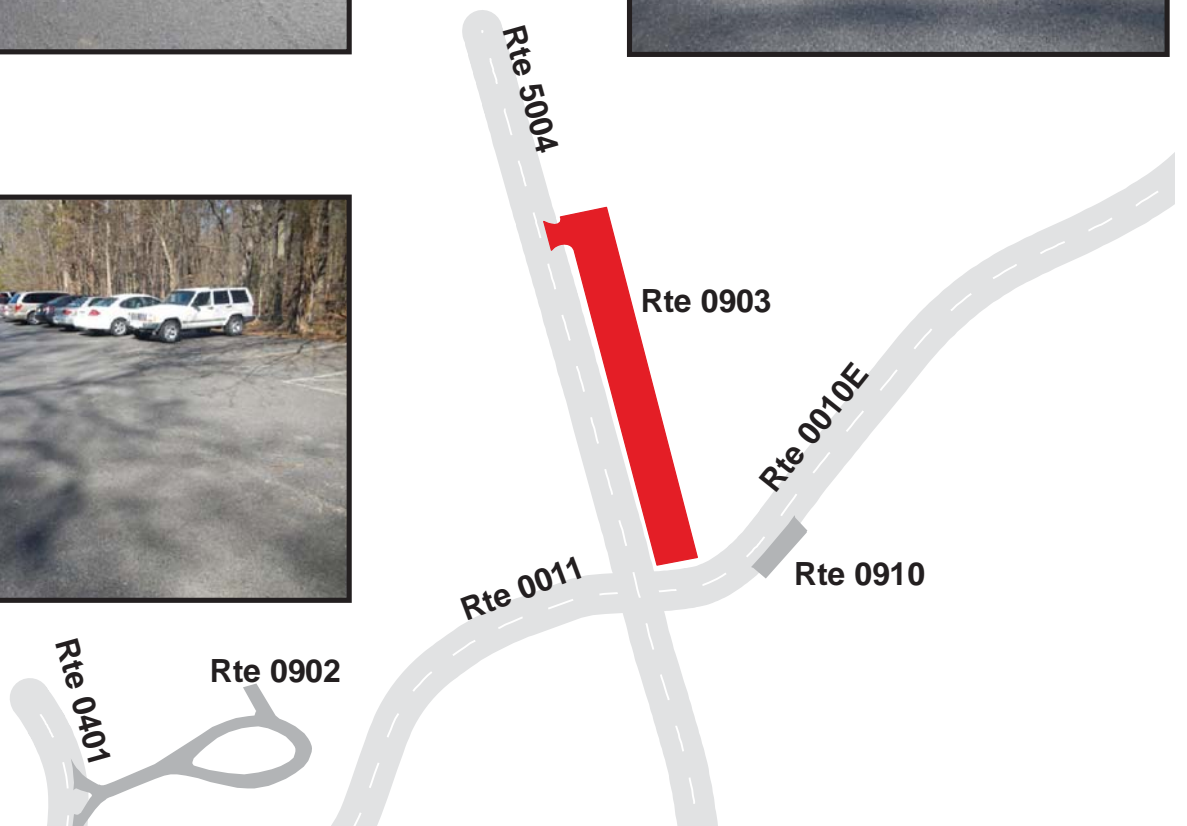
Route 0903

Route Number	Public / NonPublic	Date Visited	Area (sq ft)	Lane Miles *	Surface Type
0903	PUBLIC	2/21/2013	21,341	0.37	AS
Culverts	Drop Inlets	Gates	Curb & Gutter	Curb	PCR
1	0	0	NO CURB AND GUTTER	NO CURB	GOOD/90

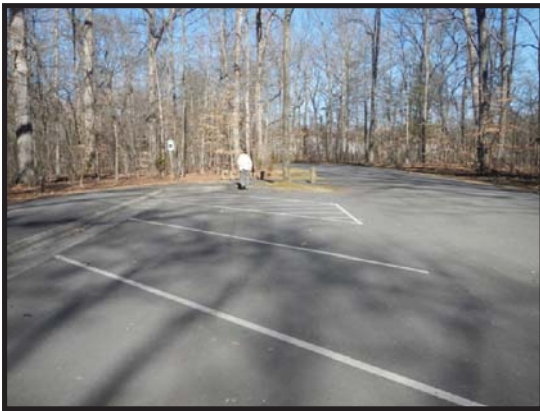
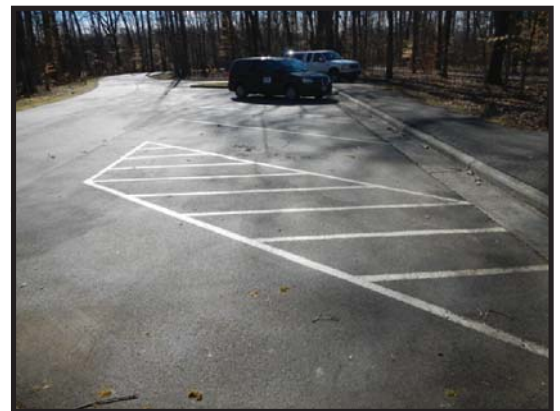
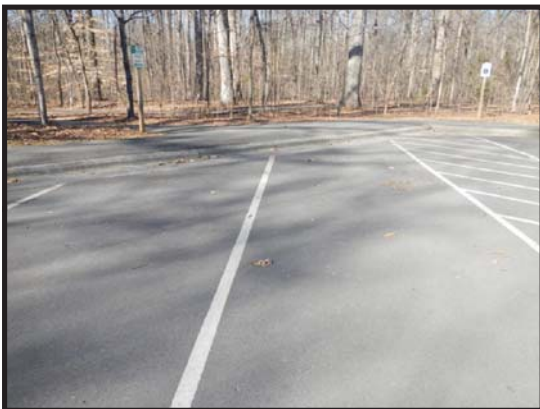
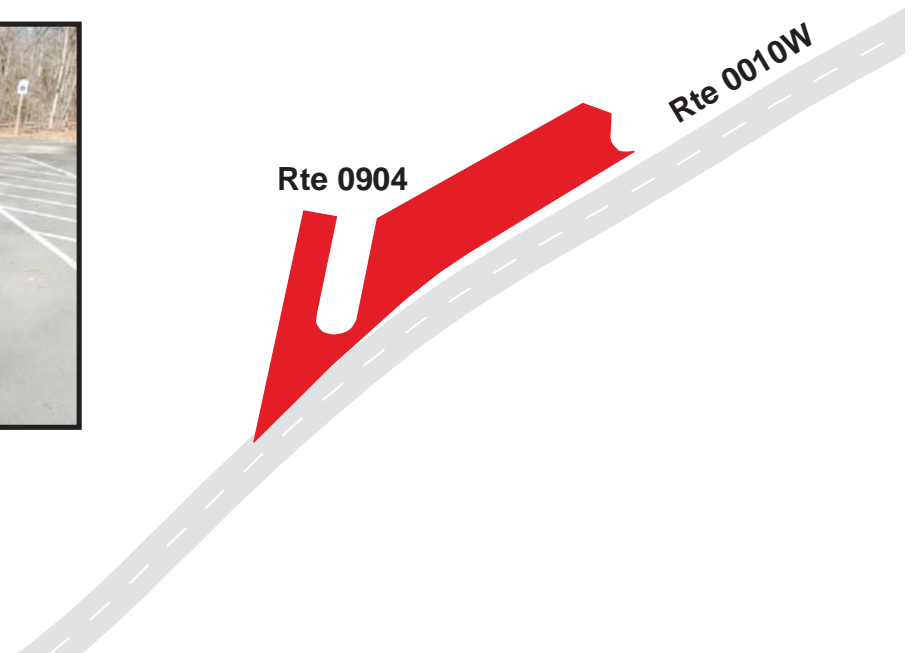
Route 0904

Route Number	Public / NonPublic	Date Visited	Area (sq ft)	Lane Miles *	Surface Type
0904	PUBLIC	2/21/2013	2,920	0.05	AS
Culverts	Drop Inlets	Gates	Curb & Gutter	Curb	PCR
0	0	0	CONCRETE CURB AND GUTTER	NO CURB	GOOD/90

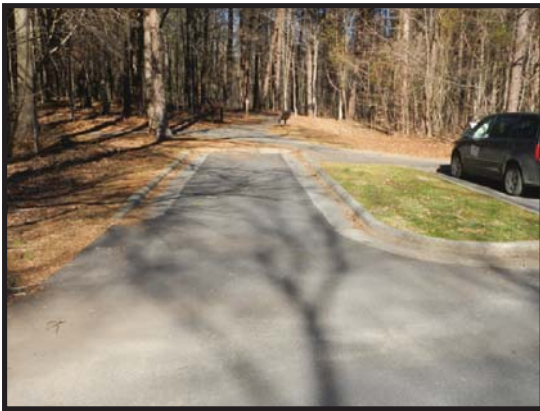
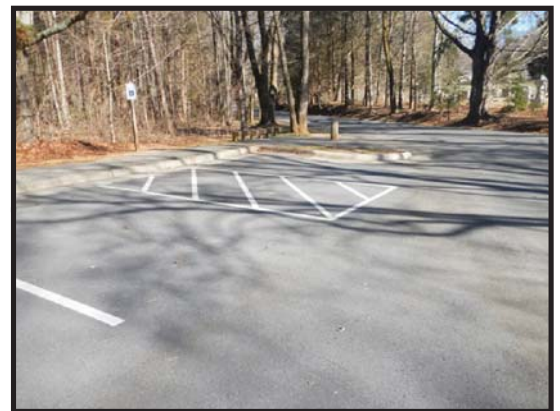
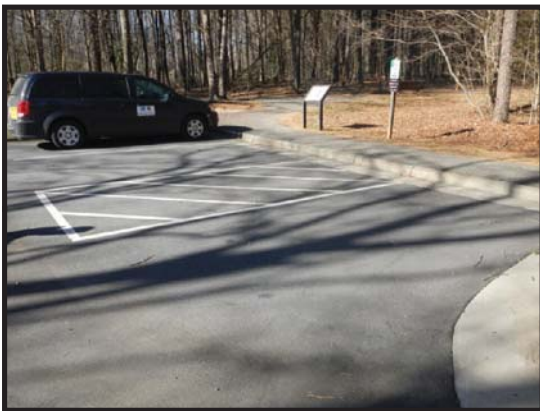
Route 0905

Route Number	Public / NonPublic	Date Visited	Area (sq ft)	Lane Miles *	Surface Type
0905	PUBLIC	2/21/2013	3,163	0.05	AS
Culverts	Drop Inlets	Gates	Curb & Gutter	Curb	PCR
0	0	0	CONCRETE CURB AND GUTTER	NO CURB	GOOD/90

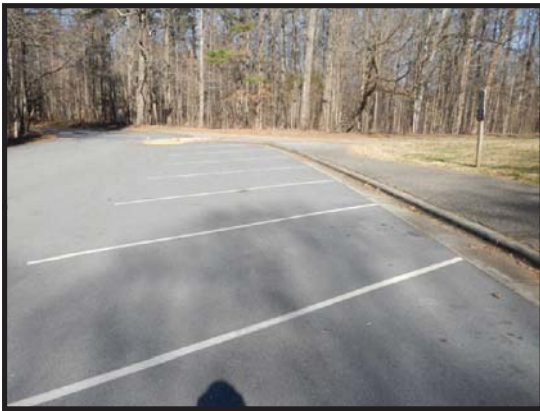
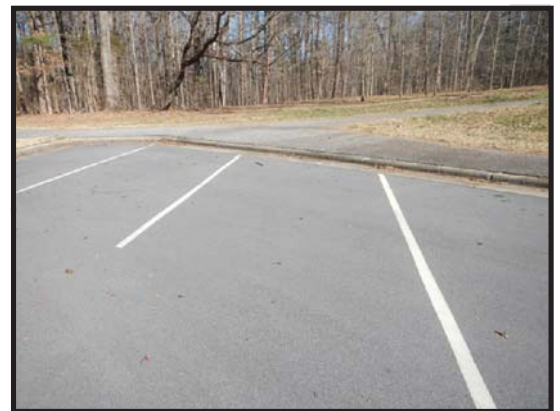
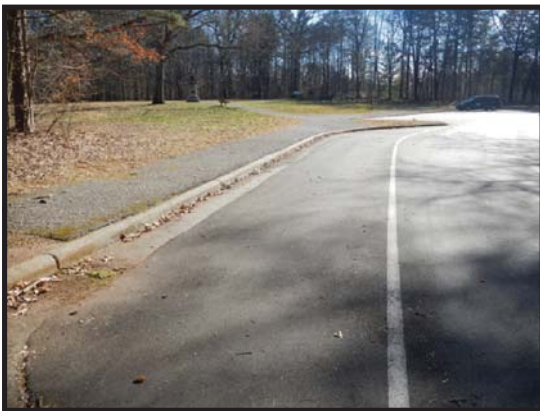
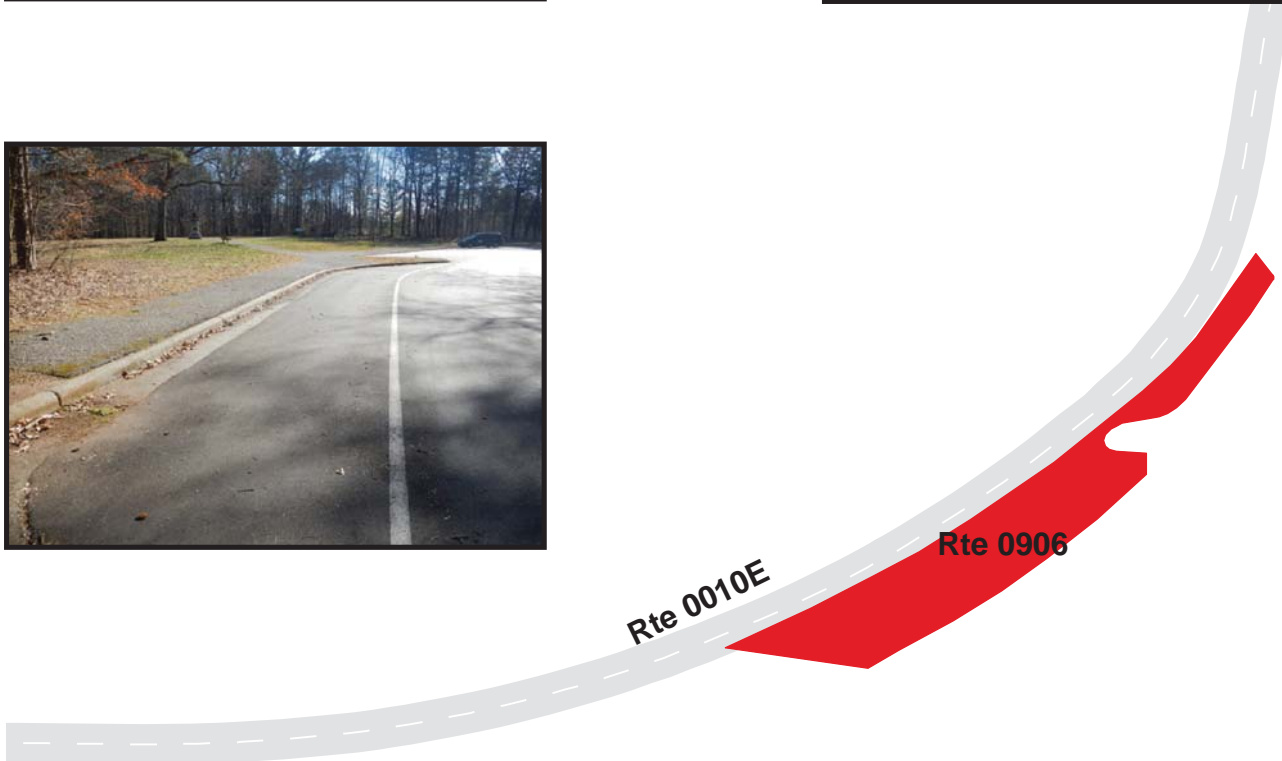
Route Number	Public / NonPublic	Date Visited	Area (sq ft)	Lane Miles *	Surface Type
0906	PUBLIC	2/21/2013	5,457	0.09	AS
Culverts	Drop Inlets	Gates	Curb & Gutter	Curb	PCR
0	0	0	CONCRETE CURB AND GUTTER	NO CURB	GOOD/90

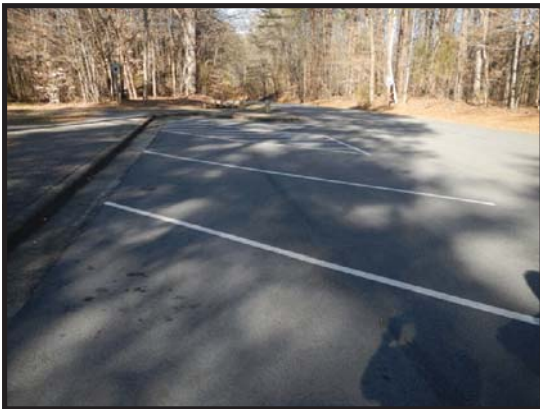
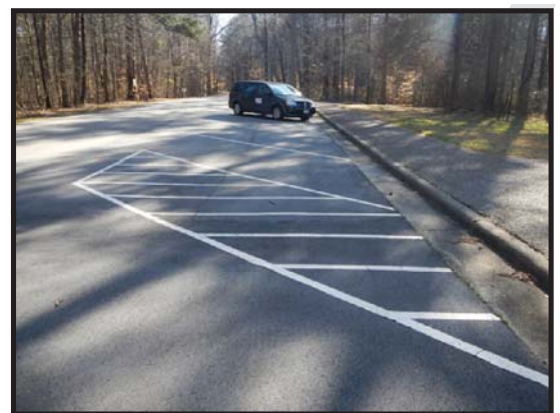
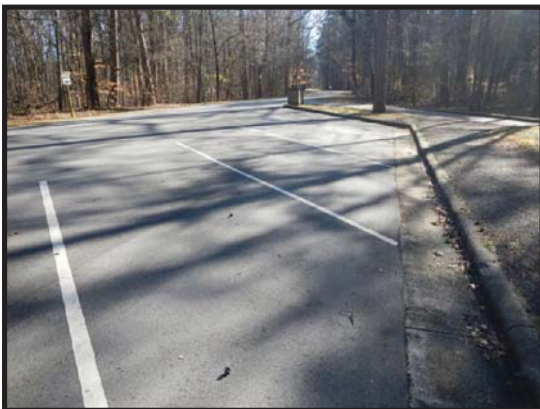
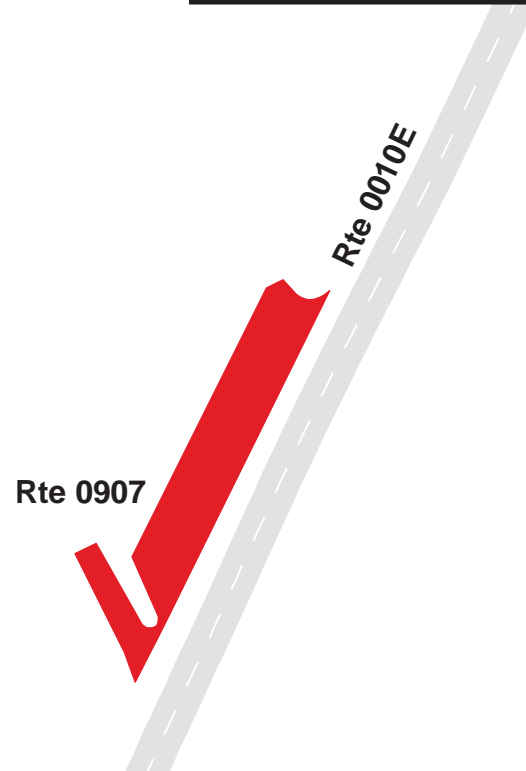
Route 0907

Route Number	Public / NonPublic	Date Visited	Area (sq ft)	Lane Miles *	Surface Type
0907	PUBLIC	2/21/2013	3,563	0.06	AS
Culverts	Drop Inlets	Gates	Curb & Gutter	Curb	PCR
0	0	0	CONCRETE CURB AND GUTTER	NO CURB	GOOD/90

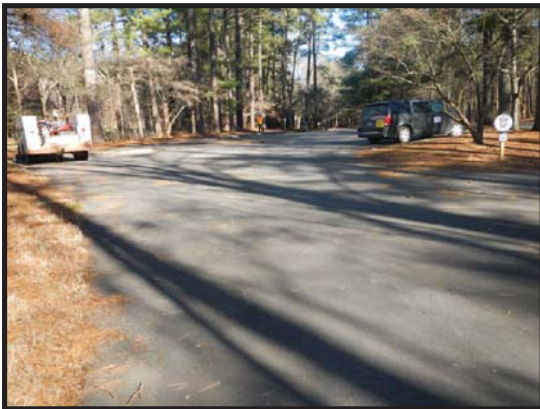
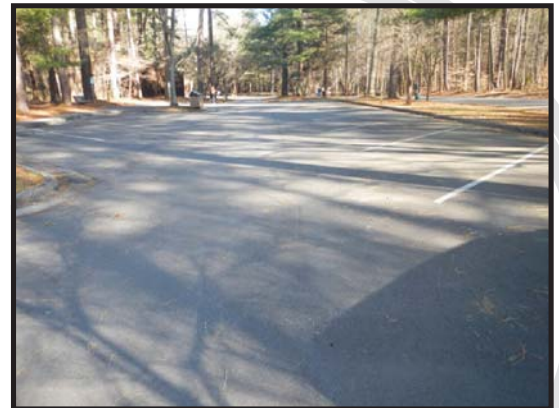
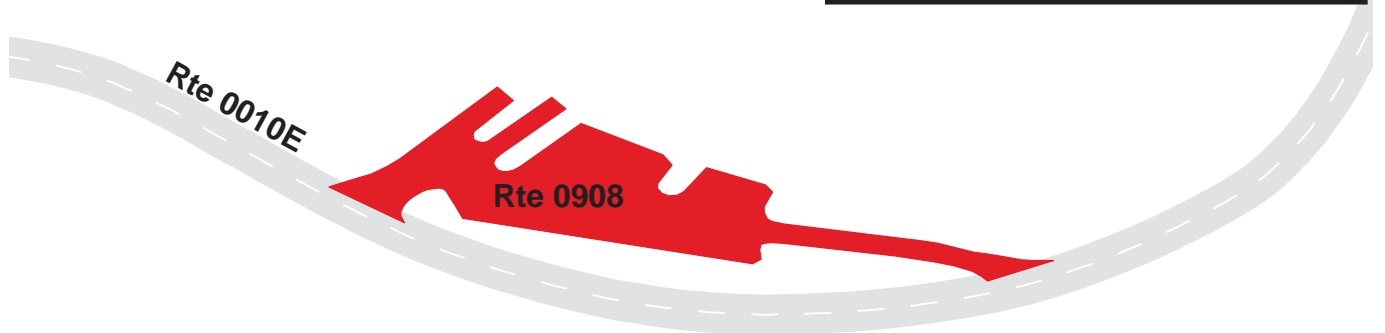
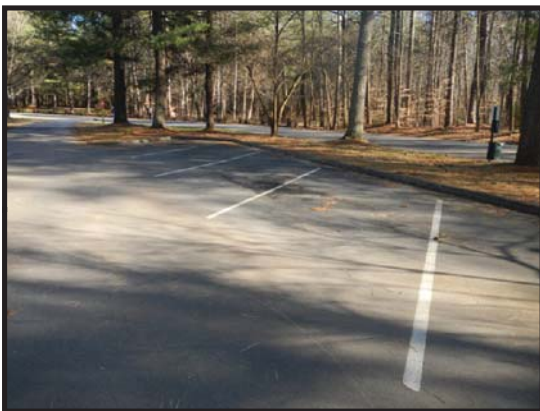
Route 0908

Route Number	Public / NonPublic	Date Visited	Area (sq ft)	Lane Miles *	Surface Type
0908	PUBLIC	2/21/2013	13,452	0.23	AS
Culverts	Drop Inlets	Gates	Curb & Gutter	Curb	PCR
0	0	0	CONCRETE CURB AND GUTTER	NO CURB	GOOD/90

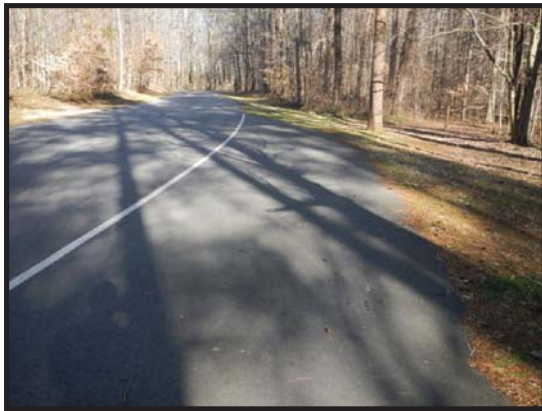
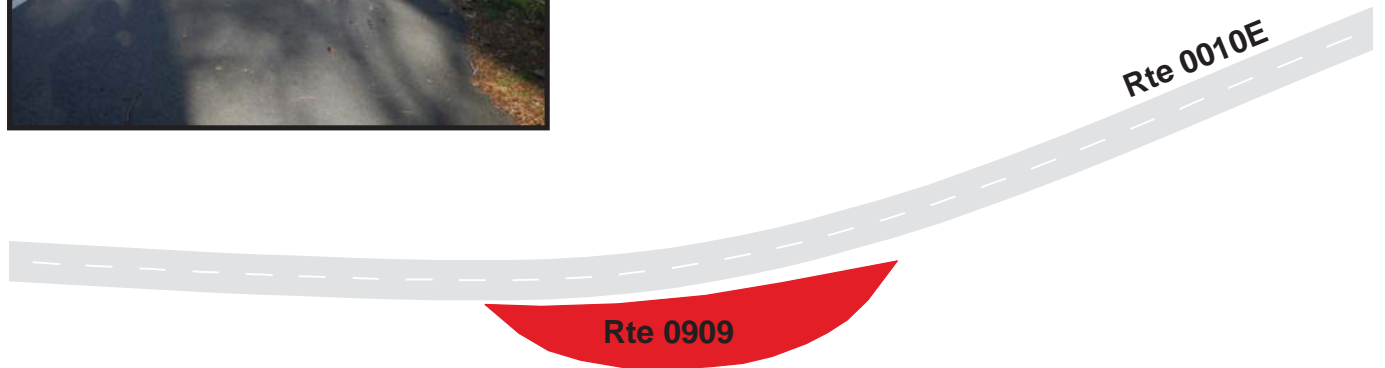
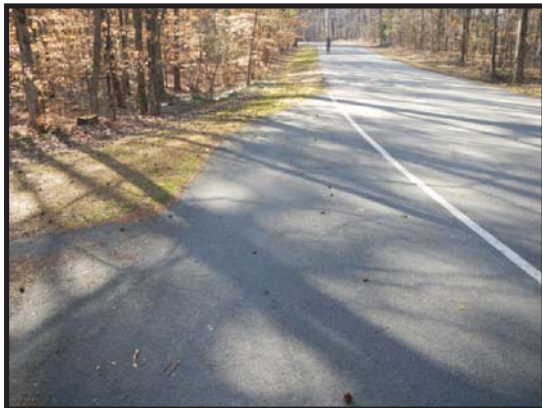
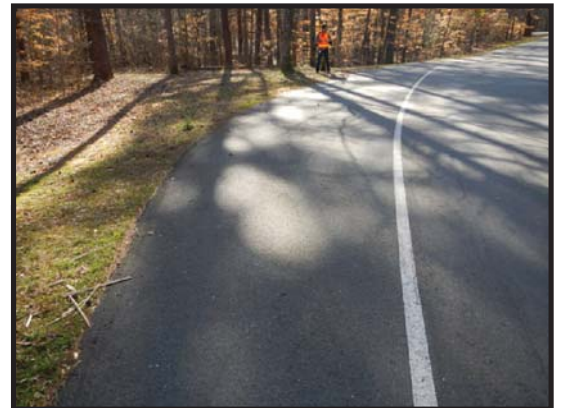
Route 0909

Route Number	Public / NonPublic	Date Visited	Area (sq ft)	Lane Miles *	Surface Type
0909	PUBLIC	2/21/2013	2,164	0.04	AS
Culverts	Drop Inlets	Gates	Curb & Gutter	Curb	PCR
0	0	0	NO CURB AND GUTTER	NO CURB	GOOD/90

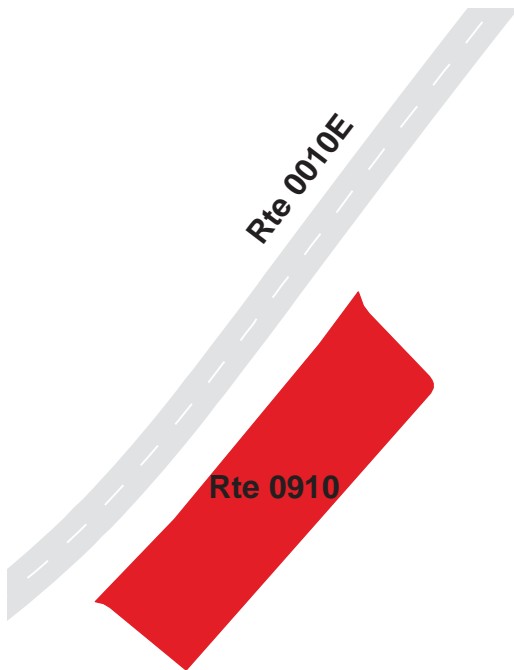
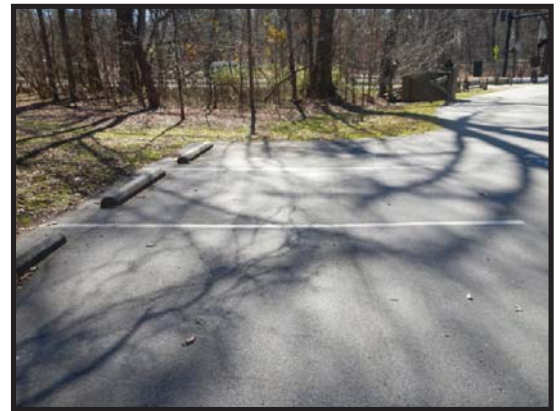
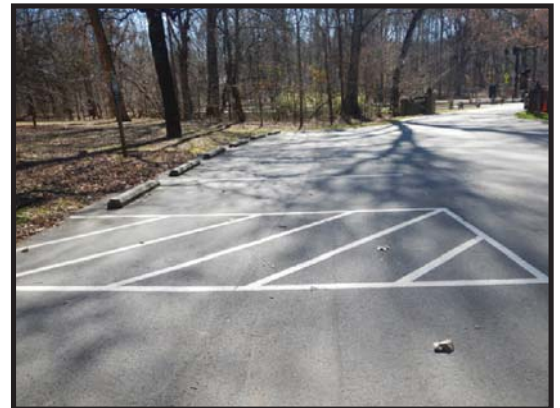
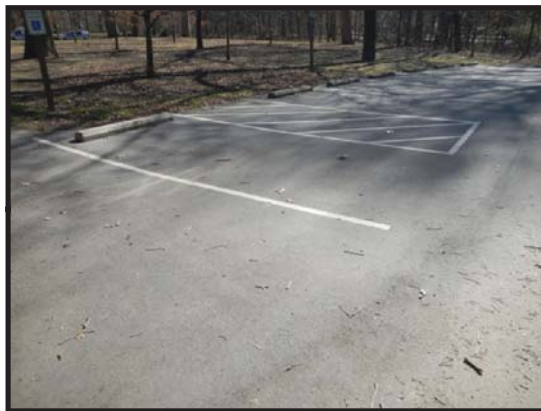
Route 0910

Route Number	Public / NonPublic	Date Visited	Area (sq ft)	Lane Miles *	Surface Type
0910	PUBLIC	2/21/2013	1,659	0.03	AS
Culverts	Drop Inlets	Gates	Curb & Gutter	Curb	PCR
0	0	0	NO CURB AND GUTTER	NO CURB	GOOD/90

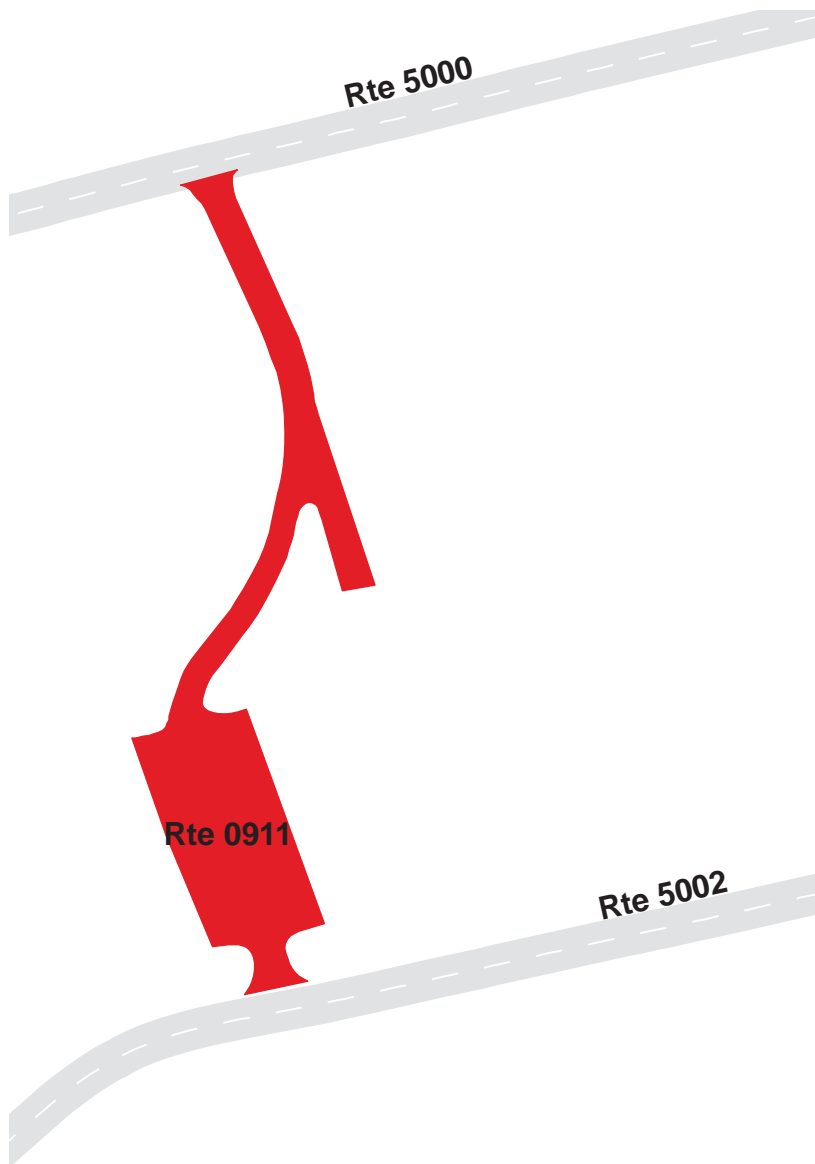
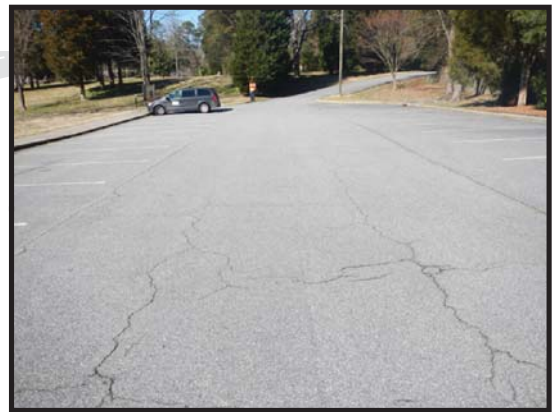
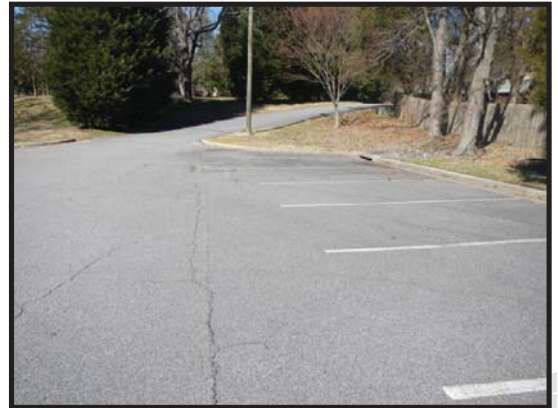
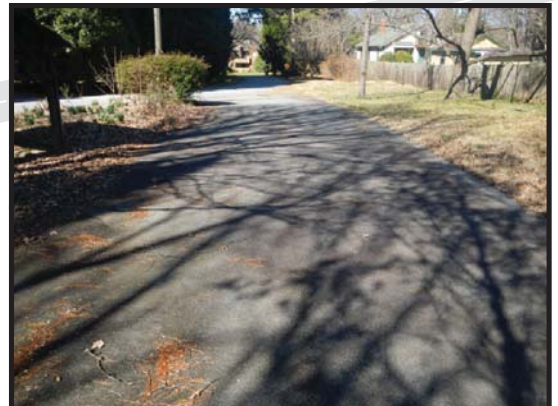
Route 0911

Route Number	Public / NonPublic	Date Visited	Area (sq ft)	Lane Miles *	Surface Type
0911	PUBLIC	2/21/2013	17,312	0.30	AS
Culverts	Drop Inlets	Gates	Curb & Gutter	Curb	PCR
0	2	2	CONCRETE CURB AND GUTTER	WOOD CURB	FAIR/73
