# Federal Lands Highway Road Inventory Program

Road Inventory and Condition Assessment

## Guadalupe Mountains National Park GUMO - 7180

### Cycle 5 Report

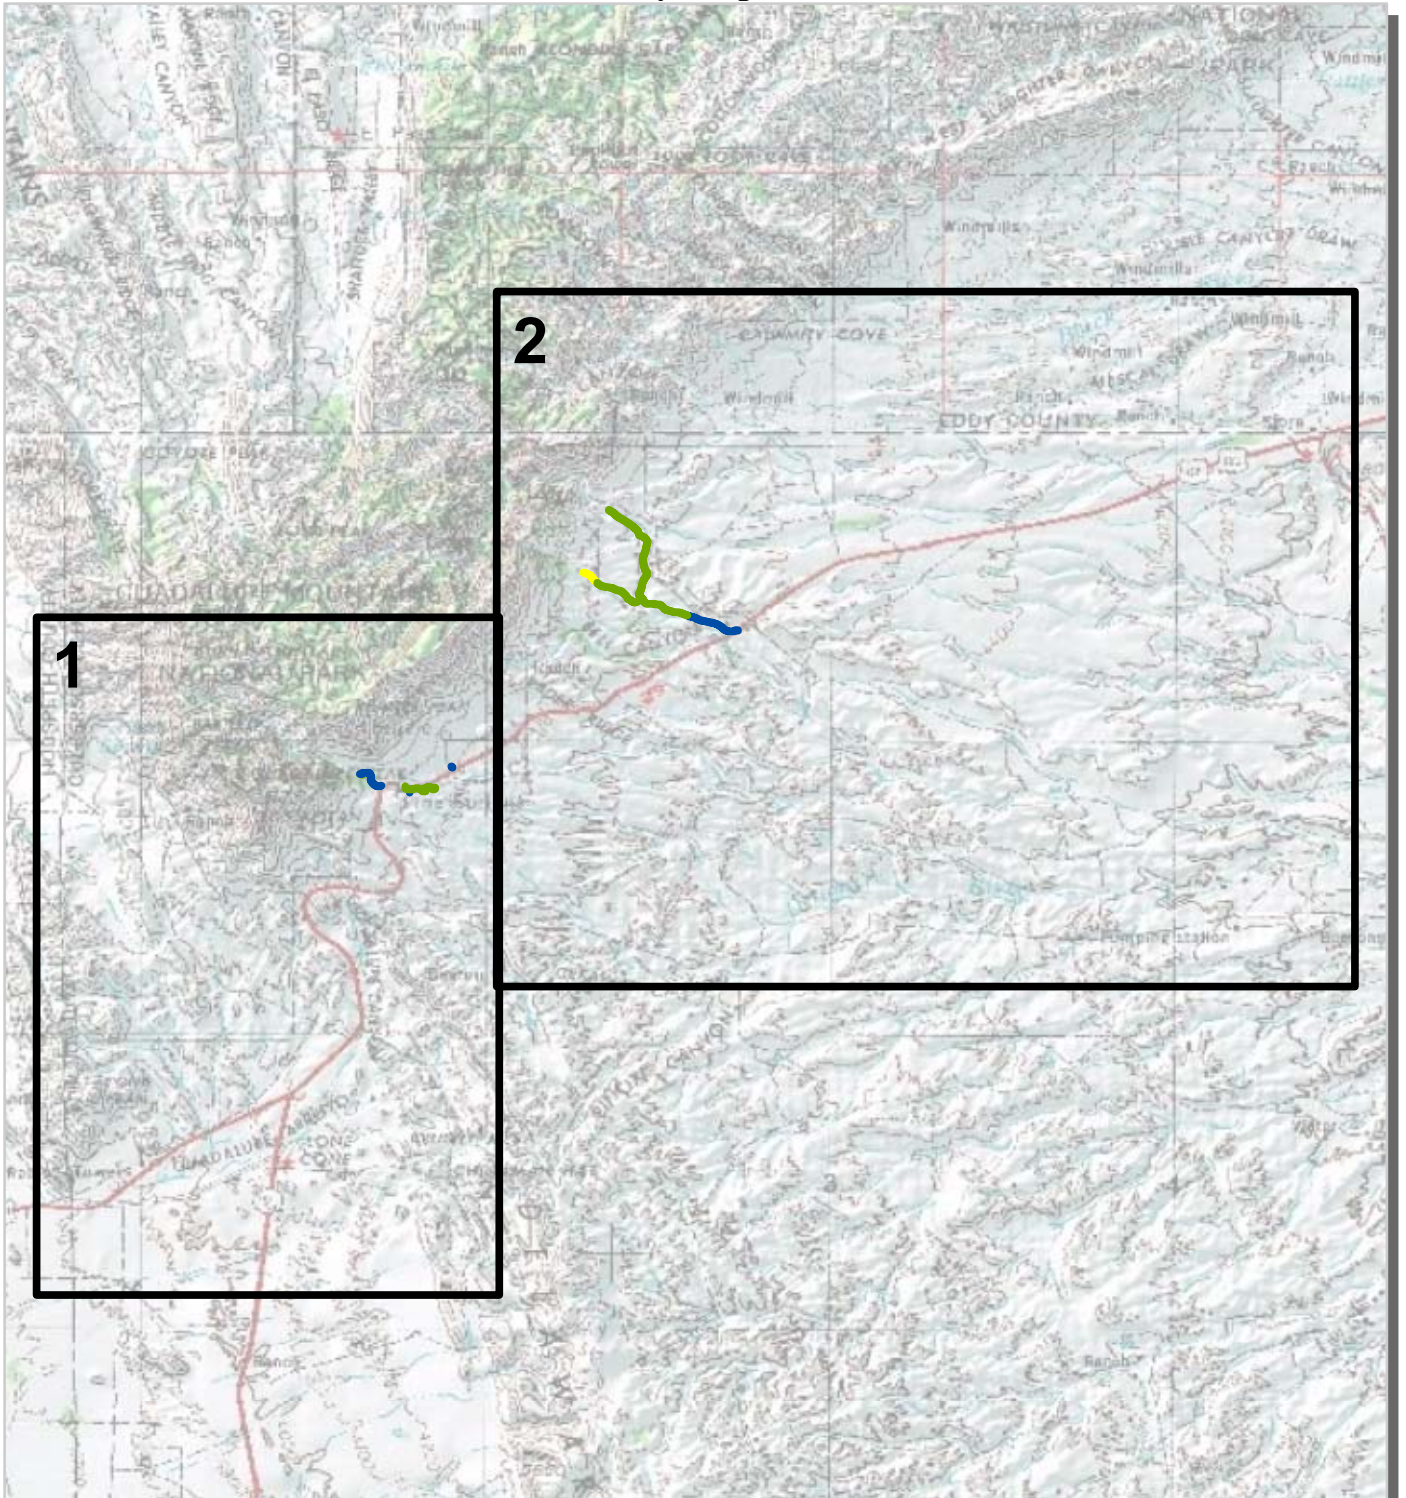
# Guadalupe Mountains National Park Route Condition Map PCR - Mile by Mile Key Map

PCR	Poor	<span style="display: inline-block; width: 15px; height: 15px; background-color: red; border: 1px solid black;"></span>	Fair	<span style="display: inline-block; width: 15px; height: 15px; background-color: yellow; border: 1px solid black;"></span>	Good	<span style="display: inline-block; width: 15px; height: 15px; background-color: green; border: 1px solid black;"></span>	Excellent	<span style="display: inline-block; width: 15px; height: 15px; background-color: blue; border: 1px solid black;"></span>	No Data	<span style="display: inline-block; width: 15px; height: 15px; background-color: black; border: 1px solid black;"></span>
	(0 - 60)		(61 - 84)	(85 - 94)		(95 - 100)

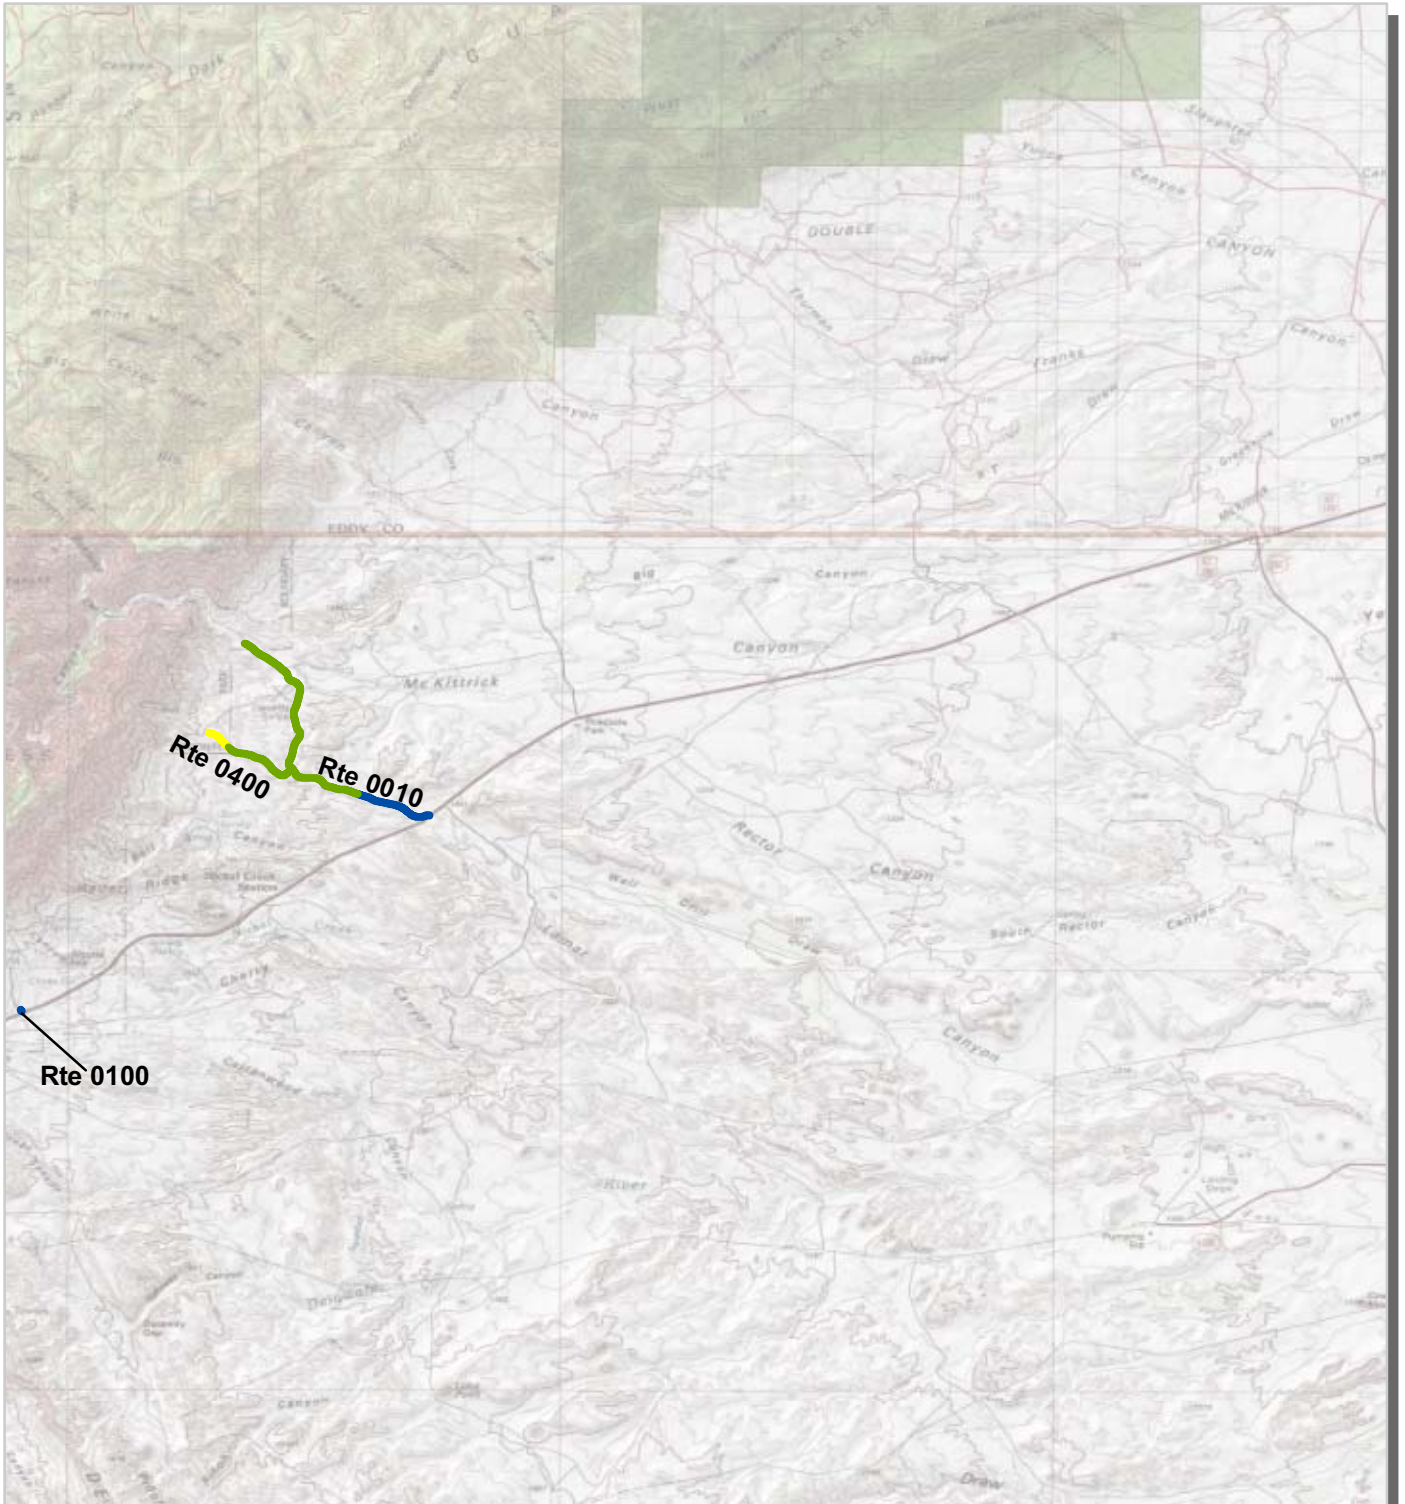
#### Area 2

PCR	Poor	<span style="display: inline-block; width: 15px; height: 15px; background-color: red; border: 1px solid black;"></span>	Fair	<span style="display: inline-block; width: 15px; height: 15px; background-color: yellow; border: 1px solid black;"></span>	Good	<span style="display: inline-block; width: 15px; height: 15px; background-color: green; border: 1px solid black;"></span>	Excellent	<span style="display: inline-block; width: 15px; height: 15px; background-color: blue; border: 1px solid black;"></span>	No Data	<span style="display: inline-block; width: 15px; height: 15px; background-color: black; border: 1px solid black;"></span>
	(0 - 60)		(61 - 84)	(85 - 94)		(95 - 100)

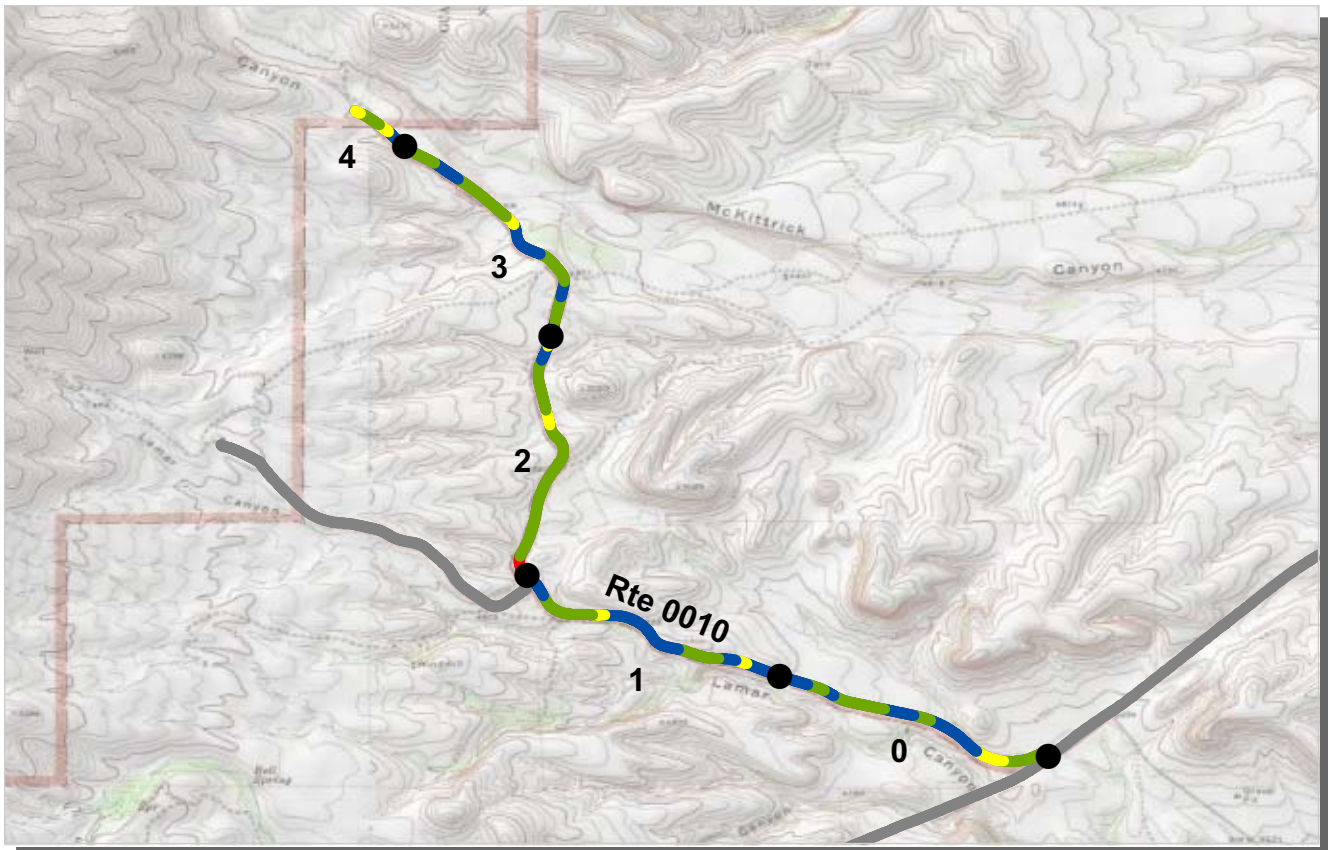
**ROUTE: 0010 MCKITTRICK CANYON ROAD**

<i>Section Number</i>	0	1	2	3	4
<i>Section Length (mi)</i>	1.00	1.00	1.00	1.00	0.22
<i>Cross Section Information</i>					
Number of Lanes	2	2	2	2	2
Paved Width (ft)	23	23	23	23	23
Lane Width (ft)	10	10	10	10	10
<i>Roadway Condition Information</i>					
SCR (Surface Condition Rating)	91	92	91	94	95
PCR (Pavement Condition Rating)	95	94	91	94	85
<i>Distress Index Values</i>					
Structural Crack Index	91	98	94	98	96
Transverse Cracking Index	91	92	92	94	98
Patching Index	100	100	100	100	100
Rutting Index	95	95	91	96	95
Roughness Condition Index (RCI)	100	96	90	94	69

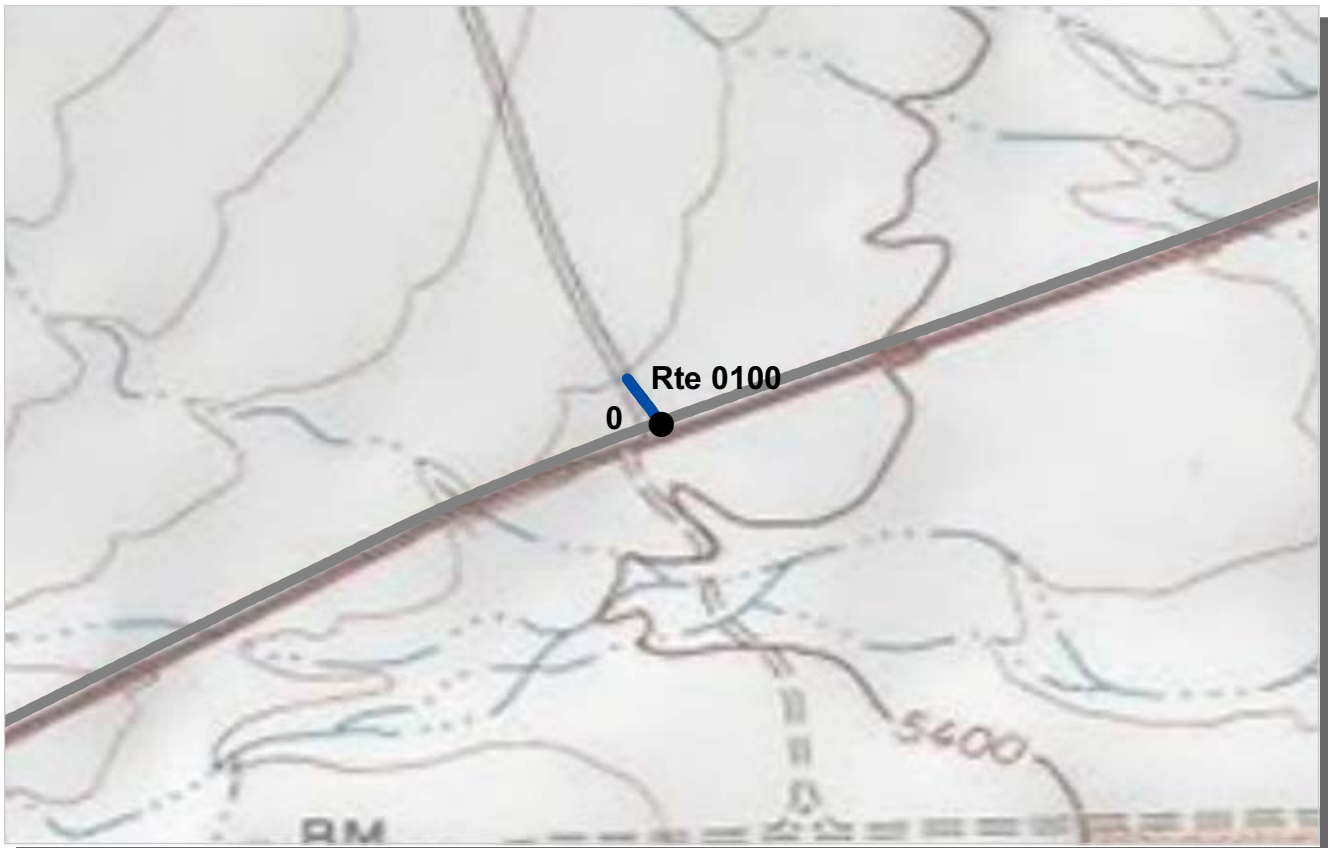
**ROUTE: 0100 FRIJOLE VISITOR CENTER ROAD**

<b>Section Number</b>	0				
<b>Section Length (mi)</b>	0.04				
<b>Cross Section Information</b>					
Number of Lanes	2				
Paved Width (ft)	26				
Lane Width (ft)	13				
<b>Roadway Condition Information</b>					
SCR (Surface Condition Rating)	95				
PCR (Pavement Condition Rating)	95				
<b>Distress Index Values</b>					
Structural Crack Index	99				
Transverse Cracking Index	99				
Patching Index	100				
Rutting Index	95				
Roughness Condition Index (RCI)	NC

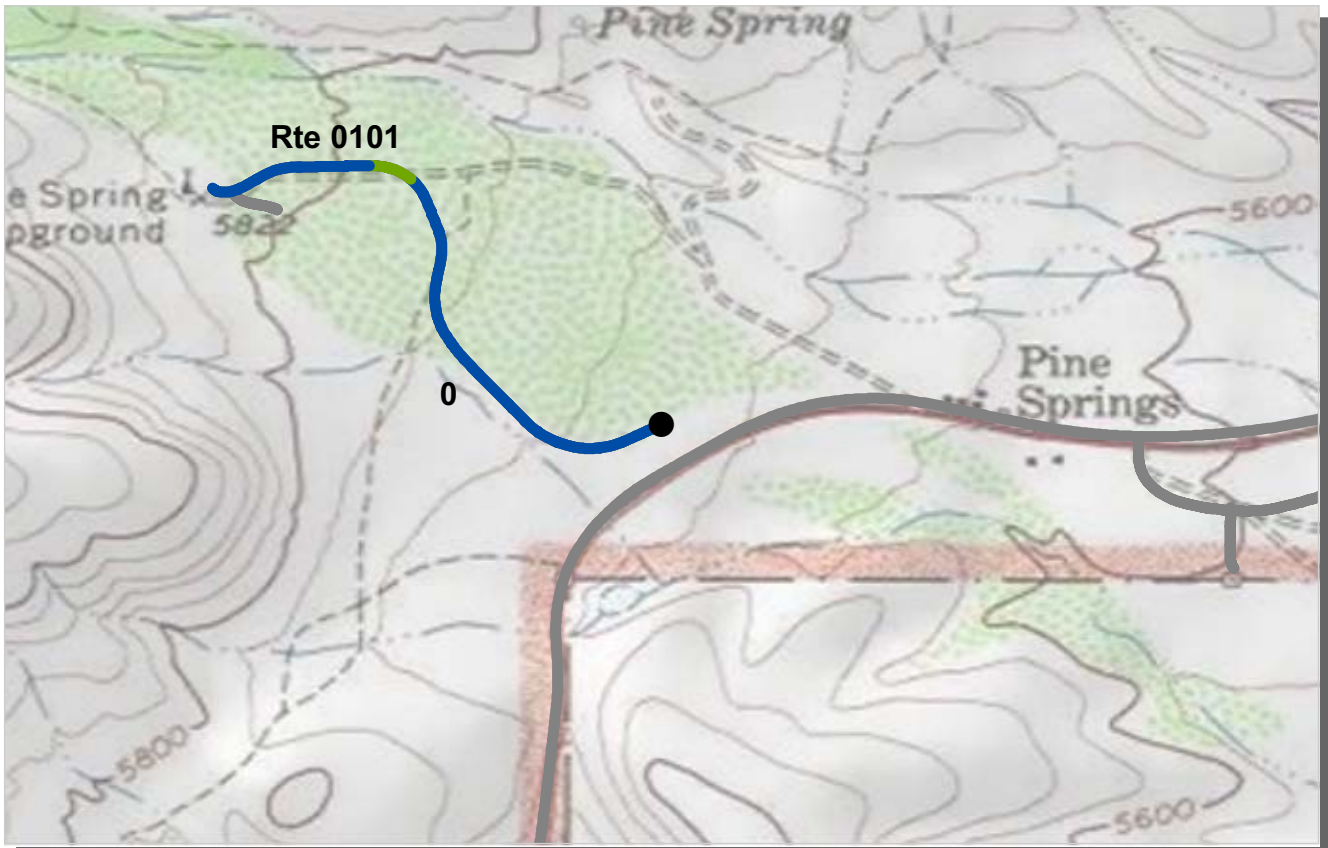
**ROUTE: 0101 PINE CANYON DRIVE**

<b>Section Number</b>	0				
<b>Section Length (mi)</b>	0.61				
<b>Cross Section Information</b>					
Number of Lanes	2				
Paved Width (ft)	23				
Lane Width (ft)	10				
<b>Roadway Condition Information</b>					
SCR (Surface Condition Rating)	99				
PCR (Pavement Condition Rating)	96				
<b>Distress Index Values</b>					
Structural Crack Index	100				
Transverse Cracking Index	100				
Patching Index	99				
Rutting Index	99				
Roughness Condition Index (RCI)	92

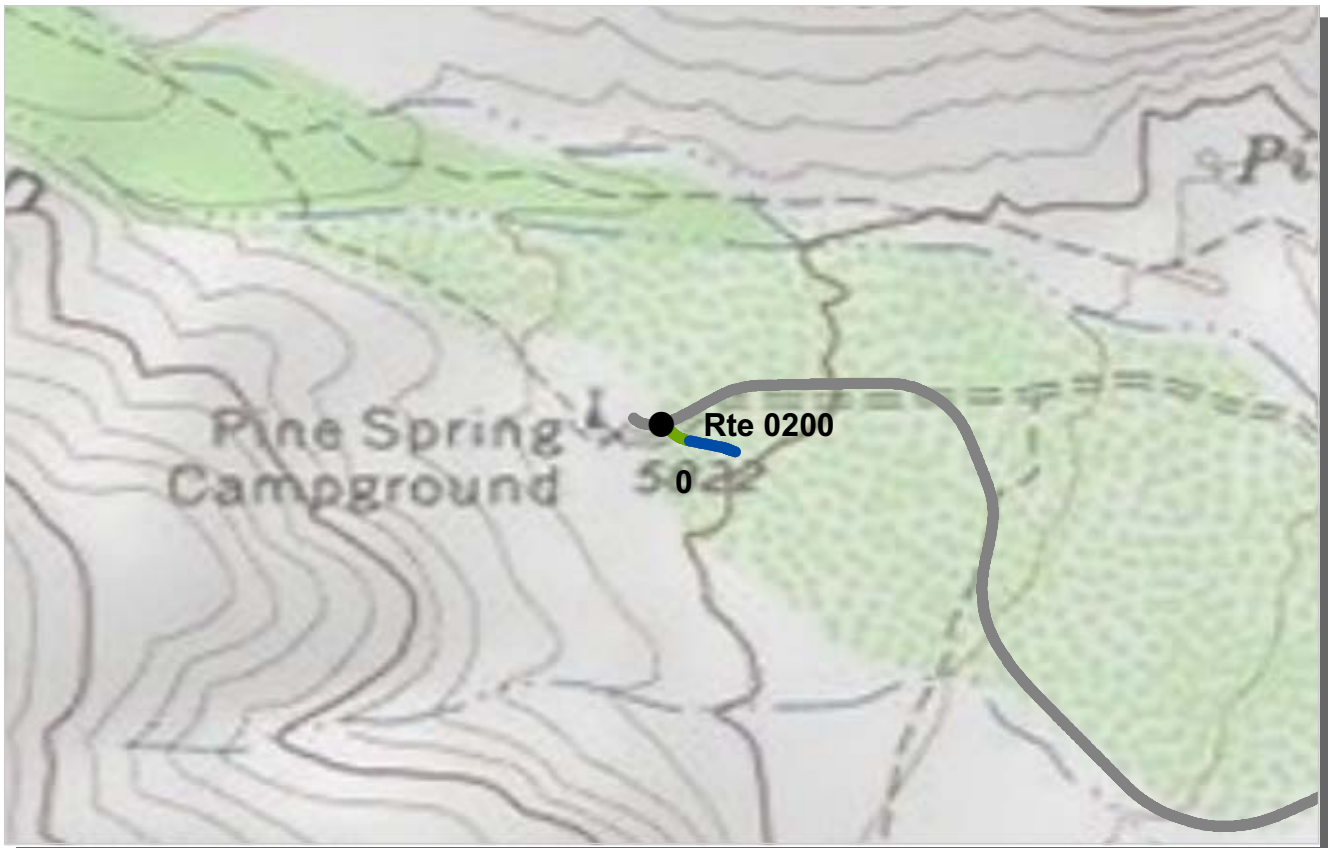
**ROUTE: 0200 PINE SPRINGS CAR CAMPGROUND**

<b>Section Number</b>	0				
<b>Section Length (mi)</b>	0.05				
<b>Cross Section Information</b>					
Number of Lanes	2				
Paved Width (ft)	23				
Lane Width (ft)	10				
<b>Roadway Condition Information</b>					
SCR (Surface Condition Rating)	94				
PCR (Pavement Condition Rating)	94				
<b>Distress Index Values</b>					
Structural Crack Index	100				
Transverse Cracking Index	100				
Patching Index	100				
Rutting Index	94				
Roughness Condition Index (RCI)	NC

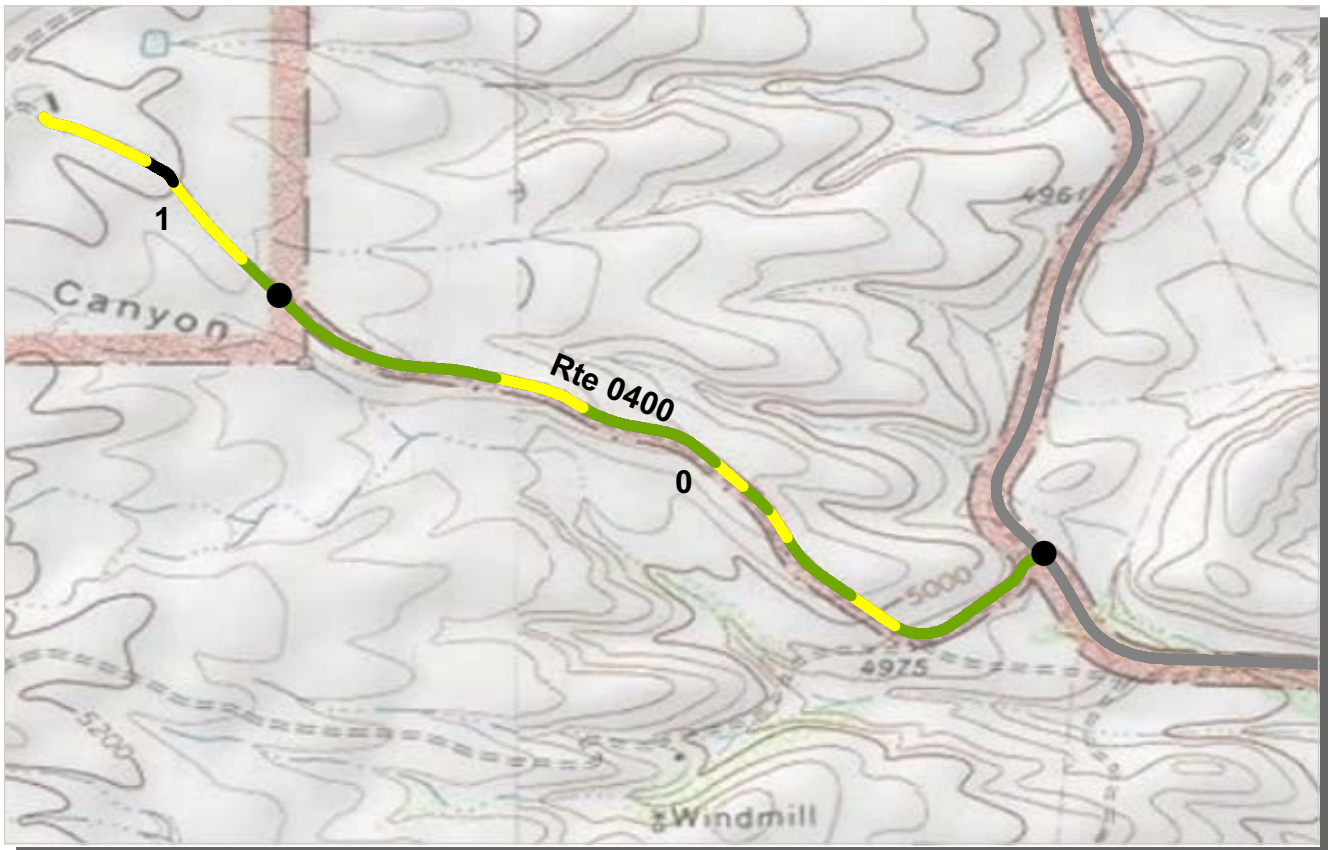
**ROUTE: 0400 PRATT DRIVE**

<i>Section Number</i>	0	1			
<i>Section Length (mi)</i>	1.00	0.34			
<i>Cross Section Information</i>					
Number of Lanes	2	2			
Paved Width (ft)	16	17			
Lane Width (ft)	8	8			
<i>Roadway Condition Information</i>					
SCR (Surface Condition Rating)	92	91			
PCR (Pavement Condition Rating)	86	80			
<i>Distress Index Values</i>					
Structural Crack Index	94	94			
Transverse Cracking Index	92	93			
Patching Index	100	100			
Rutting Index	92	91			
Roughness Condition Index (RCI)	78	64

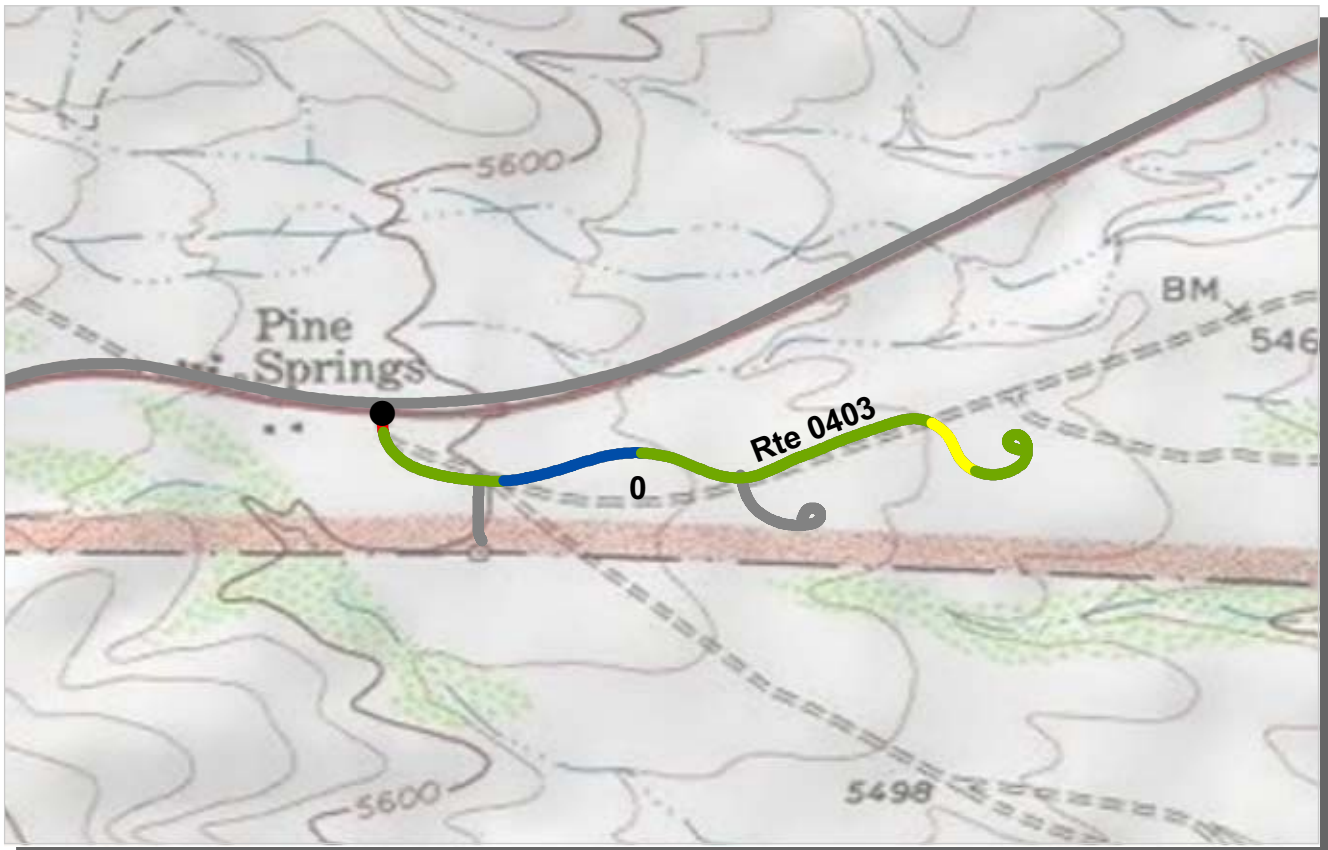
**ROUTE: 0403 PARK VIEW DRIVE**

<b>Section Number</b>	0				
<b>Section Length (mi)</b>	0.68				
<b>Cross Section Information</b>					
Number of Lanes	2				
Paved Width (ft)	21				
Lane Width (ft)	10				
<b>Roadway Condition Information</b>					
SCR (Surface Condition Rating)	92				
PCR (Pavement Condition Rating)	90				
<b>Distress Index Values</b>					
Structural Crack Index	94				
Transverse Cracking Index	98				
Patching Index	100				
Rutting Index	92				
Roughness Condition Index (RCI)	86

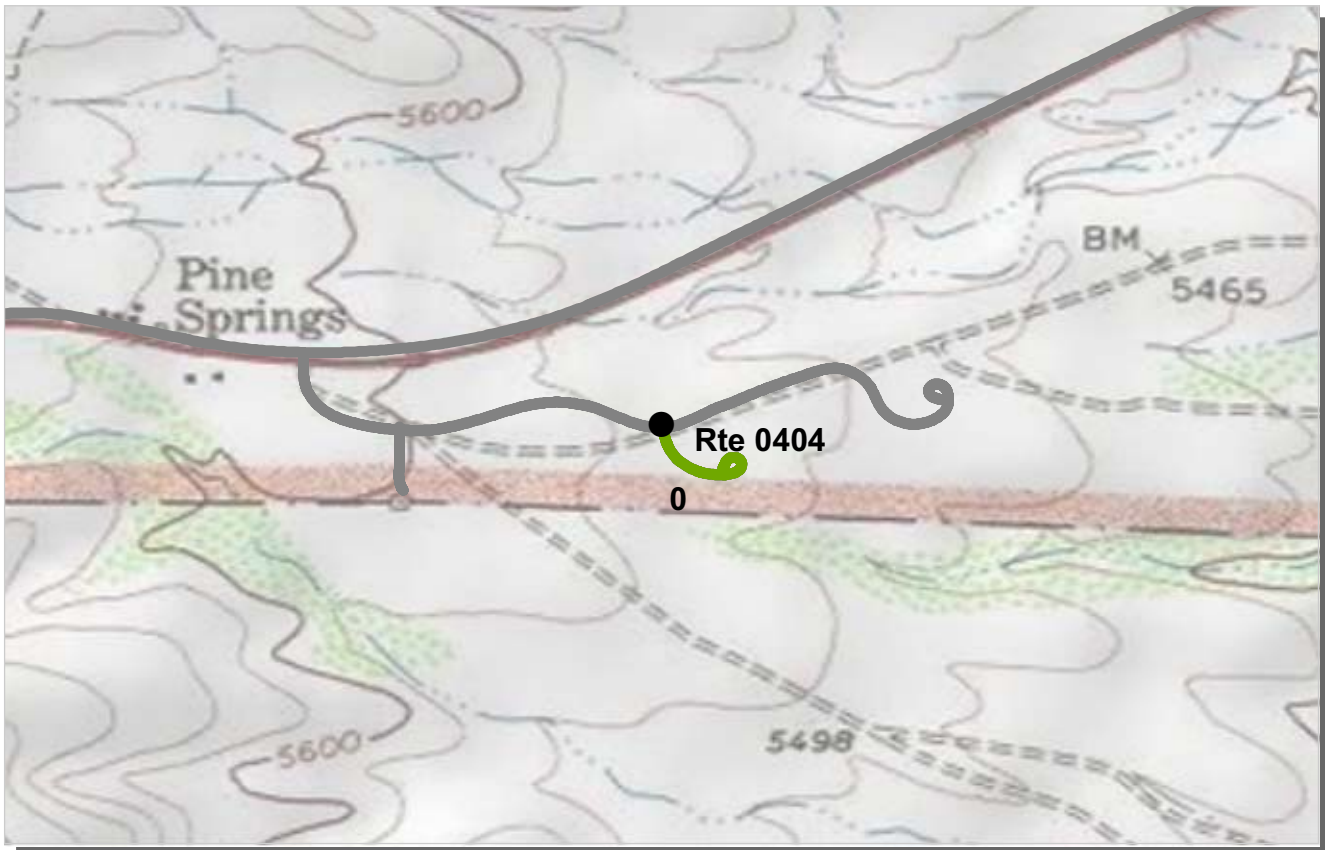
**ROUTE: 0404 BEAR CANYON VISTA**

<b>Section Number</b>	0				
<b>Section Length (mi)</b>	0.12				
<b>Cross Section Information</b>					
Number of Lanes	2				
Paved Width (ft)	21				
Lane Width (ft)	11				
<b>Roadway Condition Information</b>					
SCR (Surface Condition Rating)	90				
PCR (Pavement Condition Rating)	90				
<b>Distress Index Values</b>					
Structural Crack Index	92				
Transverse Cracking Index	97				
Patching Index	100				
Rutting Index	90				
Roughness Condition Index (RCI)	NC

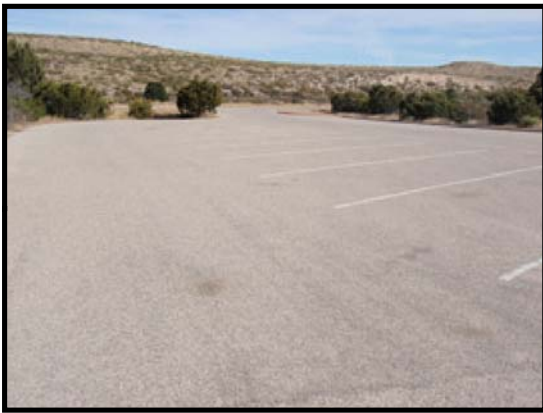
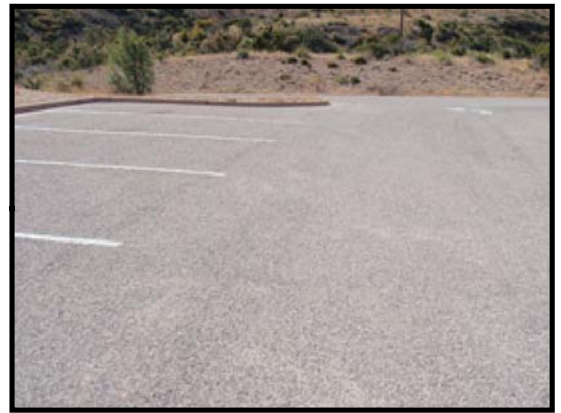
Route Number	Public / NonPublic	Date Visited	Area (sq ft)	Lane Miles *	Surface Type
0900	PUBLIC	12/3/2010	53,036	0.91	AS
Culverts	Drop Inlets	Gates	Curb & Gutter	Curb	PCR
1	2	0	CONCRETE CURB AND GUTTER	NO CURB	FAIR/73

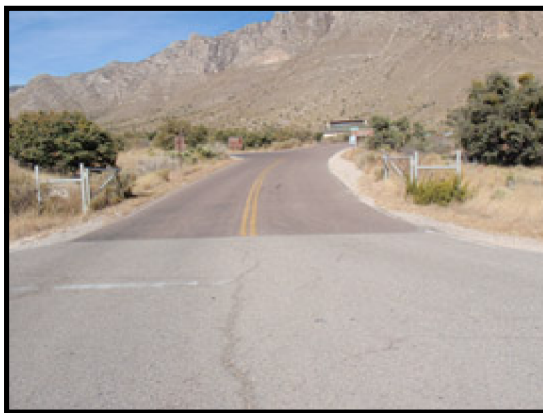
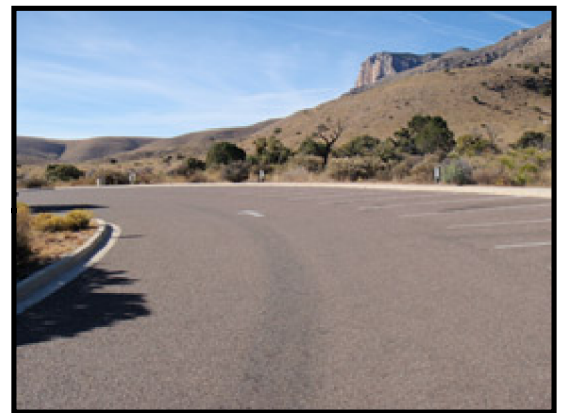
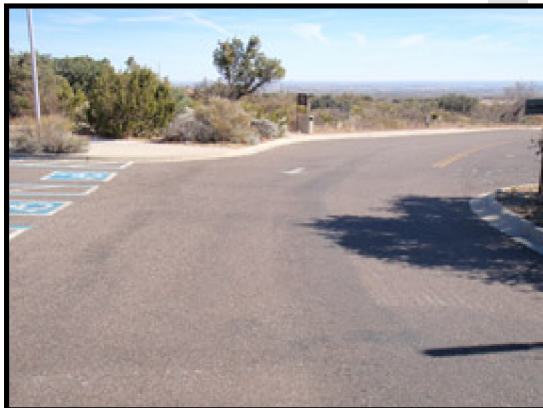
## Route 0903

Route Number	Public / NonPublic	Date Visited	Area (sq ft)	Lane Miles *	Surface Type
0903	PUBLIC	12/3/2010	69,274	1.19	AS
Culverts	Drop Inlets	Gates	Curb & Gutter	Curb	PCR
0	0	1	CONCRETE CURB AND GUTTER	NO CURB	FAIR/73

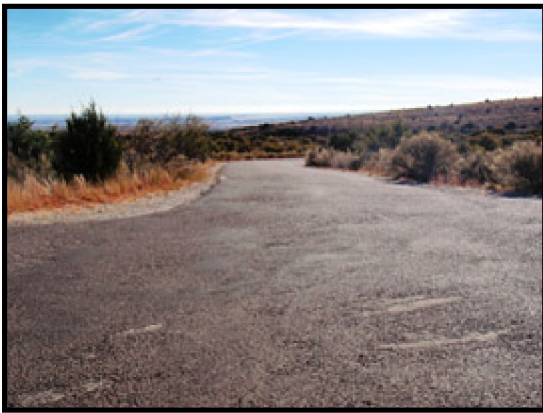
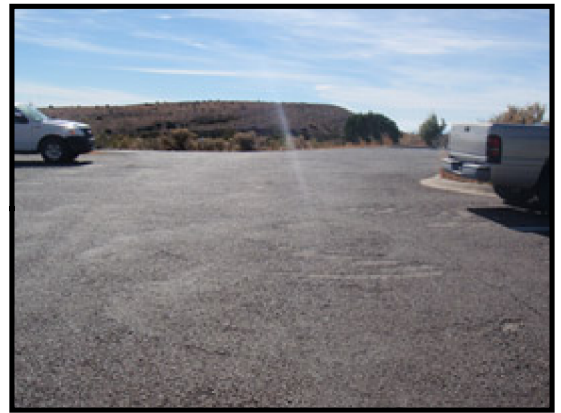
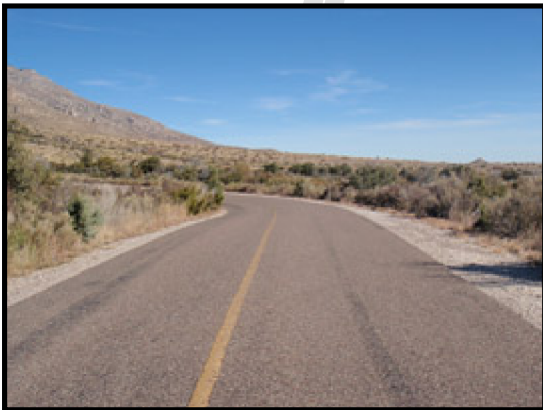
## Route 0904

Route Number	Public / NonPublic	Date Visited	Area (sq ft)	Lane Miles *	Surface Type
0904	NONPUBLIC	12/3/2010	14,035	0.24	AS
Culverts	Drop Inlets	Gates	Curb & Gutter	Curb	PCR
0	0	0	CONCRETE CURB AND GUTTER	NO CURB	POOR/45

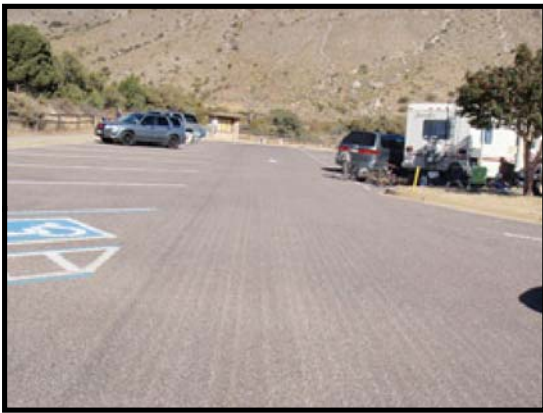
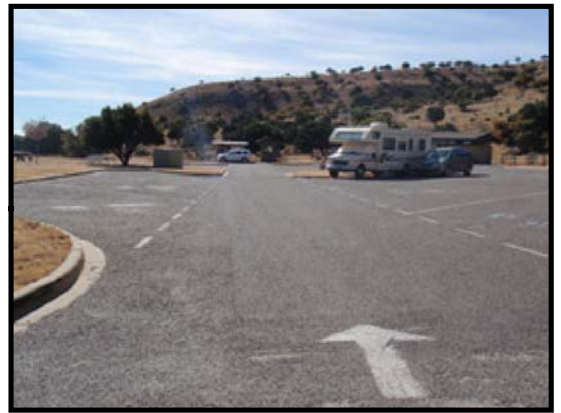
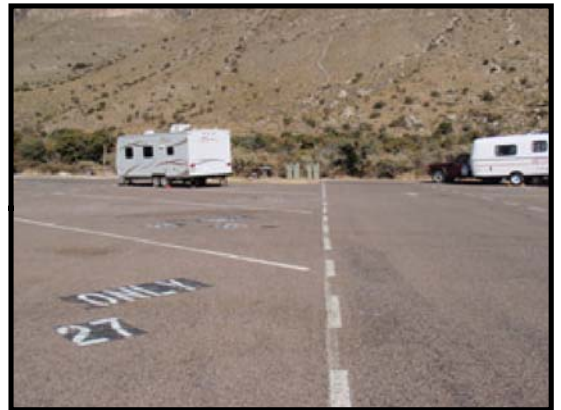
Route Number	Public / NonPublic	Date Visited	Area (sq ft)	Lane Miles *	Surface Type
0905	PUBLIC	12/3/2010	45,476	0.78	AS
Culverts	Drop Inlets	Gates	Curb & Gutter	Curb	PCR
0	1	0	CONCRETE CURB AND GUTTER	NO CURB	FAIR/73

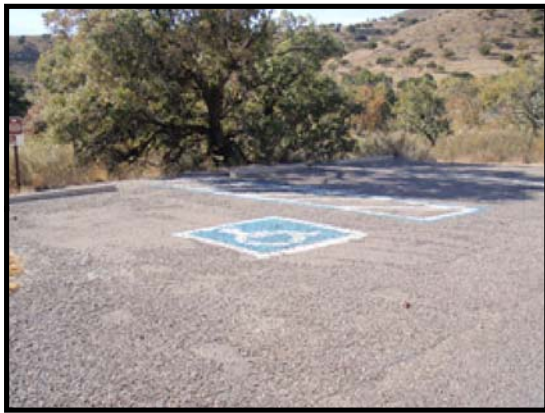
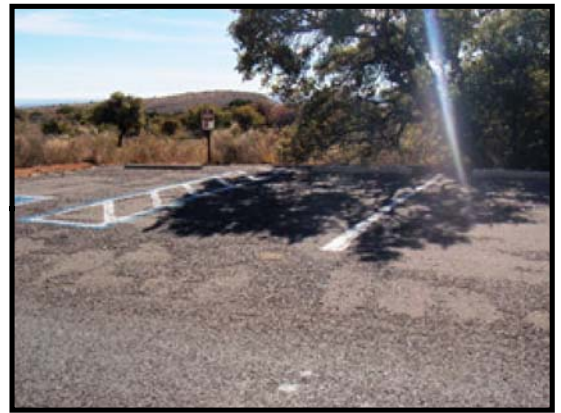
## Route 0906

Route Number	Public / NonPublic	Date Visited	Area (sq ft)	Lane Miles *	Surface Type
0906	PUBLIC	12/3/2010	972	0.02	AS
Culverts	Drop Inlets	Gates	Curb & Gutter	Curb	PCR
0	0	0	NO CURB AND GUTTER	NO CURB	POOR/45

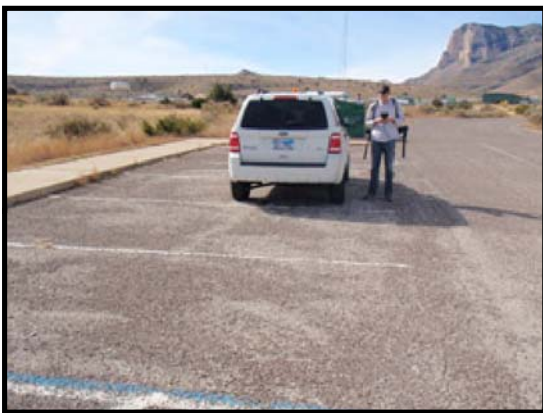
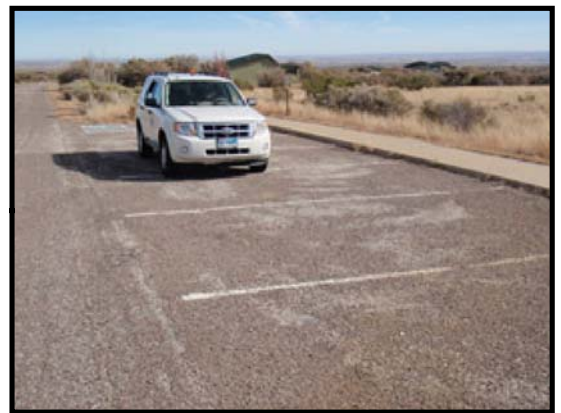
Route Number	Public / NonPublic	Date Visited	Area (sq ft)	Lane Miles *	Surface Type
0913	NONPUBLIC	12/3/2010	1,408	0.02	AS
Culverts	Drop Inlets	Gates	Curb & Gutter	Curb	PCR
0	0	0	NO CURB AND GUTTER	NO CURB	FAIR/73

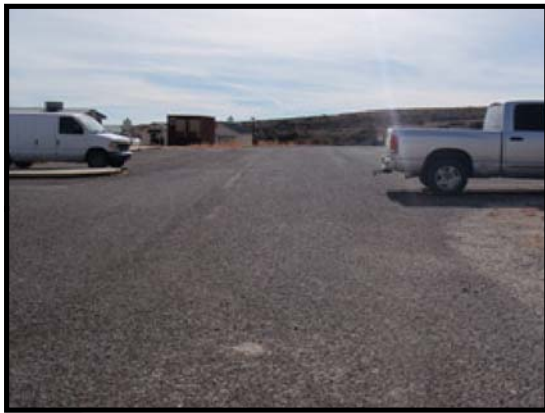
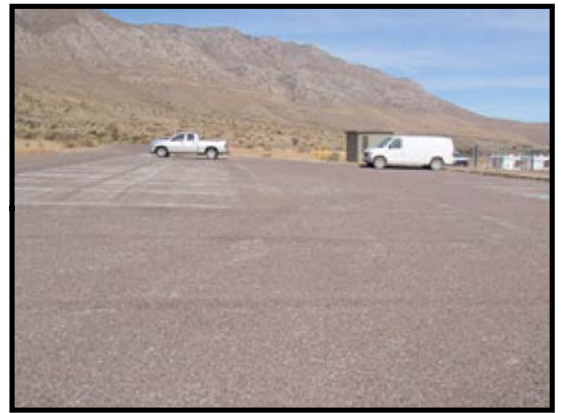
## Route 0914A

Route Number	Public / NonPublic	Date Visited	Area (sq ft)	Lane Miles *	Surface Type
0914A	NONPUBLIC	12/3/2010	10,194	0.18	AS
Culverts	Drop Inlets	Gates	Curb & Gutter	Curb	PCR
0	0	0	CONCRETE CURB AND GUTTER	CONCRETE CURB	FAIR/73

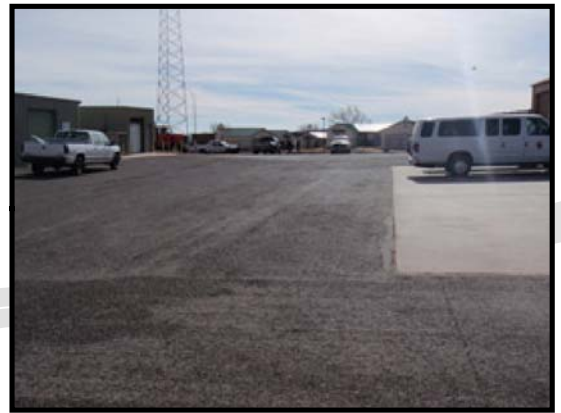
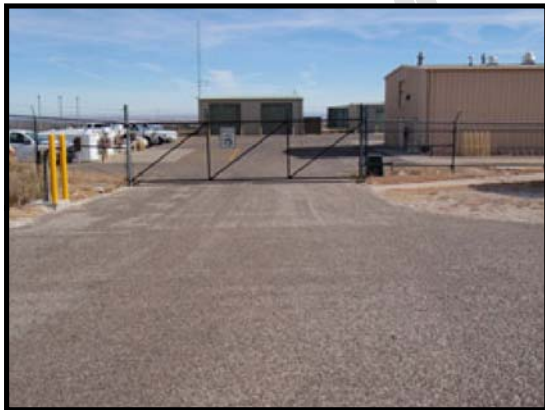
## Route 0914B

Route Number	Public / NonPublic	Date Visited	Area (sq ft)	Lane Miles *	Surface Type
0914B	NONPUBLIC	12/3/2010	35,892	0.62	AS
Culverts	Drop Inlets	Gates	Curb & Gutter	Curb	PCR
1	0	1	NO CURB AND GUTTER	NO CURB	FAIR/73

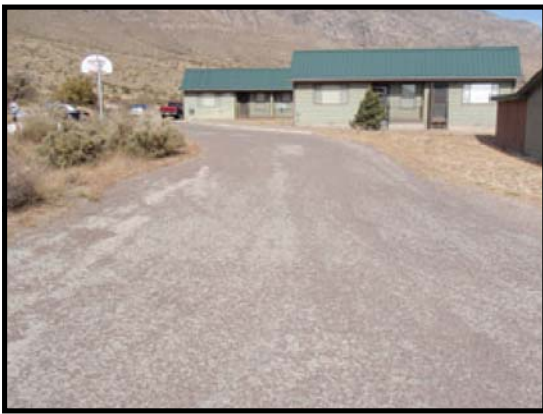
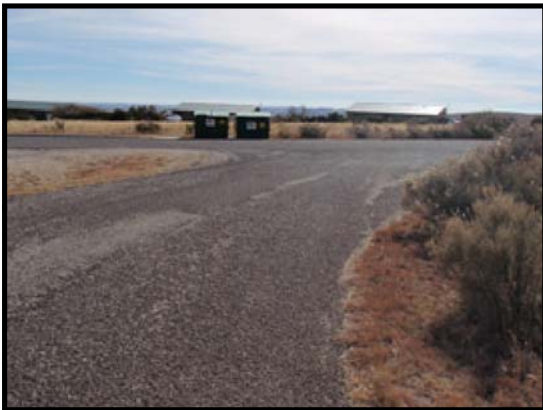
## Route 0915

Route Number	Public / NonPublic	Date Visited	Area (sq ft)	Lane Miles *	Surface Type
0915	NONPUBLIC	12/3/2010	6,977	0.12	AS
Culverts	Drop Inlets	Gates	Curb & Gutter	Curb	PCR
0	0	0	CONCRETE CURB AND GUTTER	NO CURB	POOR/45

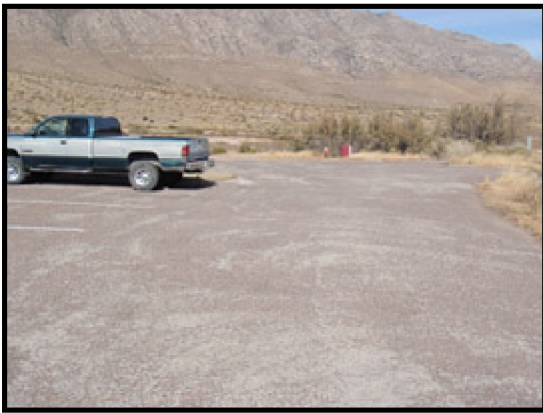
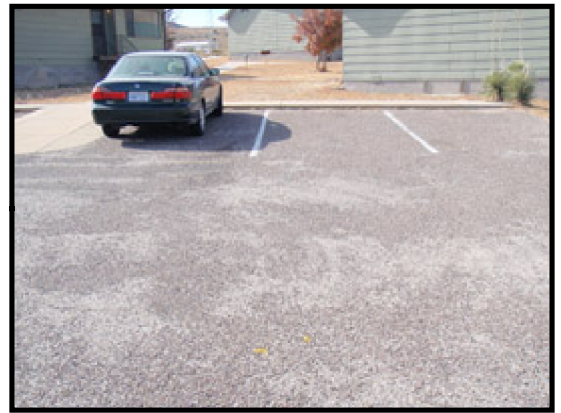
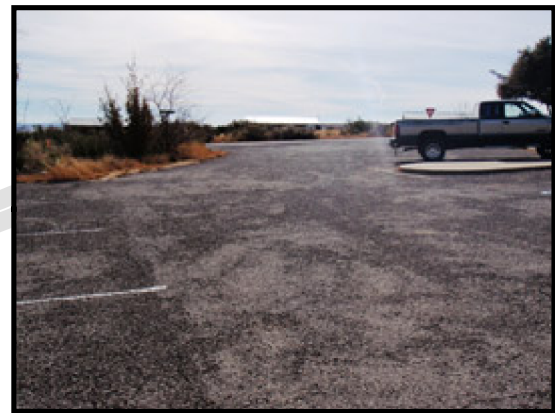
## Route 0916

Route Number	Public / NonPublic	Date Visited	Area (sq ft)	Lane Miles *	Surface Type
0916	NONPUBLIC	12/3/2010	7,515	0.13	AS
Culverts	Drop Inlets	Gates	Curb & Gutter	Curb	PCR
1	0	0	NO CURB AND GUTTER	NO CURB	POOR/45

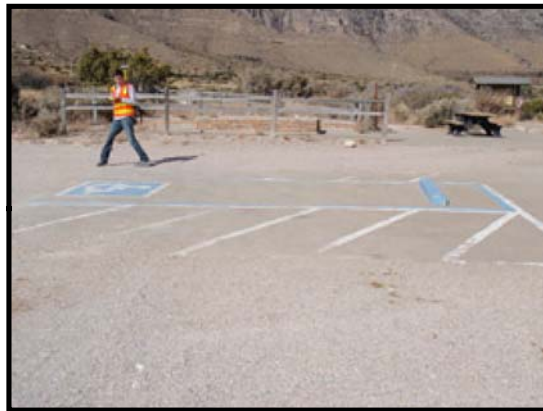
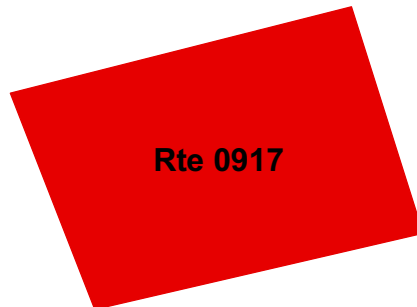
## Route 0917

Route Number	Public / NonPublic	Date Visited	Area (sq ft)	Lane Miles *	Surface Type
0917	PUBLIC	12/3/2010	616	0.01	CO
Culverts	Drop Inlets	Gates	Curb & Gutter	Curb	PCR
0	0	0	NO CURB AND GUTTER	NO CURB	FAIR/73
