Federal Lands Highway Road Inventory Program

Road Inventory and Condition Assessment

George Washington Carver National Monument
GWCA - 6360

Cycle 5 Report

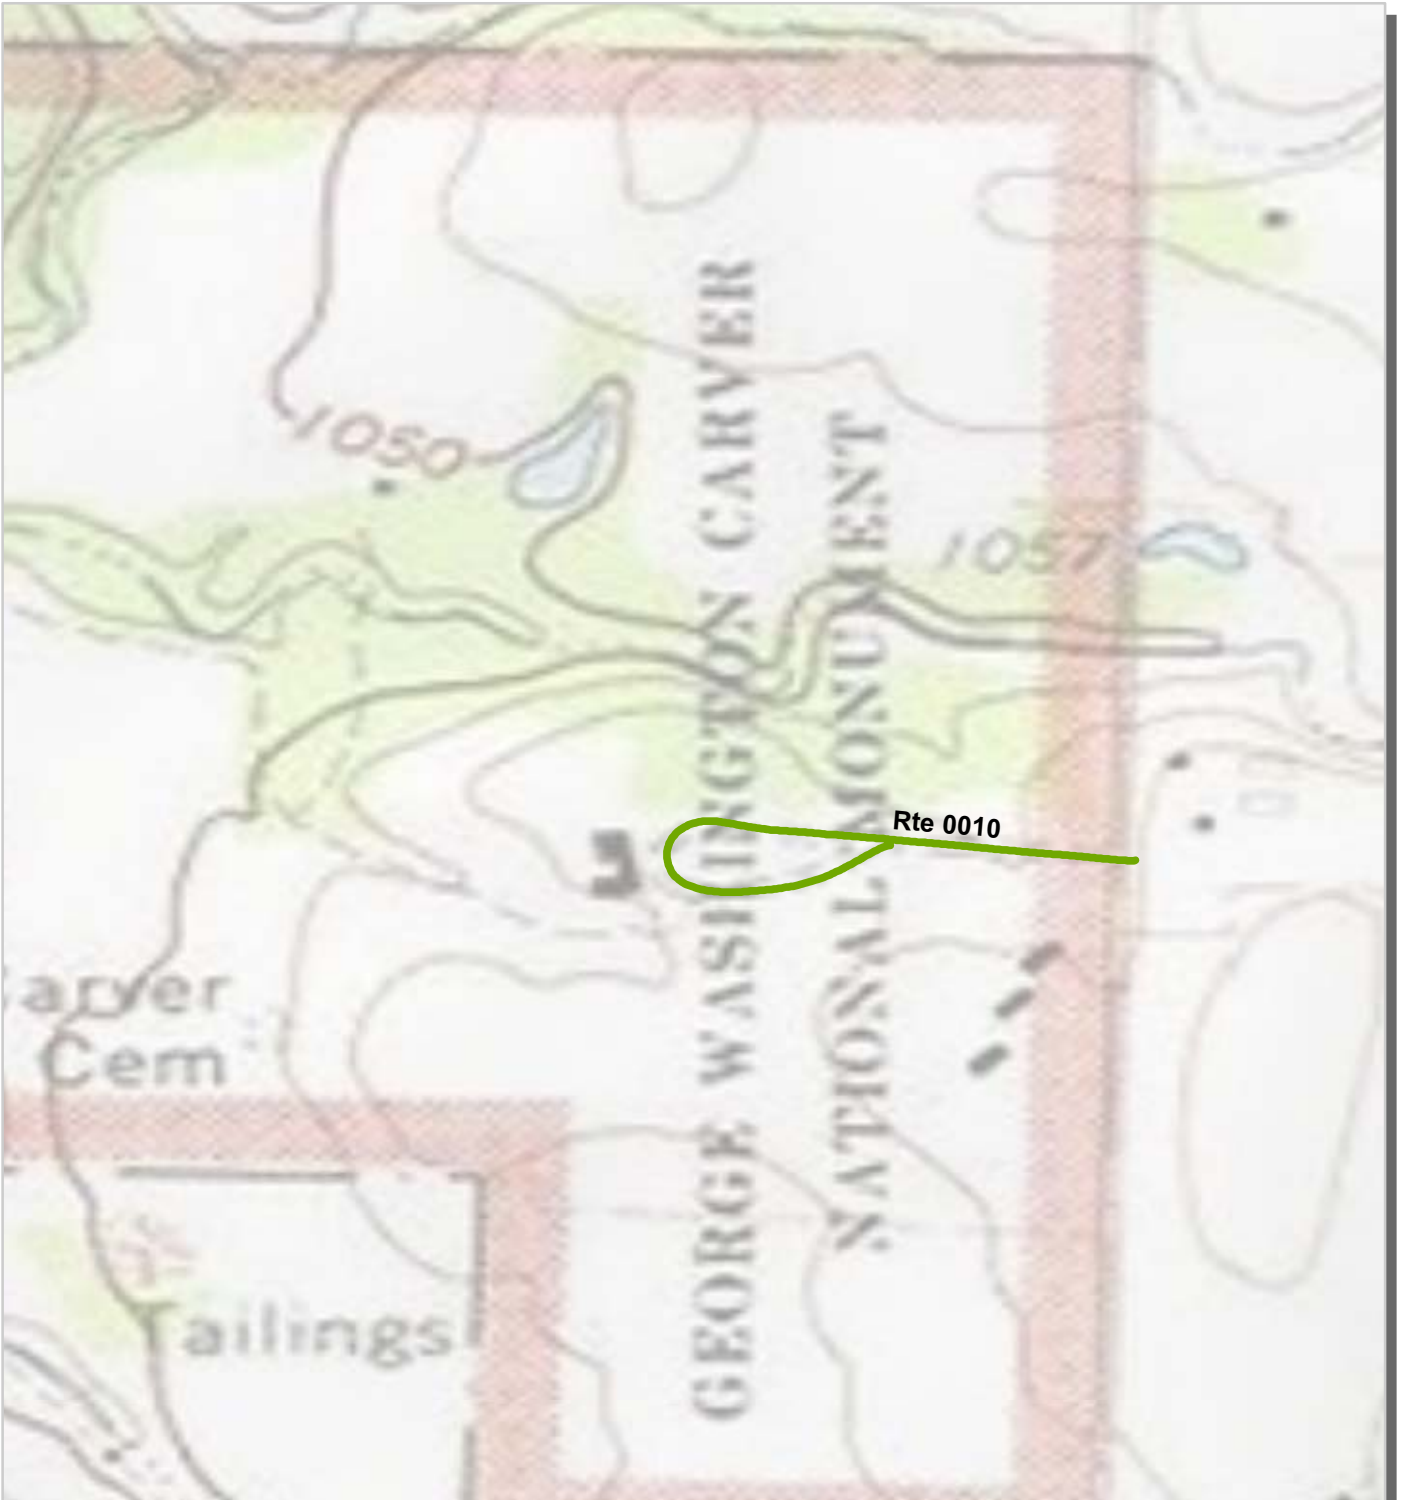
**George Washington Carver National Monument
Route Condition Map
PCR - Mile by Mile
Area 1**

* If the PCR rating is not available for a section, the SCR rating will be displayed. See appendix for definitions and formulas.

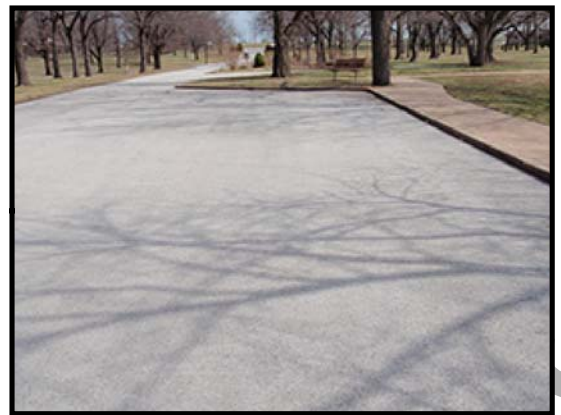
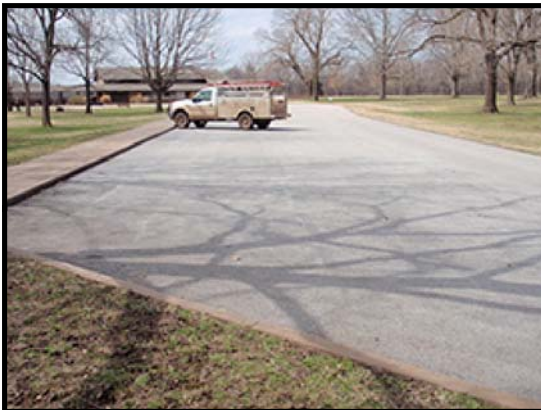
Route 0900AZ

Route Number	Public / NonPublic	Date Visited	Area (sq ft)	Lane Miles *	Surface Type
0900AZ	PUBLIC	3/16/2011	4,656	0.08	AS
Culverts	Drop Inlets	Gates	Curb & Gutter	Curb	PCR
0	0	0	NO CURB AND GUTTER	CONCRETE CURB	GOOD/90

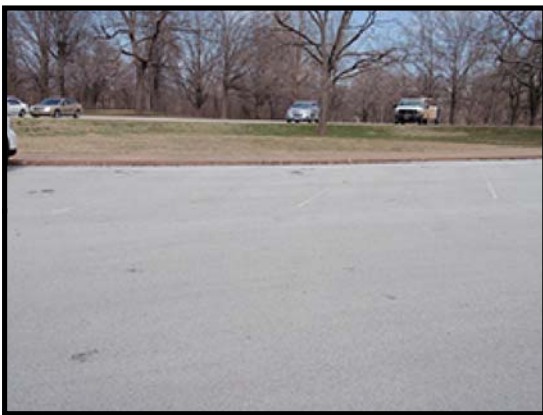
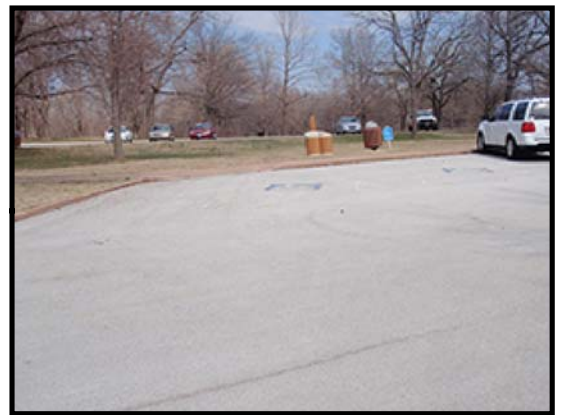
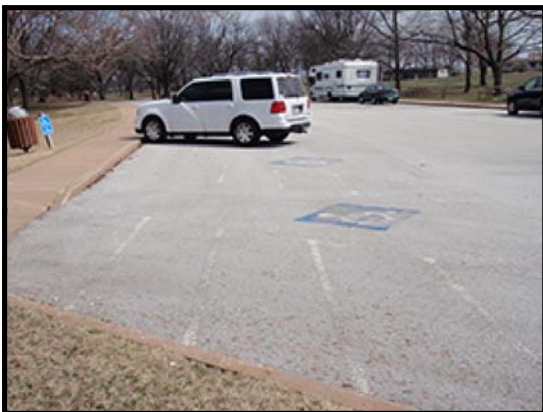
Route 0900BZ

Route Number	Public / NonPublic	Date Visited	Area (sq ft)	Lane Miles *	Surface Type
0900BZ	PUBLIC	3/16/2011	5,778	0.10	AS
Culverts	Drop Inlets	Gates	Curb & Gutter	Curb	PCR
0	0	0	NO CURB AND GUTTER	CONCRETE CURB	GOOD/90

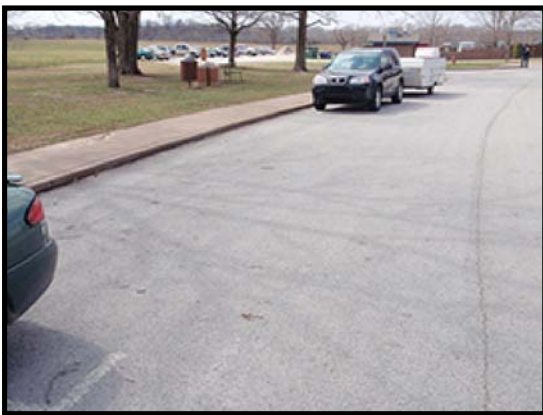
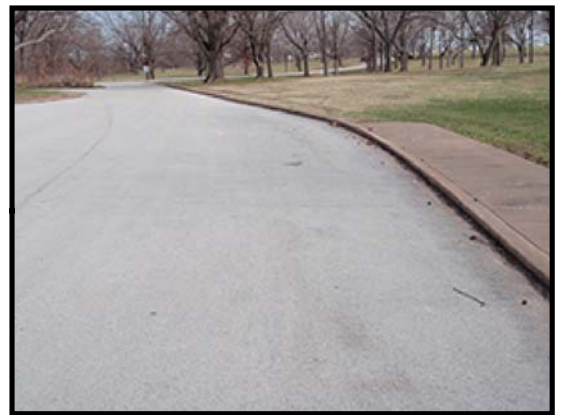
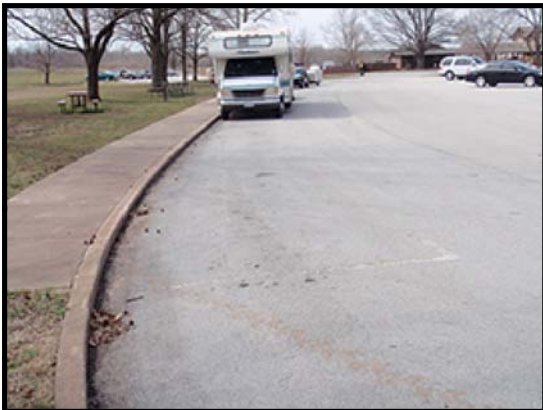
Route 0900CZ

Route Number	Public / NonPublic	Date Visited	Area (sq ft)	Lane Miles *	Surface Type
0900CZ	PUBLIC	3/16/2011	2,671	0.05	AS
Culverts	Drop Inlets	Gates	Curb & Gutter	Curb	PCR
0	1	0	NO CURB AND GUTTER	CONCRETE CURB	GOOD/90

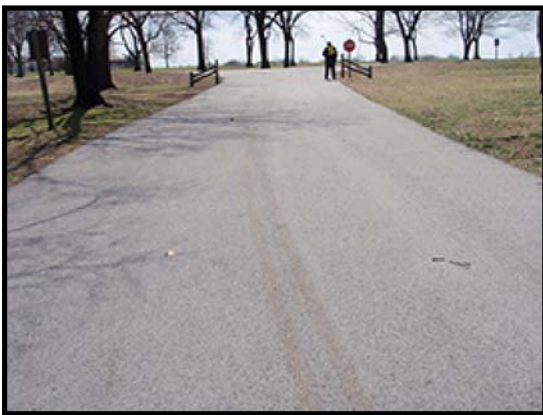
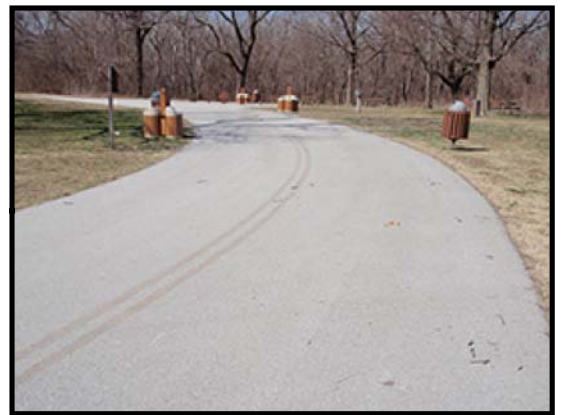
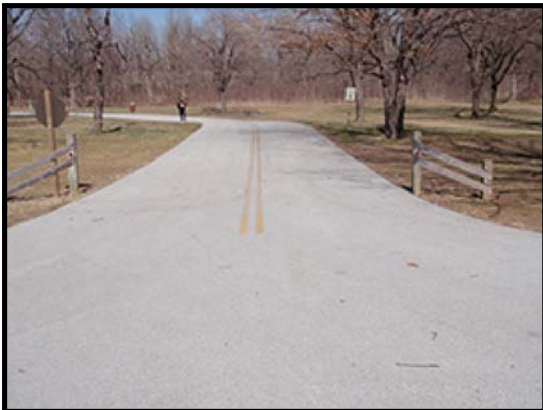
Route 0901

Route Number	Public / NonPublic	Date Visited	Area (sq ft)	Lane Miles *	Surface Type
0901	PUBLIC	3/16/2011	9,773	0.17	AS
Culverts	Drop Inlets	Gates	Curb & Gutter	Curb	PCR
0	0	0	NO CURB AND GUTTER	NO CURB	GOOD/90

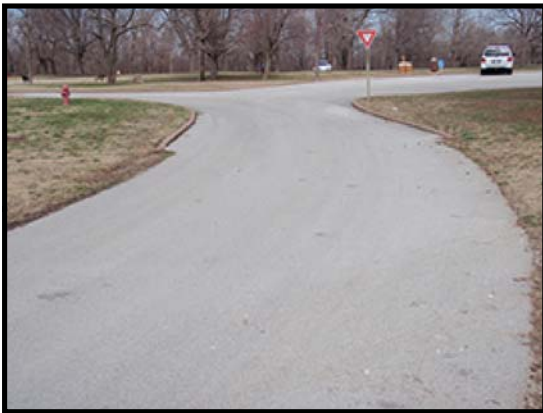
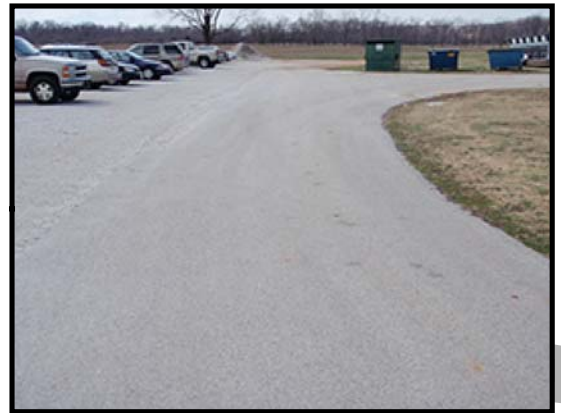
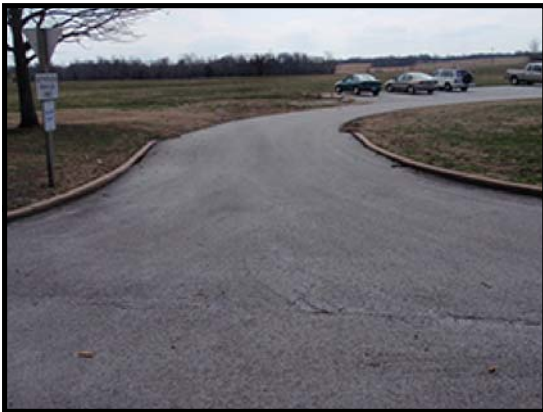
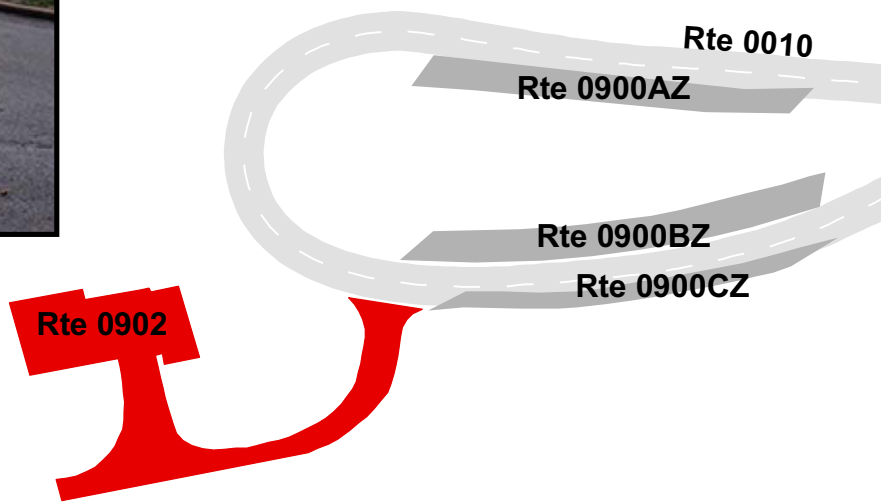
Route 0902

Route Number	Public / NonPublic	Date Visited	Area (sq ft)	Lane Miles *	Surface Type
0902	NONPUBLIC	3/16/2011	12,233	0.21	AS
Culverts	Drop Inlets	Gates	Curb & Gutter	Curb	PCR
0	0	0	NO CURB AND GUTTER	CONCRETE CURB	FAIR/73
