Federal Lands Highway Road Inventory Program

Road Inventory and Condition Assessment

Haleakala National Park
HALE

Cycle 5 Report

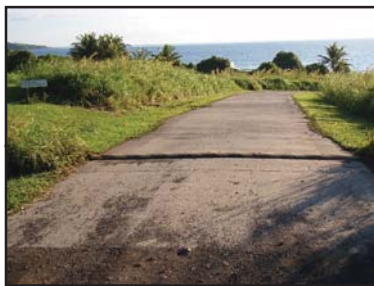
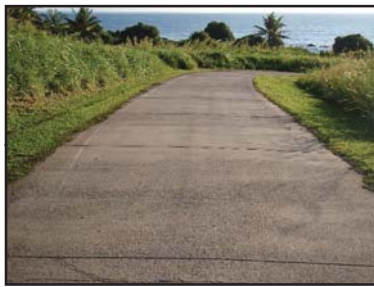
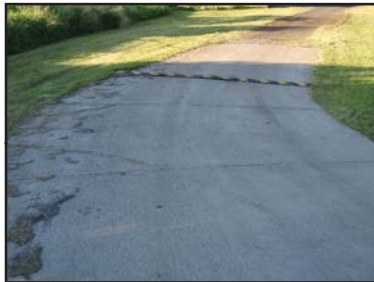
Inspection Date	FMSS Number	User Access	Surface Type						
1/14/2012	2653	PUBLIC	CONCRETE						
Paved Length (mi.) / Width (ft.)	Lane Miles (11' Widths)	Condition Rating / PCR							
0.08 miles / 16 feet	0.11	GOOD / 90							
Curb Type		Curb & Gutter Type							
NO CURB		NO CURB AND GUTTER							
Culverts	Drop Inlets	Gates							
0	0	0							
Route Condition Legend – Pavement Condition Rating (PCR)									
Poor	(0 - 60)	Fair	(61 - 84)	Good	(85 - 94)	Excellent	(95 - 100)	Not Rated	
See Appendix for definitions and formulas

NOTE: Routes at Kipahulu were not recollected during the second Cycle 5 collection trip in 2014. Therefore, the information shown on this page is from the first Cycle 5 collection trip which was in January 2012.

Unpaved portions of Route 0203 are shown in gray, dashed lines.

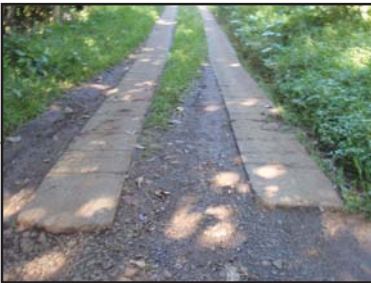
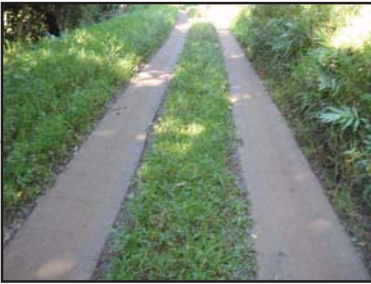
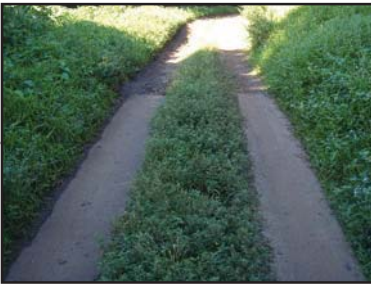
Route 0204BZ is a two-track, concrete wheelpath road with a grass median.

Unpaved portions of Route 0204ZZ are shown in gray, dashed lines.

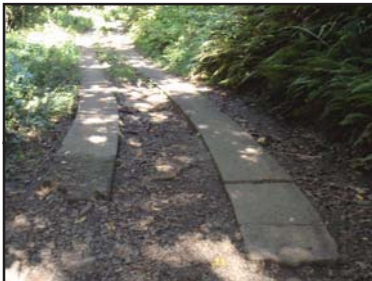
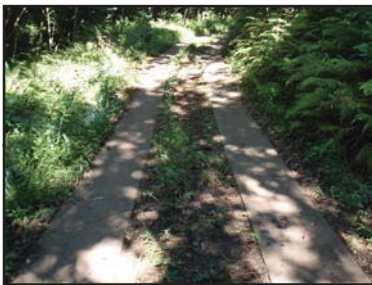
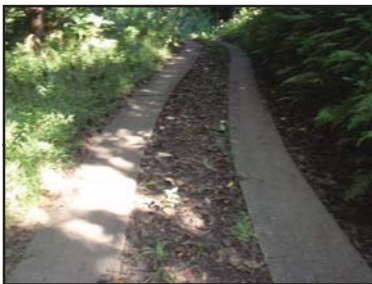
Route 0204DZ is a two-track, concrete wheelpath road with a grass median.

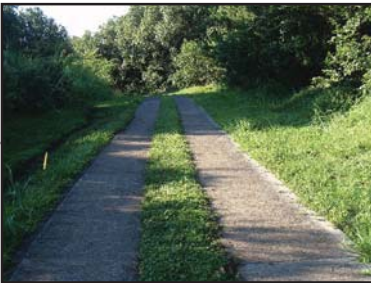
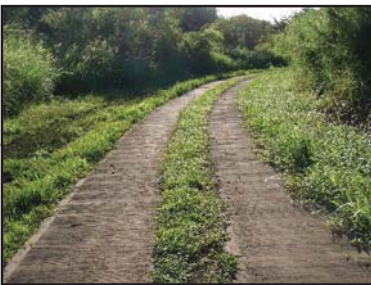
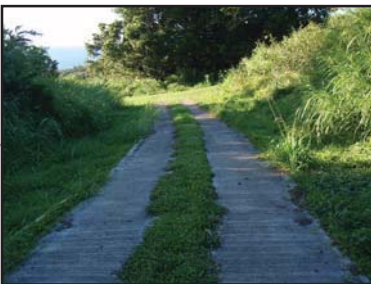
Route 0405 is a two-track, concrete wheelpath road with a grass median.

Unpaved portions of Route 0405 are shown in gray, dashed lines.

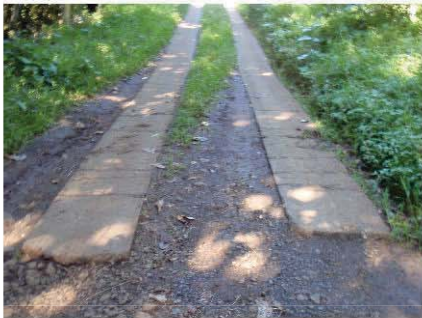
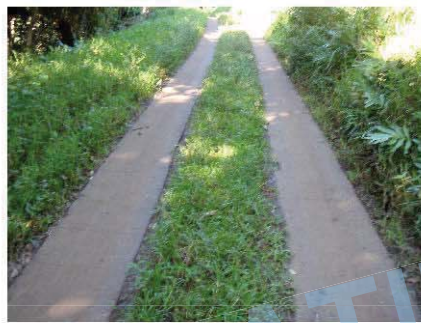
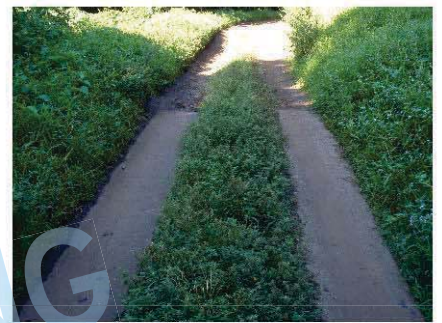
MRL Route 0204BZ Subcomponent Record

Route Number	Public / Non Public	Date Visited	Area (sq ft)	Lane Miles **	Paved Length (mi)	Paved Width (ft)
0204BZ	PUBLIC	1/14/2012	697	0.012	0.033	4
Culverts	Drop Inlets	Gates	Curb & Gutter	Curb	PCR	Surface Type
0	0	0	NO	NO	45 POOR	CO

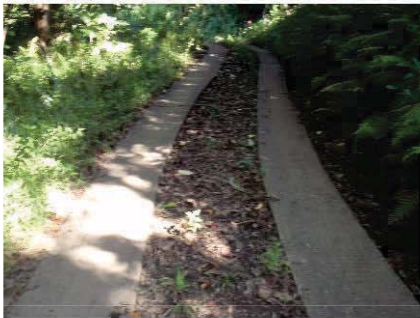
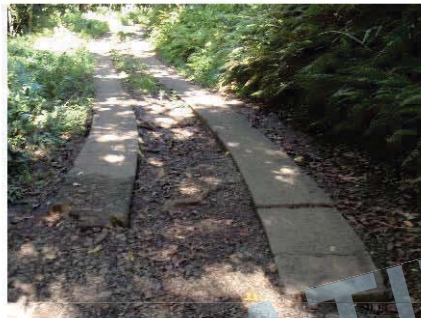
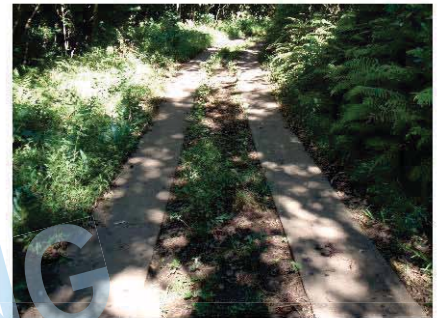
Route Number	Public / Non Public	Date Visited	Area (sq ft)	Lane Miles **	Paved Length (mi)	Paved Width (ft)
0204DZ	PUBLIC	1/14/2012	781	0.013	0.037	4
Culverts	Drop Inlets	Gates	Curb & Gutter	Curb	PCR	Surface Type
0	0	0	NO	NO	45 POOR	CO

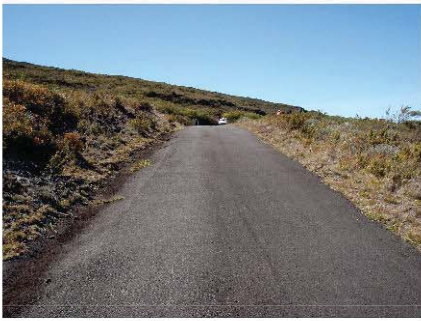
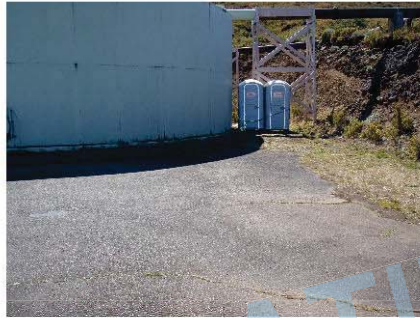
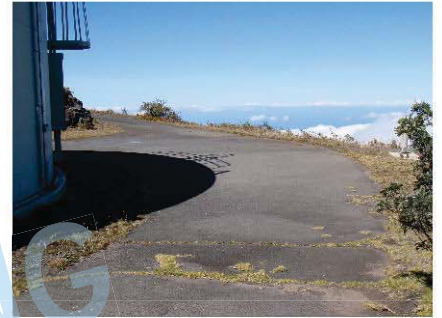
Haleakala National Park MRP Route 0403 RAIN SHED SERVICE ROAD

Route Number	Public / Non Public	Date Visited	Area (sq ft)	Lane Miles *	Surface Type
0403	NONPUBLIC	1/13/2012	7295	0.126	AS
Culverts	Drop Inlets	Gates	Curb & Gutter	Curb	PCR
1	0	1	NO	NO	73 FAIR

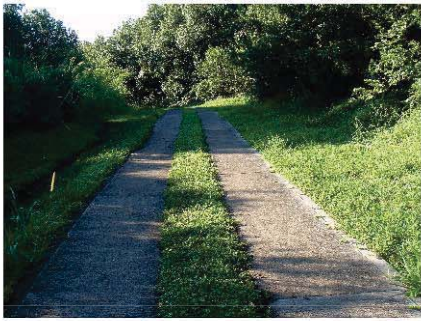
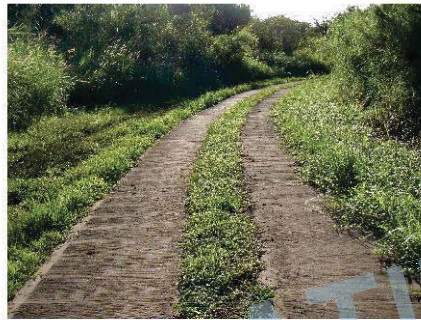
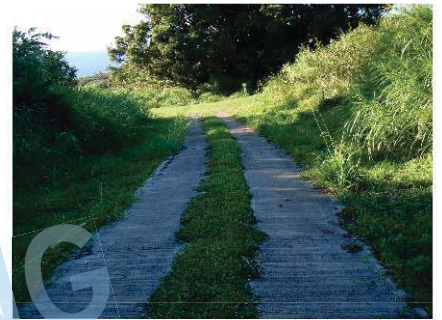
Route Number	Public / Non Public	Date Visited	Area (sq ft)	Lane Miles **	Paved Length (mi)	Paved Width (ft)
0405	NONPUBLIC	1/14/2012	7719	0.133	0.17	8.6
Culverts	Drop Inlets	Gates	Curb & Gutter	Curb	PCR	Surface Type
0	0	0	NO	NO	73 FAIR	CO

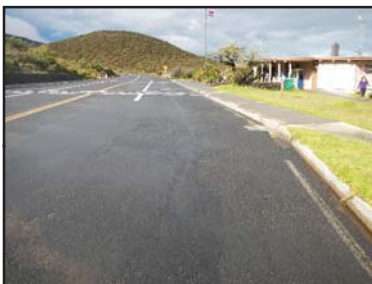
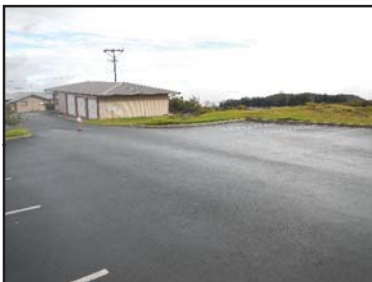
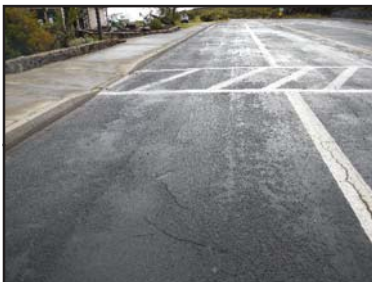
Inspection Date	FMSS Number	User Access	Surface Type
4/1/2014	31833	PUBLIC	ASPHALT
Area (Sq. Ft.)	Lane Miles (11' Widths)	Curb Reveal (Inches)	Curb Recommendation
11,113	0.19	NOT APPLICABLE	LIGHT REPAIR
Curb Type		Curb & Gutter Type	
NO CURB		CONCRETE CURB AND GUTTER	
Culverts	Drop Inlets	Gates	
0	2	0	
Pavement Recommendation		Condition Rating / PCR	
PREVENTIVE MAINTENANCE		GOOD / 90

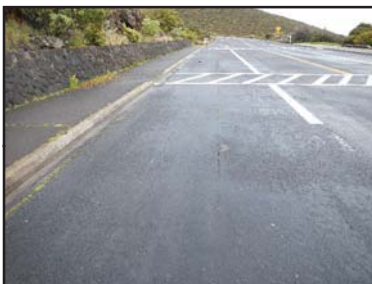
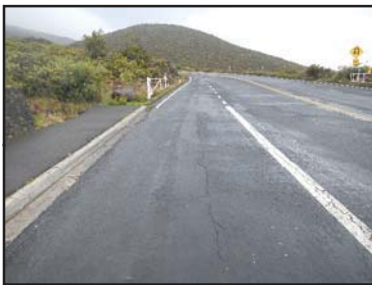
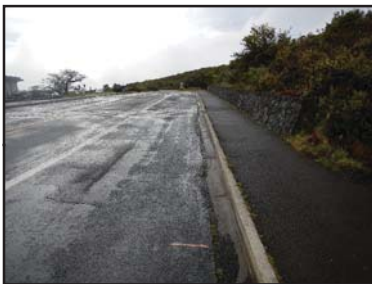
ROUTE 0901: HALEMAU'U 8,000 FOOT TRAILHEAD PARKING

Inspection Date	FMSS Number	User Access	Surface Type						
4/1/2014	31833	PUBLIC	ASPHALT						
Area (Sq. Ft.)	Lane Miles (11' Widths)	Curb Reveal (Inches)	Curb Recommendation						
2,995	0.05	NOT APPLICABLE	LIGHT REPAIR						
Curb Type		Curb & Gutter Type							
NO CURB		CONCRETE CURB AND GUTTER							
Culverts	Drop Inlets	Gates							
0	0	0							
Pavement Recommendation		Condition Rating / PCR							
HEAVY 3R TREATMENTS		POOR / 53							
Route Condition Legend – Pavement Condition Rating (PCR)									
Poor	(0 - 60)	Fair	(61 - 84)	Good	(85 - 94)	Excellent	(95 - 100)	Not Rated	
See Appendix for definitions and formulas

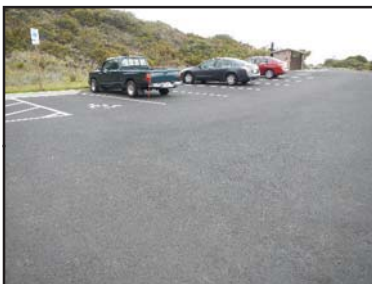
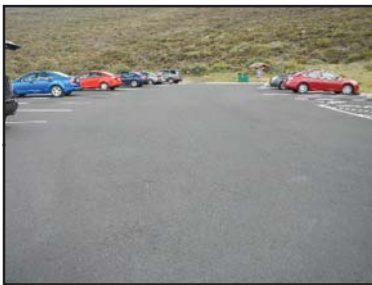
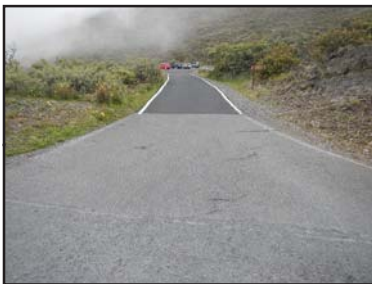
Inspection Date	FMSS Number	User Access	Surface Type
3/27/2014	31835	PUBLIC	ASPHALT
Area (Sq. Ft.)	Lane Miles (11' Widths)	Curb Reveal (Inches)	Curb Recommendation
12,176	0.21	NOT APPLICABLE	DO NOTHING
Curb Type		Curb & Gutter Type	
NO CURB		CONCRETE CURB AND GUTTER	
Culverts	Drop Inlets	Gates	
0	0	0	
Pavement Recommendation		Condition Rating / PCR	
PREVENTIVE MAINTENANCE		GOOD / 90

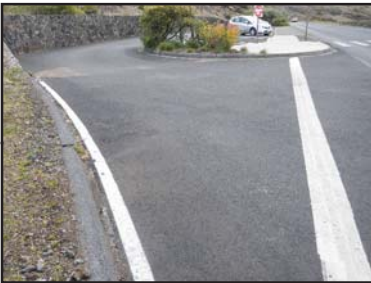
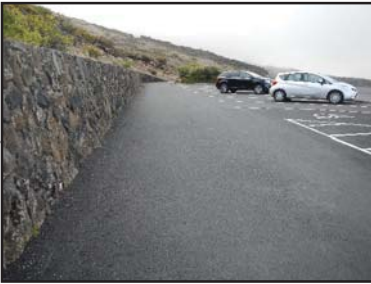
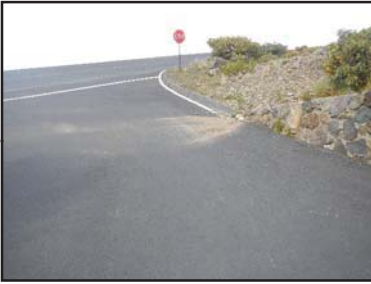
Inspection Date	FMSS Number	User Access	Surface Type
3/27/2014	31836	PUBLIC	ASPHALT
Area (Sq. Ft.)	Lane Miles (11' Widths)	Curb Reveal (Inches)	Curb Recommendation
8,178	0.14	5	LIGHT REPAIR
Curb Type		Curb & Gutter Type	
ASPHALT CURB		CONCRETE CURB AND GUTTER	
Culverts	Drop Inlets	Gates	
0	0	0	
Pavement Recommendation		Condition Rating / PCR	
DO NOTHING		EXCELLENT / 97

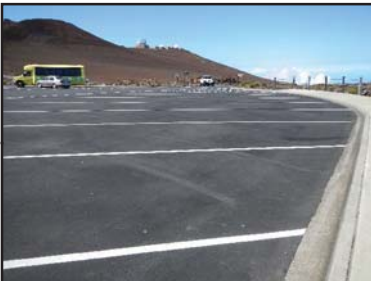
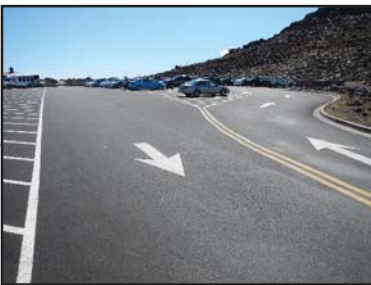
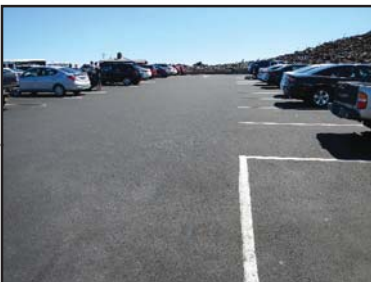
Inspection Date	FMSS Number	User Access	Surface Type
3/27/2014	31830	PUBLIC	ASPHALT
Area (Sq. Ft.)	Lane Miles (11' Widths)	Curb Reveal (Inches)	Curb Recommendation
44,003	0.76	NOT APPLICABLE	DO NOTHING
Curb Type		Curb & Gutter Type	
NO CURB		CONCRETE CURB AND GUTTER	
Culverts	Drop Inlets	Gates	
0	1	0	
Pavement Recommendation		Condition Rating / PCR	
DO NOTHING		EXCELLENT / 97

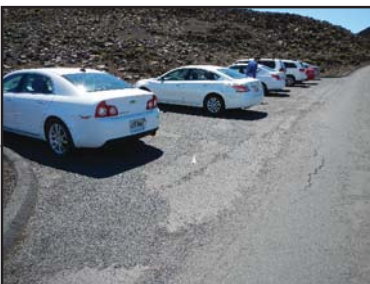
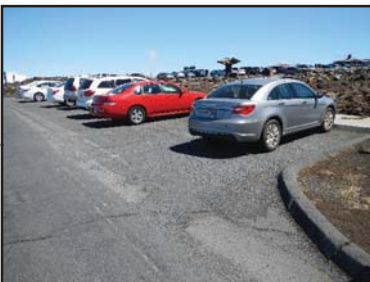
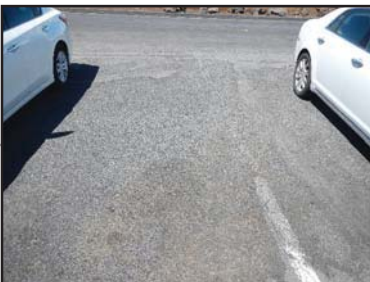
Inspection Date	FMSS Number	User Access	Surface Type
3/27/2014	31830	PUBLIC	ASPHALT
Area (Sq. Ft.)	Lane Miles (11' Widths)	Curb Reveal (Inches)	Curb Recommendation
2,085	0.04	6	DO NOTHING
Curb Type		Curb & Gutter Type	
ASPHALT & CONCRETE CURB		NO CURB AND GUTTER	
Culverts	Drop Inlets	Gates	
0	0	0	
Pavement Recommendation		Condition Rating / PCR	
LIGHT 3R TREATMENTS		FAIR / 73

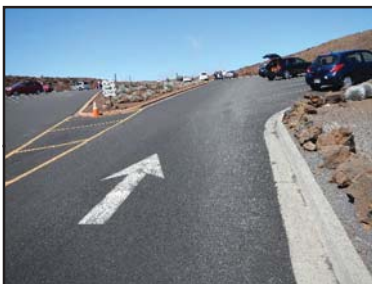
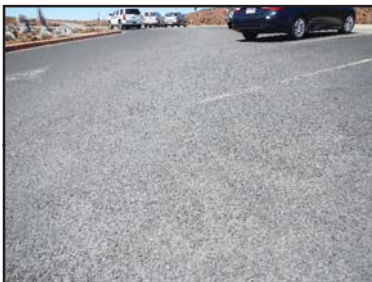
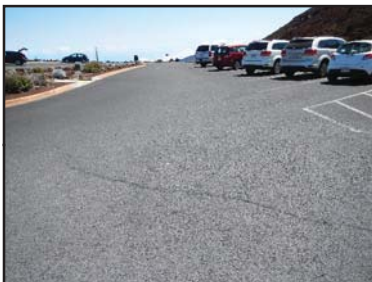
Inspection Date	FMSS Number	User Access	Surface Type
3/27/2014	31831	PUBLIC	ASPHALT
Area (Sq. Ft.)	Lane Miles (11' Widths)	Curb Reveal (Inches)	Curb Recommendation
20,100	0.35	NOT APPLICABLE	DO NOTHING
Curb Type		Curb & Gutter Type	
NO CURB		CONCRETE CURB AND GUTTER	
Culverts	Drop Inlets	Gates	
0	0	0	
Pavement Recommendation		Condition Rating / PCR	
LIGHT 3R TREATMENTS		FAIR / 73	
Route Condition Legend – Pavement Condition Rating (PCR)			
Poor	(0 - 60)	Fair	(61 - 84)
		Good	(85 - 94)
		Excellent	(95 - 100)
		Not Rated	
See Appendix for definitions and formulas

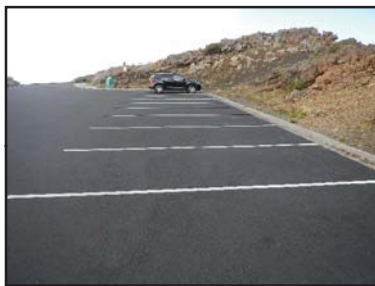
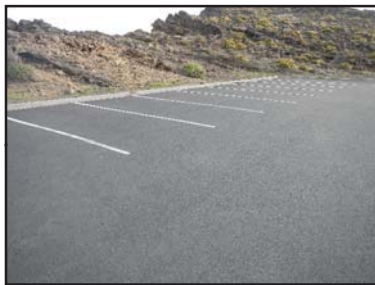
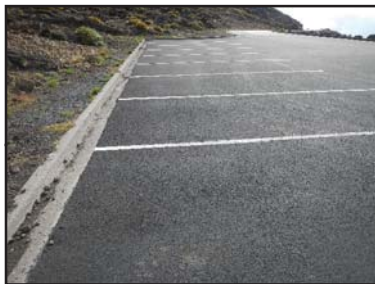
ROUTE 0905BZ: KALAHAKU OVERLOOK PARKING B

Inspection Date	FMSS Number	User Access	Surface Type						
3/27/2014	31837	PUBLIC	ASPHALT						
Area (Sq. Ft.)	Lane Miles (11' Widths)	Curb Reveal (Inches)	Curb Recommendation						
4,239	0.07	NOT APPLICABLE	LIGHT REPAIR						
Curb Type		Curb & Gutter Type							
NO CURB		CONCRETE CURB AND GUTTER							
Culverts	Drop Inlets	Gates							
0	0	0							
Pavement Recommendation		Condition Rating / PCR							
DO NOTHING		EXCELLENT / 97							
Route Condition Legend – Pavement Condition Rating (PCR)									
Poor	(0 - 60)	Fair	(61 - 84)	Good	(85 - 94)	Excellent	(95 - 100)	Not Rated	
See Appendix for definitions and formulas

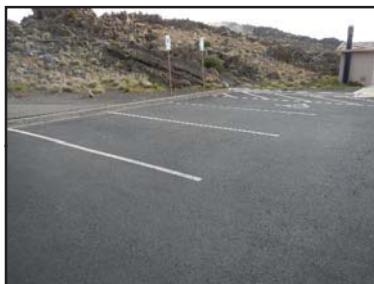
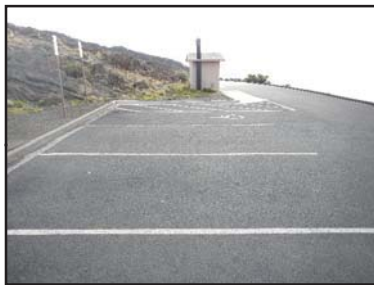
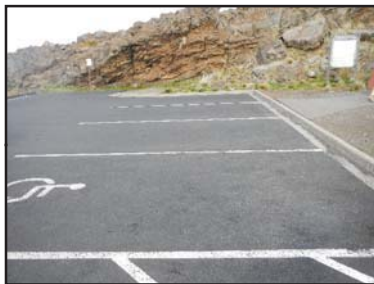
ROUTE 0906ZZ: HOSMER GROVE CAMPGROUND PARKING AREAS

Inspection Date	FMSS Number	User Access	Surface Type
3/27/2014	31837	PUBLIC	ASPHALT
Area (Sq. Ft.)	Lane Miles (11' Widths)	Curb Reveal (Inches)	Curb Recommendation
1,318	0.02	NOT APPLICABLE	DO NOTHING
Curb Type		Curb & Gutter Type	
NO CURB		CONCRETE CURB AND GUTTER	
Culverts	Drop Inlets	Gates	
0	0	0	
Pavement Recommendation		Condition Rating / PCR	
DO NOTHING		EXCELLENT / 97	
Route Condition Legend – Pavement Condition Rating (PCR) Poor (0 - 60) Fair (61 - 84) Good (85 - 94) Excellent (95 - 100) Not Rated See Appendix for definitions and formulas

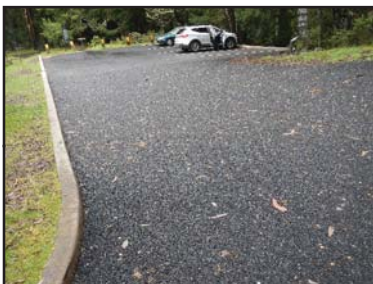
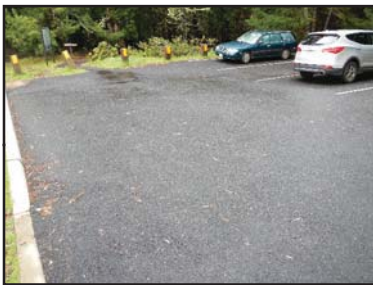
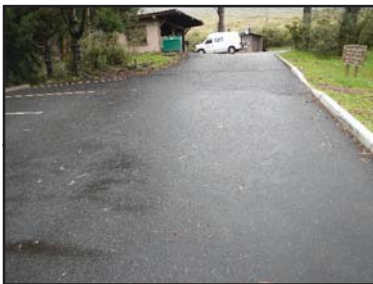
ROUTE 0906BZ: HOSMER GROVE CAMPGROUND PARKING B

Inspection Date	FMSS Number	User Access	Surface Type						
4/1/2014	31832	PUBLIC	ASPHALT						
Area (Sq. Ft.)	Lane Miles (11' Widths)	Curb Reveal (Inches)	Curb Recommendation						
7,003	0.12	6	DO NOTHING						
Curb Type		Curb & Gutter Type							
CONCRETE CURB		NO CURB AND GUTTER							
Culverts	Drop Inlets	Gates							
0	0	0							
Pavement Recommendation		Condition Rating / PCR							
PREVENTIVE MAINTENANCE		GOOD / 90							
Route Condition Legend – Pavement Condition Rating (PCR)									
Poor	(0 - 60)	Fair	(61 - 84)	Good	(85 - 94)	Excellent	(95 - 100)	Not Rated	
See Appendix for definitions and formulas

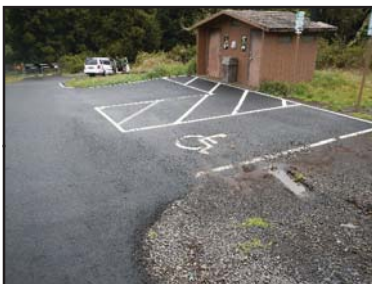
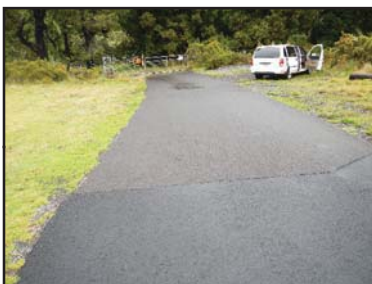
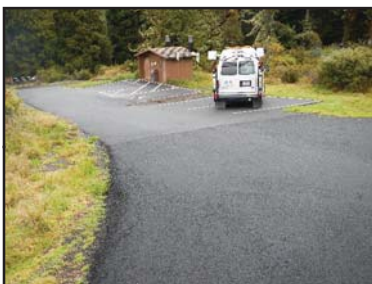
ROUTE 0906CZ: HOSMER GROVE CAMPGROUND PARKING C

Inspection Date	FMSS Number	User Access	Surface Type						
4/1/2014	31832	PUBLIC	ASPHALT						
Area (Sq. Ft.)	Lane Miles (11' Widths)	Curb Reveal (Inches)	Curb Recommendation						
4,736	0.08	NOT APPLICABLE	N/A						
Curb Type		Curb & Gutter Type							
NO CURB		NO CURB AND GUTTER							
Culverts	Drop Inlets	Gates							
0	0	1							
Pavement Recommendation		Condition Rating / PCR							
PREVENTIVE MAINTENANCE		GOOD / 90							
Route Condition Legend – Pavement Condition Rating (PCR)									
Poor	(0 - 60)	Fair	(61 - 84)	Good	(85 - 94)	Excellent	(95 - 100)	Not Rated	
See Appendix for definitions and formulas

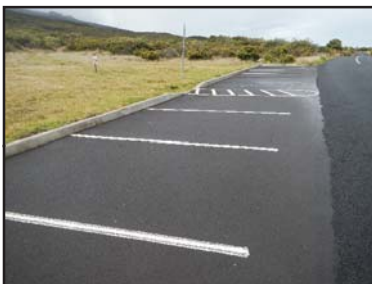
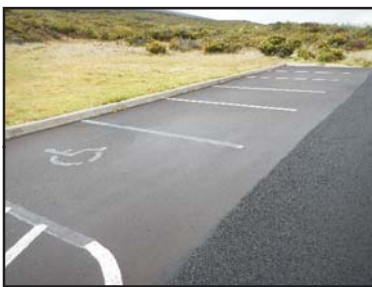
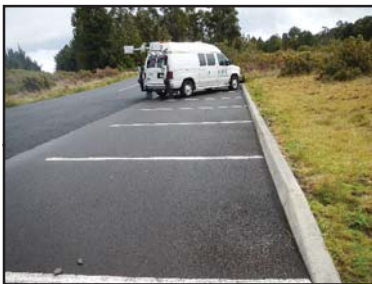
Inspection Date	FMSS Number	User Access	Surface Type						
4/1/2014	31832	PUBLIC	ASPHALT						
Area (Sq. Ft.)	Lane Miles (11' Widths)	Curb Reveal (Inches)	Curb Recommendation						
1,858	0.03	7	DO NOTHING						
Curb Type		Curb & Gutter Type							
CONCRETE CURB		NO CURB AND GUTTER							
Culverts	Drop Inlets	Gates							
0	0	0							
Pavement Recommendation		Condition Rating / PCR							
PREVENTIVE MAINTENANCE		GOOD / 90							
Route Condition Legend – Pavement Condition Rating (PCR)									
Poor	(0 - 60)	Fair	(61 - 84)	Good	(85 - 94)	Excellent	(95 - 100)	Not Rated	
See Appendix for definitions and formulas

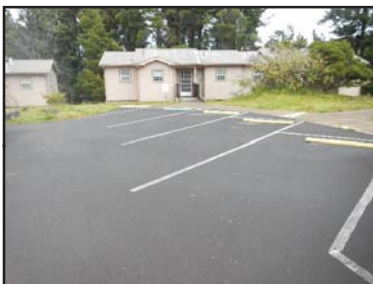
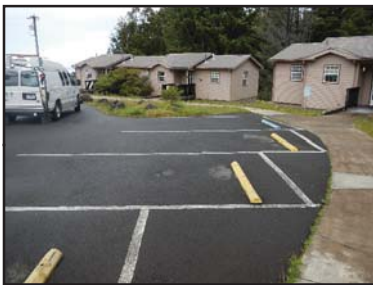
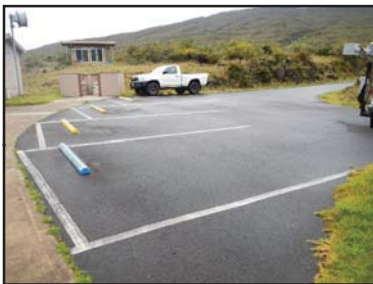
Inspection Date	FMSS Number	User Access	Surface Type						
4/1/2014	102613	NONPUBLIC	ASPHALT						
Area (Sq. Ft.)	Lane Miles (11' Widths)	Curb Reveal (Inches)	Curb Recommendation						
1,310	0.02	NOT APPLICABLE	N/A						
Curb Type		Curb & Gutter Type							
NO CURB		NO CURB AND GUTTER							
Culverts	Drop Inlets	Gates							
0	0	0							
Pavement Recommendation		Condition Rating / PCR							
PREVENTIVE MAINTENANCE		GOOD / 90							
Route Condition Legend – Pavement Condition Rating (PCR)									
Poor	(0 - 60)	Fair	(61 - 84)	Good	(85 - 94)	Excellent	(95 - 100)	Not Rated	
See Appendix for definitions and formulas

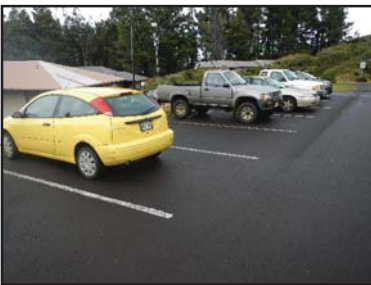
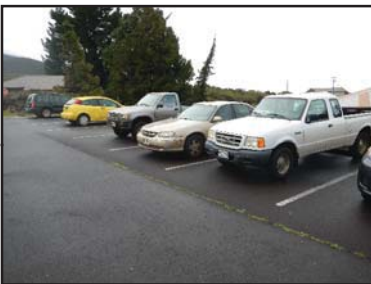
Inspection Date	FMSS Number	User Access	Surface Type						
4/1/2014	102613	NONPUBLIC	ASPHALT						
Area (Sq. Ft.)	Lane Miles (11' Widths)	Curb Reveal (Inches)	Curb Recommendation						
1,729	0.03	NOT APPLICABLE	N/A						
Curb Type		Curb & Gutter Type							
NO CURB		NO CURB AND GUTTER							
Culverts	Drop Inlets	Gates							
0	0	0							
Pavement Recommendation		Condition Rating / PCR							
PREVENTIVE MAINTENANCE		GOOD / 90							
Route Condition Legend – Pavement Condition Rating (PCR)									
Poor	(0 - 60)	Fair	(61 - 84)	Good	(85 - 94)	Excellent	(95 - 100)	Not Rated	
See Appendix for definitions and formulas

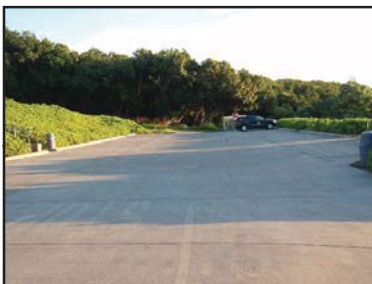
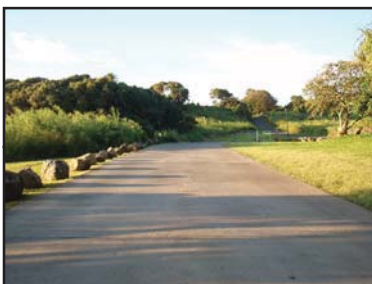
ROUTE 0913: HEADQUARTERS EMPLOYEE PARKING LOT

Inspection Date	FMSS Number	User Access	Surface Type						
1/14/2012	39535	PUBLIC	CONCRETE						
Area (Sq. Ft.)	Lane Miles (11' Widths)	Curb Reveal (Inches)	Curb Recommendation						
50,288	0.87		NOT COLLECTED						
Curb Type		Curb & Gutter Type							
CONCRETE CURB		NO CURB AND GUTTER							
Culverts	Drop Inlets	Gates							
0	1	1							
Pavement Recommendation		Condition Rating / PCR							
PREVENTIVE MAINTENANCE		GOOD / 90							
Route Condition Legend – Pavement Condition Rating (PCR)									
Poor	(0 - 60)	Fair	(61 - 84)	Good	(85 - 94)	Excellent	(95 - 100)	Not Rated	
See Appendix for definitions and formulas

NOTE: Routes at Kipahulu were not recollected during the second Cycle 5 collection trip in 2014. Therefore, the information shown on this page is from the first Cycle 5 collection trip which was in January 2012.

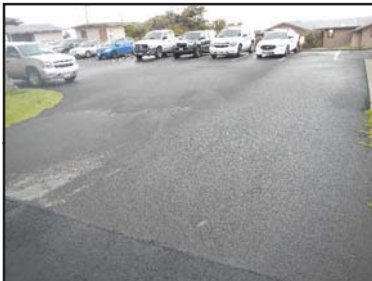
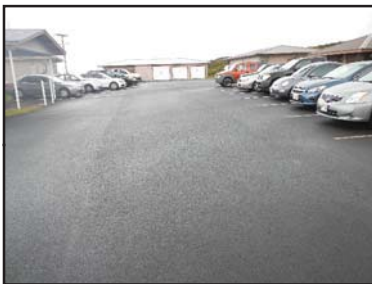
Inspection Date	FMSS Number	User Access	Surface Type						
4/1/2014	31834	NONPUBLIC	ASPHALT						
Area (Sq. Ft.)	Lane Miles (11' Widths)	Curb Reveal (Inches)	Curb Recommendation						
11,492	0.20	5	DO NOTHING						
Curb Type		Curb & Gutter Type							
CONCRETE CURB		NO CURB AND GUTTER							
Culverts	Drop Inlets	Gates							
0	0	0							
Pavement Recommendation		Condition Rating / PCR							
PREVENTIVE MAINTENANCE		GOOD / 90							
Route Condition Legend – Pavement Condition Rating (PCR)									
Poor	(0 - 60)	Fair	(61 - 84)	Good	(85 - 94)	Excellent	(95 - 100)	Not Rated	
See Appendix for definitions and formulas

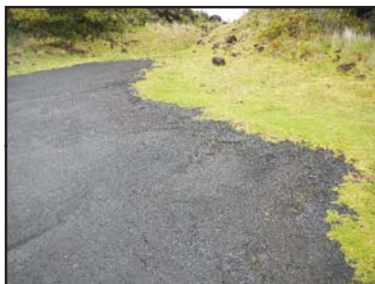
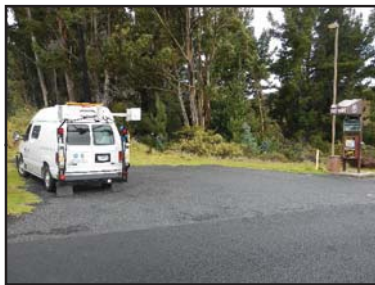
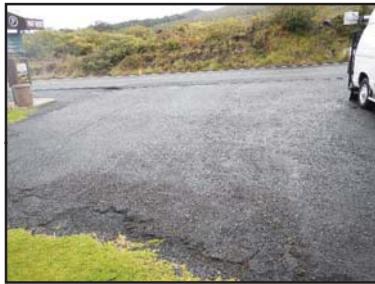
Inspection Date	FMSS Number	User Access	Surface Type
4/1/2014	NOT AVAILABLE	NONPUBLIC	ASPHALT
Area (Sq. Ft.)	Lane Miles (11' Widths)	Curb Reveal (Inches)	Curb Recommendation
1,435	0.03	NOT APPLICABLE	N/A
Curb Type		Curb & Gutter Type	
NO CURB		NO CURB AND GUTTER	
Culverts	Drop Inlets	Gates	
0	0	0	
Pavement Recommendation		Condition Rating / PCR	
LIGHT 3R TREATMENTS		FAIR / 73	
Route Condition Legend – Pavement Condition Rating (PCR) Poor (0 - 60) Fair (61 - 84) Good (85 - 94) Excellent (95 - 100) Not Rated See Appendix for definitions and formulas

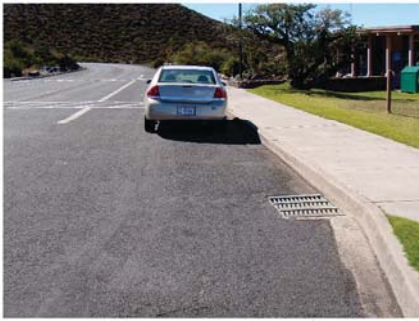
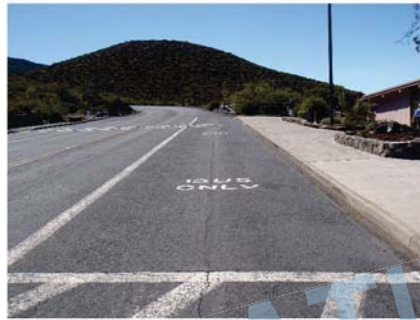
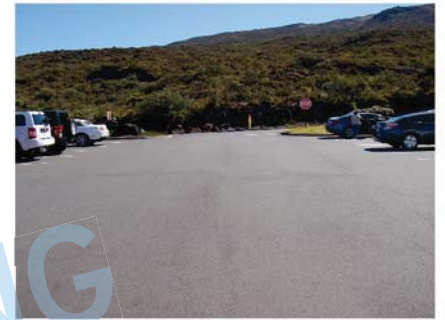
Route Number	Public / Non Public	Date Visited	Area (sq ft)	Lane Miles *	Surface Type
0900AZ	PUBLIC	1/13/2012	11113	0.191	AS
Culverts	Drop Inlets	Gates	Curb & Gutter	Curb	PCR
0	2	0	CONCRETE	NO	73 FAIR

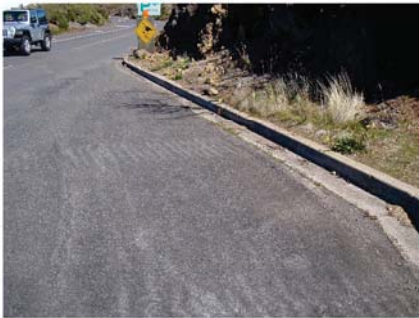
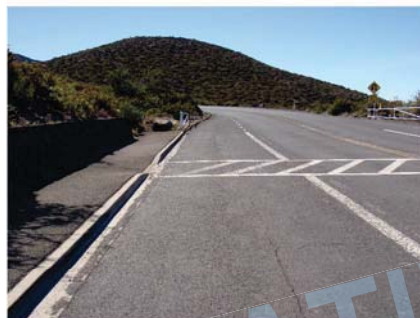
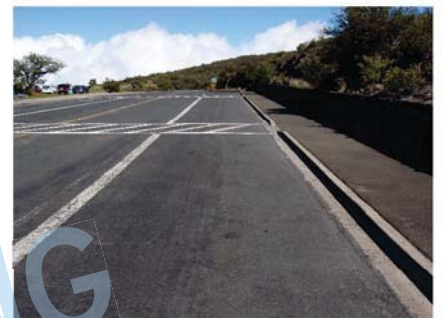
Route 0900BZ Subcomponent Record

Route Number	Public / Non Public	Date Visited	Area (sq ft)	Lane Miles *	Surface Type
0900BZ	PUBLIC	1/13/2012	2995	0.052	AS
Culverts	Drop Inlets	Gates	Curb & Gutter	Curb	PCR
0	0	0	CONCRETE	NO	73 FAIR

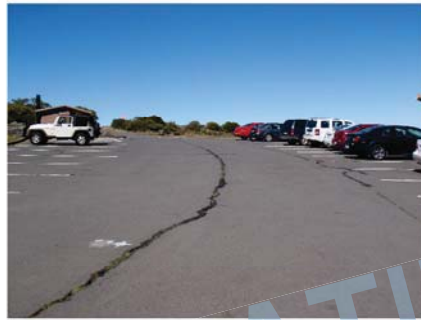
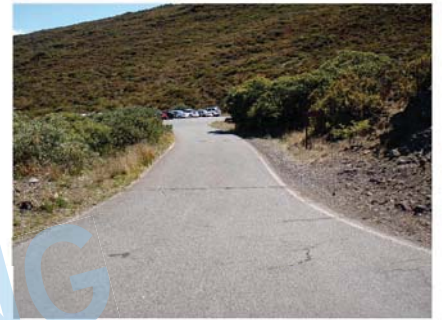
Route Number	Public / Non Public	Date Visited	Area (sq ft)	Lane Miles *	Surface Type
0901	PUBLIC	1/13/2012	12176	0.21	AS
Culverts	Drop Inlets	Gates	Curb & Gutter	Curb	PCR
0	0	0	CONCRETE	NO	45 POOR

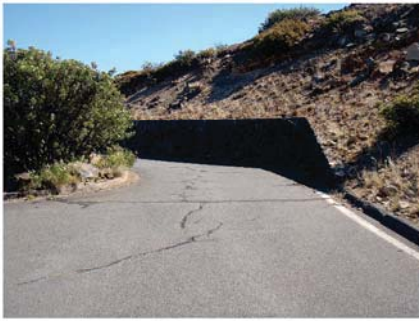
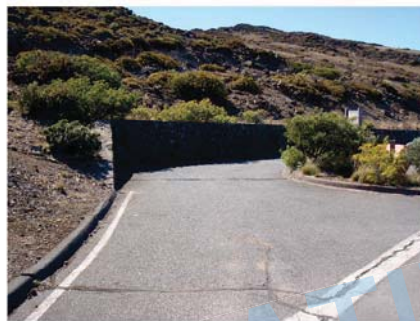
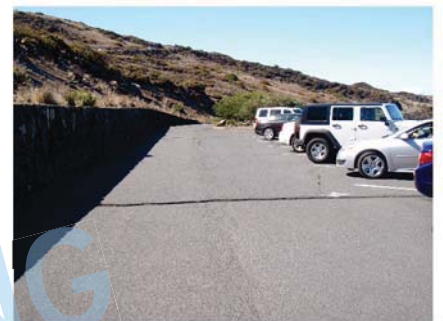
Route Number	Public / Non Public	Date Visited	Area (sq ft)	Lane Miles *	Surface Type
0902	PUBLIC	1/13/2012	8178	0.141	AS
Culverts	Drop Inlets	Gates	Curb & Gutter	Curb	PCR
0	0	0	CONCRETE	ASPHALT	45 POOR

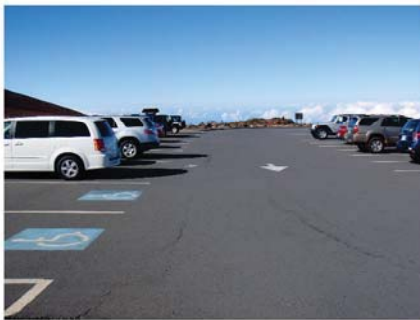
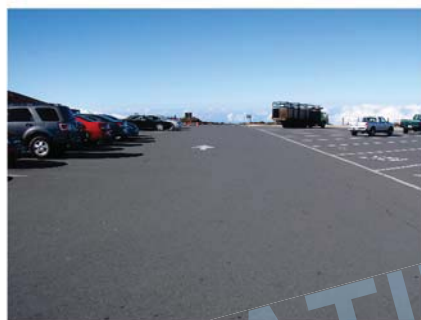
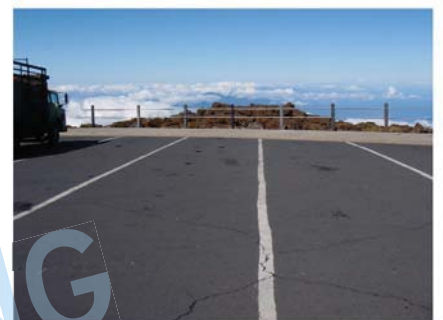
Route Number	Public / Non Public	Date Visited	Area (sq ft)	Lane Miles *	Surface Type
0903AZ	PUBLIC	1/13/2012	44003	0.758	AS
Culverts	Drop Inlets	Gates	Curb & Gutter	Curb	PCR
0	1	0	CONCRETE	NO	73 FAIR

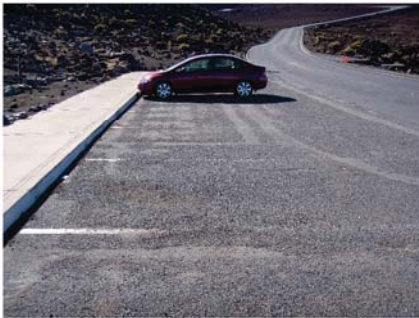
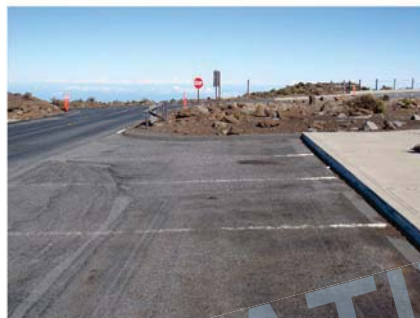
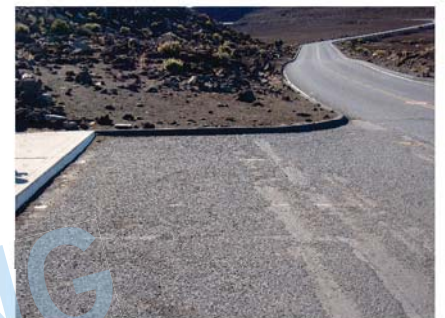
Route 0903BZ Subcomponent Record

Route Number	Public / Non Public	Date Visited	Area (sq ft)	Lane Miles *	Surface Type
0903BZ	PUBLIC	1/13/2012	2085	0.036	AS
Culverts	Drop Inlets	Gates	Curb & Gutter	Curb	PCR
0	0	0	NO	ASPHALT/ CONCRETE	45 POOR

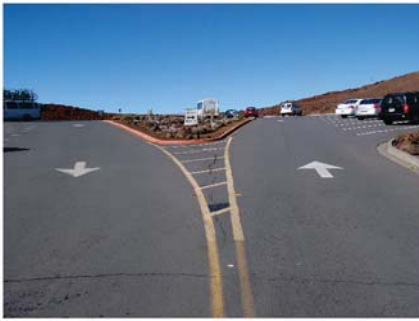
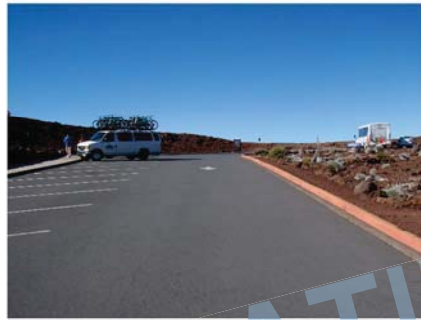
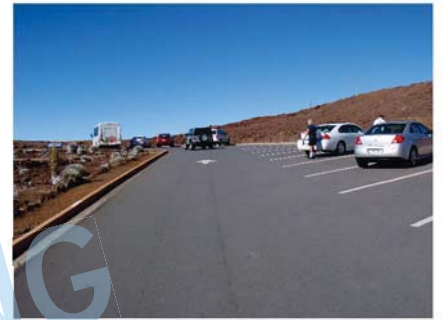
Haleakala National Park Route 0904 RED HILL SUMMIT PARKING LOT

Route Number	Public / Non Public	Date Visited	Area (sq ft)	Lane Miles *	Surface Type
0904	PUBLIC	1/13/2012	20100	0.346	AS
Culverts	Drop Inlets	Gates	Curb & Gutter	Curb	PCR
0	0	0	CONCRETE	NO	90 GOOD

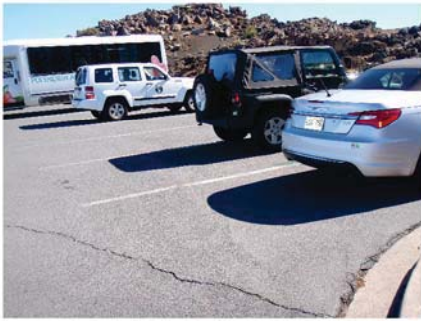
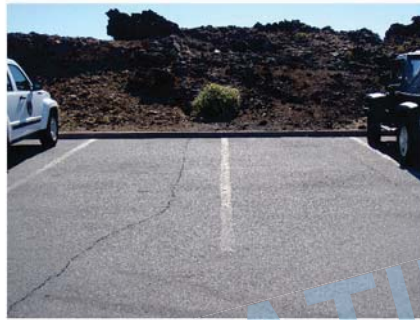
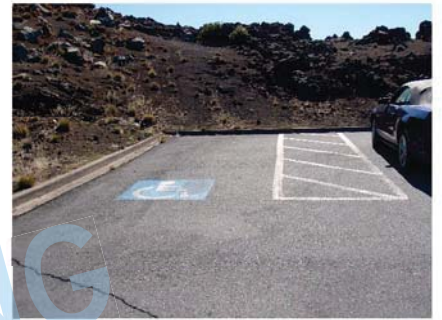
Route Number	Public / Non Public	Date Visited	Area (sq ft)	Lane Miles *	Surface Type
0905AZ	PUBLIC	1/13/2012	4239	0.073	AS
Culverts	Drop Inlets	Gates	Curb & Gutter	Curb	PCR
0	0	0	CONCRETE	CONCRETE	73 FAIR

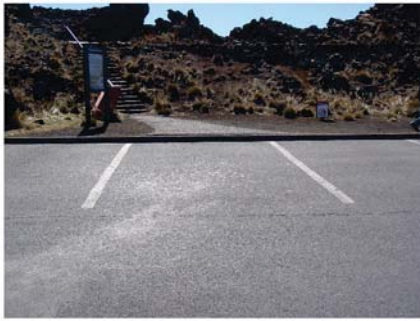
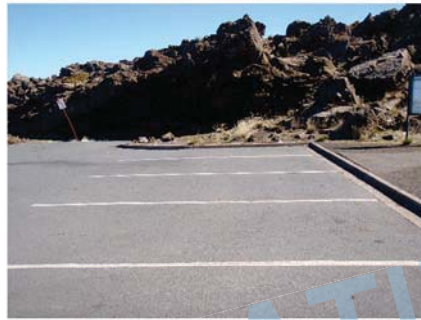
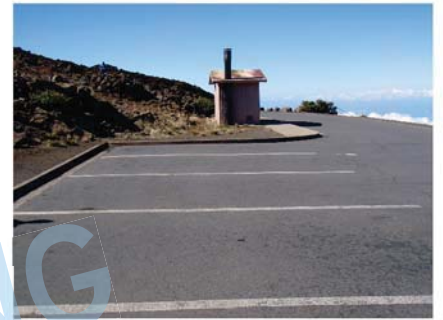
Route 0905BZ Subcomponent Record

Route Number	Public / Non Public	Date Visited	Area (sq ft)	Lane Miles *	Surface Type
0905BZ	PUBLIC	1/13/2012	1318	0.023	AS
Culverts	Drop Inlets	Gates	Curb & Gutter	Curb	PCR
0	0	0	CONCRETE	NO	90 GOOD

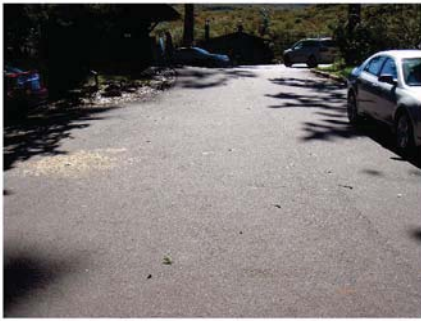
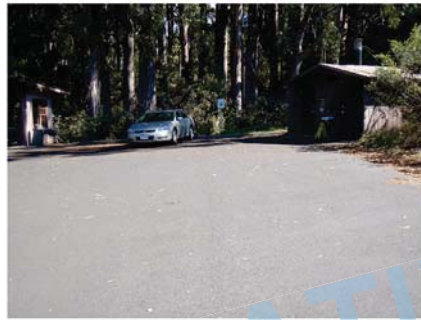
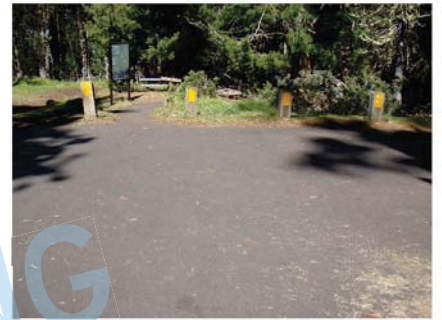
Route 0906AZ Subcomponent Record

Route Number	Public / Non Public	Date Visited	Area (sq ft)	Lane Miles *	Surface Type
0906AZ	PUBLIC	1/13/2012	7003	0.121	AS
Culverts	Drop Inlets	Gates	Curb & Gutter	Curb	PCR
0	0	0	NO	CONCRETE	90 GOOD

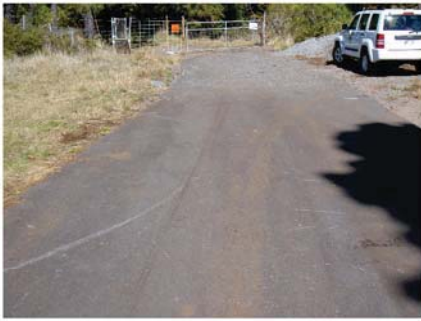
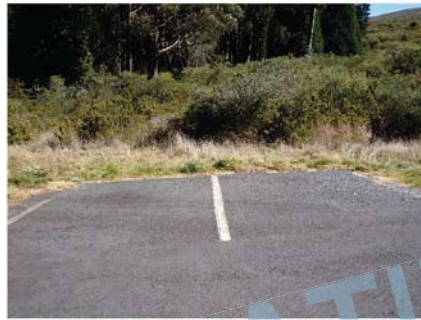
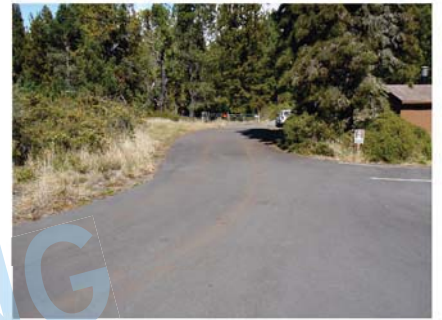
Route 0906BZ Subcomponent Record

Route Number	Public / Non Public	Date Visited	Area (sq ft)	Lane Miles *	Surface Type
0906BZ	PUBLIC	1/13/2012	4353	0.075	AS
Culverts	Drop Inlets	Gates	Curb & Gutter	Curb	PCR
0	0	1	NO	NO	90 GOOD

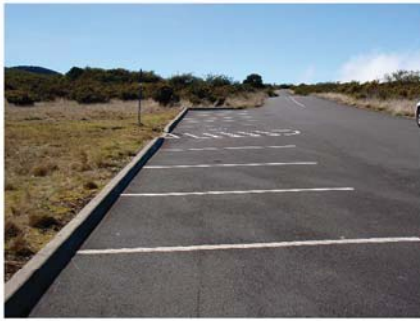
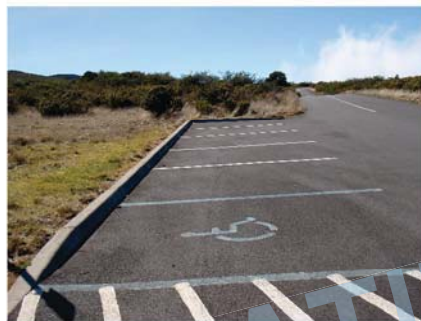
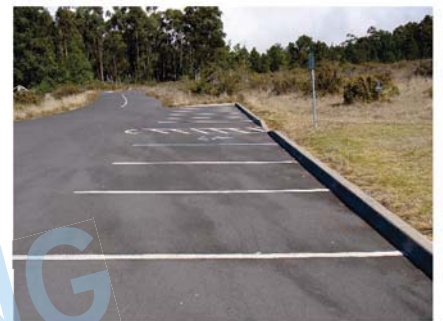
Route Number	Public / Non Public	Date Visited	Area (sq ft)	Lane Miles *	Surface Type
0906CZ	PUBLIC	1/13/2012	1858	0.032	AS
Culverts	Drop Inlets	Gates	Curb & Gutter	Curb	PCR
0	0	0	NO	CONCRETE	90 GOOD

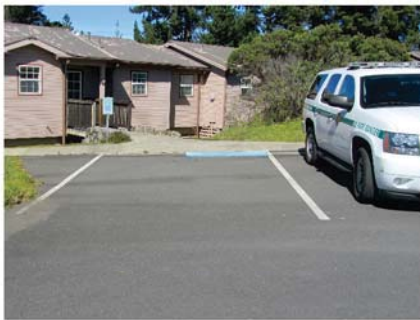
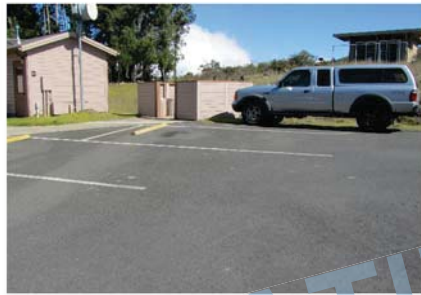
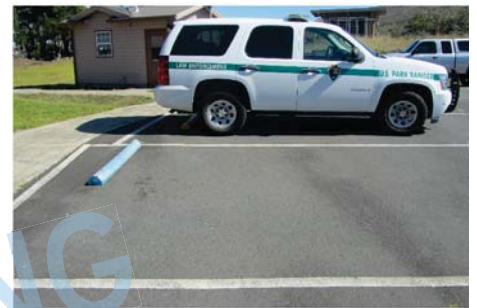
Route Number	Public / Non Public	Date Visited	Area (sq ft)	Lane Miles *	Surface Type
0908AZ	NONPUBLIC	1/13/2012	1310	0.023	AS
Culverts	Drop Inlets	Gates	Curb & Gutter	Curb	PCR
0	0	0	NO	NO	90 GOOD

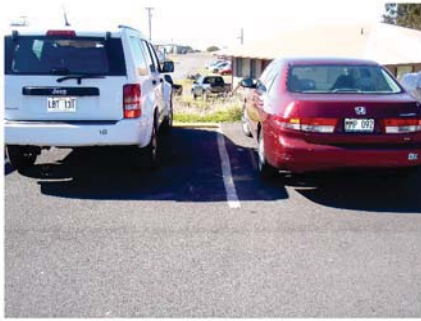
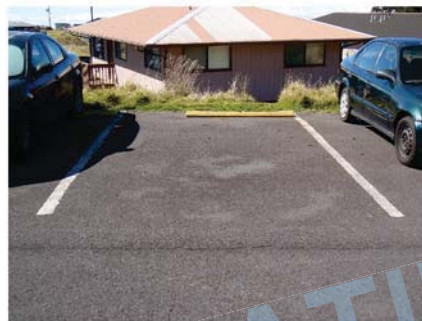
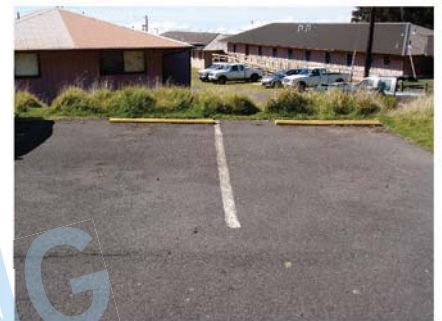
Route Number	Public / Non Public	Date Visited	Area (sq ft)	Lane Miles *	Surface Type
0908BZ	NONPUBLIC	1/13/2012	1729	0.03	AS
Culverts	Drop Inlets	Gates	Curb & Gutter	Curb	PCR
0	0	0	NO	NO	73 FAIR

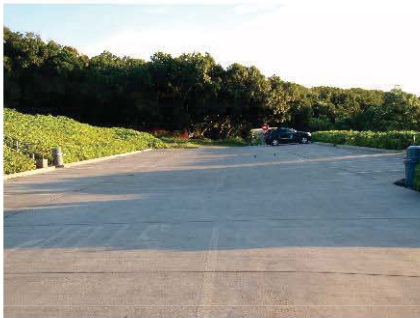
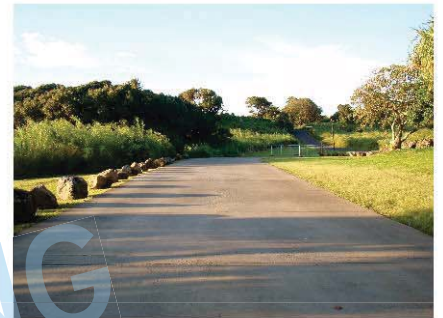
Haleakala National Park Route 0910 KIPAHULU VISITOR CENTER PARKING

Route Number	Public / Non Public	Date Visited	Area (sq ft)	Lane Miles *	Surface Type
0910	PUBLIC	1/14/2012	50288	0.866	CO
Culverts	Drop Inlets	Gates	Curb & Gutter	Curb	PCR
0	1	1	NO	CONCRETE	90 GOOD

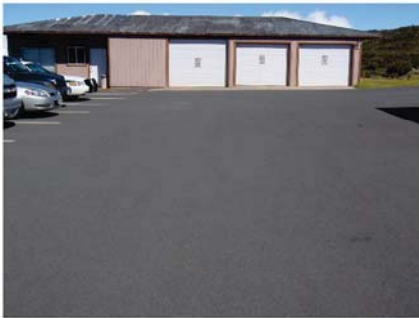
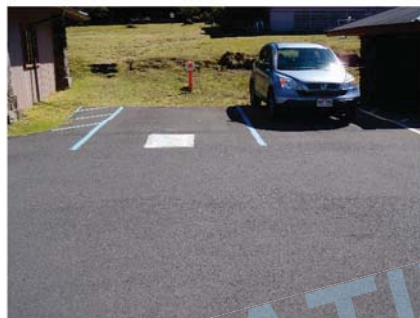
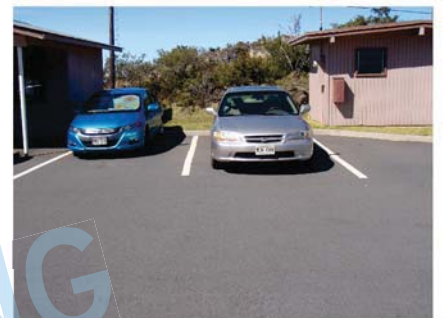
Route Number	Public / Non Public	Date Visited	Area (sq ft)	Lane Miles *	Surface Type
0913	NONPUBLIC	1/13/2012	11492	0.198	AS
Culverts	Drop Inlets	Gates	Curb & Gutter	Curb	PCR
0	0	0	NO	CONCRETE	90 GOOD
