Federal Lands Highway Road Inventory Program

Road Inventory and Condition Assessment

Hampton National Historic Site

Cycle 5 Report

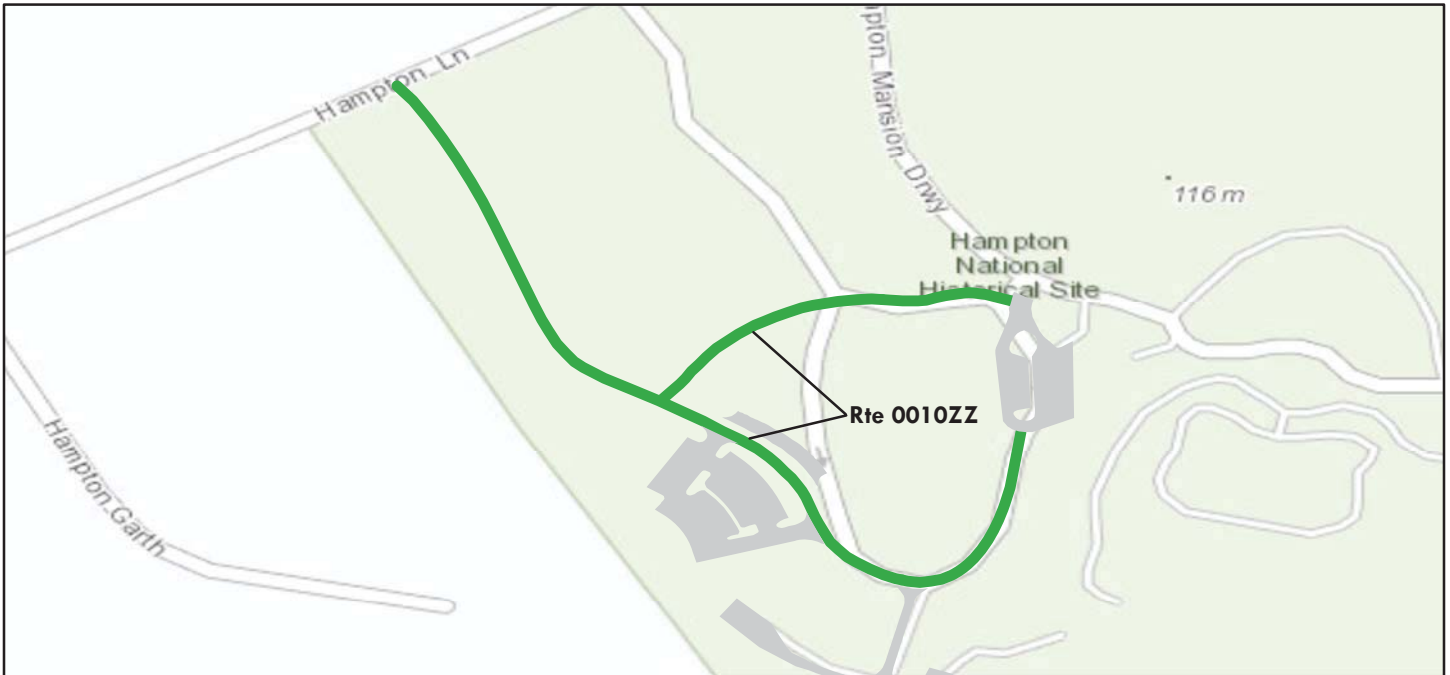
SUMMARY ROUTE

Route Condition Legend – Pavement Condition Rating (PCR)										
Poor	(0 - 60)	Fair	(61 - 84)	Good	(85 - 94)	Excellent	(95 - 100)	No Data		N ↑
See Appendix for definitions and formulas										
Inspection Date:	7/30/2014	Section Number								
Paved Length (Miles):	0.33	Section Length (MI)								
Surface Type:	ASPHALT	Route Summary								
Roadway Condition Information										
Pavement Condition Rating (PCR)	87									
Surface Condition Rating (SCR)	87									
Roughness Condition Index (RCI)	N/A									
Distress Index Values										
Structural Crack Index	87									
Transverse Cracking Index	100									
Patching Index	100									
Rutting Index	93									
International Roughness Index (IRI)	N/A									
Lane & Width Information										
Number of Lanes	2									
Paved Width (ft)	20									
Lane Width (ft)	10

The condition shown on this page reflects the overall condition; it might not reflect individual subcomponent ratings.

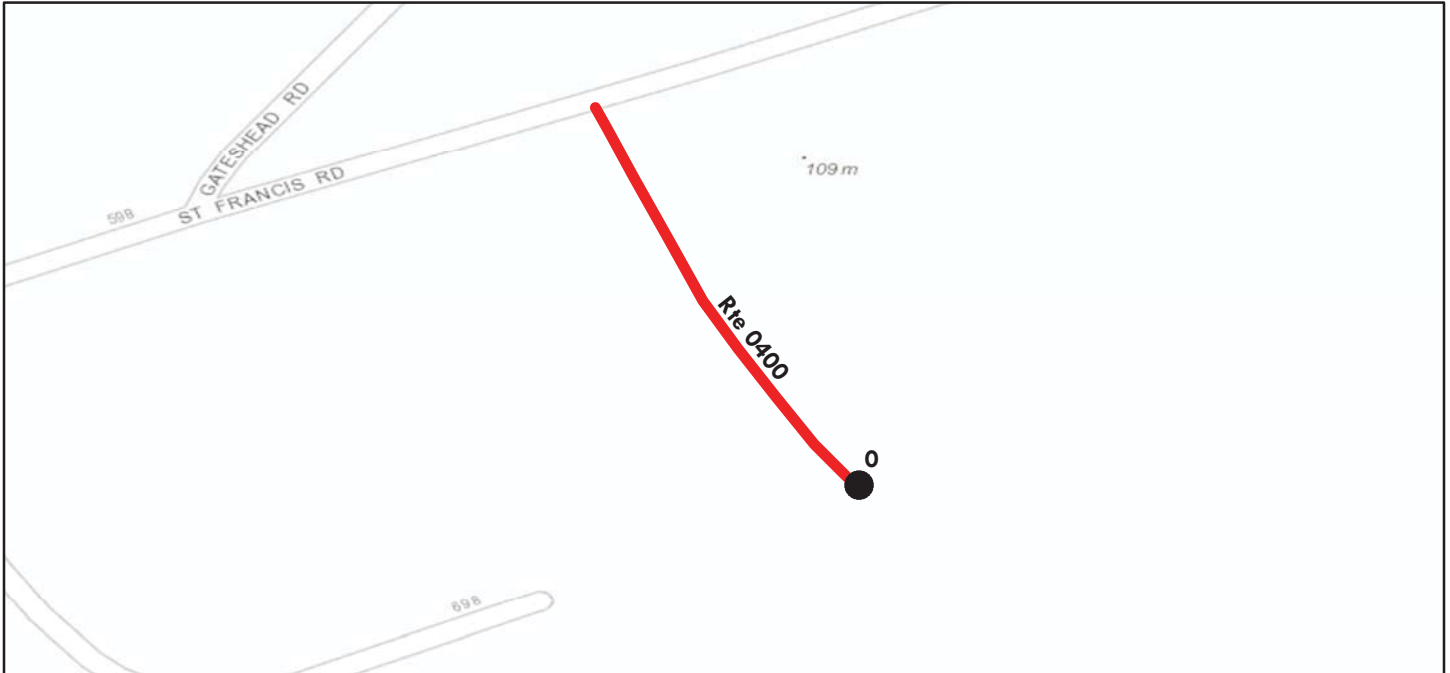
ROUTE 0400: FARM ROAD

Route Condition Legend – Pavement Condition Rating (PCR)										
Poor	(0 - 60)	Fair	(61 - 84)	Good	(85 - 94)	Excellent	(95 - 100)	No Data		N ↑
See Appendix for definitions and formulas										
Inspection Date:	7/30/2014	Section Number	0							
Paved Length (Miles):	0.09	Section Length (MI)	0.09							
Surface Type:	ASPHALT	Route Summary								
Roadway Condition Information										
Pavement Condition Rating (PCR)		30	30							
Surface Condition Rating (SCR)		30	30							
Roughness Condition Index (RCI)		N/A	N/A							
Distress Index Values										
Structural Crack Index		N/A	N/A							
Transverse Cracking Index		53	53							
Patching Index		53	53							
Rutting Index		53	53							
International Roughness Index (IRI)		N/A	N/A							
Lane & Width Information										
Number of Lanes		2	2							
Paved Width (ft)		17	17							
Lane Width (ft)		8.5	8.5

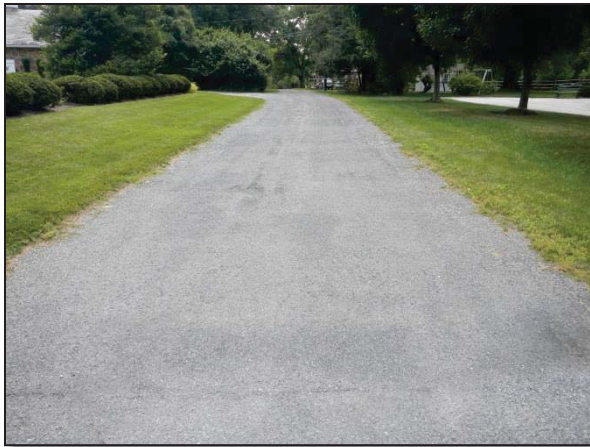
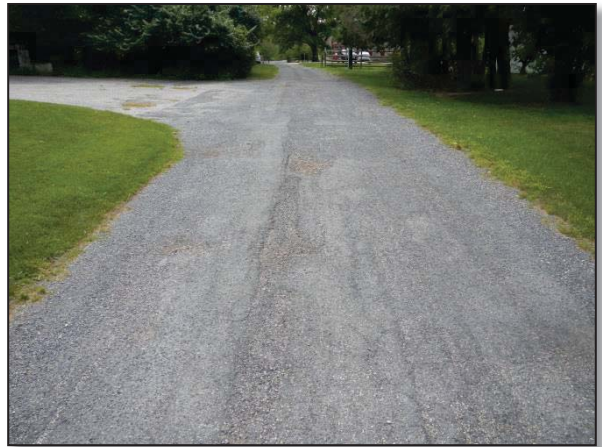
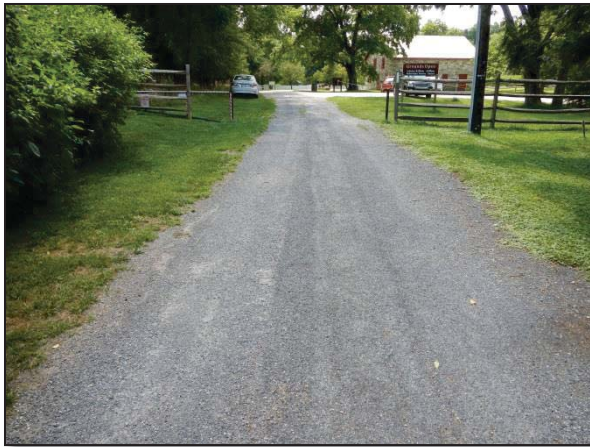
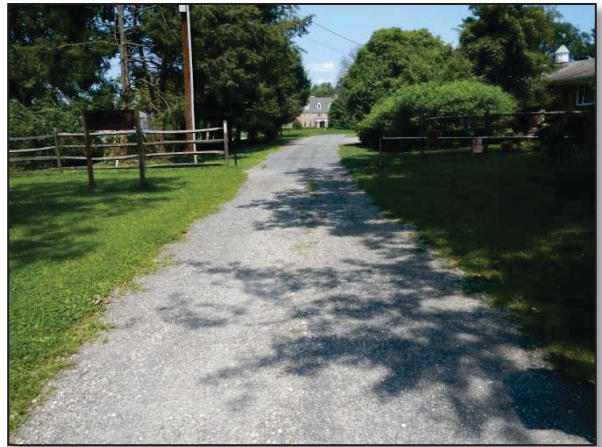
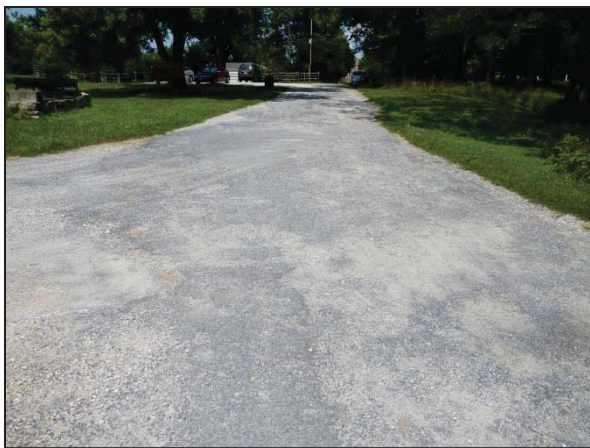
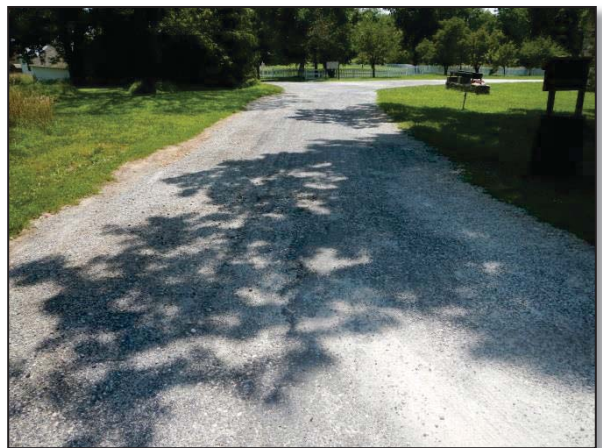
Hampton National Historic Site
ROUTE 0400: FARM ROAD
Condition Photos

ROUTE NUMBER	ROUTE NAME	FUNCTIONAL CLASS	PAVED LENGTH	SURFACE TYPE	AVERAGE SURFACE CONDITION RATING (SCR)	AVERAGE PAVEMENT CONDITION RATING (PCR)
0010ZZ	MAIN ENTRANCE ROAD	1	0.33	ASPHALT	87	87
0400	FARM ROAD	1	0.09	ASPHALT	30	30

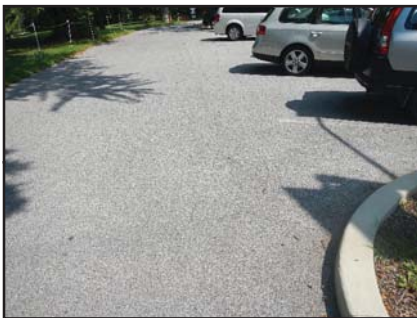
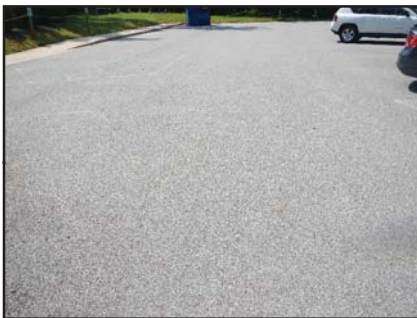
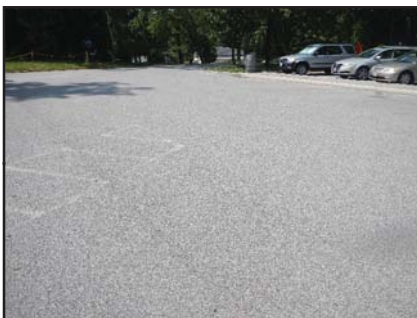
Inspection Date	FMSS Number	User Access	Surface Type
7/30/2014	107554	PUBLIC	ASPHALT
Area (Sq. Ft.)	Lane Miles (11' Widths)	Curb Reveal (Inches)	Curb Recommendation
11,566	0.20	6	DO NOTHING
Curb Type		Curb & Gutter Type	
CONCRETE CURB		CONCRETE CURB AND GUTTER	
Culverts	Drop Inlets	Gates	
1	1	0	
Pavement Recommendation		Condition Rating / PCR	
PREVENTIVE MAINTENANCE		GOOD / 90

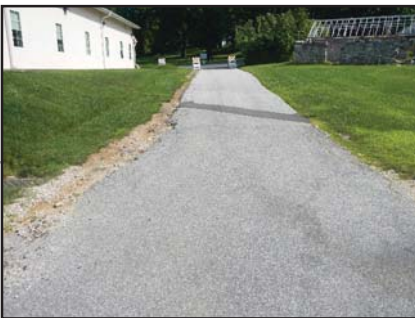
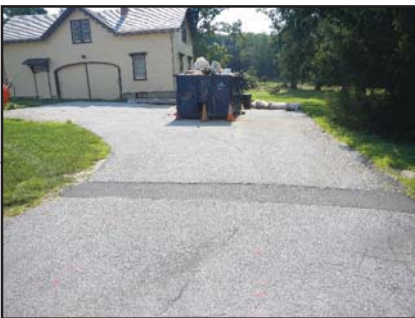
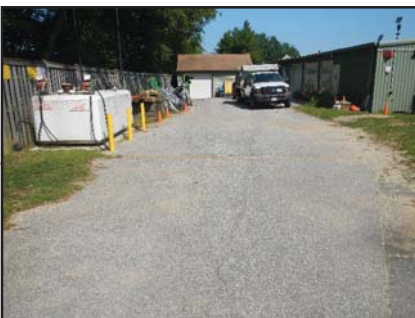
ROUTE 0902: GARDEN / MAINTENANCE AREA

Inspection Date	FMSS Number	User Access	Surface Type
7/30/2014	104709	NONPUBLIC	ASPHALT
Area (Sq. Ft.)	Lane Miles (11' Widths)	Curb Reveal (Inches)	Curb Recommendation
8,528	0.15	NOT APPLICABLE	NOT APPLICABLE
Curb Type		Curb & Gutter Type	
NO CURB		NO CURB AND GUTTER	
Culverts	Drop Inlets	Gates	
1	2	0	
Pavement Recommendation		Condition Rating / PCR	
HEAVY 3R TREATMENTS		POOR / 45

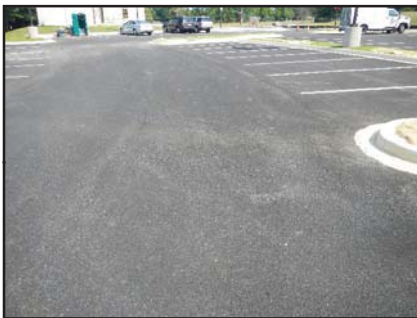
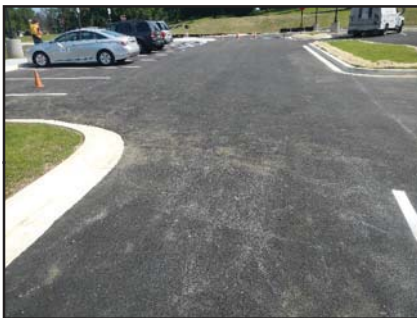
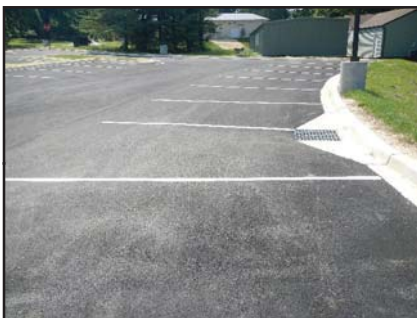
ROUTE 0903: LOWER VISITOR PARKING LOT

Inspection Date	FMSS Number	User Access	Surface Type
7/30/2014	94406	PUBLIC	ASPHALT
Area (Sq. Ft.)	Lane Miles (11' Widths)	Curb Reveal (Inches)	Curb Recommendation
19,102	0.33	NOT APPLICABLE	DO NOTHING
Curb Type		Curb & Gutter Type	
NO CURB		CONCRETE CURB AND GUTTER	
Culverts	Drop Inlets	Gates	
1	2	0	
Pavement Recommendation		Condition Rating / PCR	
DO NOTHING		EXCELLENT / 97

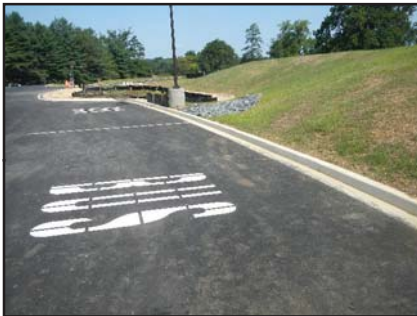
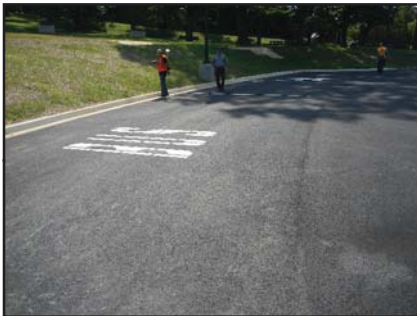
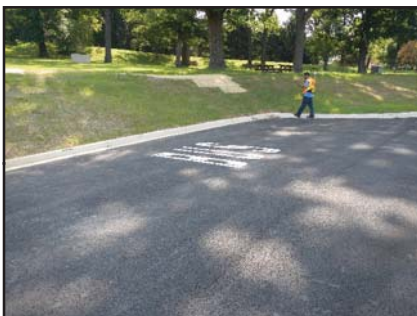
ROUTE 0907: TOUR BUS PARKING

Inspection Date	FMSS Number	User Access	Surface Type
7/30/2014	115871	PUBLIC	ASPHALT
Area (Sq. Ft.)	Lane Miles (11' Widths)	Curb Reveal (Inches)	Curb Recommendation
2,680	0.05	NOT APPLICABLE	DO NOTHING
Curb Type		Curb & Gutter Type	
NO CURB		CONCRETE CURB AND GUTTER	
Culverts	Drop Inlets	Gates	
0	0	0	
Pavement Recommendation		Condition Rating / PCR	
DO NOTHING		EXCELLENT / 97
