# Federal Lands Highway Road Inventory Program

Road Inventory and Condition Assessment

## Horseshoe Bend National Military Park HOBE

### Cycle 5 Report

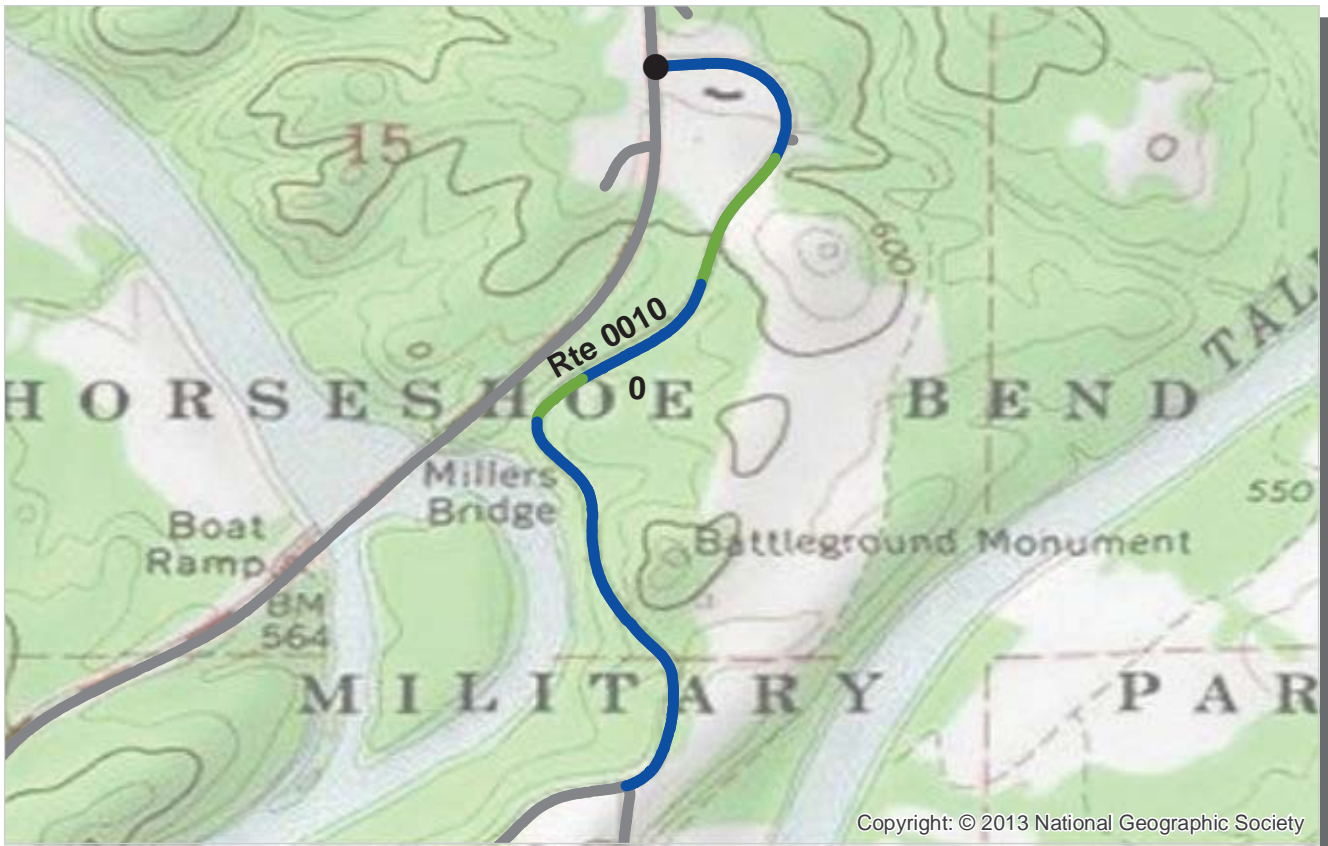
**ROUTE: 0010 TOUR ROAD**

<b>Section Number</b>	0				
<b>Section Length (mi)</b>	0.93				
<b>Cross Section Information</b>					
Number of Lanes	2				
Paved Width (ft)	20				
Lane Width (ft)	10				
<b>Roadway Condition Information</b>					
SCR (Surface Condition Rating)	95				
PCR (Pavement Condition Rating)	95				
<b>Distress Index Values</b>					
Structural Crack Index	100				
Transverse Cracking Index	100				
Patching Index	100				
Rutting Index	95				
Roughness Condition Index (RCI)	NC

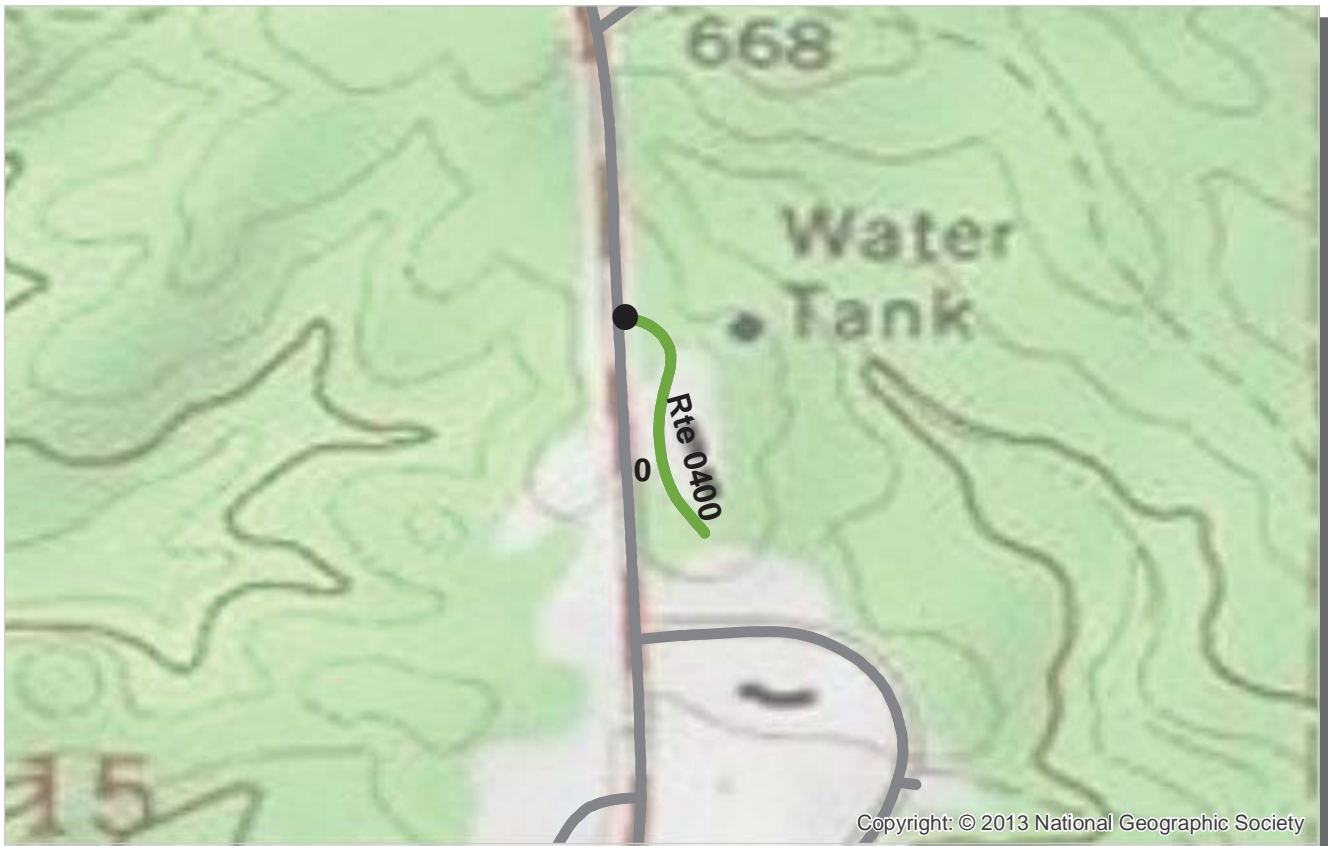
**ROUTE: 0400 QUARTERS DRIVEWAY**

<b>Section Number</b>	0				
<b>Section Length (mi)</b>	0.12				
<b>Cross Section Information</b>					
Number of Lanes	2				
Paved Width (ft)	20				
Lane Width (ft)	10				
<b>Roadway Condition Information</b>					
SCR (Surface Condition Rating)	94				
PCR (Pavement Condition Rating)	94				
<b>Distress Index Values</b>					
Structural Crack Index	99				
Transverse Cracking Index	100				
Patching Index	100				
Rutting Index	94				
Roughness Condition Index (RCI)	NC

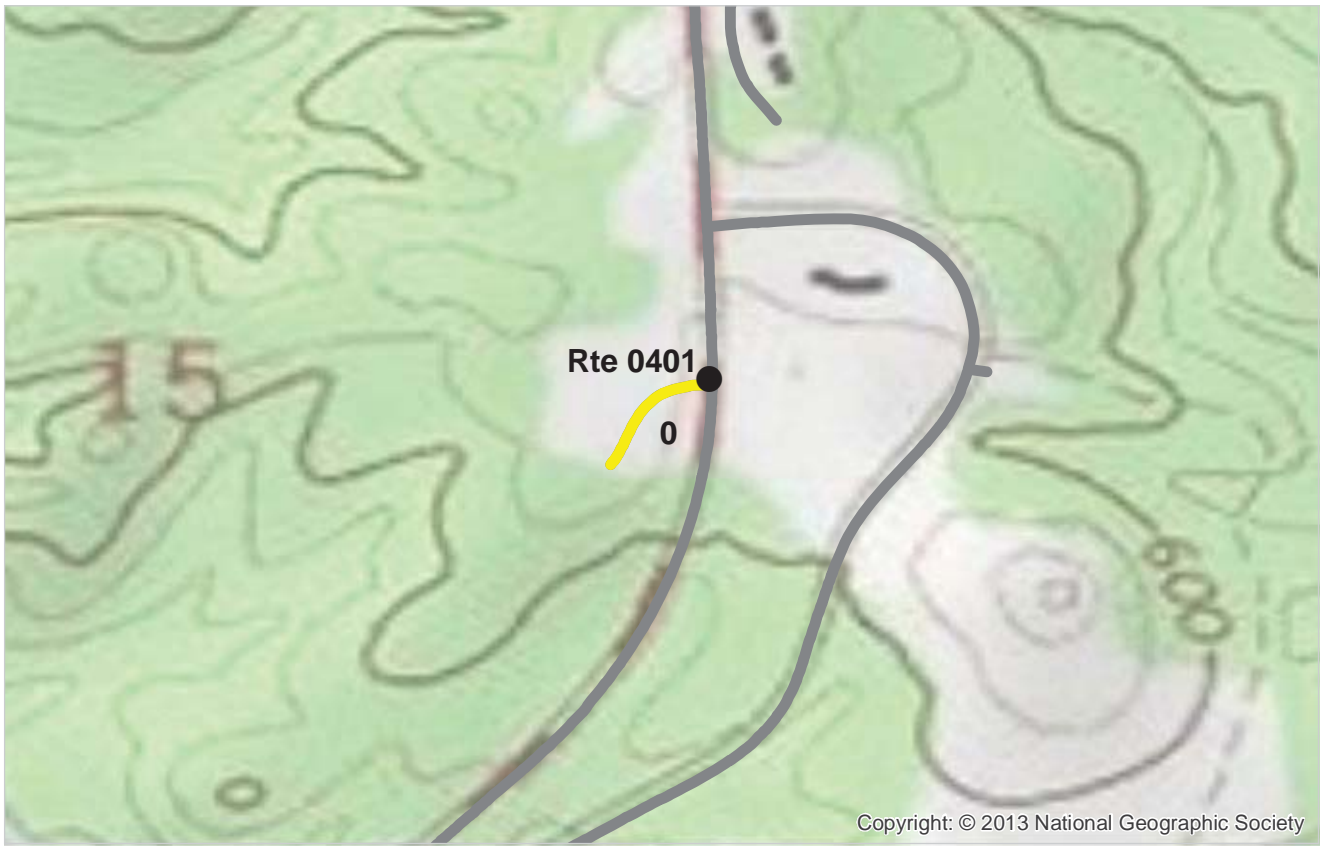
**ROUTE: 0401 MAINTENANCE DRIVE**

<b>Section Number</b>	0				
<b>Section Length (mi)</b>	0.06				
<b>Cross Section Information</b>					
Number of Lanes	1				
Paved Width (ft)	11				
Lane Width (ft)	11				
<b>Roadway Condition Information</b>					
SCR (Surface Condition Rating)	82				
PCR (Pavement Condition Rating)	82				
<b>Distress Index Values</b>					
Structural Crack Index	94				
Transverse Cracking Index	91				
Patching Index	98				
Rutting Index	82				
Roughness Condition Index (RCI)	NC

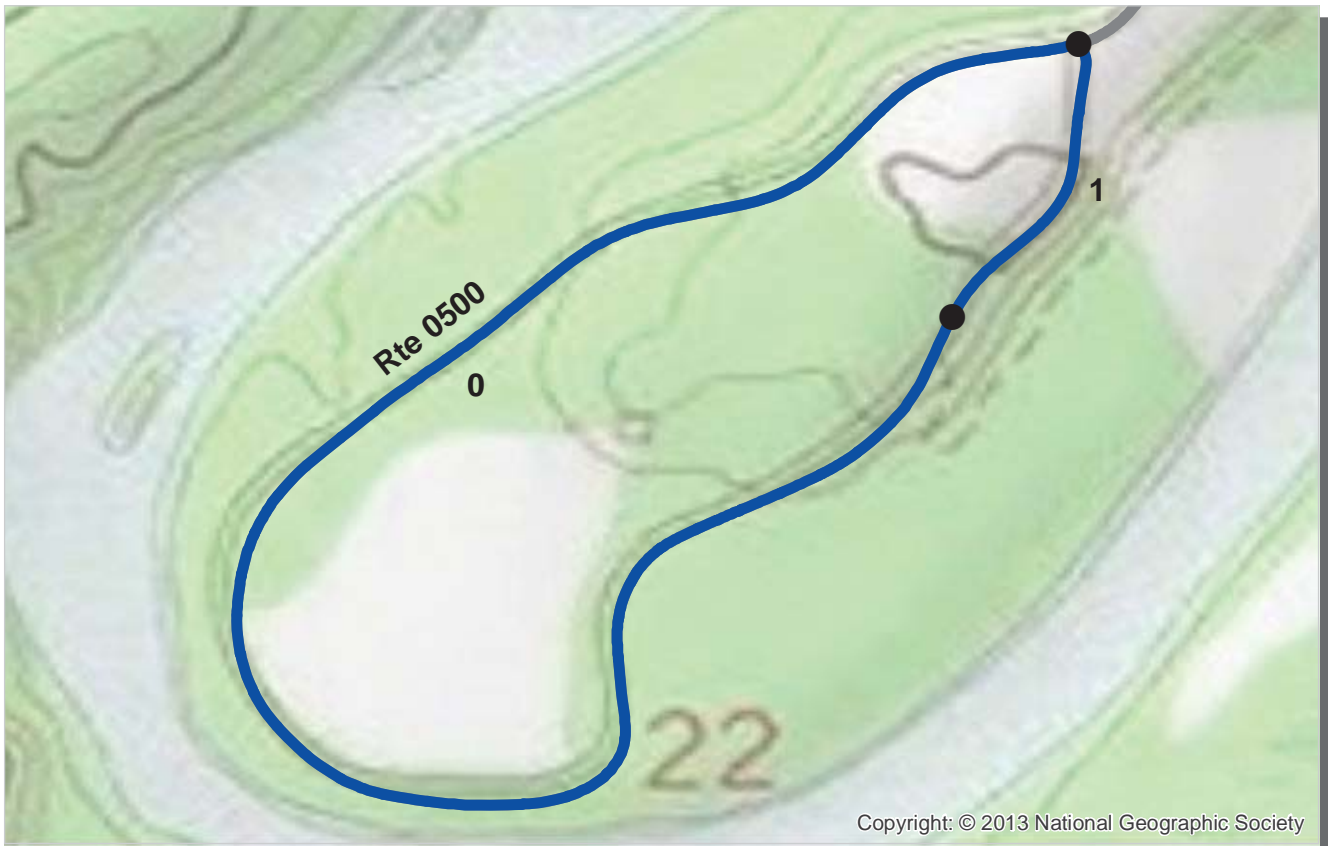
**ROUTE: 0500 ONE WAY LOOP TOUR ROAD**

<i>Section Number</i>	0	1			
<i>Section Length (mi)</i>	1.00	0.15			
<i>Cross Section Information</i>					
Number of Lanes	1	1			
Paved Width (ft)	14	12			
Lane Width (ft)	14	12			
<i>Roadway Condition Information</i>					
SCR (Surface Condition Rating)	97	99			
PCR (Pavement Condition Rating)	97	99			
<i>Distress Index Values</i>					
Structural Crack Index	100	100			
Transverse Cracking Index	100	100			
Patching Index	100	100			
Rutting Index	97	99			
Roughness Condition Index (RCI)	NC	NC

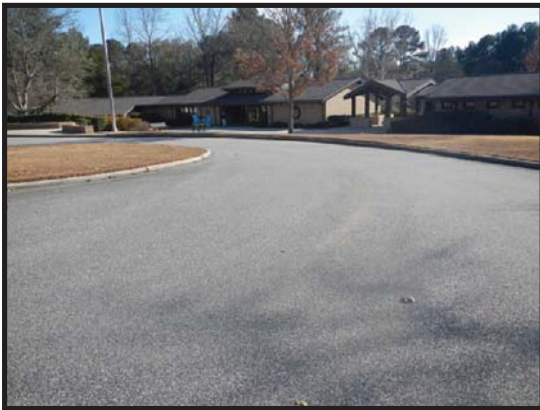
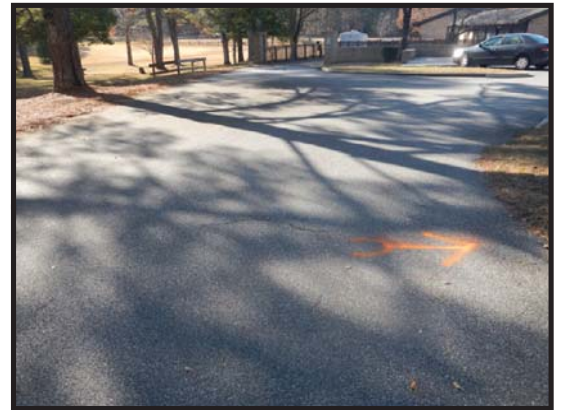
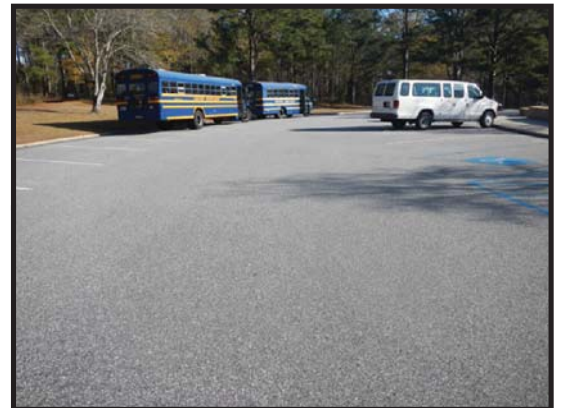
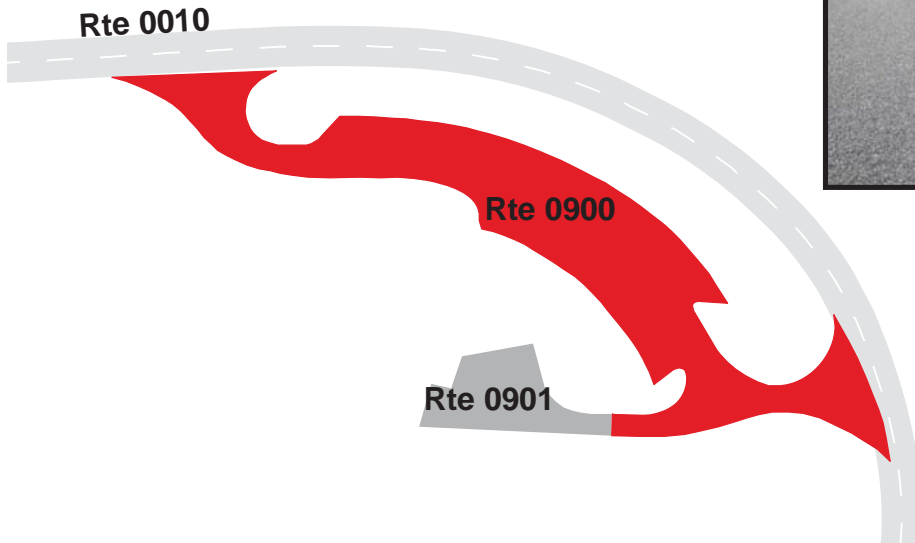
Route Number	Public / NonPublic	Date Visited	Area (sq ft)	Lane Miles *	Surface Type
0900	PUBLIC	12/1/2012	20,468	0.35	AS
Culverts	Drop Inlets	Gates	Curb & Gutter	Curb	PCR
1	3	0	NO CURB AND GUTTER	CONCRETE CURB	GOOD/90

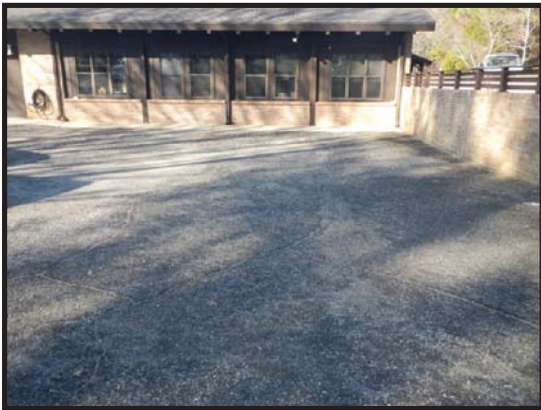
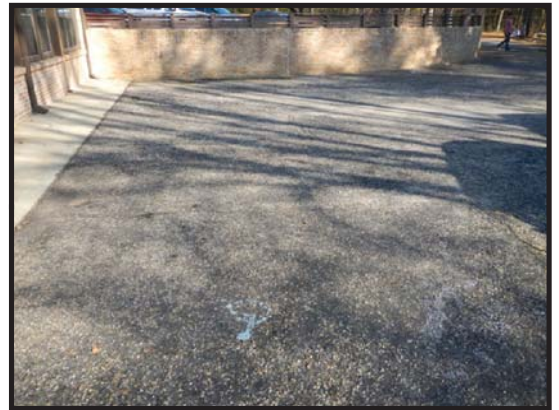
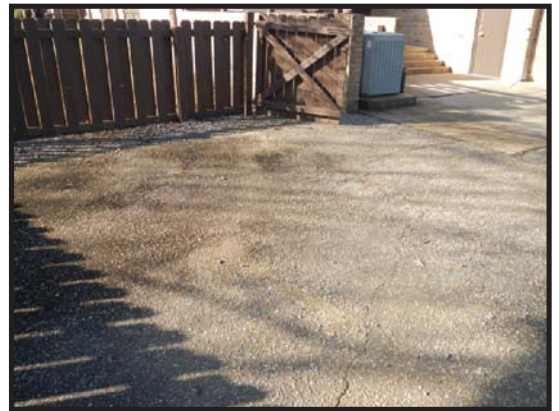
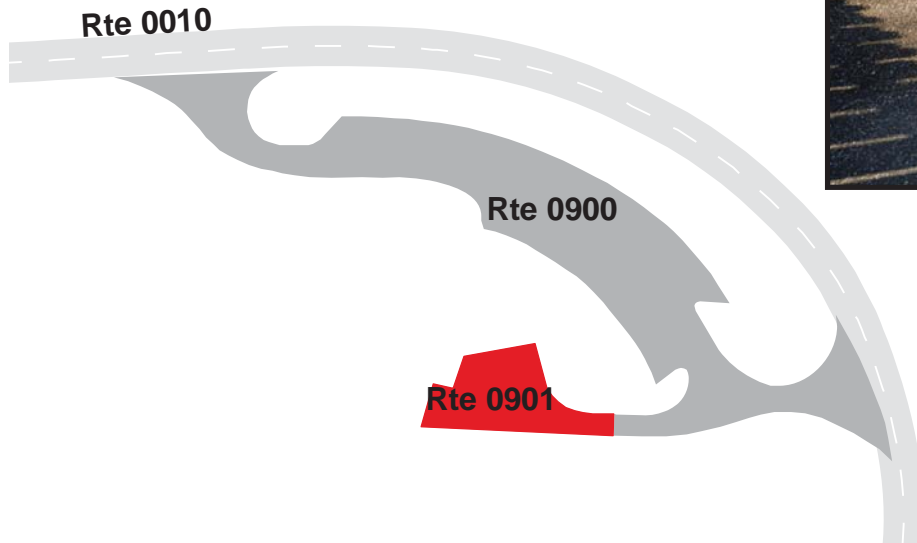
## Route 0901

Route Number	Public / NonPublic	Date Visited	Area (sq ft)	Lane Miles *	Surface Type
0901	NONPUBLIC	12/1/2012	3,497	0.06	AS
Culverts	Drop Inlets	Gates	Curb & Gutter	Curb	PCR
0	0	2	NO CURB AND GUTTER	NO CURB	POOR/45

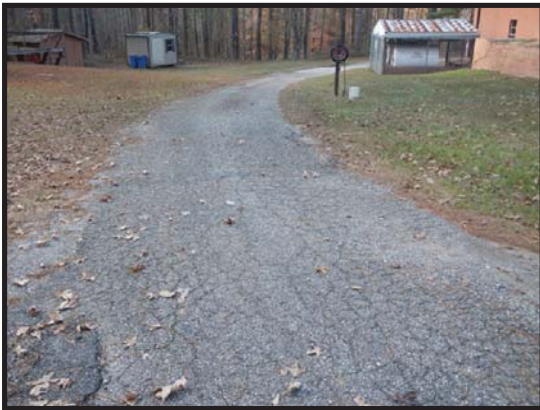
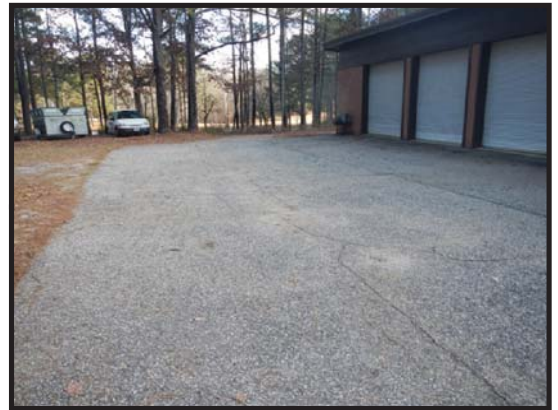
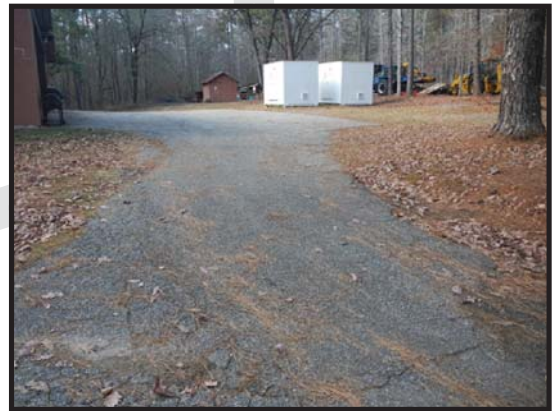
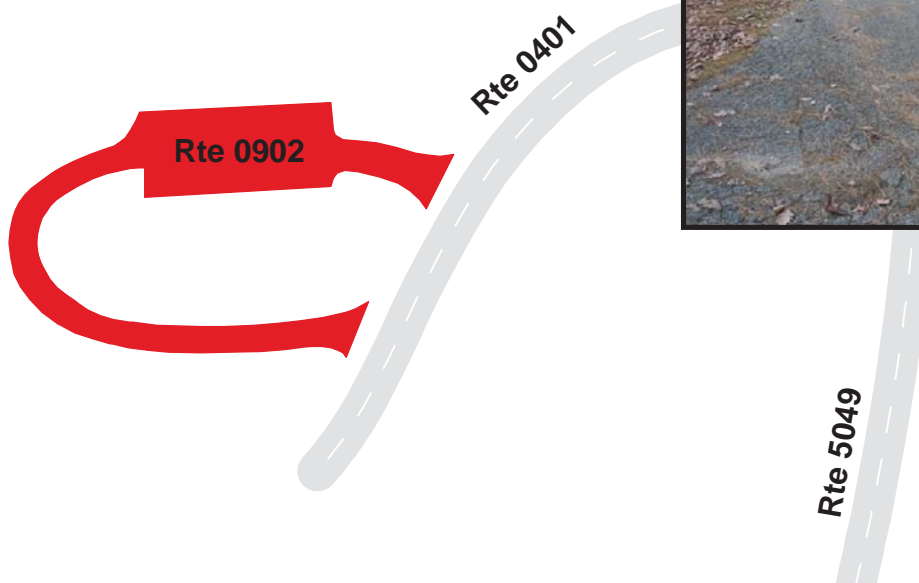
## Route 0902

Route Number	Public / NonPublic	Date Visited	Area (sq ft)	Lane Miles *	Surface Type
0902	NONPUBLIC	12/1/2012	5,547	0.10	AS
Culverts	Drop Inlets	Gates	Curb & Gutter	Curb	PCR
0	0	0	NO CURB AND GUTTER	NO CURB	POOR/45

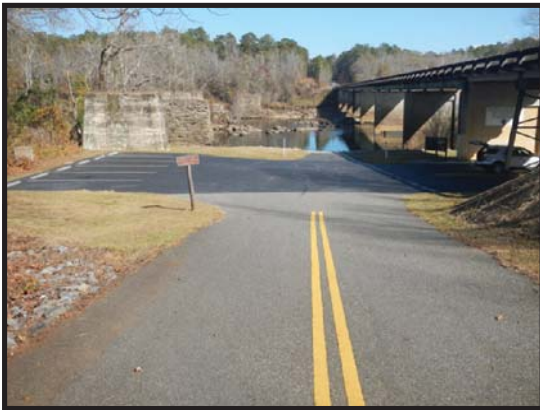
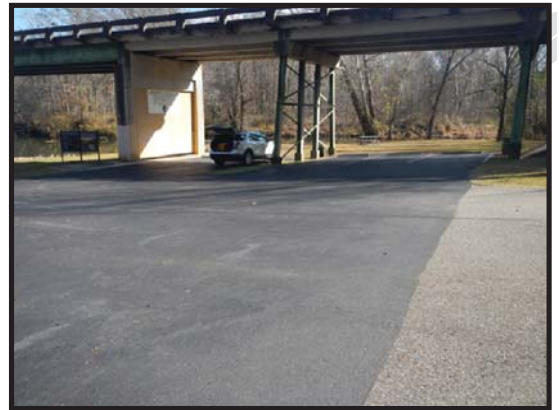
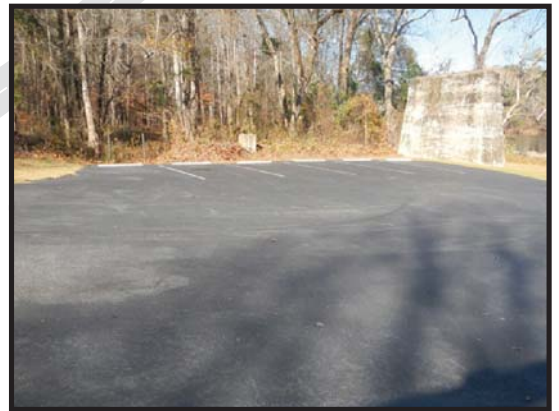
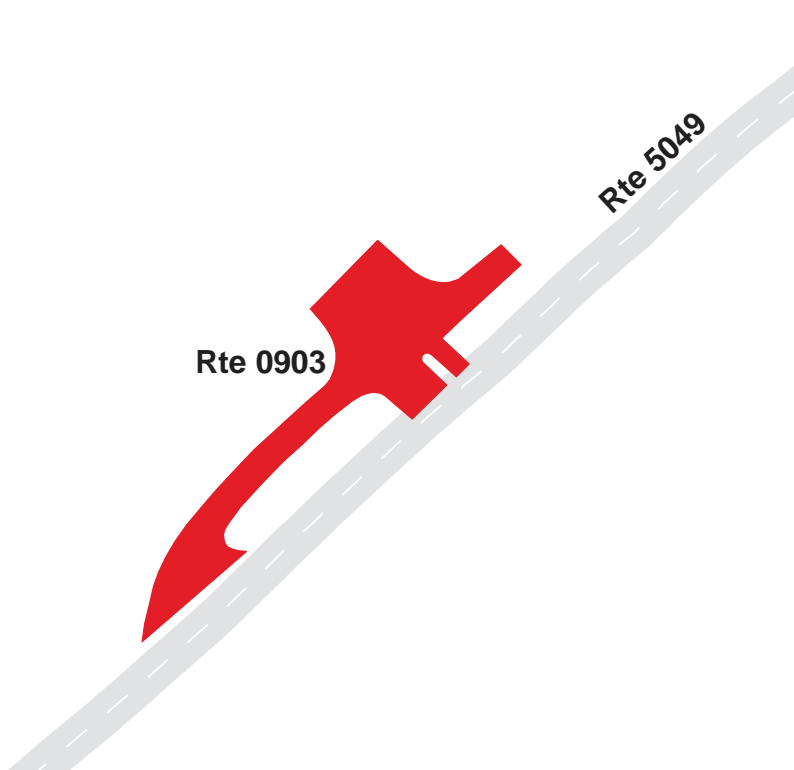
## Route 0903

Route Number	Public / NonPublic	Date Visited	Area (sq ft)	Lane Miles *	Surface Type
0903	PUBLIC	12/1/2012	10,283	0.18	AS
Culverts	Drop Inlets	Gates	Curb & Gutter	Curb	PCR
0	0	1	NO CURB AND GUTTER	NO CURB	FAIR/73

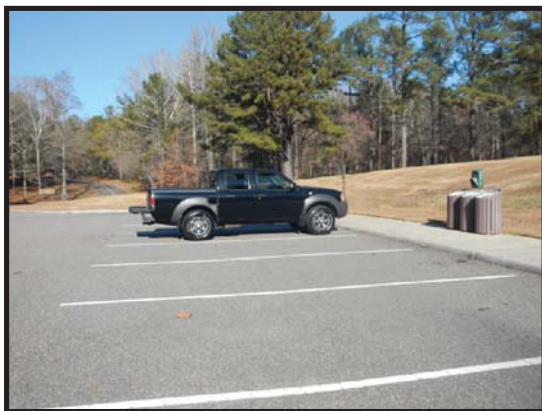
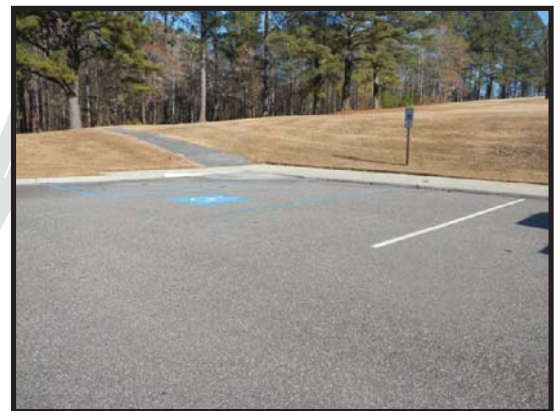
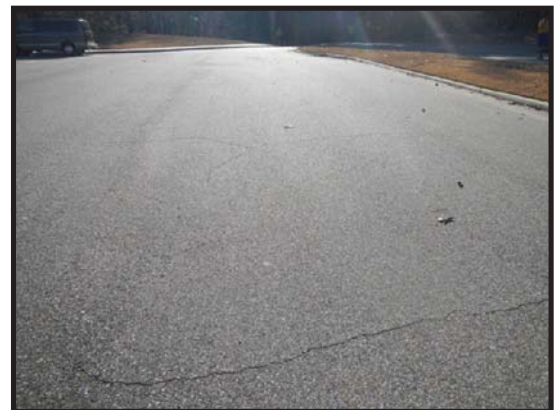
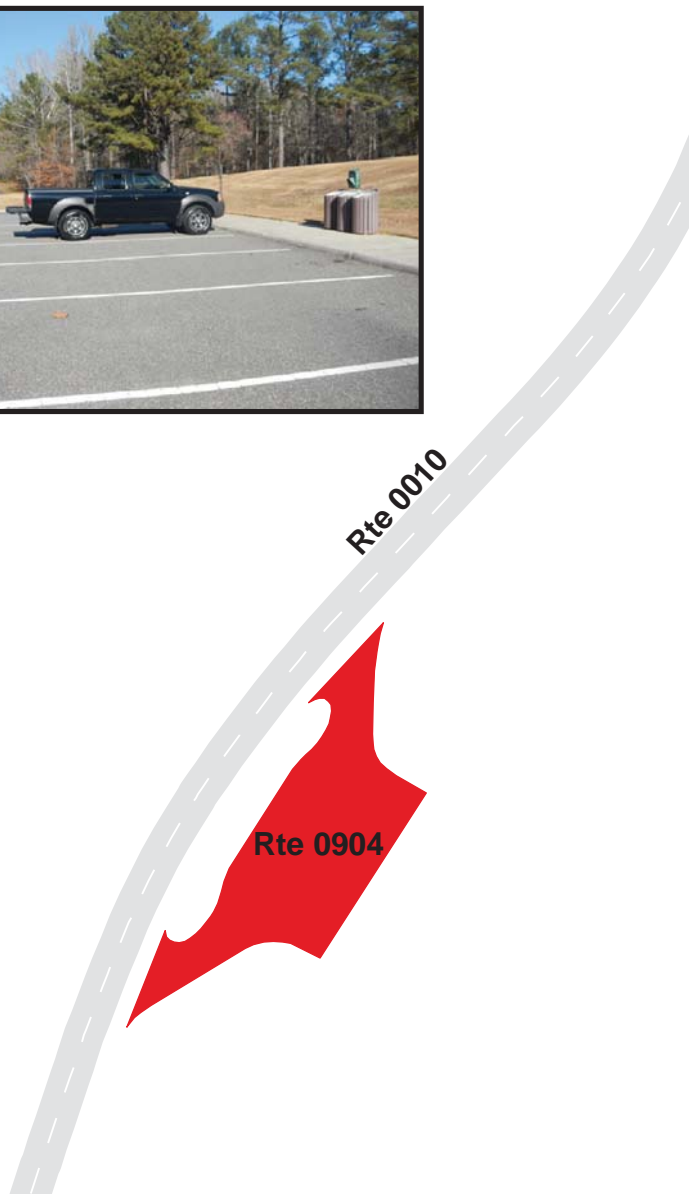
## Route 0904

Route Number	Public / NonPublic	Date Visited	Area (sq ft)	Lane Miles *	Surface Type
0904	PUBLIC	12/1/2012	8,538	0.15	AS
Culverts	Drop Inlets	Gates	Curb & Gutter	Curb	PCR
0	0	0	NO CURB AND GUTTER	CONCRETE CURB	GOOD/90

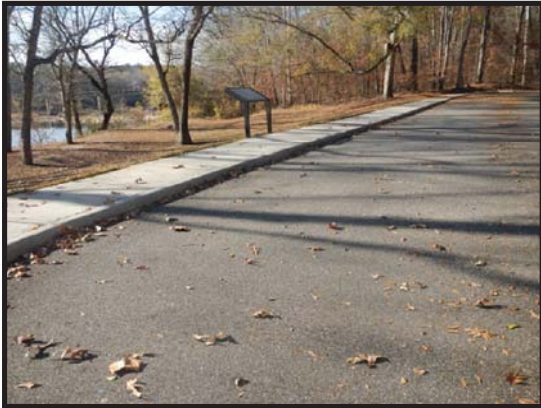
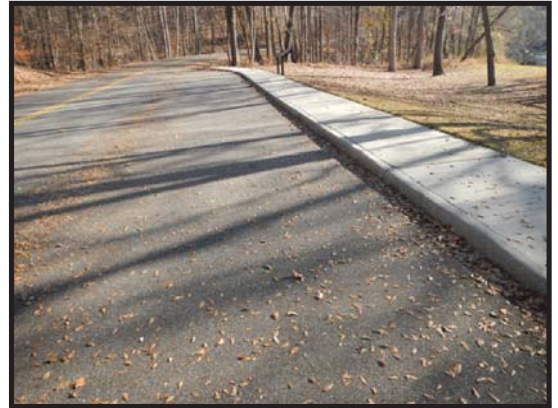
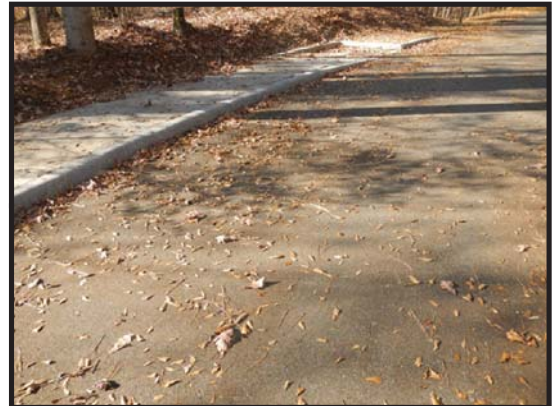
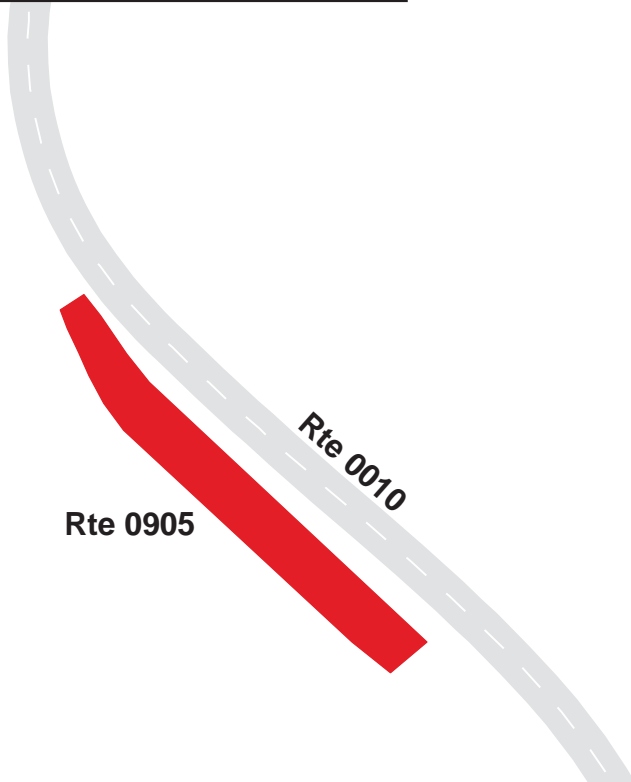
## Route 0905

Route Number	Public / NonPublic	Date Visited	Area (sq ft)	Lane Miles *	Surface Type
0905	PUBLIC	12/1/2012	3,815	0.07	AS
Culverts	Drop Inlets	Gates	Curb & Gutter	Curb	PCR
0	0	0	NO CURB AND GUTTER	CONCRETE CURB	GOOD/90

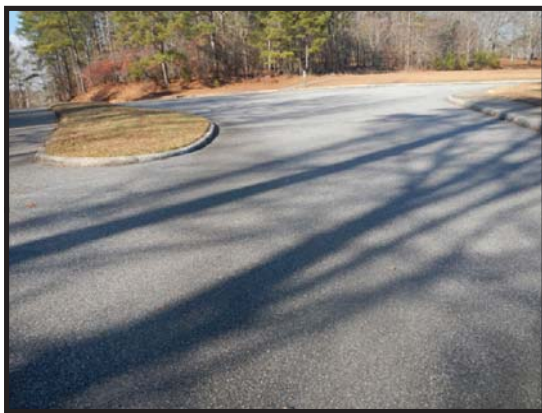
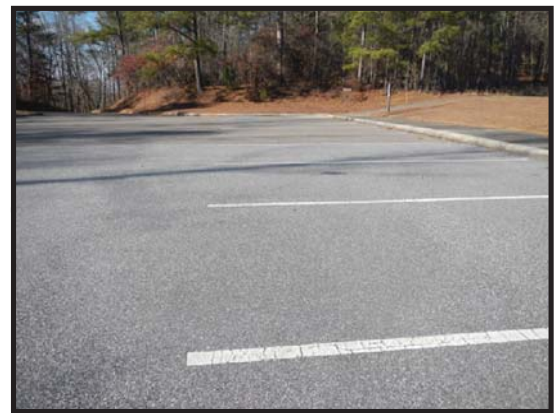
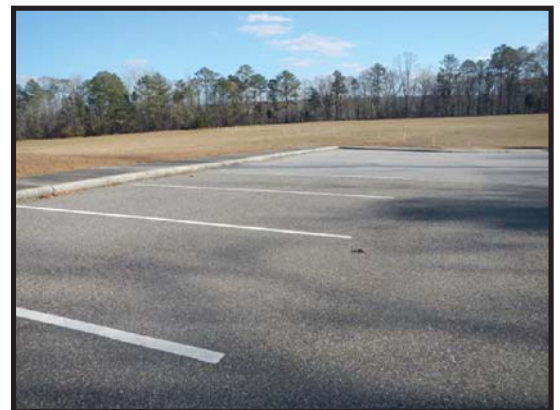
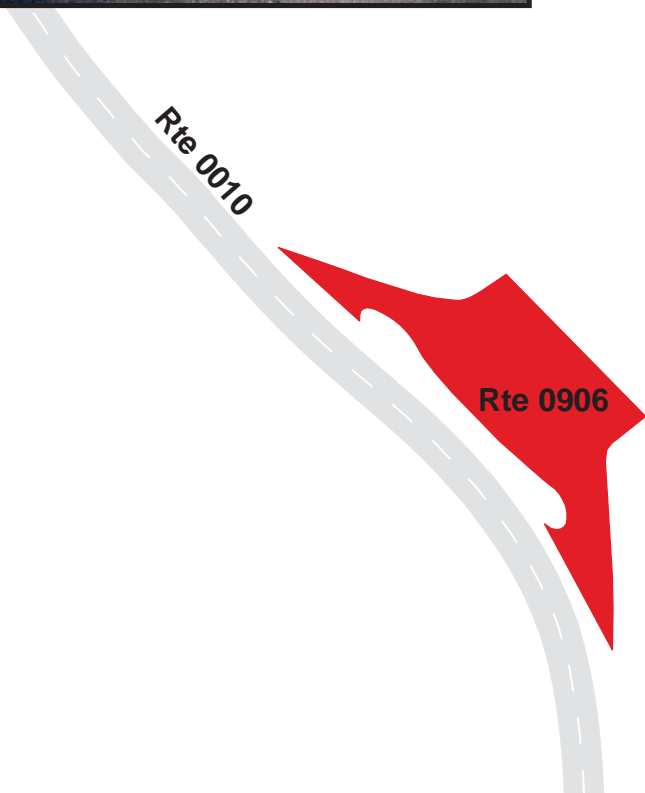
## Route 0906

Route Number	Public / NonPublic	Date Visited	Area (sq ft)	Lane Miles *	Surface Type
0906	PUBLIC	12/1/2012	8,856	0.15	AS
Culverts	Drop Inlets	Gates	Curb & Gutter	Curb	PCR
0	0	0	NO CURB AND GUTTER	CONCRETE CURB	GOOD/90

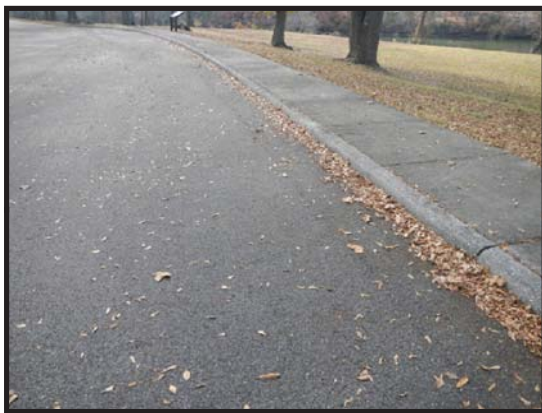
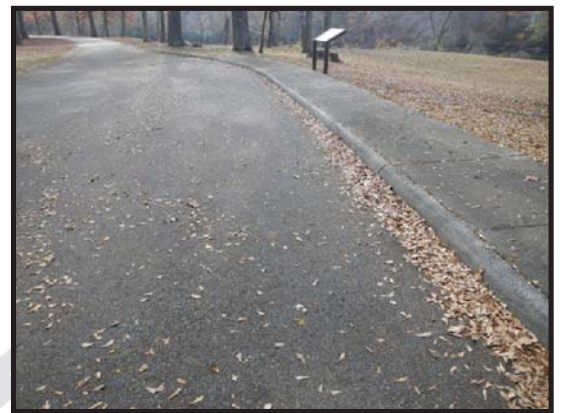
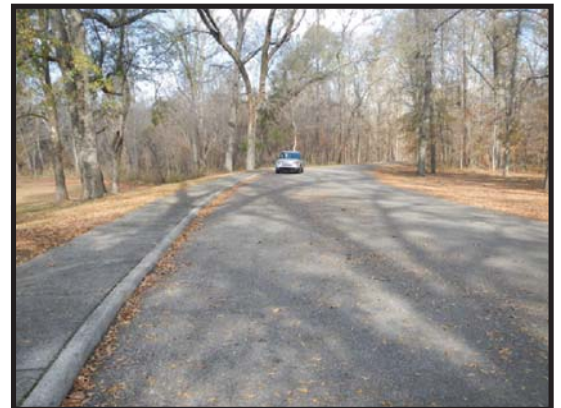
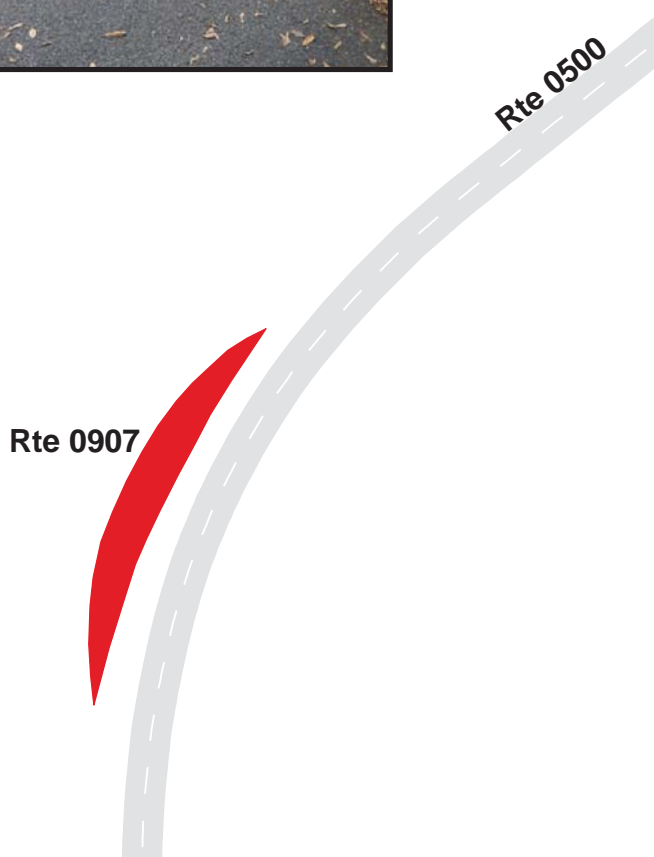
## Route 0907

Route Number	Public / NonPublic	Date Visited	Area (sq ft)	Lane Miles *	Surface Type
0907	PUBLIC	12/1/2012	4,506	0.08	AS
Culverts	Drop Inlets	Gates	Curb & Gutter	Curb	PCR
0	0	0	NO CURB AND GUTTER	CONCRETE CURB	GOOD/90

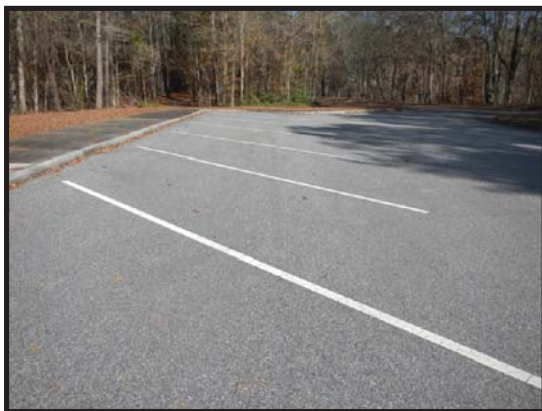
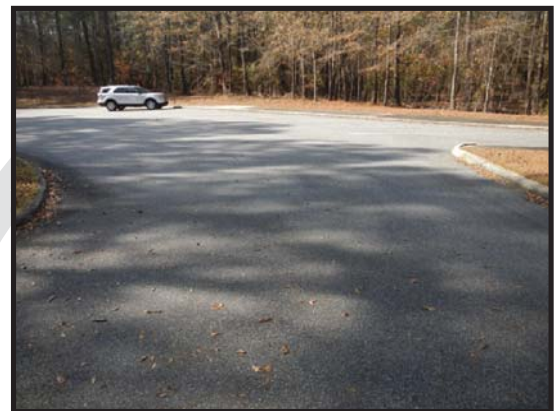
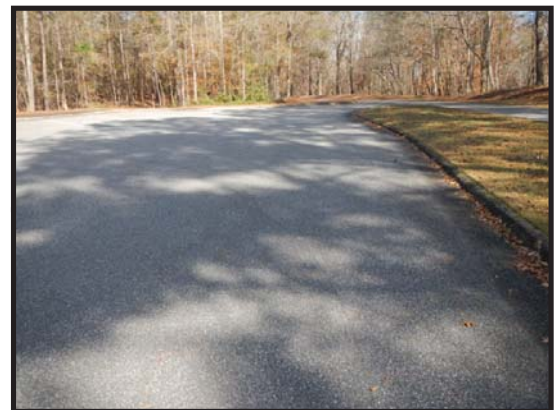
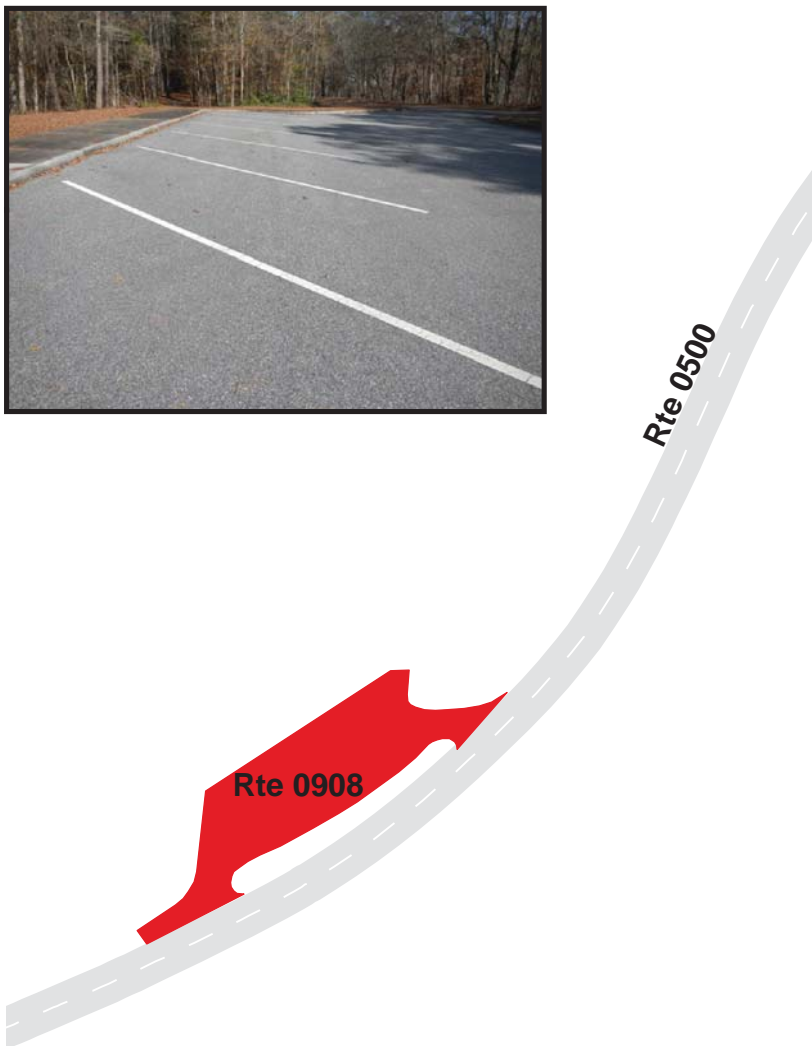
## Route 0908

Route Number	Public / NonPublic	Date Visited	Area (sq ft)	Lane Miles *	Surface Type
0908	PUBLIC	12/1/2012	9,456	0.16	AS
Culverts	Drop Inlets	Gates	Curb & Gutter	Curb	PCR
0	1	0	NO CURB AND GUTTER	CONCRETE CURB	GOOD/90

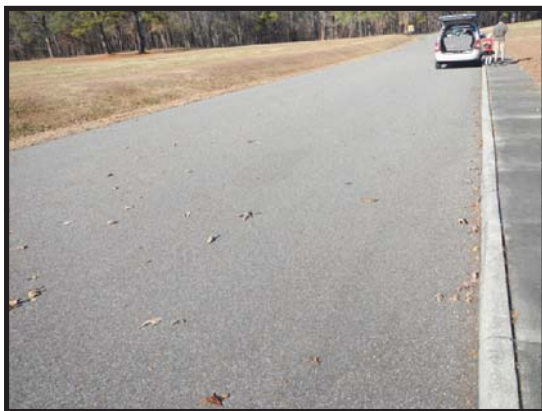
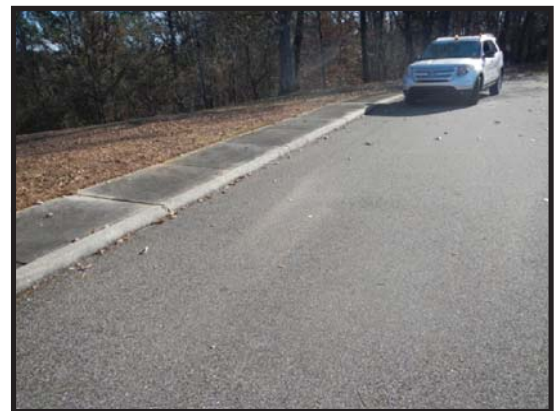
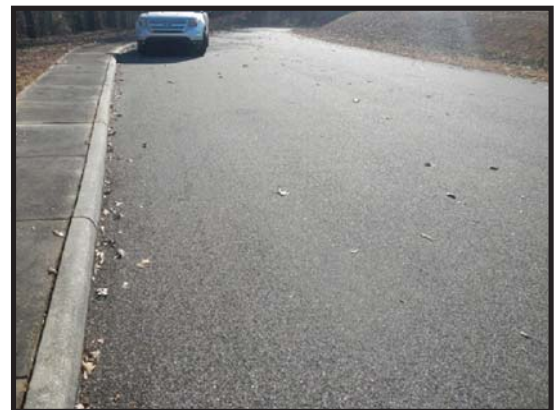
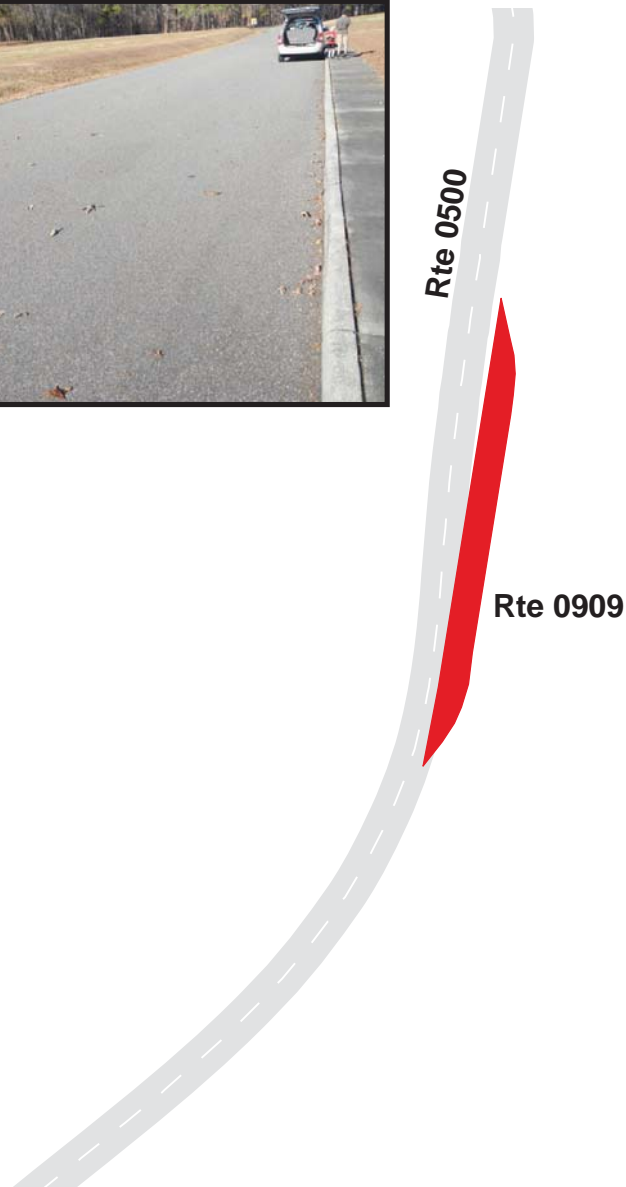
## Route 0909

Route Number	Public / NonPublic	Date Visited	Area (sq ft)	Lane Miles *	Surface Type
0909	PUBLIC	12/1/2012	1,817	0.03	AS
Culverts	Drop Inlets	Gates	Curb & Gutter	Curb	PCR
0	0	0	NO CURB AND GUTTER	CONCRETE CURB	GOOD/90
