Federal Lands Highway Road Inventory Program

Road Inventory and Condition Assessment

Hopewell Culture National Historical Park HOCU

Cycle 5 Report

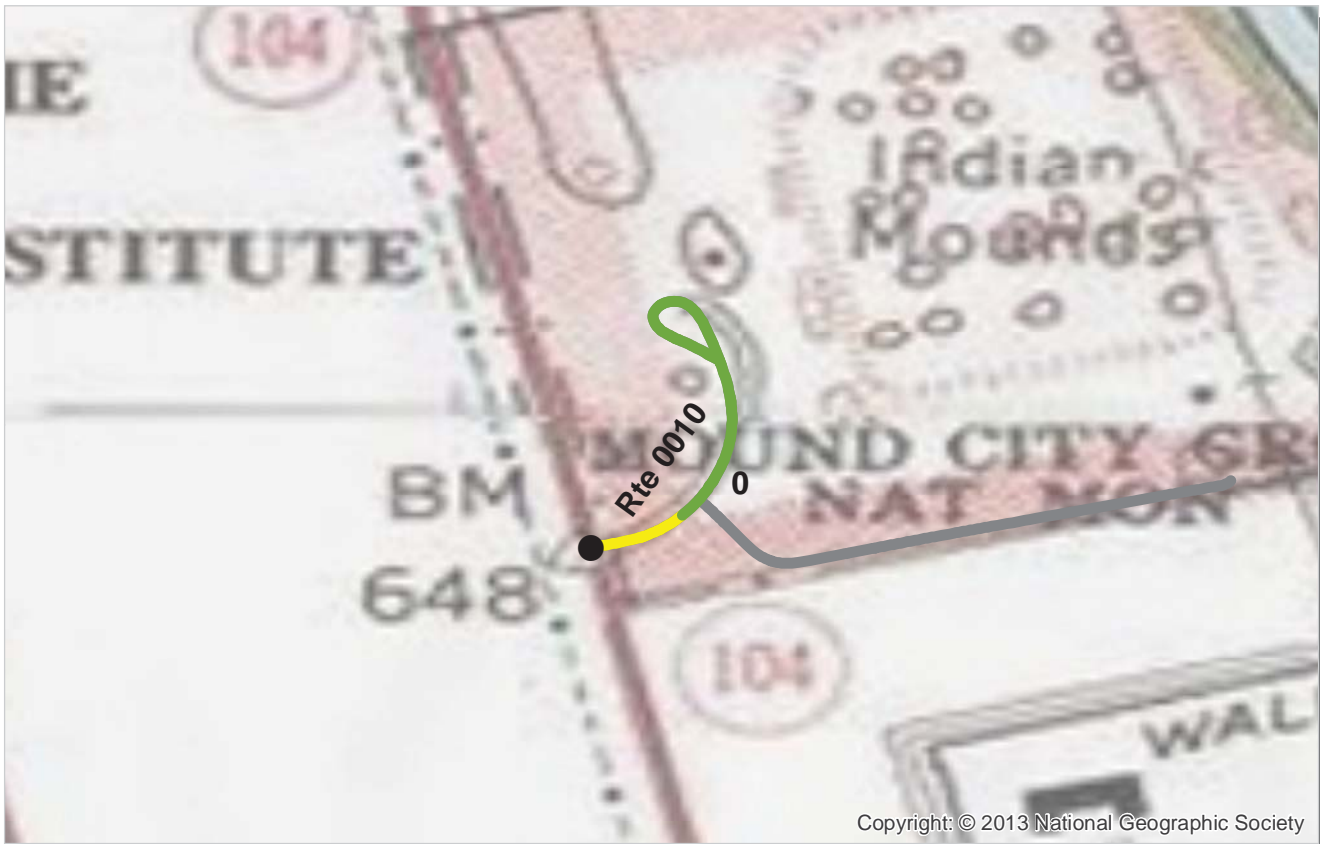
ROUTE: 0010 ENTRANCE ROAD MOUND CITY

| SCR (Surface Condition Rating) | 93 | | | | |
| PCR (Pavement Condition Rating) | 93 | | | | |
| Structural Crack Index | 96 | | | | |
| Transverse Cracking Index | 93 | | | | |

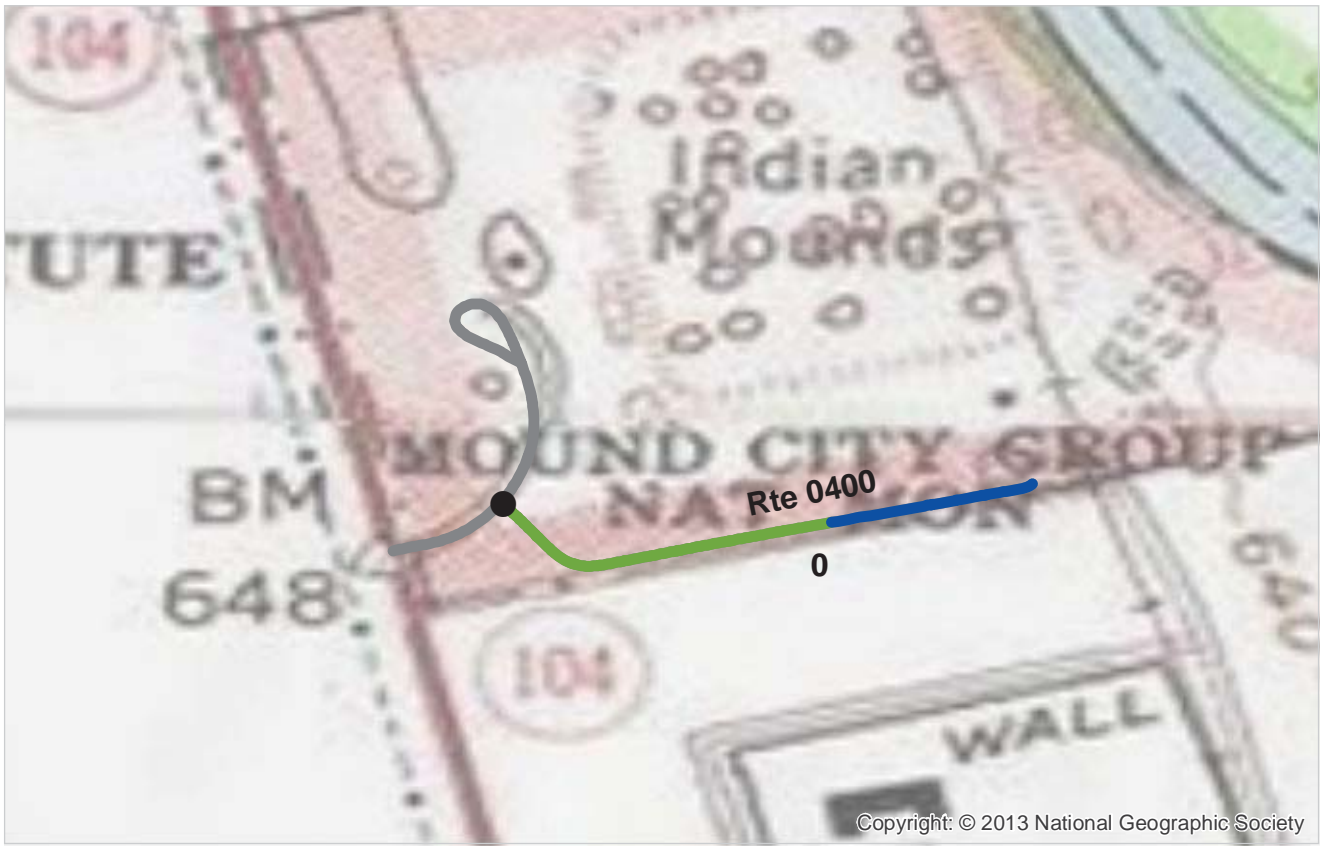
ROUTE: 0400 PORTSMOUTH ROAD

| SCR (Surface Condition Rating) | 95 | | | | |
| PCR (Pavement Condition Rating) | 95 | | | | |
| Structural Crack Index | 99 | | | | |
| Transverse Cracking Index | 96 | | | | |

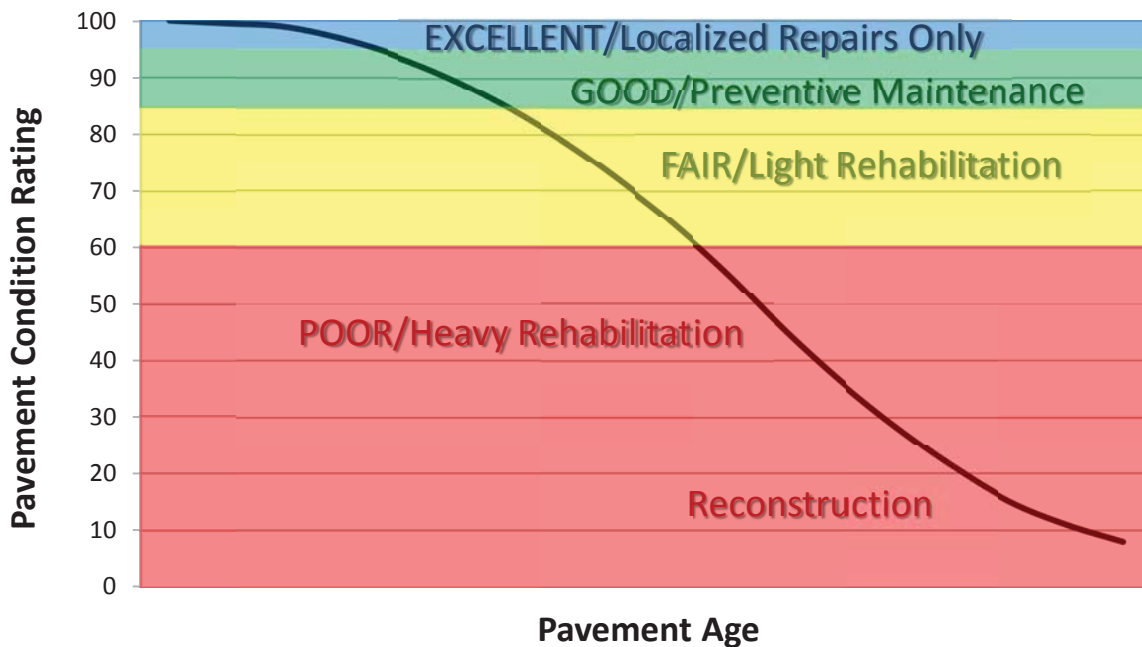
Condition Categories and Treatments

- Excellent/New: PCR of 95-100. Pavements in this range will require only spot repairs.
- Good: PCR of 85-94. Pavements in this range will likely be candidates for Preventive Maintenance. Examples include Chip and Slurry Seals, Micro Surfacing and Thin Overlays.
- Fair: PCR of 61-84. Pavements in this range will likely be candidates of Light Rehabilitation (L3R). Examples include single-lift overlays up to 2.5 inches in total thickness, milling and overlays.
- Poor: PCR of 60 or below. Pavements in this range will likely be candidates of Heavy Rehabilitation or Reconstruction (H3R or 4R). Examples include Pulverization, Multiple Lift Overlays, and Reconstruction.

Specific Maintenance and Rehabilitation activities should be evaluated and recommended at the project level. Site-specific conditions that influence treatment type should be determined based on performing a subsurface investigation and/or pavement condition survey, and not be based solely on RIP data. Additionally, RIP produces a snapshot of conditions the year in which the data was collected. For further information or to obtain additional Pavement Management System’s data from our Highway Pavement Management Application (HPMA) please contact the Eastern Federal Lands pavement team.
