Federal Lands Highway Road Inventory Program

Road Inventory and Condition Assessment

Home of Franklin D. Roosevelt National Historic Site HOFR

Cycle 5 Report

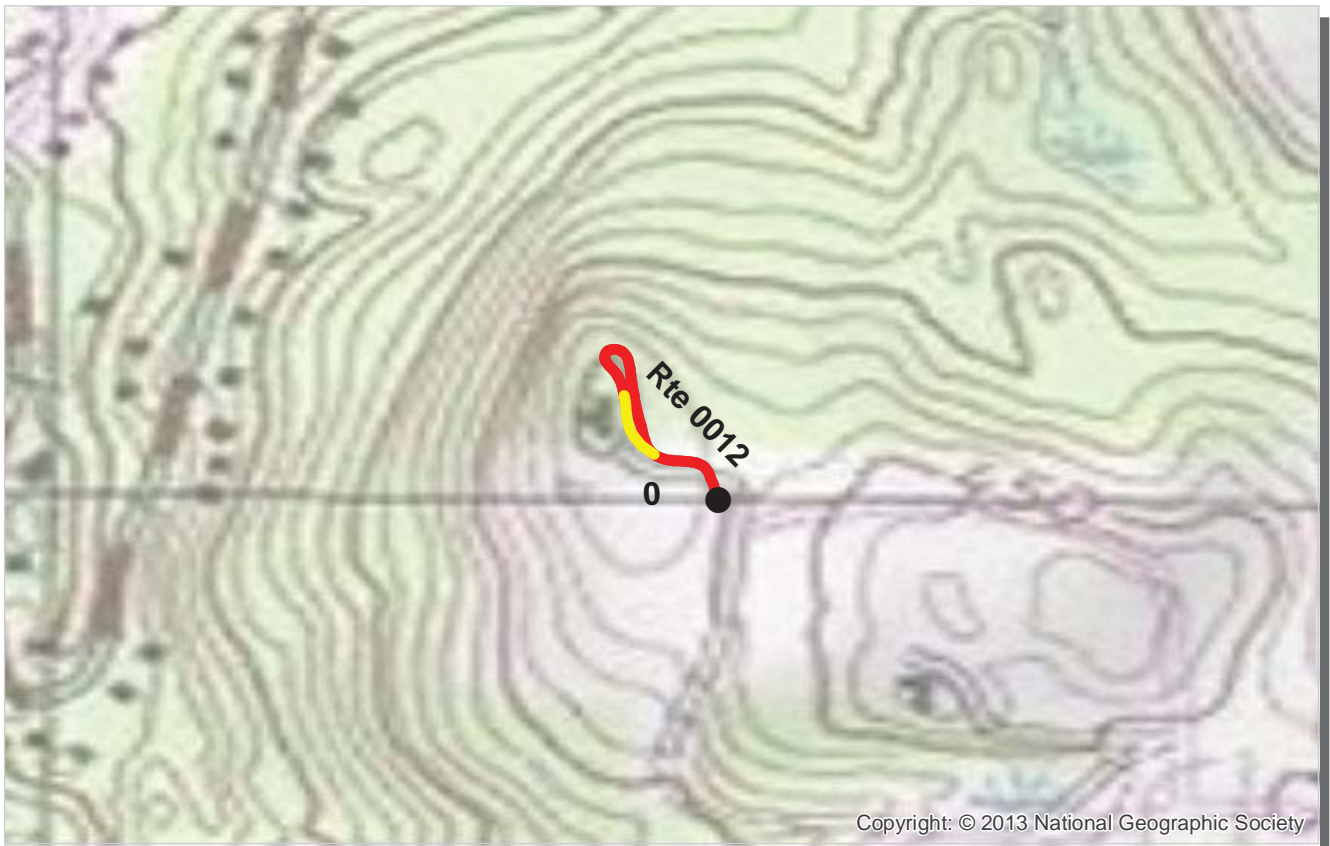
ROUTE: 0012 TOP COTTAGE ENTRANCE DRIVE

Section Number	0				
Section Length (mi)	0.15				
Cross Section Information					
Number of Lanes	1				
Paved Width (ft)	14				
Lane Width (ft)	9				
Roadway Condition Information					
SCR (Surface Condition Rating)	42				
PCR (Pavement Condition Rating)	42				
Distress Index Values					
Structural Crack Index	42				
Transverse Cracking Index	88				
Patching Index	99				
Rutting Index	77				
Roughness Condition Index (RCI)	NC

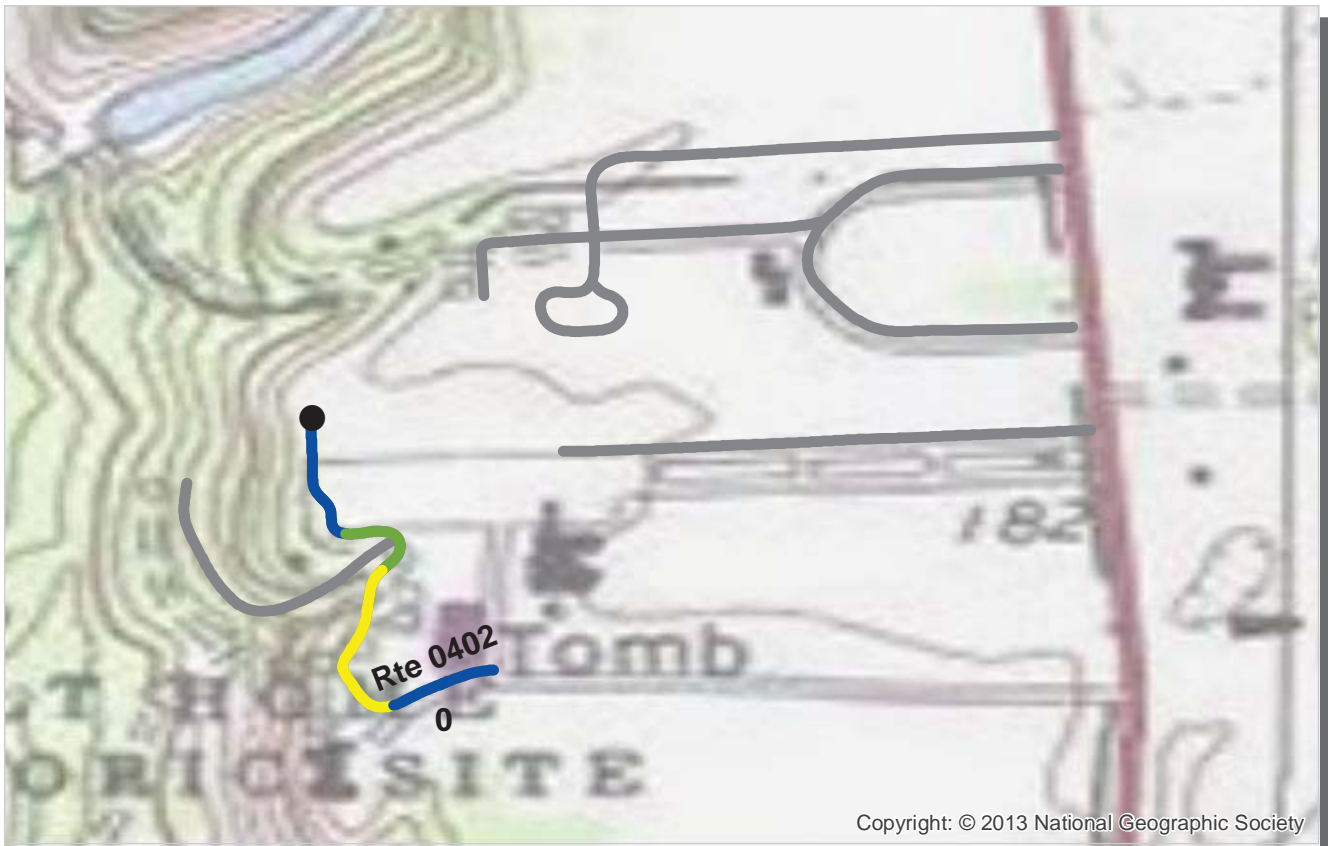
ROUTE: 0402 SERVICE ROAD

Section Number	0				
Section Length (mi)	0.22				
Cross Section Information					
Number of Lanes	1				
Paved Width (ft)	17				
Lane Width (ft)	17				
Roadway Condition Information					
SCR (Surface Condition Rating)	85				
PCR (Pavement Condition Rating)	85				
Distress Index Values					
Structural Crack Index	85				
Transverse Cracking Index	98				
Patching Index	99				
Rutting Index	98				
Roughness Condition Index (RCI)	NC

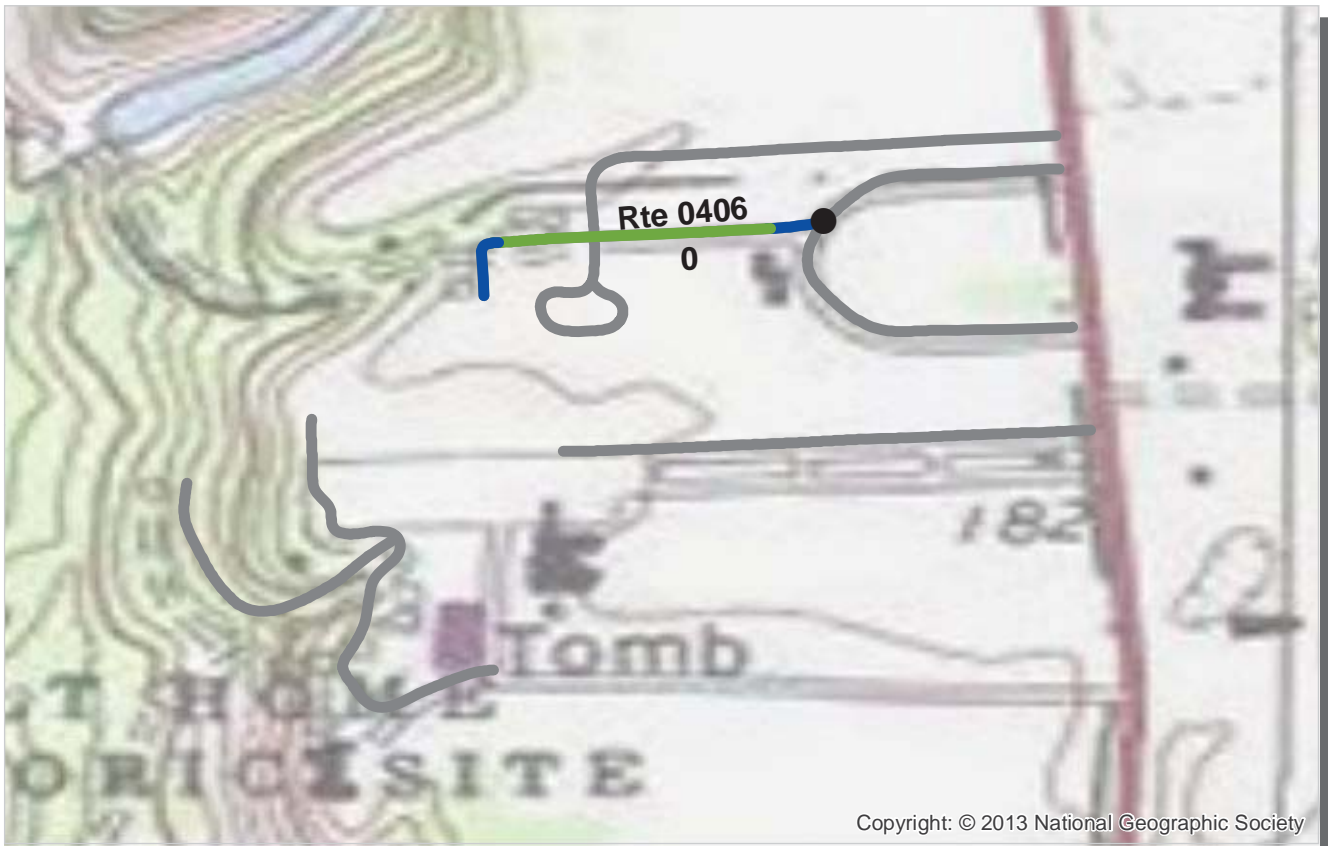
ROUTE: 0406 BELLEFIELD MANSION REAR SERVICE DRIVE

Section Number	0				
Section Length (mi)	0.15				
Cross Section Information					
Number of Lanes	2				
Paved Width (ft)	16				
Lane Width (ft)	8				
Roadway Condition Information					
SCR (Surface Condition Rating)	93				
PCR (Pavement Condition Rating)	93				
Distress Index Values					
Structural Crack Index	95				
Transverse Cracking Index	93				
Patching Index	100				
Rutting Index	98				
Roughness Condition Index (RCI)	NC

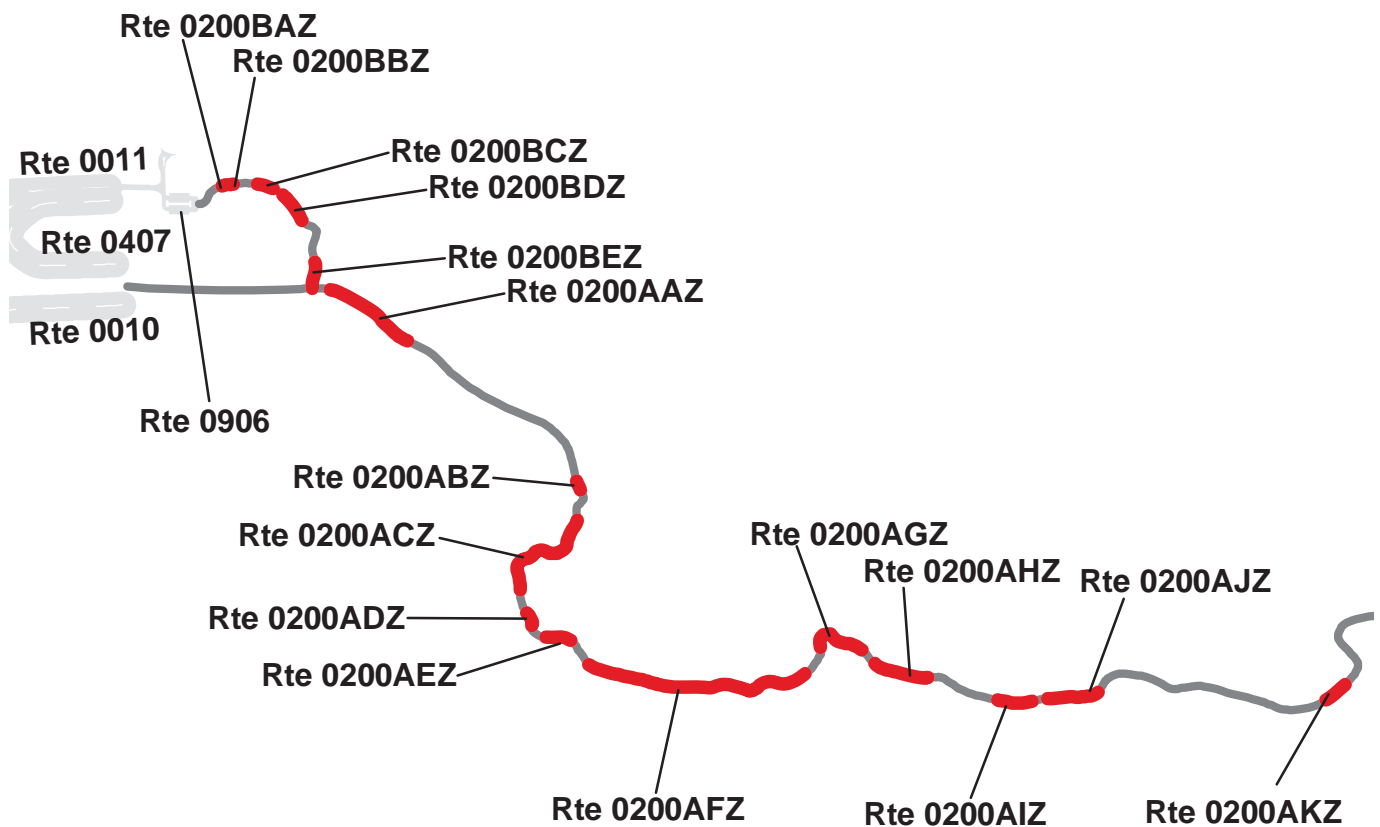
Route 0200AAZ

Route Number	Public / NonPublic	Date Visited	Area (sq ft)	Lane Miles *	Paved Length (mi)	Paved Width (ft)
0200AAZ	PUBLIC	7/1/2012	5,122	0.09	0.10	10
Culverts	Drop Inlets	Gates	Curb & Gutter	Curb	PCR	Surface Type
0	0	0	NO CURB AND GUTTER	NO CURB	FAIR/73	AS

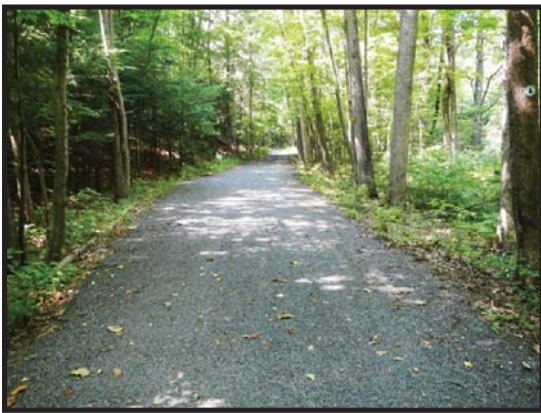
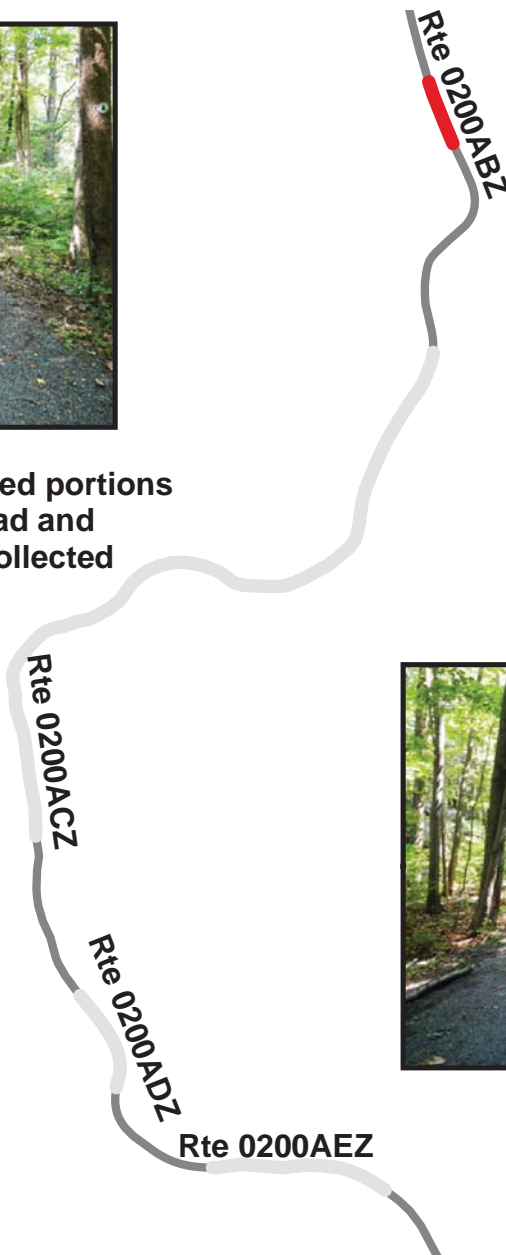
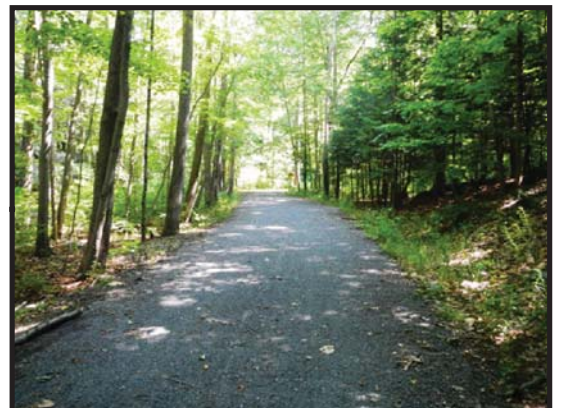
Route Number	Public / NonPublic	Date Visited	Area (sq ft)	Lane Miles *	Paved Length (mi)	Paved Width (ft)
0200ABZ	PUBLIC	7/1/2012	581	0.01	0.01	10
Culverts	Drop Inlets	Gates	Curb & Gutter	Curb	PCR	Surface Type
0	0	0	NO CURB AND GUTTER	NO CURB	FAIR/73	AS

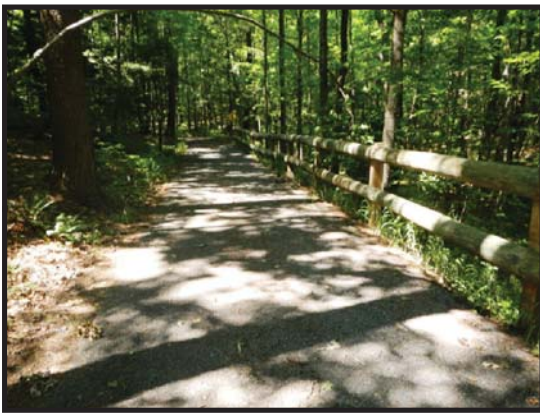
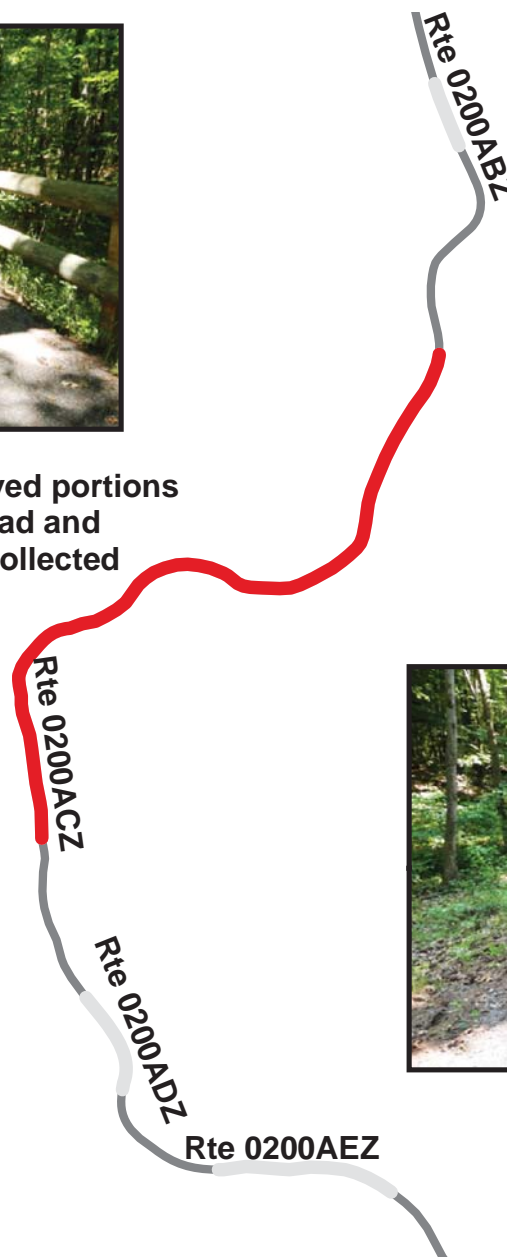
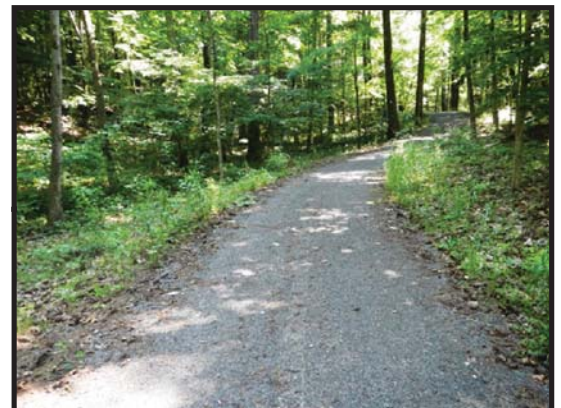
Route 0200ACZ

Route Number	Public / NonPublic	Date Visited	Area (sq ft)	Lane Miles *	Paved Length (mi)	Paved Width (ft)
0200ACZ	PUBLIC	7/1/2012	5,845	0.10	0.12	9
Culverts	Drop Inlets	Gates	Curb & Gutter	Curb	PCR	Surface Type
0	0	0	NO CURB AND GUTTER	NO CURB	FAIR/73	AS

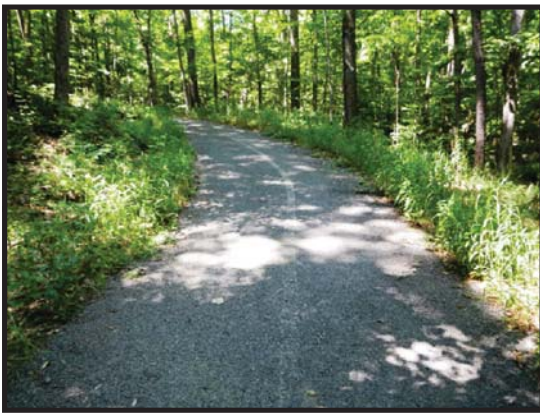
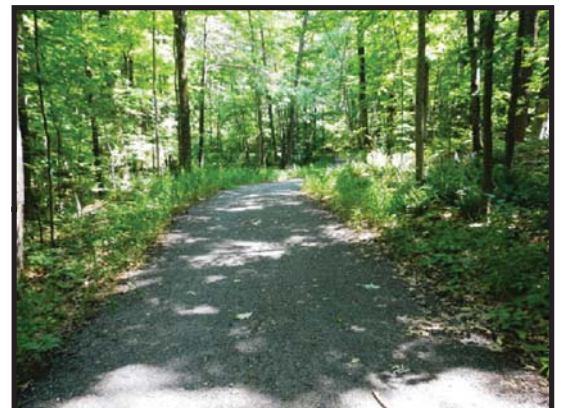
Route 0200ADZ

Route Number	Public / NonPublic	Date Visited	Area (sq ft)	Lane Miles *	Paved Length (mi)	Paved Width (ft)
0200ADZ	PUBLIC	7/1/2012	760	0.01	0.02	8
Culverts	Drop Inlets	Gates	Curb & Gutter	Curb	PCR	Surface Type
0	0	0	NO CURB AND GUTTER	NO CURB	FAIR/73	AS

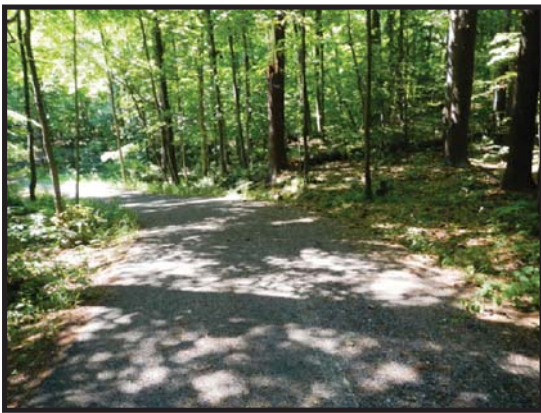
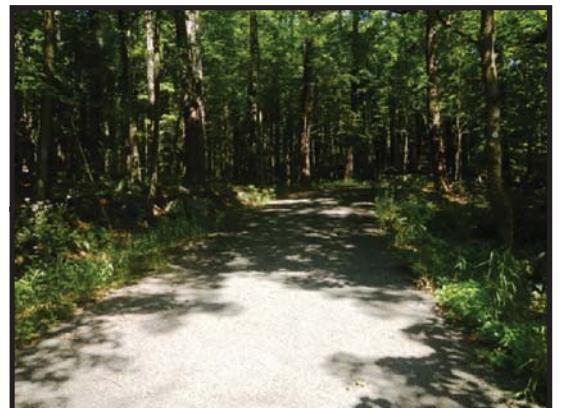
Route 0200AEZ

Route Number	Public / NonPublic	Date Visited	Area (sq ft)	Lane Miles *	Paved Length (mi)	Paved Width (ft)
0200AEZ	PUBLIC	7/1/2012	1,267	0.02	0.02	10
Culverts	Drop Inlets	Gates	Curb & Gutter	Curb	PCR	Surface Type
1	0	0	NO CURB AND GUTTER	NO CURB	POOR/45	AS

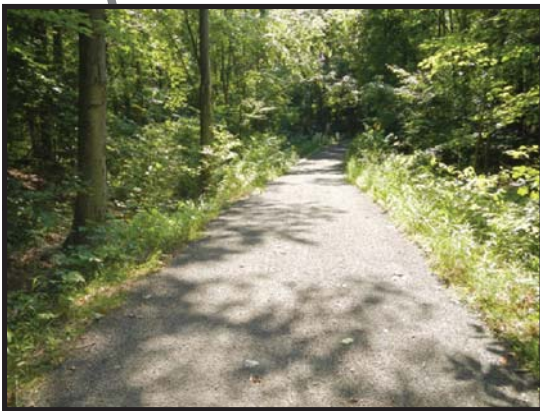
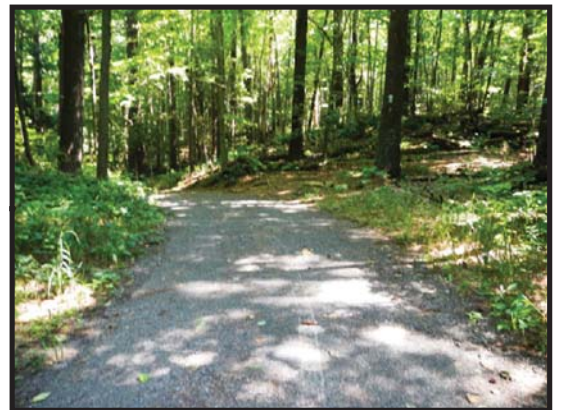
Route 0200AFZ

Route Number	Public / NonPublic	Date Visited	Area (sq ft)	Lane Miles *	Paved Length (mi)	Paved Width (ft)
0200AFZ	PUBLIC	7/1/2012	9,124	0.16	0.22	8
Culverts	Drop Inlets	Gates	Curb & Gutter	Curb	PCR	Surface Type
2	0	0	NO CURB AND GUTTER	NO CURB	FAIR/73	AS

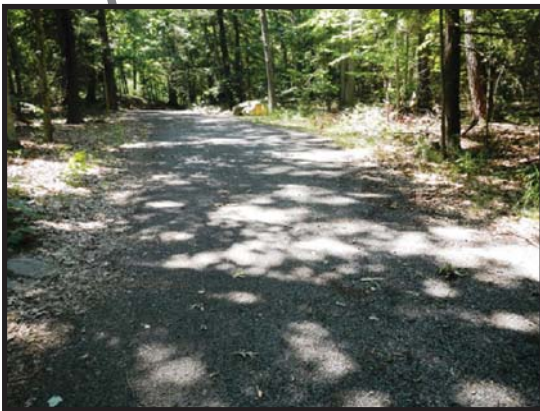
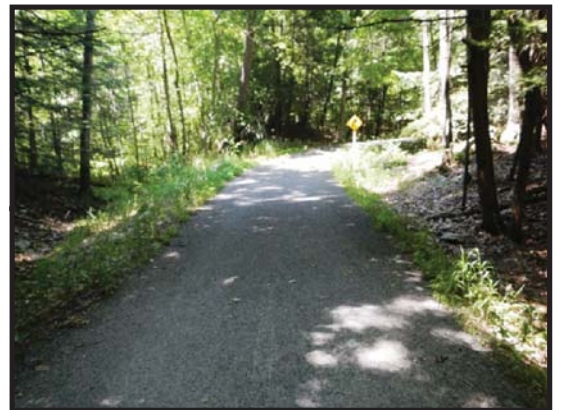
Route 0200AGZ

Route Number	Public / NonPublic	Date Visited	Area (sq ft)	Lane Miles *	Paved Length (mi)	Paved Width (ft)
0200AGZ	PUBLIC	7/1/2012	3,485	0.06	0.06	11
Culverts	Drop Inlets	Gates	Curb & Gutter	Curb	PCR	Surface Type
0	0	0	NO CURB AND GUTTER	NO CURB	POOR/45	AS

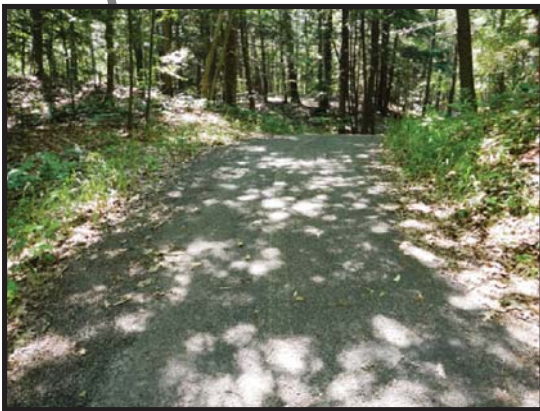
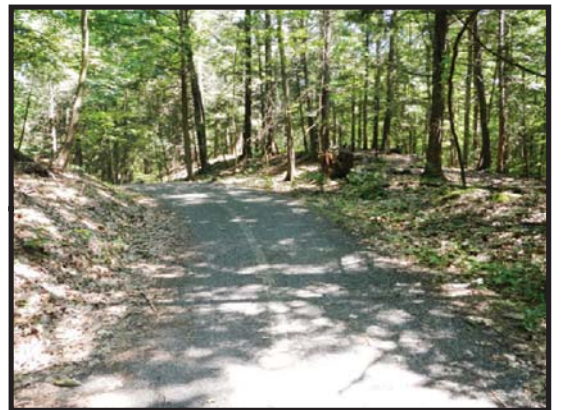
Route 0200AHZ

Route Number	Public / NonPublic	Date Visited	Area (sq ft)	Lane Miles *	Paved Length (mi)	Paved Width (ft)
0200AHZ	PUBLIC	7/1/2012	2,281	0.04	0.05	8
Culverts	Drop Inlets	Gates	Curb & Gutter	Curb	PCR	Surface Type
0	0	0	NO CURB AND GUTTER	NO CURB	GOOD/90	AS

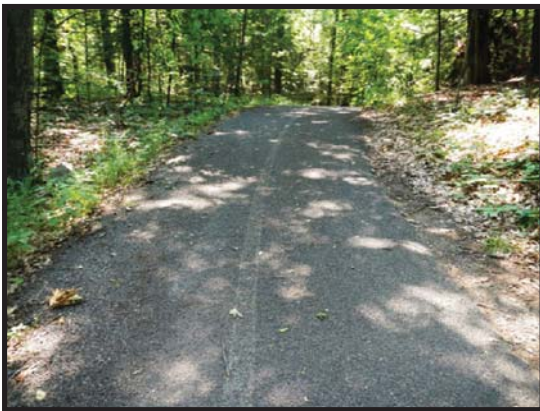
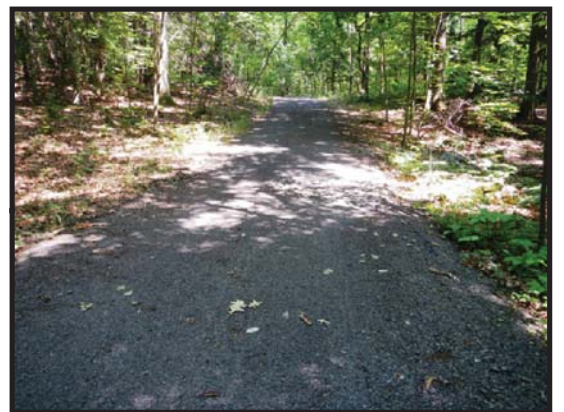
Route 0200AIZ

Route Number	Public / NonPublic	Date Visited	Area (sq ft)	Lane Miles *	Paved Length (mi)	Paved Width (ft)
0200AIZ	PUBLIC	7/1/2012	1,352	0.02	0.03	8
Culverts	Drop Inlets	Gates	Curb & Gutter	Curb	PCR	Surface Type
0	0	0	NO CURB AND GUTTER	NO CURB	GOOD/90	AS

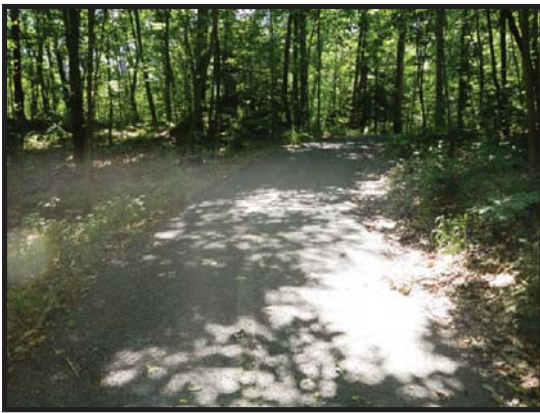
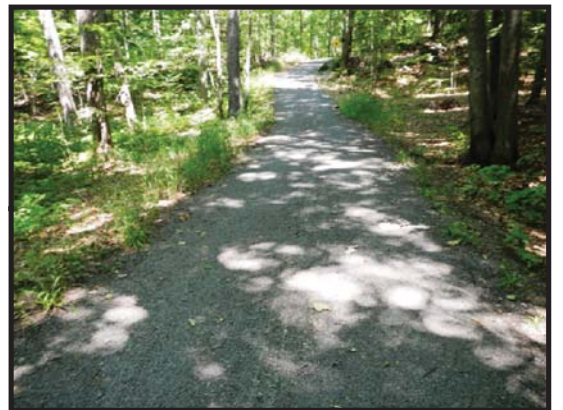
Route 0200AJZ

Route Number	Public / NonPublic	Date Visited	Area (sq ft)	Lane Miles *	Paved Length (mi)	Paved Width (ft)
0200AJZ	PUBLIC	7/1/2012	2,070	0.04	0.05	8
Culverts	Drop Inlets	Gates	Curb & Gutter	Curb	PCR	Surface Type
0	0	0	NO CURB AND GUTTER	NO CURB	GOOD/90	AS

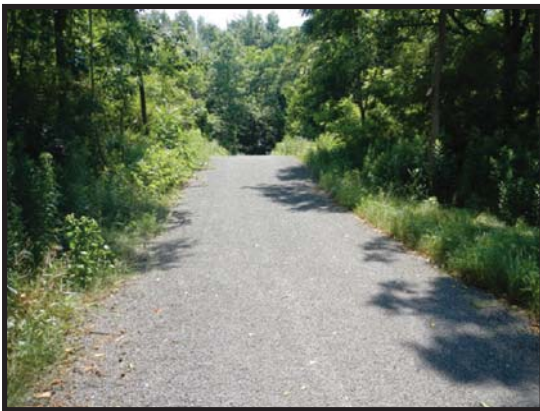
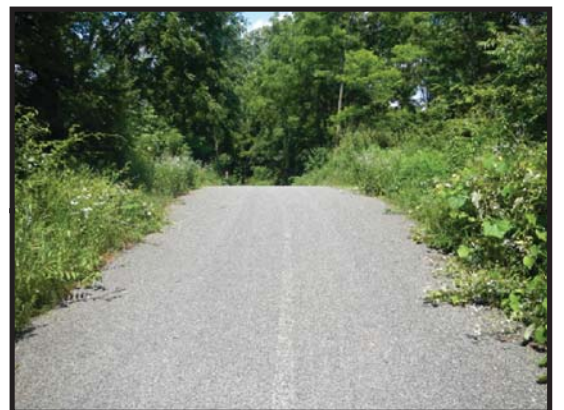
Route 0200AKZ

Route Number	Public / NonPublic	Date Visited	Area (sq ft)	Lane Miles *	Paved Length (mi)	Paved Width (ft)
0200AKZ	PUBLIC	7/1/2012	1,098	0.02	0.03	8
Culverts	Drop Inlets	Gates	Curb & Gutter	Curb	PCR	Surface Type
0	0	0	NO CURB AND GUTTER	NO CURB	FAIR/73	AS

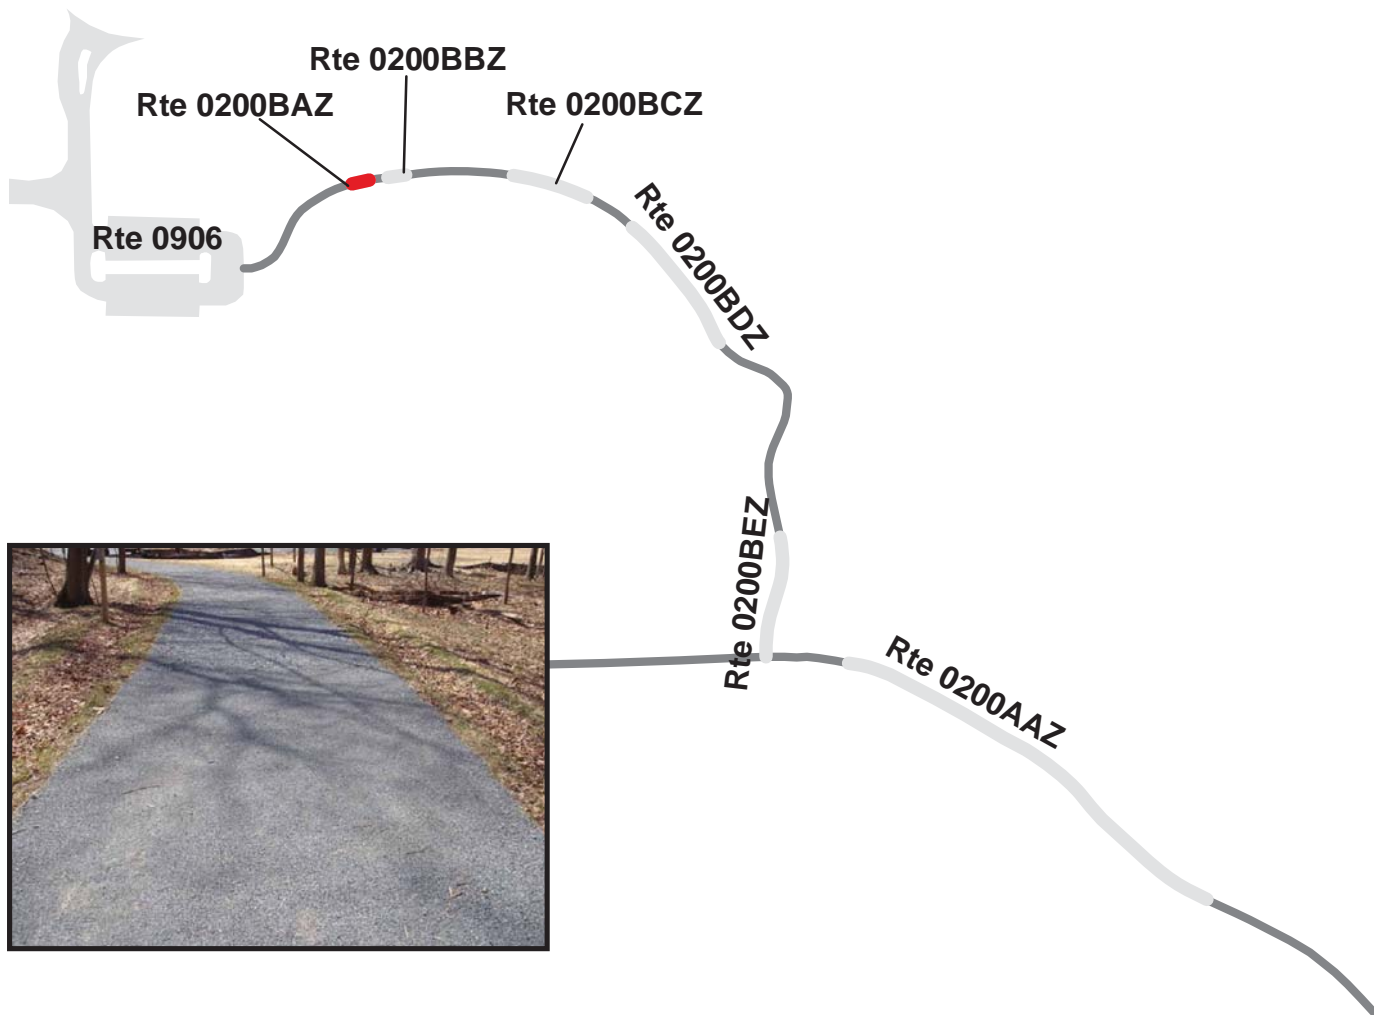
Route 0200BAZ

Route Number	Public / NonPublic	Date Visited	Area (sq ft)	Lane Miles *	Paved Length (mi)	Paved Width (ft)
0200BAZ	PUBLIC	4/9/2013	211	0.00	0.00	10
Culverts	Drop Inlets	Gates	Curb & Gutter	Curb	PCR	Surface Type
0	0	0	NO CURB AND GUTTER	NO CURB	EXCELLENT/97	AS

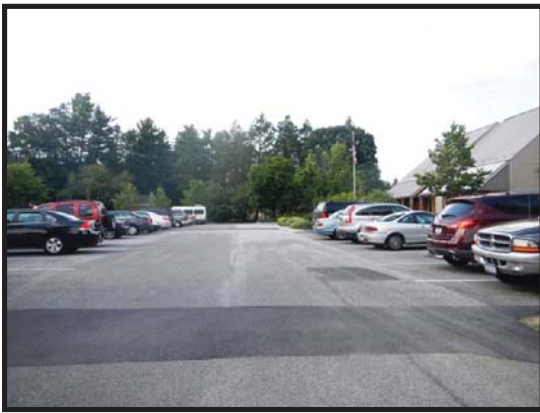
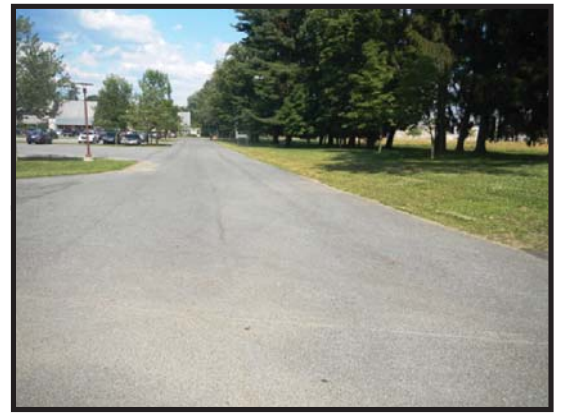
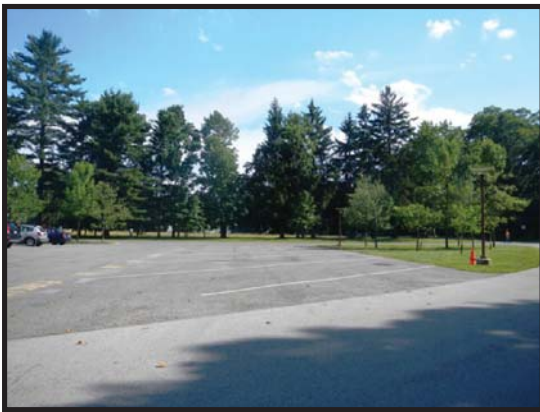
Route Number	Public / NonPublic	Date Visited	Area (sq ft)	Lane Miles *	Surface Type
0901	PUBLIC	7/1/2012	78,269	1.35	AS
Culverts	Drop Inlets	Gates	Curb & Gutter	Curb	PCR
0	10	0	NO CURB AND GUTTER	STONE CURB	GOOD/90

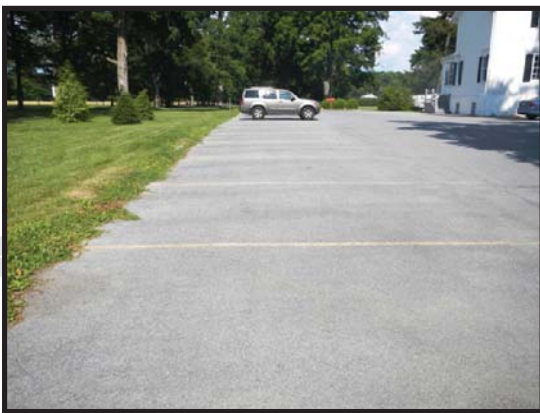
Route 0903A

Route Number	Public / NonPublic	Date Visited	Area (sq ft)	Lane Miles *	Surface Type
0903A	PUBLIC	7/1/2012	2,715	0.05	AS
Culverts	Drop Inlets	Gates	Curb & Gutter	Curb	PCR
0	0	0	NO CURB AND GUTTER	NO CURB	GOOD/90

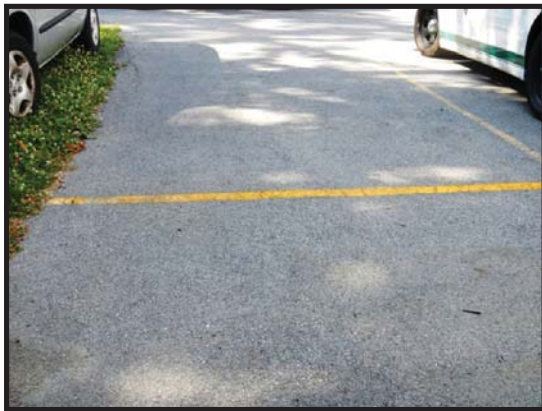
Route Number	Public / NonPublic	Date Visited	Area (sq ft)	Lane Miles *	Surface Type
0903B	PUBLIC	7/1/2012	1,095	0.02	AS
Culverts	Drop Inlets	Gates	Curb & Gutter	Curb	PCR
0	0	0	NO CURB AND GUTTER	NO CURB	GOOD/90

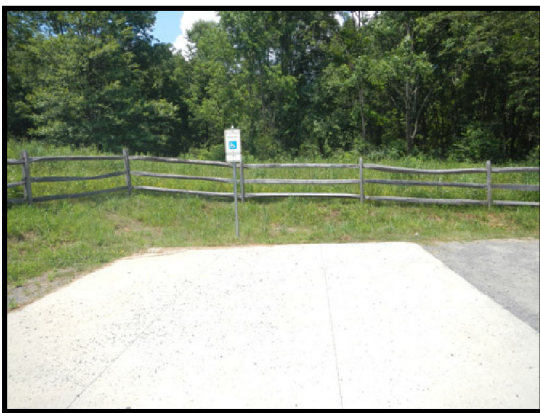
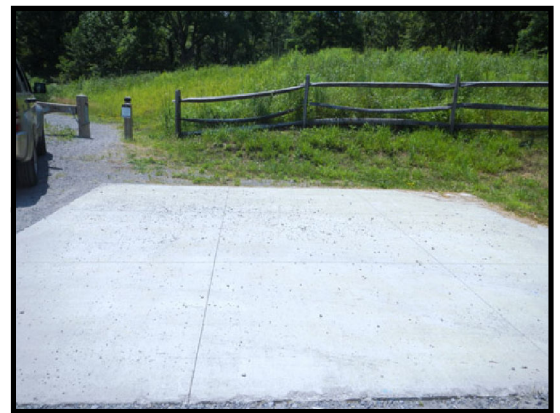
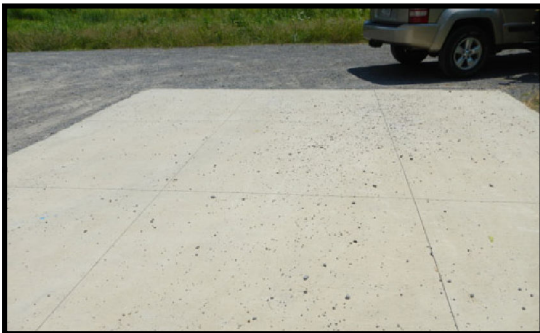
Route Number	Public / NonPublic	Date Visited	Area (sq ft)	Lane Miles *	Surface Type
0905	PUBLIC	7/1/2012	289	0.01	AS
Culverts	Drop Inlets	Gates	Curb & Gutter	Curb	PCR
0	0	0	NO CURB AND GUTTER	NO CURB	GOOD/90

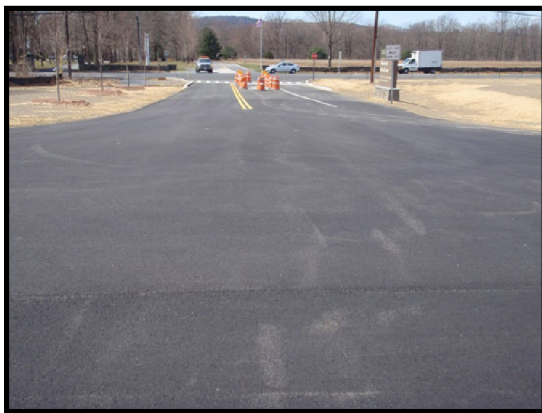
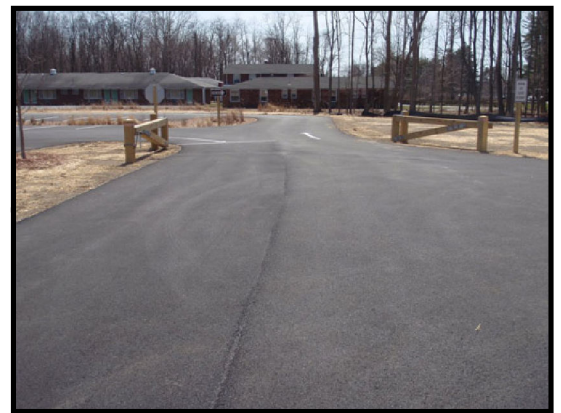
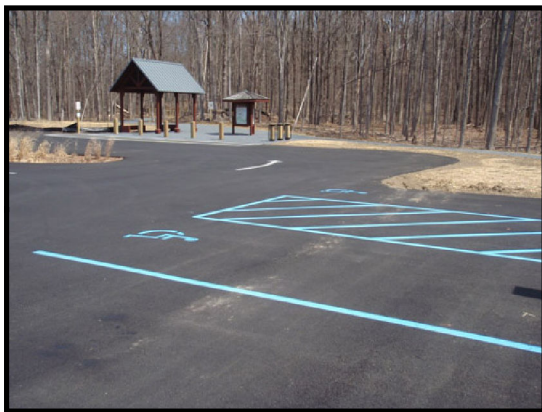
Route 0906

Route Number	Public / NonPublic	Date Visited	Area (sq ft)	Lane Miles *	Surface Type
0906	PUBLIC	4/9/2013	35,240	0.61	AS
Culverts	Drop Inlets	Gates	Curb & Gutter	Curb	PCR
0	0	1	NO CURB AND GUTTER	CONCRETE CURB	EXCELLENT/97
