# Federal Lands Highway Road Inventory Program

Road Inventory and Condition Assessment

## Hopewell Furnace National Historic Site HOFU

### Cycle 5 Report

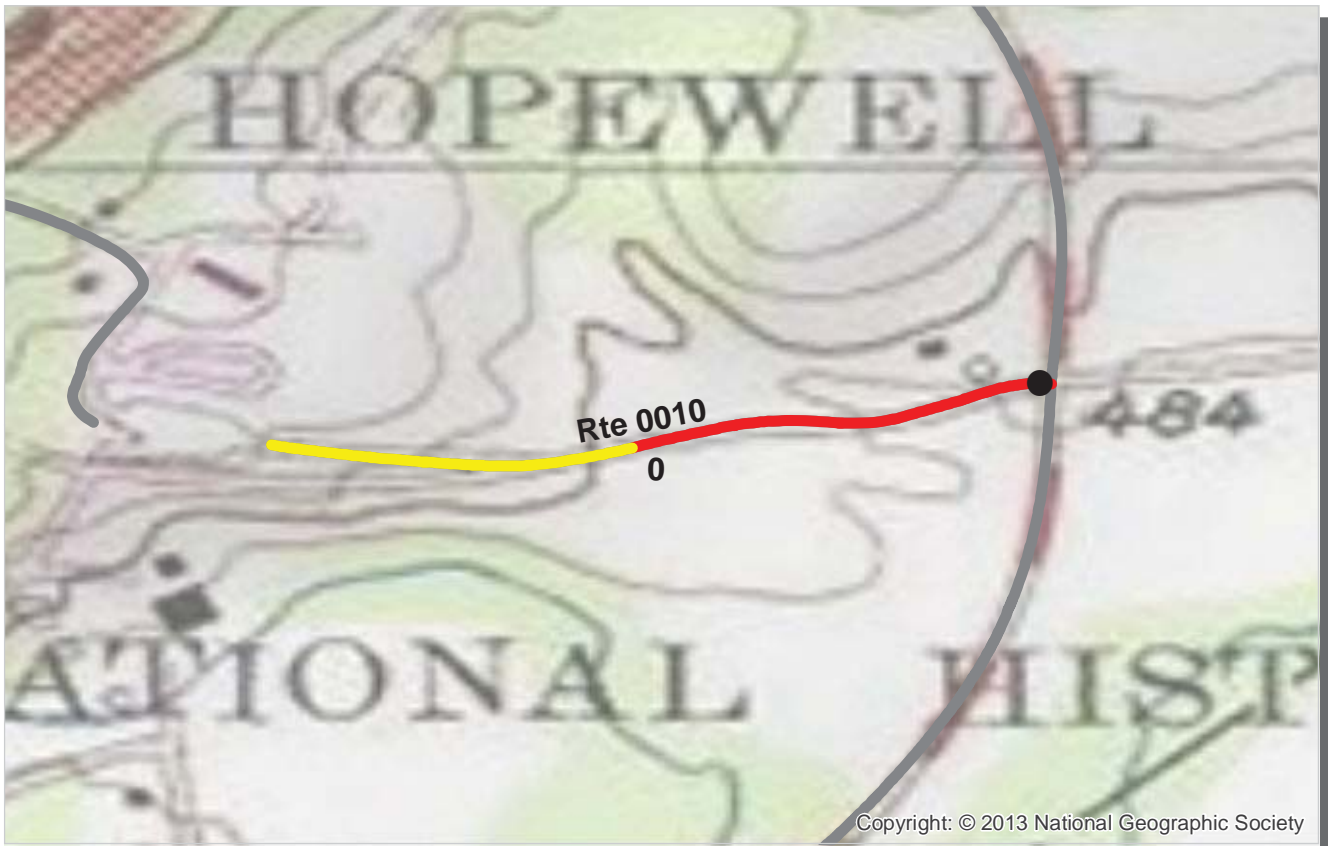
**ROUTE: 0010 ENTRANCE ROAD**

<b>Section Number</b>	0				
<b>Section Length (mi)</b>	0.30				
<b>Cross Section Information</b>					
Number of Lanes	2				
Paved Width (ft)	17				
Lane Width (ft)	8				
<b>Roadway Condition Information</b>					
SCR (Surface Condition Rating)	64				
PCR (Pavement Condition Rating)	64				
<b>Distress Index Values</b>					
Structural Crack Index	64				
Transverse Cracking Index	73				
Patching Index	100				
Rutting Index	99				
Roughness Condition Index (RCI)	NC

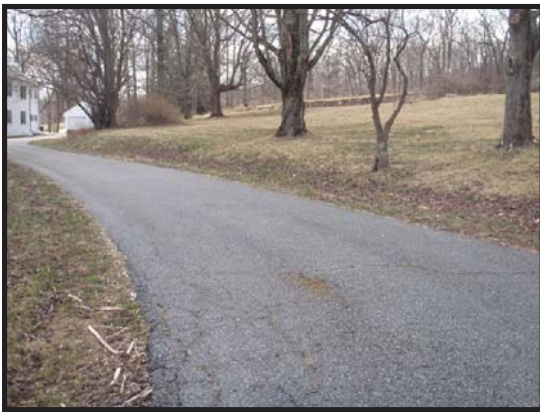
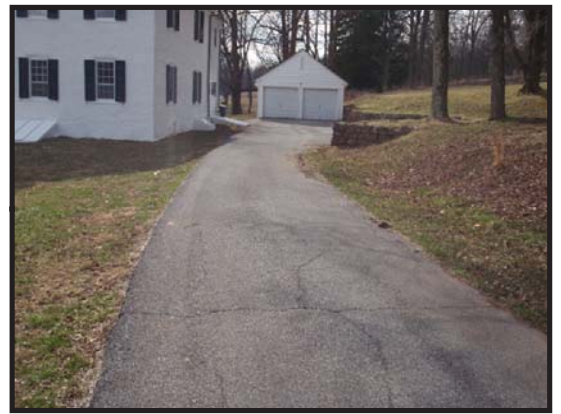
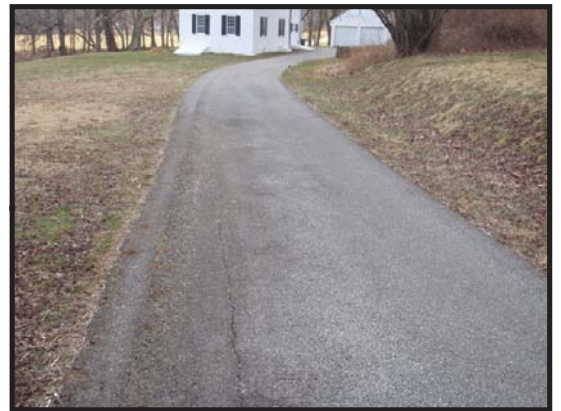
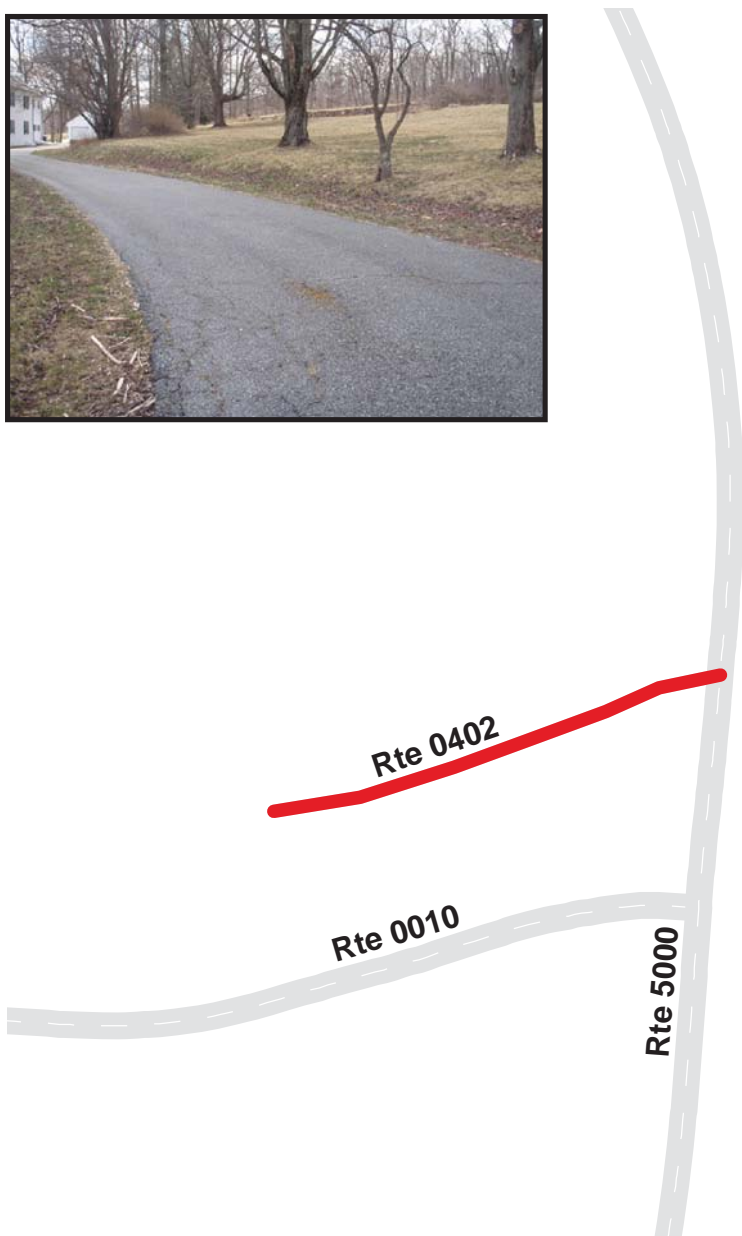
Route Number	Public / NonPublic	Date Visited	Area (sq ft)	Lane Miles *	Paved Length (mi)	Paved Width (ft)
0402	NONPUBLIC	4/3/2013	3,062	0.05	0.06	10
Culverts	Drop Inlets	Gates	Curb & Gutter	Curb	PCR	Surface Type
1	0	0	NO CURB AND GUTTER	NO CURB	POOR/45	AS

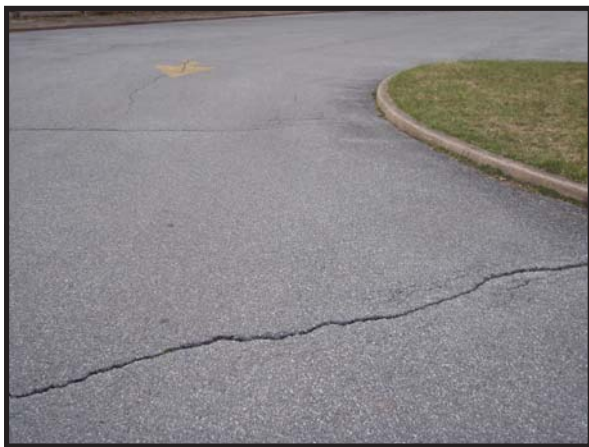
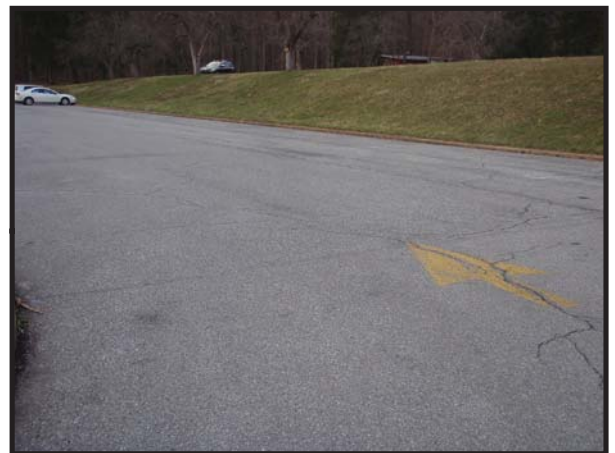
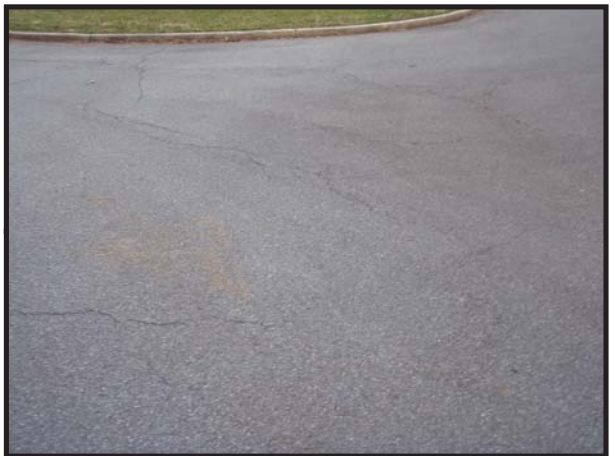
Route Number	Public / NonPublic	Date Visited	Area (sq ft)	Lane Miles *	Surface Type
0900	PUBLIC	4/3/2013	29,689	0.51	AS
Culverts	Drop Inlets	Gates	Curb & Gutter	Curb	PCR
0	1	0	NO CURB AND GUTTER	CONCRETE CURB	POOR/45

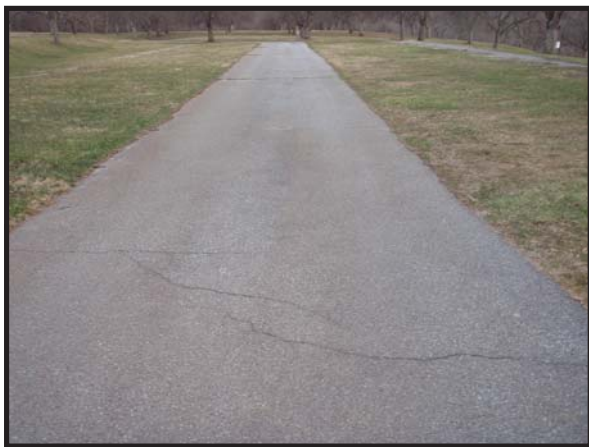
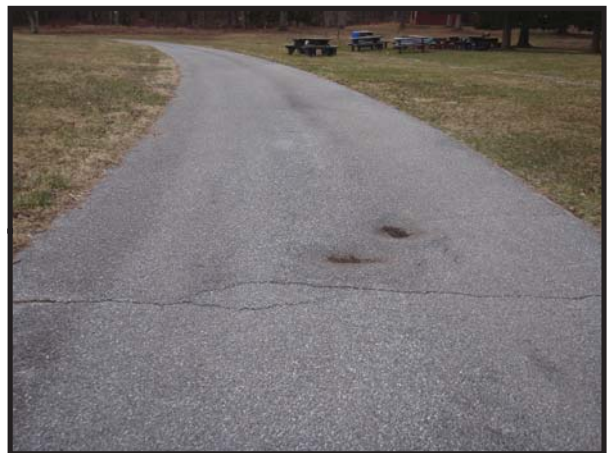
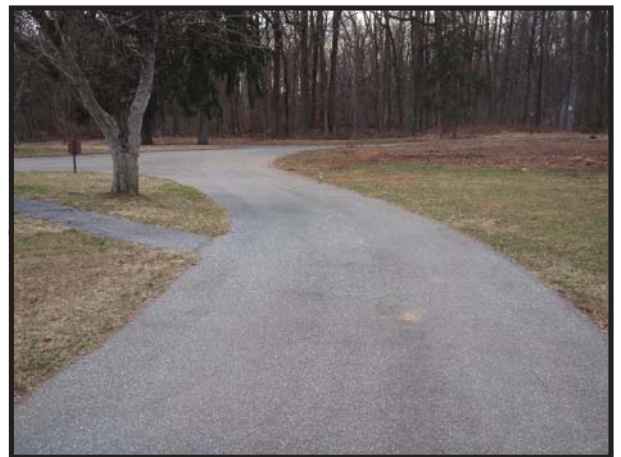
## Route 0901

Route Number	Public / NonPublic	Date Visited	Area (sq ft)	Lane Miles *	Surface Type
0901	PUBLIC	4/3/2013	9,250	0.16	AS
Culverts	Drop Inlets	Gates	Curb & Gutter	Curb	PCR
0	0	0	NO CURB AND GUTTER	CONCRETE CURB	FAIR/73

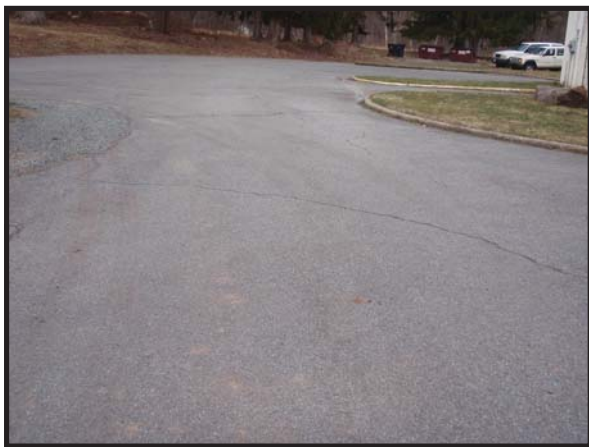
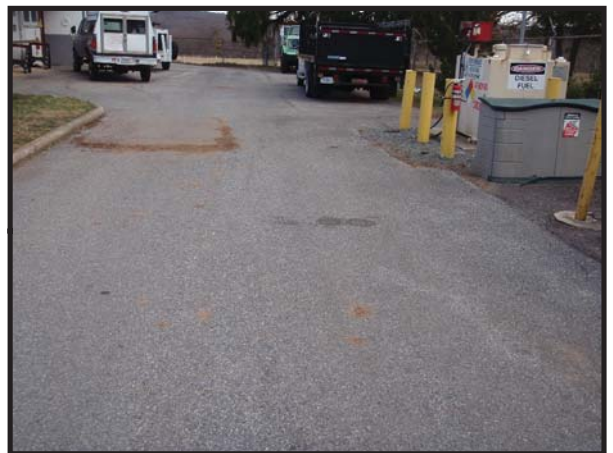
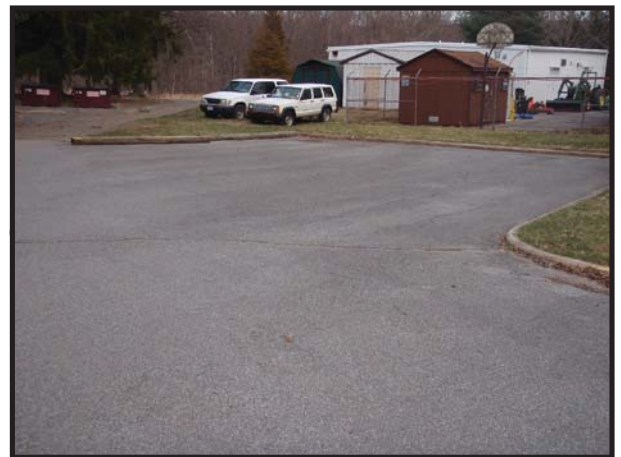
## Route 0903

Route Number	Public / NonPublic	Date Visited	Area (sq ft)	Lane Miles *	Surface Type
0903	NONPUBLIC	4/3/2013	16,647	0.29	AS
Culverts	Drop Inlets	Gates	Curb & Gutter	Curb	PCR
0	2	1	NO CURB AND GUTTER	CONCRETE CURB	POOR/45
